Soil/Structure Interaction of Temporary Roadways

Andrew Steven Lees

A thesis submitted for the
degree of Doctor of Philosophy

Department of Civil &
Environmental Engineering

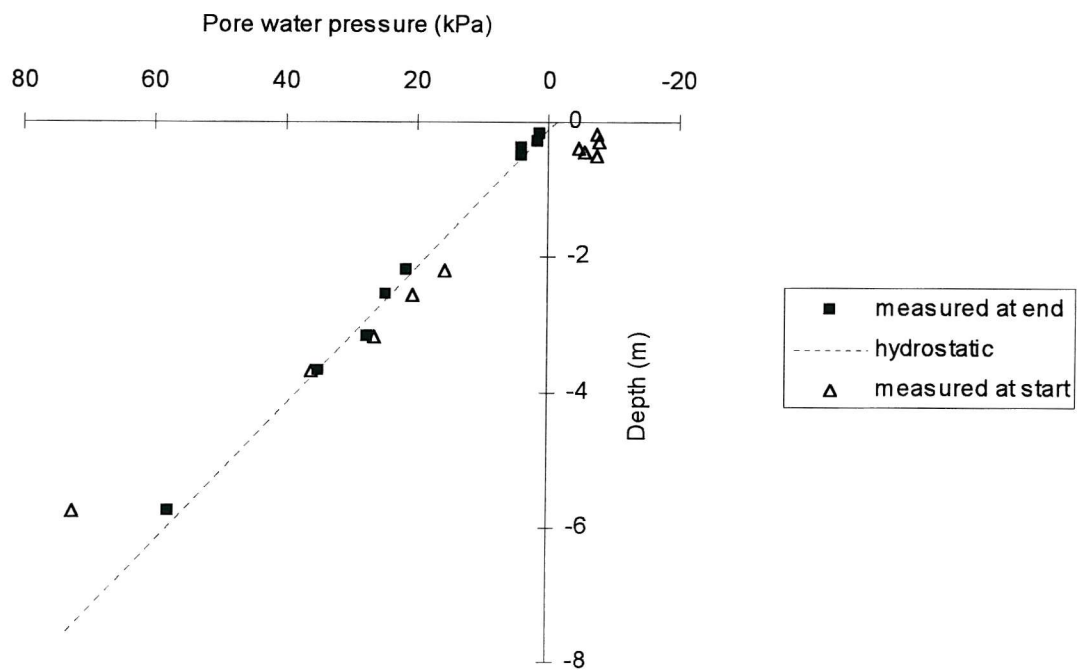
Figure 3.7: Pore water pressure profiles during re-consolidation
