SOLID PARTICLE EROSION OF CVD DIAMOND COATINGS

David William Wheeler

Thesis submitted for the degree of Doctor of Philosophy

January 2001

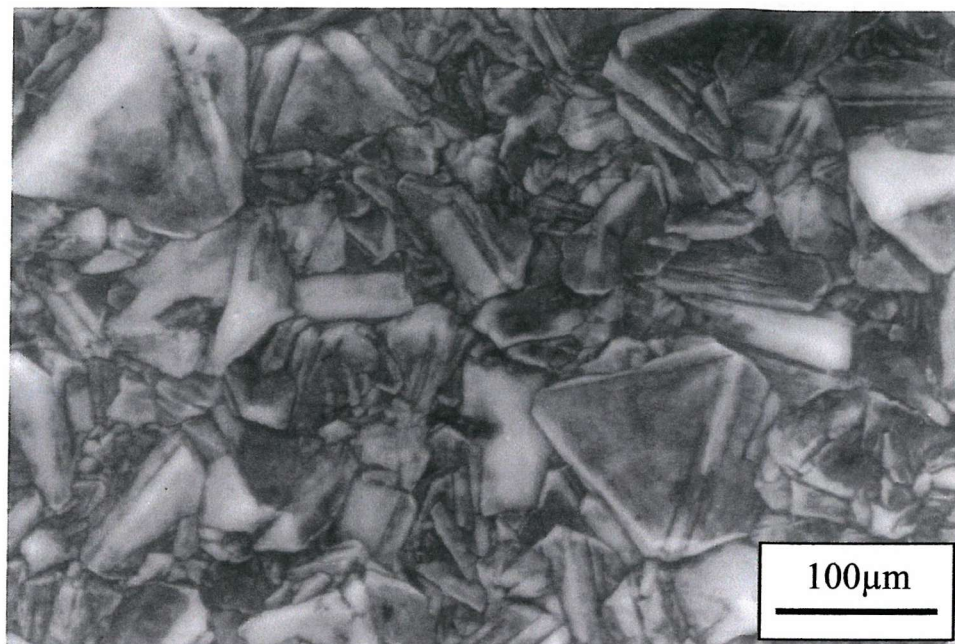
Fig. 3.6: As-grown surface of a 165 μm CVD diamond film on WC-6Co.

At the end of the deposition process the surface of the coating has an appearance like that shown in Figure 3.6. It shows the grains to have an essentially random orientation, though under conditions diamond films can be grown with a specific crystallographic texture, for instance on the (100) or (111) planes.

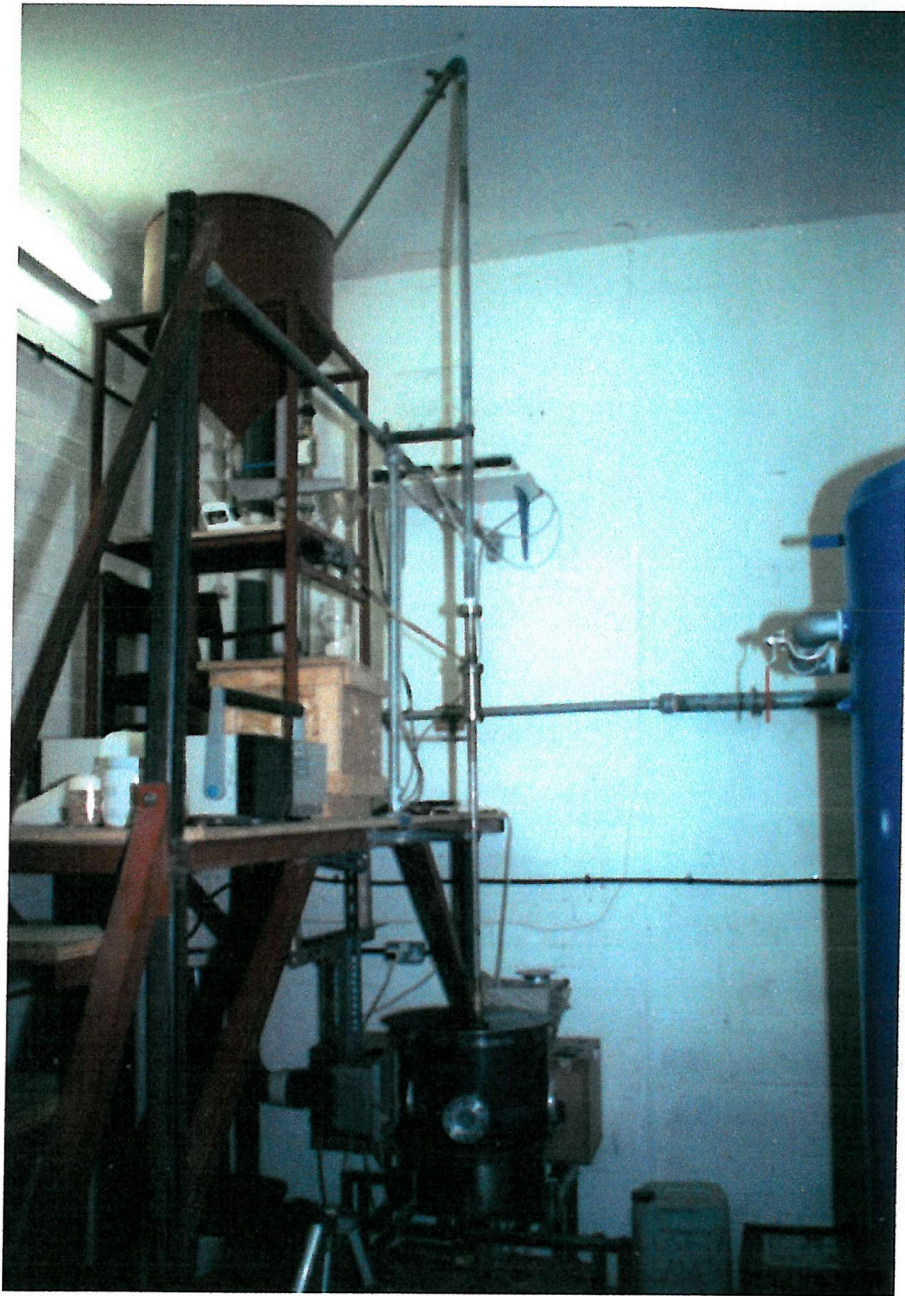
Fig. 5.2: Photograph of the air-sand erosion rig, showing the erosion chamber (bottom, centre), the sand injection nozzle (centre), the sand hopper (top, left) and the air reservoir (extreme right).

A schematic diagram of the main constituents of the rig can be seen in Figure 5.1 and a photograph is shown in Figure 5.2. The rig specification is also listed in Table 5.2. The air is supplied by a 30 kW rotary screw compressor, capable of a maximum output of $380 \text{ m}^3 \text{ hr}^{-1}$ at a pressure of 7 bar g, and then fed through a two-column desiccant dryer. This lowers the dew point to -70°C . After passing through a receiver, a flow regulator and a flow meter, sand is injected into the air-stream in a sand injection chamber. The sand injector is fed by means of a vibratory feeder and hopper arrangement. The vibratory feeder supplies the sand into a split funnel, the position of which can be altered relative to the position of the feeder, to control the amount of injected sand. This air-sand mixture is subsequently accelerated down a type 316 stainless steel tube, 16mm diameter and 1 metre in length, before entering an enclosed erosion chamber where it strikes the test specimen before leaving the chamber. The rig was designed with aid of Computational Fluid Dynamics (CFD), which provided information on the optimum nozzle / bore diameters and particle acceleration length required. Within the erosion chamber, the impact angle between the particles and the sample can be varied from 90° to 20° . The nozzle to sample stand-off distance can also be varied, the range being between 20 and 100 mm. The test sample is held in place by means of a vacuum pump. The sand is not recycled and large particles collect in the base of the erosion

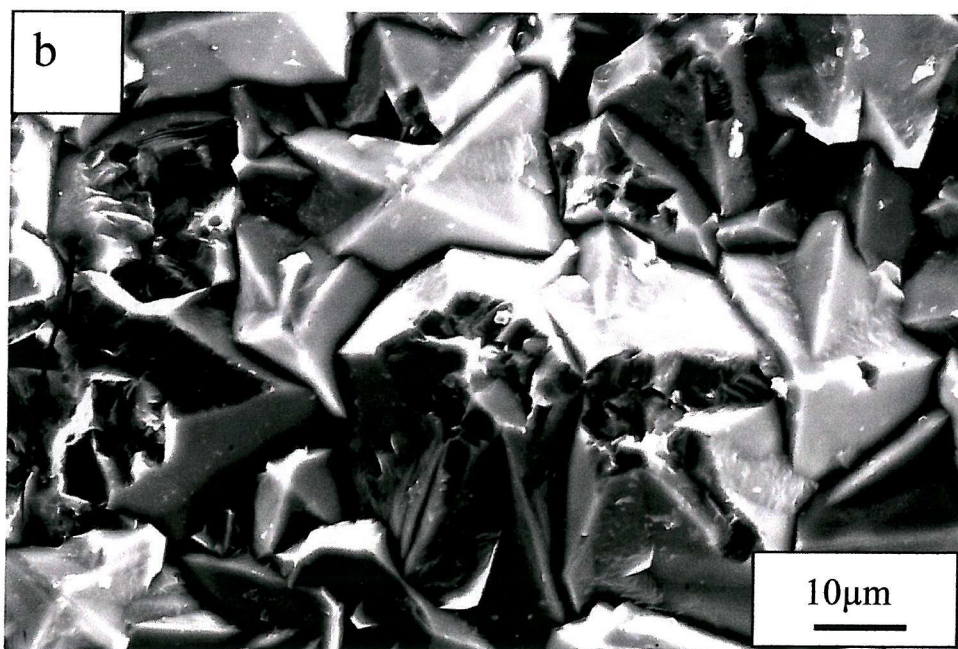
Fig. 8.9: Micrographs of an as-grown 90µm CVD diamond coating on tungsten showing (a) the untested surface and (b) the eroded surface after 1 hour at 268 m s⁻¹.

During Stage 1, the most prominent areas of the coating surface are removed by a micro-chipping action. This occurs both on lapped, as well as as-grown, coatings, though in the former case it is on a much smaller scale. In general, this stage does not account for a significant percentage of the overall coating life. An example of the chipping features can be seen in Figure 8.8, which shows the lapped surface of a 120 μm coating after four hours at 268 m s^{-1} . The untested surface is also included for comparison. Figure 8.9 shows the equivalent micrographs for an as-grown 90 μm coating.

Surface micro chipping is the main contributor to the steady state erosion rate of the coatings; examples of this type of damage have already been shown in Figures 8.8 and 8.9. It is the only feature of note on the surface of the diamond prior to the advent of the circumferential cracks and pin-holes. Erosion studies of other brittle materials have often reported radial and lateral cracks, which have not been seen in the present case. In order to understand the reasons for this it is necessary to consider the nature of the erodent and the target materials.

The appearance of a newly formed circumferential crack can also provide clues in determining the nature of the event that precipitated its formation. As can be seen in Figure 8.9, the newly formed circumferential cracks are often discontinuous, rather than a complete ring, or even a complete partial ring. This is significant because it supports the argument that stress waves are responsible. These types of features produced by liquid impact tend to be short and discontinuous owing to the short

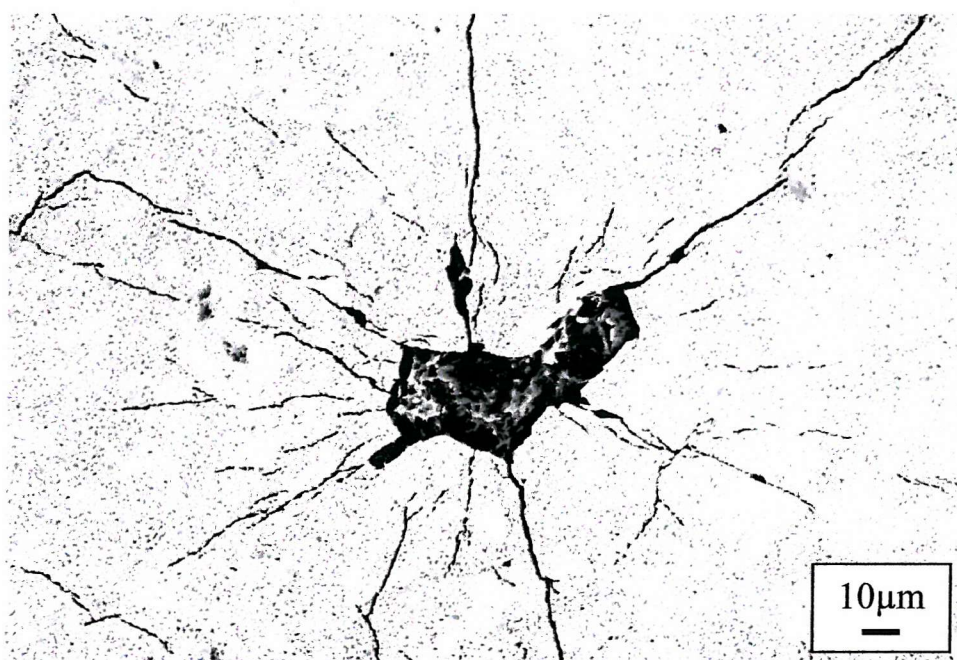
Fig. 10.12: Micrograph of the nucleation surface of the same sample as Figures 10.7 and 10.8, showing cracks propagating away from tungsten-free areas, which were thought to be delaminated regions of the coating prior to dissolution of the substrate.

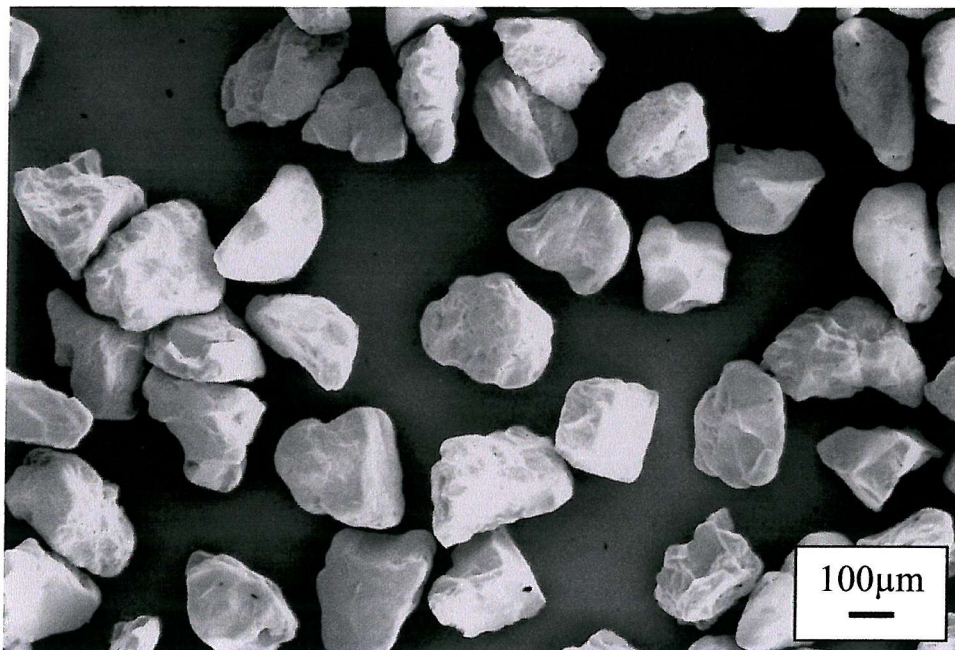
Fig. 11.14: Micrograph of unused 180-250µm sand.

One aspect of the impact conditions that has not been considered is that of particle morphology. The shape of sand particles is known to vary with size. Smaller diameter particles are predominantly angular while larger particles assume a more spherical morphology. Table 11.7 below lists the characteristics of the sand used in the present tests. Micrographs of the four erodent sizes are shown in Figures 11.13 to 11.16.
