Thesis: Luis Vicente Wilches Peña (2018) "Microstructural Alterations During HPT Tests on Annealed 52100 Bearing Steel", University of Southampton, Faculty of Engineering and Physical Sciences, School of Engineering, PhD Thesis, 196 p.

## Microstructural Alterations During HPT Tests on Annealed 52100 Bearing Steel

Thesis for the degree of Doctor of Philosophy

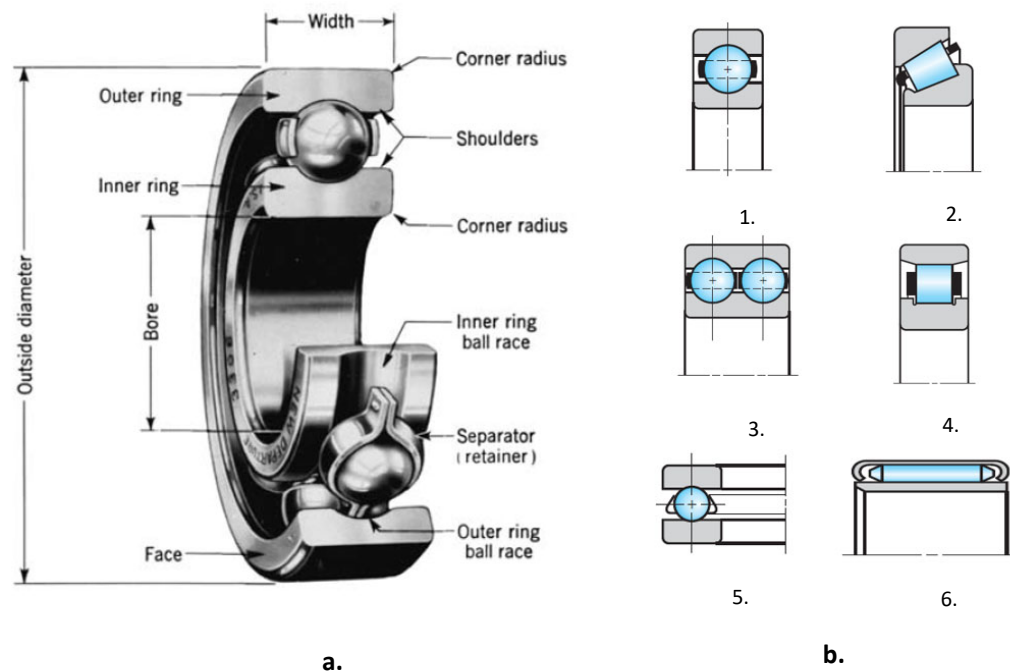
Figure 2-1 Rolling bearing schematic configurations. a) Elements assembled in a typical deep groove bearing. b) Different standard bearing types used according to the load requirements: 1. Deep groove single balls, 2. Steep tapered angle roller, 3. Double row balls, 4. Straight roller, 5. Pure thrust roller ball, 6. Needle roller. Adapted from [17].

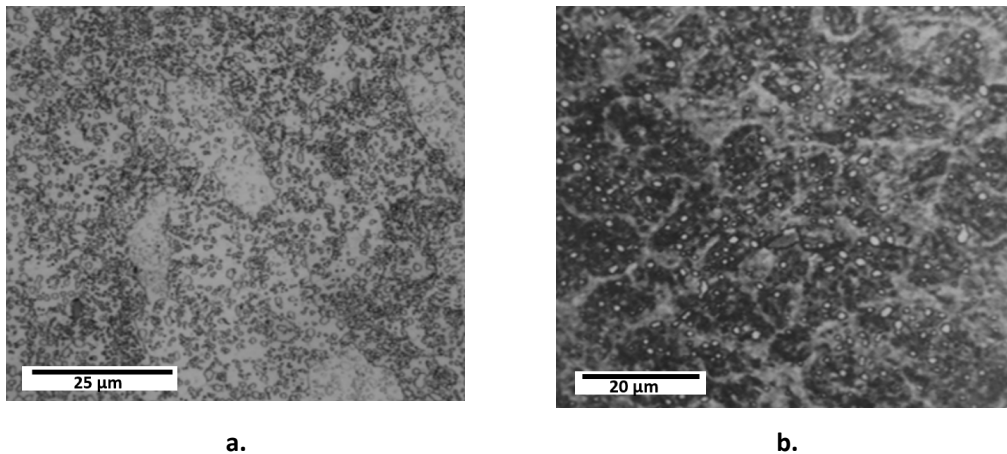
Figure 2-2 Microstructures of AISI 52100 in its delivery states. a) Spheroidized state, the small dots are carbides in a ferritic matrix.[22]. b) Hardened state: austenitised for 30 minutes at 845°C, oil quenched, and tempered 1 h at 175°C. The white dots are spheroidized cementite carbides in a tempered martensite structure [24].

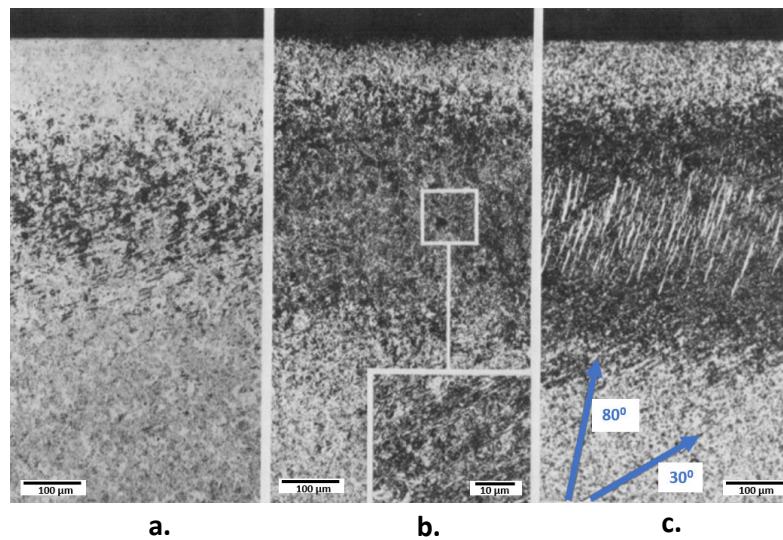
Figure 2-7 Micrographs of the microstructural changes in sections transverse to the contact surface revealed by etching with Nital. a) DER in its early stage. b) Fully developed bands at 30° to the surface b. and c. bands at 80°. c) The number of cycles increases from the left to the right. Adapted from [39].

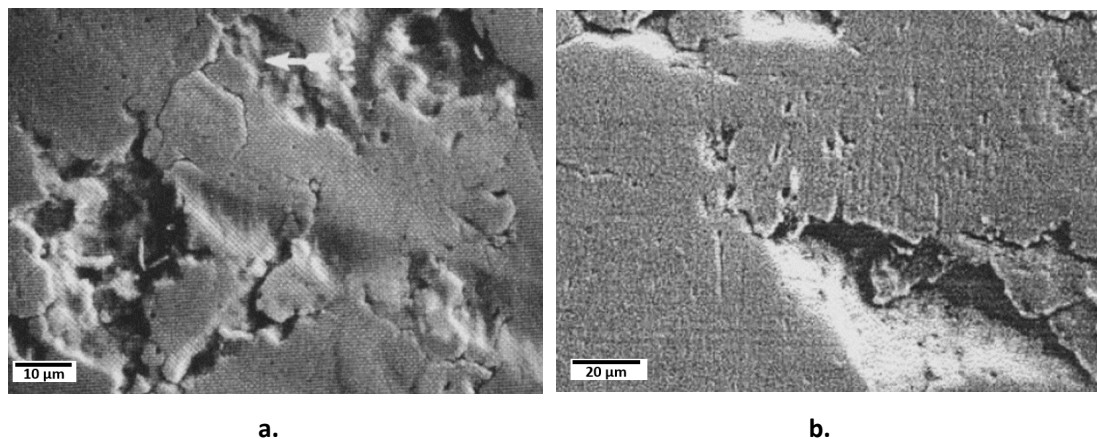
Figure 2-8 SEM images of a spalls a) and micropitting, b) of a worn rolling element bearing affected by contact fatigue. Note the small holes or “pits” close to the cracks and spalls in b Adapted from [40].

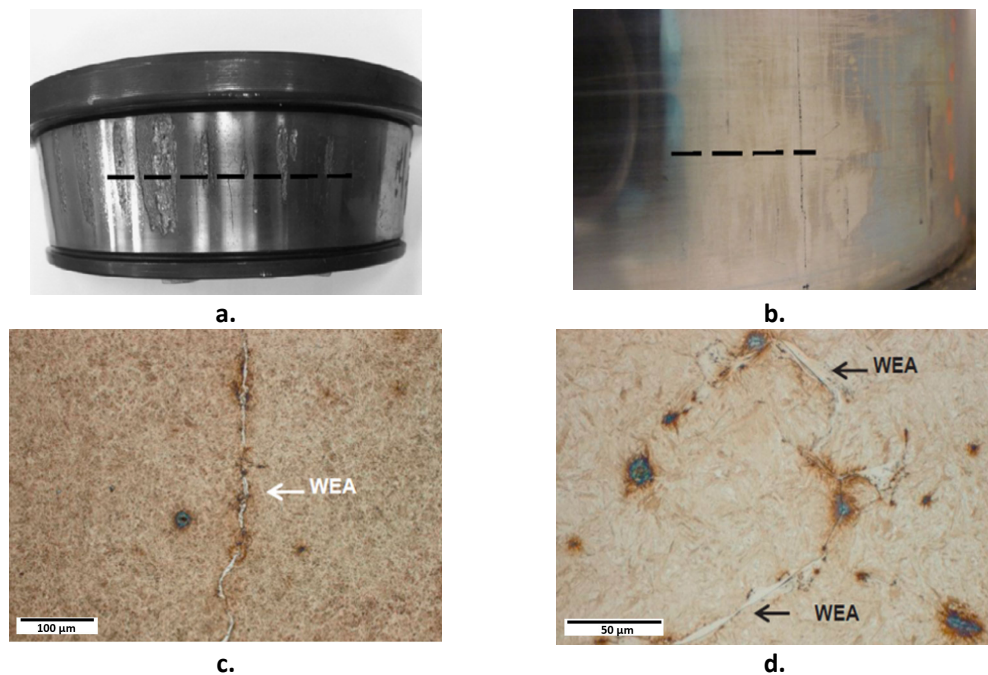
Figure 2-10 Damage produced by WSF in an AISI 52100 bearing inner race. The dotted lines in a) and b) indicate the cross sections showed by LOM in c) and d). The bearing in a) and c) has an outer diameter of 215 mm whilst the bearing in b) and d) has an inner diameter of 93 mm. Adapted from [48].

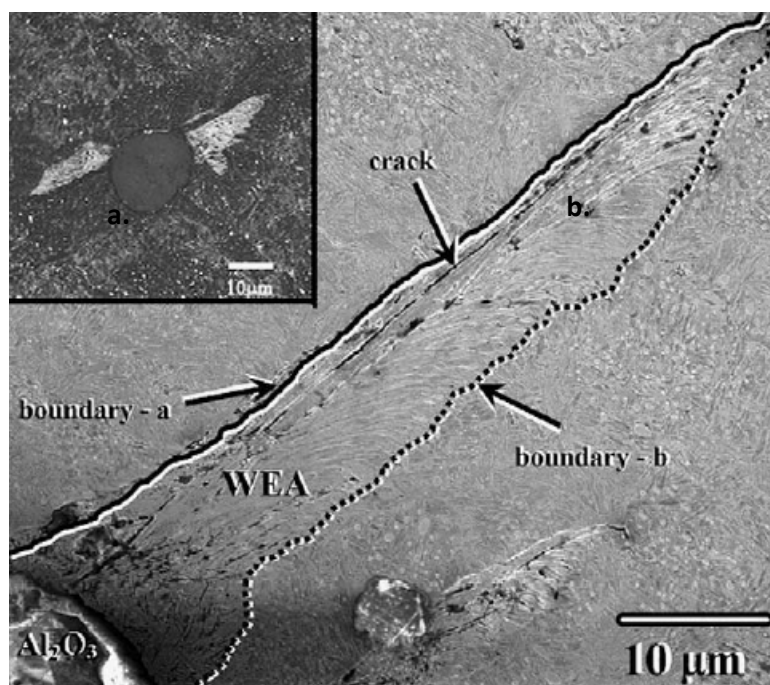
Figure 2-12 SEM / SEI of a Butterfly wing formed around an  $\text{Al}_2\text{O}_3$  inclusion in an AISI 52100 bearing steel. Note the two different borders, a) with crack, b) without crack [60].

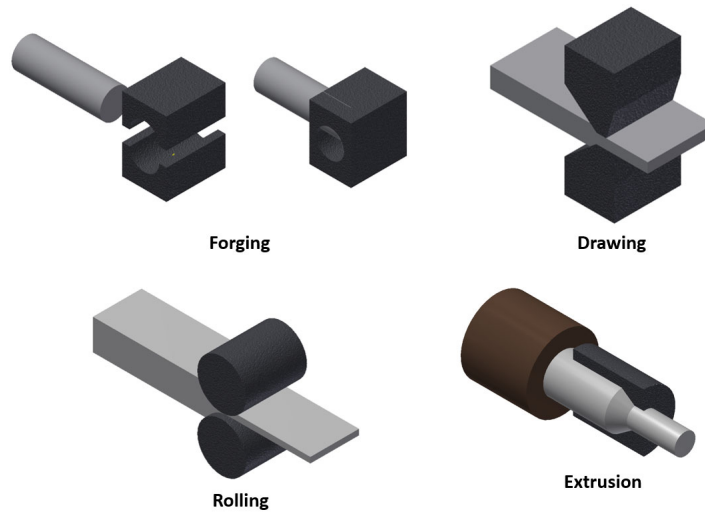
Figure 2-15 Classic plastic deformation processes used to shape metals that often are combined with heat treatment to refine grains. Adapted from [69].

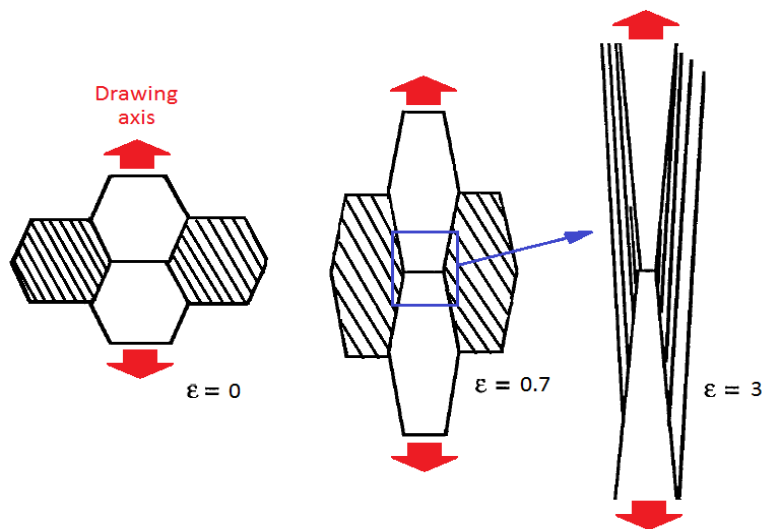
Figure 2-16 Schematic drawing showing the development of microstructure during the drawing of a eutectoid steel [68].

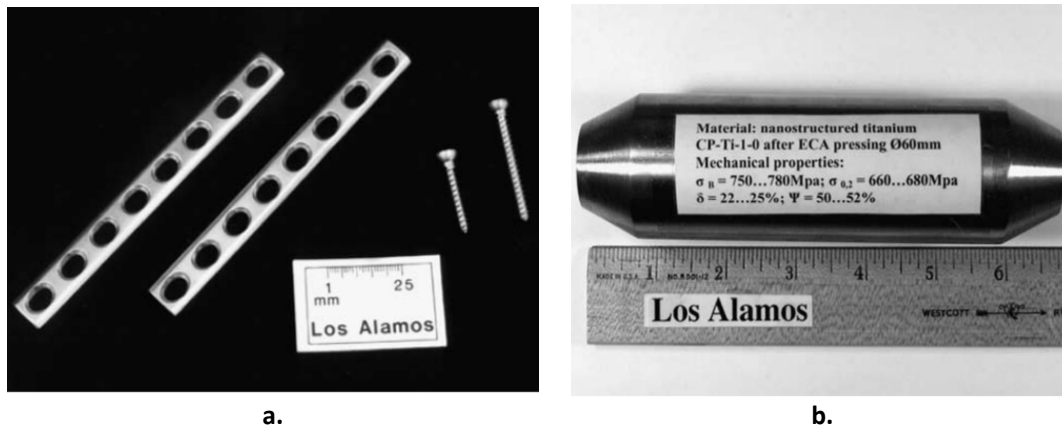
Figure 2-21 Applications of nano structured materials processed by Severe Plastic Deformation. a) implants for bone osteosynthesis made of nano structured Ti. b) Structural rod (50 mm diameter, 170 mm length) processed from ECAP billets. Adapted from [75].

An example of their use could be for bicycle components such as gearing, pedals, shifters, rims and spokes; the experience acquired with these products could be used in specialist applications in aircraft, automobiles and boats (ref). Another good example of their applications is in the production of medical components and pieces in small lots, such as implants for bone osteosynthesis made of nano structured Ti (figure 2-21 a)).

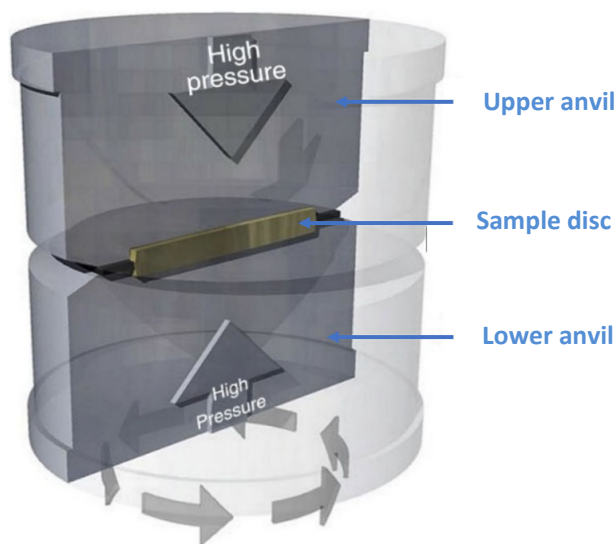
Figure 2-22 HPT process with hydrostatic pressure and torsional stress applied to the sample disc. Adapted from [77].

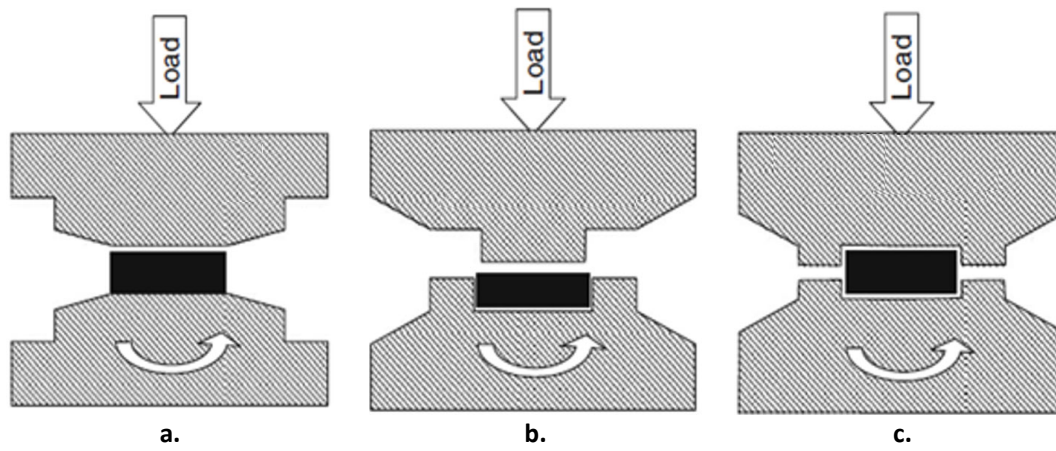
Figure 2-23 HPT constraint conditions: a) unconstrained, b) constrained and c) quasi-constrained [78].

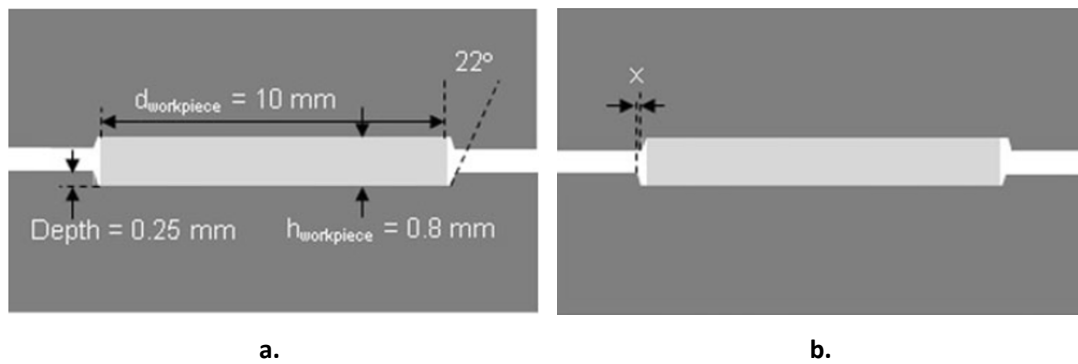
Figure 2-24 Anvils with two different alignments. a) Good alignment with relative displacements, measured by  $X$ , of less than  $X=25\mu\text{m}$ . b) Poor alignment with displacements more than  $X=25\mu\text{m}$ . Adapted from [78].

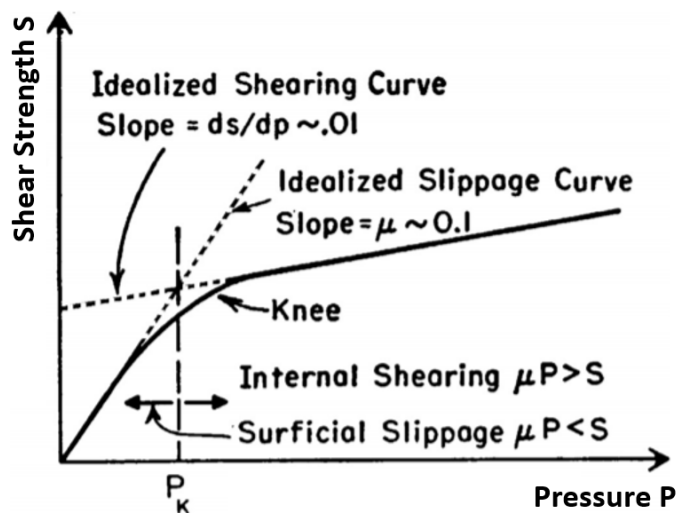
Figure 2-42 Schematic relationship between shear strength and pressure. Two main regions can be identified from the change of slope of the curve [16].

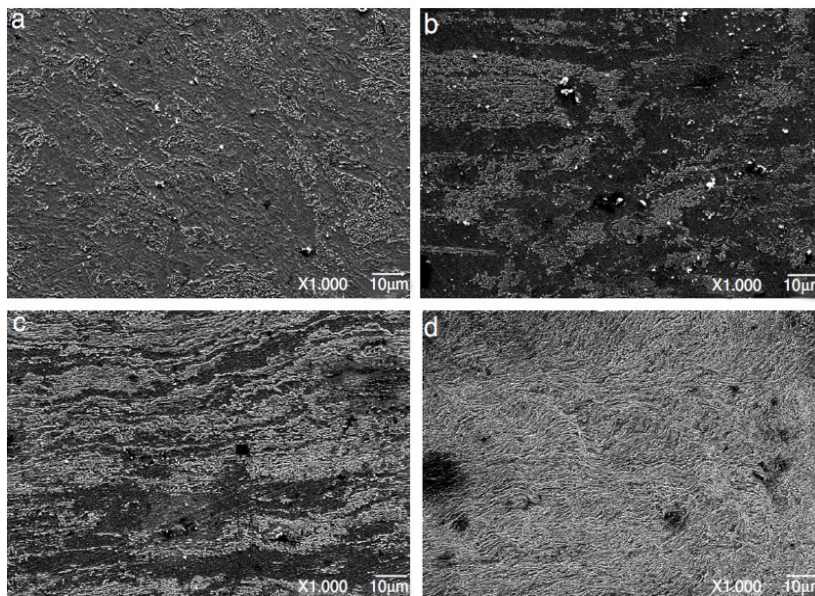
Figure 2-43 SEM images taken at 4 mm from the sample centre after HPT using 6 GPa and a.  $\frac{1}{4}$  turn, b. 1 turn, c. 2 turns and d. 5 turns [97].

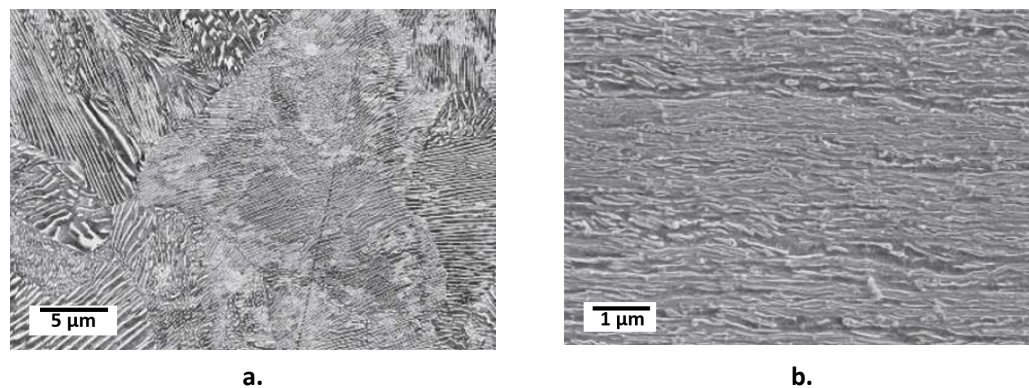
Figure 2-45 Microstructural evolution of a sample of UIC 900A from a. its original condition to b. after HPT with 0.6 turns [98].

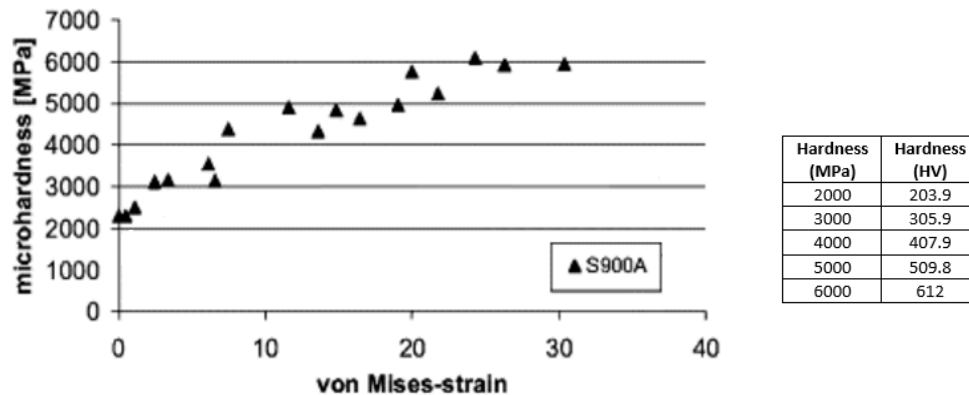
Figure 2-46 Hardness evolution of the pearlitic rail steel UIC 900A after HPT using 5.7 GPa with 0.15 and 0.6 turns [98].

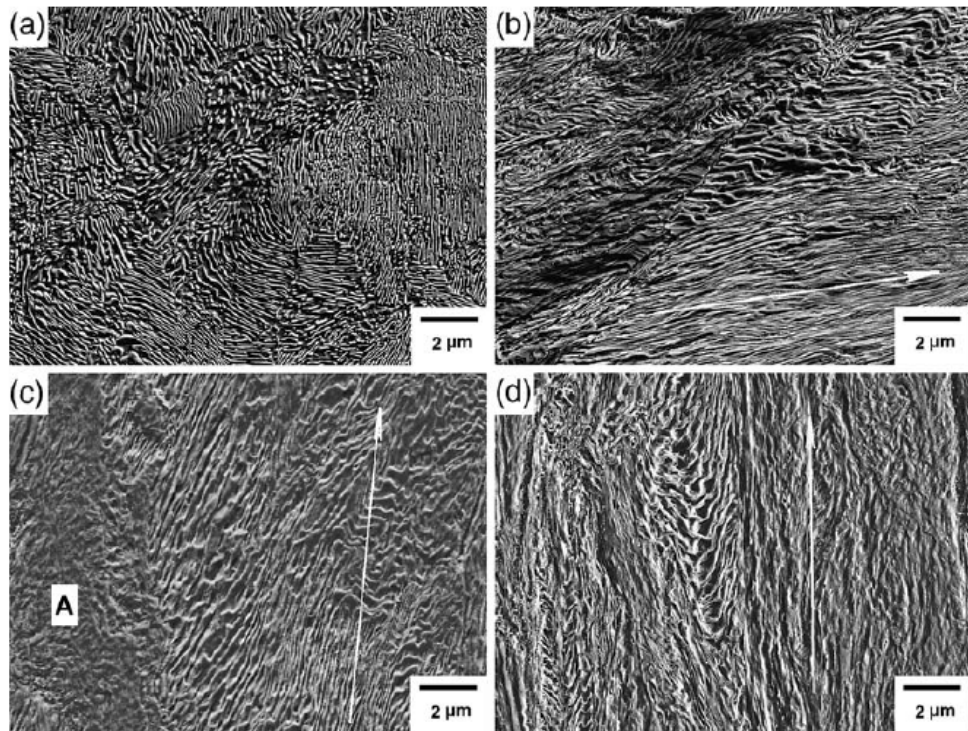
Figure 2-47 Microstructural evolution of a commercial carbon steel UIC 860V processed by HPT using 7 GPa and at different numbers of turns: (a.)  $N = 0$ , (b.)  $N = 1$ , (c.)  $N = 2$ , and (d.)  $N = 3$ . The white arrow shows the shear orientation [11].

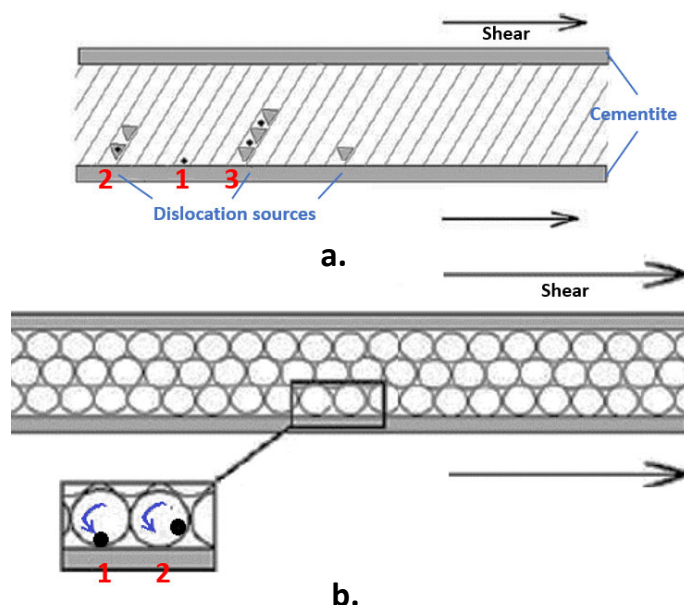
Figure 2-50 Schematic of carbon dissolution from the pearlite structures through the (a.) Formation, (b.). Transition and Fragmentation stages. Adapted from [11].

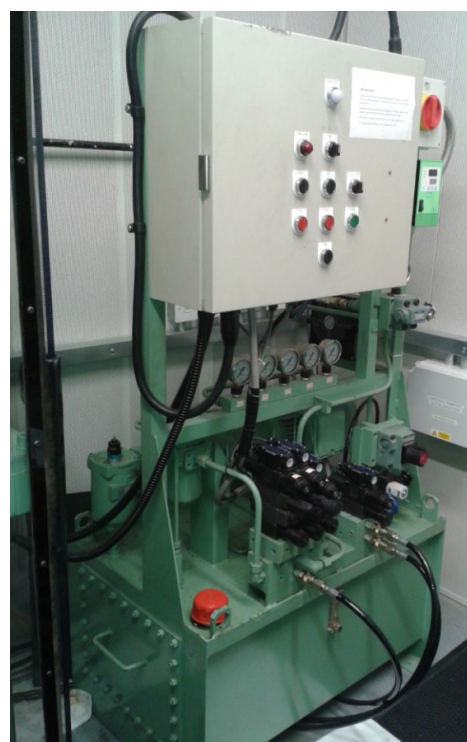
b.

Figure 3-4 Images of the HPT testing machine available in the SPD Lab. a) The machine itself, b) the hydraulic unit and control system required to operate the machine.

The pressure and torsion are produced by a hydraulic unit (figure 3-4 b); if the temperature of the oil reached 30°C, the machine was stopped to protect the power source. Three pre-set pressures could be selected through buttons on the control panel of the machine: 1, 3 and 6 GPa, however, other pressure values were available by varying manually the pressure in the hydraulic unit. Thus, lower and higher pressures such as 0.5 GPa, and 8.4 GPa were possible. All disc samples were processed under the same rotational speed of the bottom anvil (1 rpm); the speed was measured manually with a chronometer. The rotational speed could be changed directly by the hydraulic unit, but this option was never used. Likewise, the HPT machine allows the rotation sense to be changed but this option was also not used. All tests were conducted rotating in an anticlockwise sense with respect to the top anvil.

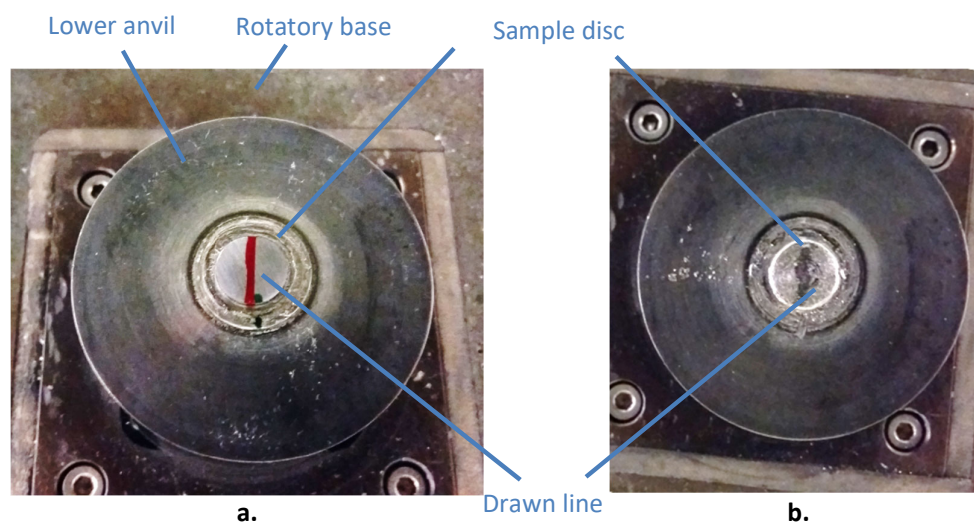
Figure 3-5 HPT sample in lower anvil. a) Before conducting HPT b) After conducting the HPT test with the sample stuck to the lower anvil. Tests conducted under 1 GPa 1 turn 1 rpm

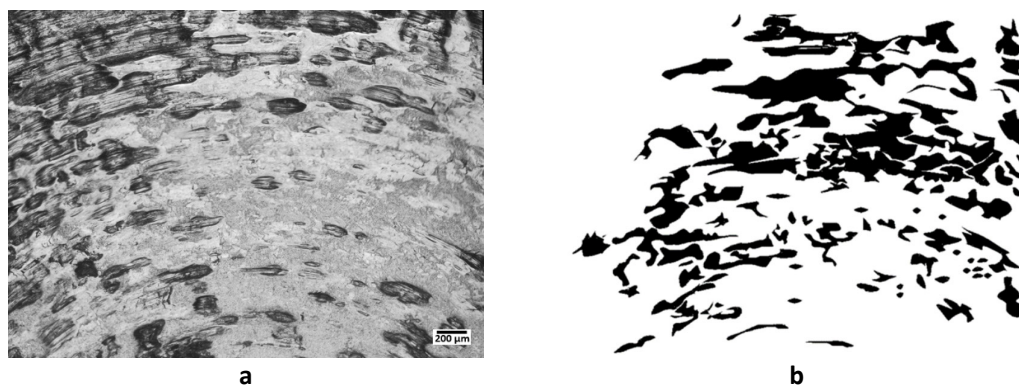
Figure 3-8 Top surface of a disc sample processed using 3 GPa and 1 turn. a) Micrograph taken at a radial distance of 2.5 mm from the centre. b) IPP Image J to determine the %WES in the HPT samples from stage 2

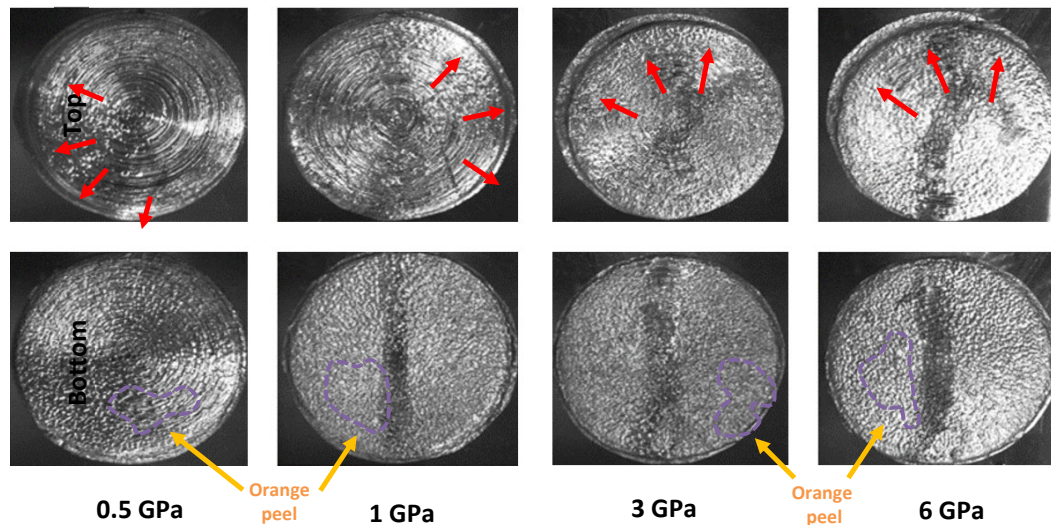
Figure 4-1. Top and bottom surface of annealed AISI 52100 samples after conducting HPT tests using 0.5, 1 GPa, 3 GPa, 6 GPa and 1 turn. Samples after tests with flash removed. Top surfaces exhibit circular grooves (except for those processed using 6 GPa) and the effects of misalignment (red arrows), whilst bottom surfaces showed a roughness pattern similar to an orange peel (enclosed with orange dotted lines).

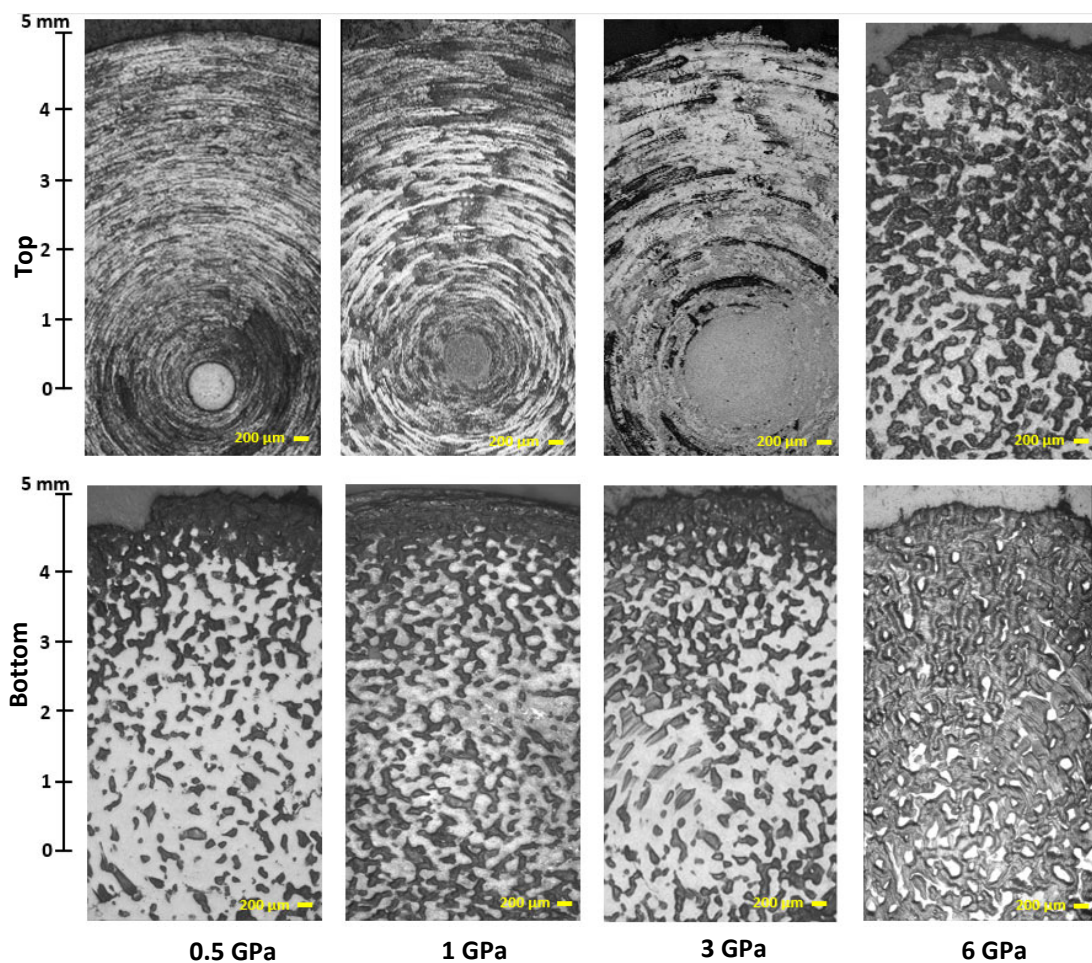
Figure 4-2. Montages of top and bottom surface of annealed AISI 52100 samples after conducting HPT tests using 0.5, 1 GPa, 3 GPa, 6 GPa and 1 turn. Details of the same sample after polishing (to a depth of 40  $\mu\text{m}$ ) and etching. The top surface exhibited grooves alternated by white patches. The bottom surface showed var amounts of *orange peel* pattern as a function of the pressure applied. The images were taken from samples of stage 2. LOM, 2% Nital.

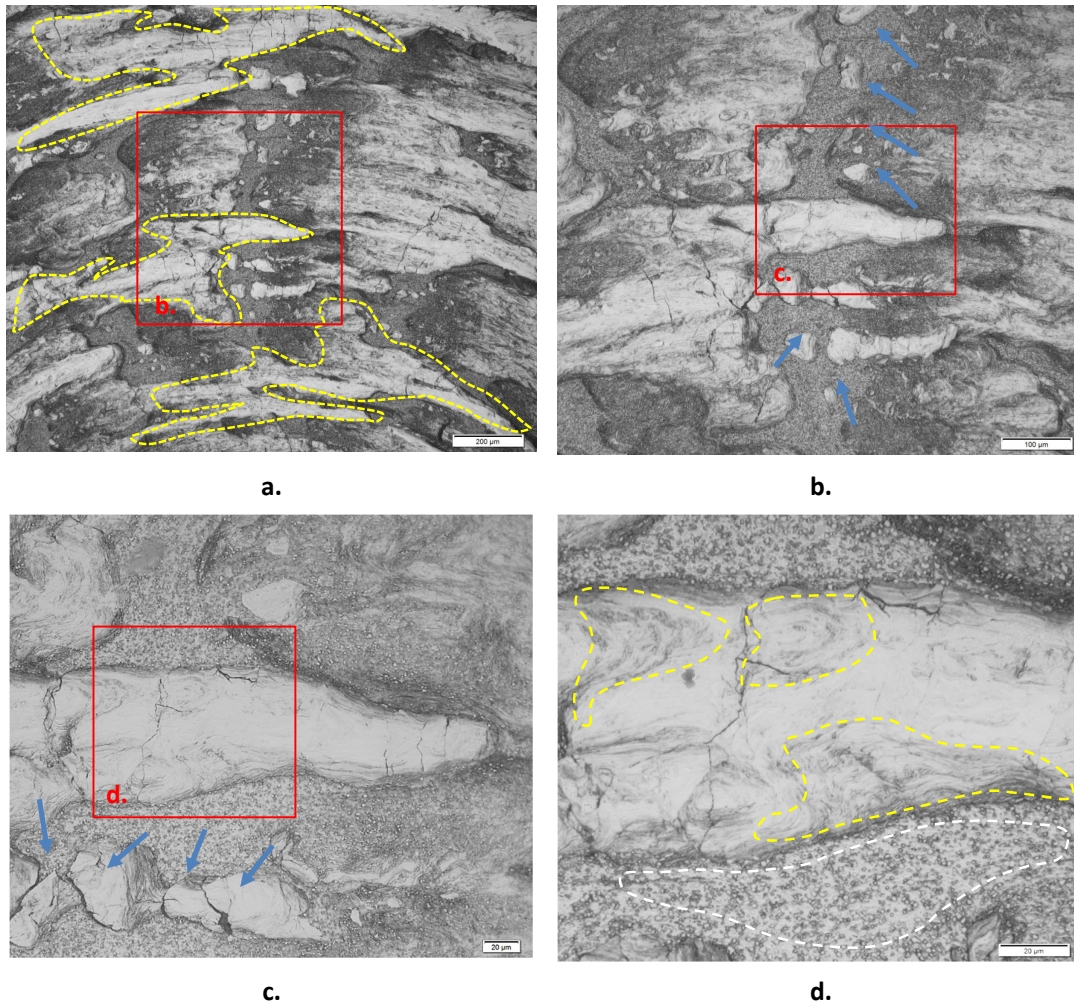
Figure 4-3. Details of WES structure on the top surface of a sample processed using 1 GPa 1 turn. The red rectangles show the regions detailed in the next image. a) Overlapping TWEAs (enclosed by yellow dotted line). b) Isolated TWEAs (indicated by blue arrows) c) Cracks in TWEAs and across them (blue arrows). d) Fibre / layered structures inside the TWEAs (regions enclosed by yellow dotted line), and a region of the ferritic matrix (enclosed by white dotted line). LOM Nital 2%.

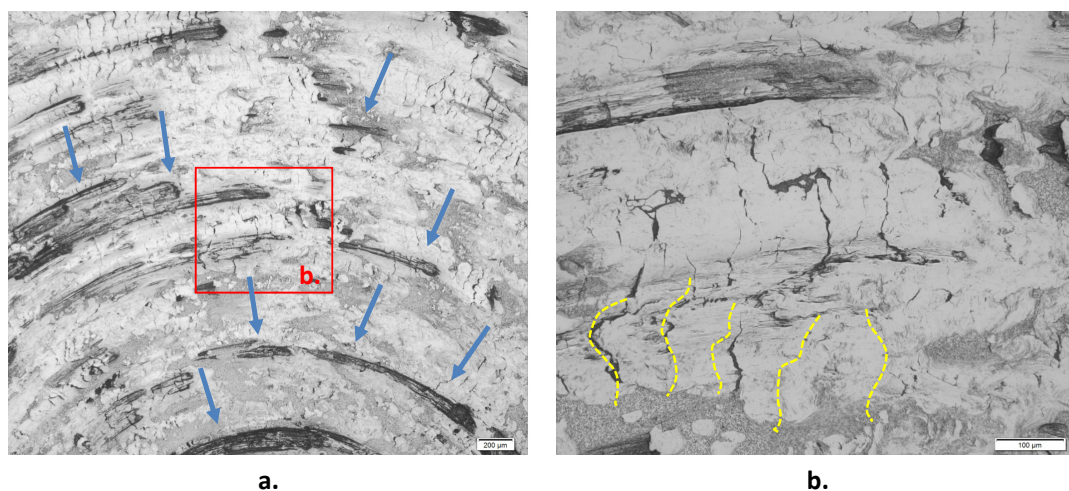
Figure 4-5. Details of WES structure on the top surface of a sample processed using 3 GPa 1 turn. The red rectangle shows the region detailed in the next image. a) Large grooves affecting the top surface. b) Radial brittle cracks and evidence of delamination are visible inside the TWEAs (Yellow dotted lines). LOM Nital 2%.

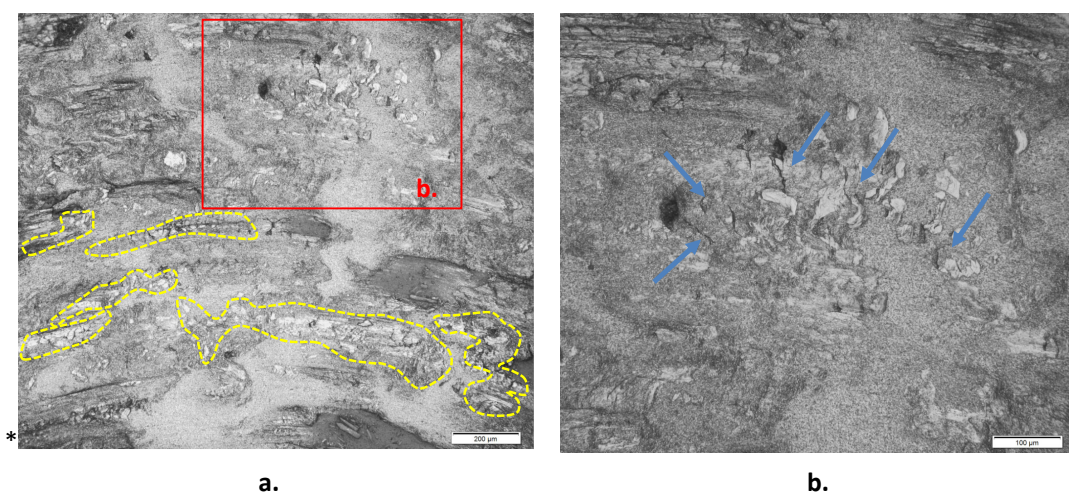
Figure 4-6. Details of WES structure on the top surface of a sample processed using 3 GPa 3 turns. The red rectangle shows the regions detailed in the next image. a) High plastic deformation and clusters of small TWEAs oriented in the sliding direction (enclosed by yellow dotted lines). b) Cracks affecting TWEAs and the ferritic matrix. LOM Nital 2%.

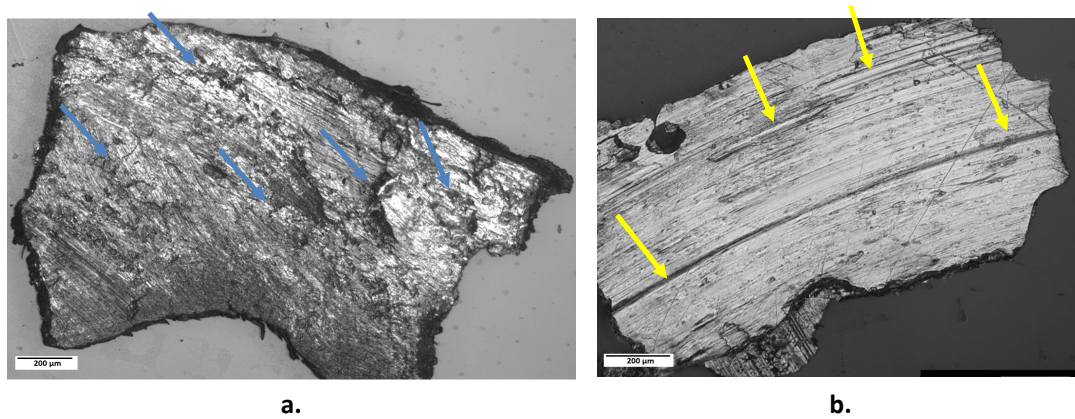
Figure 4-7. Debris produced during a HPT test (3 GPa 3 turns). a) Evidence of delamination (blue arrows) and b) grooves (yellow arrows). LOM Nital 2%.

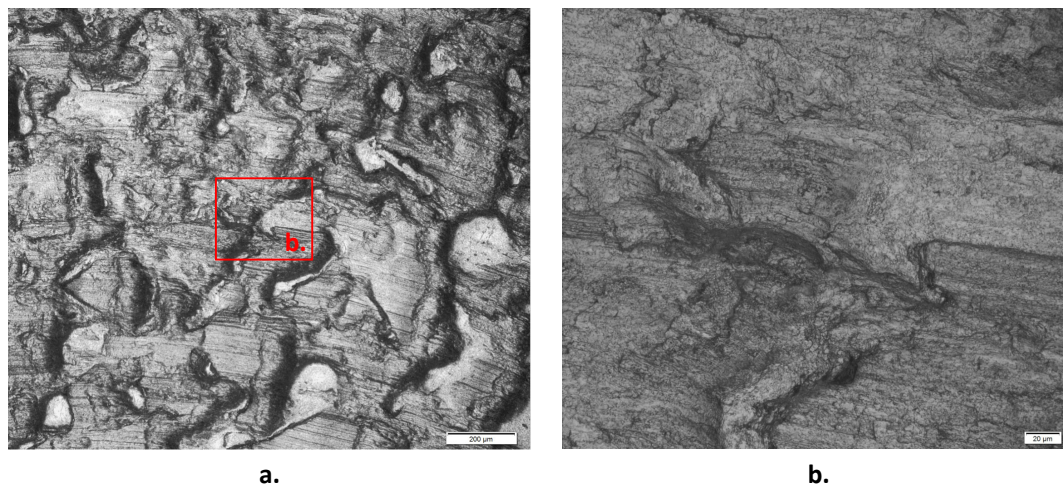
Figure 4-9. Details of the bottom surface of a sample processed by 6 GPa 1 turn. a) The red rectangle shows the region detailed in the next image. b) Details of the deformed surface

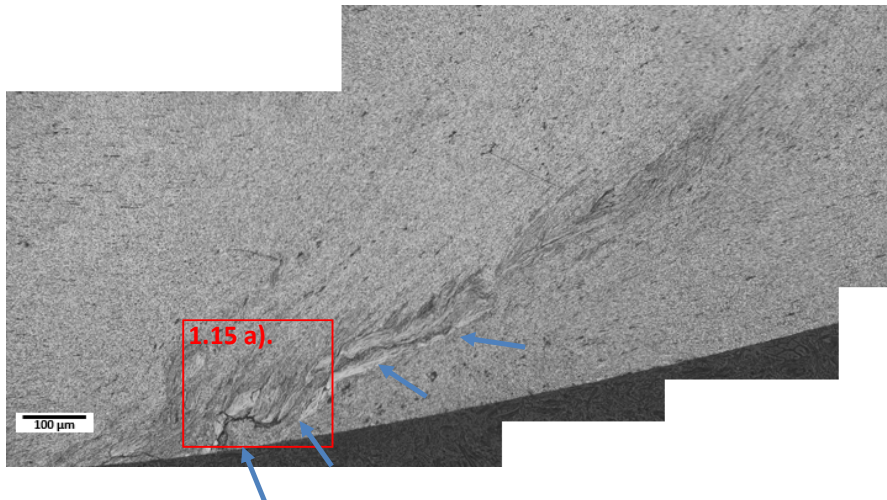
Figure 4-15. Large system of cloud and solid SWEAs linked to a crack network (blue arrows). The red rectangle shows the region detailed in figure 4-16 a). LOM 2% Nital

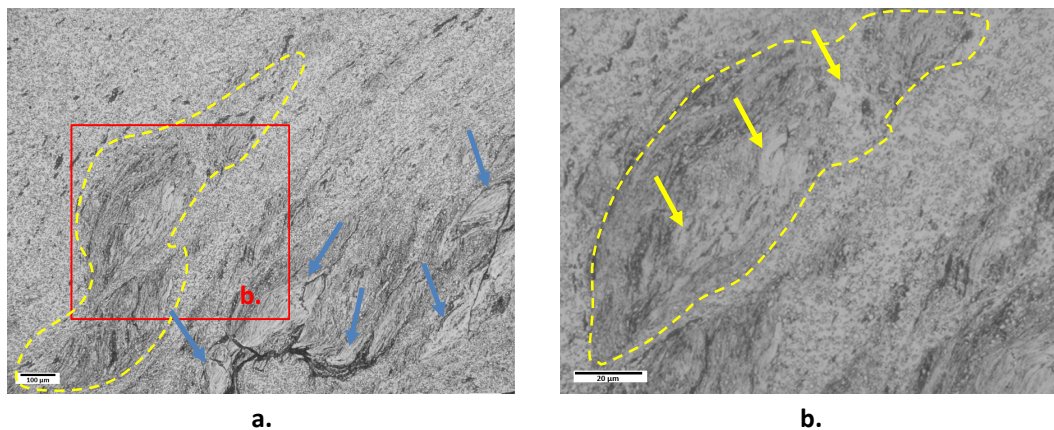
Figure 4-16. Details of large cloud and solid SWEAs. The red rectangle shows the region detailed in the next image. a.) Cloud SWEAs (enclosed by yellow dotted line), and cracks (blue arrows). b.) Cloud SWEAs (enclosed by yellow dotted line) with some solid SWEAs inside (indicated by yellow arrows). LOM 2% Nital.

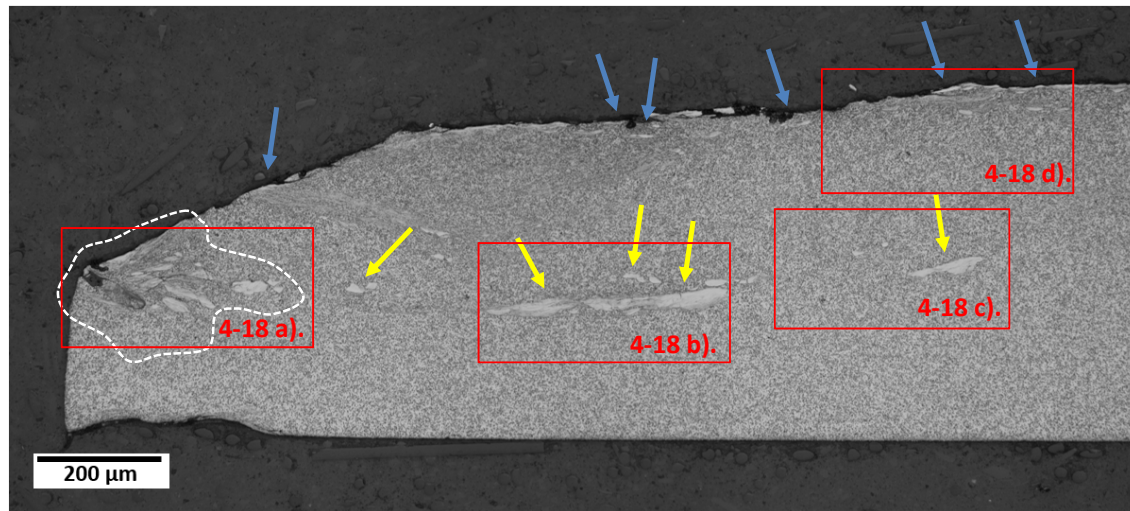
Figure 4-17. TWEAs (indicated by blue arrows) and SWEAs inside the sample (indicated by yellow arrows) in a cross section of a sample processed by 3 GPa 2 turns. The red rectangles show the regions detailed in figure 4-18. Some SWEAs also appeared at the edge of the sample in another well-defined WES group (enclosed by white dotted line) LOM 2% Nitral.

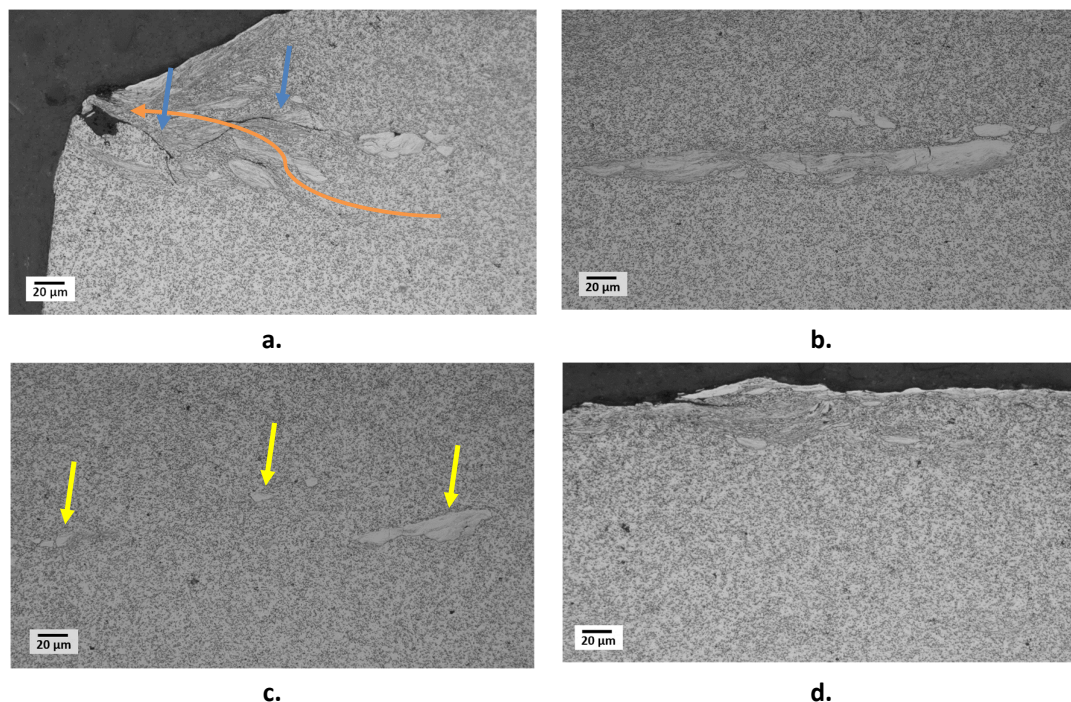
Figure 4-18. Details of TWEAs and SWEAs in a cross section of a sample processed by 3 GPa 2 turns. a) SWEAs and cracks (indicated by blue arrows) at the edge of the sample. b) Elongated SWEA system located far from any border of the sample. c) Small and isolated SWEAs located at a radial distance of approximately 4 mm and at a depth of 200  $\mu\text{m}$  from the top surface (Yellow arrows). d) TWEAs located at a radial distance of approximately 4 mm. LOM 2% Nital

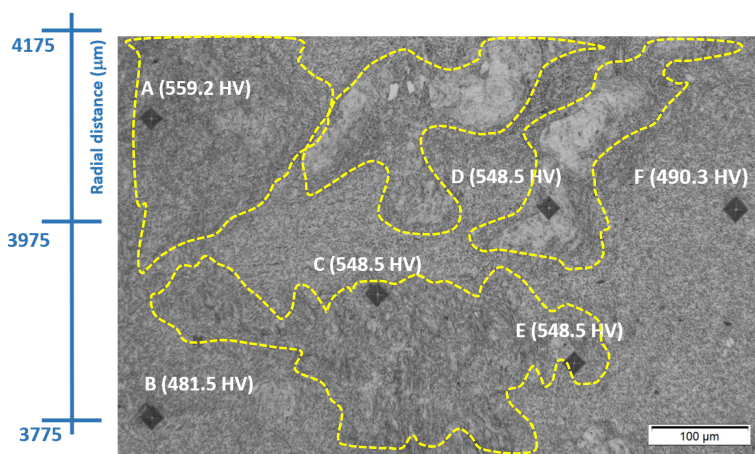
Figure 4-20 Cloud SWEAs located at radial distances of between 3775 and 4175  $\mu\text{m}$ ; points A, C, D, E correspond to measurements on SWEAs (enclosed yellow dotted lines). Sample processed through 3 GPa 2 turns. LOM 2% Nital

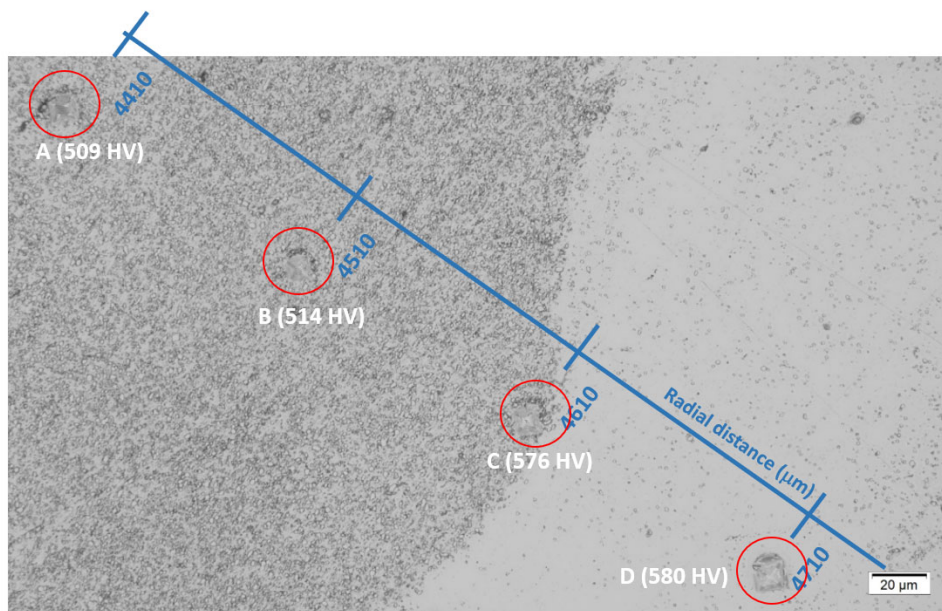
Figure 4-21 Solid SWEA located at radial distances of between 4410 and 4710  $\mu\text{m}$ ; points C, D correspond to SWEAs. Sample processed through 3 GPa 2 turns. LOM Nital 2%.

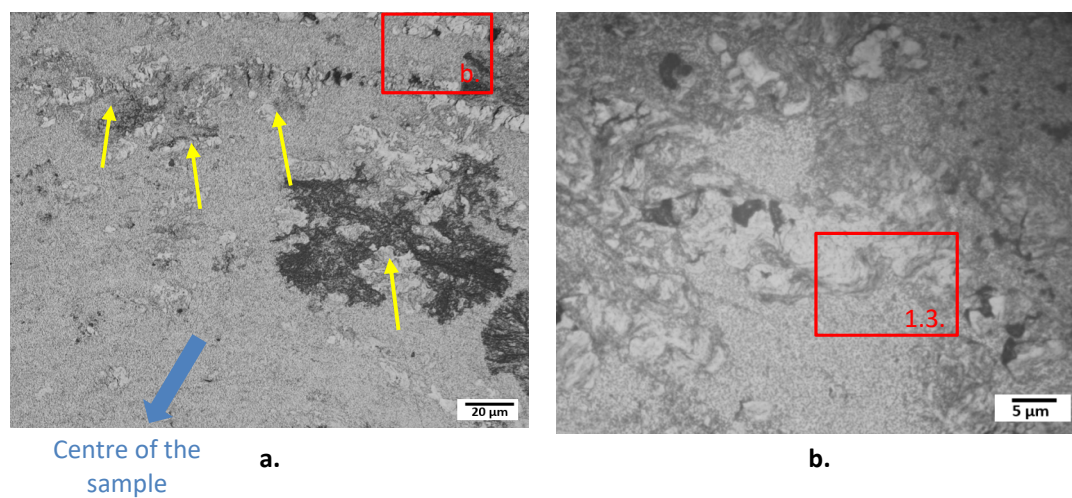
Figure 4-22 Top surface of a sample processed using 3 GPa 3 turns. The red rectangles show the regions detailed in figure 1.23 a), b) Images taken at increasing magnifications to localise the analysed region. LOM Nital 2%

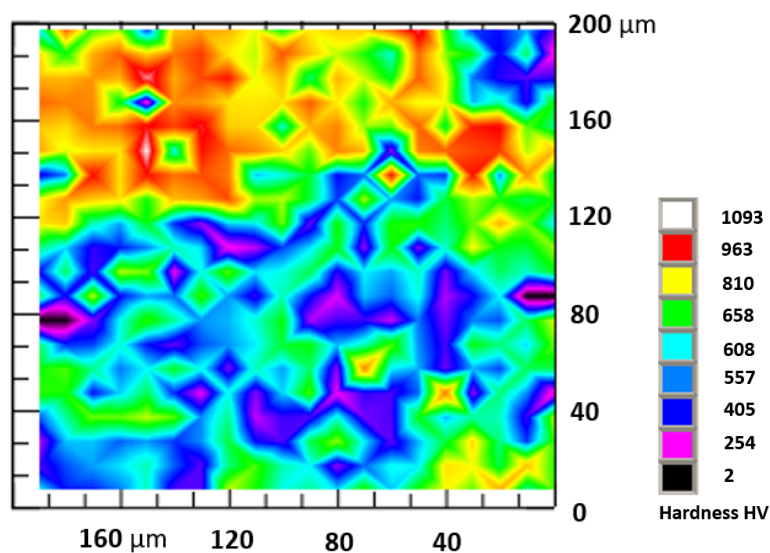
Figure 4-23. Nano hardness map taken from the red area shown in figure 4-22 b).

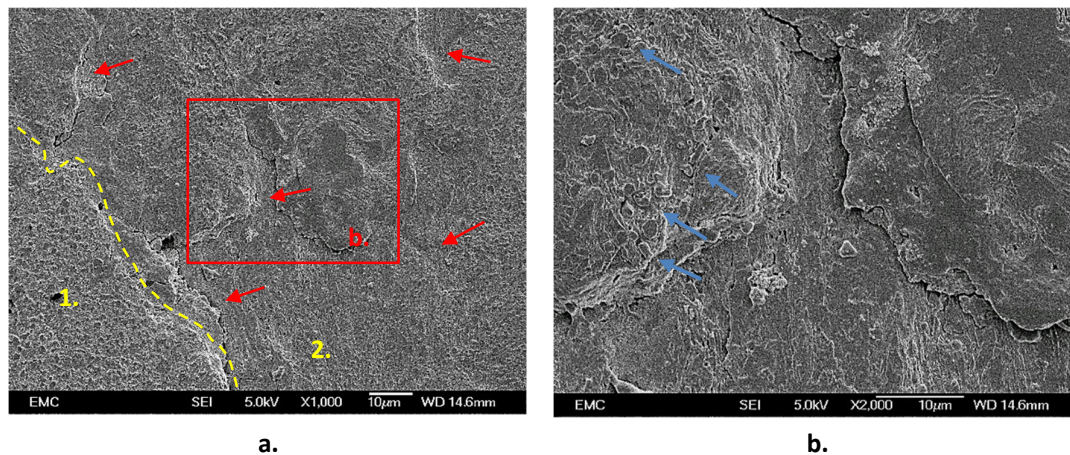
Figure 5-2. Details of TWEAs structure on the top surface of a sample processed using 0.5 GPa 1 turn, in a region located at a radial distance of 3.5 mm. The red rectangle indicates the area shown at higher magnification in (b). a) Differences between the appearance of the deformed ferritic matrix (1) and TWEAs (2). TWEAs layers appeared to overlap (red arrows) b) High plastic deformation produced by severe sliding. SEM / SEI, Nital 2%

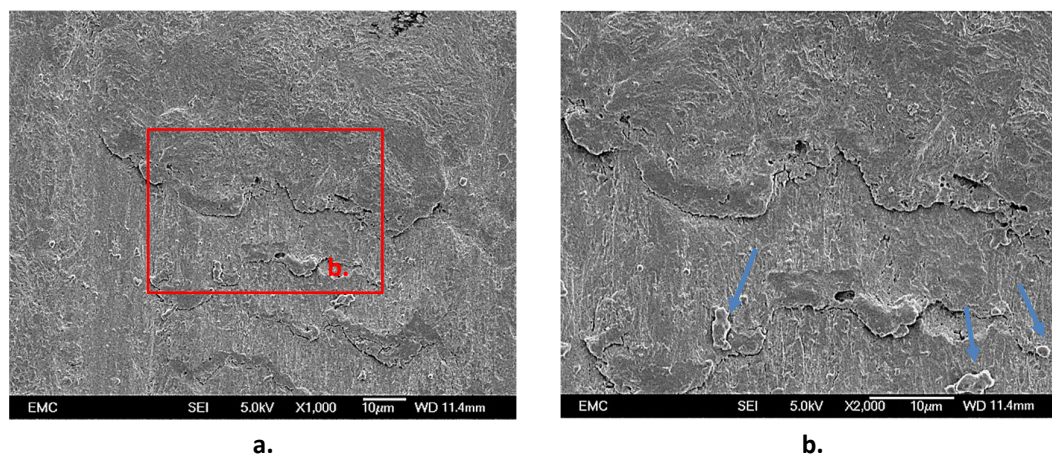
Figure 5-3. Formation of flakes in a TWEA located at a radial distance of 3.5 mm on the top surface of a disc sample processed by 1 GPa 1 turns. The red rectangle indicates the area shown at higher magnification in b). Blue arrows in b) shows debris produced by material detaching from the flakes. SEM / SEI, Nital 2%
