Thesis: Luis Vicente Wilches Peña (2018) "Microstructural Alterations During HPT Tests on Annealed 52100 Bearing Steel", University of Southampton, Faculty of Engineering and Physical Sciences, School of Engineering, PhD Thesis, 196 p.

## Microstructural Alterations During HPT Tests on Annealed 52100 Bearing Steel

Thesis for the degree of Doctor of Philosophy

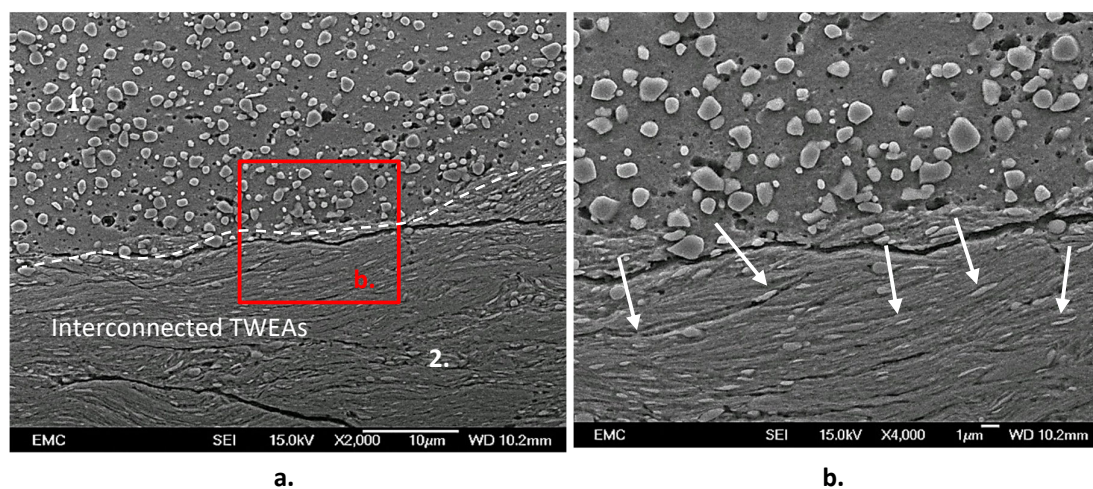
Figure 5-6. Details of the image shown in figure 5-5. The red rectangle indicates the area shown at higher magnification in (b). a) The carbide distribution in the ferritic matrix in region 1 is different to that found in the TWEAs in region 2. b) Highly deformed carbides linked to the fibrous structure in a cloud TWEA (white arrows). SEM/SEI Nital 2%.

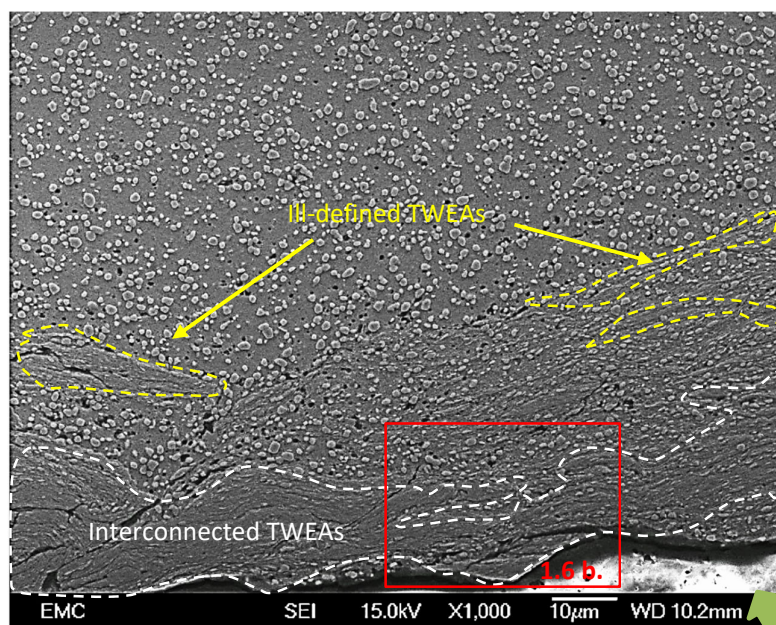
Figure 5-7. Axial section at a radial distance of 4 mm of a disc sample processed by 1 GPa 2 turns. The red rectangle indicates the area shown at higher magnification in figure 5-6. The white dotted line encloses interconnected TWEAs present close to the top surface. Other isolated TWEAs appear at greater depths beneath the surface, at depths close to 100  $\mu\text{m}$  (yellow arrows). The green arrow indicates the top surface of the sample. SEM / SEI, Nital 2%

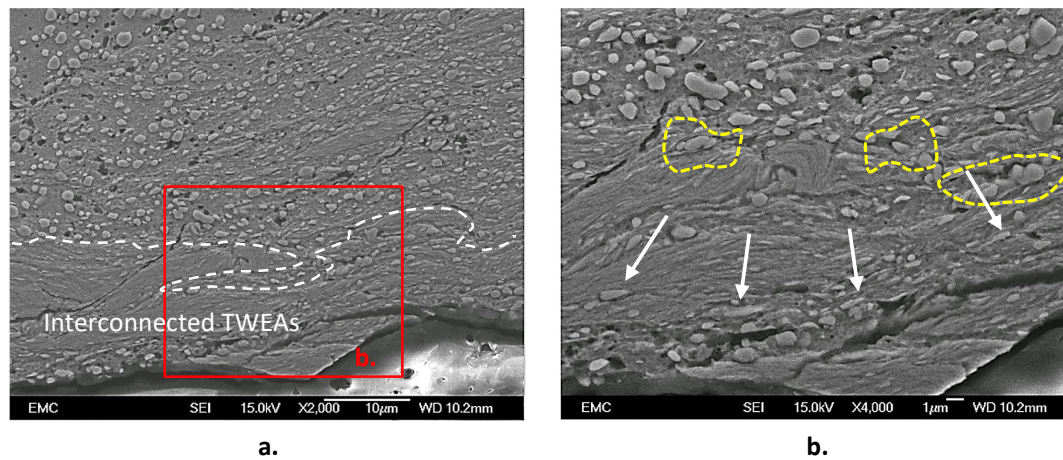
Figure 5-8. Details of the image shown in figure 5-7. The red rectangle indicates the area shown at higher magnification in b). a) The depth to which TWEAs extended beneath the top surface is not regular along its length. A fibre / layered structure is visible inside the TWEAs. Deformed carbides appeared between the fibres /layers (white arrows in b)); some of these seemed to be linked to the fibre/layered structure (enclosed by yellow dotted lines in b)). SEM/SEI Nital 2%.

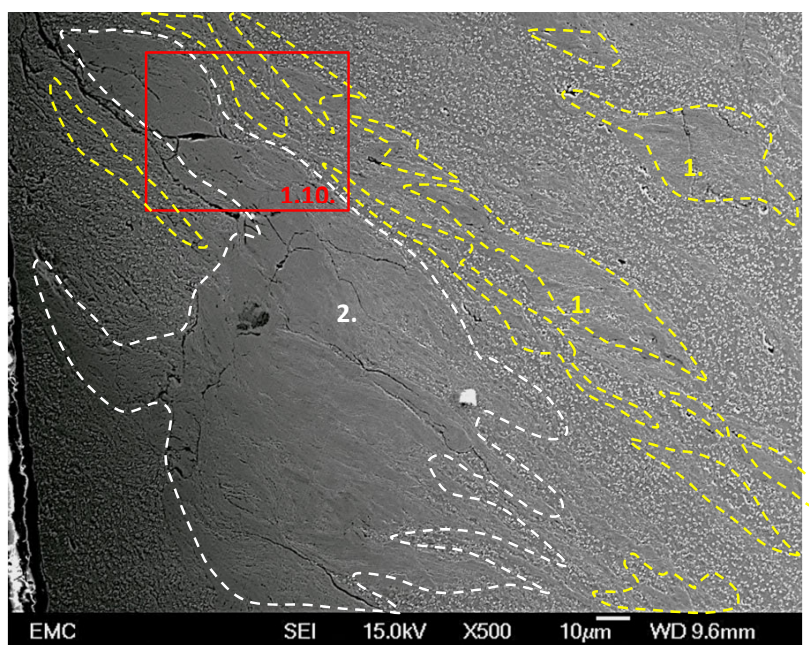
Figure 5-9. Solid WEAs (white dotted lines, region 1) and cloud SWEAs (yellow dotted line, region 2) located close to the edge of a sample processed by 3 GPa 2 turns. The red rectangle indicates the area shown at higher magnification in figure 1-10. SEM/SEI 2% Nital.

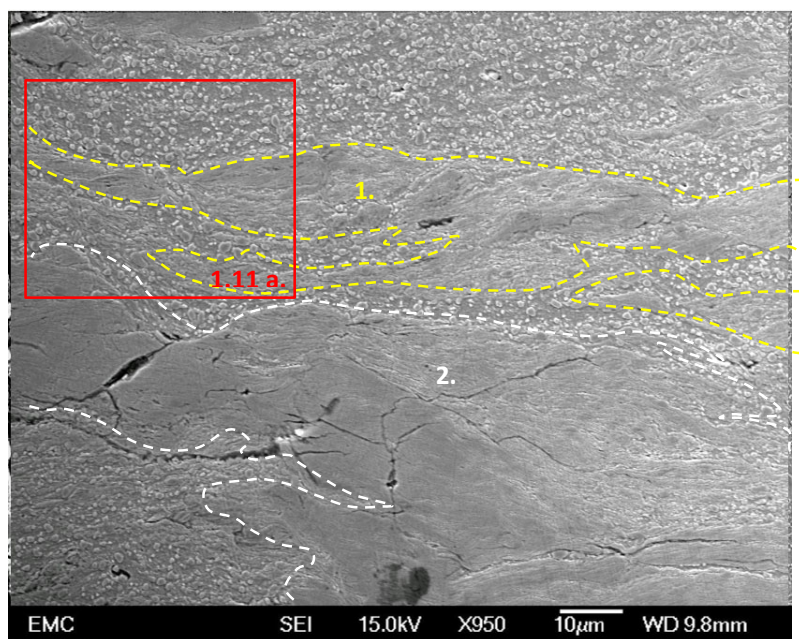
Figure 5-10. Details of the SWEAs system shown in figure 5-9. Yellow dotted lines enclose clouds (region 1), whilst the white dotted lines enclose the solid SWEAs (region 2). The red rectangle indicates the area shown at higher magnification in figure 1-11. SEM/SEI 2% Nital.
