Water policy and resilience of potable water infrastructure to climate risks in rural Malawi

Miriam Dalitso Joshua^{a,*}, Emma Tompkins^a, Kate Schreckenber^b, Cosmo Ngongondo^c, Esther Gondwe^d, Sosten Chiotha^d

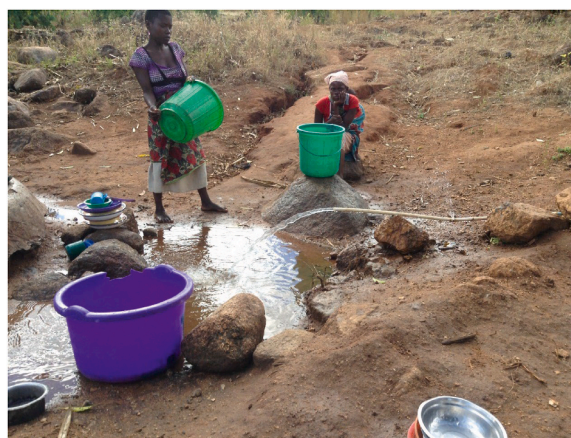
Fig. 8. Damaged pipe in Mtuluma (Source: Matthews Tsirizeni, LEAD).

Additionally, the study established that most water infrastructure was vulnerable to floods because they were mostly below design standards. A survey of selected infrastructure specifically intakes and distribution pipes showed limited application of design standards (Figs. 8 and 9). This was echoed in one key informant report that “most structures are constructed or rehabilitated by local artisan supervised by untrained people who do not know the implications of under designed structures” (KI-GOV). In some locations, the intakes are above water level during dry seasons and drought conditions (Figs. 8 and 9).

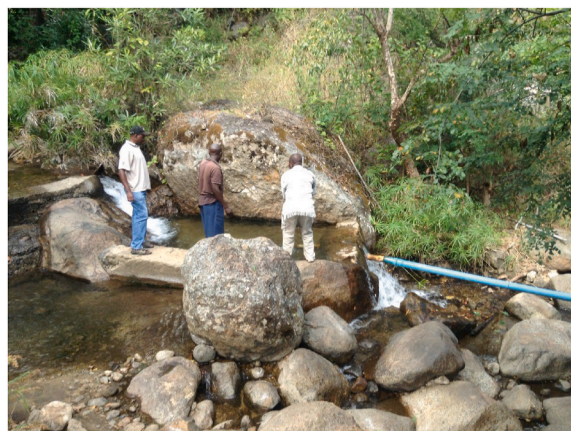
Fig. 9. One of the intake structures in Mtuluma (Source: Matthews Tsirizeni, LEAD).
