Triaxial Tests to Assess the Effects of Densification, Lateral Spreading and Grain Breakage on Settlement Behaviour of Full-Size Railway Ballast

Abstract Predicting the rate of deterioration of ballasted track due to cumulative plastic settlement is a major challenge for railway infrastructure owners. For track on a stiff subgrade, more than 50% of the total deformation originates from the ballast through grain rearrangement (compaction), lateral spreading and possibly grain breakage. Despite much research, knowledge of the mechanisms by and extent to which these three processes contribute to permanent settlement is limited, and permanent settlement is still usually estimated empirically. This paper describes the rationale and initial results of triaxial tests on full-size granite railway ballast, carried out to investigate the relative importance of the processes responsible for ballast settlement. Specimens of full-size railway ballast 600 mm high and 300 mm in diameter were subjected to cycles of deviator stress between 10 kPa and 50, 100 or 200 kPa. Tests were carried out over up to 500,000 load cycles at a frequency of 3 Hz and an effective confining stress (cell pressure) of

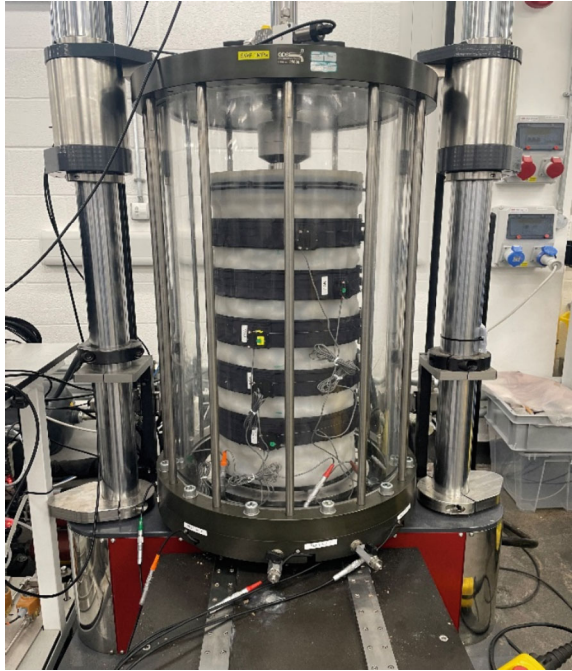
Fig. 1 Triaxial set-up with 5 radial belts

The experiments were conducted in a large triaxial apparatus on specimens 600 mm in height and 300 mm in diameter (Fig. 1). Granite ballast from the Mountsorrel quarry in Leicestershire, UK with a grain size distribution conforming to the Network Rail standard was used. Tests on three different specimens were conducted, all at a cell pressure of 30 kPa. A conventional 2.5 m long \times 0.29 m wide G44 sleeper loaded by 50% of a 25 tonne (250 kN) axle will exert vertical stress, averaged over the whole of the sleeper area, of 172 kPa. Assuming a horizontal stress of $(1 - \sin \phi')$ times the vertical effective stress with $\phi = 45^\circ$ gives a horizontal effective stress of about 50 kPa. Although in principle the horizontal effective stress should increase in proportion to the vertical, this adds to the complexity of the testing regime and when attempted can give counter-intuitive results [6]. Hence, for simplicity, the cell pressure for the tests reported in this paper was kept constant at 30 kPa while cyclic deviator stresses up to maxima of 50, 100 and 200 kPa were applied.

Output data were recorded at a frequency of 60 Hz (20 data points per cycle) to prevent aliasing. Five equally-spaced radial belts were used to track the change in circumference of the sample. Two sensors within the load cell were used to measure

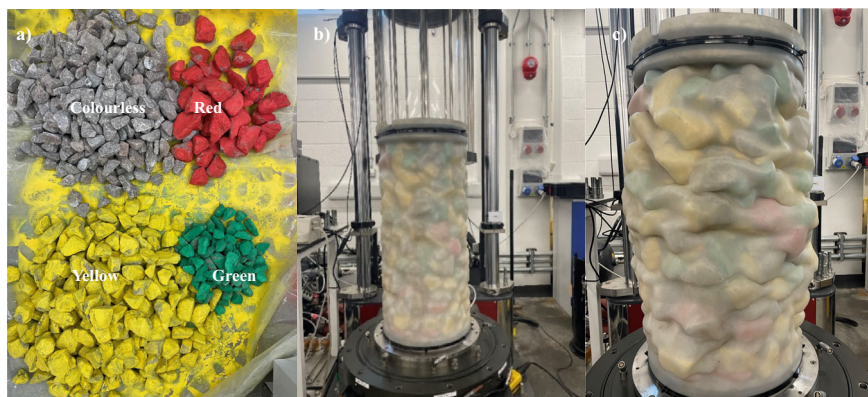
Fig. 2 **a** Ballast sample used in test 3 (63 mm > Red > 50 mm > Yellow > 40 mm < Colourless < 31.5 mm < Green < 22.4 mm. **b** Test 3 sample before the test. **c** Test 3 sample after the test

the variations in cyclic load and axial displacement with time. Sieve tests were conducted before and after each test, and the results used to assess grain breakage. Grains in Test 3 were painted with Arco Heavy-Duty Line Marking paint to assist with this (Fig. 2).

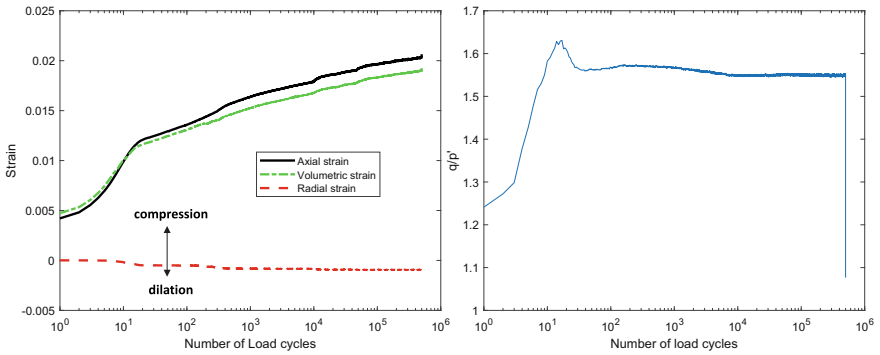
Fig. 4 a Axial, radial and volumetric strain versus number of load cycles for Test 2. b q/p' versus number of load cycles

In Test 2 (Fig. 4a), lateral spreading was more significant than in Test 1 but still small. This is not altogether surprising as, relative to the vertical load, the lateral confining stress was smaller in Test 2 than in Test 1. Most of the vertical settlement is accounted for by volumetric change. Again, volumetric and axial strain were ongoing at the end of the test after 500,000 cycles. Grain breakage was detectable but small, with broken fragments accounting for 0.56 parts per 10,000 by mass (0.0056%) by the end of the test (an actual mass of 3.45 g). To ascertain when this breakage occurred, it would be necessary to carry out tests with progressively fewer loading cycles.

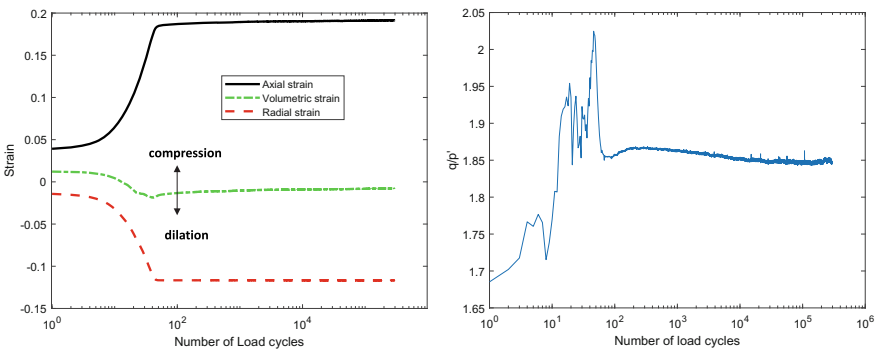
Fig. 5 a Axial, radial and volumetric strain versus number of load cycles for Test 3. b q/p' versus Number of load cycles

Figure 5a shows the result of Test 3, which are quite different from those of Test 1 and Test 2. The specimen to collapse between 10 and 45 cycles when the stress ratio q/p' increased from about 1.7 to the target value of 2. This was accompanied by substantial axial and radial strain (settlement and lateral spreading) but relatively little volumetric change (densification). After 45 load cycles the specimen dilated slightly and the axial and radial strains remained almost constant while the stress ratio q/p' cycled to a maximum, apparently stable, value of about 1.85. This suggests that the specimen may have failed, with the associated geometric distortion sufficient to enable cycling at a stable stress ratio up to a maximum value of q of about 160 kPa, with a small increase in radial stress (from 30 to 32 kPa) due to the stretching of the rubber membrane calculated according to [24] Method.
