Periglacial discontinuities observed in Jurassic mudstones between Buckinghamshire and Warwickshire

Giles Hemmings¹, Kevin Briggs^{2*}, Harry Saroglou¹, Kevin Raven³ and Simon Butler⁴

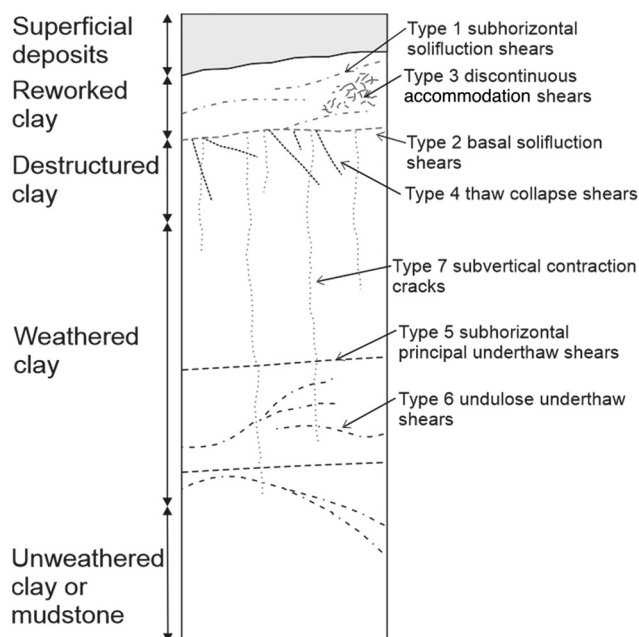
Fig. 2. Types of periglacial discontinuities in weathered Eocene clay, redrawn from Spink (1991).

The Spink (1991) periglacial discontinuity types shown in Figure 2 are:

- Type 1 subhorizontal solifluction shears (up to 40° dip) that occurred within reworked and deconstructed upper material. Trial pit excavations showed that the shears had a persistence of 0.5–2.0 m and dipped at 0–40°, commonly subparallel to the ground surface.
- Type 2 basal solifluction shears were individually laterally extensive and found at or close to the base of the reworked

material only. These shears represent a planar basal surface and the highest level of geohazard in construction.

- Type 3 discontinuous solifluction accommodation shears comprised very closely spaced (<200 mm) and randomly oriented networks of discontinuous (<100 mm) minor shears in the reworked clay. The shears were attributed to internal adjustment movements associated with solifluction.

- Type 4 high angle thaw collapse shears were high-angle shears found in the *in situ* deconstructed clays below the reworked material. They had lengths of 1–2 m, fading out downwards and truncated at the top by the overlying reworked clay. These shears were attributed to collapse associated with localized pockets of thawing within and beneath low-relief features of the palaeo topography. The thaw collapse shears did not occur on slopes angles greater than about 5°.

- Type 5 subhorizontal principal underthaw shears (described as ~7° dip) were identified beneath the Type 4 shears close to the boundary between the weathered and unweathered clay. These were continuous, planar shear surfaces. They were bedding parallel and occurred in discrete, more plastic clay beds between more silty layers. Spink (1991) attributed types 5 and 6 shears to upward thaw of permafrost generating pore pressures in excess of hydrostatic, leading to the overlying frozen ground sliding en-masse downslope, possibly combined with lateral stress relief associated with valley formation.

- Type 6 undulose secondary underthaw shears were discontinuous (2–3 m persistence) near the boundary between the weathered and unweathered clay. However, Type 6 shears were low-angle accommodation shears (generally less than 30°) with no preferred orientation. Both types 5 and 6 shears commonly occurred at depths of several metres below the ground surface (i.e. significantly deeper than types 1–4).

- Type 7 subvertical contraction cracks were observed in the weathered *in situ* clay, to depths of up to 5 m below ground level (bgl), but not within the reworked uppermost zone. Spink (1991) attributed them to tensile failure rather than shearing. The cracks were not infilled by silt or foreign material, as observed in brecciated mudstone (Murton *et al.* 2001; Hutchinson 2010) and in thermal contraction cracks in present-day periglacial environments.

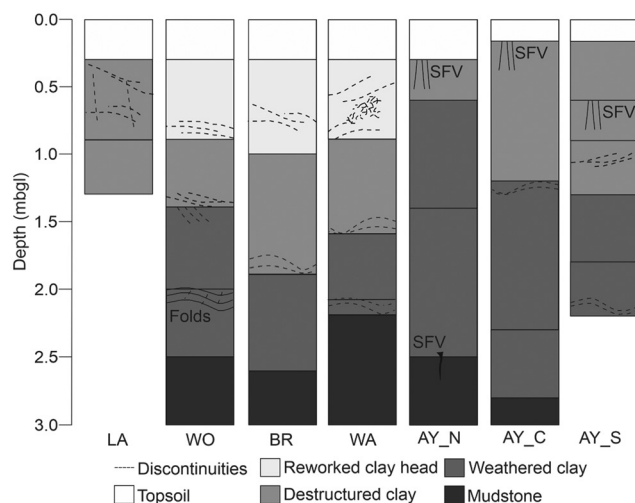
Fig. 3. Schematic ground profiles from excavations at earthwork sites near Ladbroke (LA), Wormleighton (WO), Brackley (BR), Waddesdon (WA), Aylesbury north (AY_N), Aylesbury central (AY_C) and Aylesbury south (AY_S), showing the location of observed discontinuities, folds and sand-filled veins (SFV). The site locations are shown in Figure 1.

A series of case studies is presented from five exemplar sites where observations were compared to the seven types of periglacial discontinuity described in the Spink (1991) classification. The location and type of structures within the ground profile at each site are summarized in Figure 3.

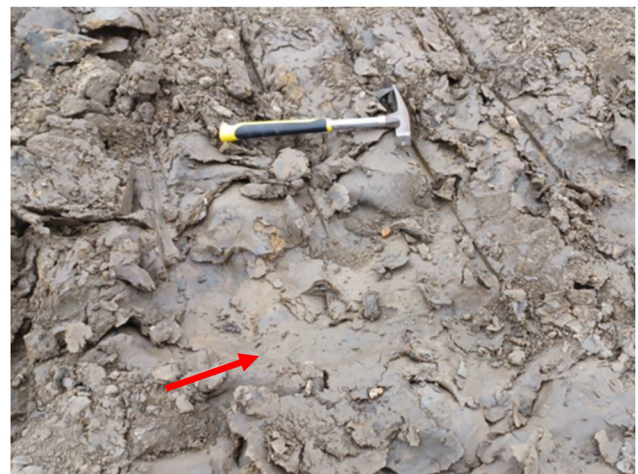
Fig. 4. Shears in the form of undulose pillow-like polished surfaces at c. 0.6 m bgl in the Charmouth Mudstone Formation (Lias Group) near Ladbroke (LA), Warwickshire. The hammer is 280 mm long.

Figure 4 shows that the shear planes took the form of undulose, hummocky ‘pillow-like’ polished surfaces within the clays. Individual shear surfaces (Fig. 5) appeared to have a persistence

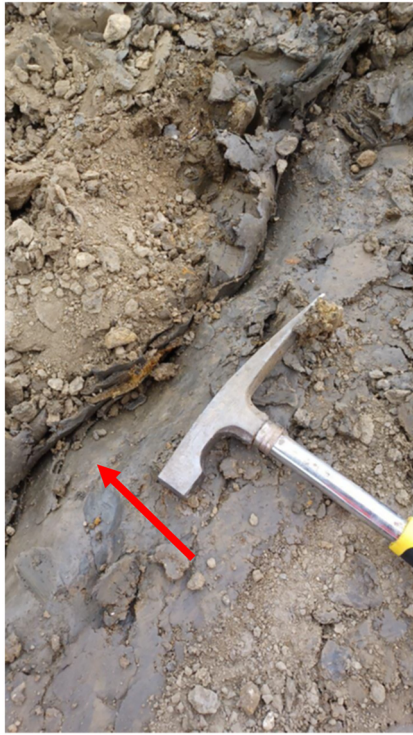
Fig. 5. An individual discontinuity surface at 0.6 m bgl in the Charmouth Mudstone Formation (Lias Group) near Ladbroke (LA), Warwickshire.

of between 0.5 and 2 m, but the outer limit of one ‘pillow’ form was often very closely to closely underlain or overlain by an adjacent ‘pillow’. Individual patches and fields of overlapping shears in this form extended for up to 100 m. Reliable orientation data were difficult to obtain, but undulose shears at *c.* 5–15° dip were intersected by steeper shears of similar persistence with dips of up to 60°. The higher angle shears had a clear southward-dipping orientation, toward the hill.

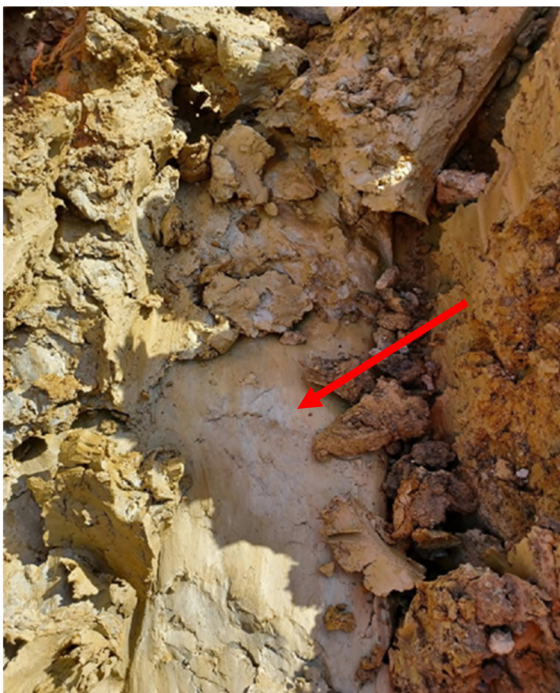
Fig. 8. Shallow dipping, undulose, closely spaced shears (Type 1) at 0.6 m below the original ground surface in orange to brown mottled grey silty clay of destructured Whitby Mudstone (Lias Group) near Brackley (BR), Northamptonshire.

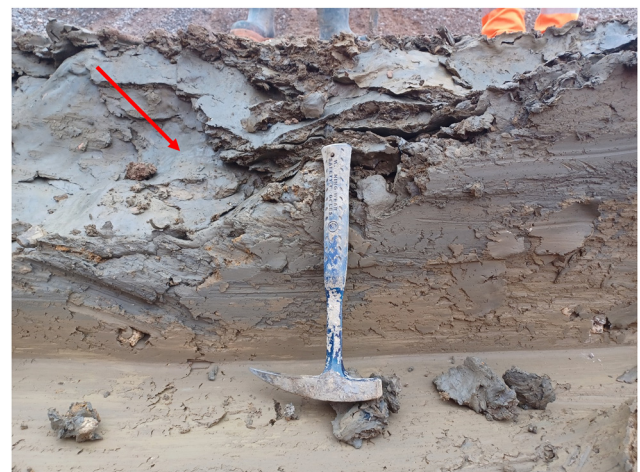
Fig. 9. Frequent shallowly becoming steeply dipping, undulose, closely spaced shears (Type 1) in head deposits at 0.6–0.8 m depth below original ground level in excavations near Waddesdon (WA), Buckinghamshire. The hammer is 330 mm long.

Excavation of the upper 2 m revealed numerous periglacial discontinuities both within the head deposits and at the base of the destructured clay below (Fig. 9). Periglacial discontinuities were present in multiple locations of the complete linear excavation, with

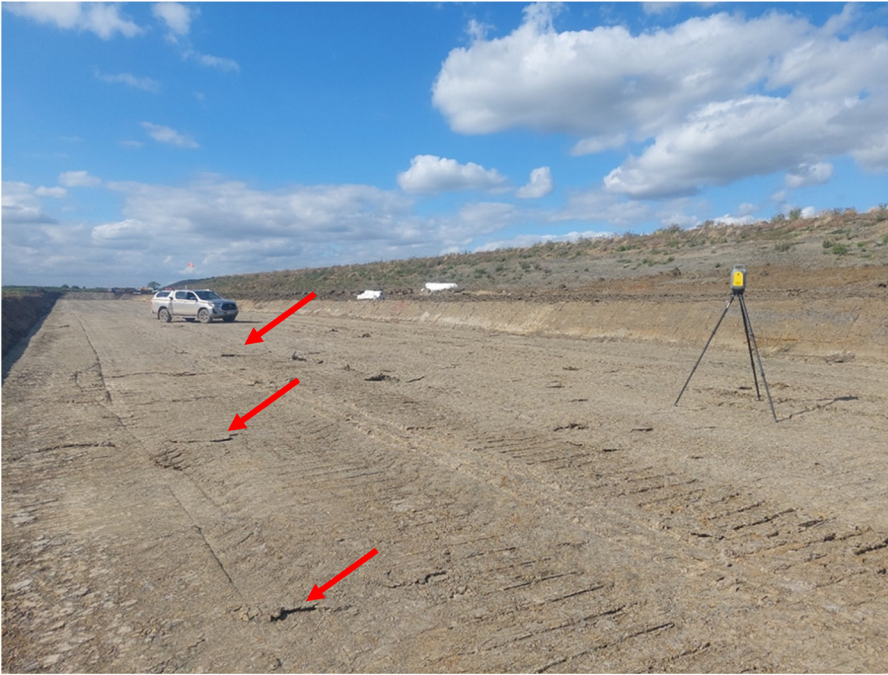
Fig. 10. The base of a 2 m excavation near Waddesdon (WA), Buckinghamshire. Some deeper shear surfaces are evident over a 40 m length after initial proof rolling with a vibrating roller.

10 m exposed length at the designed base of the excavation. Figure 10 shows that the deepest sheared surfaces became more evident after proof rolling at the base of the excavation with a vibrating roller. Some temporarily over-steep (~1 in 2) excavation sidewalls showed instability within one day of excavation, including an ~100 m long, 1–2 m deep mass in the head deposits and the destructured clay (Fig. 11). This was activated along numerous, discontinuous shear surfaces, rather than a planar basal (Type 2) shear surface.

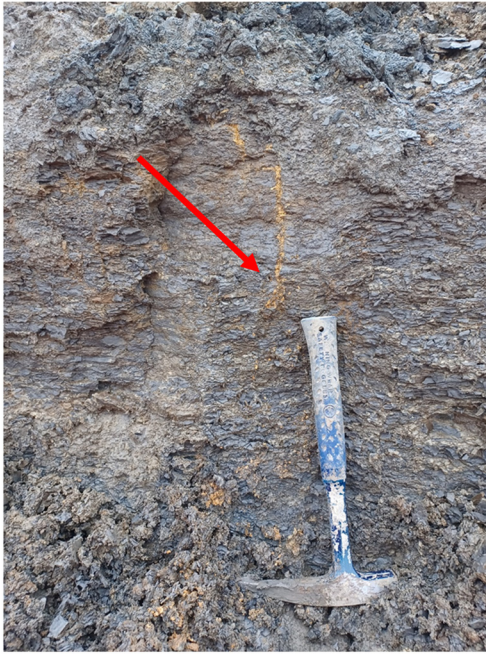
Fig. 12. Orange yellow silt and sand filled thin subvertical veins (Type 7 contraction cracks) in extremely weak mudstone (at *c.* 2.5 m below original ground level) become folded and irregular as they terminate in the overlying weathered clays of the Kimmeridge Clay Formation (Ancholme Group) in an excavation near Aylesbury (AY), Buckinghamshire. The hammer is 330 mm long.

Towards the north of the site, extremely weak bluish grey and brown laminated mudstone at 2.5–3 m bgl contained orange and yellow silt and sand-filled thick subvertical veins. These veins became folded and irregular upward as they terminated in the weathered clays above (Fig. 12).
