The Evolution of White Etching Cracks (WECs) in Rolling Contact Fatigue-Tested 100Cr6 steel

A.D. Richardson[a]*, M.-H. Evans[a], L. Wang[a], R.J.K. Wood[a], M. Ingram[b], B. Meuth[a]

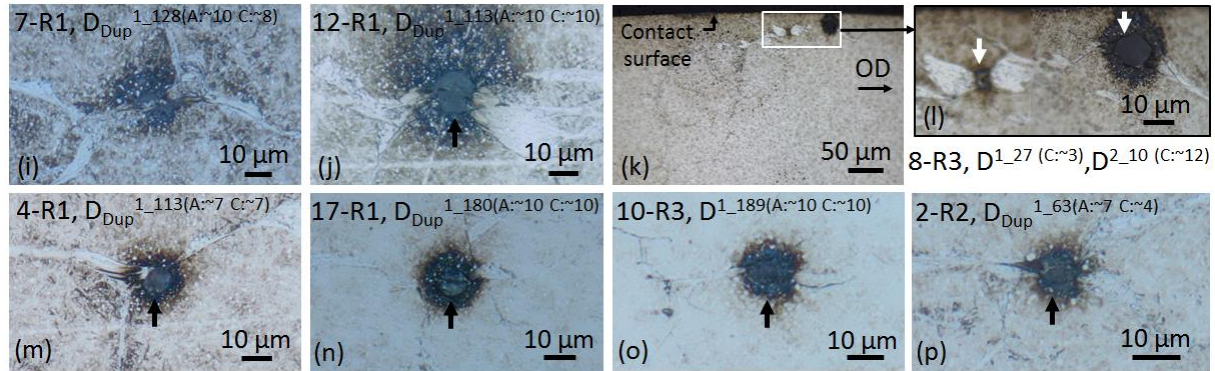
10 individual WECs were recorded. 8 of these were mapped from start to finish (imaging at every slice), no surface connections being recorded. Through WEC tomography, the 3D morphology of one of the fully mapped WECs (WEC-10 R2) can be seen in **Video 1**. 5/8 WECs had their respective images at x500 magnification aligned in strips from start to finish, an example is shown in **Fig. 8**. 24 butterflies were recorded. 12 inclusion interactions were recorded (see **Fig. 8** and **9** for examples), 9 inclusions interacting with the 8 fully mapped WECs, with multiple inclusion-WEC interactions being recorded for single WECs. Every WEC had at least 1 inclusion-WEC interaction. Small sized (~2-15 μm) globular sulfide-oxides (D_{Dup}) and globular oxide (D) were the most common inclusions found. All 12 inclusions were evaluated as having either a rank of 1

Through analysis of 3x rollers only, one WEC (WEC-9 R1) was found, this WEC being comparable (but smaller in size) to the smallest WECs recorded at 6 hours. It should also be noted that this WEC could be judged as a butterfly, however due to the forking nature of the crack tip it is of the authors opinion that this is an extended butterfly or WEC. WEC-9 R1 was subsequently mapped (serial sectioned). No connection to the surface was made. After mapping, standard sectioning resumed.

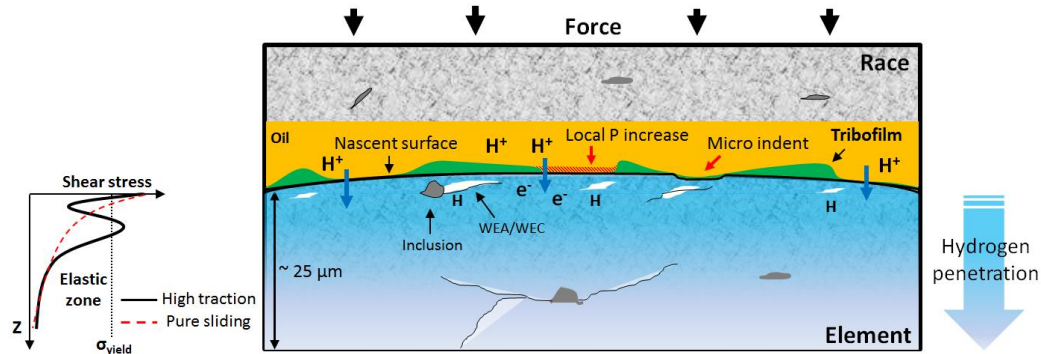
(ii) micro-indentations at the contact surface causing local regions of mixed/boundary lubrication regimes increasing the traction coefficient; (iii) areas of localised increase in contact pressure, and (iv) increase in the concentration of mobile diffusible hydrogen over longer RCF operation [44], where locally at the near surface, higher localised penetration and concentrations may exist and aid in the acceleration of these features. **Fig. 15** illustrates the hypothesised mechanisms for the formation of these features.

Fig. 15. Hypothesised mechanisms of near surface (<25 μm) WEA/WECs formation. H^+ denotes molecular hydrogen, H denoting mono atomic hydrogen diffused into the bearing steel. e^- denotes free electrons at the fresh nascent surface. 'P' and 'σ' denote pressure and yield stress respectively.

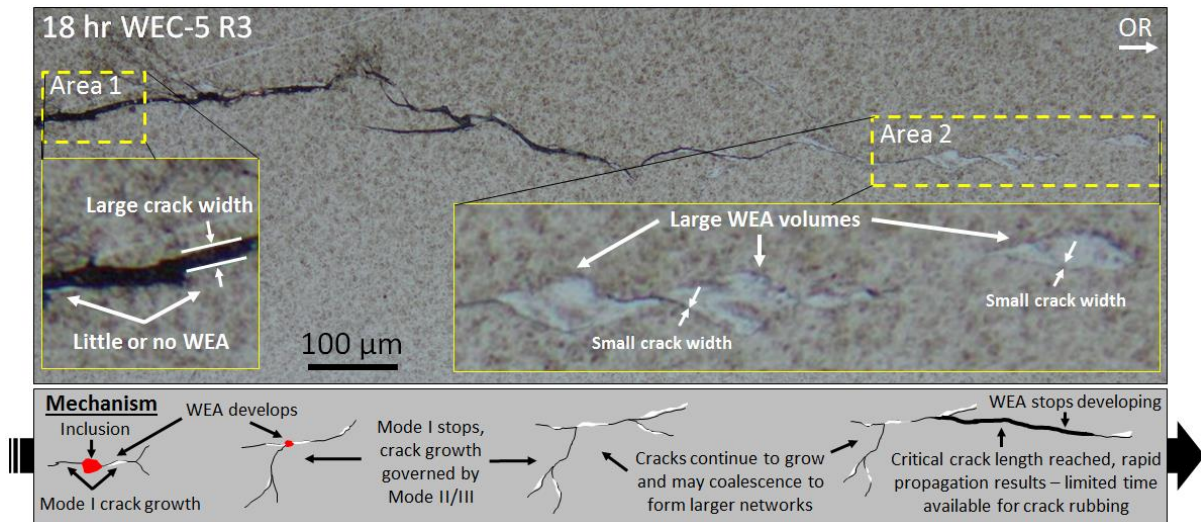
Through metallographic analysis it is indicated that the angle of crack propagation, crack width and zone of maximum subsurface shear stresses, can influence the degree of WEA generated. WEA analysis has shown that the amount of WEA associated with a crack increases the nearer to 0° or perpendicular to the axis of compression a crack propagates (see **Fig.14 (c)**). A vertical crack ±90° parallel to the axis of compression is found to have very little WEA associated (see **Fig.14 (c)**). This is also exhibited clearly in the 18 hour crack shown in **Fig. 17**. As suggested by others [36], it is proposed that a vertically branching crack will be subjected to a much lesser amount of crack rubbing. The localisation of strain has been found to be strongly reliant on crack orientation in relation to stress [63]. High strain rate compressive tests have shown regions of WEA [64], this being in comparison to equivalent tensile tests, as a result it is proposed that crack rubbing/beating under RCF shear stresses or compressive loading result in WEA formations and thus adiabatic shearing is an unlikely cause [65]. The crack width also appears to influence WEA formations. For example in **Fig. 18** it is seen that very little or no WEAs are associated with sections (Area 1) of the WEC that have large crack width when compared to crack faces that are close together (Area 2). It is proposed that for adjacent crack faces that are further apart, less action is available for crack rubbing/beating. This is not to say however that these particular areas of the WEC network would have not been associated with WEAs at some point during operation. The proposed mechanism (see **Fig. 18.**) to explain this is as follows; (i) Inclusion initiation of butterfly and 'star-like' WECs with subsequent generation of WEAs due to crack rubbing/beating. (ii) WECs propagate and WEAs continue to develop. (iii) short crack growth from inclusions/butterflies by Mode I loading [66] stops and further growth is governed by Mode II/III shear loading if the Mode II/III stress intensity factor threshold is surpassed [66], WECs may propagate and coalesce to form larger networks. Until a critical length is reached, crack growth rate may be slow, where once exceeded rapid propagation results under applied stress. (iv) Due to the rapid growth of the crack and crack volume, the time and action available for WEA development is alleviated and thus a reduction or non-existent presence of WEA is seen. In the event of hydrogen diffusion, hydrogen acts to decrease the Mode I/II stress limits for crack growth and propagation [66, 67], it may be reasoned that this step increase in WEC formations is due to a threshold concentration of hydrogen being reached for a decrease in Mode II crack growth [44].

Fig. 17. Optical image of a WEC demonstrating the influence of crack angle w.r.t the axis of compression and depth of maximum subsurface shear stresses ($\tau_{0, max}$ = 92 μm, $\tau_{uni, max}$ = 145 μm) on the formation of WEAs. (a) Area 1 and 2 show two different orientations of crack propagation, Area 1 shows cracks at an angle θ to the axis of compression along with a vertical crack parallel to the compression axis, and the zones of maximum subsurface shear stresses are also shown. Area 2 shows a vertical crack parallel to the compression axis. (b) and (c) show magnified x500 images of the two areas respectively. (d) Is a schematic demonstrating the influence of crack orientation angle w.r.t the direction of compression and the associated action of crack rubbing/beating.
