Title: Observing early stage rail axle bearing damage

Observing early stage rail axle bearing damage

A novel condition monitoring system has for the first time enabled reliable extraction from service and detailed forensic examination of failing rail axle bearings, before the usual catastrophic destruction of the evidence. Computed Tomography has been used to produce a map of the damage allowing targeted sectioning of subsurface cracking. Traditional metallographic techniques have revealed large white etched layers associated with the subsurface cracking, while observations with a scanning electron microscope have confirmed rolling contact fatigue crack propagation, possibly initiated from pre-existing electrical arcing damage of the raceways.

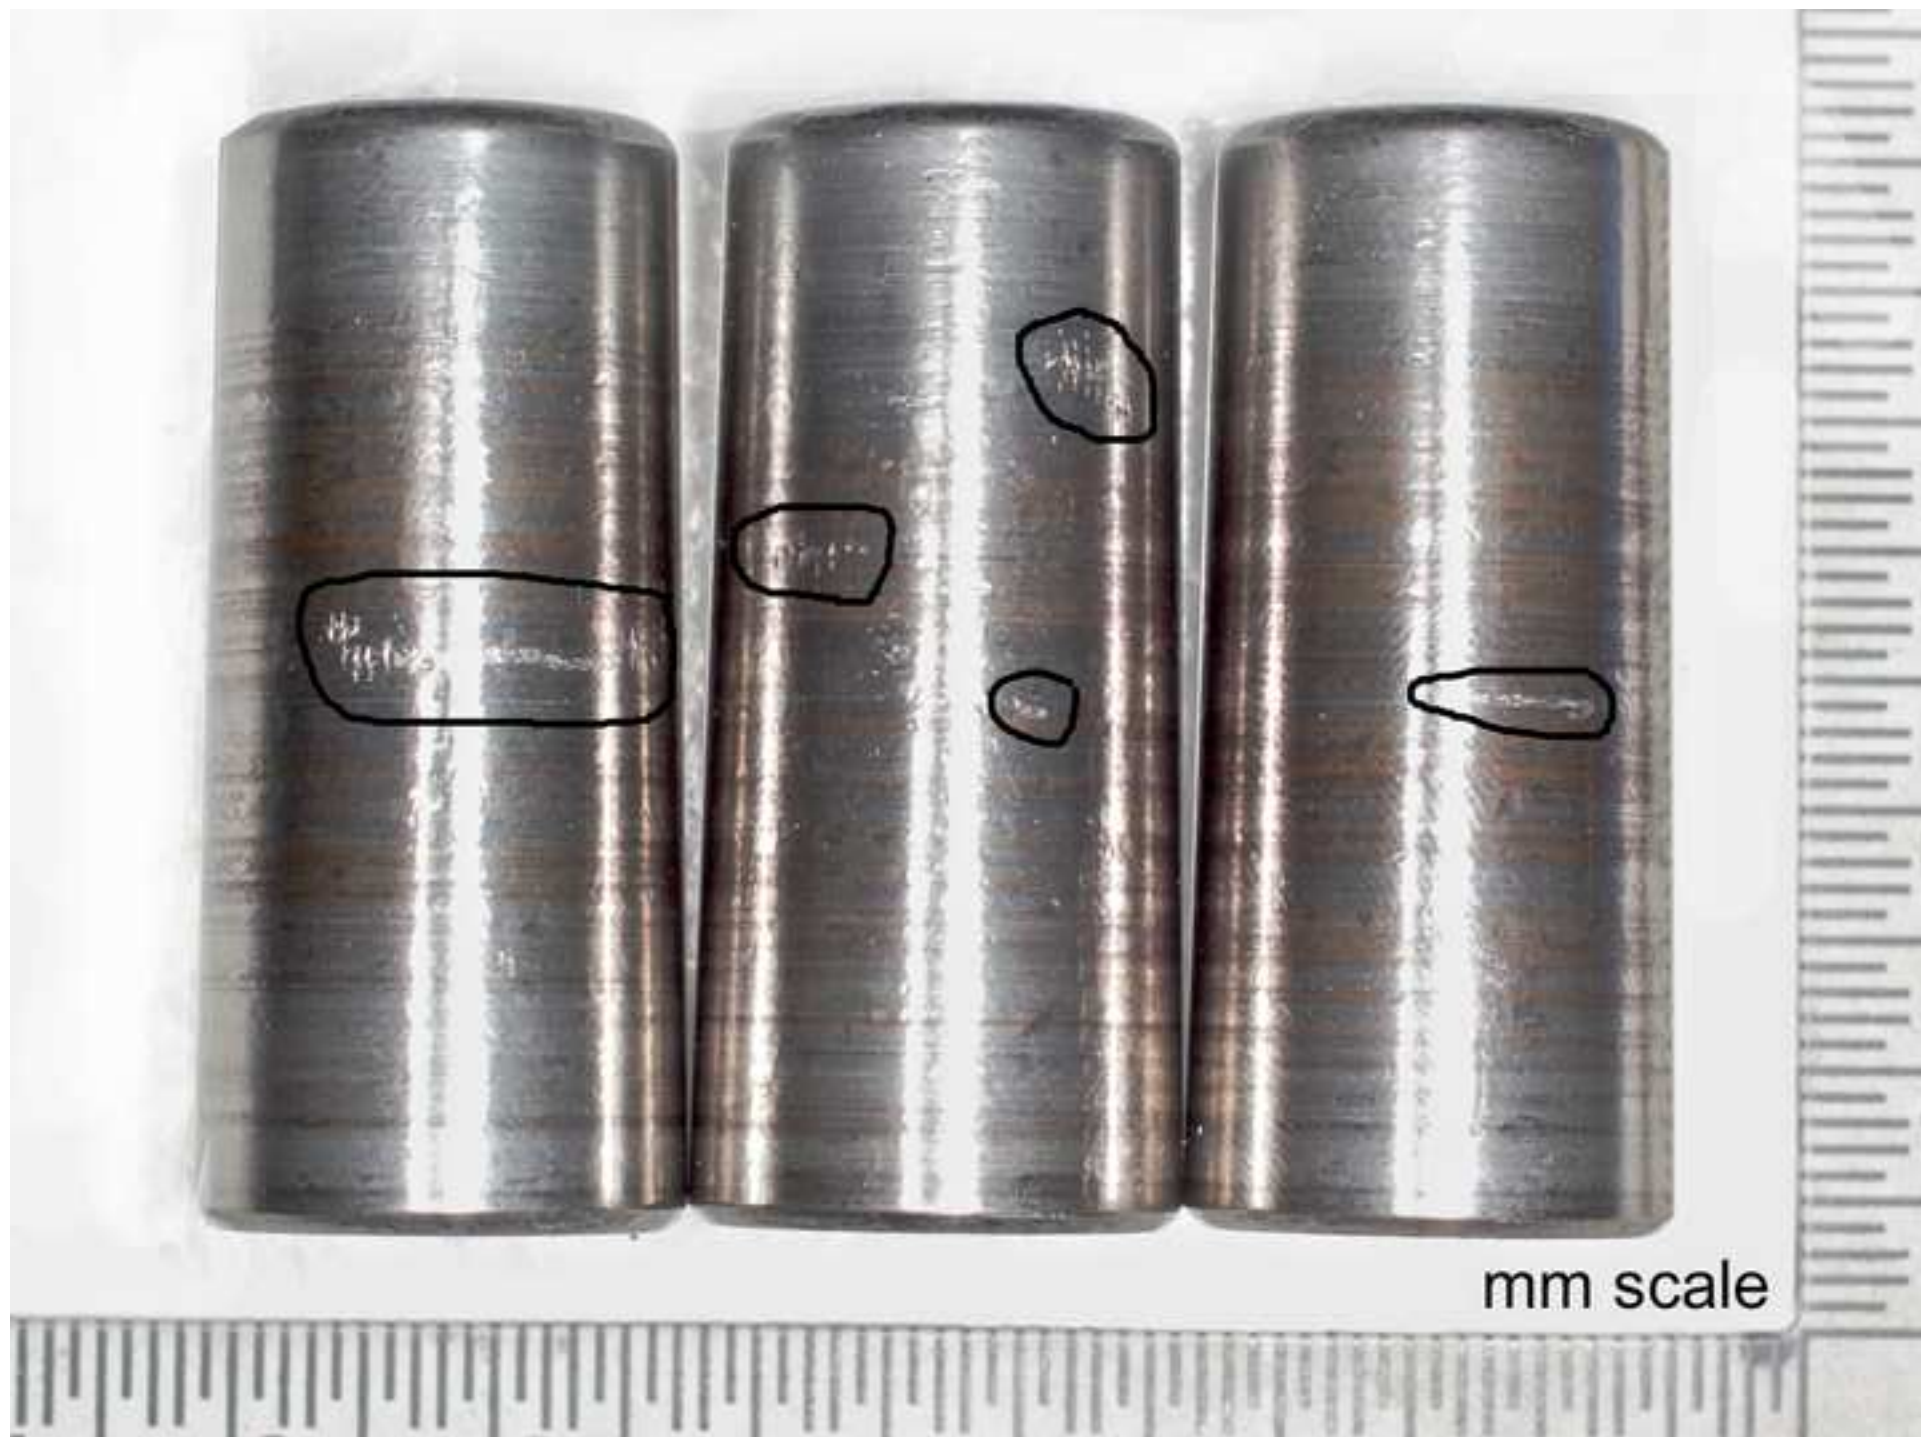
Figure 13 90mm 500dpi
[Click here to download high resolution image](#)

- Figure 13. Three consecutive tapered rollers from the inboard side of the failed bearing. Sites of suspected electrical pitting are circled.
- Figure 14. Two montage images displaying the orientation, position and pattern of one group of electrical pitting marks found on both a roller and the inner (cone) ring.

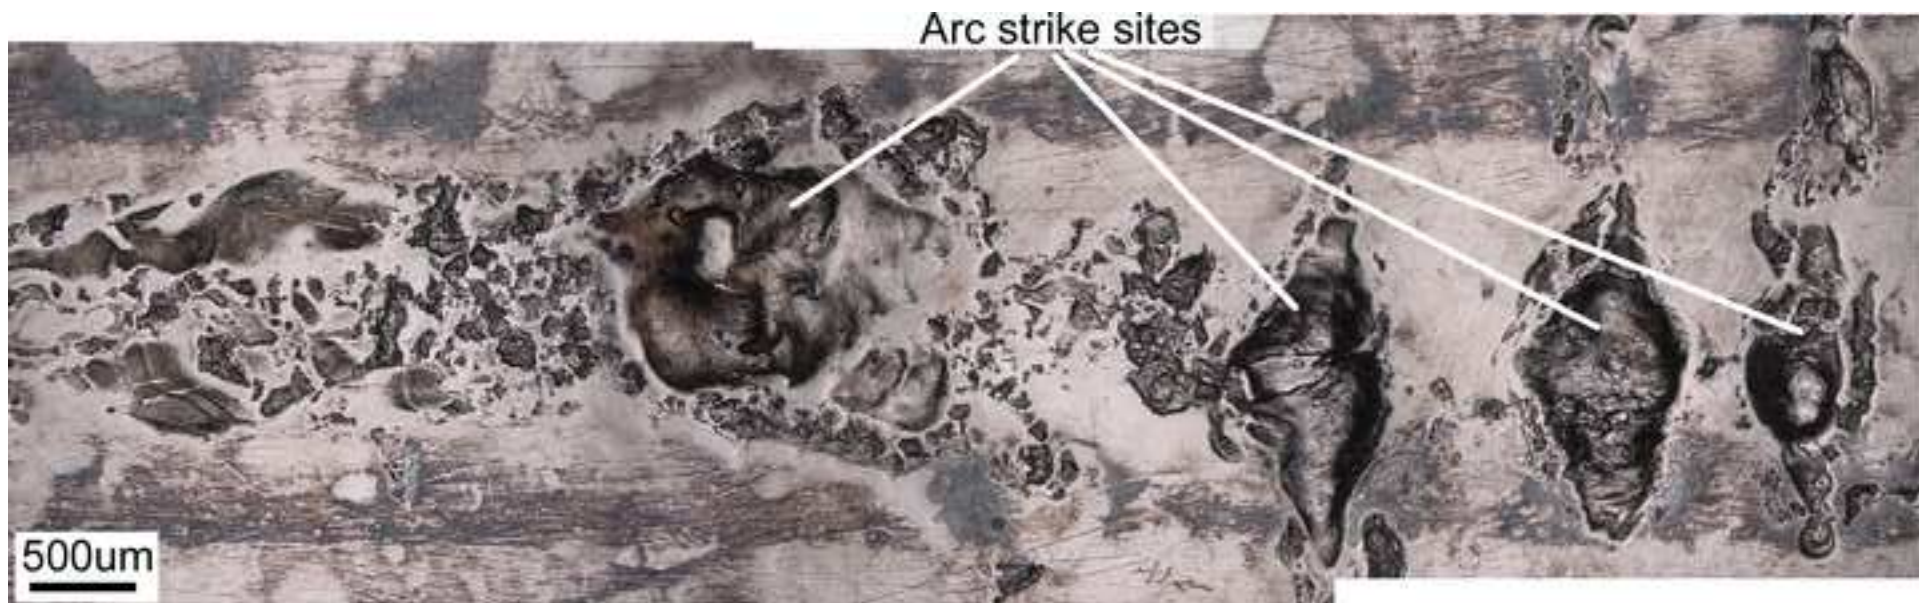
Figure 15 140mm 500dpi
[Click here to download high resolution image](#)

- Figure 15. Montage microscope image showing part of a group of pit marks created by electrical arcing on a roller.
- Figure 16. Line profile with insert showing render of a three-dimensional Alicona 3 cm wide strip of bearing damage.

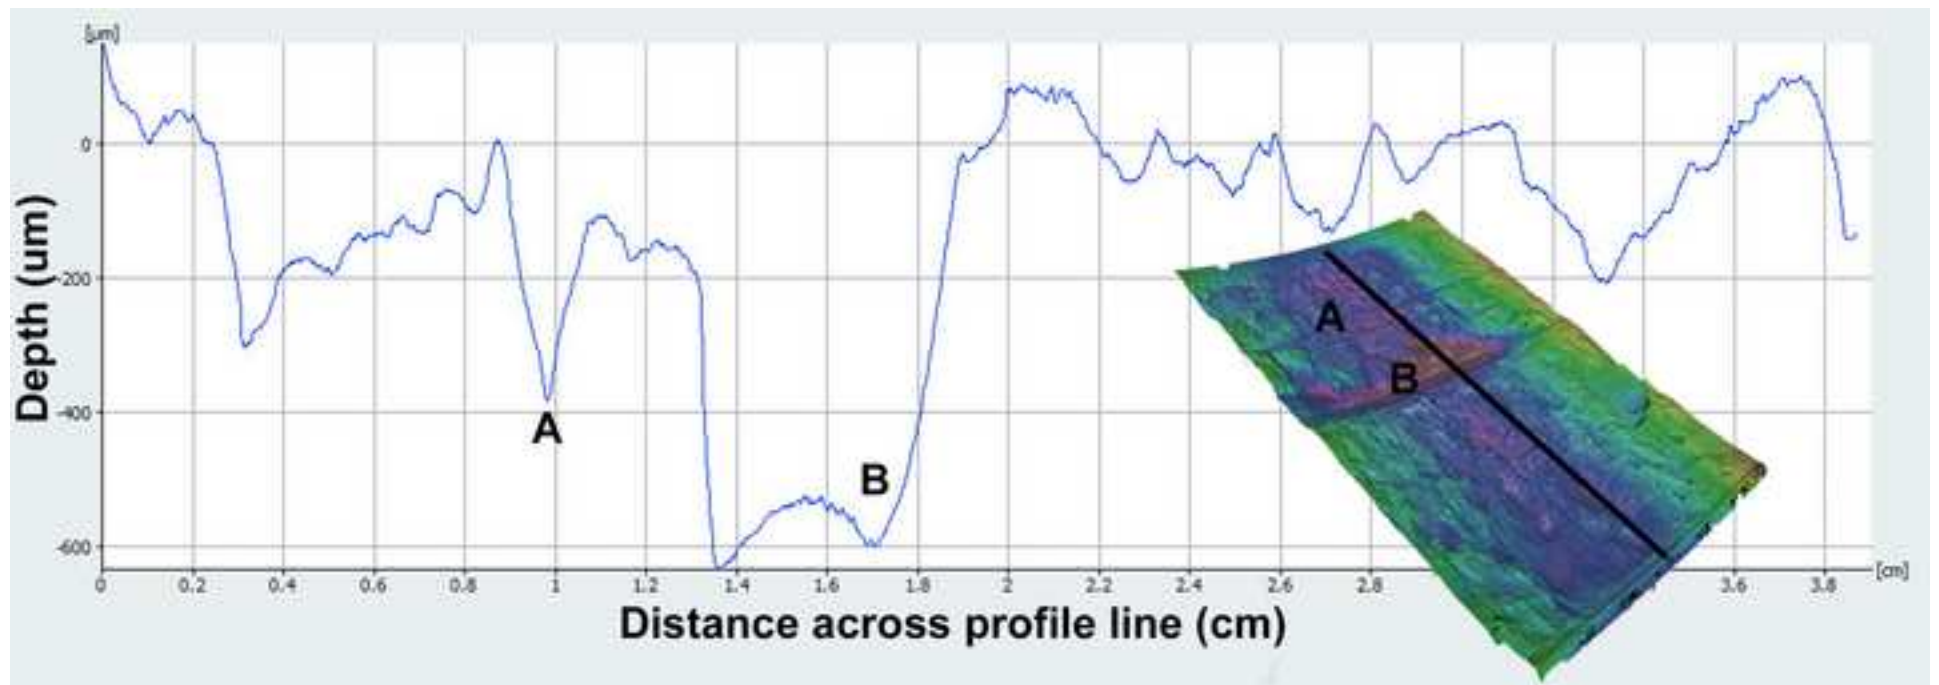
Figure 16 140mm 500dpi
[Click here to download high resolution image](#)

The maximum and average depth of damage to this current bearing were 0.824 mm and 0.215 mm, respectively; the damage covered the full width of the raceway and extended to 60° of the circumference. This large width to depth ratio is typical of RCF bearing failures, which are driven by the Hertzian shear stresses. Equations reproduced in [Ref 2] can be used to determine the depth of maximum Hertzian shear stress for a line contact of a roller on a flat surface. Approximating the bearing taper geometry and using a static bearing loading of 35 kN, the Hertzian depth can be found to be ≈ 0.58 mm, however this depth increases with loading. Interestingly the white etched layers (see Figure 16) were found at depths of ≈ 0.4 mm and 0.6 mm (A and B respectively), which are clearly within the band of maximum shear stress. This result suggests that the high loading event created the two layers.

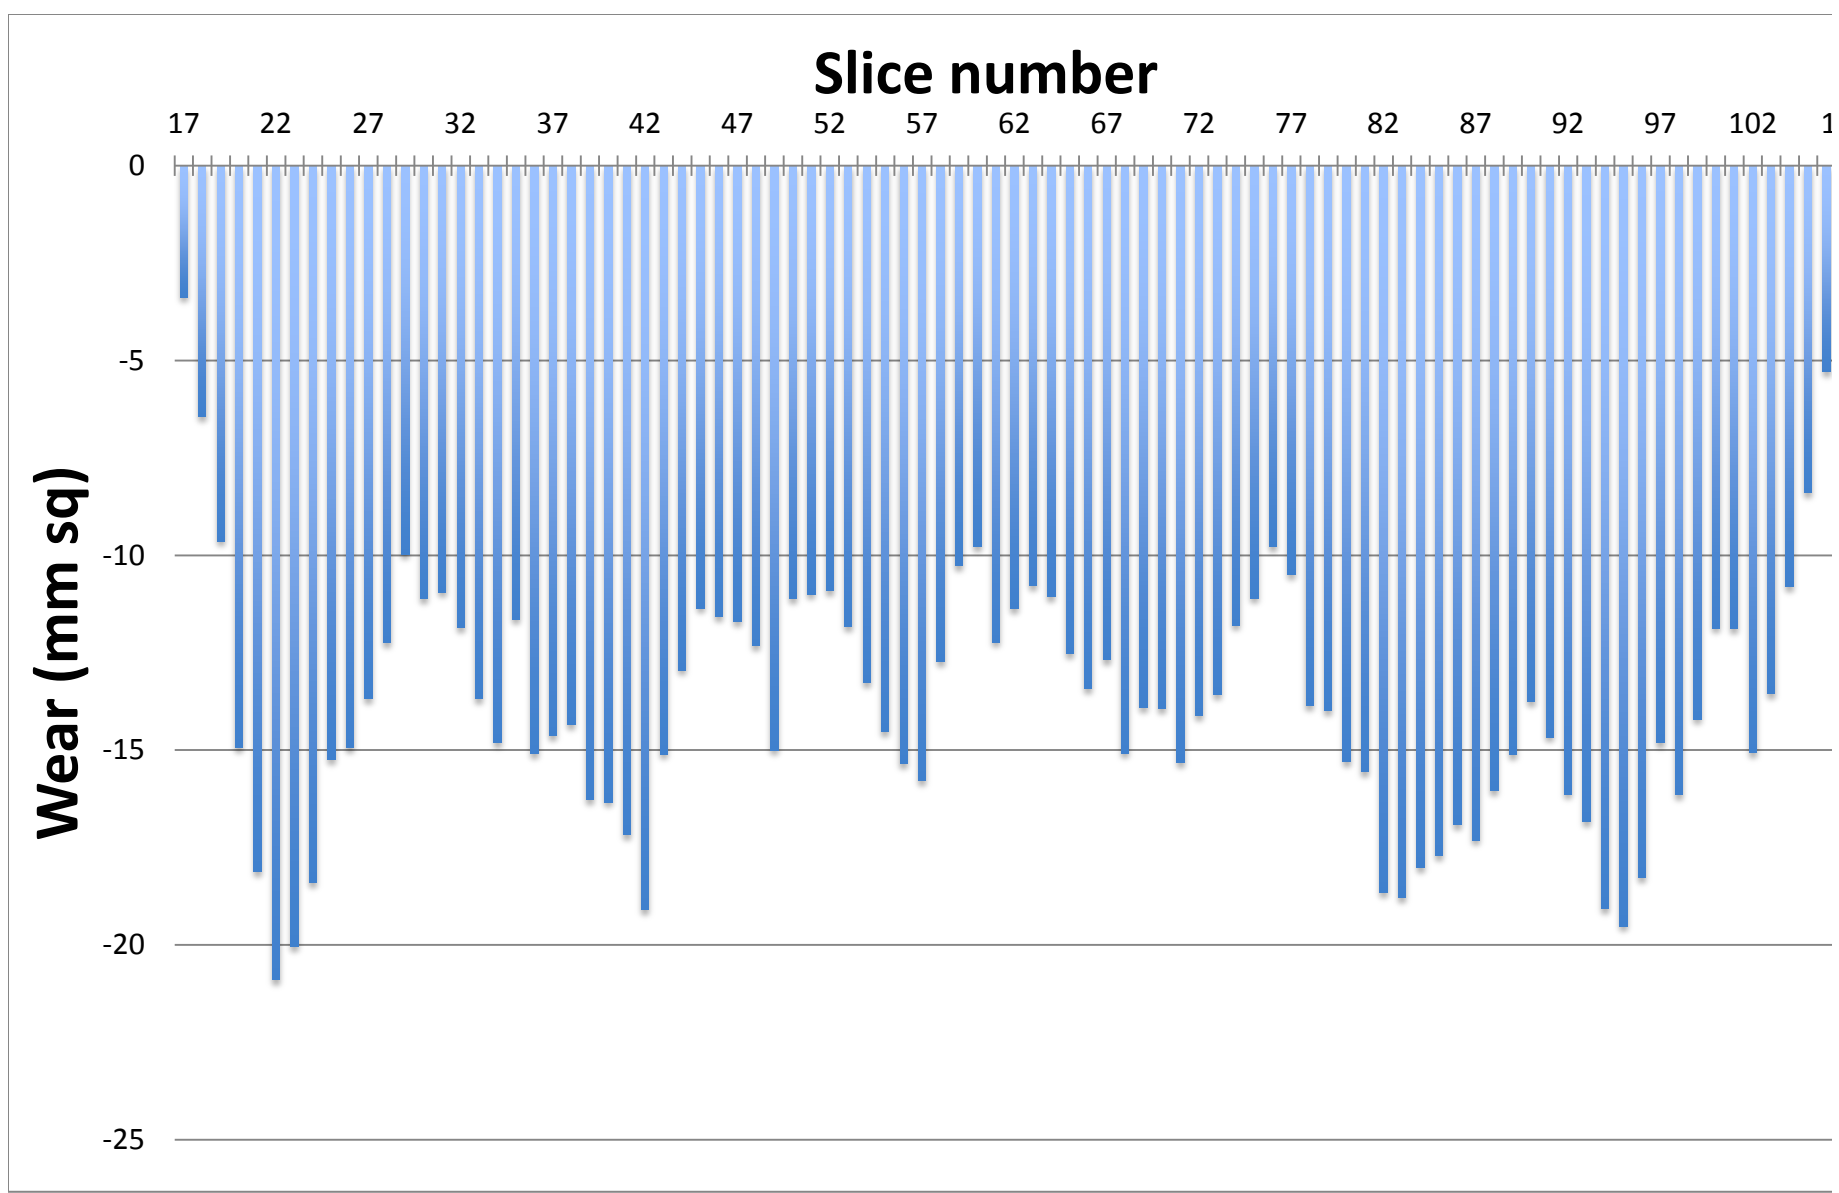
Figure 20 excel graph

- Figure 19. Graph showing Talyrond data. For clarity the profile depth of the 10 mm and 20 mm data have been off-set by +2 and +1 mm, respectively.
- Figure 20. Graph showing the wear measured from each CT slice through the damaged bearing.

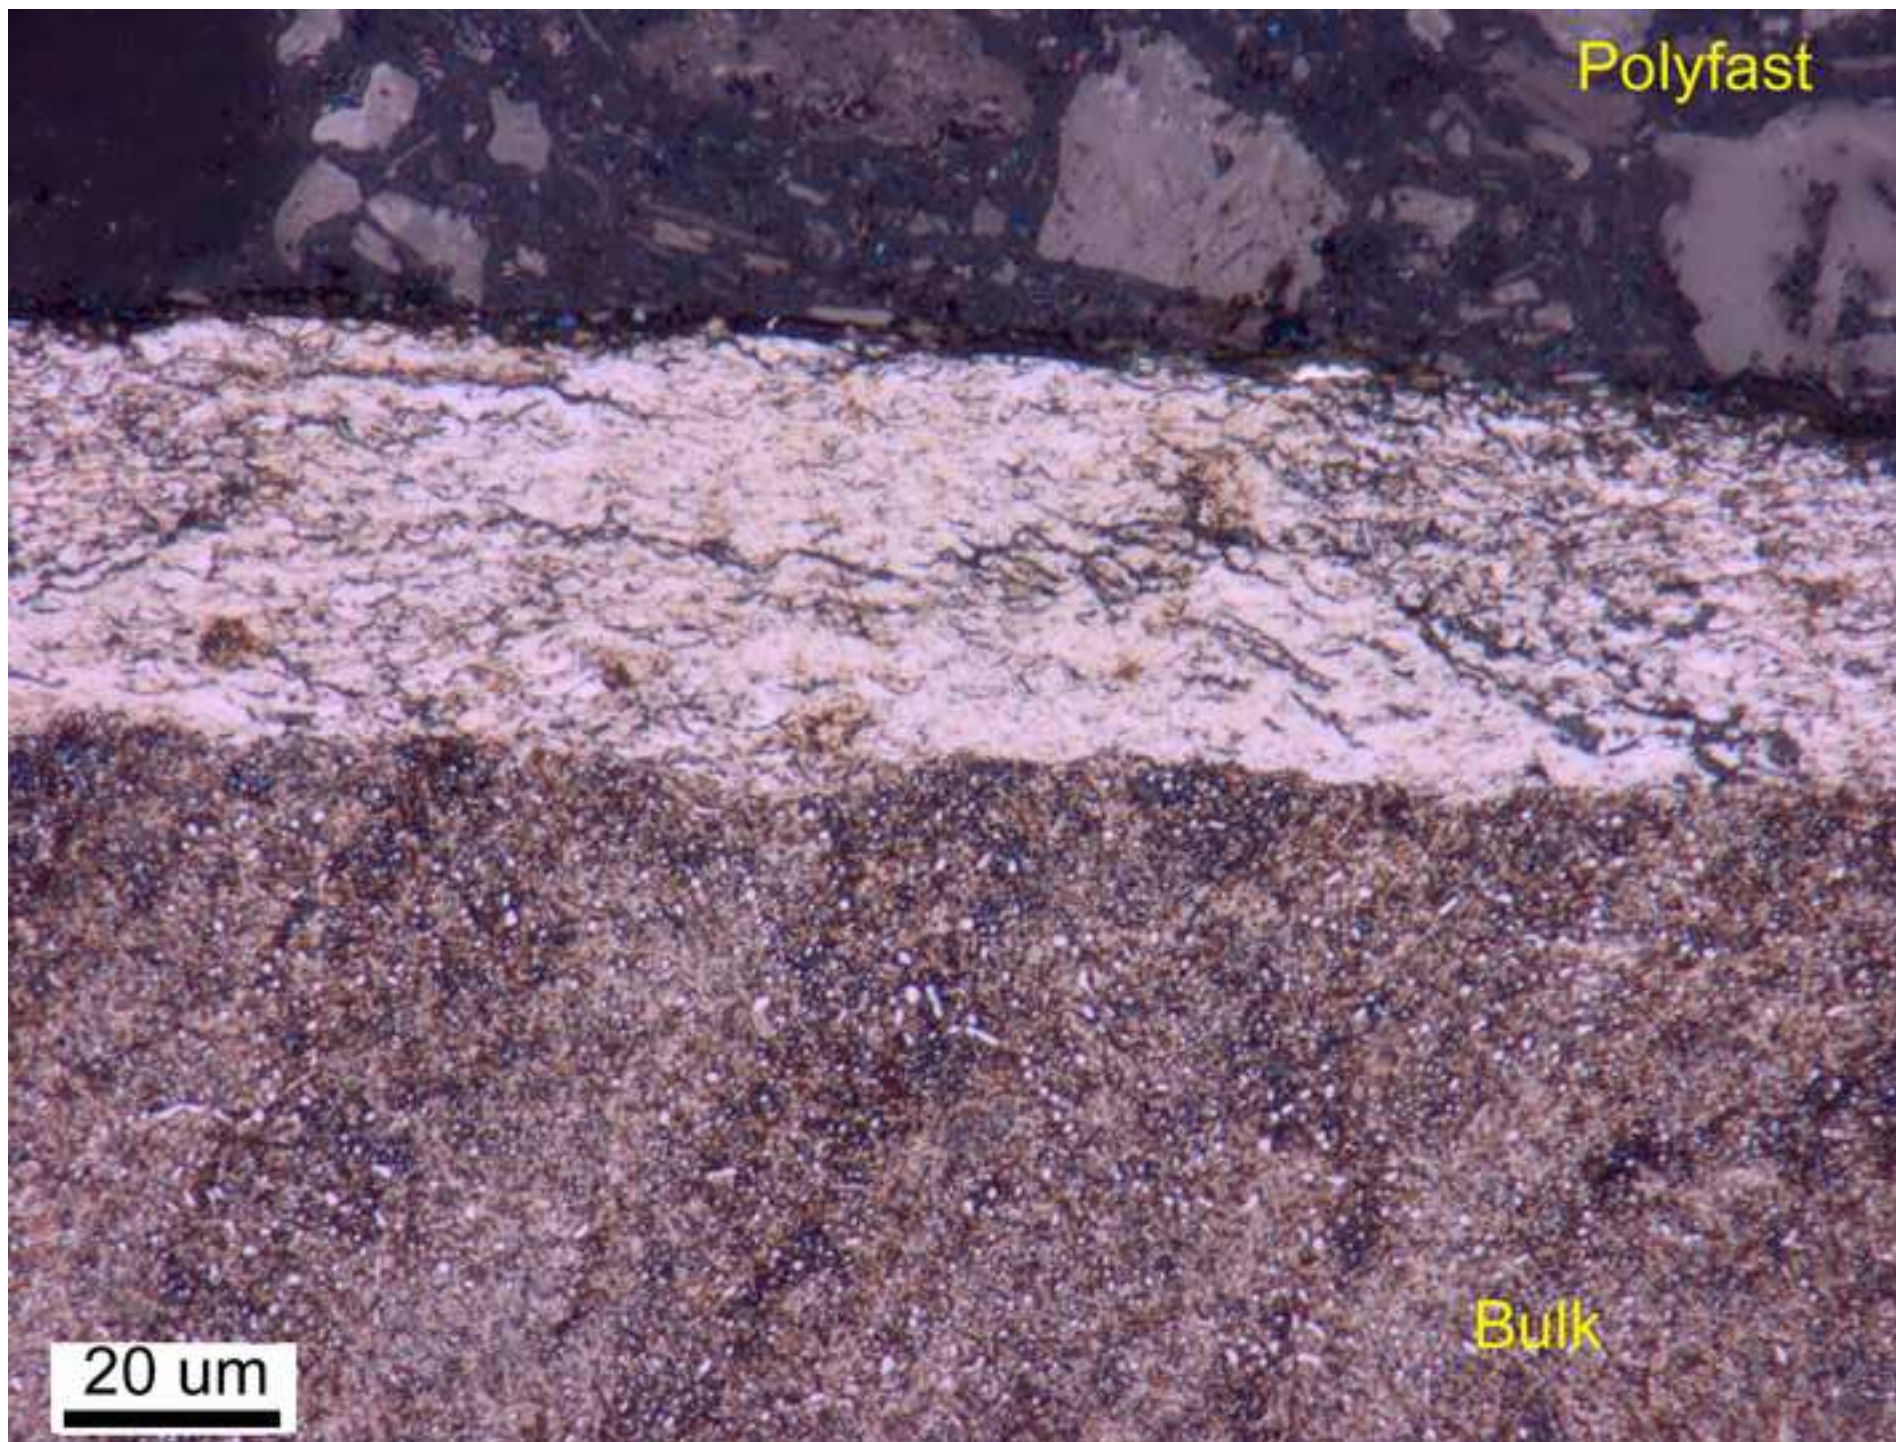
Figure 25 90mm 500dpi
[Click here to download high resolution image](#)

7, 11 and 12. When sectioned, polished and etched, the layers retained a white hue when viewed with optical microscopy. The composition of the white etched layers found in the sample has not yet been determined. It can be assumed that they are not inclusions, as EDAX examination did not find any unusual compositional elements present. In Figure 27 the white etched layer can be differentiated based on contrast; elements of greater atomic mass (the white layer in this case) appear brighter in a back-scattered electron image. It is postulated that the layers are transformed bulk material, which occurred due to large subsurface shear stresses. Further inspection and examination of the white layers with nano-hardness and EBSD is planned and will be reported at a later date. Whatever their composition, the white etched layers clearly contain many micro-cracks and voids (see Figures 24-27) and are present across most of the damaged arc (Figure 7). The layers are also externally smooth with clearly defined edges and as such represent a significant stress discontinuity with the surrounding bulk material (no local 'keying' or blending). The layers have been identified as the origin sites of fractures (see Figures 11, 12, 23 and 24). Those fractures display features consistent with a cyclic crack propagation mechanism, confirming the presence of RCF. RCF was further identified through the shape and form of the debris collected from the bearing grease.

- Figure 25. Optical image of the white etched layer. This section was made in rolling direction across slices at site B as highlighted in [Figure 23a](#). The sample was etchant with a 2% Nital solution.

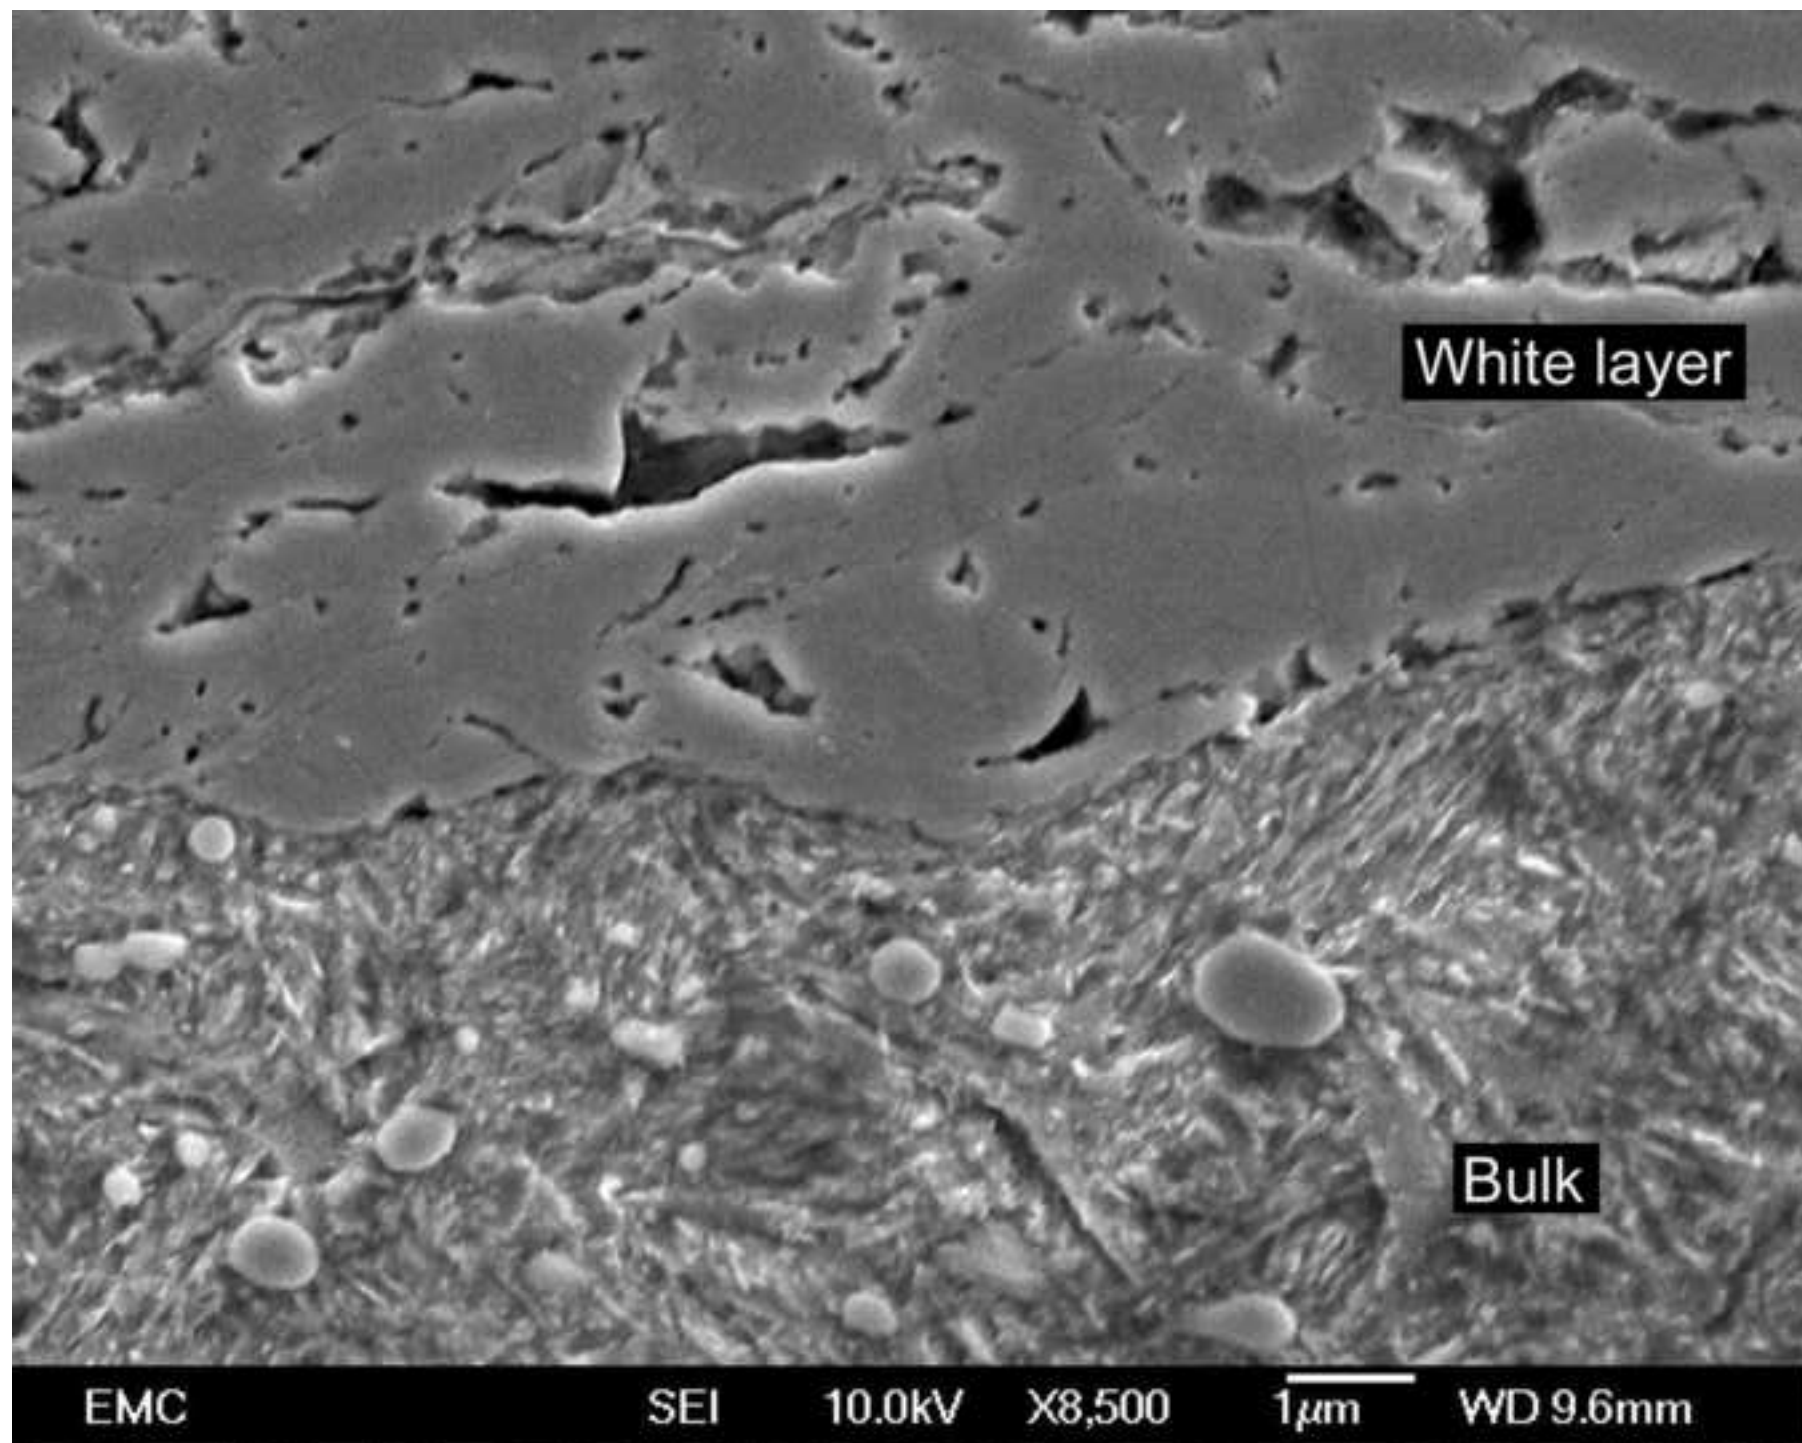
Figure 26 90mm 500dpi
[Click here to download high resolution image](#)

- Figure 26. SEM micrograph showing the polished and etched cross-section of the interface between a white layer (top part) and the bulk bearing steel (lower part). The sample was etched with a 2% Nital solution.

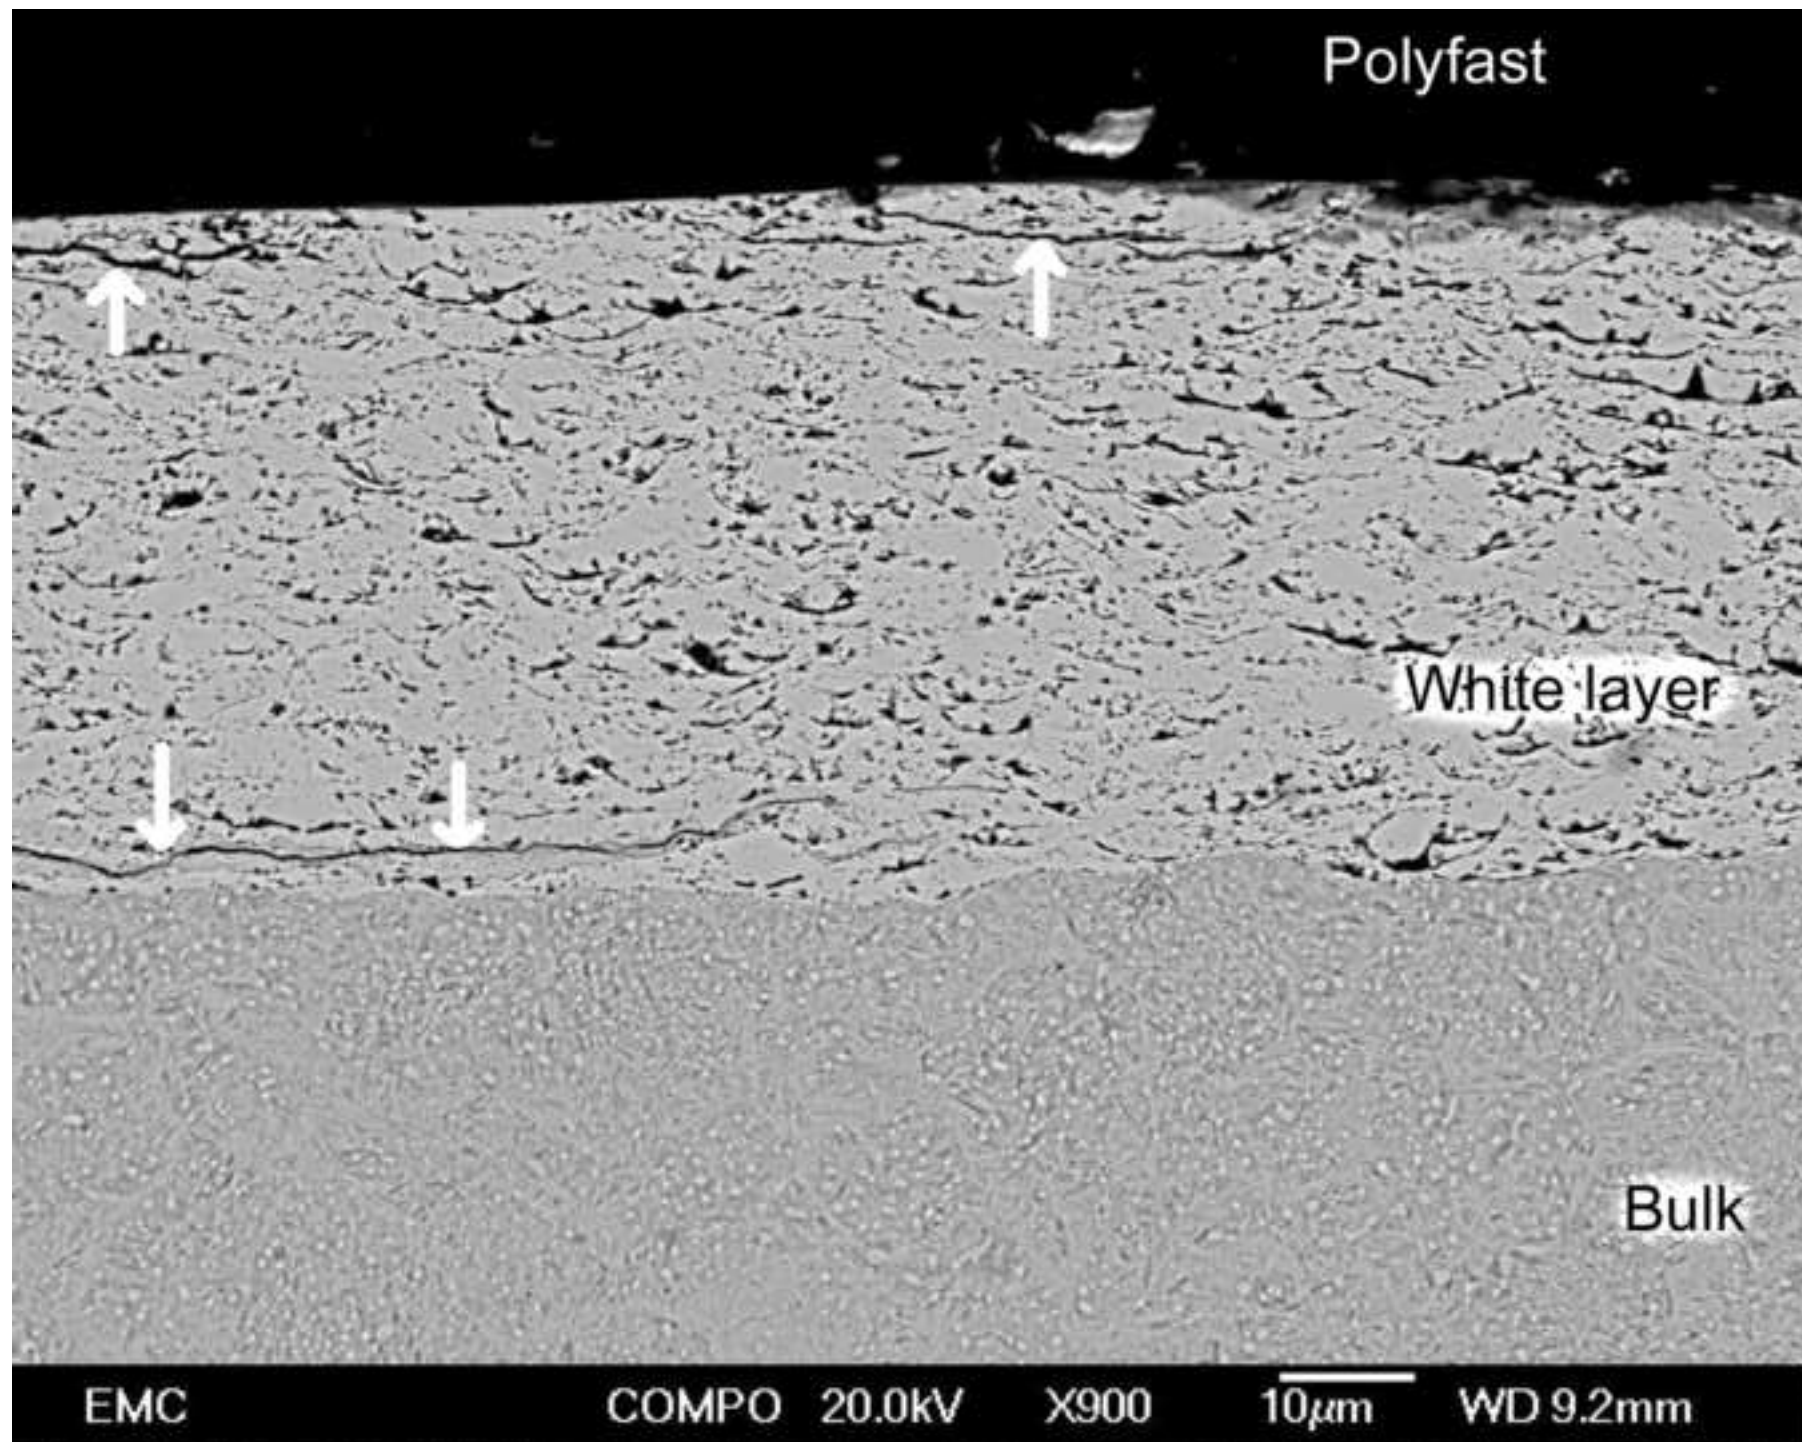
Figure 27 90mm 500dpi
[Click here to download high resolution image](#)

Figure 27. SEM micrograph in backscatter mode showing the white etched layer and the bulk bearing material.
