# The influence of structural response on ballast performance on a high speed railway

David Milne<sup>1</sup>, Louis Le Pen<sup>1</sup>, William Powrie<sup>1</sup>, David Thompson<sup>1</sup>,  
Geoff Watson<sup>1</sup>, Simon Morley<sup>2</sup>, Mick Hayward<sup>2</sup>

<sup>2</sup> Network Rail High Speed Ltd, London, United Kingdom

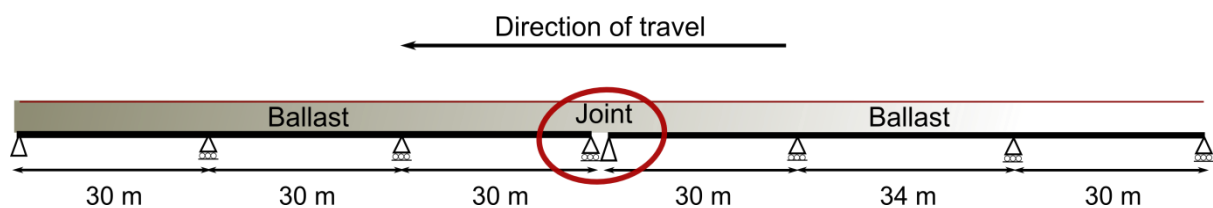
Figure 1 Configuration of bridge decks either side of structural expansion joint studied

The site investigated is located just beyond a structural expansion joint, where rapid recurrence of a track defect has necessitated regular unplanned maintenance. The joint studied is between two triple span decks of a multi-deck viaduct (Figure 1). Each deck is 30 m long with the exception of the middle span of the deck approaching the defect, which is 34 m. At the joint CWR is supported by a 500 mm depth of ballast over a steel spanning plate between decks (Figure 2). The plate is fixed to the deck approaching the defect and free to move on the other. This design is used for all joints within the bridge and defects were observed at other joints between equal length deck sections. The defect at the joint studied was the most severe, however.

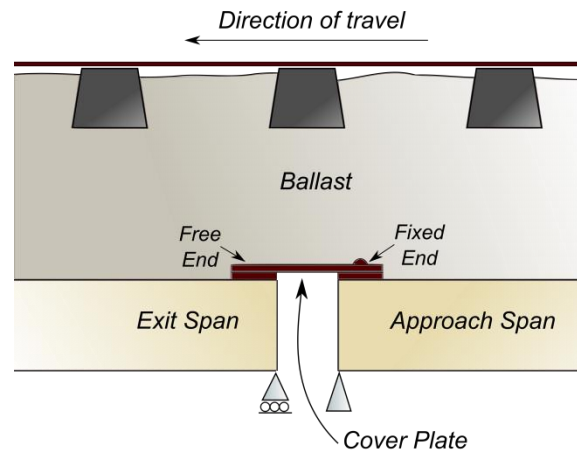
Figure 2 Sketch of expansion joint design.

As the joint design means that the ballast is continuous over the joint this cyclic extension-contraction behaviour could cause localised settlement. If permanent, this may lead to voiding beneath sleepers at this location. Alternatively it could result in a dilative process, which might locally affect structure of the ballast such that it is unable to provide adequate resistant to loads from passing trains or is more susceptible to vibration. Further research into the effects of the bridge behaviour on the ballast is needed to establish in detail how defects may form due to interaction with the bridge.
