UNDERSTANDING THE SEQUENCE OF DAMAGE IN COMPLEX HYBRID COMPOSITE-METALLIC STRUCTURES SUBJECT TO OUT-OF-PLANE LOADING INVESTIGATED USING COMPUTED TOMOGRAPHY

T. Allen*, S. Ahmed, P.A.S. Reed, I. Sinclair, S.M. Spearing

¹Faculty of Engineering and the Environment, University of Southampton, United Kingdom
Email: tma1e12@soton.ac.uk

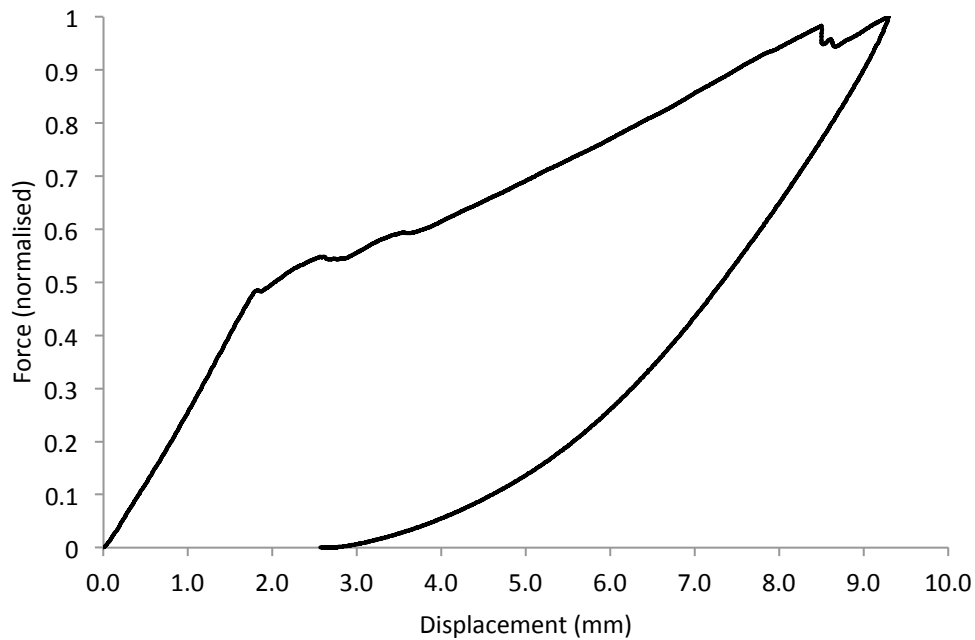
Figure 1: A typical uninterrupted load displacement plot for the HCMS test specimen

A typical load-displacement curve for the HCMS test specimen reveals two key features of interest (Figure 1). The first is indicative of a reduction in the structural stiffness occurring at ~50% off the top load, the second a distinct load drop at ~95%. To describe the sequence of damage a QSI test was performed, with seven CT scan points along the load path for detailed non-destructive damage assessment (Table 1); the peak load was selected as just after the load drop feature. An interrupted test on a single specimen was used in order to account for potential specimen variability seen in preliminary tests. The specimen was tested ex-situ from the CT scanner; i.e. the scans were completed

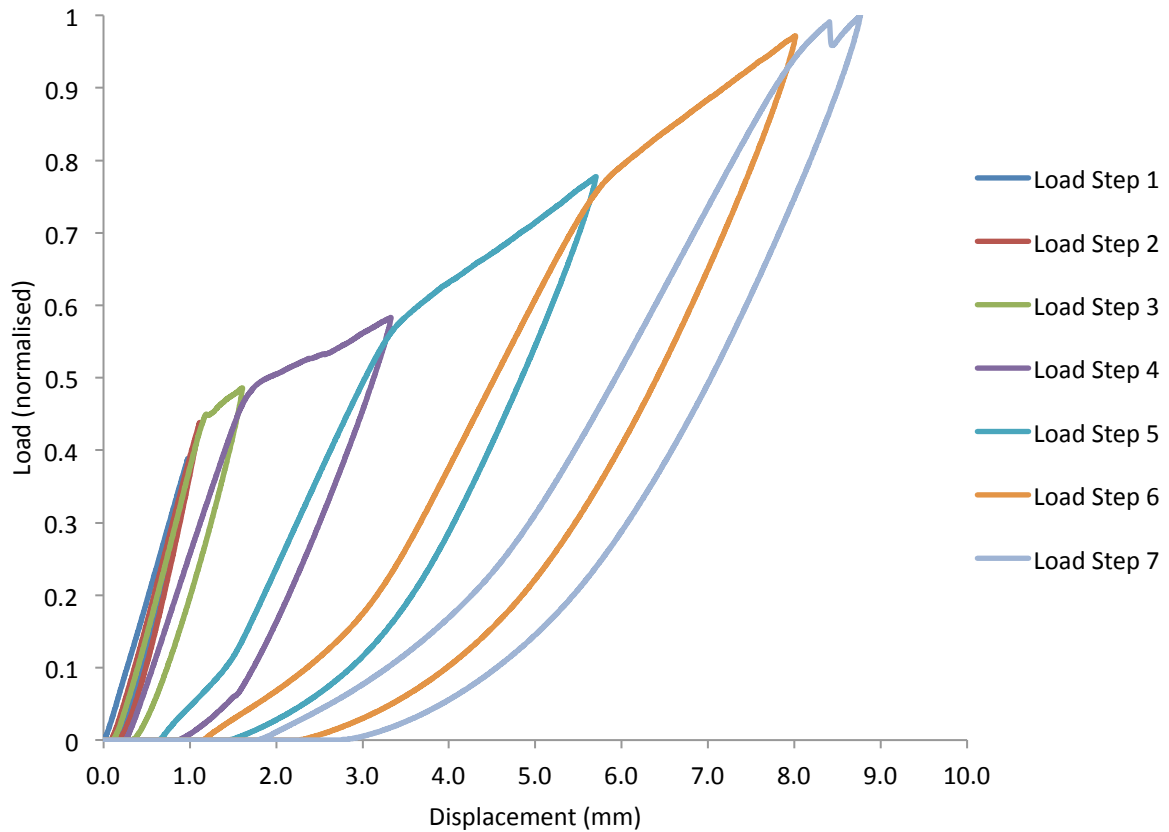
Figure 2: Interrupted quasi-static indentation test

The interrupted test (Figure 2) followed a very similar profile to the uninterrupted tests (Figure 1) indicating that the use of an interrupted test methodology is sufficient to describe the process of damage in the specimen. The first two load steps at 0.40 and 0.45 demonstrated a largely elastic structural response. After 0.45 the response became non-linear. Between the 0.50 and 0.75 load steps the slope of the load-deflection curve remains approximately constant. Increasing permanent deformation is seen with each load step when the structure was unloaded. At a load of ~ 0.98 a distinct load drop occurred.

The aim of this study was to describe the progression of damage in HCMS. Two damage events were observed in the load-displacement curve of the specimen (Figure 2). The first event is not a distinct load drop as noted by other authors on purely composite structures [4, 6], but did cause a reduction to the structural stiffness of the test specimen. The scan data from the first inspection point after this event shows that multiple damage mechanism have occurred. Due to the nature of the test it is not possible to conclude which mechanisms occurred first, or if multiple events happened simultaneously. The small amounts of matrix cracking can be expected to have a limited effect on the stiffness of the CFRP [12] and the aluminium is in the location through the thickness of the highest tensile stress under bending. As such, it is proposed that yielding of the aluminium substrate causes the first reduction in the structural stiffness seen on the load-displacement curve. The second feature of interest on the load-displacement curve is a distinct load drop. The CT data confirmed that fibre fracture occurred in the outermost CFRP ply and more severe delamination at the outer most CFRP ply interface between the final two load steps. It is suggested that the fibre fracture can be attributed to this load drop, due to the presence of the delamination in the penultimate load step. The presence of fibre fracture in this location can be expected to reduce the residual tensile strength of the structure [4].
