INSTRUMENTATION SYSTEMS FOR AND FAILURE MECHANISMS OF
AN
INDUCED SLOPE FAILURE PROJECT

Document presented for PhD in the Department
of Civil Engineering, University of Southampton.
February 1996.

ABSTRACT

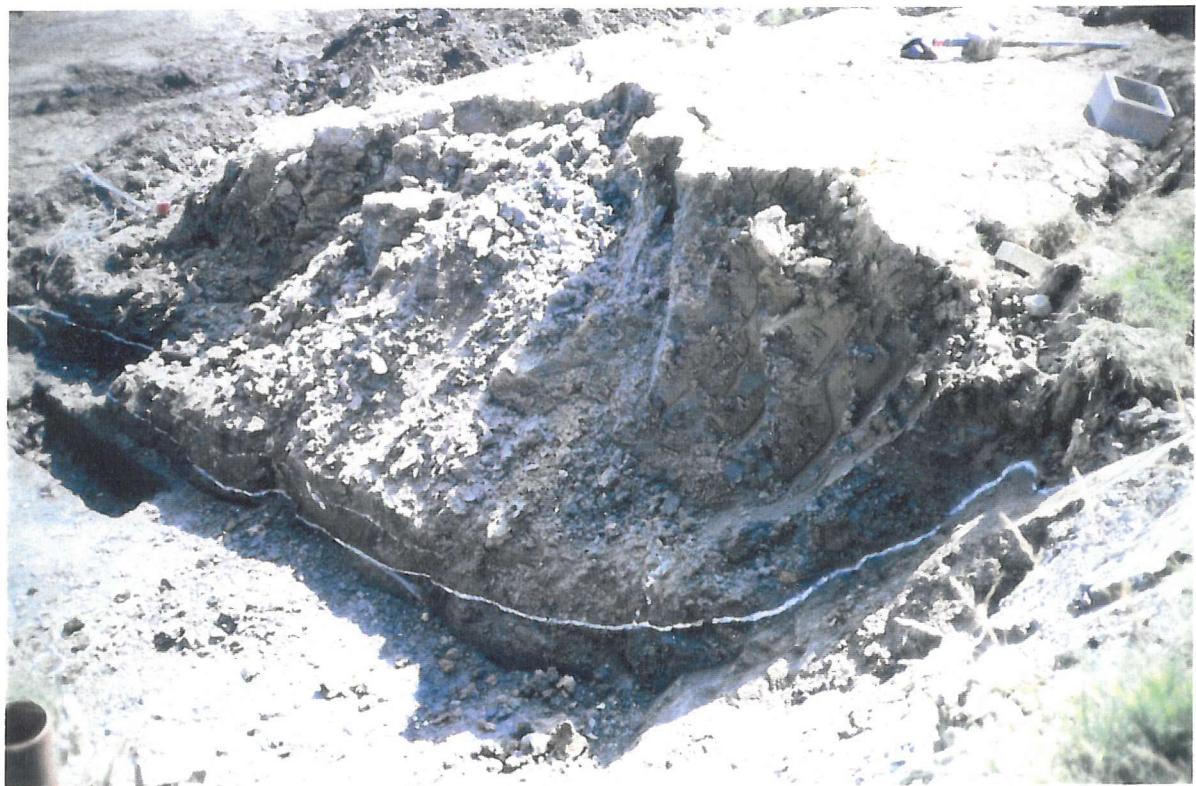
Plate 5-4. Highlighted slip surface Trench 1.

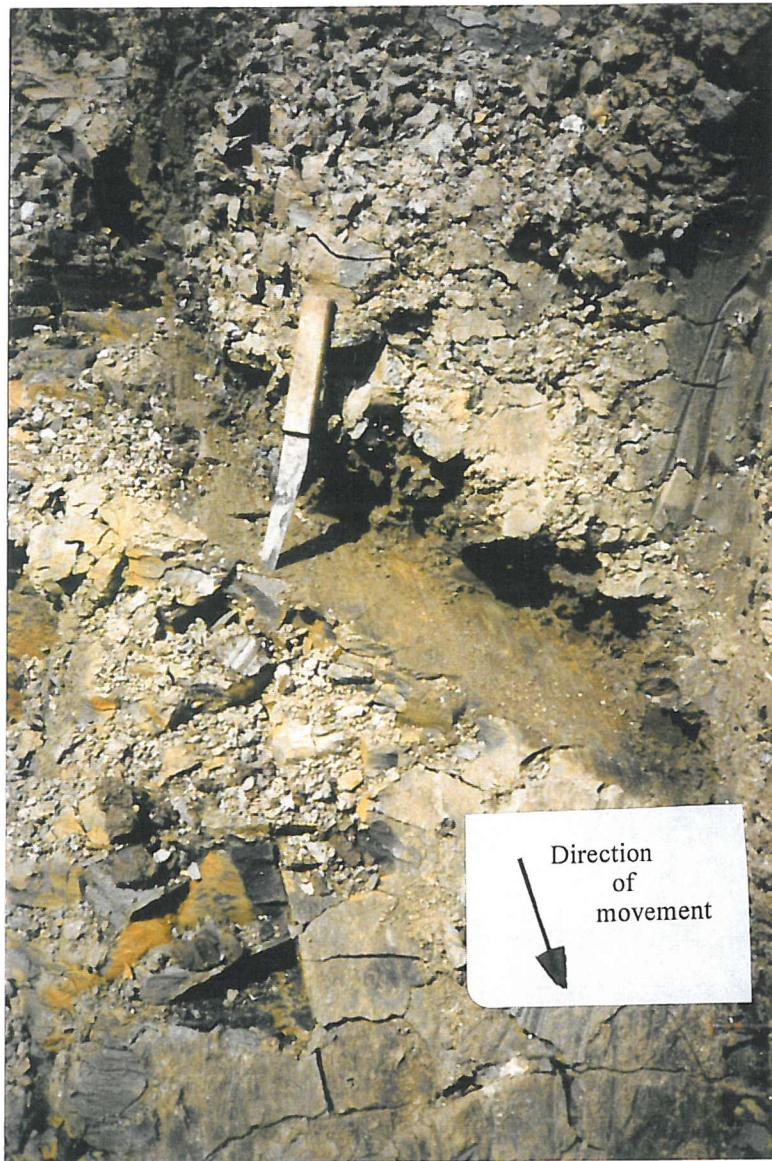
Plates 15-6, 15-7 and 15-8 show the nature of the slip surface in the three zones.

Plate 15-6. Slip surface in "mid" region.

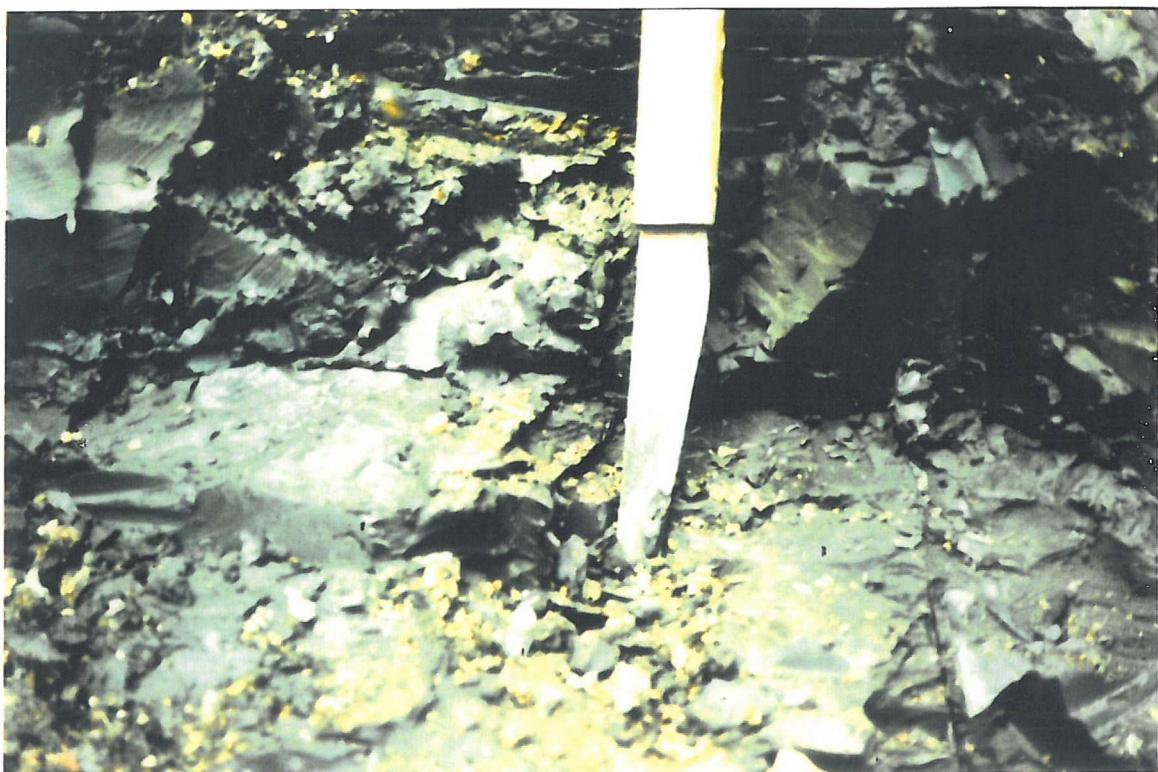
Plate 15-7. Slip surface between mid-zone and basal slip.

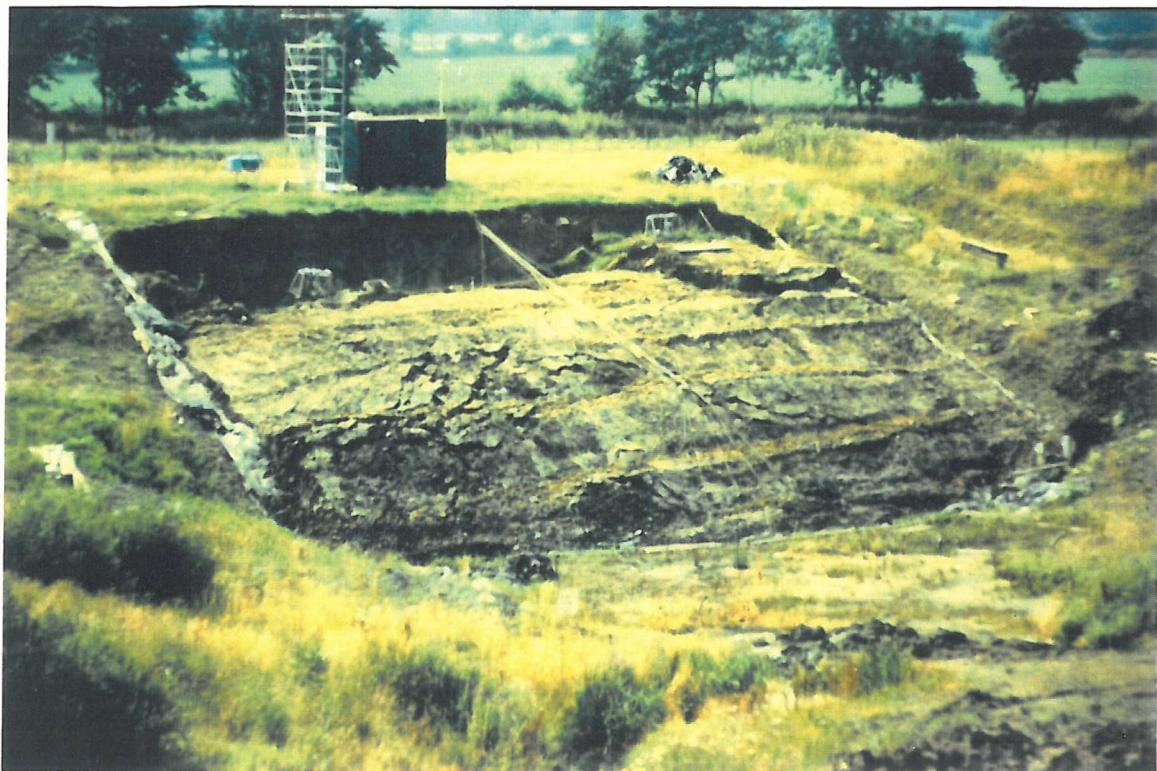
Figure 16-8 shows the (surveyed) surface movement vectors for all the inclinometers and the forward wire extensometer anchors and frames for three pre-collapse and one post collapse surveys. The vectors indicate a "fan" of movement (Figure 16-9) pivoting towards the north-west corner of the slope. This corner of the slope was noted to hang up during final slope collapse (Plate 16-1).

The slip surface emerging below the northern side shear break will have created additional "friction" increasing the resistance to sliding, and especially resisting any acceleration in the rate of sliding. Plate 16-1 shows the slope post-collapse. It can be seen that the north west corner hung up during collapse but also that the northern end generally moved less than the southern end. The effect of the northern isolating trench not having been quite deep enough appears to have retarded the rate of failure but not, apparently, to have affected its shape.

Plate 16-1. Slope post collapse, Day 197

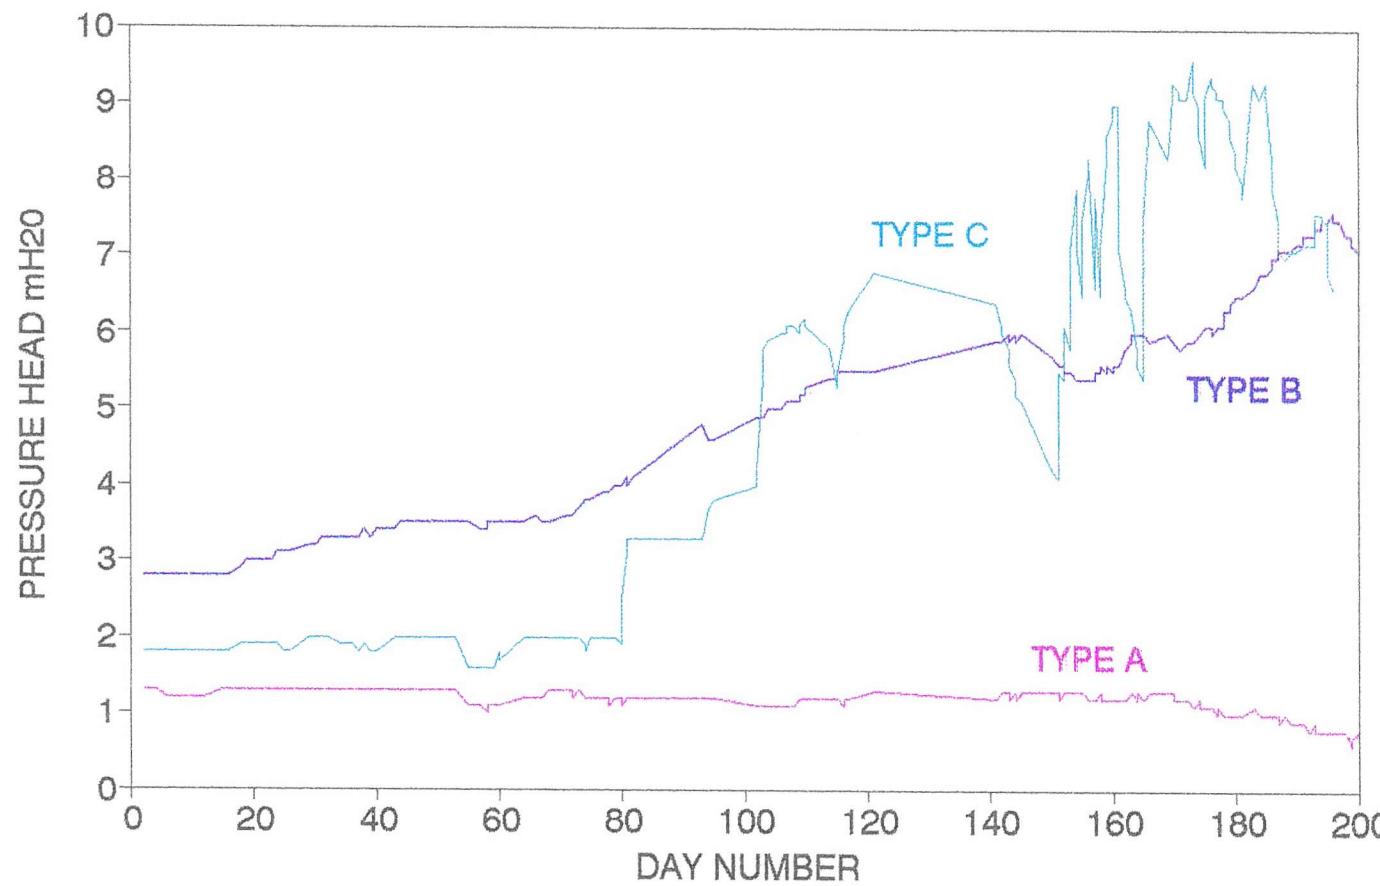
Figure 11-6 A,B & C type piezometer responses to recharge

The response of the slope to recharge events was monitored by the use of the piezometers. The response of the piezometers can basically be divided into three types as shown in Figure 11-6

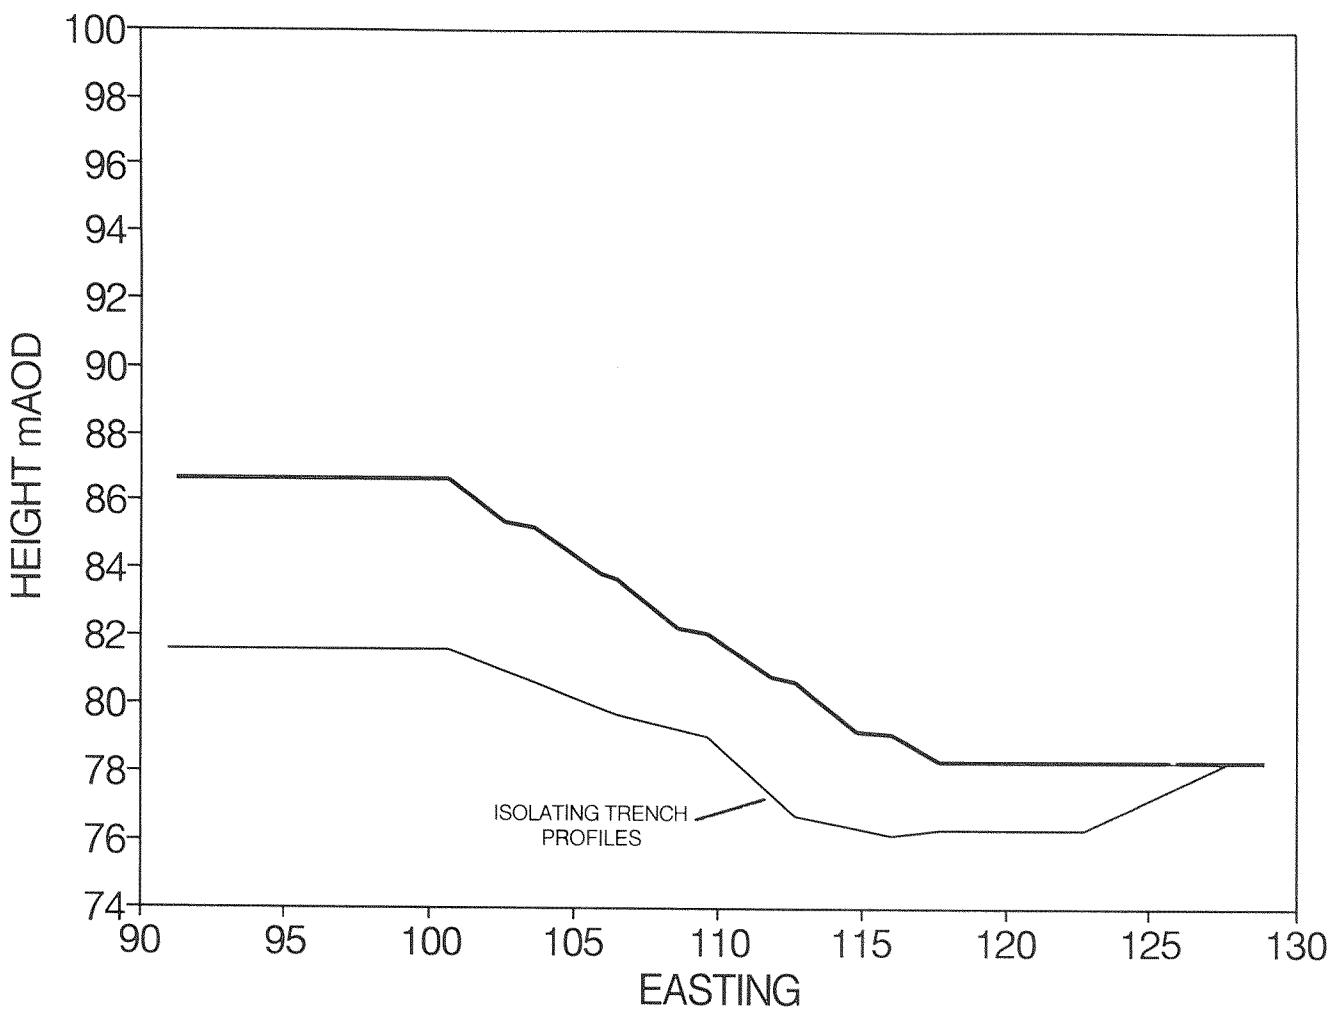
Figure 12-1 Isolating trench profiles

Figure 12-1 shows the profiles of the isolating trenches, the shape basically being determined by the reach and digging power of the Poclain VC15 excavator. Below about 10 metres depth (from top of slope) the digging was found to be extremely difficult due to the hardness of the clay, the lower section of the side shear breaks

represent the maximum depth that could be achieved with the power of the VC15 excavator. Plate 12-1 shows the southern side shear break exposed during the post-failure dig out. The double layer of PVC sheeting can clearly be seen. Note that the movement appears to have involved the inner layer of soil moving against the plastic rather than a plastic to plastic movement as had originally been expected.

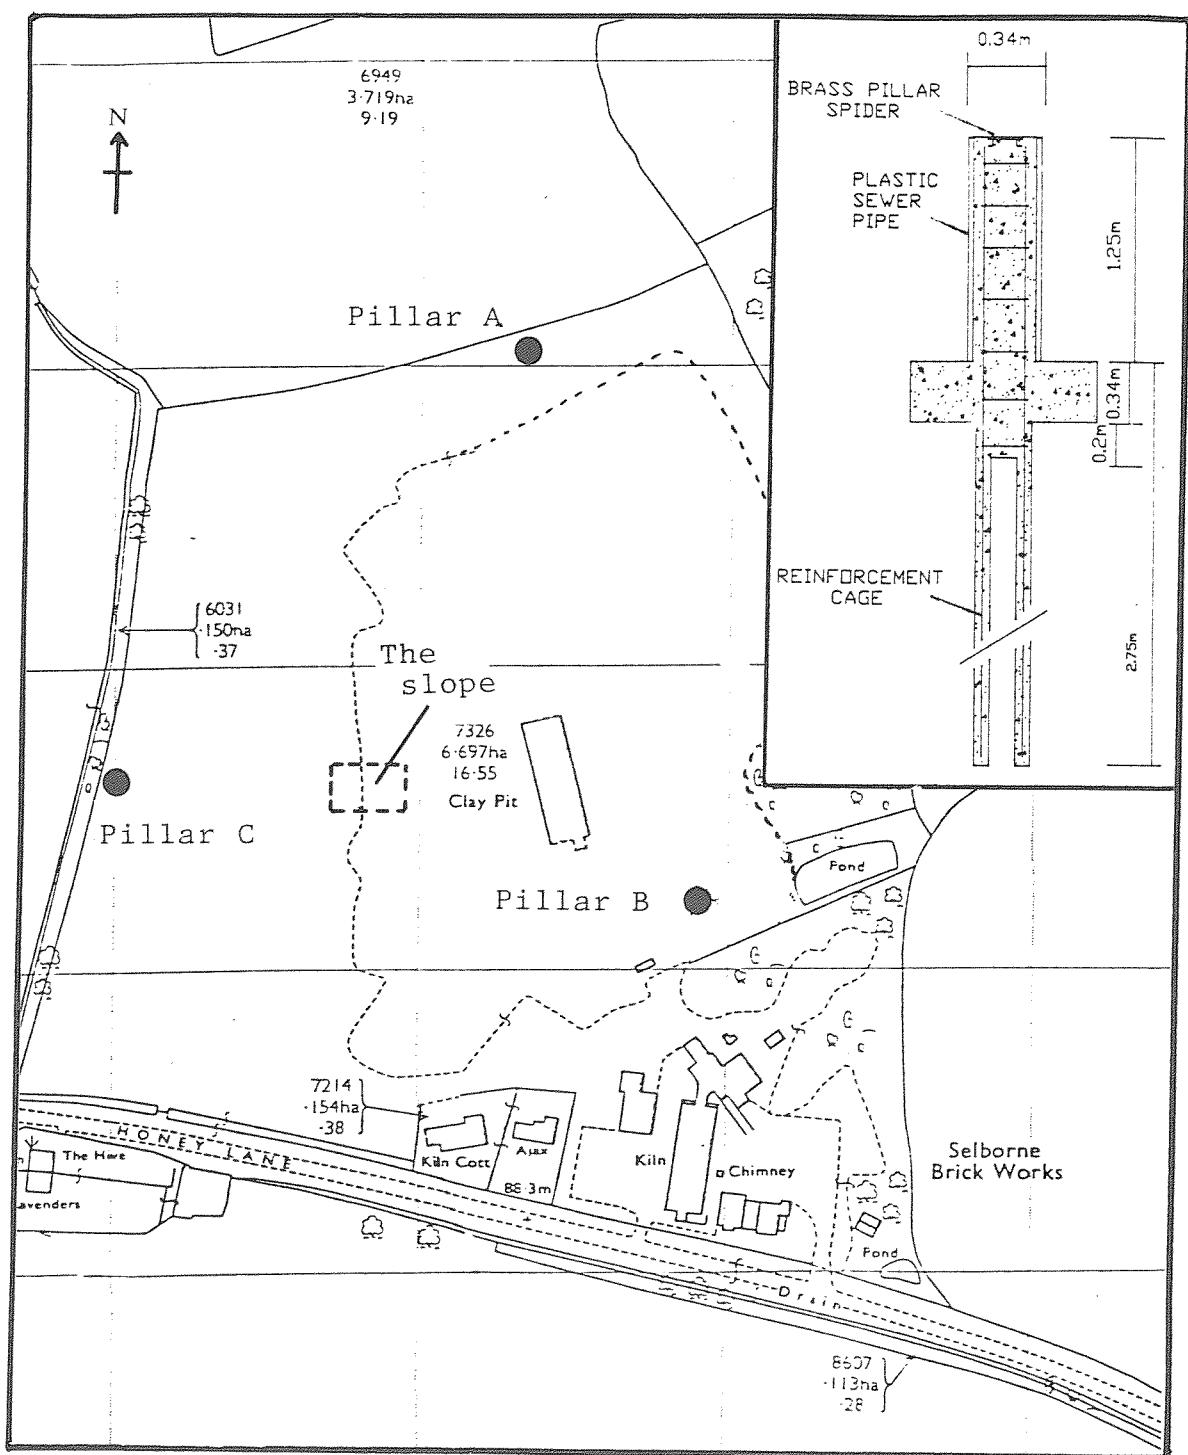
Figure 13-1 Location of survey reference pillars

As part of a final year undergraduate project (Dover 1988) three survey reference pillars were built at the locations shown on Figure 13-1. Three pillars were used since this represents the minimum number required to establish whether or not any of the reference objects were moving, and if so to quantify the direction and magnitude of any such movements.

It was essential that the reference pillars remained stable for the duration of the project. To try and ensure this each pillar was founded on three 2.75m deep reinforced concrete piles drilled using Southampton University's own "Minute Man" rotary drilling rig. The construction details of the survey pillars are shown on the insert to Figure 13-1. Each reference pillar had an Ordnance Survey brass triangulation spider set and accurately levelled into its top. The spider was to allow accurate placing and re-placing of the survey instruments during monitoring.

C were installed such that they were founded below a depth likely to be subject to seasonal moisture changes (Figure 13-1). Monitoring points on the slope face were founded below an impermeable plastic sheet which reduced seasonal moisture content changes. Material on the slope face, especially towards the base of the slope, was also undergoing swelling due to unloading affects following slope formation. This swelling will have been of a greater magnitude than seasonal swelling and also have extended to a greater depth from the slope face.

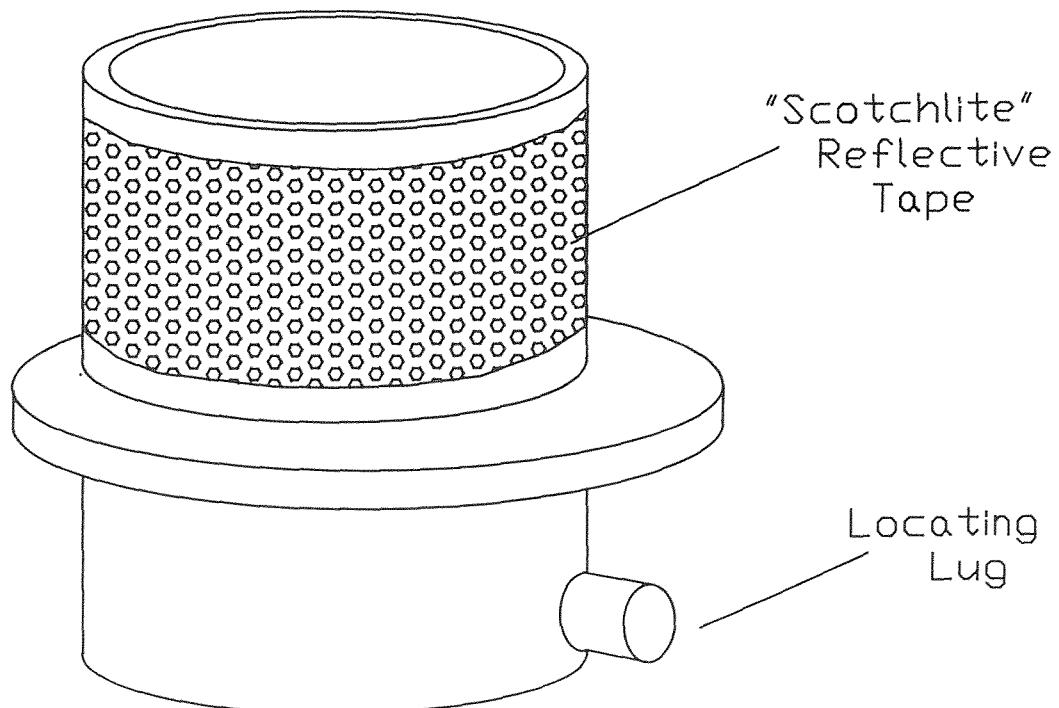
Figure 13-2 Reflective inclinometer top targets

No free-standing targets as described in M Dover's report were actually installed nor were any inclinometer targets produced by Geotechnical Instruments Limited, but reflecting inclinometer top targets were produced by technicians within the civil engineering department at Southampton University, to a specification drawn up by the author (see Figure 13-2).

Scotchlite survey reflective material were produced to fit into the top of the twelve inclinometer access tubes. Details of the targets are shown on Figure 13-2.

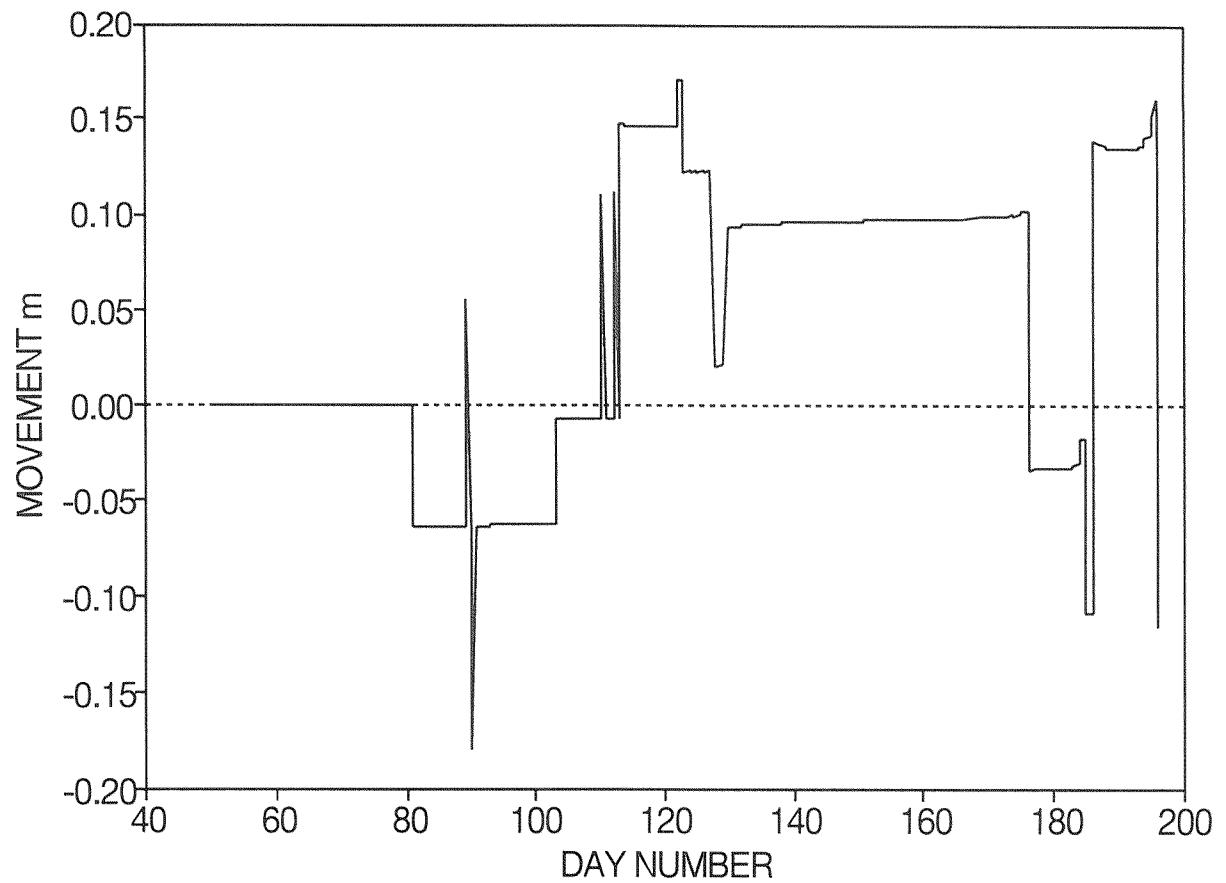
Figure 14-31 Example of unrefined wire extensometer output

The detailed site diaries kept throughout the project, log all disruptions and adjustments made to the wire extensometers by the site staff from installation through to collapse. Careful inspection of results and cross-calibration with the information in the site diaries allows an initial output such as Figure 14-31 to be refined to the plot shown in Figure 14-32.

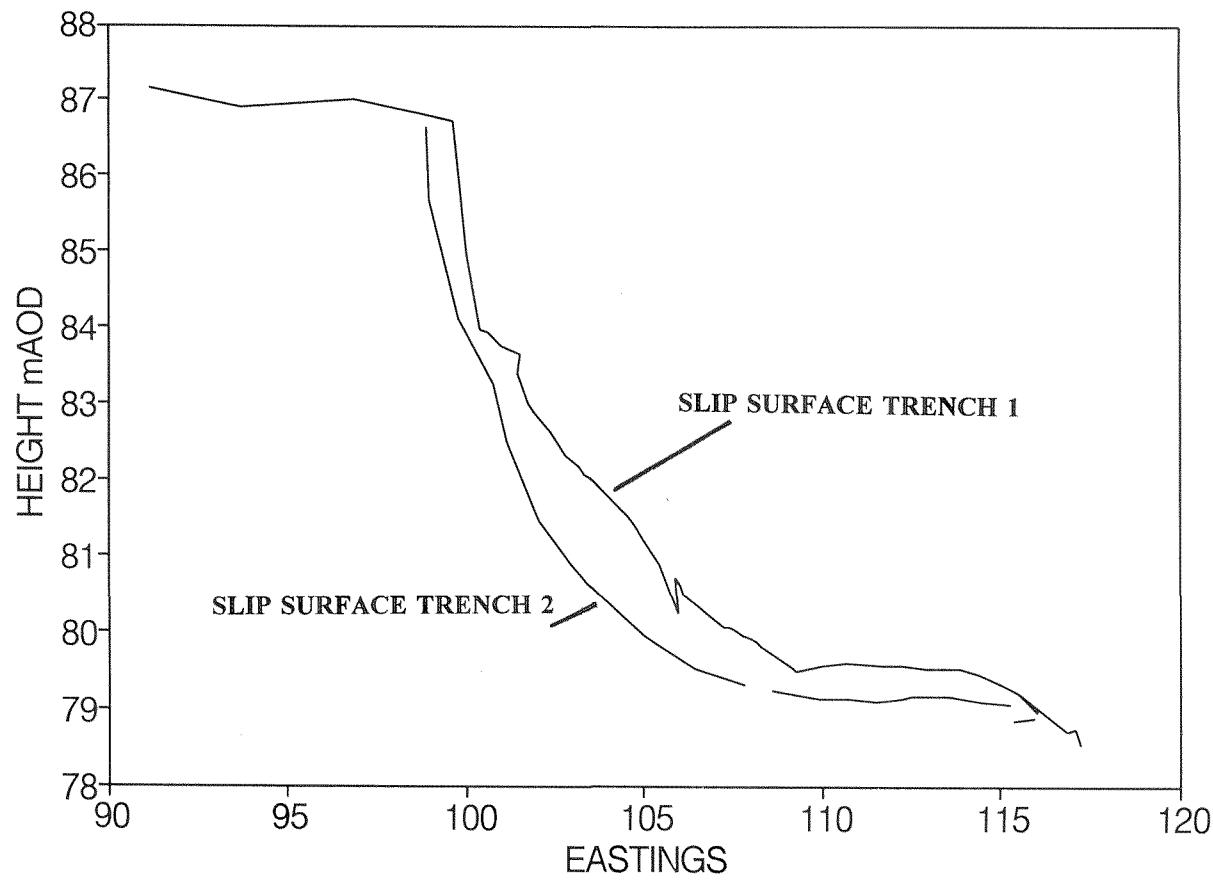
Figure 15-1 Surveyed slip surface locations

The detailed survey data for the slip surface position in each trench is presented as Figure 15-1. It is clear that there was a south-north cross fall on the slip surface. To allow accurate comparisons of instrument data the slip surface and instrument elevations can be projected onto an interpolated centreline profile. Figure 15-2 shows the interpolated centreline slip surface profile, the original cut slope profile and the post collapse centreline surface profile. Instrument positions have been adjusted to a centreline profile by altering the instrument elevation by a value equivalent to the difference in projected slip surface elevation at the instrument location to that at the centreline. Figures 14-29 and 14-30 illustrate the process for the critical inclinometer elements, similar adjustments have been made for piezometer locations.

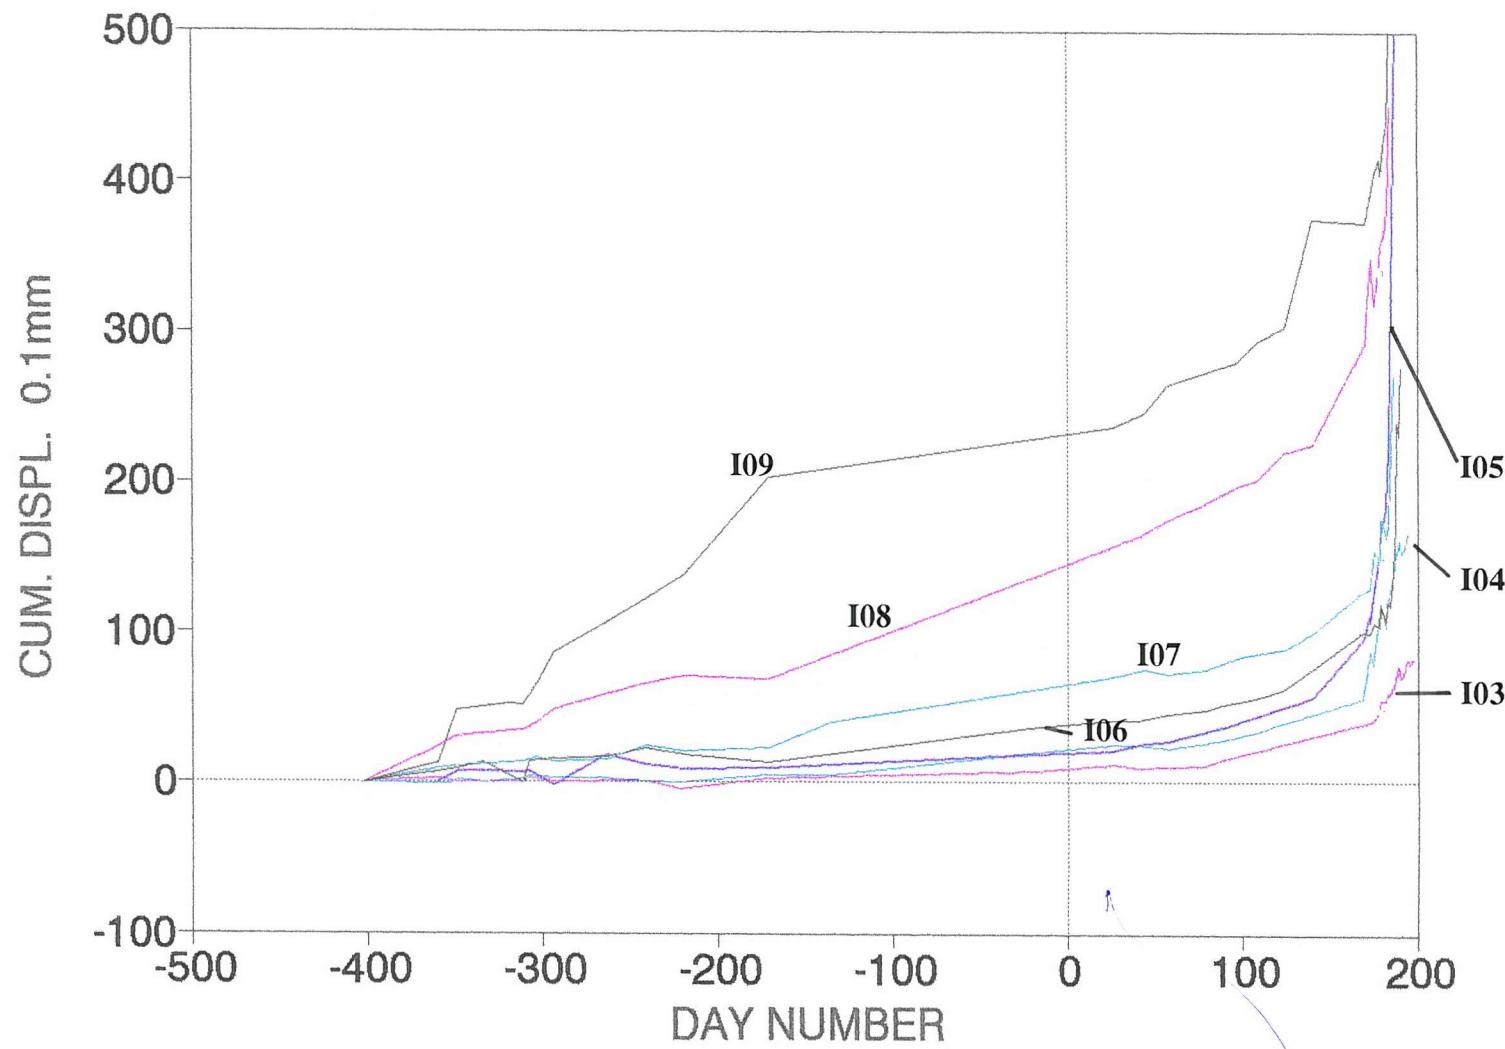
Figure 16-1 Time displacement curves for key inclinometer elements

The displacement-time curves for the critical elements of the manually read inclinometer access tubes affected by the failure are presented as Figure 16-1, where critical element refers to the 0.5 metre reading length including the slip surface. This diagram shows that movements were developing immediately following slope formation. Inclinometer 09, one bench up from the slope base, experienced significant displacements (10mm) before day -300. Inclinometers 08 and 07 were moving similarly but at a slower pace. The mechanisms involved with the development of these early strains are not necessarily concerned with the ensuing slope instability, but rather with stress relief.

It is notable that the greatest reduction in pore water pressure takes place in piezometers V17 and V18. These two piezometers are located in the zone which, due to its geometrical position, will suffer the greatest degree of internal shearing during slope collapse. It has already been seen from inclinometers 05 and 06 (Figure 16-1) that displacements in this region did not occur until comparatively late in the failure

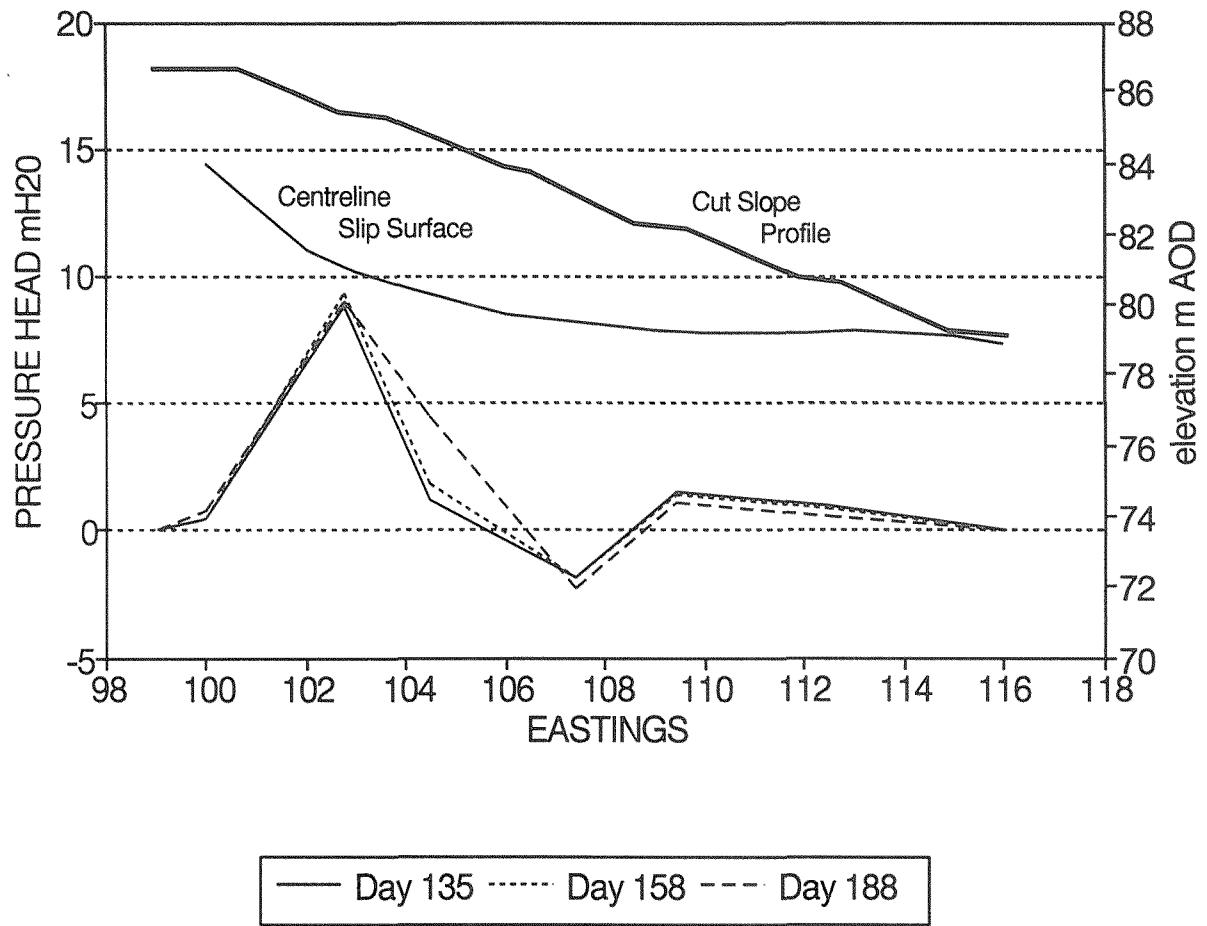
Figure 16-2 Pore pressure distributions along the slip surface at day numbers 136, 158 and 188

Figure 16-2 shows the interpolated pore water pressure distributions along the eventual slip surface at day numbers 136, 158 and 188. The pore water pressure on the slip surface does not appear to increase despite there being known increases in the recharge head, but there are accelerations in the displacement of the slip mass with increases of recharge head (Figure 16-1). It appears that the increased recharge pressures are being rendered ineffective by reducing shear strengths and subsequent increasing movements along the slip surface leading to greater dilation and hence no net increase in the measured piezometric heads. Figure 16-3 shows the pressure heads for piezometers V14, V17, V18 and V19, which are all close to the slip surface, in the days leading to slope collapse. Points P and Q mark rises in the recharge head over this period. It can clearly be seen that the pressure heads fall despite the increase in applied head, the fall in pressure head being matched by an acceleration of the slip mass (Figure 16-1).

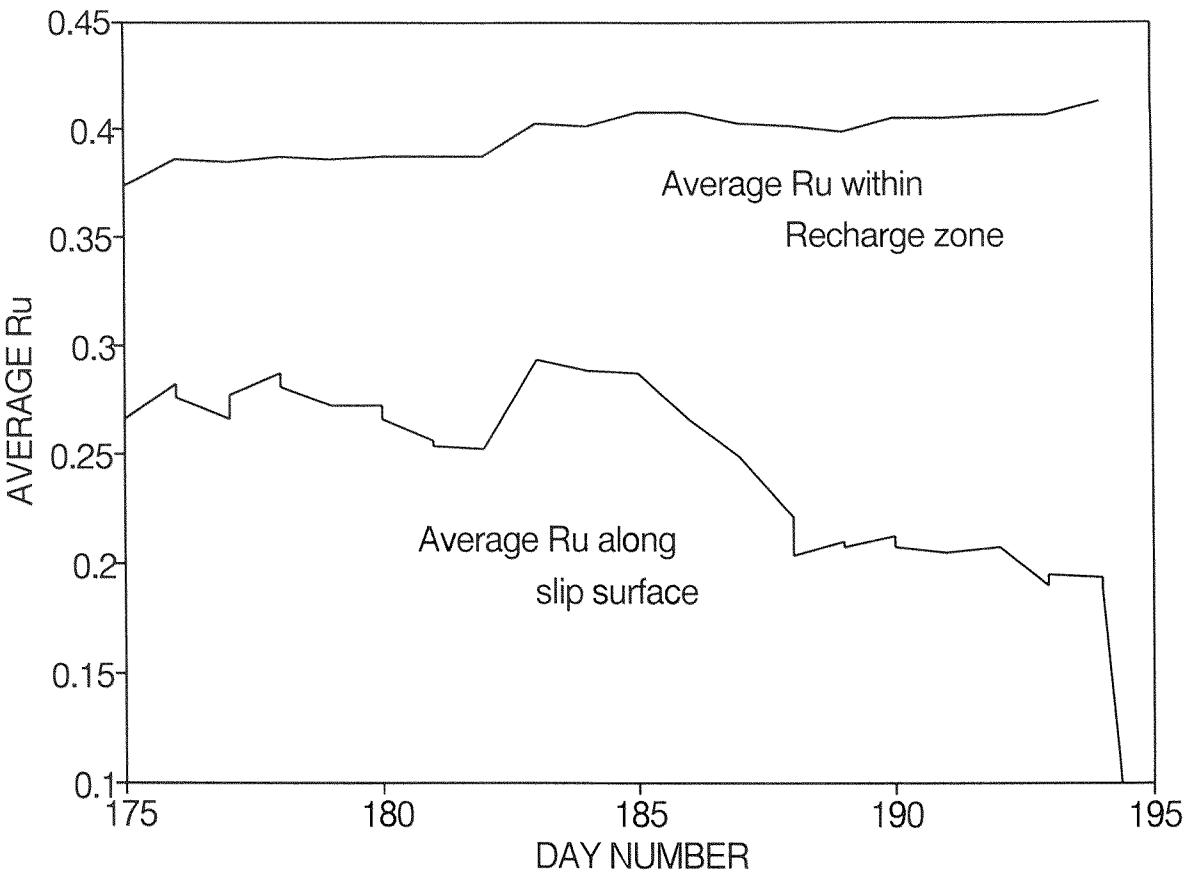
Figure 16-4 Slip surface and recharge zone r_u 's in the twenty days prior to slope collapse

Figure 16-4 presents the increase in the average pore pressure ratio (r_u) within the recharge zone over the last 20 days before slope collapse and the corresponding reduction in r_u along the slip surface, the two lines illustrating the direct response of pore water pressure to dilation along the slip surface.

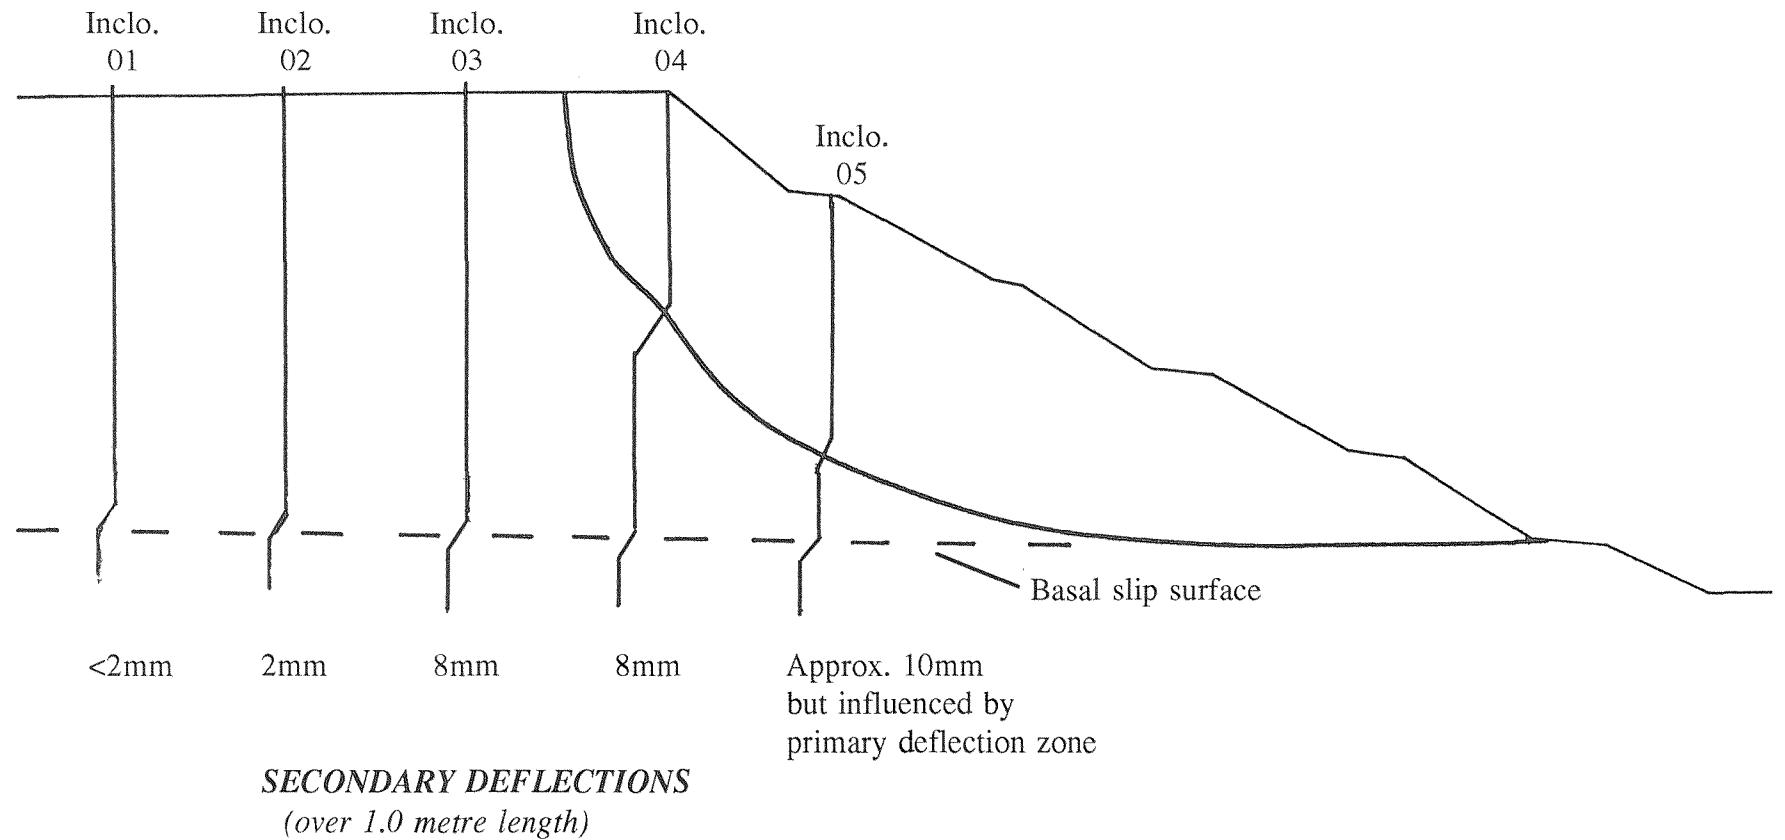
Figure 16-5a Secondary displacements. Inclinometers 01 to 05.

Figure 16-5a and 16-5b show the records for inclinometers 01 to 05 situated towards the upper part of the slope and behind the slope crest. It can be seen that below the main failure there were significant movements along a line extended from the eventual basal failure plane. These movements decrease in magnitude with distance from the

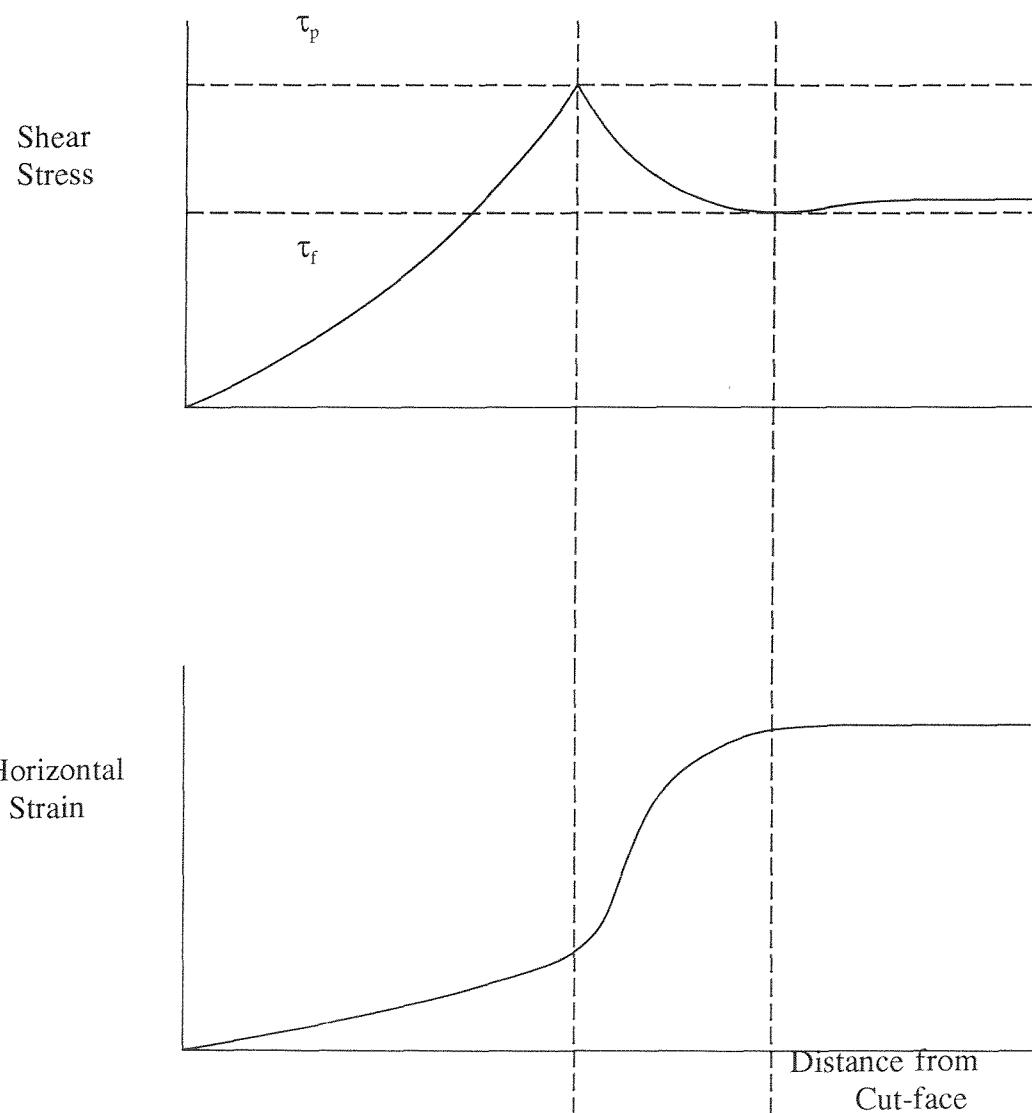
Figure 16-6 "End of Region" Zone; shear stresses decreasing from peak to residual values

termed the "end of region" by Palmer and Rice (1973). The "end of region" being the zone where the shear strength is decreasing from a peak to a residual value (Figure 16-6).

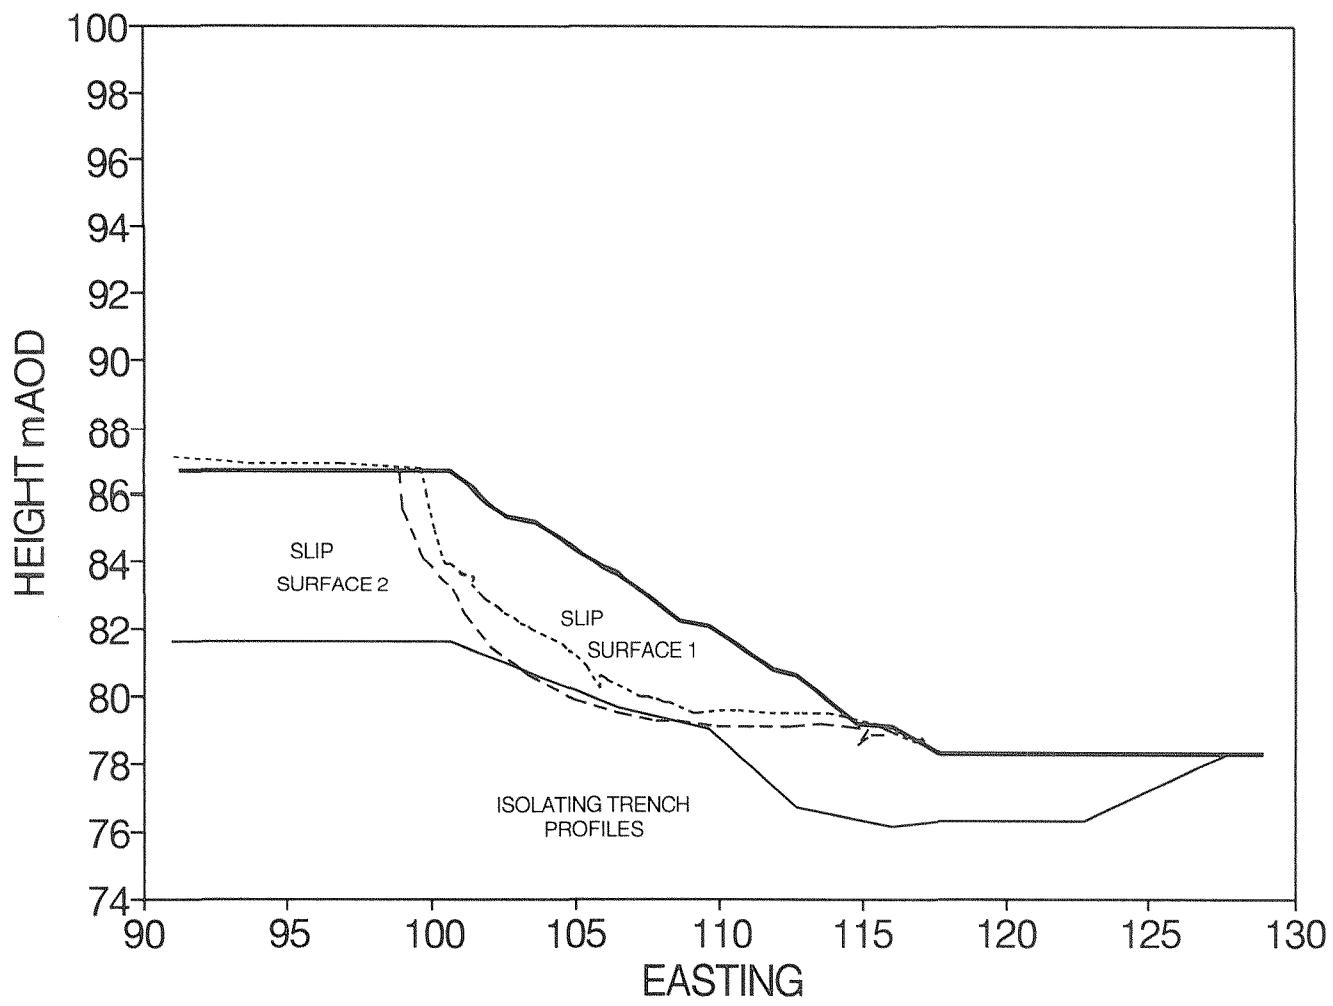
Figure 16-10 Side shear break and slip surface profiles

Figure 16-10 shows the profile of the side shear break's and the two surveyed slip surface sections. SS1 which is only 2.5 metres from the southern side shear break is above the lower level of the isolating trench, the slip therefore having been contained within the isolated zone illustrating that the side shear break was successful and did not significantly affect the failure pattern in this region. SS2 which is situated just north of the slope centreline coincides with the side shear break profile at about half way down the slope, but is probably too remote from the isolating trench to have been significantly affected. If allowance is made for the lateral variation of the slip surface then the likely projected slip surface position at the northern side shear break is shown

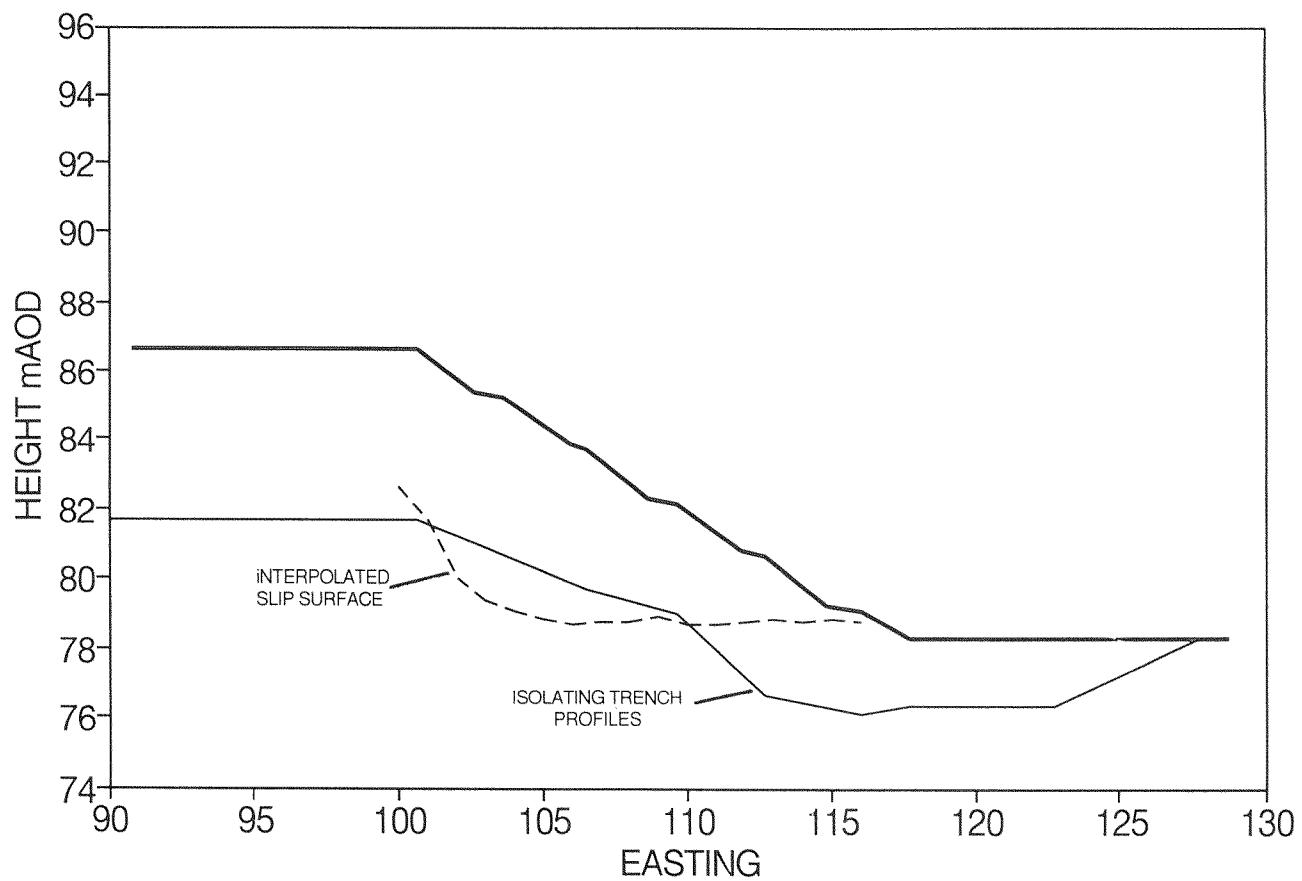
Figure 16-11 Projected slip surface profile at northern side shear break

as Figure 16-11. It can be seen from this figure that the slip surface is well below the side shear break. This is of course speculative and the effect of the isolating trench may have been to modify the shape of the slip surface upwards, but since it has already been shown that a basal slip was forming well in advance of side shear break construction and that the lower section of the slip surface is considered to be preferred bedding plane controlled this is thought unlikely.
