INSTRUMENTATION SYSTEMS FOR AND FAILURE MECHANISMS OF
AN
INDUCED SLOPE FAILURE PROJECT

Document presented for PhD in the Department
of Civil Engineering, University of Southampton.
February 1996.

ABSTRACT

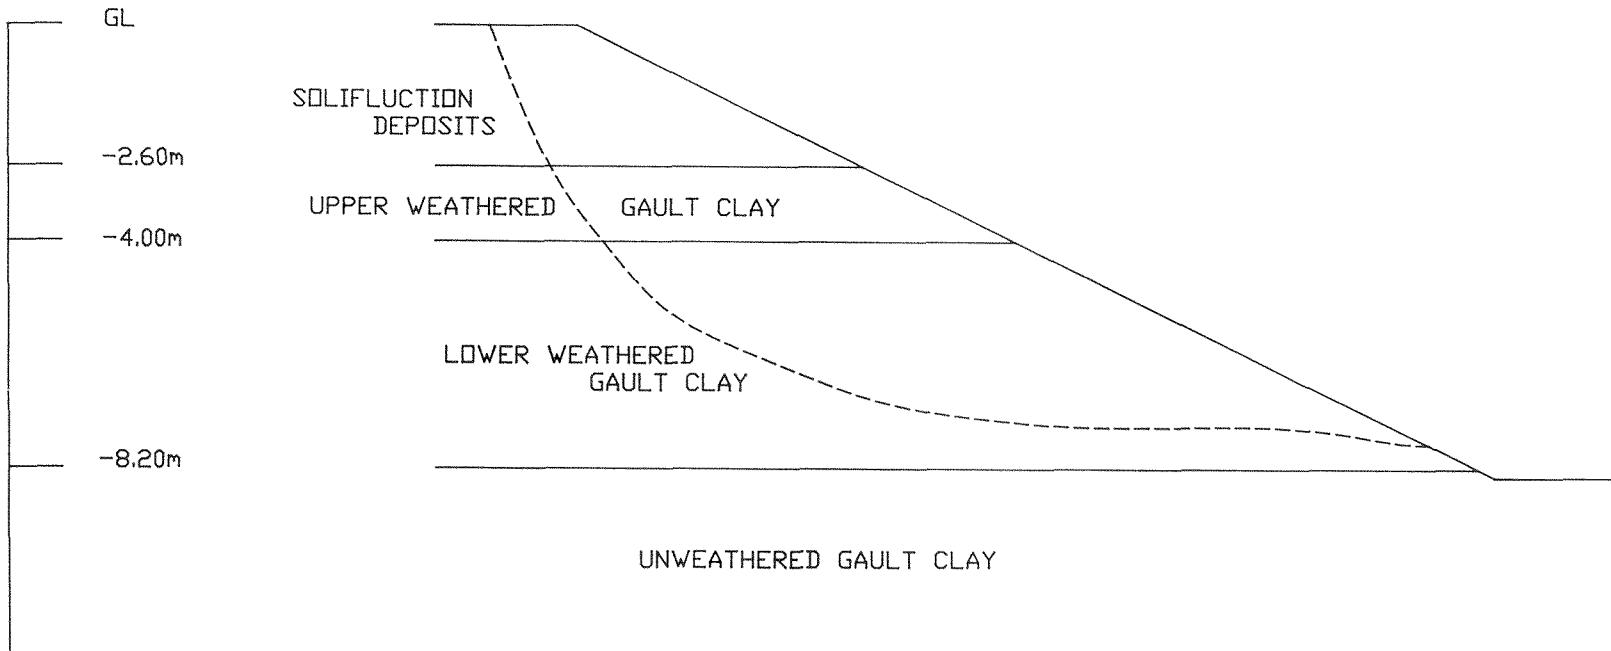
Figure 16-12 Section for SLOPE analysis

The section analyzed is shown on Figure 16-12. Restrictions within the program allow only a maximum of 30 data points to define both the strata and slip surface profiles. In order that as many points as possible could be used to give an accurate representation of the slip surface the surface profile of the slope was reduced to the straight line shown on Figure 16-12. Soil parameters and geological profile are as given in Section 6.1.

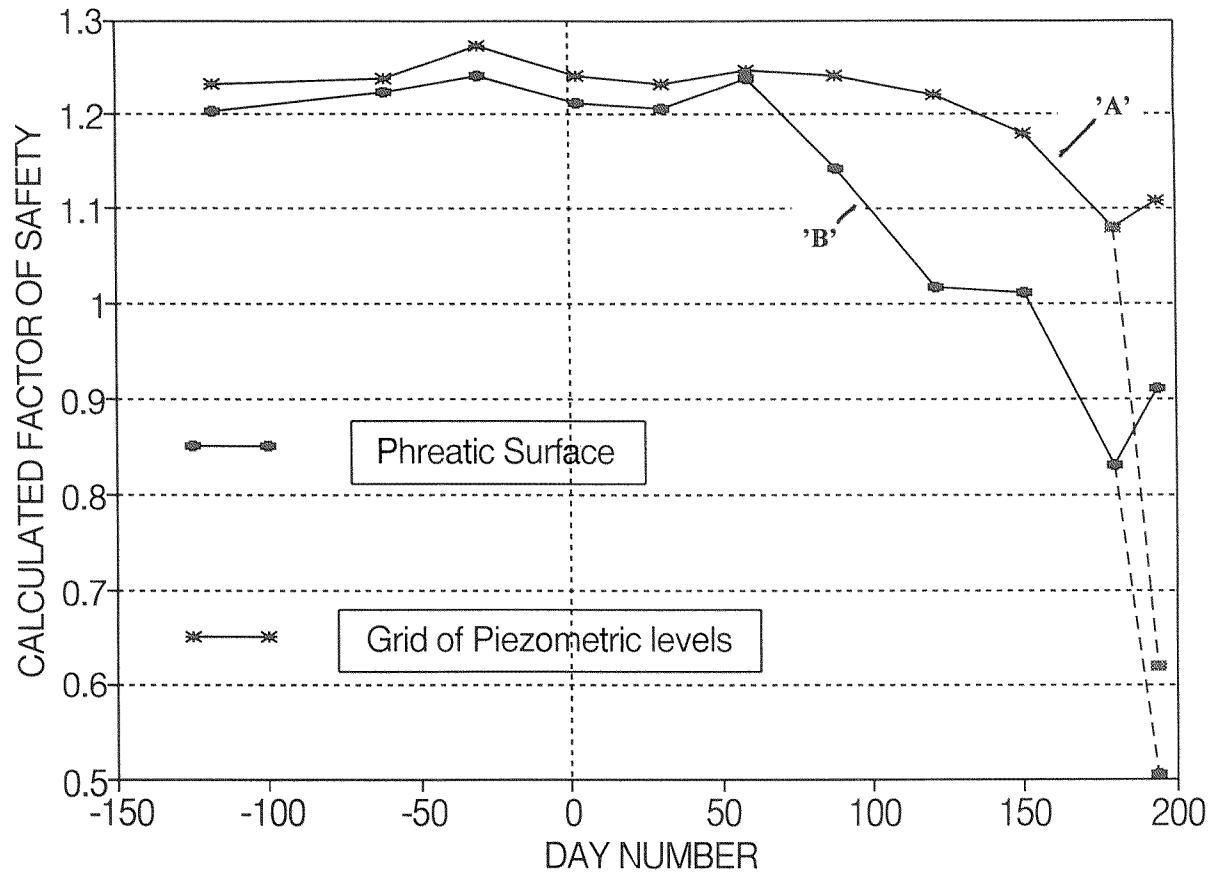
Figure 16-13 Factors of safety from Janbu analysis

Analyses were carried out for 11 dates ranging from day -118 to day 194 i.e. from well before recharge commenced up to just before final slope collapse. Line 'A' on Figure 16-13 represents the results of these analysis in graphical form. Note at no point does the analysis give a factor of safety (FoS) less than 1.0, that is, according to these analyses the slope never actually failed! This is largely as a result of the method used to represent pore water pressures in the "SLOPE" program. In this instance the pore water pressures have been entered as a grid of piezometric levels as shown in Figure 16-14, the pore water pressure acting on the slip surface being interpolated from the four nearest grid positions. The negative pore water pressures in the region of pore pressure grid coordinates (6,5) and (7,5) affect the analysis significantly by reducing the interpolated pore water pressure acting on the basal part of the slip surface. If, however, a Janbu analysis is carried out using a phreatic

surface calculated to represent the pore water pressures known to be acting on the slip surface then the result shown by line 'B' on Figure 16-13 is produced. The difference in FoS between the two methods is simply a function of the assumptions made and the way in which the program interprets the piezometer information used to evaluate the pore pressure acting at the slip surface. The danger in using a slope stability program without an understanding of the mechanisms involved becomes clear.

Figure 16-13 also shows an apparent increase in FoS from day 180 to day 194. This is as a result of the of pore water pressure reduction that took place as failure progressed, the dissipation of pore water pressure being due to dilation as the soil sheared during failure (see Section 16.1). Also as mentioned above by day 194 the soil parameters used in the analysis are clearly inappropriate. An analysis carried out for day 194 (just prior to collapse but post what could be termed engineering failure) using residual strength parameters gave an FoS of about 0.6, shown by the dashed lines on Figure 16-13.

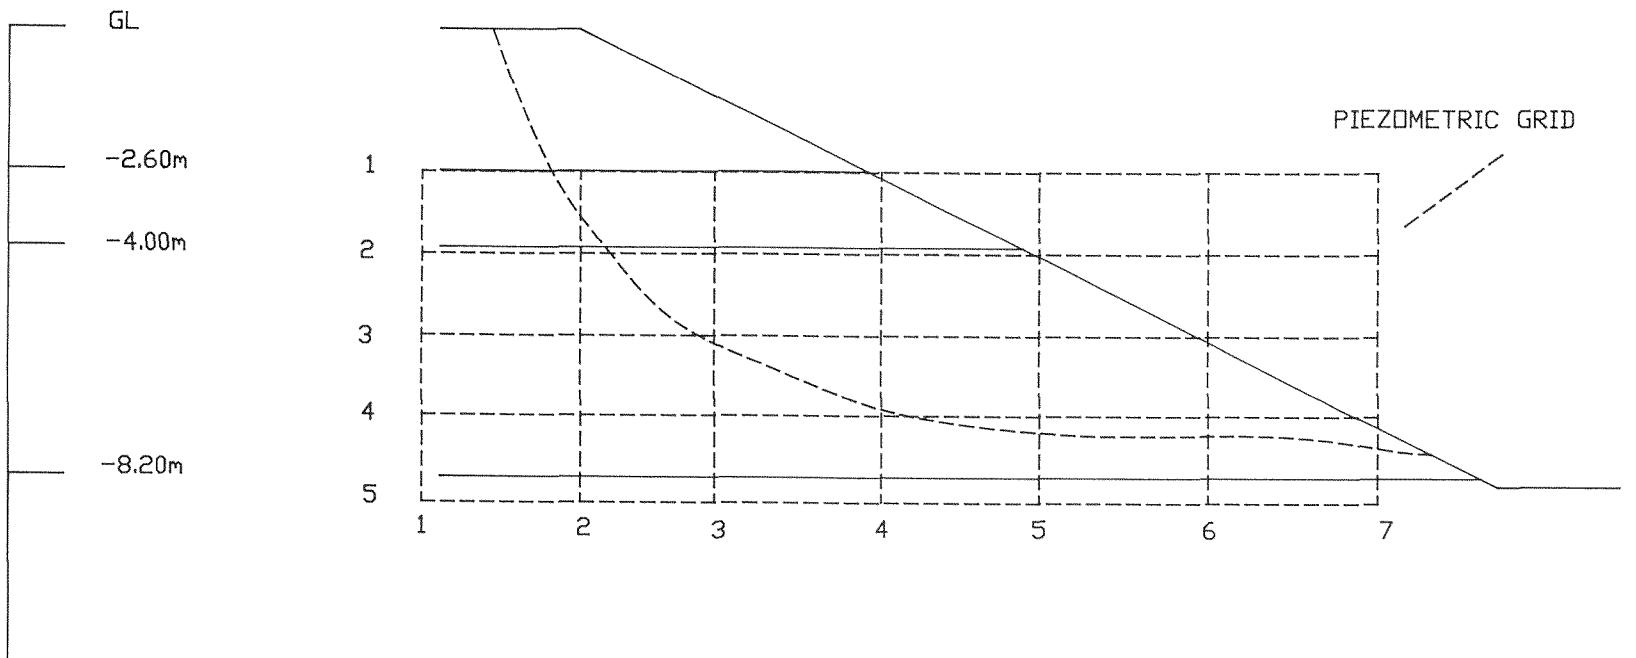
Figure 16-14 Piezometric grid for SLOPE analysis

The grid positions are those input to the computer program SLOPE (Borin 1993) in order to represent the pore pressure regime at the site. The pore pressures at each grid position were interpolated from the field data.
