# **Experimental Investigation of the Influence of Floodwater due to Ship Grounding on Motions and Global Loads**

## **ABSTRACT**

Damaged ship; motions; global loads; free surface; transient flooding; ship grounding

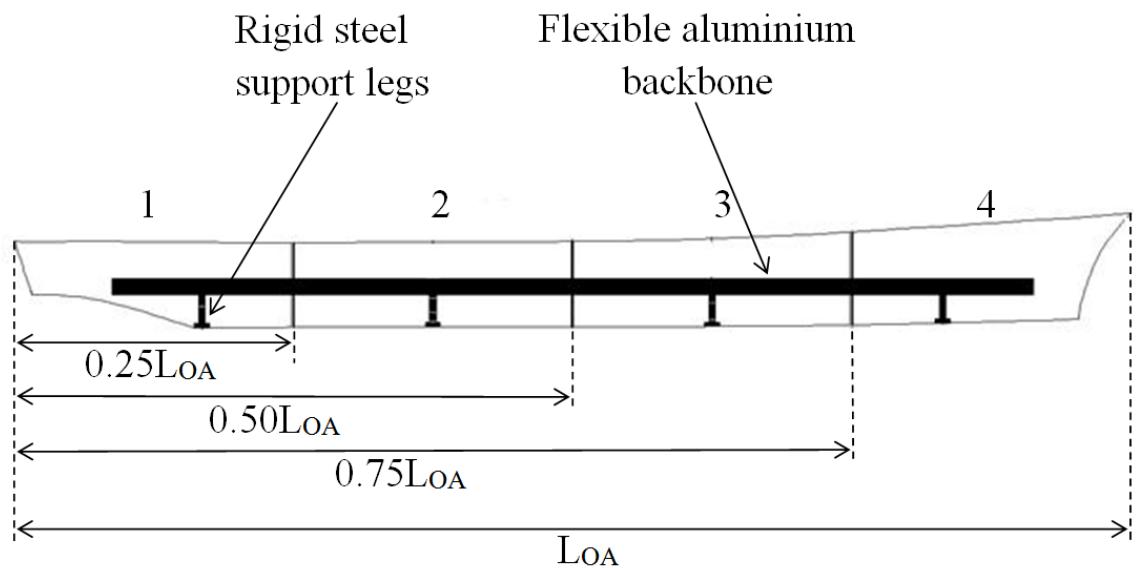
Figure 1: Schematic of flexible model hull

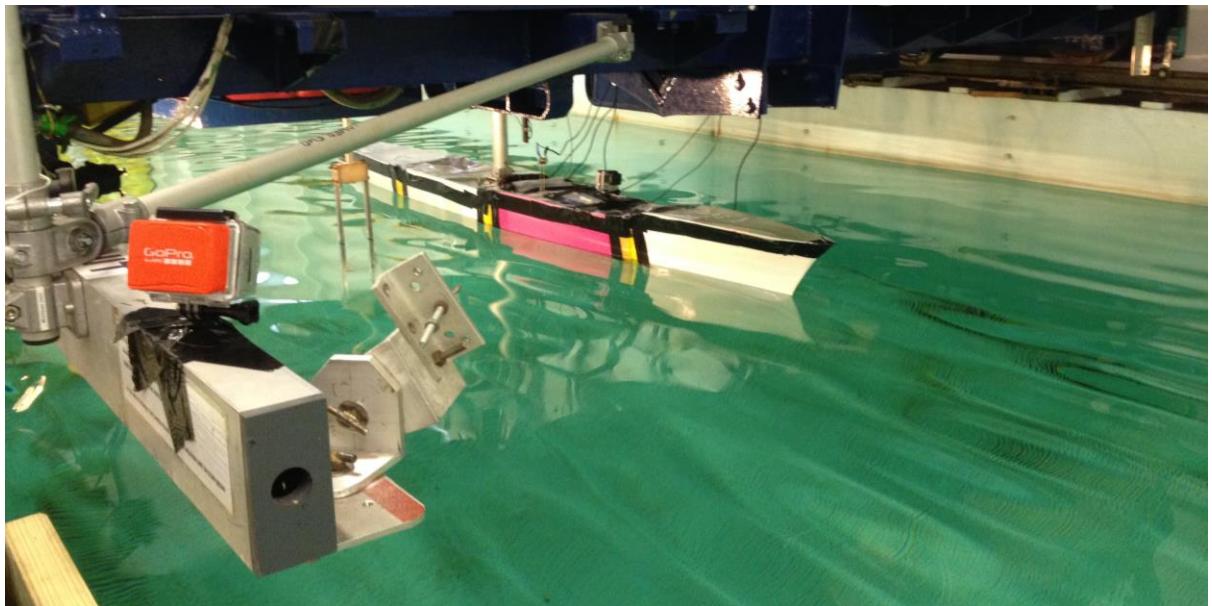
Figure 2: Experimental set-up of the frigate hull. The intact compartments are painted white and the damaged compartment in pink

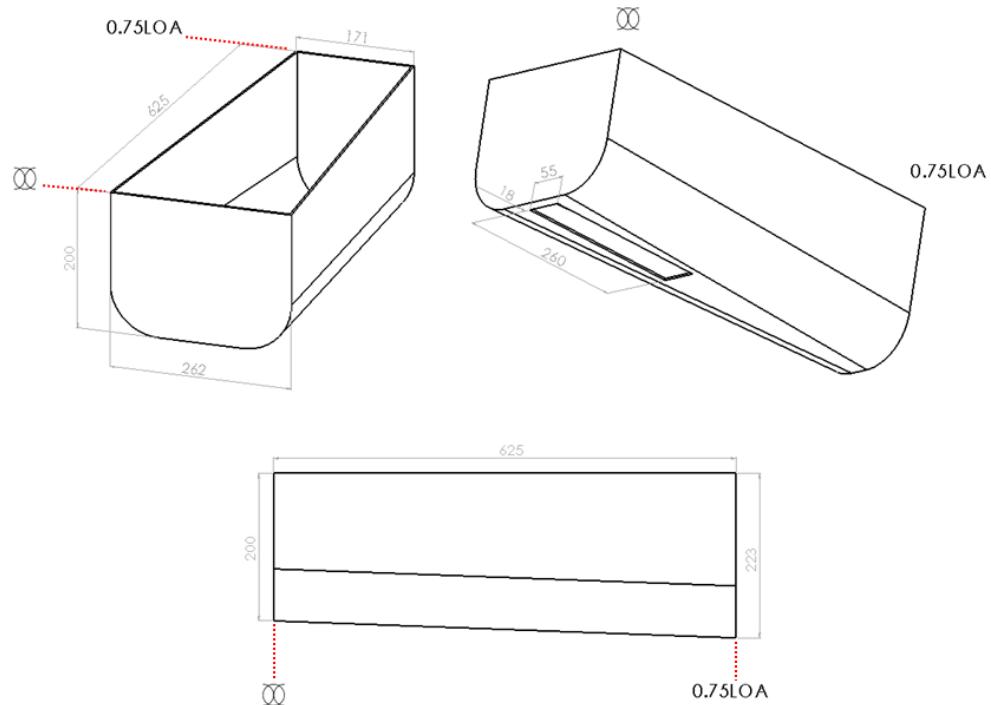
Figure 3: Schematic of damaged compartment

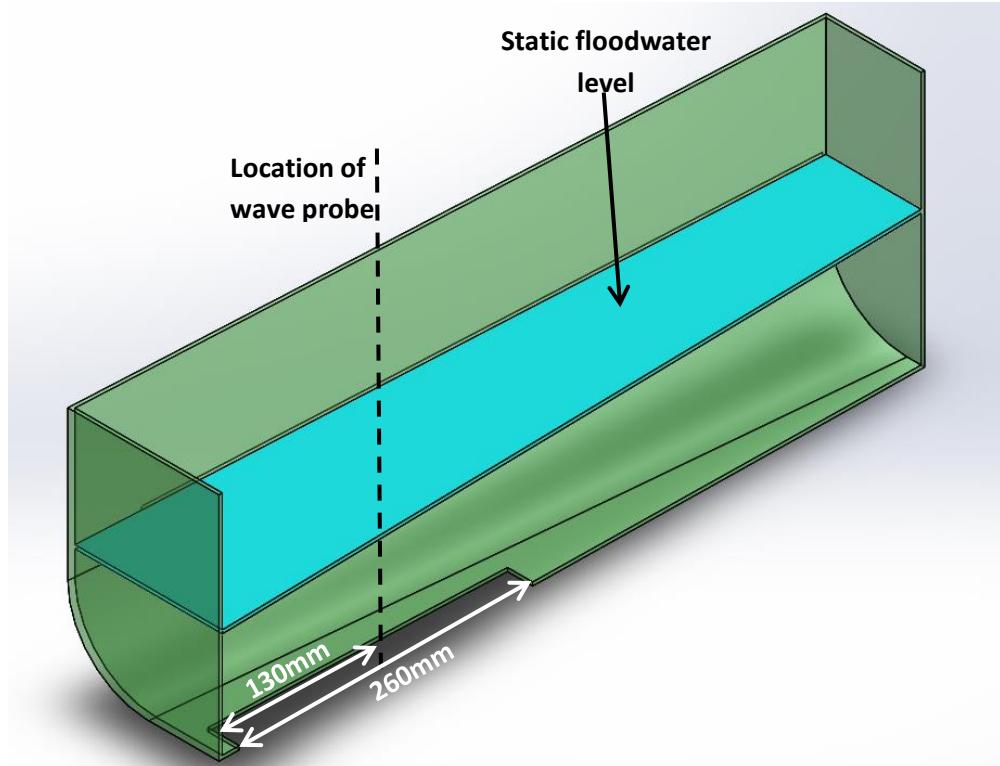
Figure 4: Cross-section through the damaged compartment showing the static floodwater level and the location of the wave probe halfway along the damage opening

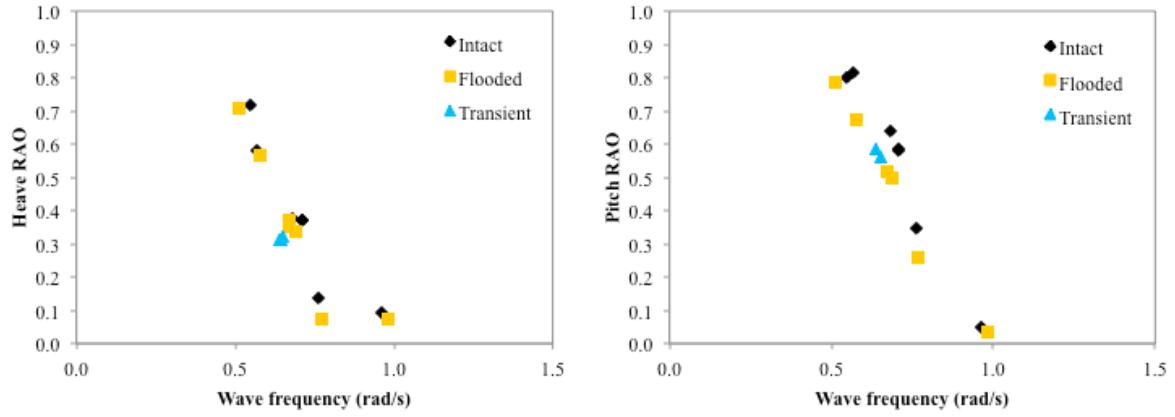
Figure 5: Heave and pitch RAOs measured in the intact, flooded and transient conditions at  $F_n = 0$  (presented full scale)

Figures 5 and 6 present the heave, pitch and vertical bending moment RAOs for the ship measured in the intact, flooded and transient conditions at  $F_n = 0$ . The equivalent comparisons for the intact and

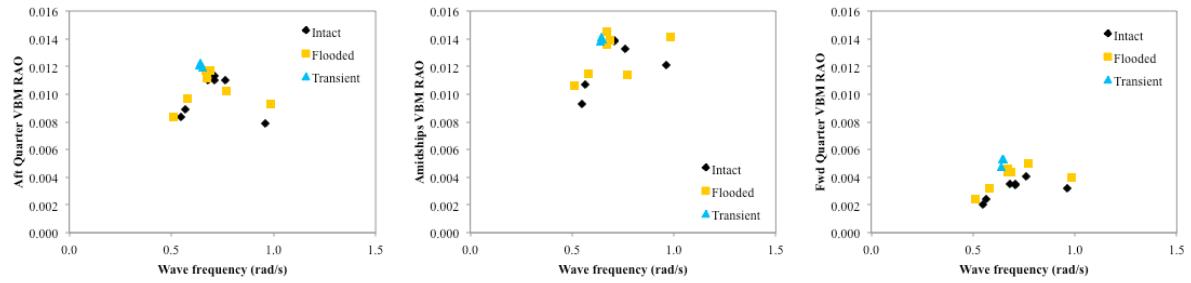
Figure 6: Vertical bending moment RAOs at the forward and aft quarters and amidships for the intact, flooded and transient conditions, at  $F_n = 0$  (presented full scale)

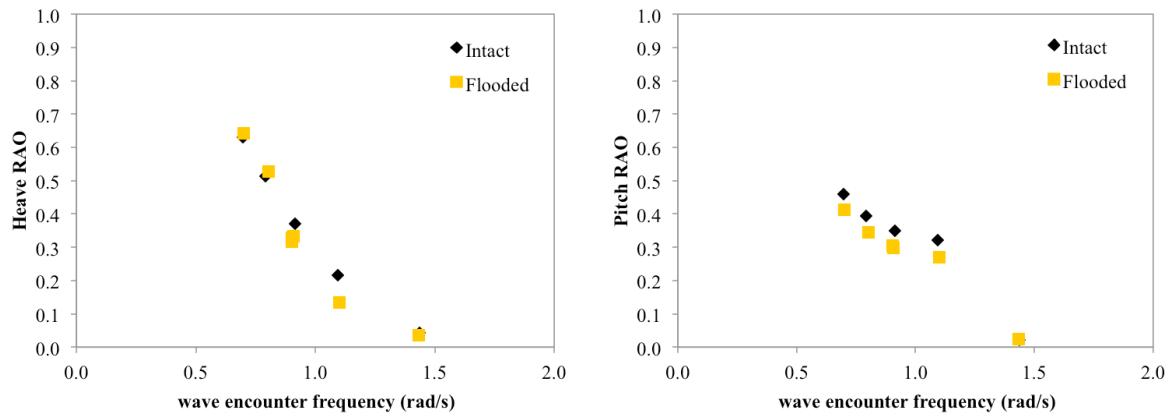
Figure 7: Heave and pitch RAOs measured in the intact and flooded conditions at  $F_n = 0.157$  (presented full scale)

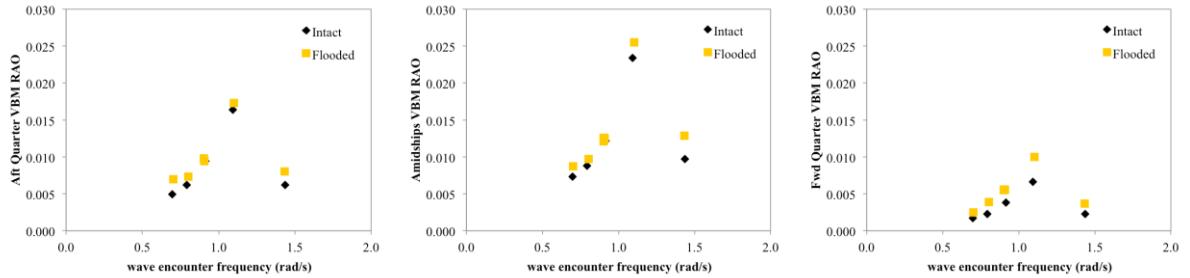
Figure 8: Vertical bending moment RAOs at the forward and aft quarters and amidships for the intact and flooded conditions, at  $F_n = 0.157$  (presented full scale)

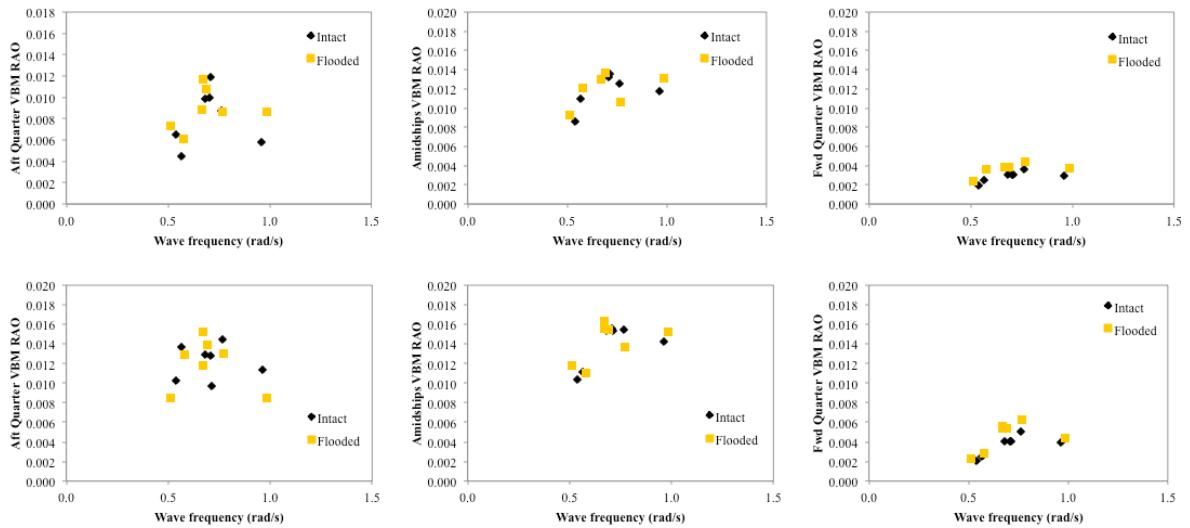
Figure 9: Vertical bending moment RAOs calculated using the double positive amplitude (upper row) and the double negative amplitude (lower row), for  $F_n = 0$ . Results presented at full scale.

Some interesting trends are visible in the results in Figures 9 and 10. The sagging vertical bending moment RAO (double negative amplitude) is of a higher magnitude than the hogging vertical bending moment RAO at zero speed. This difference is most visible at the forward quarter and when the ship is in its flooded condition. The disparity between the magnitude of the hogging and sagging responses becomes more pronounced when the ship is travelling at a Froude number of 0.157. In particular, it is noticeable at amidships and the aft quarter the trend in the relative magnitudes of the intact and damaged RAOs reverses in the hogging condition compared to all other results, with the intact RAO having a greater magnitude than the damaged RAO. These differences in hogging and sagging at different locations is likely to be due to the floodwater mass being added close to amidships whilst differences in the relative magnitudes of the intact and damaged RAOs are due to the presence of floodwater resulting in a shift of the vertical bending moment distribution of the vessel. These results highlight the importance of understanding not only the overall global response of the ship, but also its distribution between hogging and sagging conditions and how the damage state will affect this distribution.

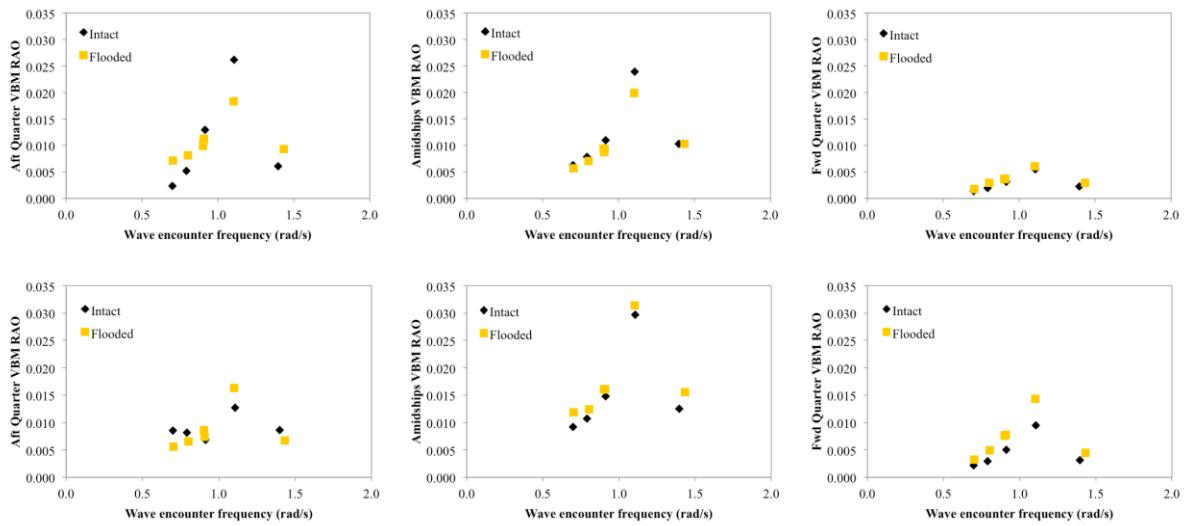
Figure 10: Vertical bending moment RAOs calculated using the double positive amplitude (upper row) and the double negative amplitude (lower row), for  $F_n = 0.157$ . Results presented at full scale.

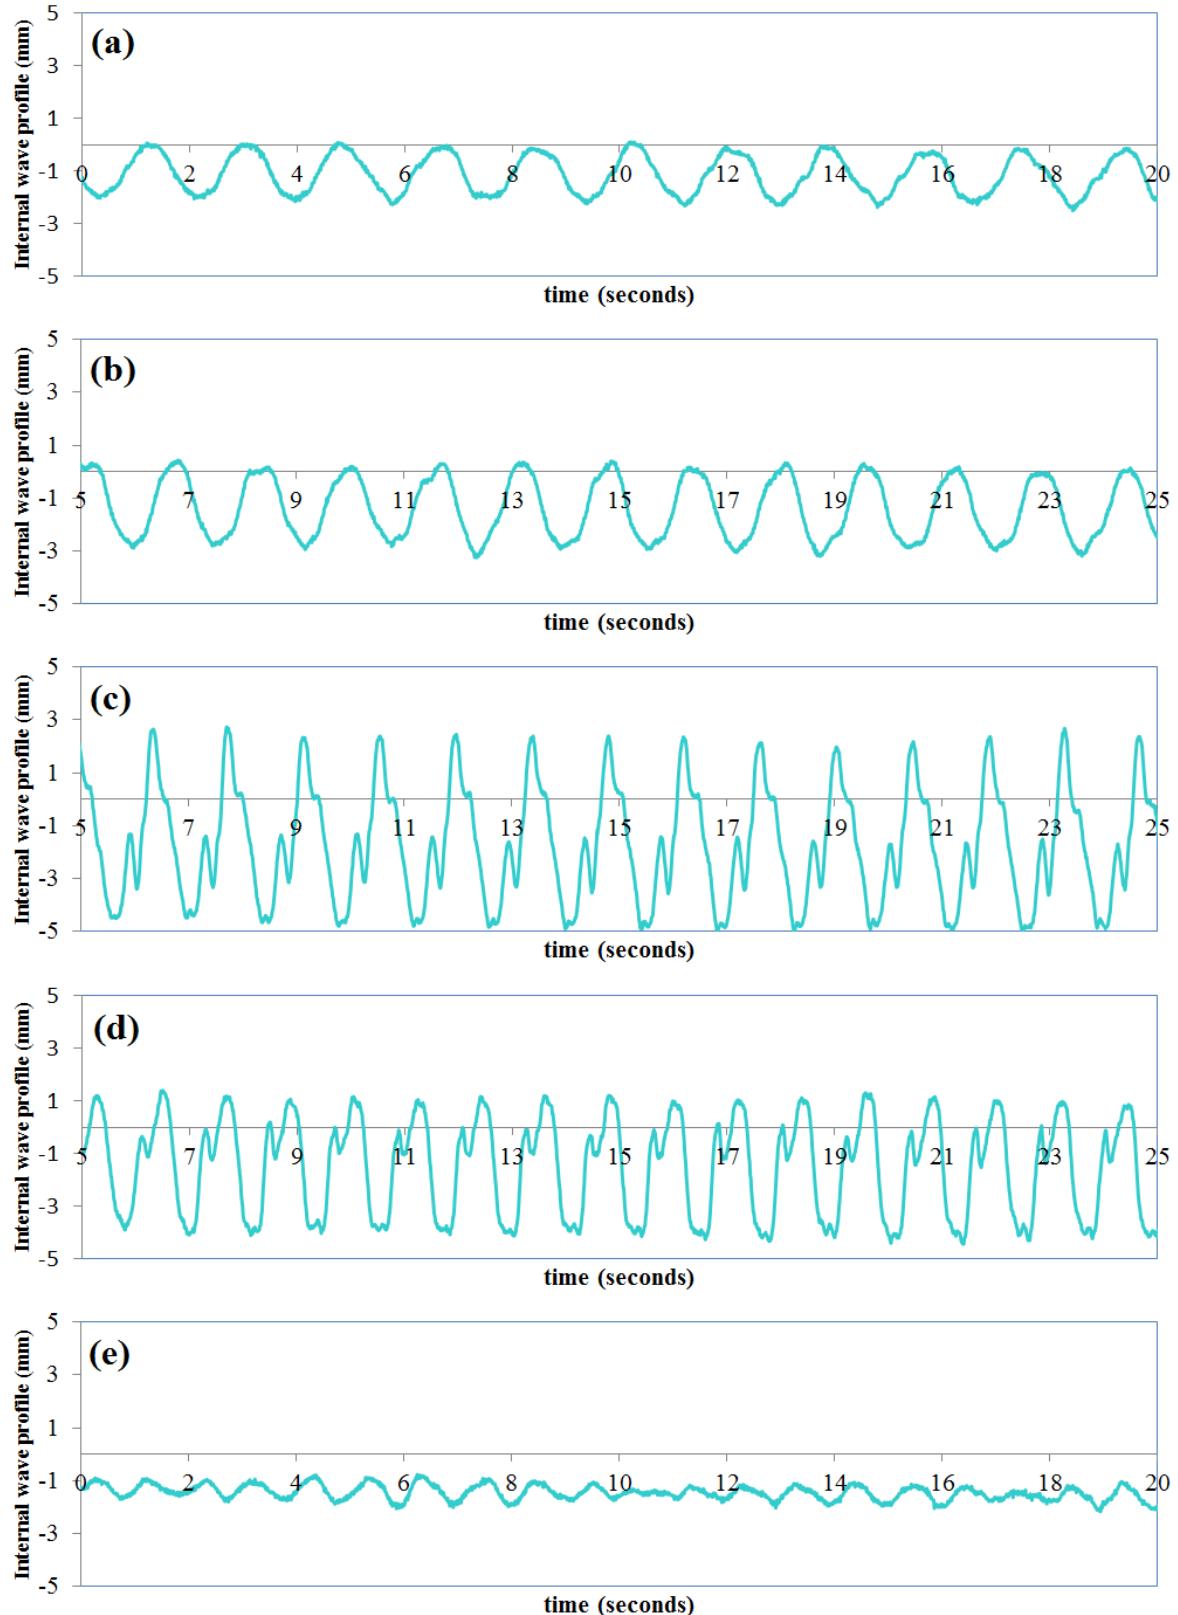
Figure 11: Internal wave profiles at each wave frequency in the flooded condition ( $F_n = 0$ ). Wave frequencies are (a) 3.49 rad/s, (b) 3.93 rad/s, (c) 4.49 rad/s, (d) 5.23 rad/s, (e) 6.28 rad/s.

Recordings were made of the movement of the floodwater free surface (the internal wave profile) at a distance halfway along the damage opening, 148 mm from the aft bulkhead of the flooded compartment at each of the regular wave frequencies tested, and both  $F_n = 0$  and  $F_n = 0.157$ . Results showing the change in internal wave profile shape are presented in Figures 11 and 12. Note that the

At  $F_n = 0$  there is a clear second order sloshing effect visible at a wave frequency of 4.49 rad/s model scale (0.68 rad/s full scale); this corresponds to  $\lambda/L_{OA} = 1.18$ , so close to the peak response of the ship, and is visible through the secondary peaks in the otherwise reasonably regular internal wave profile. The same effect is seen at  $F_n = 0.157$  wave frequencies of 0.53 rad/s and 0.59 rad/s at full scale, hence  $\lambda/L_{OA} = 1.54$  and 1.95. This shift in the wave frequencies at which sloshing effects occur is due to the change in encountered wave frequency with the introduction of forward speed and constitutes a change in the worst-case scenario for the vessel in terms of movement of floodwater within the compartment. Figures 13 and 14 demonstrate the presence of these secondary frequencies in the internal wave profile by showing an fft of the profiles corresponding to Figure 11 (c) and (d), and Figure 12 (b) and (c). Frequency spikes are clearly visible at higher frequencies than the wave frequency in all cases. At higher wave frequencies the internal wave probe shows minimal internal waves as demonstrated in Figure 11 (e) and Figure 12 (d) and (e). This indicates that the variation in the RAO from the intact condition at these frequencies is due to the change in mass and mass distribution due to the addition of floodwater rather than any sloshing effects. Sloshing effects are of more importance at the frequencies showing a large internal wave profile.

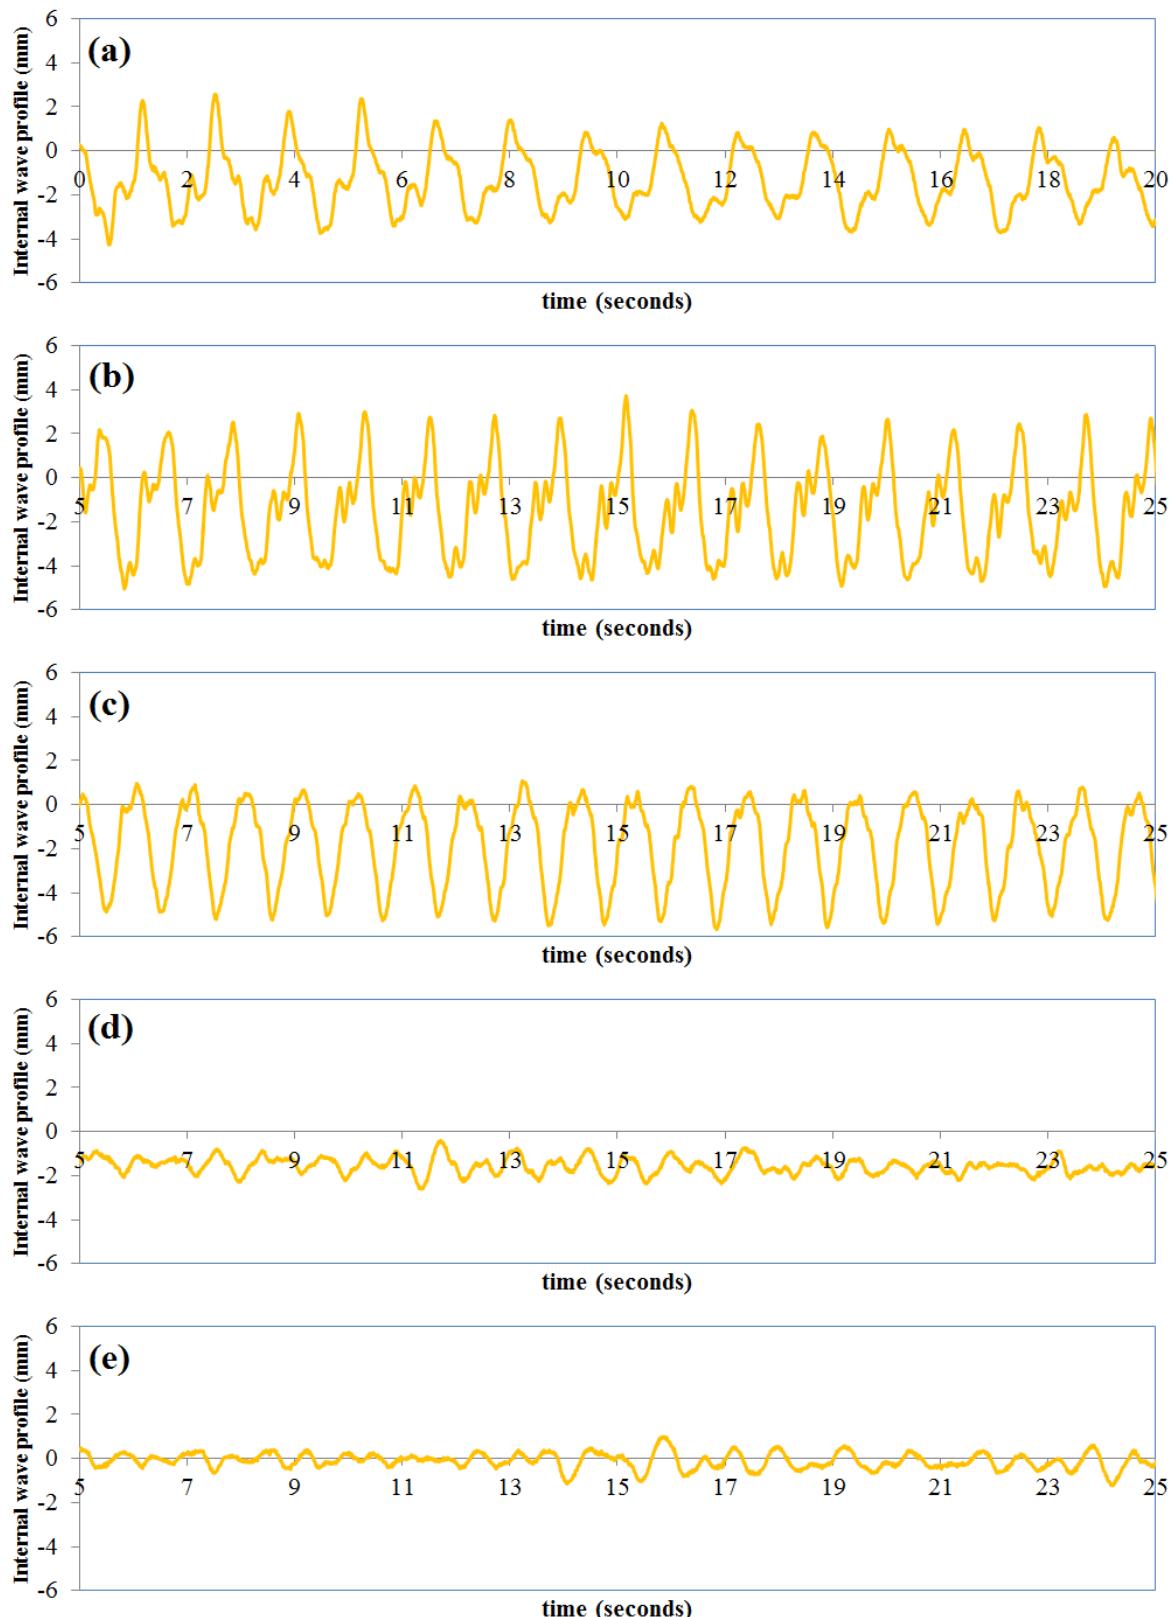
Figure 12: Internal wave profiles at each wave frequency in the flooded condition ( $F_n = 0.157$ ). Wave frequencies are (a) 3.49 rad/s, (b) 3.93 rad/s, (c) 4.49 rad/s, (d) 5.23 rad/s, (e) 6.28 rad/s.

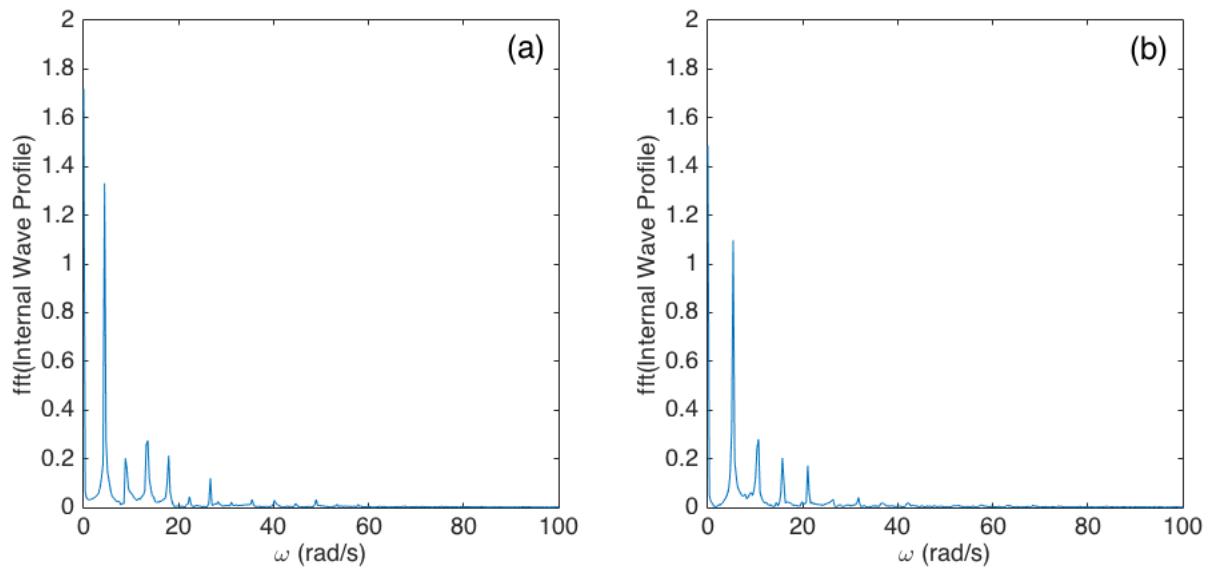
Figure 13: FFT of internal wave profiles for tests in wave frequencies of (a) 4.49 rad/s (corresponding to Figure 11 (c)) and (b) 5.23 rad/s (corresponding to Figure 11 (d)).

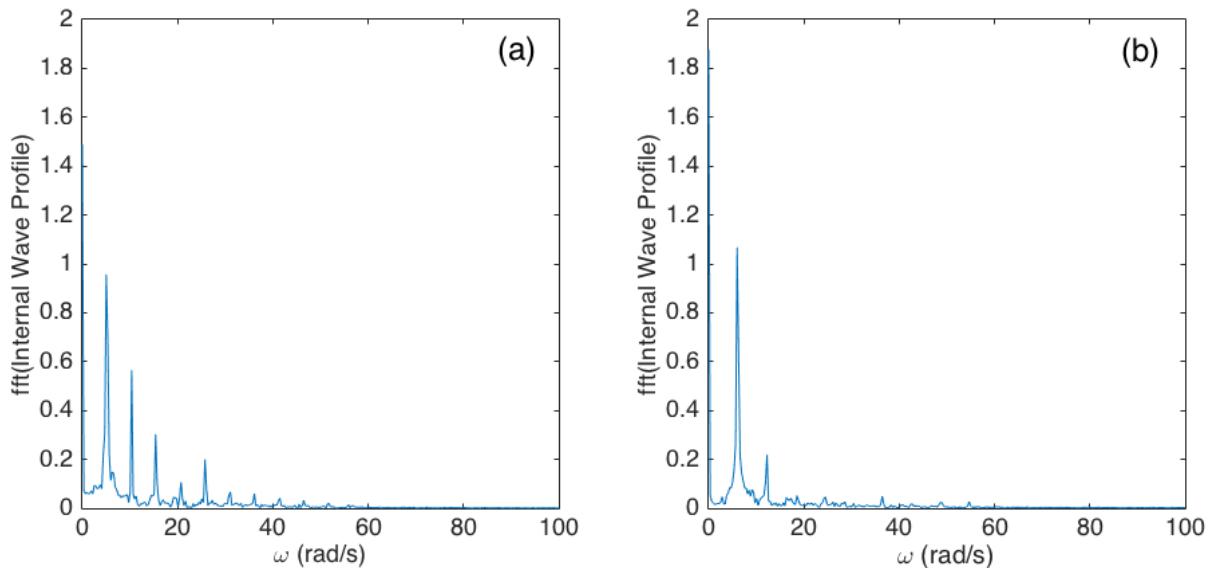
Figure 14: FFT of internal wave profiles for tests in wave frequencies of (a) 3.93 rad/s (corresponding to Figure 12 (b)) and (b) 4.49 rad/s (corresponding to Figure 12 (c)).

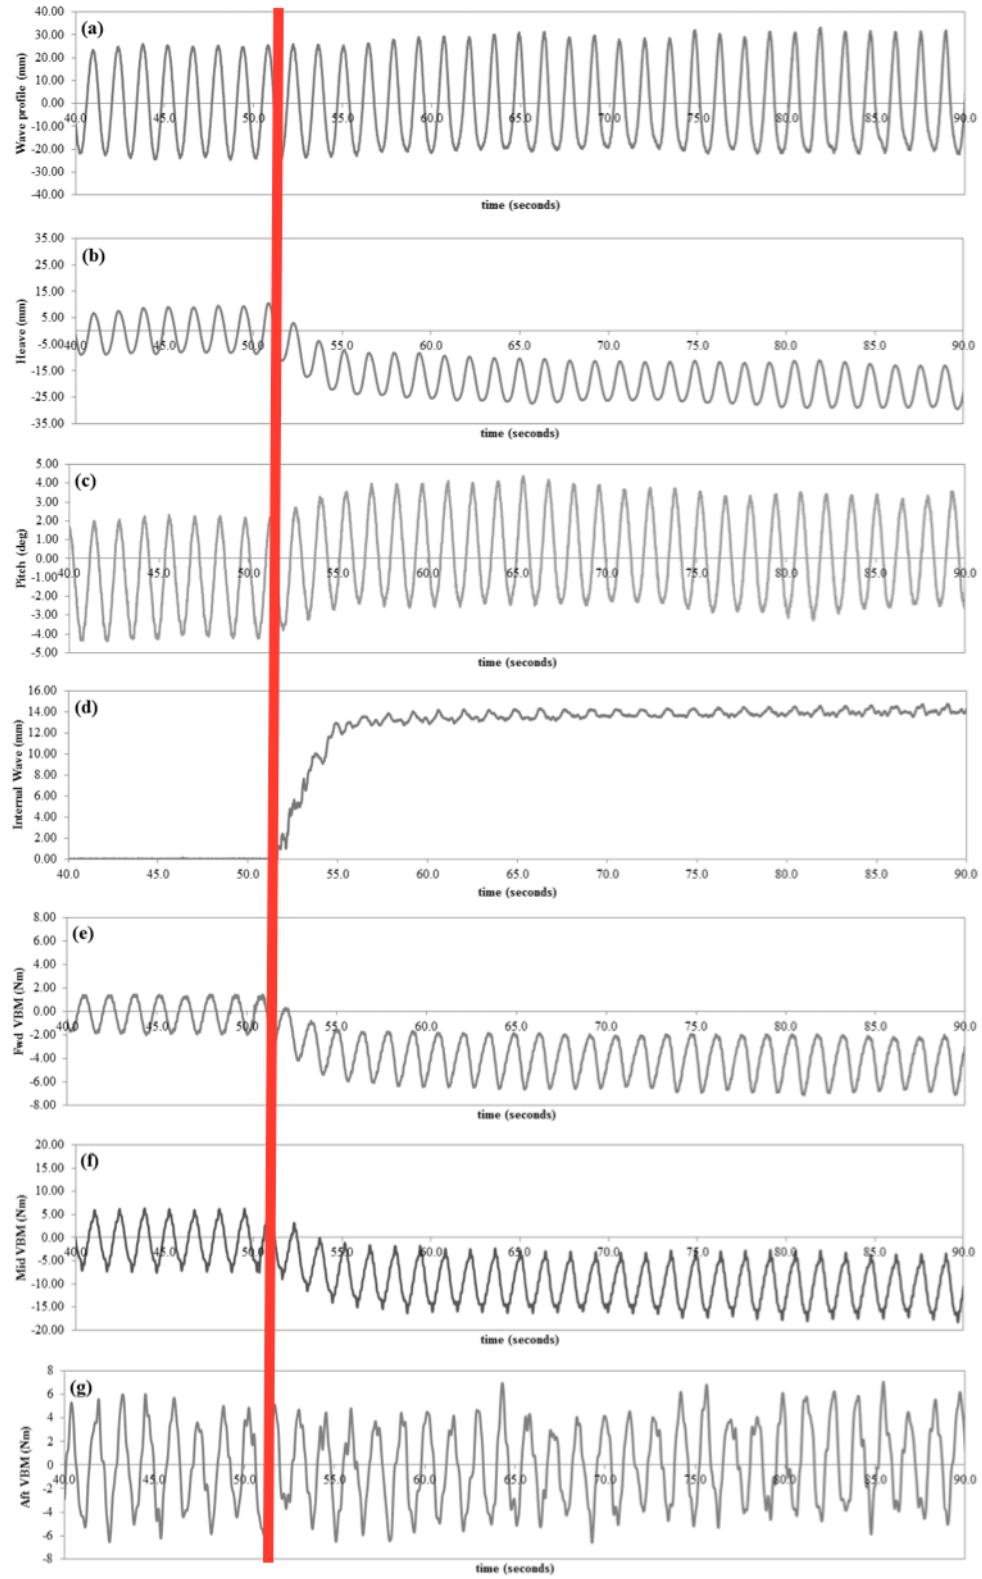
Figure 15: Wave profile and responses recorded during a transient test (presented model scale). The red line indicates the time of the damage occurring.

Figure 15 shows the change in all responses (heave, pitch, vertical bending moment at amidships and the quarters, and the internal wave profile) as the ship progressed from the intact to damaged condition during the transient tests.

From Figure 15 it is clearly visible how the responses changed as floodwater ingress occurred, in terms of magnitude and location of the zero level for each measurement. These values are quantified

Referring back to Figure 15, it can be seen that the time to flood and reach steady state appears to be relatively short (approximately 6.3 seconds when looking at the evolution of the internal wave profile). This may be a result of the size of the damage incident relative to the size of the flooded compartment; future work will look at this time to flood, and its scalability to a full scale vessel. Furthermore when

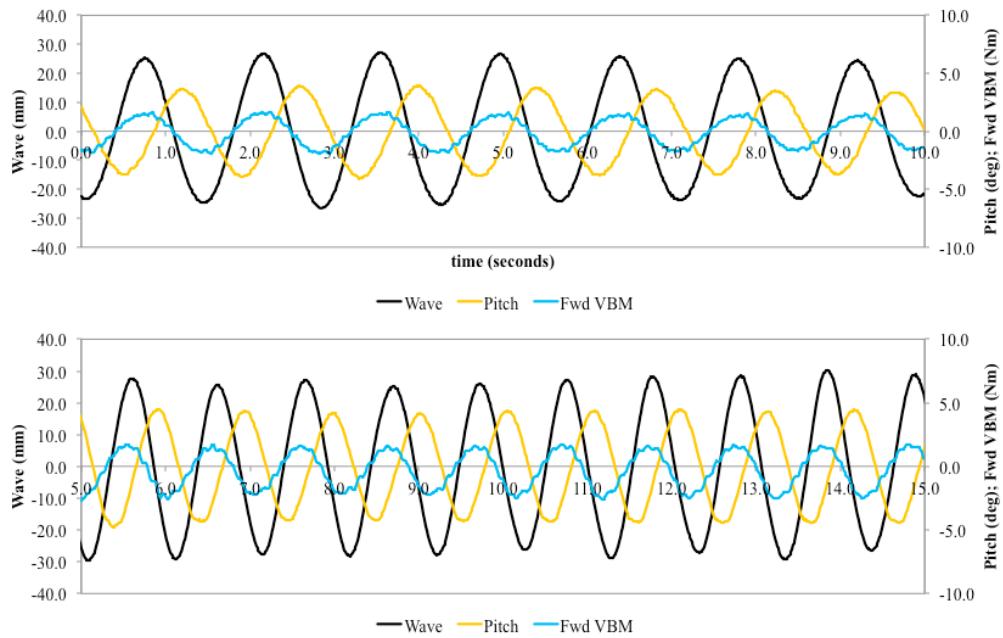
Figure 16: Phasing between wave profiles, pitch response and forward vertical bending moment at  $F_n = 0$  (upper) and  $F_n = 0.157$  (lower) for the intact vessel ( $\lambda/L_{OA} = 1.18$ )

Figures 16 shows the phasing between the wave profile and corresponding pitch response and vertical bending moment at the forward quarter for both Froude numbers tested, and the peak of the RAO curve with the ship in its intact condition. The equivalent comparison for the flooded condition is in Figure 17, and for the flooded vessel and the amidships vertical bending moment in Figure 18. The phasing between the encountered wave profile, pitch, and internal wave profile is demonstrated for the flooded ship at both Froude numbers in Figure 19. The distance between measurement locations (with amidships designated as  $x = 0$ ) is given in Table 7.

These example results show the effect of both ship speed and damage on the phasing between the ship responses and the encountered wave profile. In terms of the vertical bending moment and the pitch responses, the ship speed has little effect on the phasing between the encountered wave profile and the response. However, looking at Figure 19, there is a change in the phasing between the internal wave profile within the compartment and the encountered wave profile, hence the pitch response, at  $F_n = 0.157$  compared to  $F_n = 0$ . This is visible as a more substantial lag in the peak of the internal wave profile relative to the peak of the encountered wave profile at  $F_n = 0$  compared to  $F_n = 0.157$ .

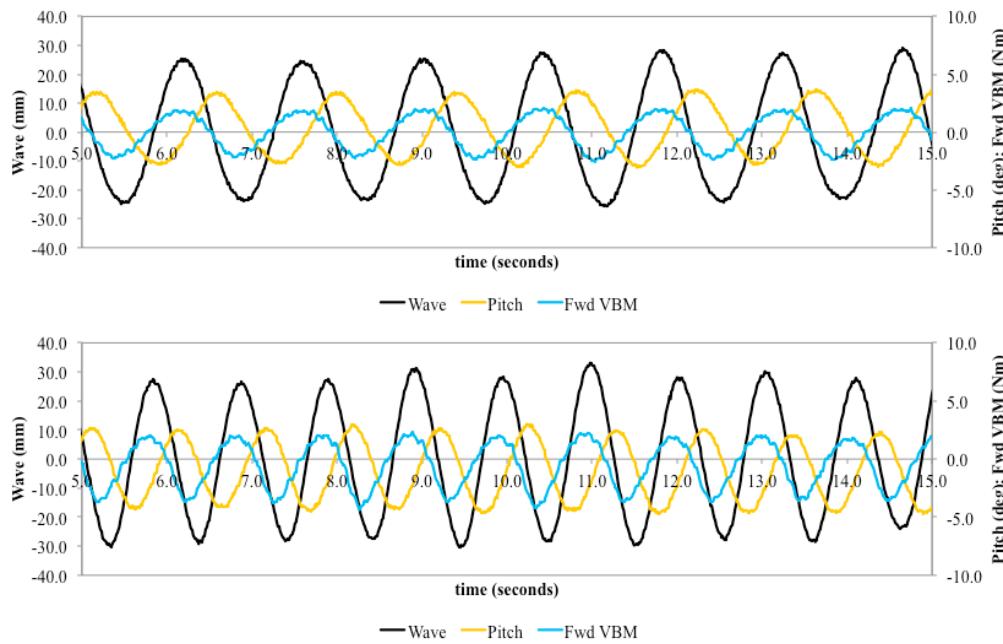
Figure 17: Phasing between wave profiles, pitch response and forward vertical bending moment at  $F_n = 0$  (upper) and  $F_n = 0.157$  (lower) for the flooded vessel ( $\lambda/L_{OA} = 1.18$ )

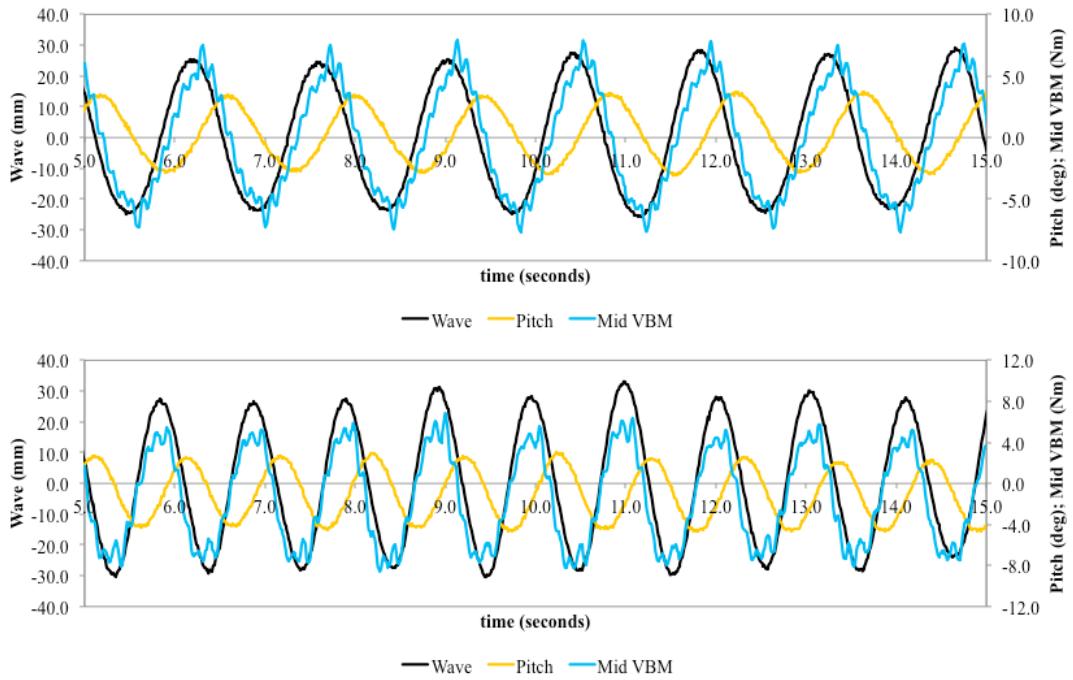
Figure 18: Phasing between wave profiles, pitch response and amidships vertical bending moment at  $F_n = 0$  (upper) and  $F_n = 0.157$  (lower) for the flooded vessel ( $\lambda/L_{OA} = 1.18$ )

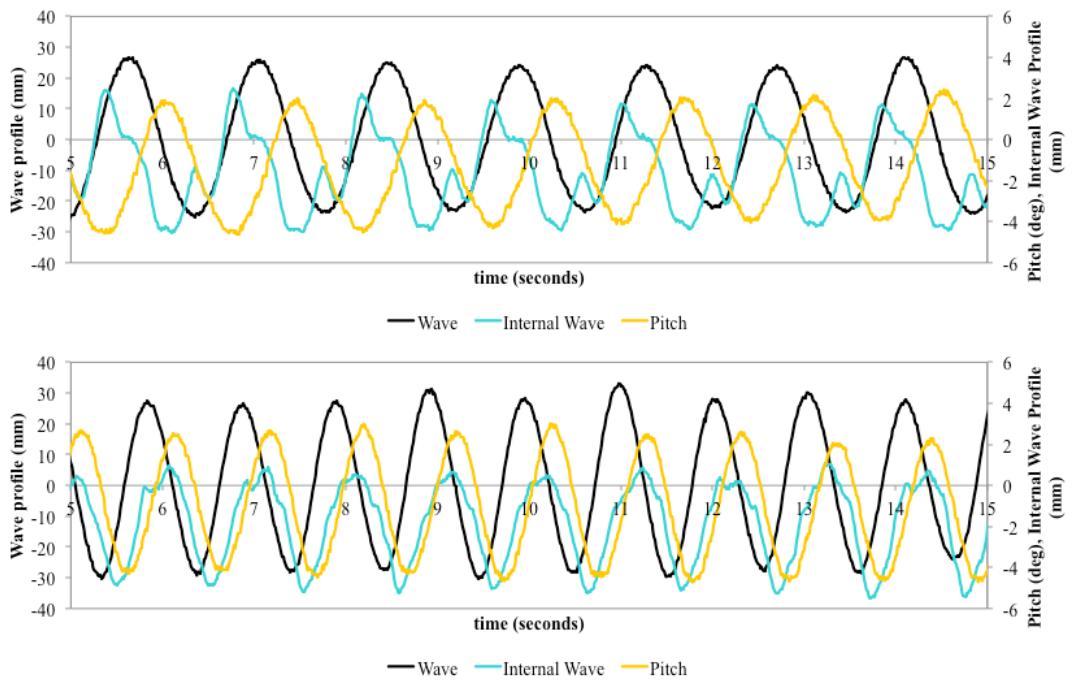
Figure 19: Phasing between wave profiles, pitch response and internal wave profile at  $F_n = 0$  (upper) and  $F_n = 0.157$  (lower) for the flooded vessel ( $\lambda/L_{OA} = 1.18$ )

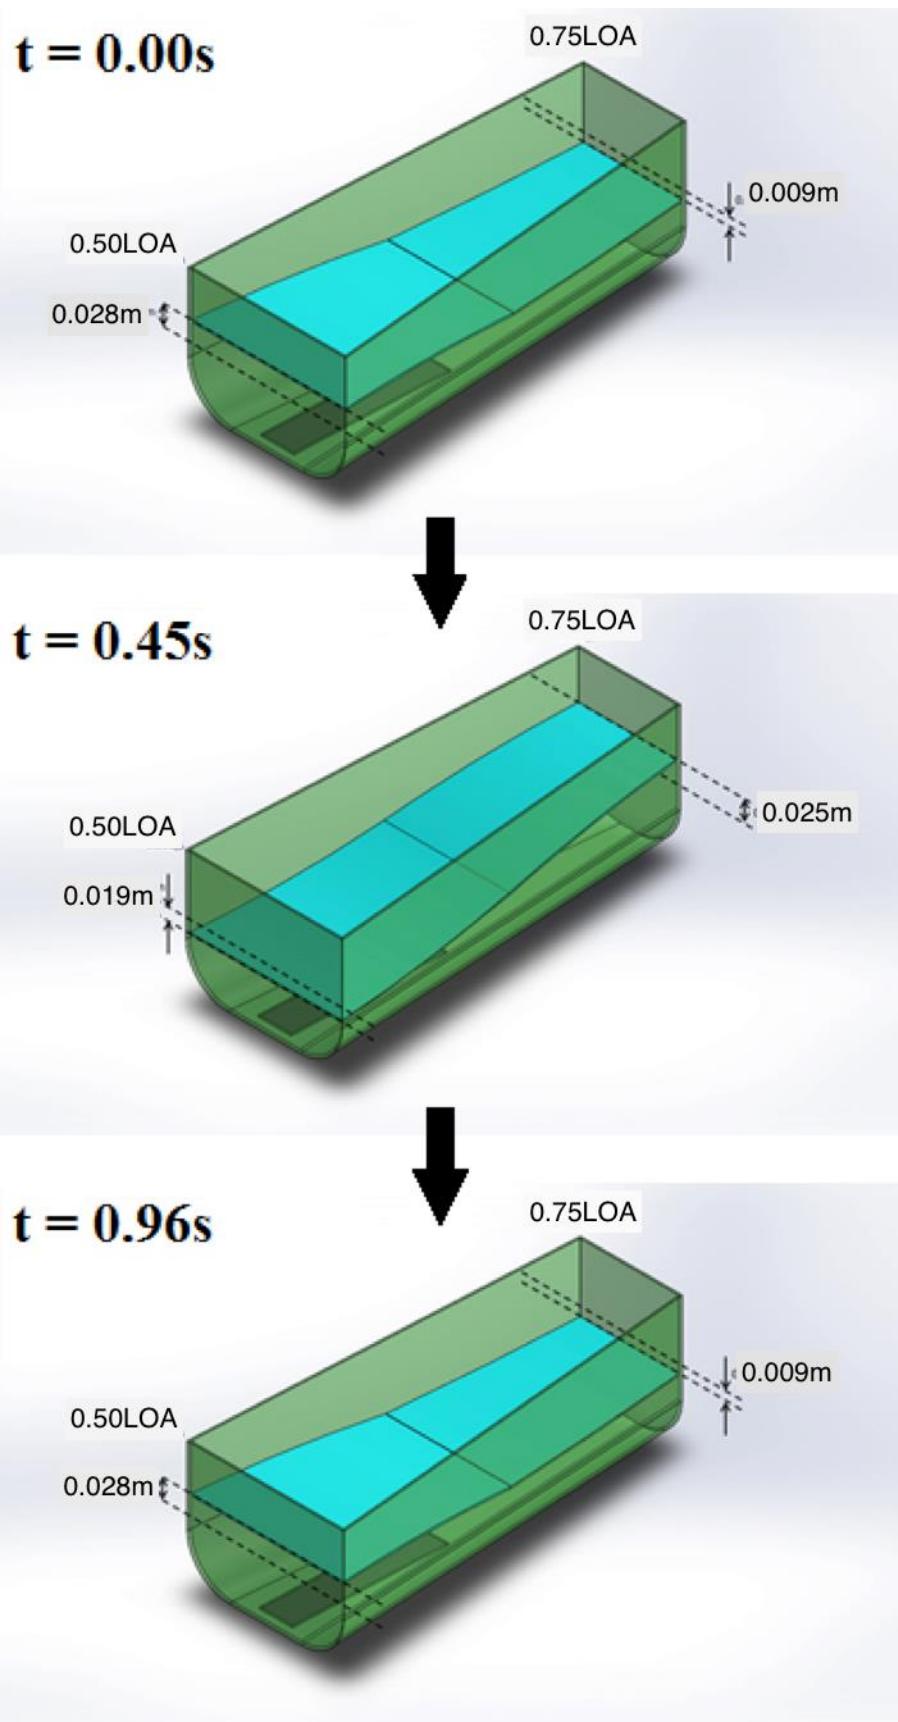
Figure 20: Schematic of floodwater sloshing during transient flooding tests

As an initial step in characterising the flow within the damaged compartment, a schematic has been produced of the water movement within the compartment during the transient flooding tests, based on the GoPro camera imagery and the recorded internal wave profile. Figure 20 presents this schematic, for the typical duration of one period of the internal wave once flooding has reached its steady state, including measurements of the elevation of the water surface above the mean surface of the floodwater in the compartment with no external wave action acting on the ship.

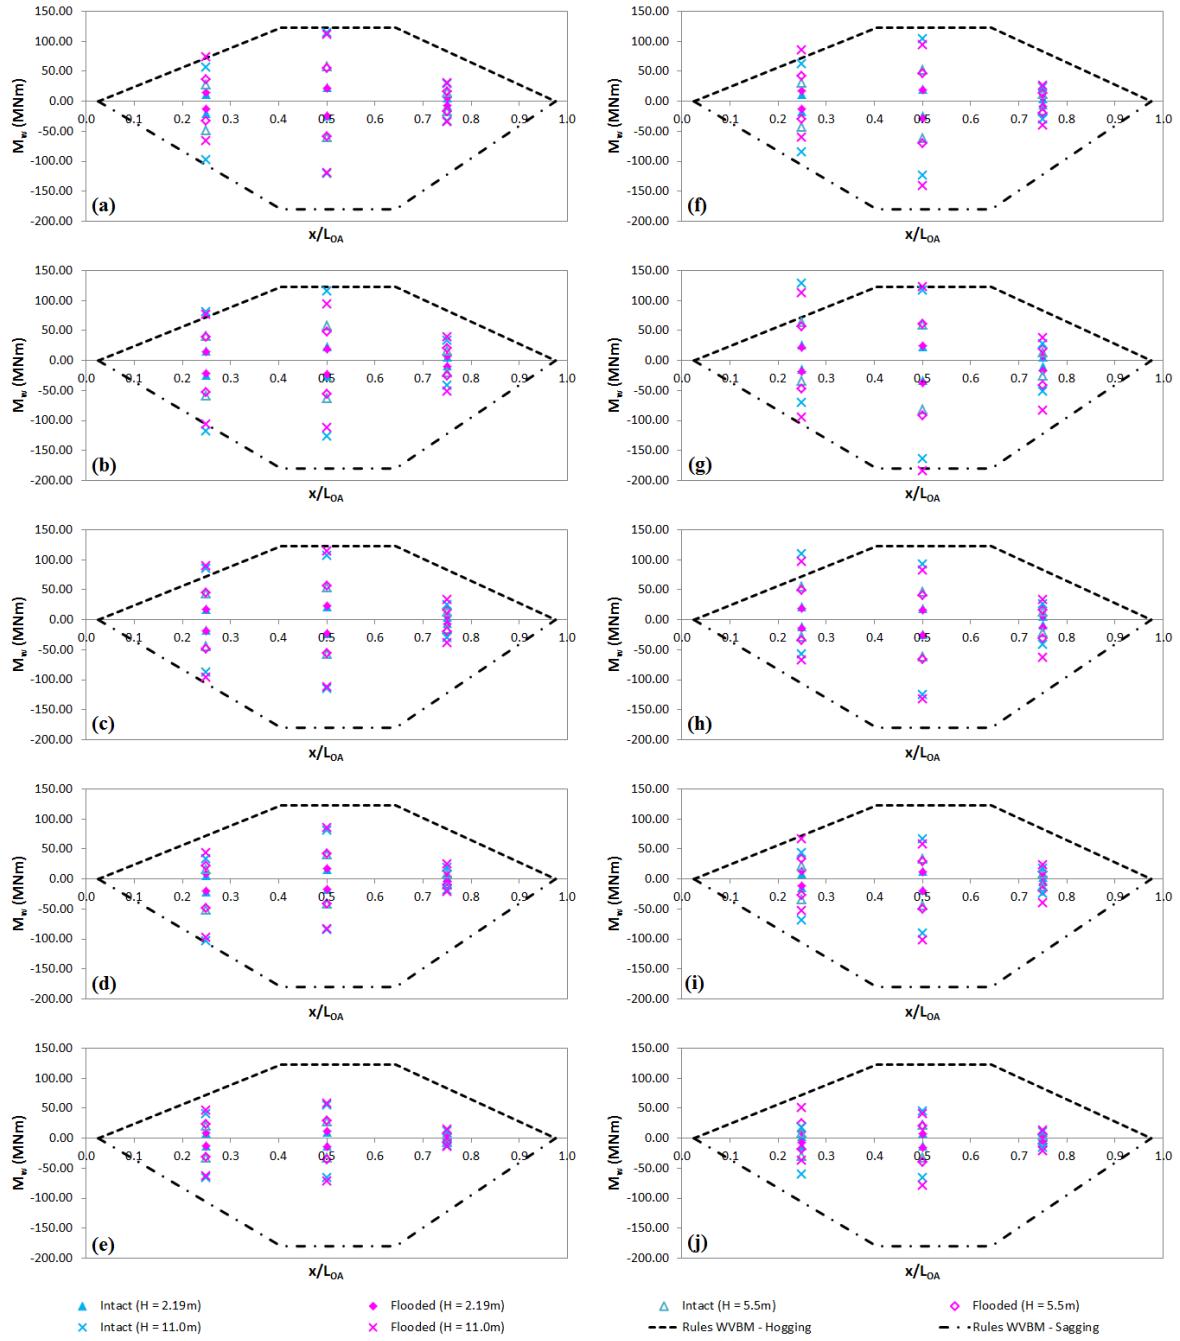
Figure 21: Comparison of hogging and sagging experimental vertical bending moment distributions along the ship to classification rules values at wave frequencies of (a,f) 0.95 rad/s, (b,g) 0.79 rad/s, (c,h) 0.68 rad/s, (d,i) 0.59 rad/s and (e,j) 0.53 rad/s. Results are presented for (a-e)  $F_n = 0$  and (f-j)  $F_n = 0.157$ . All results are presented full scale.

An initial comparison between the experimental results presented here and the distribution of allowable wave induced vertical bending moment (WVBM) calculated from the Lloyd's Register Classification Rules for Naval Ships (Lloyds Register, 2015). Figure 21 presents results for this comparison for the ship at  $F_n = 0$  and  $F_n = 0.157$  in each of the regular waves tested. Experimental results are shown for the forward and aft quarters and amidships, for the data presented previously. Rules values of WVBM were calculated assuming the vessel was suited to worldwide operation, and therefore a design sea state with a significant wave height of 5.5m was assumed. For the zero speed case the ship peak response occurred at a wave frequency of 0.68 rad/s whereas for  $F_n = 0.157$  it occurred at a wave frequency of 0.79 rad/s. In addition to the experimental results in full scale wave heights of 2.19m, two further sets of experimental scaled results (assuming linear scaling is possible) are shown: (i) corresponding to  $H = 5.5m$ , the condition for which rules values are calculated and (ii) corresponding to  $H = 11.0m$ , at which point the rules values are exceeded.

Figure 21 shows that in general the vertical bending moments of the damaged vessel measured during experiments are below the current recommended values according to classification society rule (Lloyds Register, 2015). There is less of a safety margin when the ship is travelling at speed compared to when it is stationary in both the intact and damaged cases. This is particularly visible around the peak response wave frequency (Figure 21g) at  $F_n = 0.157$ , when the results are in general close to the rules values at all three locations at which measurements were taken.
