# **Synergistic effects of cavitation erosion and corrosion for nickel aluminium bronze with oxide film in 3.5% NaCl solution**

J. Basumatary, R. J. K. Wood

National Centre of Advanced Tribology at Southampton, University of Southampton, Highfield, SO17 1BJ

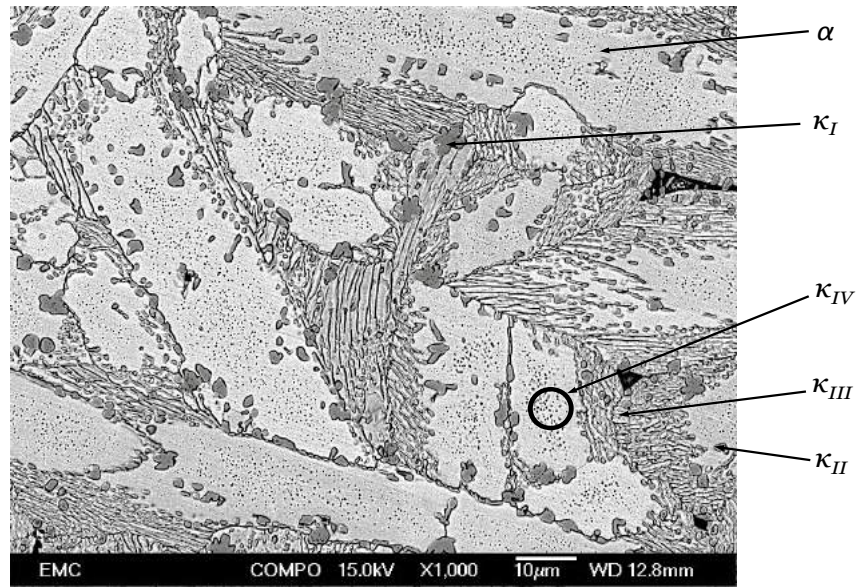
Figure 1 shows the general microstructural morphology of as-cast NAB tested in this paper under Scanning electron microscope (SEM) at 1000x magnification where,  $\kappa_I$  and  $\kappa_{II}$  are the globular dendritic structures,  $\kappa_{III}$  is the lamellar structure, and  $\kappa_{IV}$  is the very fine particulate imbedded within the  $\alpha$ -matrix.

**Fig. 1:** SEM backscattered electron image of the microstructural morphology of cast NAB at a magnification of 1000x [17].

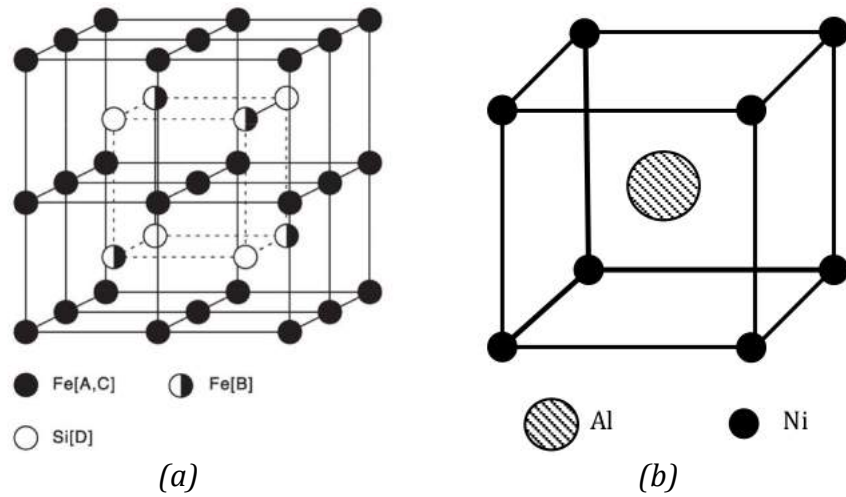
The  $\kappa_I$ ,  $\kappa_{II}$  and  $\kappa_{IV}$  phases are all distributed in the nickel-aluminium structure of  $\text{DO}_3 \text{Fe}_3\text{Al}$  crystal structure.  $\text{DO}_3$  crystal structure is an ordered face centred cuboid (FCC) crystal unit cell with four body centred cubes (BCC) and four  $\text{Fe}_3\text{Al}$  cubes arranged alternatively.  $\kappa_{III}$  phase, on the other hand, is a Ni-rich  $\text{B}_2$  structure, which is a BCC unit with Ni elements at the eight corners but with Al element at the centre of the cube. Figure 2 illustrates the crystal structures of  $\kappa_I$ ,  $\kappa_{II}$  and  $\kappa_{IV}$  phases as  $\text{DO}_3 \text{Fe}_3\text{Al}$ ,  $\kappa_{III}$  phase as  $\text{B}_2 \text{NiAl}$  [16], [18].

**Fig. 2:**(a)  $Fe_3Al$   $DO_3$  structure, and (b)  $NiAl$   $B_2$  structure [16], [18].

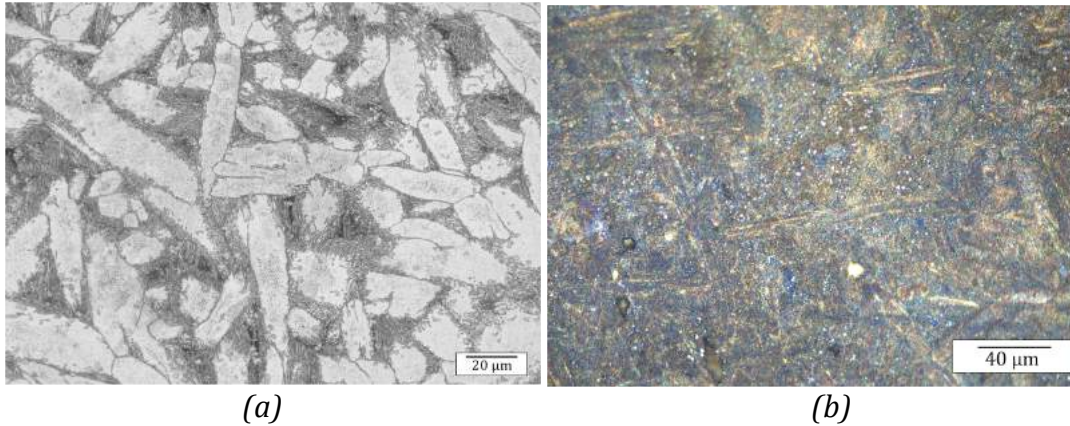
**Fig. 3:** 600x optical image of general oxide film (a) after 1 week in air; (b) after 3 months of immersion in 3.5% NaCl solution.

The other 6 samples were wet polished with 120-, 800, 1200- and 4000- SiC grit paper and then submerged in 3.5% NaCl solution for 3 months to form a thick layer of water-formed oxide film on the samples. Figure 3 shows the differences in the optical images of the oxide-films formed after 1 week of air exposure and 3 months of submersion in 3.5% NaCl solution.

From Figure 3 (a), it can be seen that considering the protective oxide film formation is a slow process, especially in the absence of corrosive environment like seawater, there is not a significance difference in the microstructure of the substrate after 1 week of exposure to air, although the  $\kappa_{III}$  phases seemed to appear more prominent, meaning localised etching or selective phase attack at the phase boundaries. Whereas, in Figure 3 (b) the sample immersed for 3 months in 3.5% NaCl solution had a completely different morphology where the microstructural details of the base material were no longer clearly visible.

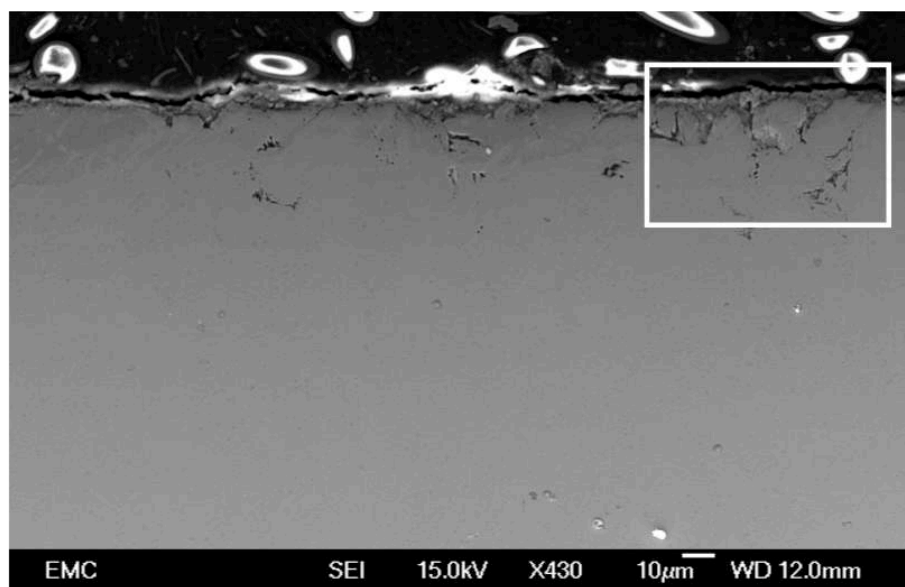
**Fig. 4:** SEM images the oxide film cross-section on the NAB substrate after 3 months of immersion in 3.5% NaCl solution: (a) selective phase corrosion attack reaching up to 40  $\mu\text{m}$  in depth; (b) the area selected in (a) showing selective corrosion of the  $\kappa_{III}$  phase under the surface.

This was verified on cross-sectioning of the NAB sample used for the current research with a thick layer of water-formed oxide layer above the substrate formed after 3 months of immersion in 3.5% NaCl solution showing crevice and selective phase corrosion attack 40  $\mu\text{m}$  deep below the surface (Figure 4(a) and (b)). The composition of the layer, obtained in EDS, mostly comprised of Cu, Al and O. Corrosion mainly took place at the  $\alpha$ - $\kappa_{III}$  lamella eutectoid phase boundaries, and its corroded depth could be as deep as 20  $\mu\text{m}$  beneath the exposed surface, propagating deeper into the substrate (as shown in Figure 4(b)).

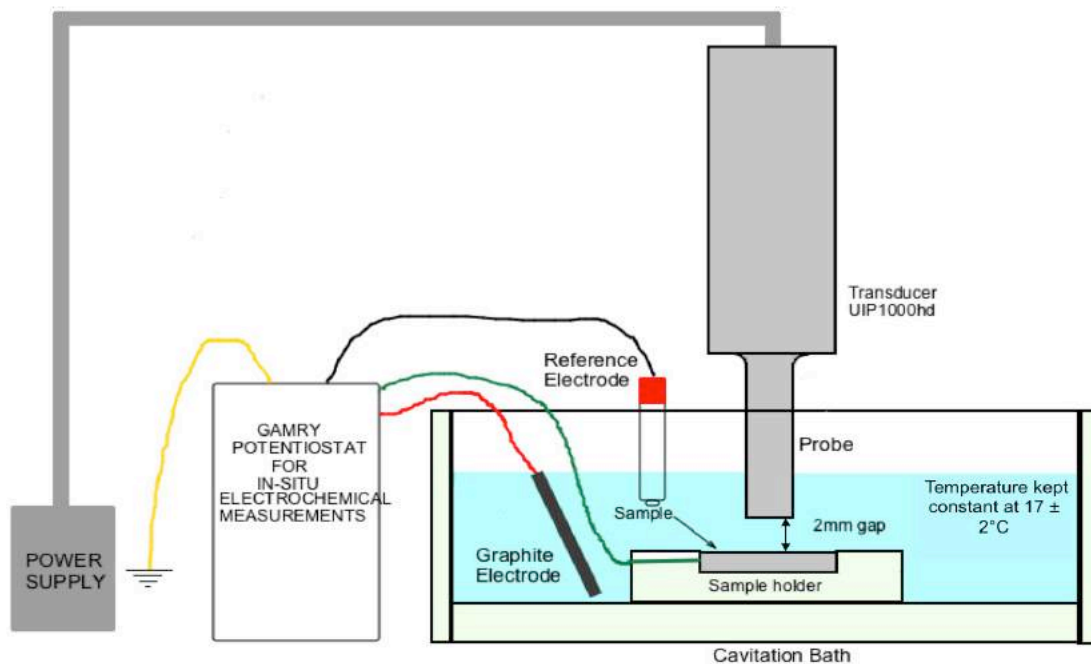
**Fig. 5:** Schematics of the cavitation rig with specimen connected to the electrochemical potentiostat, GAMRY Ref600, for cavitation erosion and corrosion measurements [5].

For the cavitation evaluation, the test samples used were cavitated in the same manner as in ref. [5] under an ultrasonic vibratory cavitation transducer, UIP1000hd, at the tribology laboratory, University of Southampton. The samples were held in a perspex bath using perspex fixture for the indirect cavitation process conforming to the ASTM standard G32-10 [38]. The samples were kept at a constant gap of 2 mm from the sonotrode tip surface. Figure 5 gives the schematics of the test arrangement [5]. The sonotrode was operated at a frequency of 19.5 kHz and peak-to-peak amplitude of 80 ( $\pm 0.2$ )  $\mu\text{m}$ .

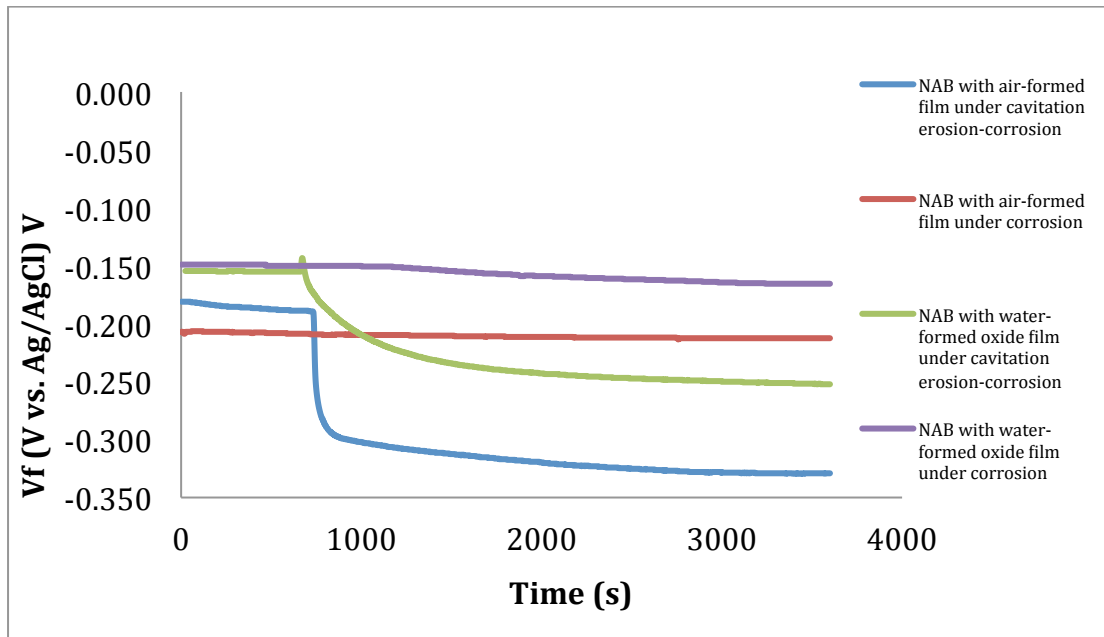
**Fig. 6:** OCP for NAB with air-formed oxide film and water-formed oxide film in 3.5% NaCl solution for 1 hour with and without cavitation.

Figure 6 is the OCP curve obtained for NAB with air-formed and water-formed oxide films in pure corrosion and erosion-corrosion in 3.5% NaCl solution, where  $V_f$  is the reference potentials in volt. From the electrochemical tests, it was seen that the water-formed oxide film had higher passivation for both pure corrosion and cavitation erosion-corrosion. The figure shows that the air-formed film NAB reached stability at -210 mV under pure corrosion, whereas the water formed film NAB reached stability at -150 mV.

It was observed that the measured OCP shifted slightly negatively by about 6 mV from -207 mV to -213 mV for air-formed film, and by almost 20 mV for water-formed film from -149 mV to -165 mV under pure corrosion tests. This indicated that the protective oxide films on both NAB samples were slowly broken down due to localized corrosion, causing selective phase attack, during its immersion in the 3.5% NaCl solution. However, there is a dramatic negative shift in OCP upon cavitation impact. The OCP of water formed film surface was more anodic by 20 - 50 mV than the air-formed film surface.

For the cavitation erosion-corrosion tests, the cavitation was applied to samples held under OCP after 600 seconds. As can be seen from Figure 6, for the air-formed film samples there was a drastic negative drop observed in the OCP from -170 mV to about -300 mV on applying cavitation, while the cavitating NAB reached stability within 120 seconds at a lower potential of -310 mV [5]. Whereas, for the water-formed oxide film NAB the OCP shifted from -151 mV to about -250 mV before attaining stability, although the negative shift and stability was attained more gradually over time in about 600 seconds.

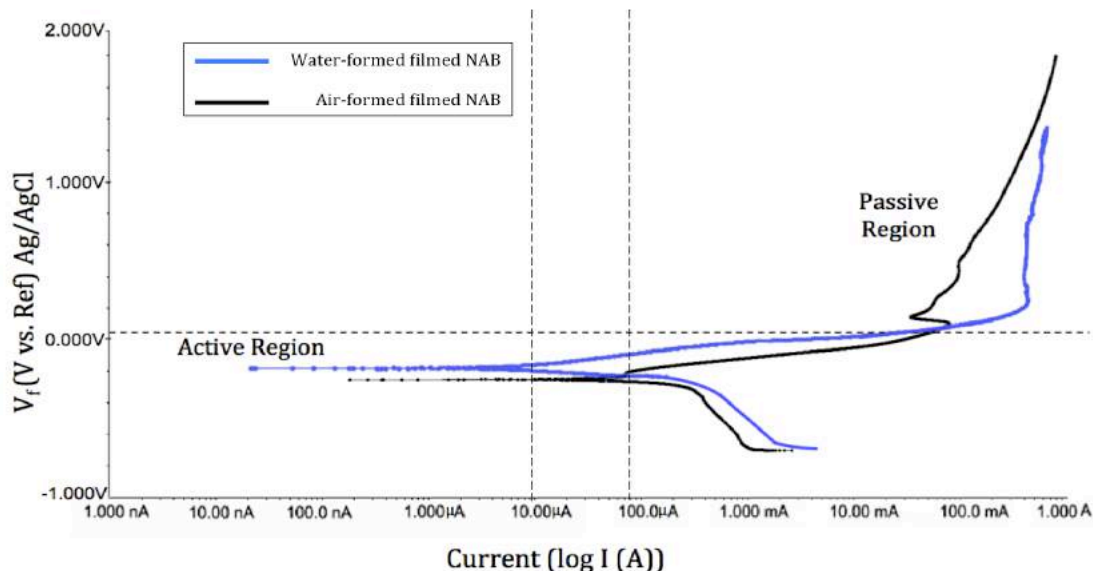
**Fig. 7:** Polarization curves for NAB with air-formed oxide film and water-formed oxide film in 3.5% NaCl solution for 6 hours.

subjected to potentiodynamic polarization at a scan rate of  $0.167 \text{ mV s}^{-1}$  under static conditions using GAMRY potentiostat in 100 ml of 3.5% NaCl solution. Figure 7 plots the two polarization curves comparing the current rate and active regions of the two samples.

From the polarization results obtained, it can be seen that the corrosion current density ( $I_{\text{corr}}$ ) of water-formed oxide filmed NAB is lower at  $1.6 \mu\text{A cm}^{-2}$  than  $I_{\text{corr}}$  of air-formed oxide filmed NAB at  $16.0 \mu\text{A cm}^{-2}$ .

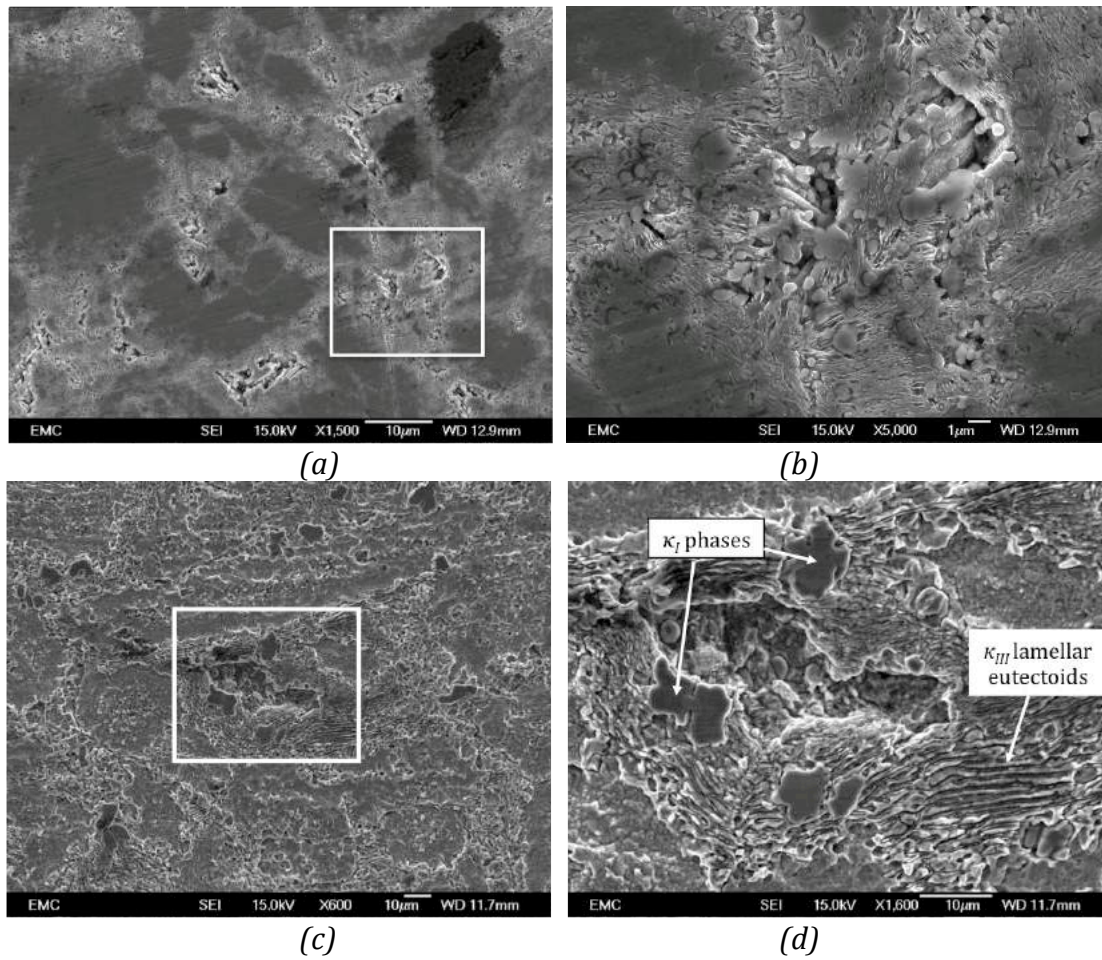
**Fig. 8:** SEM images of (a) small selective phase attack on air-formed film at a magnification of  $\times 1500$  in distilled water; and (b) magnification of the selected area at  $\times 5000$ ; (c) SEM image of a  $50\ \mu\text{m}$  large cavity on the sample surface undergone cavitation erosion-corrosion in 3.5% NaCl solution; (d) the magnified image of a cavity in (c) showing selective phase attack at the  $\alpha$ - $\kappa$  phase boundaries leaving  $\kappa_I$  globules and  $\kappa_{III}$  lamellar phases exposed [17].

For the microstructural analysis of the cavitated surface for air-formed film under SEM, it was found that the soft  $\alpha$ -matrix, especially surrounding the hard iron-rich  $\kappa$  phases, seemed to be most vulnerable to cavitation attack as compared to the  $\kappa$  phases and the precipitate-free  $\alpha$  zones. The cavity sizes ranged between 10-30  $\mu\text{m}$  in distilled water (see Figure 8(a) and (b)) as also reported in ref [5], especially at the  $\alpha$ - $\kappa_{III}$  grain boundaries. Whereas, the cavities were recorded to be much larger, 50-80  $\mu\text{m}$ , for the cavitation erosion-corrosion test in 3.5% NaCl solution. It was also found that the materials underwent selective cavitation erosion-corrosion attack in 3.5% NaCl solution at the  $\alpha$ - $\kappa_{III}$  phase boundaries as seen in Figure 8(c) and (d); hence the regions with high lamellar  $\kappa_{III}$  phases were most susceptible. Also seen in Figure 8(d) are  $\kappa$ -phases exposed due to the surrounding soft  $\alpha$  phase being eroded away.

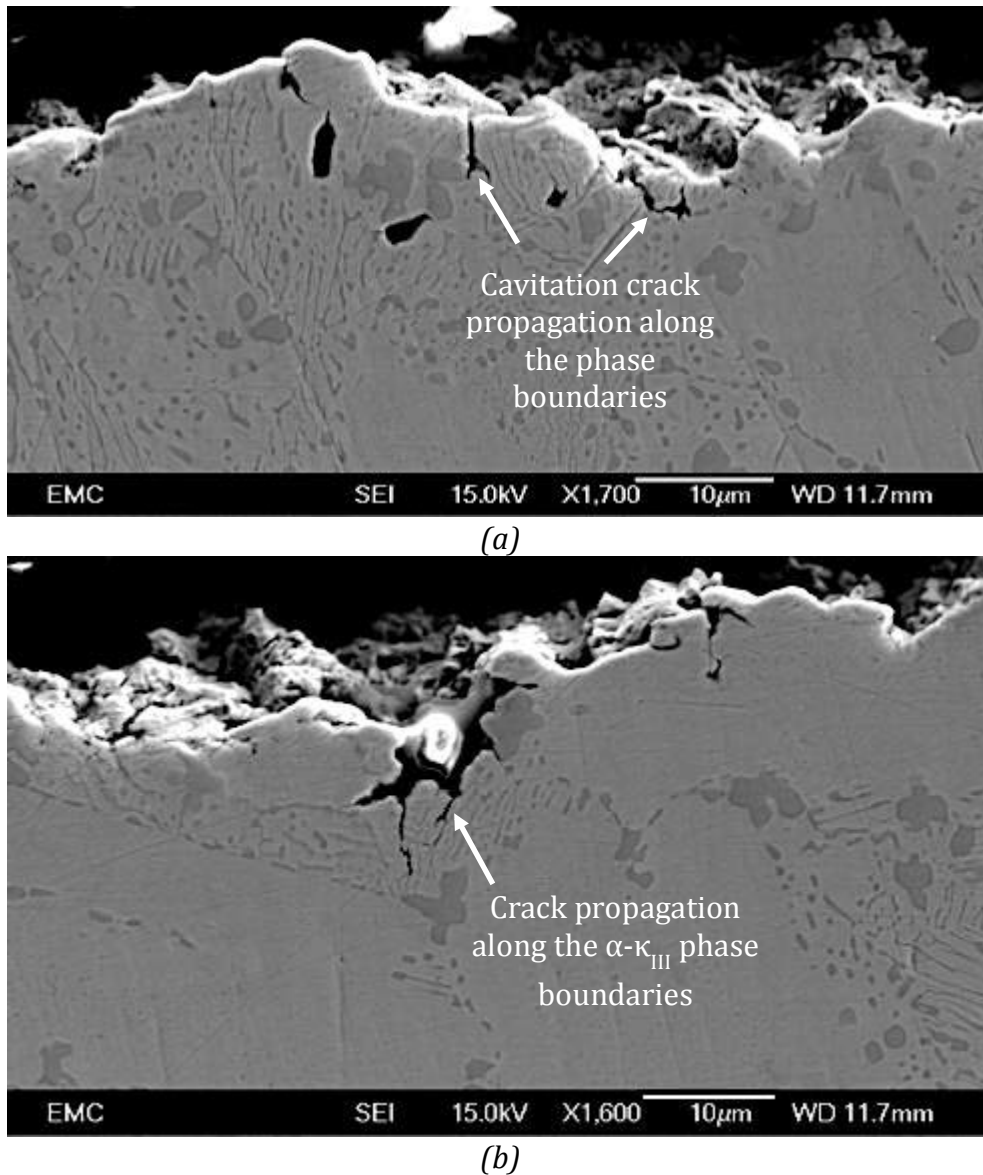
**Fig. 9:** SEM images of transverse sections of NAB after 1 hour of cavitation erosion-corrosion test in 3.5% NaCl solution with air-formed film showing crack propagation along the  $\alpha$ - $\kappa_{III}$  phase boundaries and plastic deformation.

The transverse section of the cavitation erosion pattern in an air-formed oxide filmed NAB sample is shown in Figure 9. The cross-sectional imaging confirmed that the adverse site of attack was mostly at the  $\alpha$ - $\kappa$  phase boundaries. Once the cavitation erosion took place, several micro-cracks initiated at these erosion sites, and from there on propagated into the microstructure, especially along the  $\alpha$ - $\kappa$  grain boundaries. Also, several subsurface cracks were observed, however the origin and mechanism of these cracks are not fully determined.

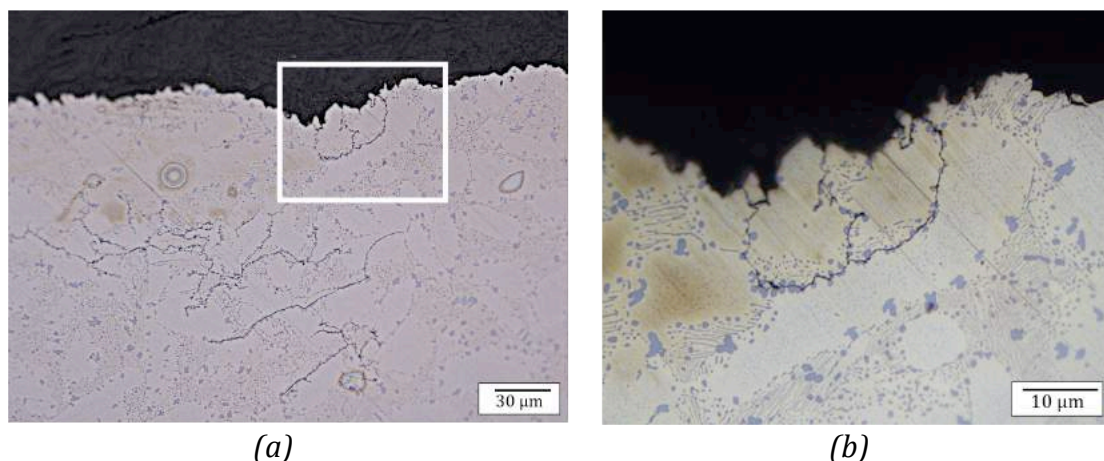
**Fig. 10:** Optical images of: (a) dendritic surface and potential subsurface cracks at 200x; and (b) detail of the selected area in Figure 10(a) of surface cracks forming along the grain boundaries at 1200x after 1 hour of cavitation erosion-corrosion test in 3.5% NaCl solution.

Figure 10 (a) and (b) show optical images of the transverse section of an air-formed filmed surface cavitated in 3.5% NaCl solution for 5 hours. Figure 10(a) shows a series of cracks formed under the surface up to a depth of 150  $\mu\text{m}$  and interesting crack formation along the  $\alpha$ - $\kappa$  phase boundaries especially beneath the largest cavity, about 50  $\mu\text{m}$  in size. Figure 10 (b) shows the magnified image of the crack feature. There are a number of stresses acting upon the surface, such as the tensile/compressive shear stress, repetitive loading of the cavitation cloud, subsurface shear stress build-up, as well as the material property itself that may mitigate cracks along the weakest grain boundaries, and several subsurface cracks, as seen in Figure 10 (a). The formations of the subsurface cracks are speculated to be due to the interaction between the slip lines of the cu-rich matrix and the hard secondary phases. The  $\alpha$ -matrix, having an FCC structure follows the preferential  $\langle 111 \rangle$  slip plane. The subsurface layer generally procures more dislocation than the surface itself. With repetitive or

cyclic loading there tends to be pile-ups of dislocations along the subsurface layer that leads to the formation of voids. This is further enhanced within the material with multi-phases with differences in the hardness. The dislocation is then said to pile against the hard secondary phases, forming voids primarily due to plastic flow of softer matrix around hard secondary phase particles within the microstructure [39]. This, combined with the accumulate subsurface strain, lower fracture toughness of the softer phase against the hard phases with higher mechanical property gives way to stress concentration at the grain boundaries, which then eventually results in the failure under cyclic impact stress generated by the cavitation clouds. And hence, causing the subsurface cracks.

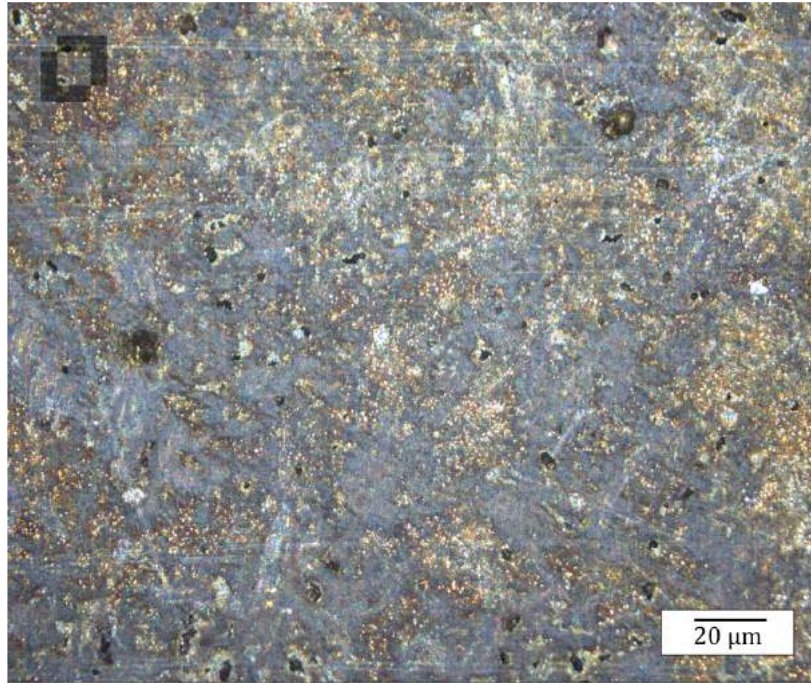
**Fig. 11:** Image of water-formed oxide filmed NAB surface before cavitation erosion-corrosion.

For the water-formed film, the wear mechanism was found to be same as the air-formed film. However, the oxide film formation, the film thickness, and the impact of corrosion in chloride solution played a significant role in the cavitation erosion-corrosion behaviour of NAB immersed in 3.5% NaCl solution for 3 months. Figure 11 shows the water-formed un-cavitated oxide film on NAB, where the microstructure of the substrate is not clearly distinguishable.

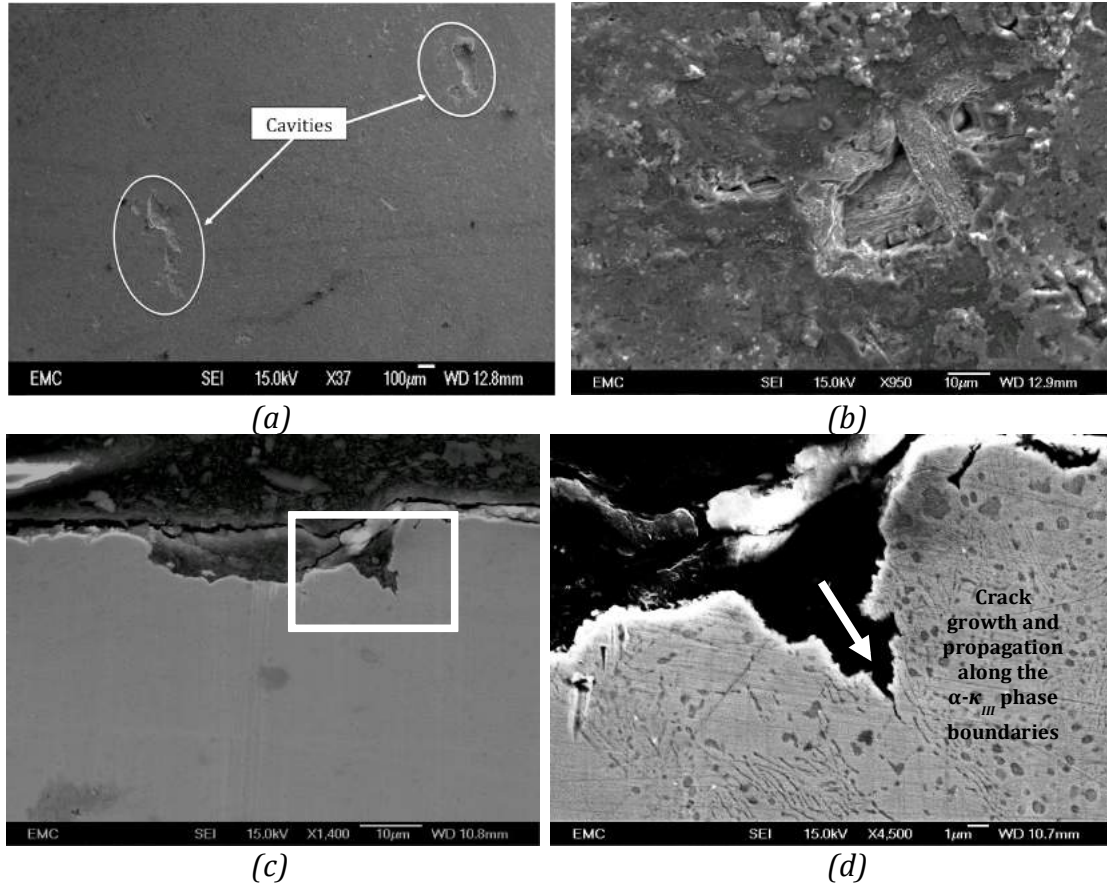
**Fig. 12:** SEM images of water-formed oxide filmed NAB sample under pure *E* conditions: (a) cavities formed on the sample surface after 1 hour of cavitation erosion-corrosion; (b) magnified image of the cavities on the surface; (c) transverse-sections of a cavity at x1400; (d) detailed magnified image of a cavity in (c) exhibiting crack growth and propagation along the  $\alpha$ - $\kappa_{III}$  phase boundaries.

From the cavitation erosion-corrosion results obtained, it was observed that the phase boundaries, as already weakened by crevice corrosion and selective phase attack, were the first site of attack for cavitation erosion-corrosion. Figure 12 (a) shows the cavitation erosion pattern on the roughened oxide surface, detailing a cavity formed due to the erosion for 1 hour in distilled water. On closer analysis under the SEM, the erosion was seen to expose the  $\alpha$ - $\kappa_{III}$  phase boundaries under the oxide film, shown in Figures 12 (b).

Figure 12 (c) shows the transverse sections of a cavity on the sample surface after 1 hour of cavitation conducted under pure E conditions for a water-formed oxide filmed NAB sample. The cavity was found to be of 30- $\mu$ m diameter with a large crack propagating into the microstructure. Figure 12 (d) shows the magnified details of the crack (highlighted in (c)) revealing the crack growth and propagation into the microstructure along the  $\alpha$ - $\kappa_{III}$  phase boundaries. Figure 12 (c) and (d) show the cavitation erosion pattern on the surface, detailing a cavity formed due to the erosion of the  $\alpha$  phase at the  $\alpha$ - $\kappa$  phase boundary, leaving globules and lamellar structures of  $\kappa_I$  and  $\kappa_{III}$  phases exposed.

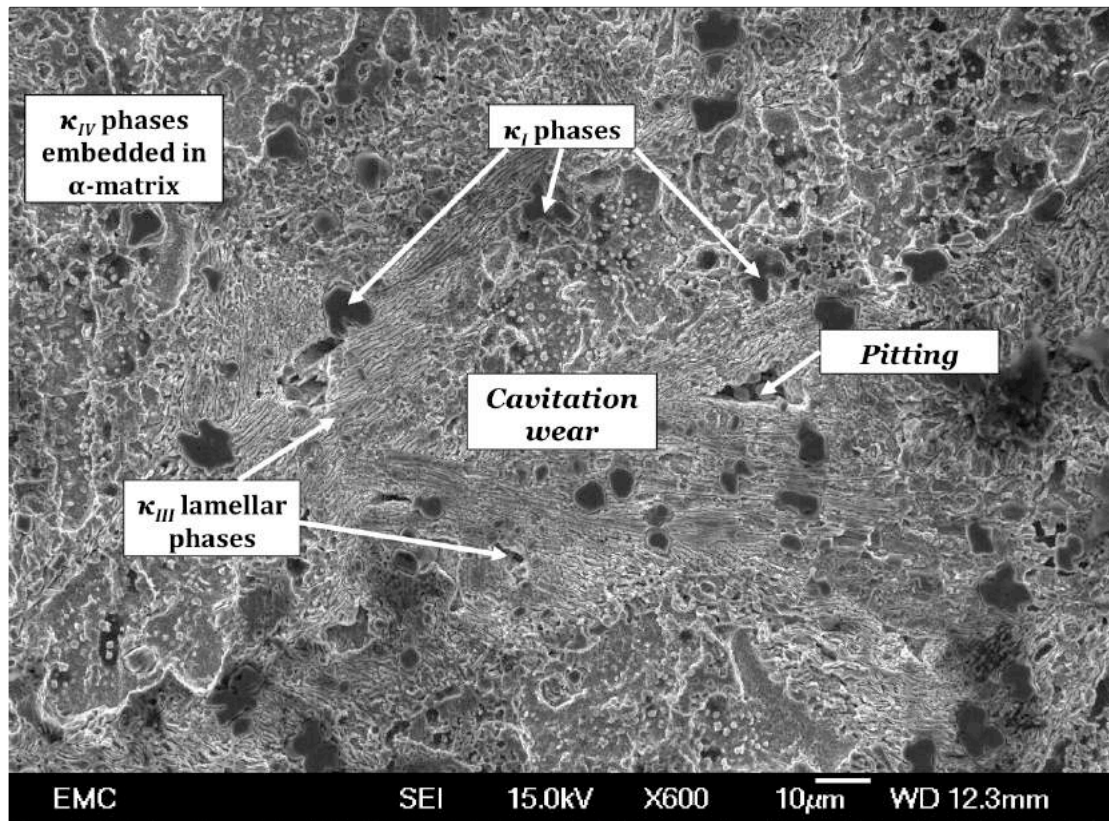
**Fig. 13:** SEM image of the eroded surface of NAB sample with water-formed oxide film after combined cavitation erosion-corrosion test conducted in 3.5% NaCl solution for 1 hour.

The wear scar images obtained after 1 hour of cavitation erosion, with the combined effect of corrosion (T) in 3.5% NaCl solution showed more aggressive wear scar and surface roughness, as seen in Figure 13, illustrating the various different phases within the microstructure. It is evident from the figure that the softer matrix has been eroded and detached, leaving behind small islands of harder iron-rich  $\kappa$  phases exposed, especially at the highest concentration of grain boundaries. Islands of  $\kappa_I$  were seen at the erosion boundaries, whereas threads of  $\kappa_{III}$  were left exposed at regions with high  $\alpha$ - $\kappa_{III}$  eutectoid phases. Furthermore, particulates of  $\kappa_{IV}$  phase were also seen to become more prominent due to the  $\alpha$ -phase erosion at the phase boundaries.

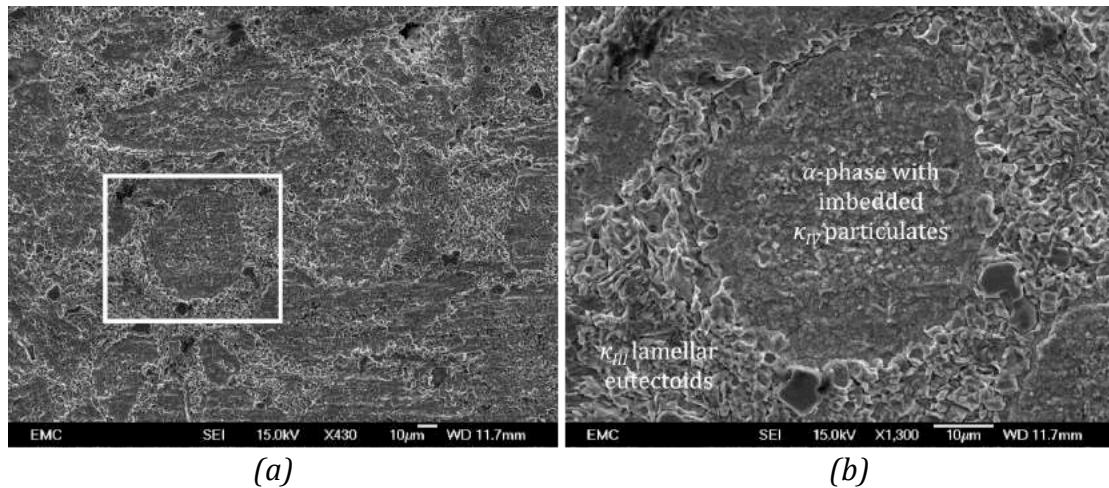
**Fig. 14:** SEM images of the distinguished phase erosion of the oxide filmed sample in 3.5% NaCl solution after 1 hour of cavitation.

For both E and T conditions, it was seen that the water-formed oxide filmed NAB surface suffered similar erosion trend. The lamellar eutectoid phase boundaries were seen to be most susceptible to corrosion attack, making them further vulnerable to wear via cavitation erosion. Hence, the roughness observed was the highest in these phase boundaries. In Figure 14(a) the phases can be easily distinguished, especially after cavitation erosion-corrosion due to selective phase attack and wear at the  $\alpha$ - $\kappa_{III}$  as well as  $\alpha$ - $\kappa_{IV}$  phase boundaries, with the exposed  $\kappa_{IV}$  phases imbedded into the soft matrix (Figure 14(b)).

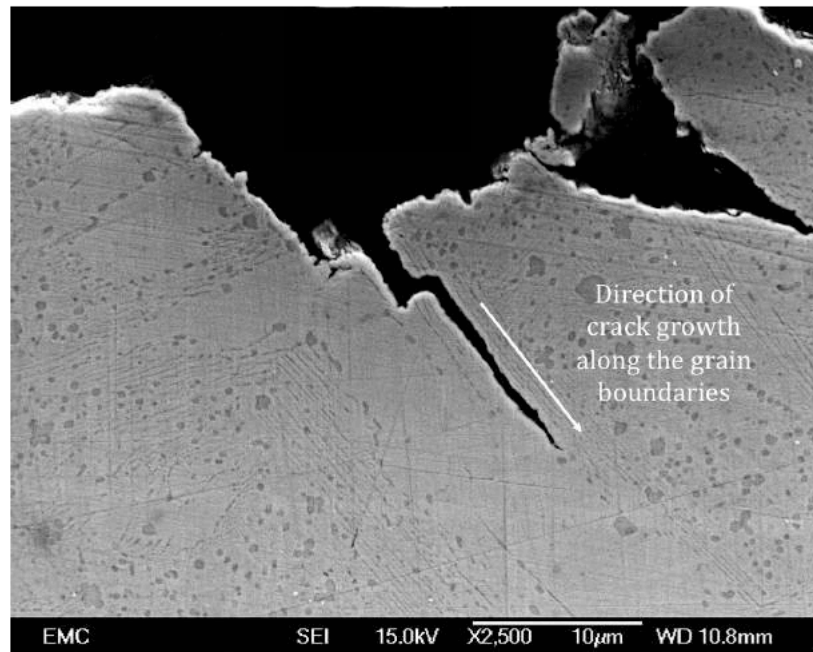
**Fig. 15:** SEM images of transverse sections of NAB after 1 hour of cavitation erosion-corrosion test in 3.5% NaCl solution with water-formed film showing cracks propagating along the lamellar eutectoid grain boundaries.

Figures 15(a) and (b) show the transverse sections of the sample surface after 1 hour of cavitation erosion-corrosion test for the water-formed oxide filmed NAB sample. The cavities were found to be of about 50-80  $\mu\text{m}$  in diameter. Figure 15 exhibits a large crack propagating into the microstructure along the  $\alpha$ - $\kappa_{III}$  phase boundaries.
