Damage in CFRP Composites Subjected to Simulated Lightning Strikes - Assessment of Thermal and Mechanical Responses

T.M. Harrell^{1a}, O.T. Thomsen¹, J.M. Dulieu-Barton¹ and S. F. Madsen²

CFRP composites; Lightning Damage; Wind Turbine Blades; Compression and Shear Testing; Thermal Imaging; Digital Image Correlation (DIC); Failure Initiation Stress

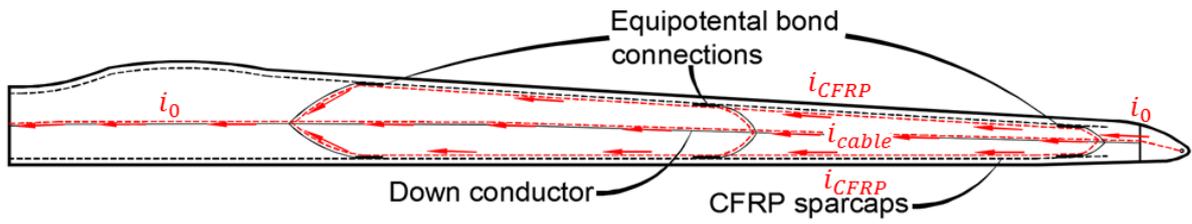
Fig. 1. Wind turbine blade with lightning protection system

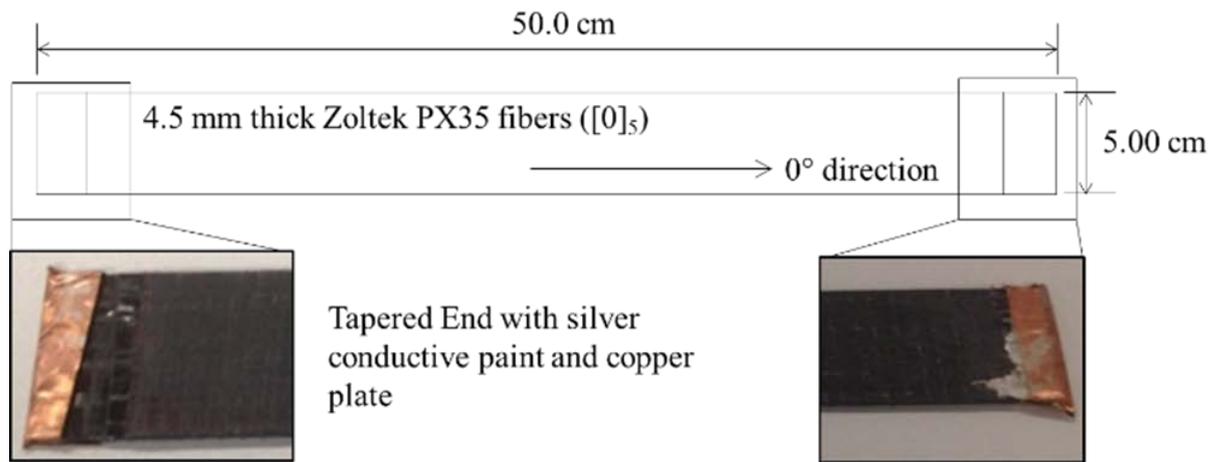
Fig. 2. CFRP strip specimen with dimensions and plating used in simulated lightning strike experiment

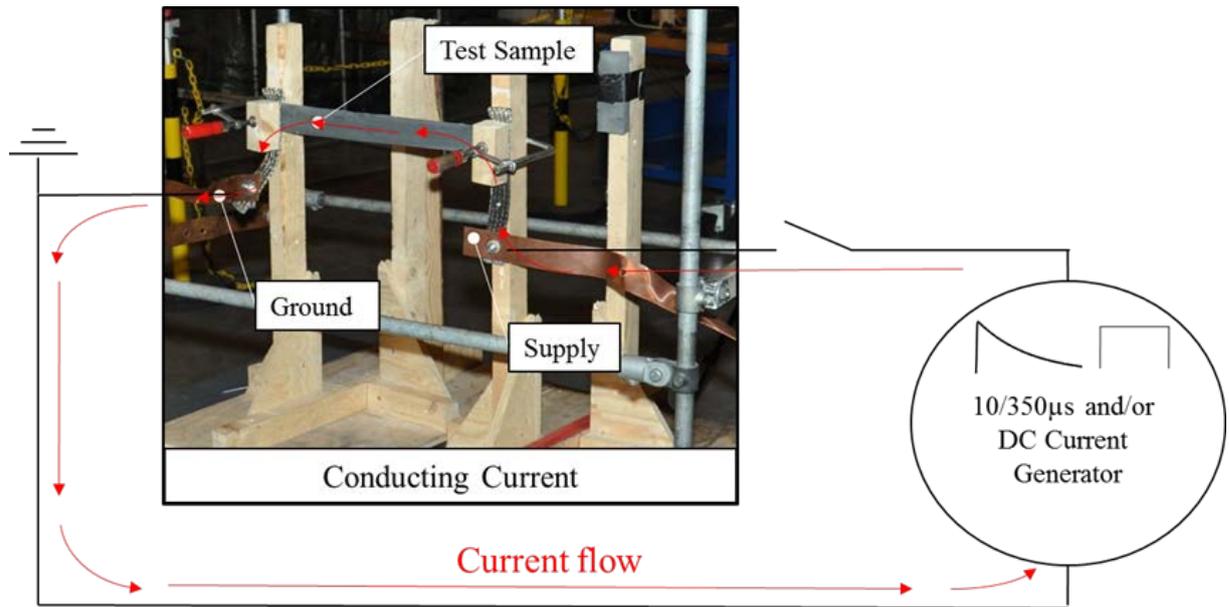
Fig. 3. Electrical circuit describing the current introduction into the CFRP sample through conducted current superimposed on an image of the experimental setup

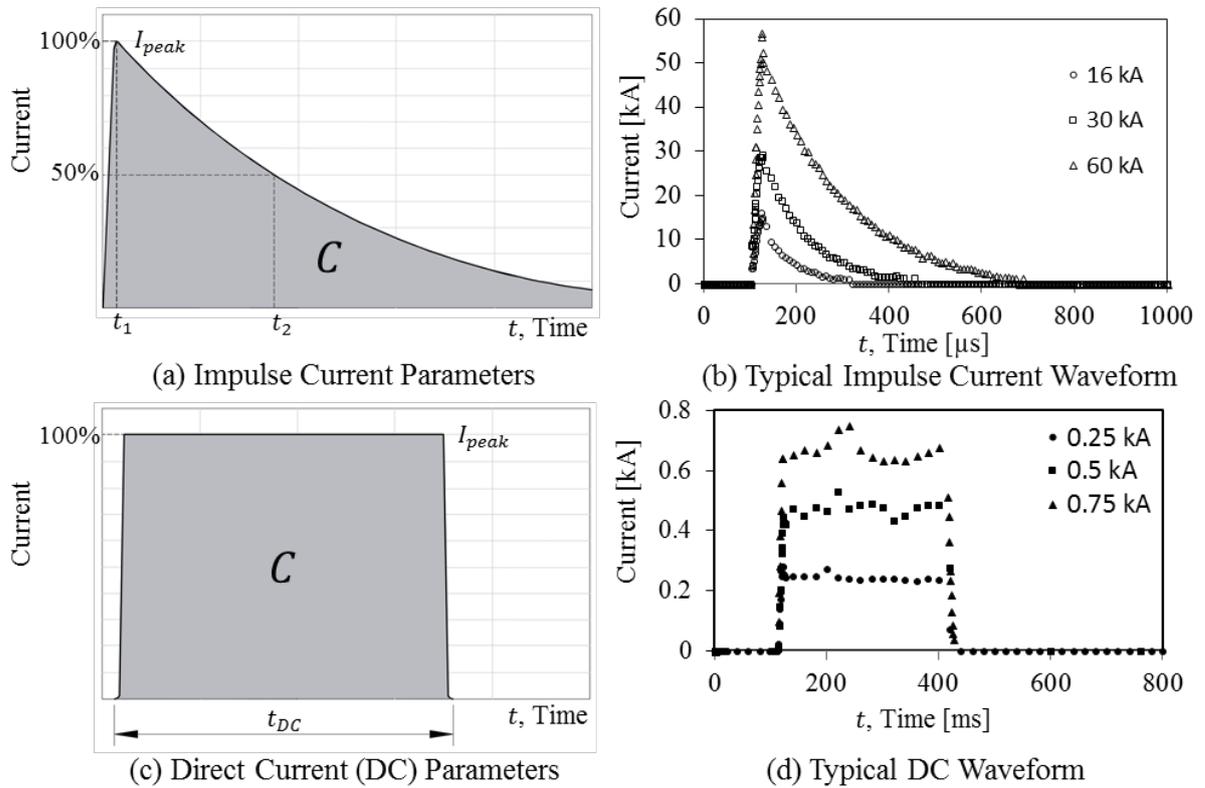
Fig. 4. Lightning strike waveform with parameters for (a-b) impulse waveform characterization, and (c-d) DC waveform characterization

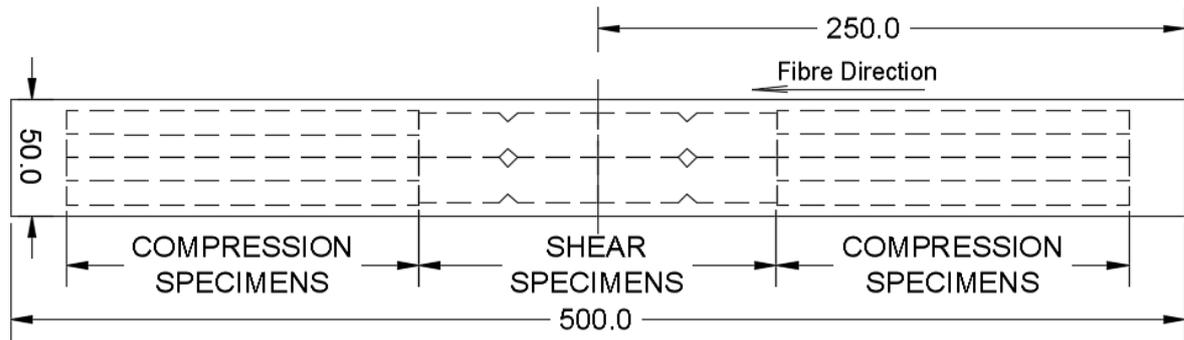
Fig. 5. Waterjet cutting scheme for CFRP compression and shear test specimens

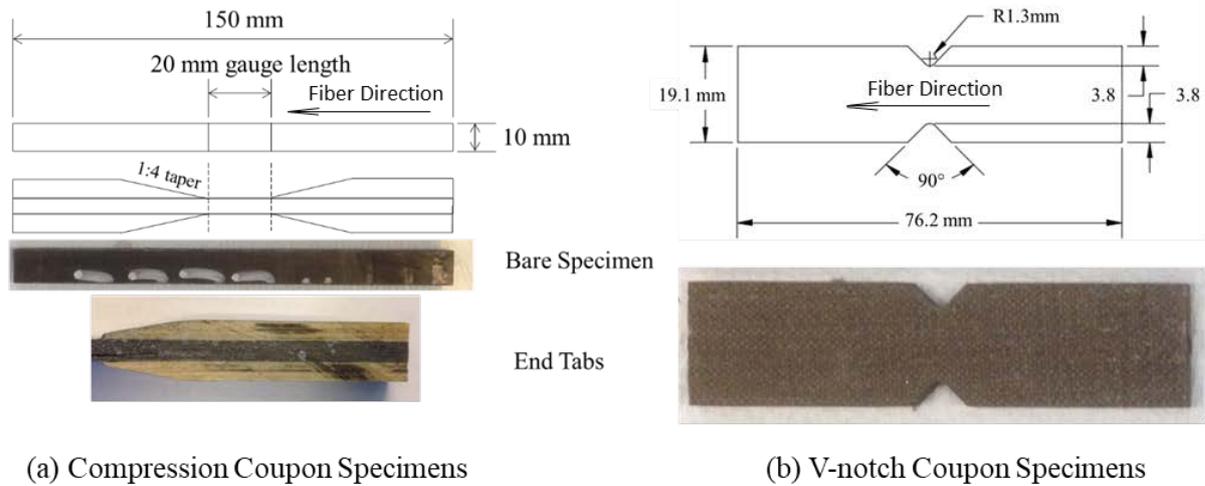
Fig. 6. (a) Compression specimen dimensions and image of a typical sample (b) shear specimen dimensions and image of a typical sample

An example of the Iosipescu V-notch shear test specimens is shown in **Fig. 6 (b)**. The shear tests were conducted using an Instron 50 kN electro-mechanical test machine with a loading rate of 0.5 mm/min in accordance with ASTM standard D5379 [16].

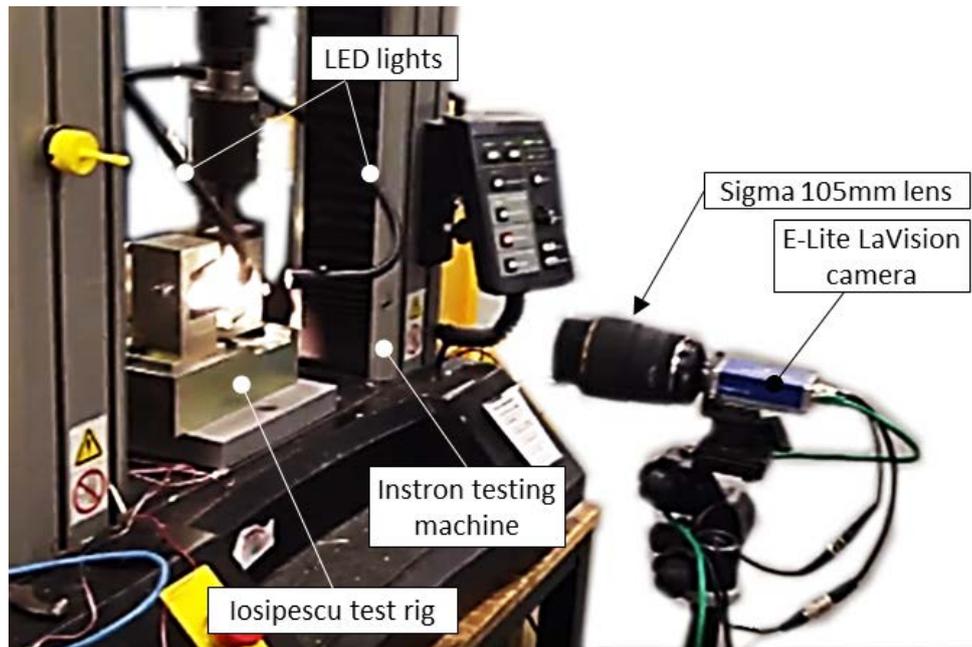
Fig. 7. Experimental setup for Iosipescu tests

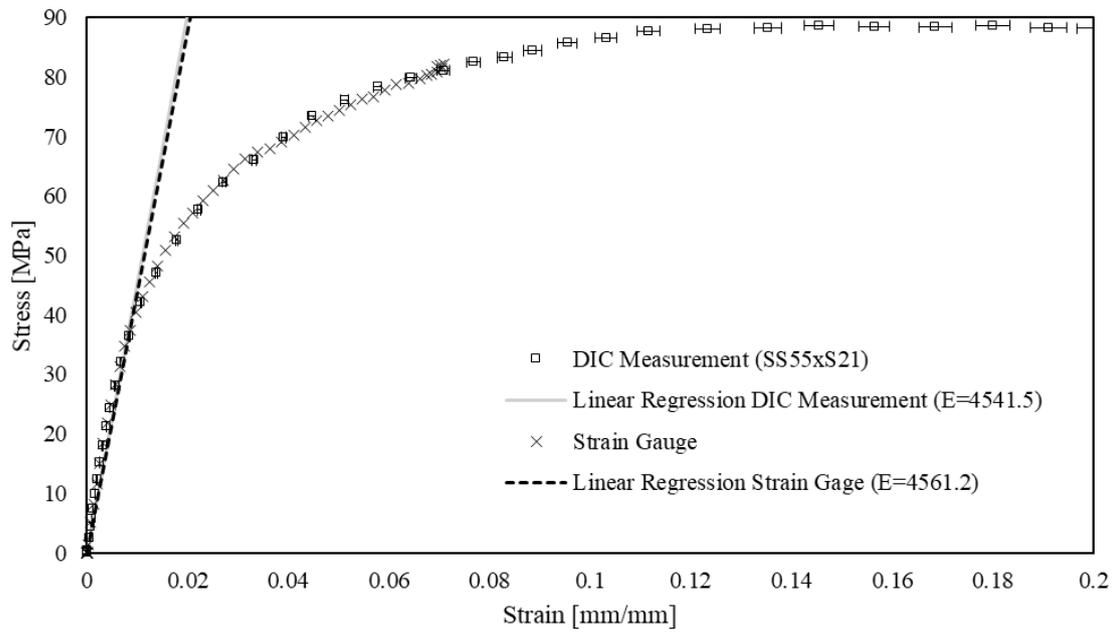
Fig. 8. Strain gauge and DIC comparison

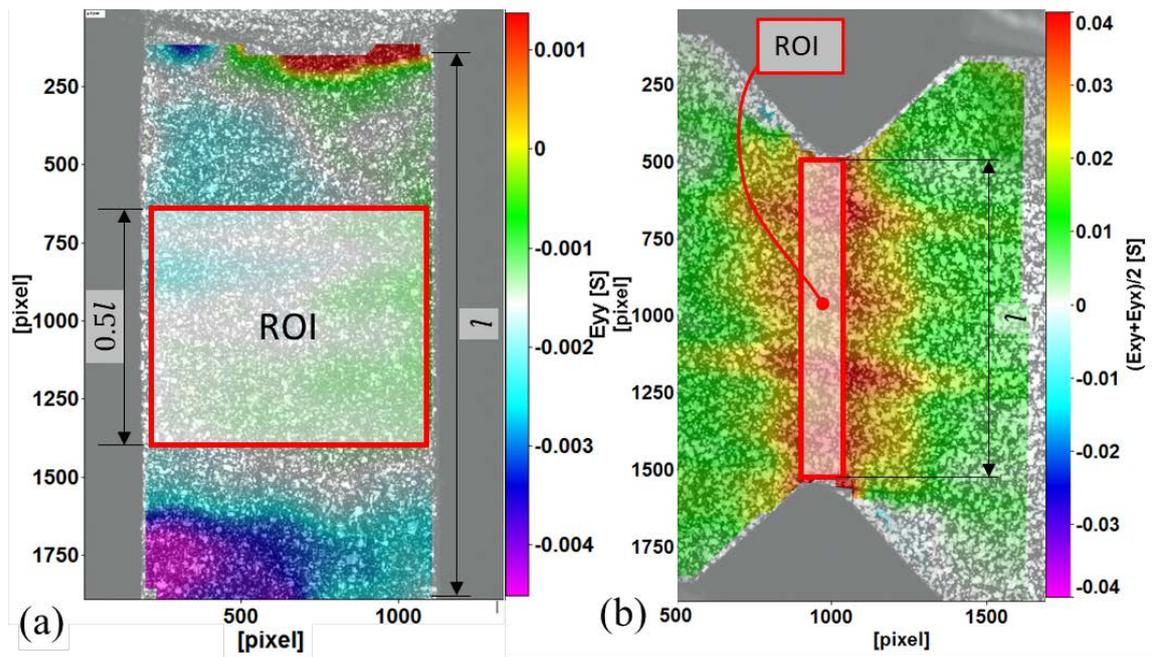
Fig. 9. Example of DIC ROIs: (a) compression specimen, and (b) shear V-notch specimen with an overlay of the ROI area used to calculate the average compression and shear strains

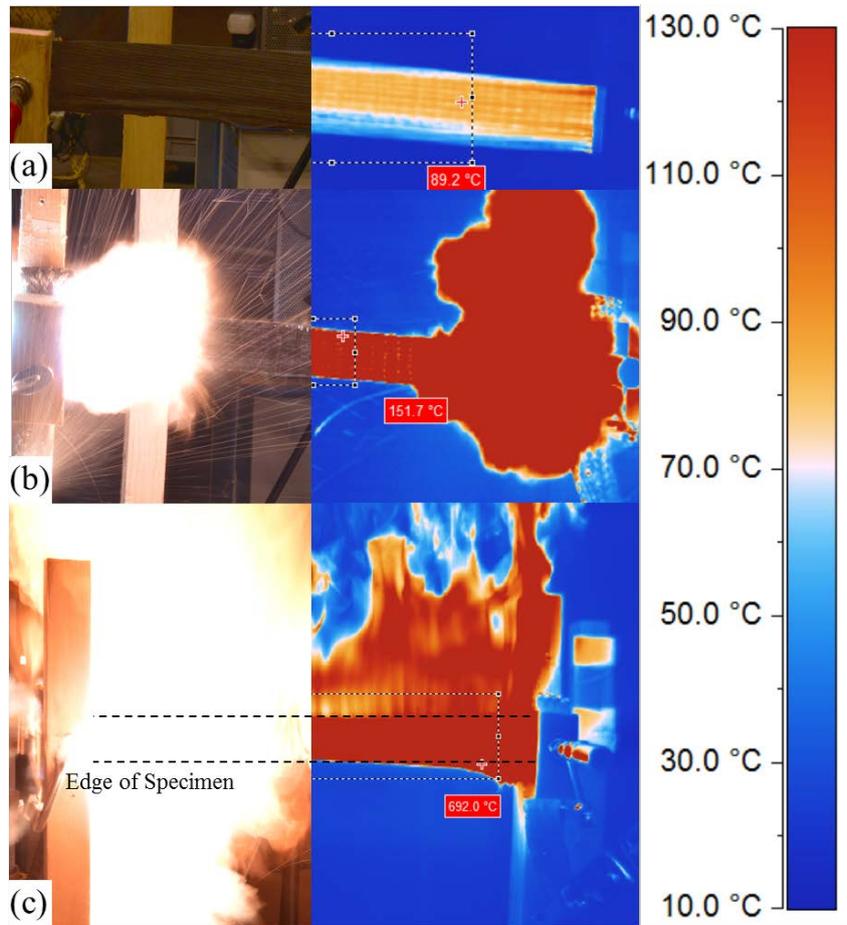
Fig. 10. Selected photos and thermal images from: (a) DC tests, (b) Impulse test, and (c) Impulse+DC test

During the DC tests there were no visual indications of suspected damage in the white light images captured and as shown on the right in **Fig. 10** (a) the infrared image displays a uniform increase in temperature. The Impulse tests also showed no visual indication of damage despite the appearance of sparks and flames as described above. In **Fig. 10** (b), the white light image on the left does show flames and sparks, but these are products of air ignition between the metallic contact point and the CFRP testing material, as the combustion temperature of the CFRP was not reached. This is confirmed in the thermal images captured after the dissipation of the flames. These show a uniform temperature increase in the sample both where the flames appeared at the contact points, as well as in the middle where no flames appeared. The Impulse+DC tests displayed more extensive visual indication of damage, with flames engulfing the sample and lasting several seconds longer than end of the current supplied to the sample; see **Fig. 10** (c). In these tests, the combustion point of the specimens was

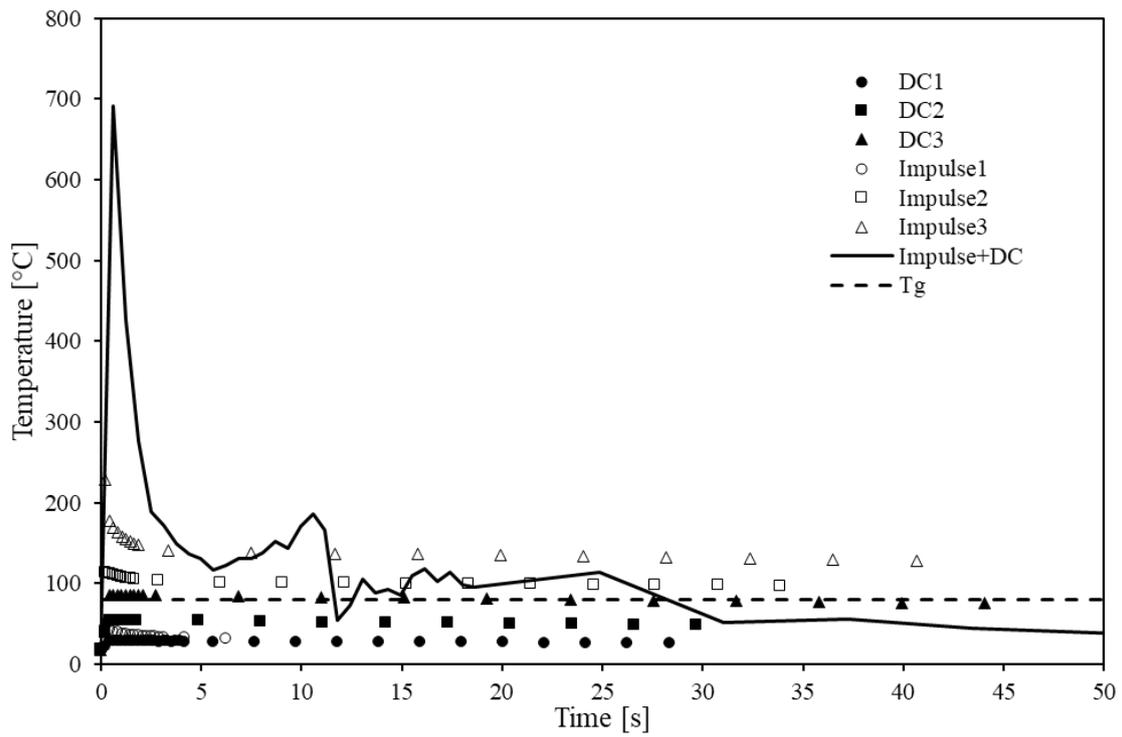
Fig. 11. Average temperature measured at the center of the specimens during lightning strike tests

The thermal data was recorded to find the maximum temperature during the lightning strike tests. The temperature data recorded at the center of the specimens is shown in **Fig. 11**. The thermal data results show that the maximum temperature always occurred after all the current was injected. This data can determine which CFRP specimens went above the glass transition temperature of 79°C for the resin system tested, and how long the specimens were above the glass transition temperature. The DC2-3, Impulse2-3 and Impulse+DC specimens all reached temperatures above the glass transition temperature for extended periods of time. Impulse+DC reached a temperature, which caused ignition of the sample and caused the sample to burn during the test. The apparent second peak of the Impulse+DC at 11s is due to flames that extinguished in the frame of the measurement.

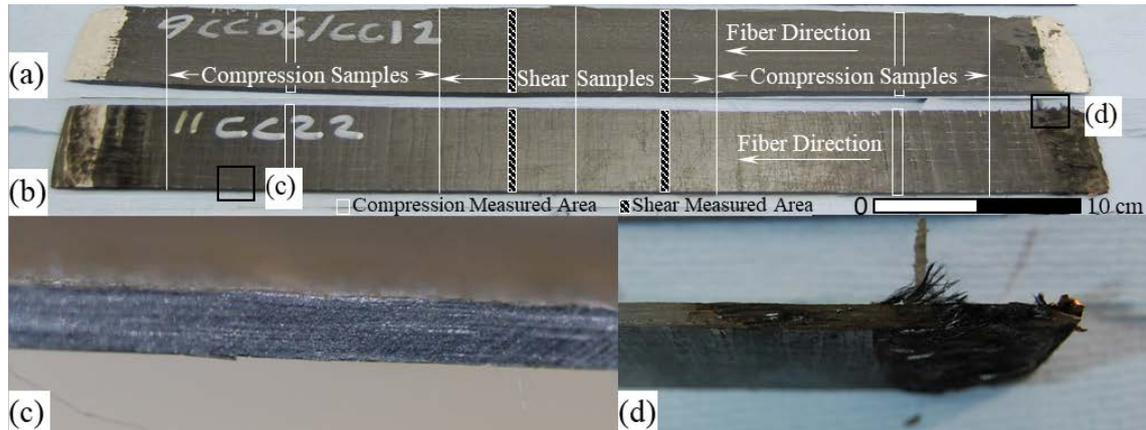
Fig. 12. DC (a) and Impulse (b) post lightning strike damaged specimens with selected cross section images showing (c) typical non-damaged cross section observed for all DC and Impulse specimens (the image shows specimen Impulse3) and (d) damage cross-section close to the connection point (< 2cm) of the Impulse3 specimen

distance of 2 cm from the connection point. Selected images from the DC3 and Impulse3 specimens are shown in **Fig. 12**. In the areas where the coupons were cut out, see **Fig. 12** (a) and (b), the material showed no visual signs of damage. Further, **Fig. 12** (c) shows what a typical cross section looks like for all the Impulse and DC samples. This typical cross section has no signs of damage, and there are no visible bulges on the top surface to suggest internal delamination damage. In **Fig. 12** (d) the image shows damaged fibers, loss of resin, and glass fiber stitching from the dry fabric pulled away from the specimen close to the connection point. Therefore, the coupons used in the mechanical tests were cut from regions away from the connection point as indicated in **Fig. 12** (a) and (b).

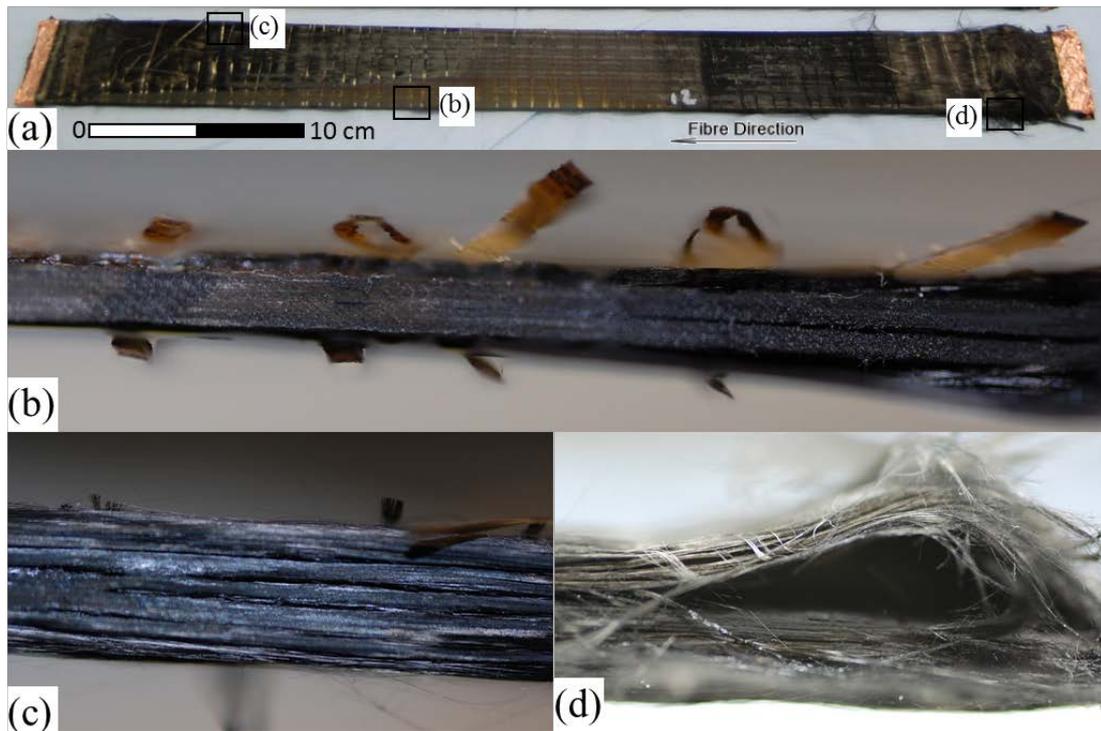
Fig. 13. Impulse+DC: (a) post lightning strike damage specimens with selected cross section images showing typical damage cross section with (b) glass fiber stitching pulled away from the laminate, (c) typical damaged cross-section, and (d) most severely damaged cross section damage close (> 2 cm) to the connection point

The Impulse+DC specimen shown in **Fig. 13** displays extensive damage. Both the top and bottom surfaces show resin damage from the flames burning the laminate, as indicated in **Fig. 13** (a). Almost all the cross section has exposed fibers and stitching as shown in **Fig. 13** (b). The resin in between the layers has burnt away which can be seen from the outer surface of the cross section, see **Fig. 13** (c). **Fig. 13**(d) and clearly shows delaminated plies.

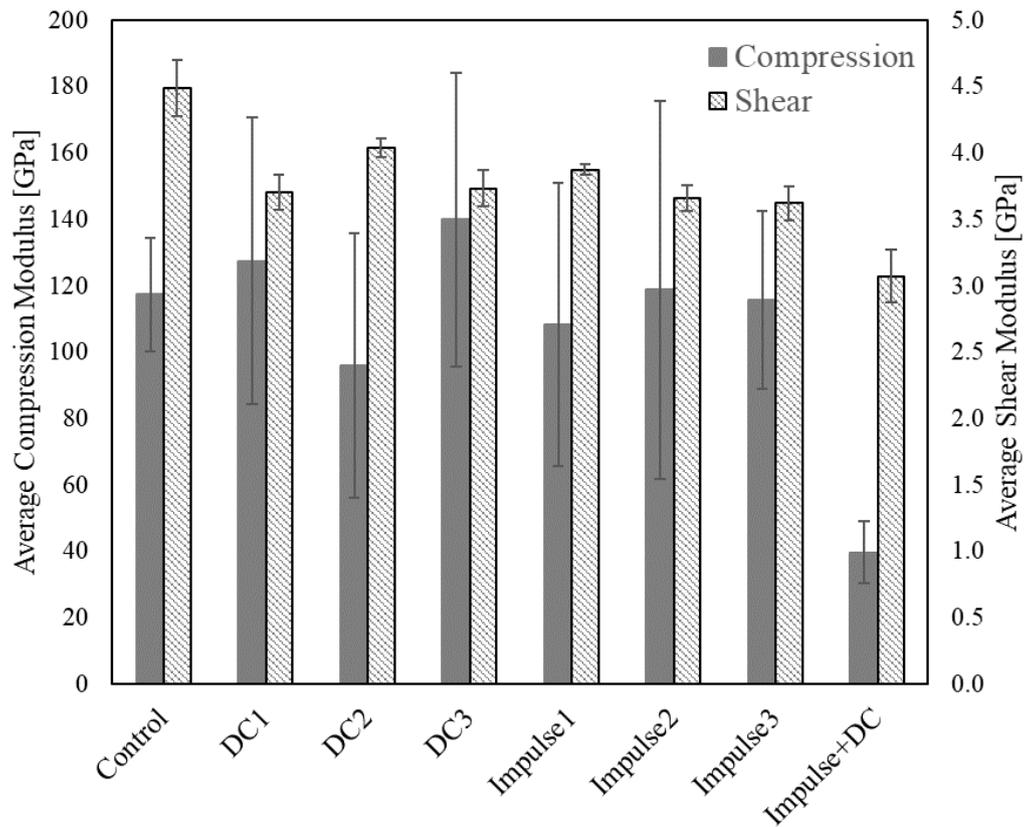
Fig. 14. Residual compression and shear modulus based on specimen waveform

The Young's (E) and shear moduli (G) for both damaged and pristine specimens were also evaluated from the test data following the procedures outlined in ASTM D6641 [14] and ASTM D5379 [15]. The results are shown in **Fig. 14**, and it is observed that only moderate changes to E and G were experienced for the DC and Impulse specimens. However, the Impulse+DC specimens showed significant reductions in both Young's (E) and shear moduli (G). The residual compressive modulus is reduced to almost a third of its pristine/undamaged value.

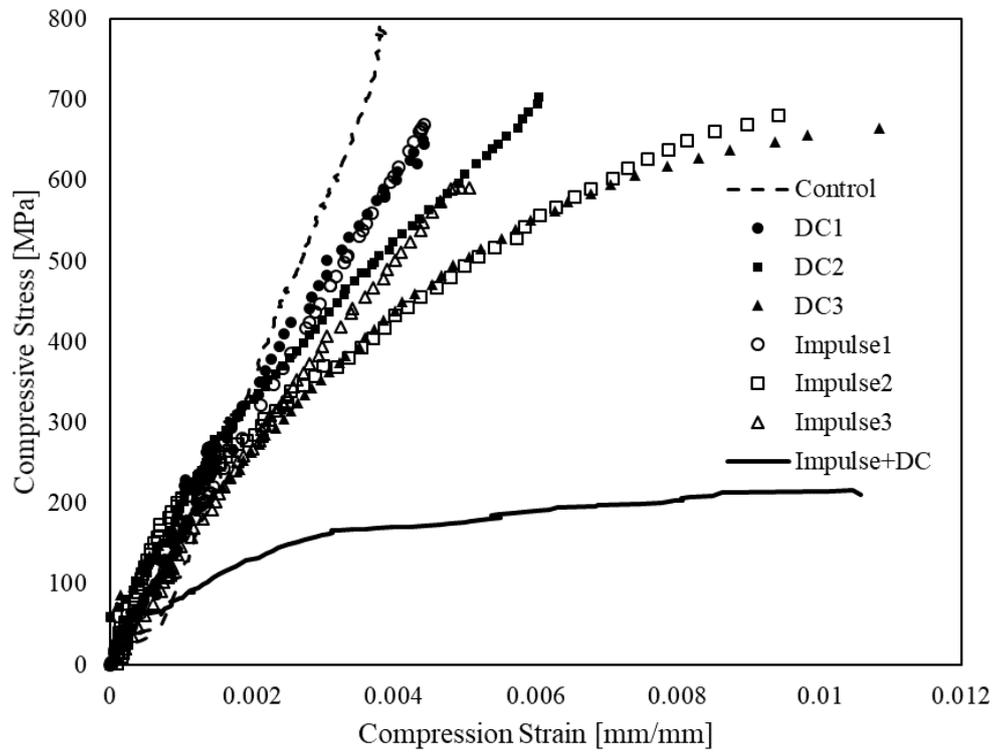
Fig. 15. Typical stress-strain curves recorded for compression specimens

The stress vs. strain relations were also recorded for all the test specimens, and typical stress-strain curves are shown in **Fig. 15** for the compression tests, and in **Fig. 16** for the shear tests. A significant change of the stress-strain response is observed for all cases (i.e. DC, Impulse and Impulse+DC), even for the DC and Impulse specimens where the residual strengths and moduli only changed modestly as shown in **Table 3** and **Table 4** and **Fig. 14**. In particular, it is observed that as the lightning strike energy level increases, the nonlinearity of the stress-strain response as well as the strain to failure increases. The former suggests that the failure initiation shear strength of the CFRP specimens, as defined in section 2.5 and Eqs. (1-3), reduces with increasing lightning strike energy levels.

The failure initiation strength provides a quantitative measure of the stress where nonlinear stress-strain behavior initiates. It is observed from **Table 5** that this reduces significantly even for DC and Impulse simulated lightning strike events that led to modest changes of (initial) stiffness (E and G) and compressive/shear strengths (see section 3.3 and 3.4), and where only limited visual damage could be identified. For the worst case scenario of the Impulse+DC simulated lightning strike event, it is also clear from **Table 5** that significant damage has been introduced. The initiation point of nonlinear behavior/response has been reduced by 60%, for that specimen. This reduction can be seen in **Fig. 15** and **Fig. 16**, as well as in **Table 4** which shows a significant reduction in shear strength.

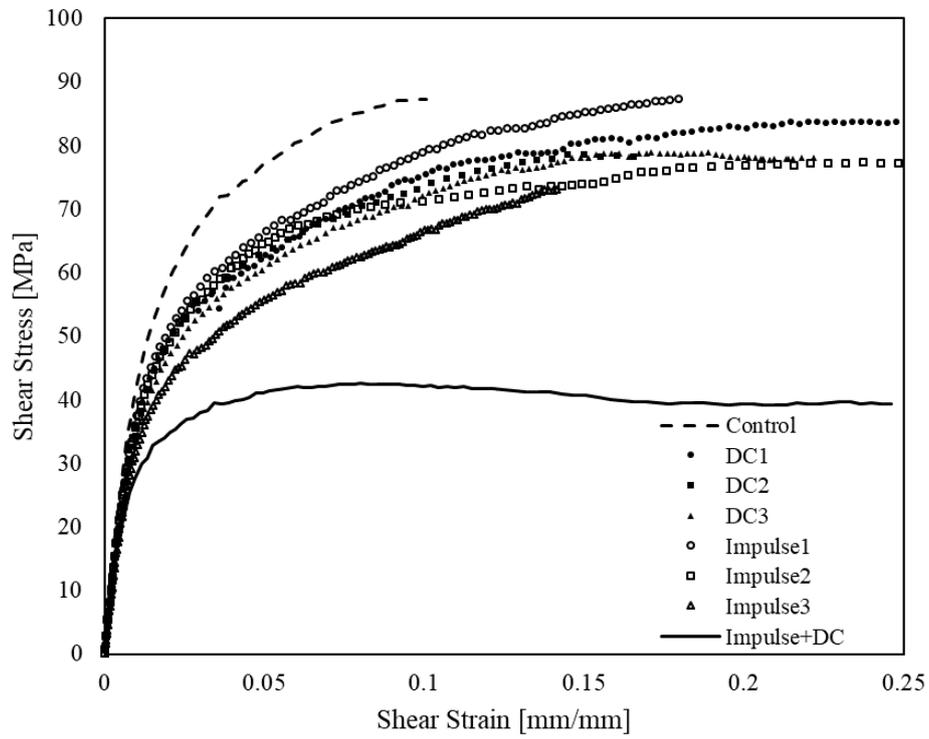
Fig. 16. Typical stress-strain curves recorded for shear specimens

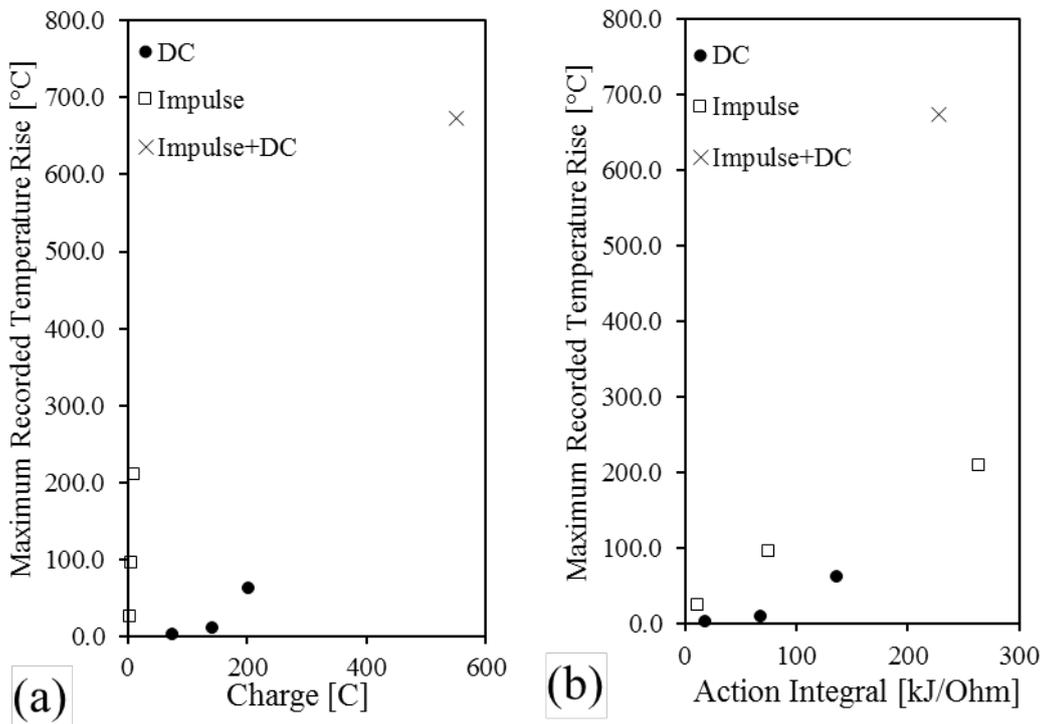
Fig. 17. Maximum temperature rise measured on the CFRP specimen surfaces using vs. (a) charge and (b) action integral (specific energy) associated with specific simulated lightning strike tests

The strong correlation between sample temperature and the severity of a lightning strike event is indicated in **Fig. 17**, which shows the surface temperature rise measured on the CFRP specimens using an infrared camera, and the charge and specific energy associated with the specific simulated lightning strike tests conducted.

It is observed from **Fig. 17** that the Impulse+DC tests conducted led to far higher specimen temperatures than the DC and Impulse tests, indicating much more damage being inflicted during the former. This corresponds very well with the results presented in sections 3.3 to 3.6 where it was shown that the Impulse+DC tests inflicted very significant damage leading to large reductions of strength, stiffness, and failure initiation strength.

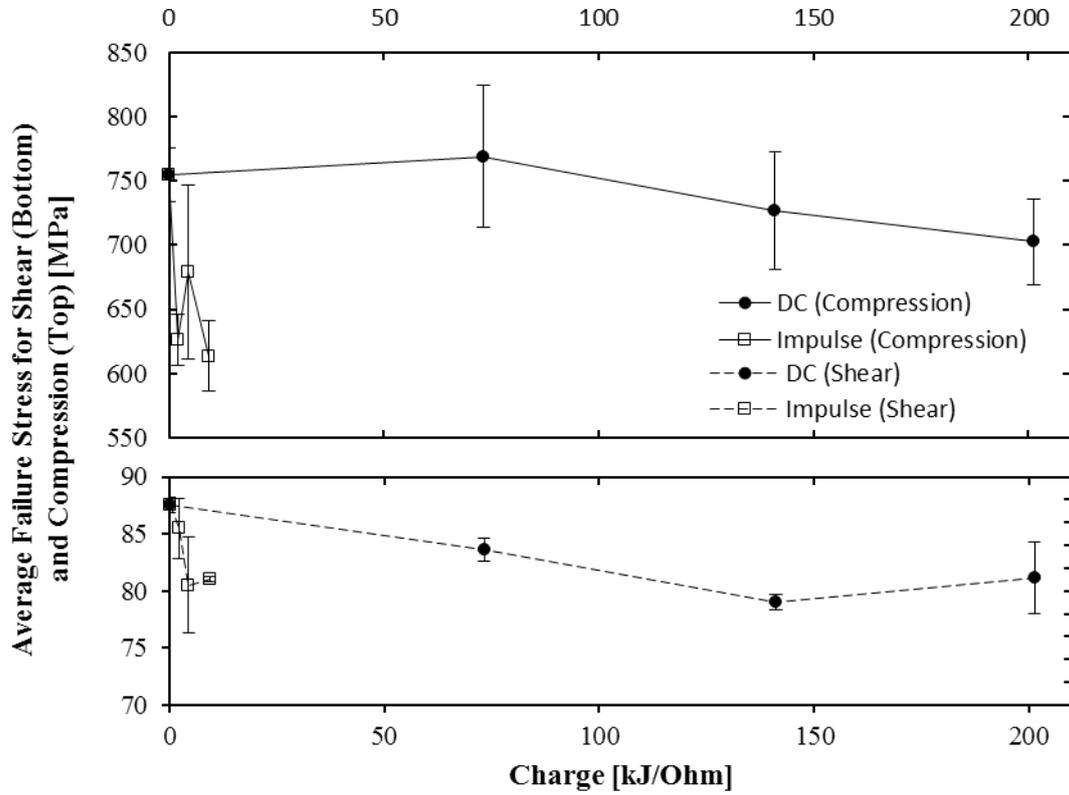
Fig. 18. Residual Strength of damaged and undamaged CFRP specimens vs. charge

Although the visual inspections conducted on the DC and Impulse coupon tests did not reveal any significant damage, the mechanical tests revealed that both types of simulated lightning strikes reduced the strength for both the compression and shear load cases. This trend can be identified by evaluating the (residual) compression and shear strength measured for the CFRP specimens that did not combust (i.e. DC1-3 and Impulse1-3) against charge, see **Fig. 18**, and specific energy, see **Fig. 19**, of the simulated lightning strike. From **Fig. 18** and **Fig. 19** it is observed that the specific energy appears to have a stronger effect in reducing the residual strengths than the charge of the lightning strike event. It should also be noted that even though the simulated lightning strike waveforms displayed large variations with respect to the amount current and charge injected into the specimens, it is clear that the both the DC and Impulse test specimens display a clear strength reduction correlation with respect to the specific energy.

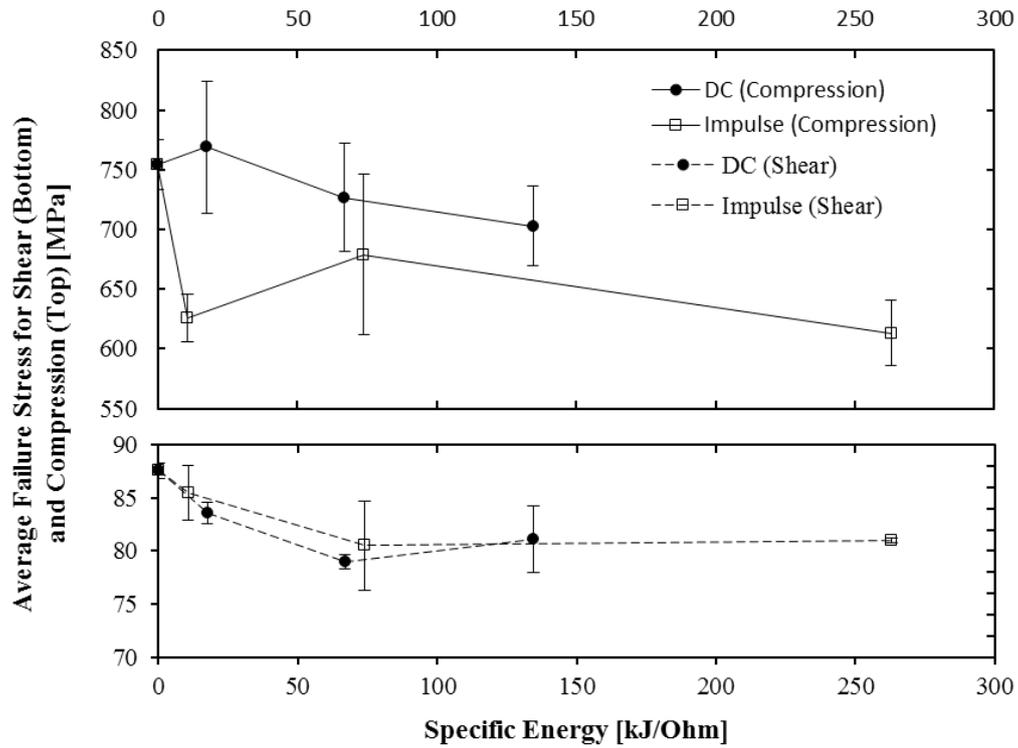
Fig. 19. Residual Strength of damaged and undamaged CFRP specimens vs. specific energy
