# TOWARDS THE TUMBLE RESISTANT MICROLIGHT

Dr. Guy Gratton, MSETP  
*School of Engineering and Design, Brunel University, UK*  
*(also Test Pilot, British Microlight Aircraft Association)*

Dr. Simon Newman  
*School of Engineering Sciences, University of Southampton, UK*

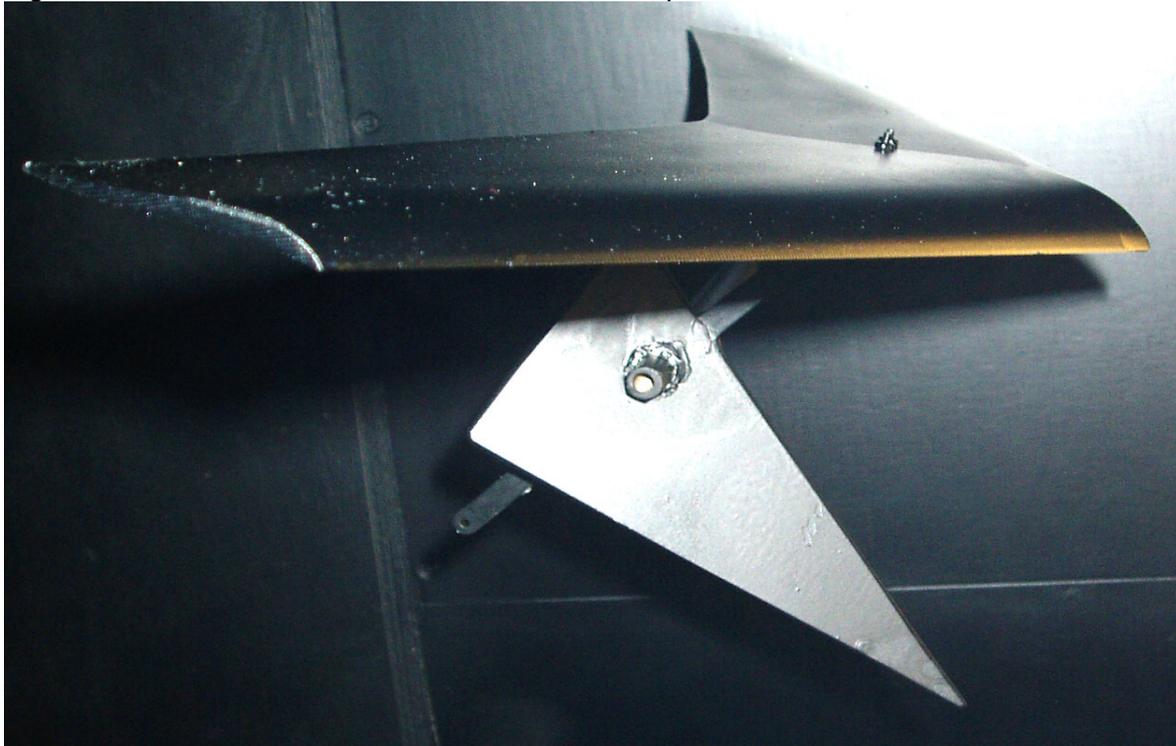
Figure 3, Scale model of Mainair Gemini Flash 2 alpha aircraft, used in wind tunnel tests

This model, which was 1:30 scaled down from the actual aircraft and set with geometry resembling an aircraft with the basebar against the front strut, was rotated in pitch within the University of Southampton's 7' x 5' (2.1m x 1.5m) low-speed wind tunnel which is fitted with Particle Image Velocimetry (PIV) equipment. No attempt was made to create a self-sustaining tumble, the subject of interest being the qualitative flow characteristics around the aircraft rather than quantitative effects. The airspeed and rotation rate were varied between 0.13-0.26m/s and 310-775°/s. Initial testing with smoke and a video camera showed the primary area of interest being 1 wing chord before and after the rotating aircraft in the direction of ambient airflow. Figure 4 below shows the flow at two spanwise stations:-

shape) of the Gemini Flash 2 alpha aircraft [21] which was the type involved in the first investigated accident; this model is shown in Figure 3 below.

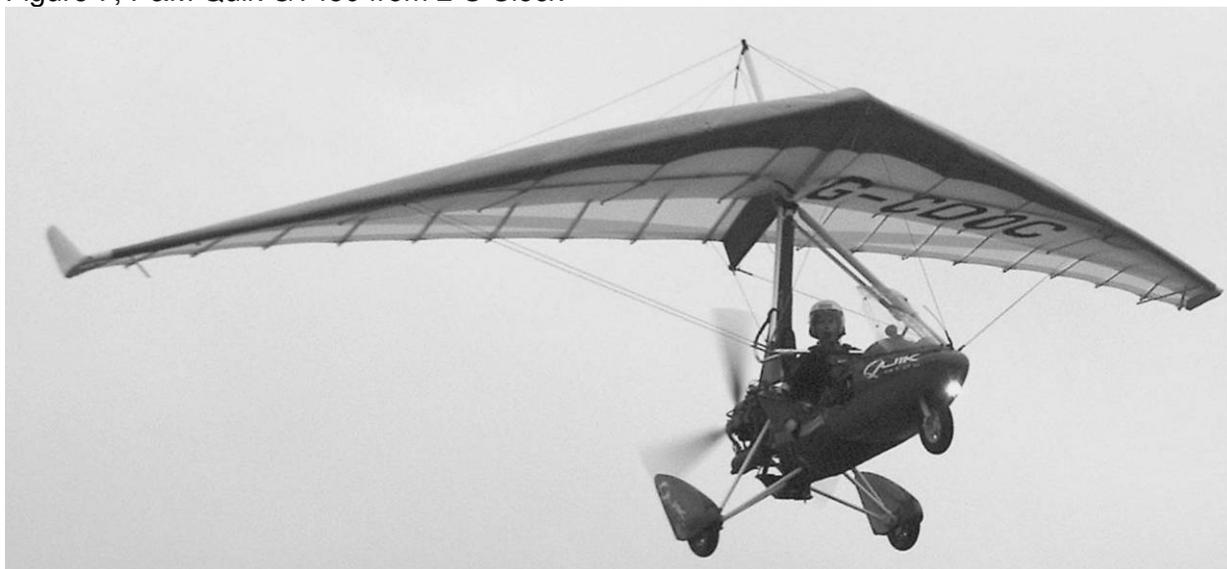
Figure 7, P&M Quik GT450 from 2 O'Clock

In flight testing various aircraft (most notably the P&M GT450 shown in Figure 7 below, and the Air Creation Tanarg), it has become apparent that whilst the critical parameter during the climb is pitch attitude, this is not readily measurable – whilst an attitude indicator could be fitted this wouldn’t be normally fitted in a private aircraft, and even if it were it is unlikely that most pilots would monitor it during (for example) a take-off and initial climb. The nature of a weightshift aircraft is that visual references make identification of attitude visually extremely approximate; so, this does not offer any significant potential. However, at a constant weight, there is a direct and approximately linear relationship between pitch attitude and airspeed.

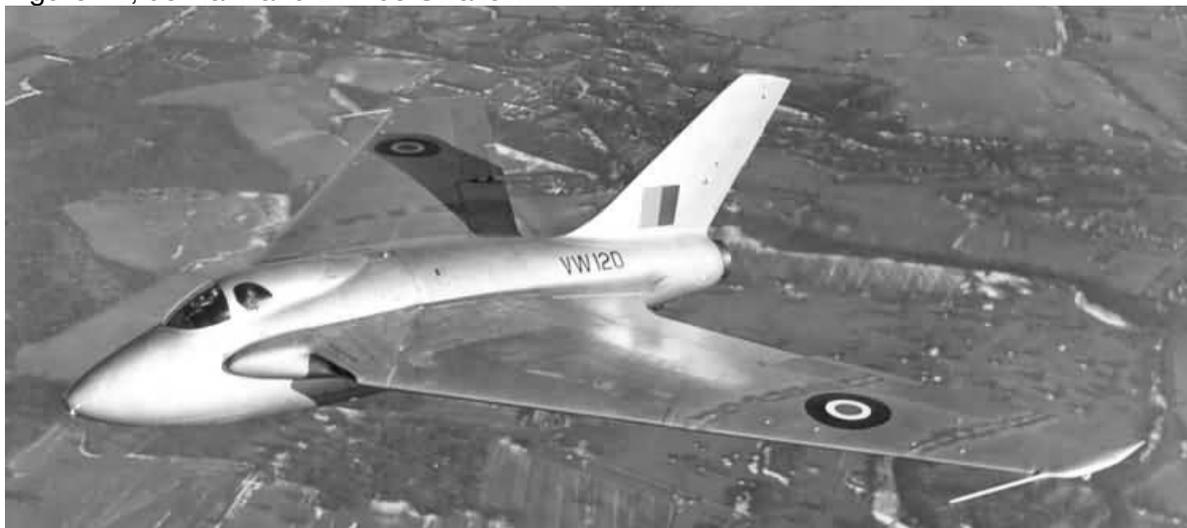
Figure 11, de Havilland DH108 Swallow

The de Havilland DH108 (Figure 11 below, also reference [28]) was a British research aircraft of which three examples were built, all in the late 1940s. The aircraft was a high performance tailless delta-winged aeroplane, designed specifically for research into the control of flying-wing aeroplanes, and into the transonic flight regime. All three of these aircraft were lost in fatal flight testing accidents.

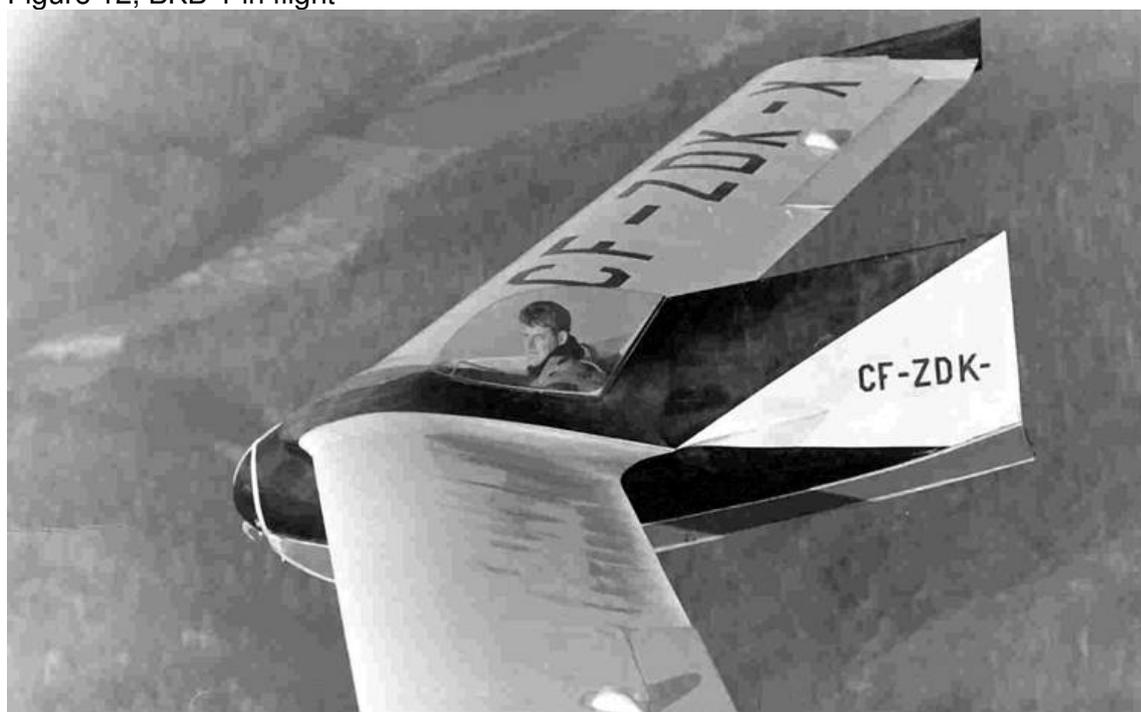
Figure 12, BKB-1 in flight

Figure 12 below was an experimental tailless swept-wing glider developed in Canada in the 1950s[32, 33], which was later developed in the USA into a powered microlight aircraft known as the Kasperwing. Both the BKB-1 and the Kasperwing were shown to be able to enter a manoeuvre which was referred to at the time as a tumble, this was displayed extensively in the USA during the 1960s. It has been reported that the sustained tumble in these aircraft was believed due to “a strong vortex occurring just above the wing” [34]. The unique characteristic of the tumble in these aircraft was that it could be entered deliberately, and subsequently recovered from.

This appears to be further evidence that a rigid tailless aircraft is capable of entering a tumble, and also that this motion is rapid and can cause structural damage to the aircraft. Commonly with the evidence of the YB-49 it indicates a nose-up tumble as the most readily entered mode, and also shows that recovery is possible – in this case symmetrically using elevon control.
