Corrosion behavior in Hank`s solution of a magnesium-hydroxyapatite composite processed by high-pressure torsion

Debora Lopes¹; Renata B. Soares¹; Moara M. Castro²; Roberto B. Figueiredo^{2,*};

Keywords: high-pressure torsion; hydroxyapatite; magnesium; metal matrix composites; corrosion

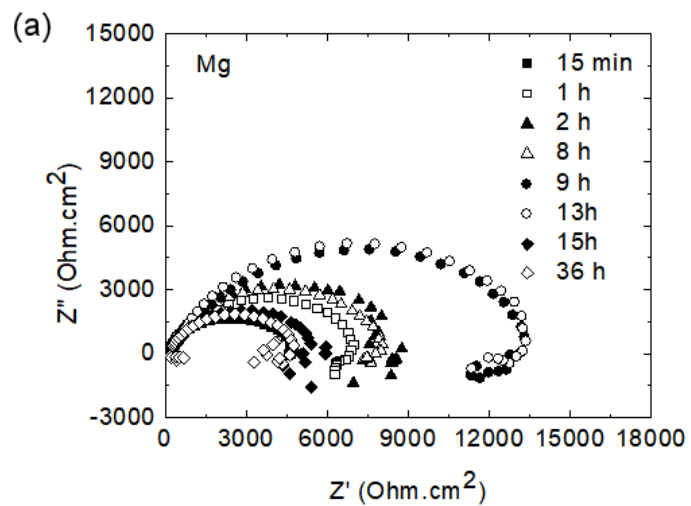
57 Figure 3 - Nyquist plots in for (a) Mg and (b,c) Mg-HA composite.
