Oil flow damage in Kraft paper 2: UV irradiation

Abstract—Ultraviolet (UV) irradiation was used as a tool to degrade Kraft paper. Using measurements of the DP as a function of irradiation time, a theoretical model was used to predict the local value of DP in the surface layer of the paper. After characterization of their mechanical properties, selected samples were exposed to oil flows mimicking ONAN, OFAF and reclamation conditions. The presence of a surface layer of low DP led to significant surface roughening under high rates of oil flow, but no significant erosion. The findings indicate that the DP value at the surface is more critical than the average (or measured) DP in determining the extent of oil flow related damage.

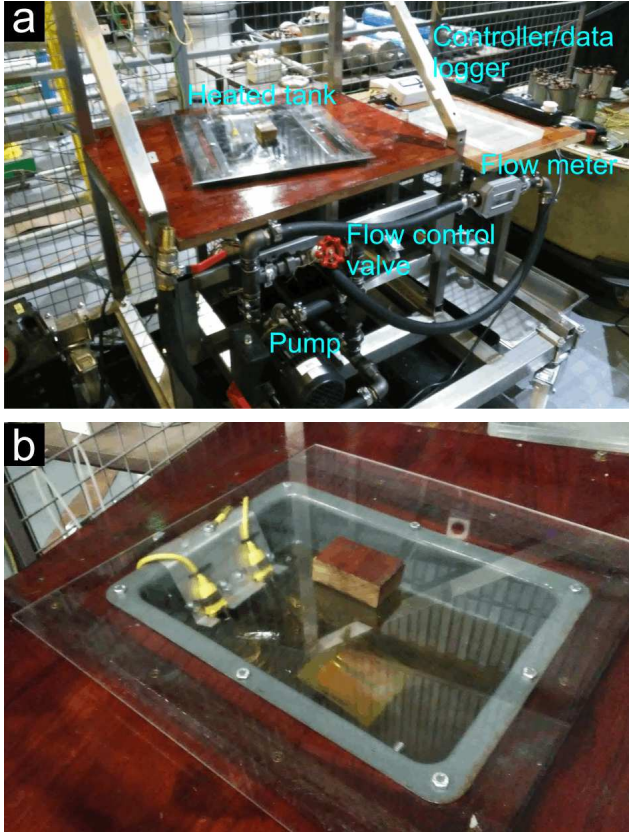
Fig. 1. Oil flow equipment; (a) overview indicating main components, (b) details of oil tank showing tilted plate sample holder.

Before flow testing, all samples were vacuum impregnated with new mineral oil (Nynas Gemini X) in glass jars. A bespoke oil flow tester was constructed and full details of the design are provided in our previous paper [9], but for completion, images of the equipment are provided in Fig. 1. The equipment (Fig. 1a) comprises a heated mineral oil-filled tank and a circulation pump. The samples to be tested are attached to a tilted plate (Fig. 1b) and in this image, oil enters from the left, passes over the sample and is drawn out from the back of the tank. The heaters are mounted behind the sample holder to avoid distorting the oil flow over the sample. An identical testing protocol was

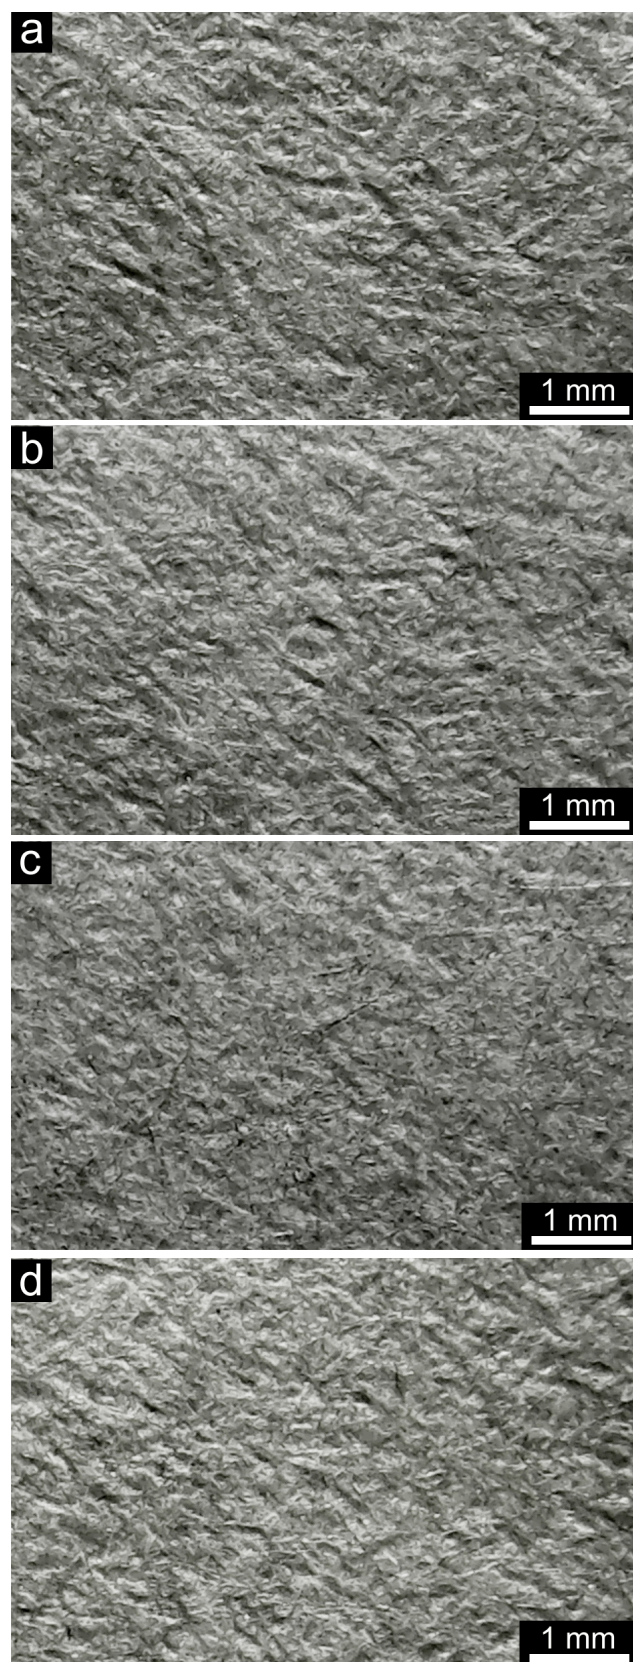
Fig. 3. Optical microscopy (a) 96 h irradiation, ONAN conditions, (b) 96 h irradiation, OFAF conditions, (c) 36 h irradiation, reclamation conditions, (d) 288 h irradiation, reclamation conditions

textures. All three samples exposed to ONAN conditions showed the texture of Fig. 3a; deep furrows (arising from the rolling process) are evident which are oriented along the fibre direction (top left to bottom right); this indicates that no significant surface damage has occurred – blue ranking (Table 1). Meanwhile, all samples exposed to OFAF conditions show a “worn” appearance (Fig. 3b) and noticeable surface damage has occurred as indicated by less distinct furrowing – green ranking. Finally, all three samples under reclamation conditions, have the “random” textures shown in Figs. 3c and 3d – red ranking. Here the lignin appears to have been completely removed by the oil flow leaving the underlying fibres exposed.

Irradiation time	Orientation	Oil flow rate		
		ONAN	OFAF	Reclamation
36 h	Longitudinal			
	Transverse			Fig. 3c
96 h	Longitudinal	Fig. 3a		
	Transverse		Fig. 3b	
288 h	Longitudinal			
	Transverse			Fig. 3d

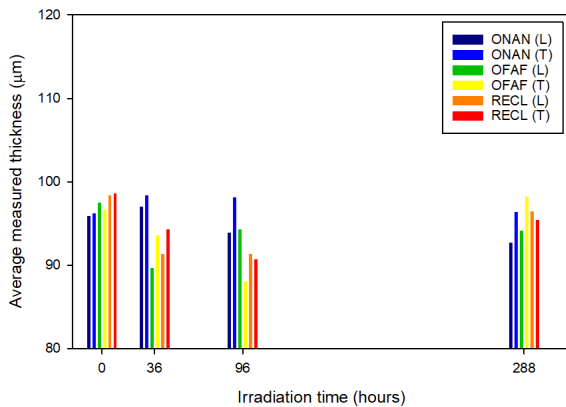
Fig. 4. Average thickness values as a function of flow conditions, orientation and irradiation time

Fig. 4 shows a histogram of average thickness values for new paper and the three irradiated papers (36, 96 and 288 h), three flow rates (ONAN, OFAF and reclamation) and two orientations (L or T). Unlike thermal aging [9], UV exposure does not appear to change the average thickness of the samples which remained at ~95 μm throughout. A statistical comparison (t-test) of all the data within each group (i.e. any fixed aging time), did not

reveal any significant erosion. Therefore, the morphological changes are confined to the surface layers of the paper (< 2 μm).
