UNIVERSITY OF SOUTHAMPTON
FACULTY OF ENGINEERING, SCIENCE & MATHEMATICS
SCHOOL OF ENGINEERING SCIENCES

Damage Tolerance of Repaired Composite Sandwich Structures

Thesis for the degree of Doctor of Philosophy

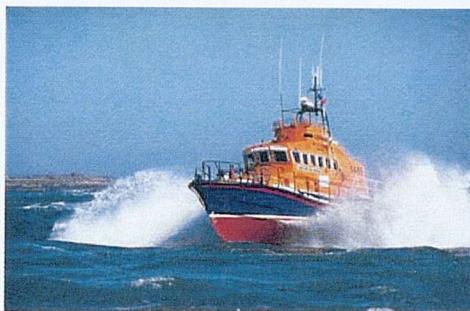
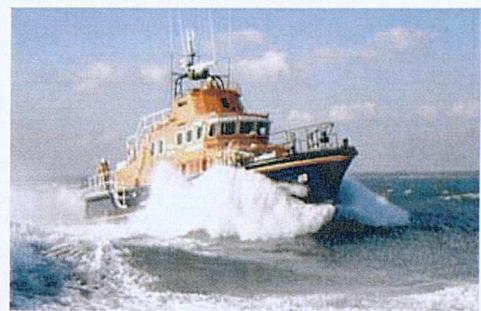
Figure 1.1: (a) Trent class all-weather lifeboat (b) Severn class all-weather lifeboat

The motivation for this current research came from the Royal National Lifeboat Institution (RNLI). The RNLI is a UK based charity that exists to save lives at sea. The organisation operates two all-weather classes of lifeboats (illustrated in Figure 1.1) where the primary structure is manufactured from advanced composite sandwich materials (see Appendix A for further information concerning RNLI lifeboats, their design and manufacture).

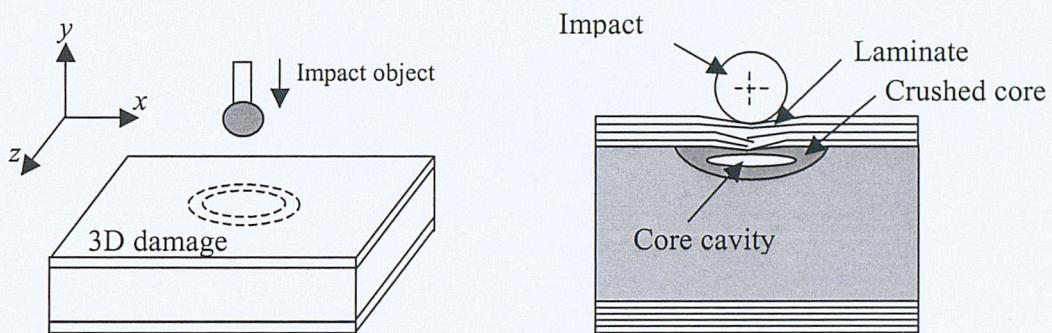
Figure 2.1: Typical impact damage in foam core sandwich structure [Abbate, 1994]

In Figure 2.1 the impact damage is composed of laminate fracture and crushing of the foam core resulting in a core cavity. Any fracture to the outside skin will be clearly visible and therefore instantly suggest that the structural integrity of the component has been compromised. However, due to the compliant nature of foam core materials the laminate skin may deform under the impact event but not fracture. In this particular case the damage within the core could go undetected, this damage is often referred as barely visible impact damage (BVID). BVID is a critical concern to designers and operators of composite sandwich structures.

The impact investigations undertaken on polymer composite sandwich structures have indicated that the damage in these structures is often more local in nature than the equivalent impact damage in monolithic composite laminates. Although face sheet damage is local, damage resulting from a crushed core and a dented face sheet will lead to a loss of core stiffness and therefore lead to premature failure of the skin due to local skin buckling. A schematic illustration of how these individual failure modes manifest themselves in a sandwich panel after an impact event has been illustrated in Figure 2.1.

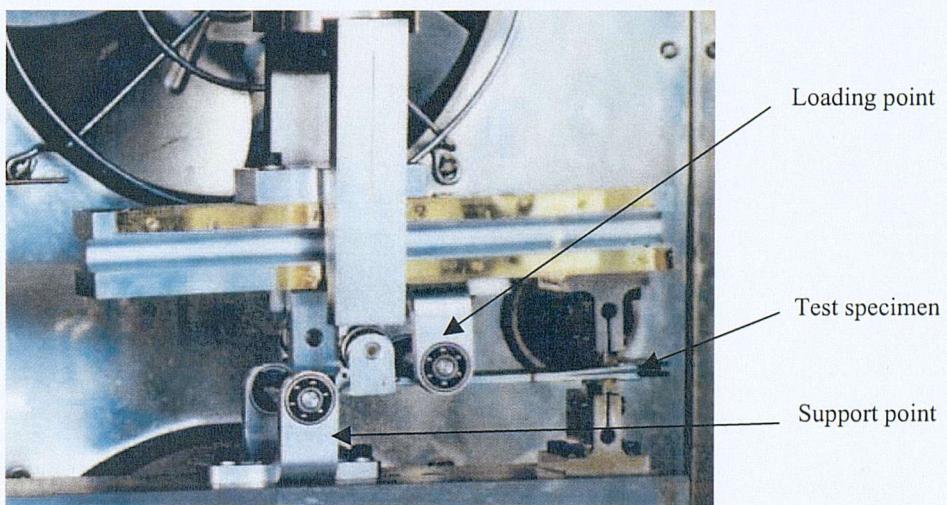
Figure 4.12: Test set-up for MMB

The MMB test method is defined with ASTM D6671-01 test standard and it describes the determination of interlaminar fracture toughness, G_c , of composite materials at various mode I to mode II loading ratios. The Mixed-Mode Bending test (MMB) is a linear combination of two pure mode tests; the DCB (mode I) and the ENF (mode II). The MMB uses a lever arrangement to introduce the pure mode I and mode II components simultaneously into a conventional DCB test specimen. The test method is shown in Figure 4.12.

The lower surface of the specimen is attached by a hinge to the base of the rig and the other end of the specimen rests on a roller a distance $2L$ from this hinge. The loading lever is attached to the upper surface of the specimen via another hinge and rests on a roller (the fulcrum) a distance 'b' from the upper hinge. During the test, a downward load P is applied to the lever a distance 'c' from the fulcrum. This leads to the following expressions for G_I and G_{II} [Kinloch *et al*, 1993].

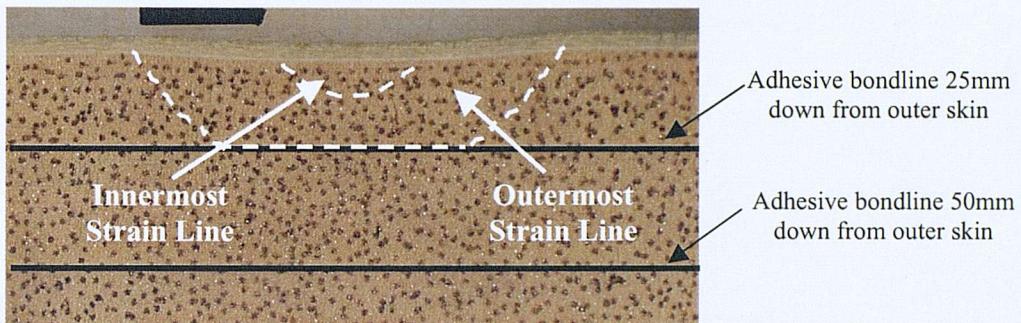
Stereography representation of the deformation profile within a virgin beam subjected to 1270J impact is given in Figure 5.6.

Figure 5.6: Strain line formation in PVC foam viewed by the stereoscopic photographic NDE technique

The two strain contours in Figure 5.6 provide some insight into the extent of the deformation experienced by the core material during the low velocity impact test. The methods of damage formation within the core will now be discussed.

At the moment the impactor strikes the surface a zone of crushed and compacted core occurs underneath the point of impact. Initial, the outermost individual cells start to crush. The plastic deformation of the core under compression is caused by cell-wall collapse due to cell wall buckling, cell wall breaking, and the formation of plastic hinges [Shipsha, 2001]. As the first cell starts to crush all plastic deformation is concentrated within this cell. Once the local compressive strain within this cell reaches the densification strain ($\varepsilon_{yy} \sim 70\%$) [Shipsha, 2001], the next connecting cell in the system starts to crush. This domino effect continues until the impact energy has been absorbed in the destruction of the foam core (the extent of the crushed and compacted core is indicated by the outermost strain line in Figure 5.6).

one another, a tensile force exists across this interface will results in the skin exhibiting a dented profile post impact test. A final observation in Figure 5.6 concerns the influence of the adhesive bondline between the first and second foam core upon the crushed core zone. The stereoscopic photographic NDE investigation clearly indicated that no relative displacement of the core material occurred below the adhesive. It appears that the adhesive is providing an internal membrane that the first core block is being crushed against.

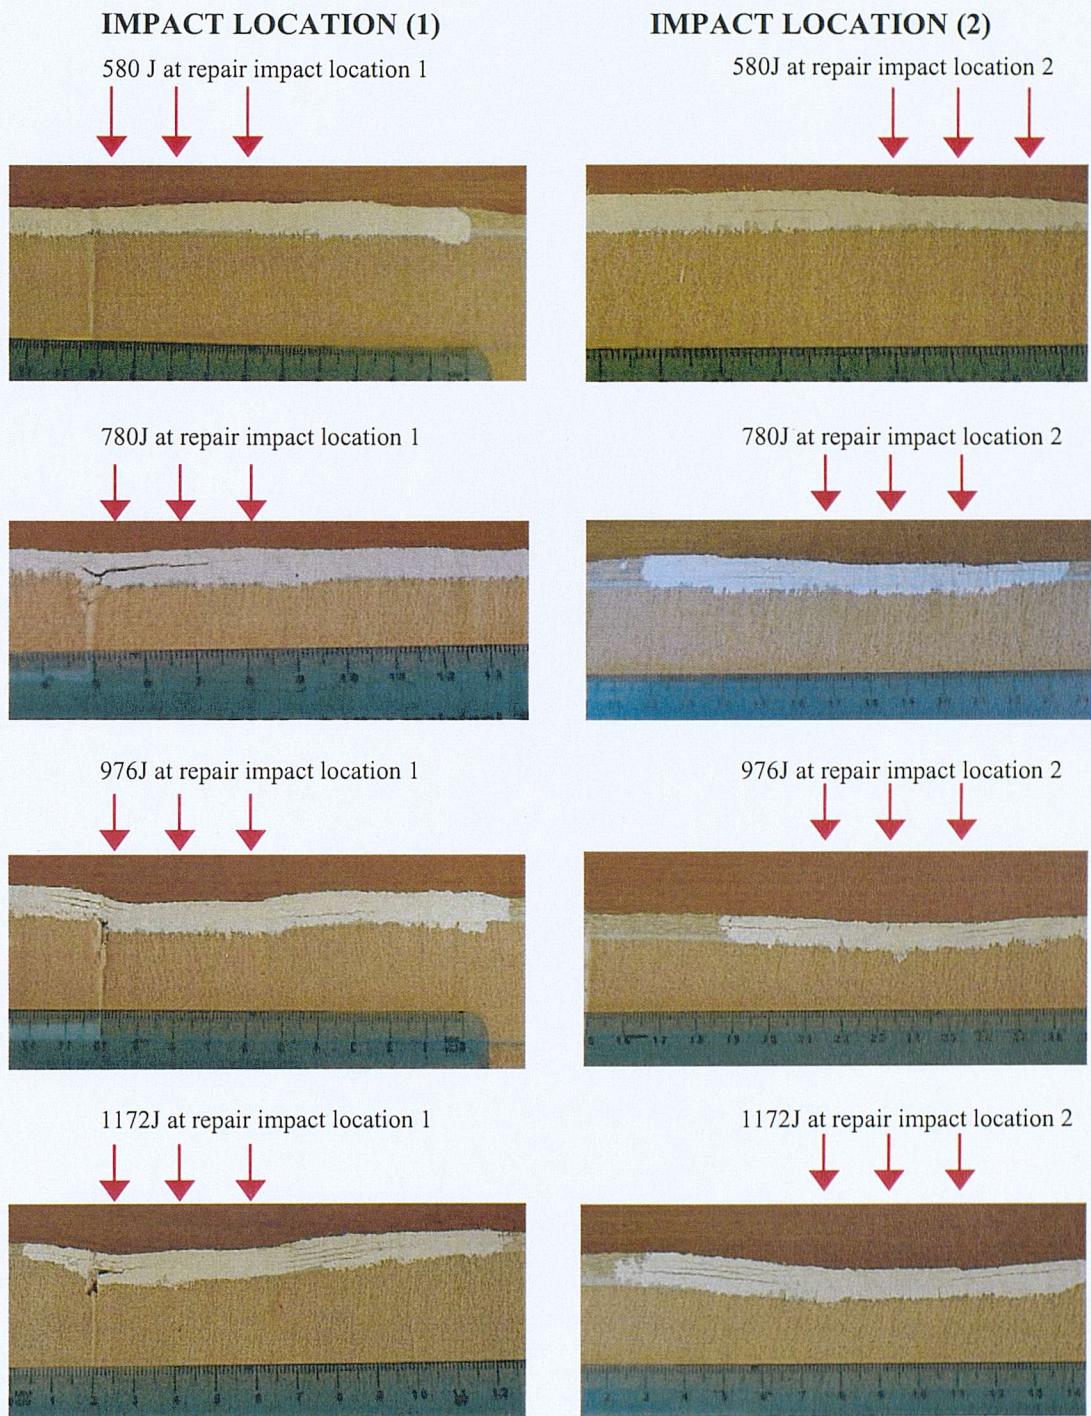
been included to illustrate the sequence of damage formation at impact location (1) and impact location (2) when subjected to varying impact energies.

Figure 5.8: Damage formation at impact location (1) and impact location (2) in the 3° scarf taper repair for a range of impact energies

BVID forming in the vertical adhesive bondline within the tapered scarf repair was observed to initiate buckling failure of the repair (see Figure 5.8 for damage location and Figure 6.8 for damage induced failure mode).

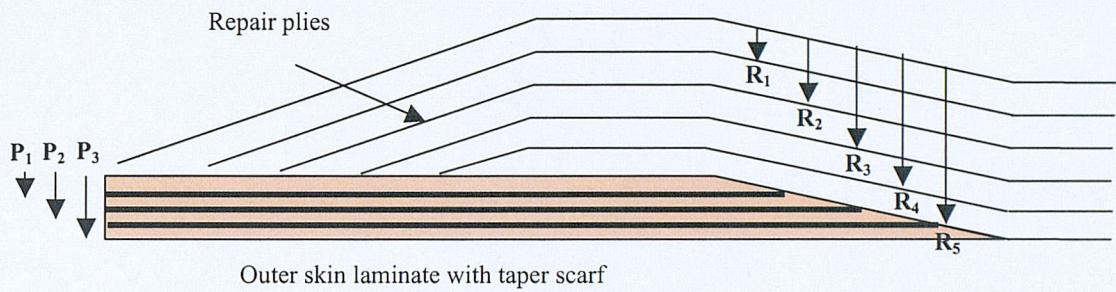
After the impact tests each sample was viewed under a microscope with 10x magnification. This approach permitted the characterisation of the various crack lengths occurring at each ply interface. In the tapered scarf repair on the outer skin, 6 individual plies are used to restore the structural efficiency of the original 4-ply outer skin laminate, i.e. in the tapered scarf repair 5 possible ply failure interfaces exist. The individual ply interfaces within the parent laminate (P1 to P3) and within the repair laminate (R1 to R5) have been illustrated in Figure 5.9.

Figure 5.9: Schematic illustration of individual ply interfaces within a tapered scarf repair

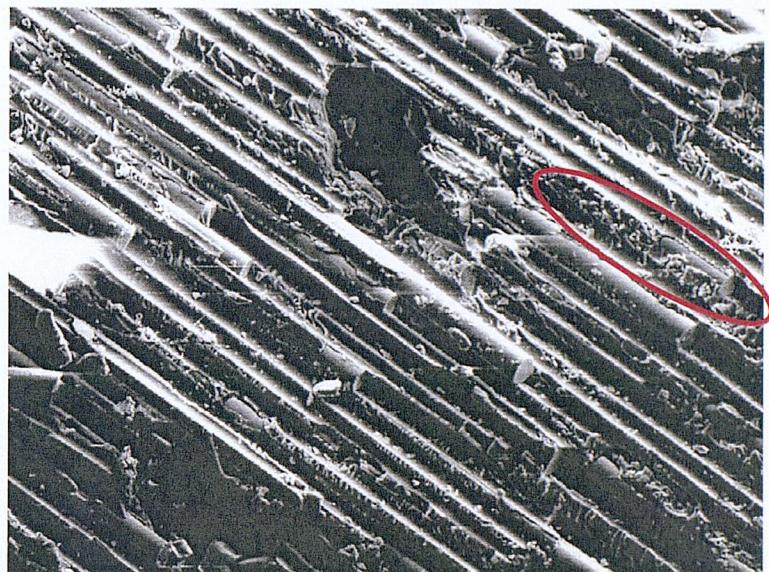
To understand the fracture mode along the tapered interface a failure investigation using a scanning electron microscopy (SEM) was undertaken. A typical 3° scarf taper repair was subjected to two 1200J impacts along the length of the taper. The repeated impacts and their close proximity to each other ensured that a delamination extend along the full length of the beam. The failed repair patch was then extracted from the beam and the failed interface was examined using the SEM. The SEM investigation revealed that mode II fracture occurred directly under and in the immediate vicinity of the impact event. This was determined by an examination of the resin failure morphology. A typical mode I failure morphology would exhibit a clean smooth cleavage of the resin from the fibres. This was not observed on the sample. In comparison, the sample contained considerable surface debris, indications of fibre bridging (which was also observed optically) with resin shear cusps in between the individual fibres. Two SEM photographs have been included in Figure 5.10 for clarity. This first photograph shows considerable fibre pullout and surface damage to the composite repair. Closer examination between the damaged fibres shows smaller resin cusps standing up from the surface and being aligned towards the top left of the photograph. The second photograph is taken on the resin rich surface of the parent laminate. The rough surface with resin cusps is once again typical of a mode II fracture. This result would confirm the findings of [Olsson, 2002] that fracture initiation of delamination damage in the face sheet of a sandwich beam is based on pure mode II.

Mode II failure cusps observed in the resin located between individual fibres

Figure 5.10: SEM photographs taken of the failed scarf repair (a) patch and (b) parent laminate surface

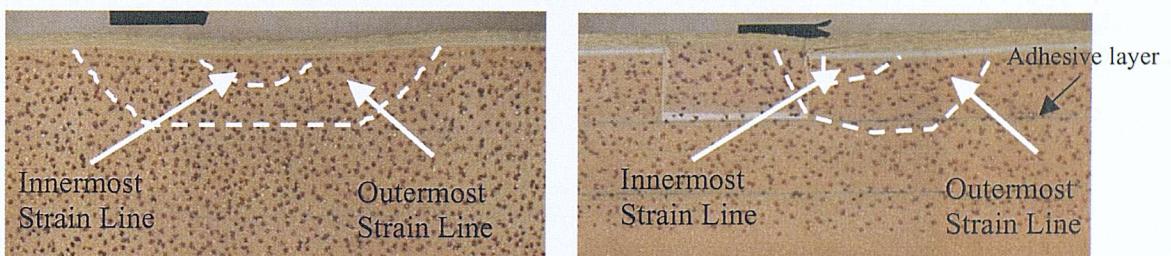
In an effort to understand the response of the replacement foam core to the 1270J impact a number of samples were examined with the stereoscopic photographic NDE technique. The strain line formation observed in the structural repair scheme subjected to a 1270J impact on the 20:1 scarf taper was similar to the 'pristine' beams (see Figure 5.11). The formation of these contour lines has been previously discussed but what effect this would have on the performance of the structure is uncertain.

Figure 5.11: Strain line formation in PVC foam in pristine and repaired beams viewed by the stereoscopic photographic NDE technique

The stereoscopic photographic NDE technique suggested that there is an apparent high displacement plateau existing directly under impact location (1). As in the 'pristine' beams, a secondary displacement plateau existed but its profile was distorted due to the existence of the 25mm wide replacement PVC plug and the vertical adhesive bondline. It appears that the vertical adhesive bondline has significantly influenced the densification of the foam core.

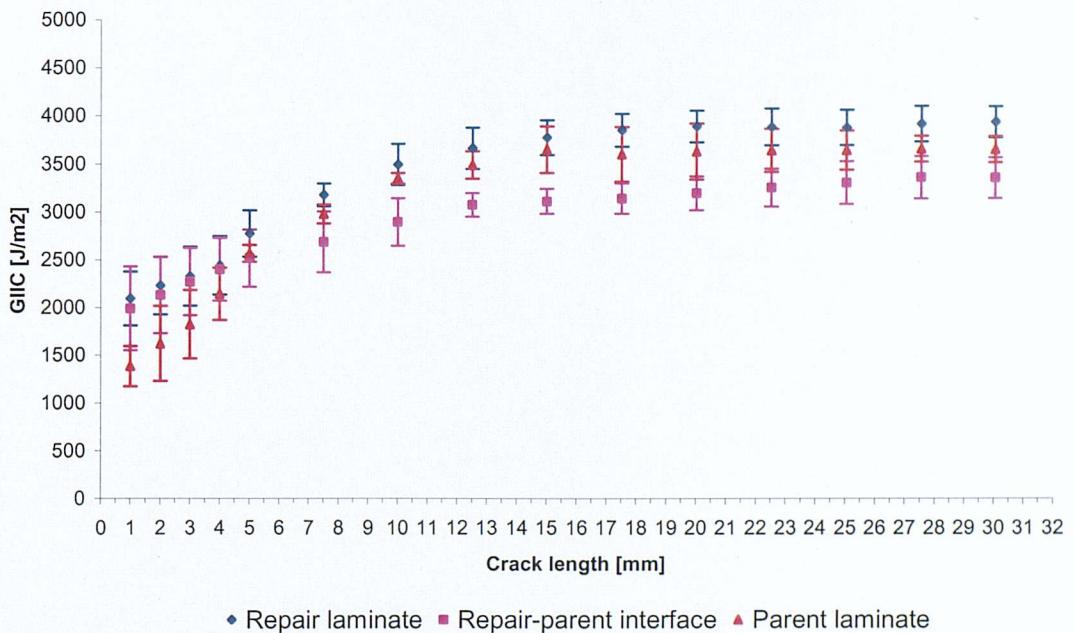
Figure 5.17: Summary of Mode II energy release rate versus crack length plot – mean values of all tested materials

The mode II fracture toughness results presented in Figure 5.17 for the three different material configurations illustrate similar characteristics to the G_{Ic} results in Figure 5.15.

A summary of the Mode II energy release rates with Mode I and Mode II pre-cracks for the parent laminate, the repair laminate and the repair-parent interface is presented in Figure 5.17 and Figure 5.18.

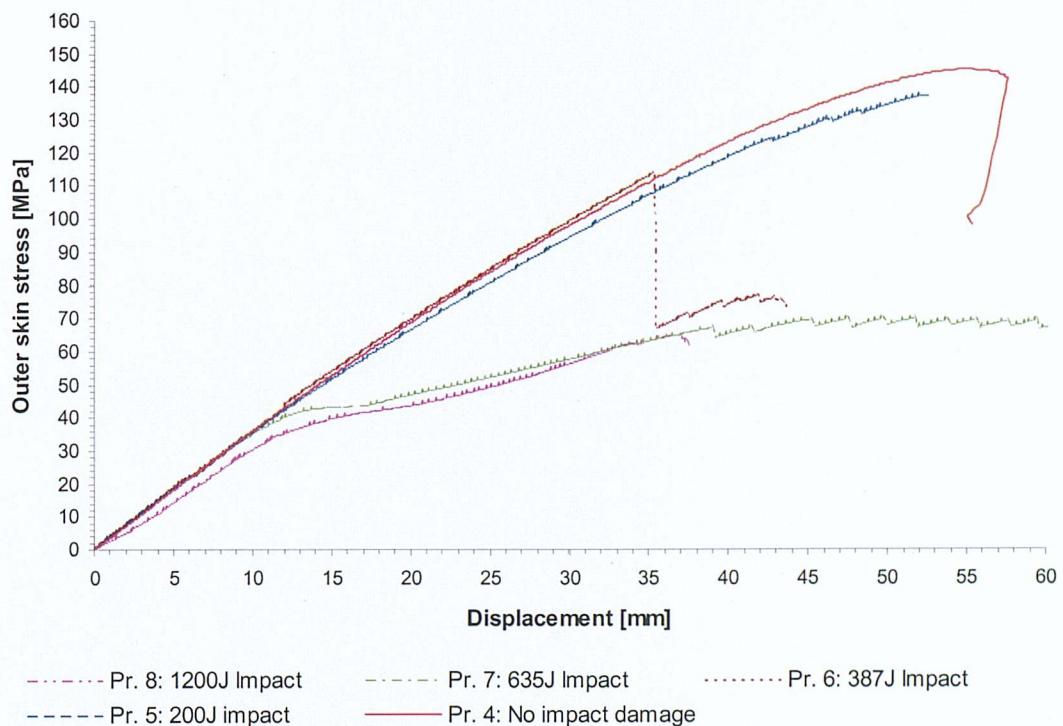
Figure 6.2: Outer skin stress versus varying impact energies.

To understand the influence of impact damage on the static performance of composite sandwich beams, a series of tests on pristine beams has been undertaken. The impact tests were conducted using the same test methodology developed in the previous chapter. The residual static outer skin stress as a function of varying impact energies is indicated in Figure 6.2.

The results in Figure 6.2 and Table 6.4 suggest that low impact energies (200J) have relatively little effect on the residual outer skin failure stress whilst high-energy impacts (>635J) have a significant effect on the residual failure stress. The slightly surprising result in Figure 6.2 is the reduction in stress for the 387J impact. In the previous impact work, a 387J impact was insufficient to cause any delamination damage in the outer skin but was sufficient to generate a residual dent of approximately 0.5mm. This research illustrates that the outer skin failure stress could be reduced by up to 18% for a skin indentation of only 0.5mm.

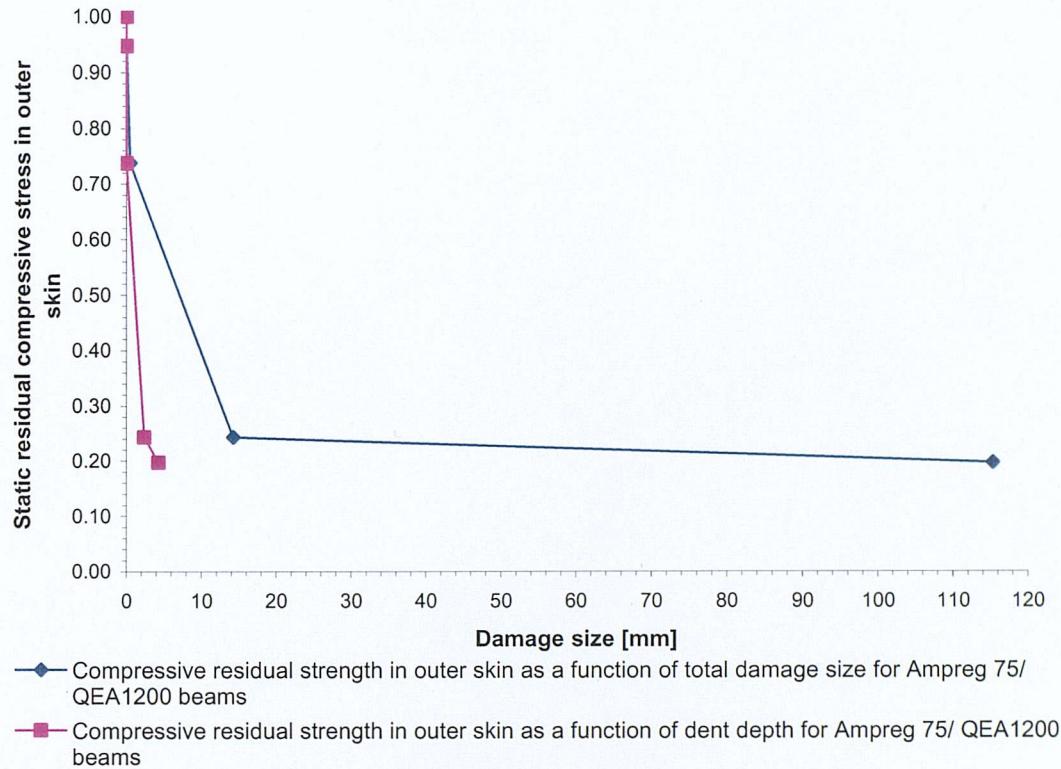
Figure 6.3: Residual compressive stress in the outer skin as a function of damage size for pristine beams

To illustrate the drastic reduction in the residual outer skin failure stress as a function of dent depth and delamination damage size Figure 6.3 has been generated. The residual strength is determined using the following formula:

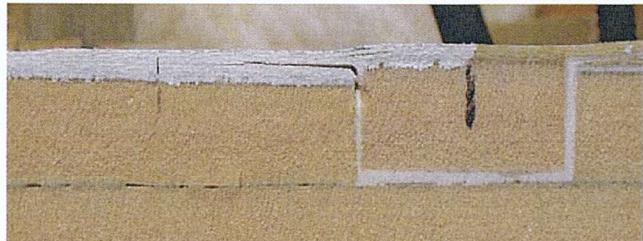
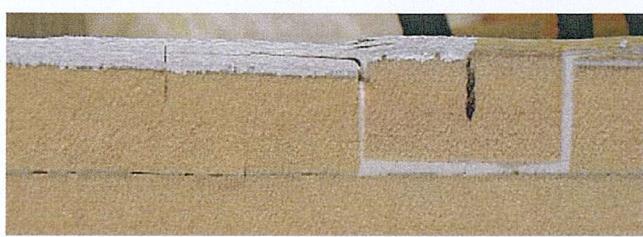
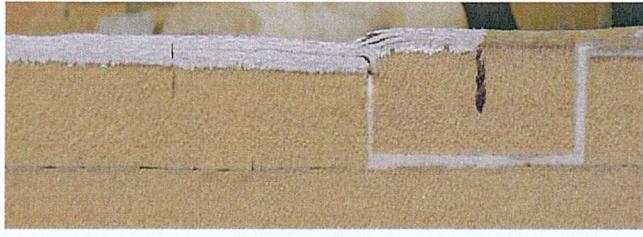
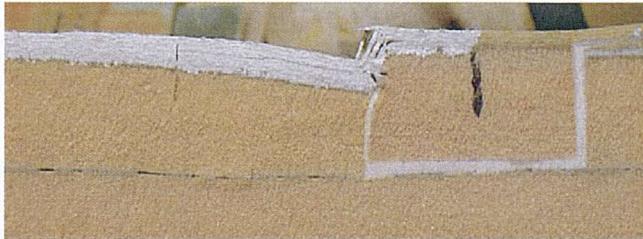
Figure 6.7: Load-failure mode sequence for Sample Rp. 6 subjected to 779J blunt object impact.

20:1 structural repair,
impacted with 779J –
initial unloaded condition

20:1 structural repair,
impacted with 779J – 5kN
load equivalent to
11.6MPa compressive
stress in outer skin

20:1 structural repair,
impacted with 779J –
10kN load equivalent to
23.2MPa compressive
stress in outer skin

20:1 structural repair,
impacted with 779J –
20kN load equivalent to
46.5MPa compressive
stress in outer skin

20:1 structural repair,
impacted with 779J –
21kN load equivalent to
48.8MPa compressive
stress in outer skin

Figure 6.7 shows the progressive failure of the 20:1 scarf repair loaded in four-point bending after it has been subjected to a 779J impact at repair location (1). Each

The extent of the damage already present in the sample is indicated in the first photograph, i.e. delamination damage along the tapered interface and two small delaminations in the repair material above the replacement foam core. During the test the delamination damage generated at the tapered interface remains static whilst the smaller delaminations start to grow and open. Eventually the outer skin kinks about the end of the taper, as indicated in the last photograph in Figure 6.7. At this point it is assumed that the composite beam has failed.

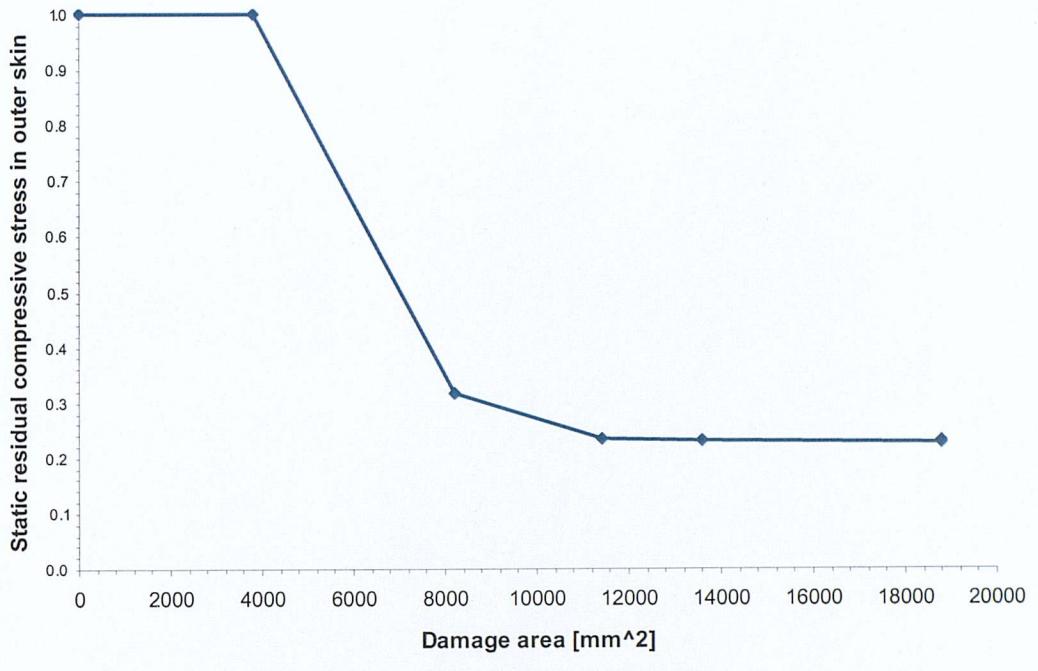
—◆— Compressive residual strength in outer skin as a function of total damage size for Type A repairs

Figure 6.8: Normalised compressive stress in the outer skin as a function of damage size for 20:1 taper scarf repairs

The static residual compressive stress in the outer skin of the 20:1 taper scarf repair as a function of damage size is indicated in Figure 6.8. The residual stress has been calculated using Equation (6.3).

The first striking difference between the static residual compressive stress for the virgin beams and the 20:1 taper scarf repair is the amount of delamination damage the structural repair can sustain before suffering a fall in the compressive stress. This is in direct contrast to the virgin beams that suffered a rapid fall in compressive stress for very small amounts of damage (i.e. 0.5mm indentation of the outer skin).

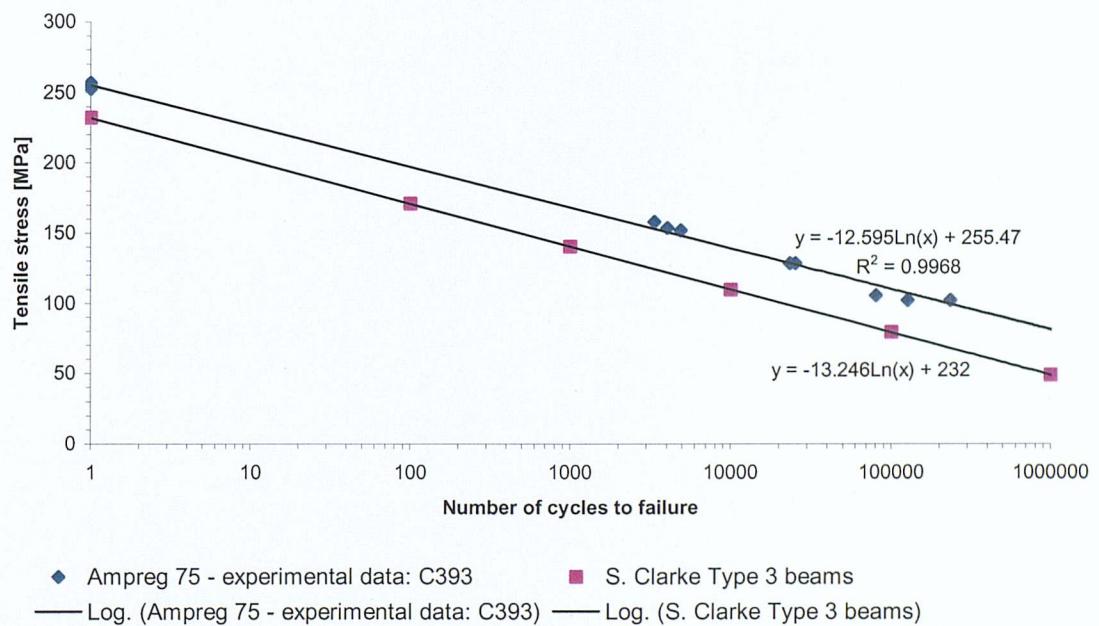
Figure 6.10: Comparison of S-N fatigue data between current test data and the Type 3 beams from Clark, 1997

In the work published by [Clark, 1997] on the ‘Long term behaviour of FRP structural foam cored sandwich beams’, he evaluated the fatigue and creep response of various marine sandwich beams. One of beam configurations, Type 3, was used as the structural design for the RNLI Severn and Trent composite sandwich hull structure, and hence evaluated as the baseline beam configuration in this investigation. The S-N fatigue curve for the Type 3 beams from Clark’s work is reproduced in Figure 6.10. The figure also contains the experimental data derived in this test programme, i.e. Table 6.5.

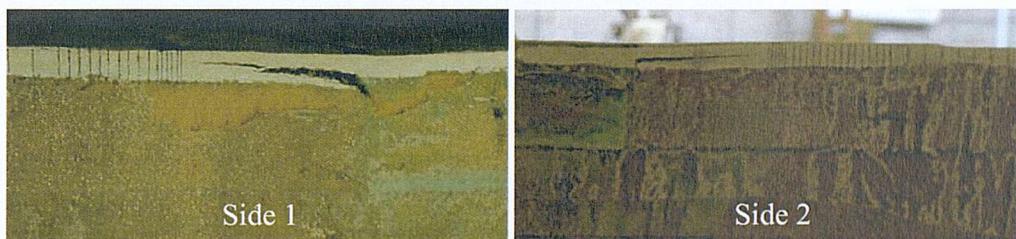
Figure 6.12: 1270J impact damage sustained by Specimen Rp.19

On side 1 of sample Rp. 19, the impact event generated a 42mm long crack propagating between the original laminate and the repair skin from the inside edge of the scarf taper towards the outer surface. Fibre bridging between the repair and the original laminate was also observed. On side 2, the impact event generated a 45mm long crack in the same location. Secondary cracks in the laminate and damage to the core material with vertical and horizontal cracks of various lengths was also observed.

To determine whether impact damage would grow when loaded with a fatigue load level below the load level sufficient to cause outer skin buckling, sample Rp. 19 was subjected to an impact at impact location 1 on the 20:1 scarf taper. The resulting damage is illustrated in Figure 6.12.

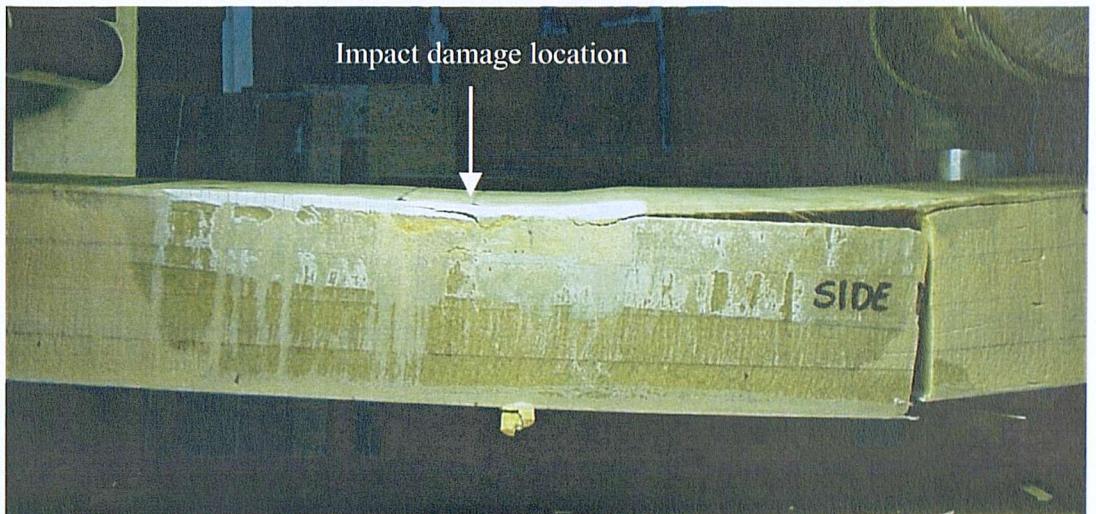
Figure 6.14: Fatigue failure mode of impacted damaged Rp. 19 tapered scarf repair

As Figure 6.14 illustrates the location of the inner skin tensile failure is on the opposite side to the location of the impact damage to the outer skin. It therefore appears that the impact damage had no influence on the failure mode of the specimen at this load level, i.e. 20% of the USL.

After 3,280,056 cycles, the impact damaged sample eventually failed by tensile failure of the inner skin (see Figure 6.14). The extent damage contained within the 20:1 tapered scarf repair had remained constant (at this load level) for over 2 million cycles.

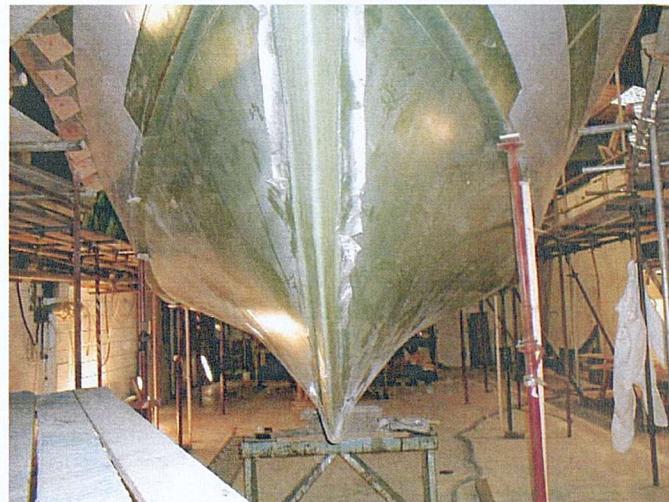
The two sandwich construction halves of the vessel are manufactured in female moulds. When the two halves of each hull are completed, they are joined and bonded along the centreline to provide a single hull moulding. This has been illustrated in Figure A.2

Figure A.2: Bondline joint between the two halves of the hull

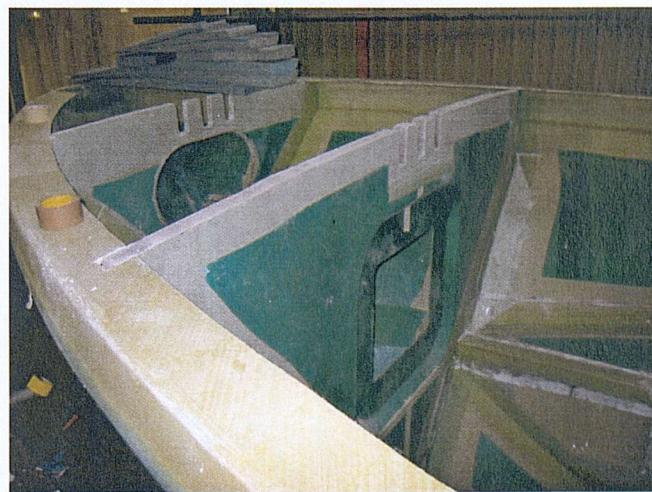
In addition to the top hat stiffeners, composite bulkheads are manufactured and bonded to the outer hull. Figure A4 shows an example of fitted bulkhead in the bow of a Trent class lifeboat, whilst Figure A5 shows the stiffening arrangement within a Severn class lifeboat. The vertical bulkheads are typically spaced 1.2m apart along the length of the vessel.

Figure A4: Bulkhead joints in bow section of Trent Lifeboat

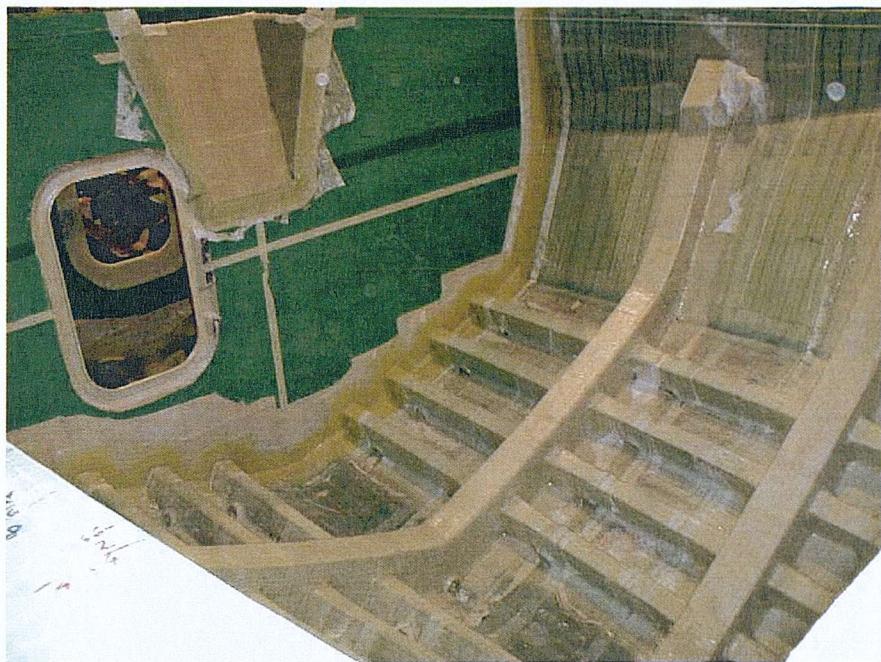
Figure A5: Stiffening arrangement within the hull of a Severn class lifeboat

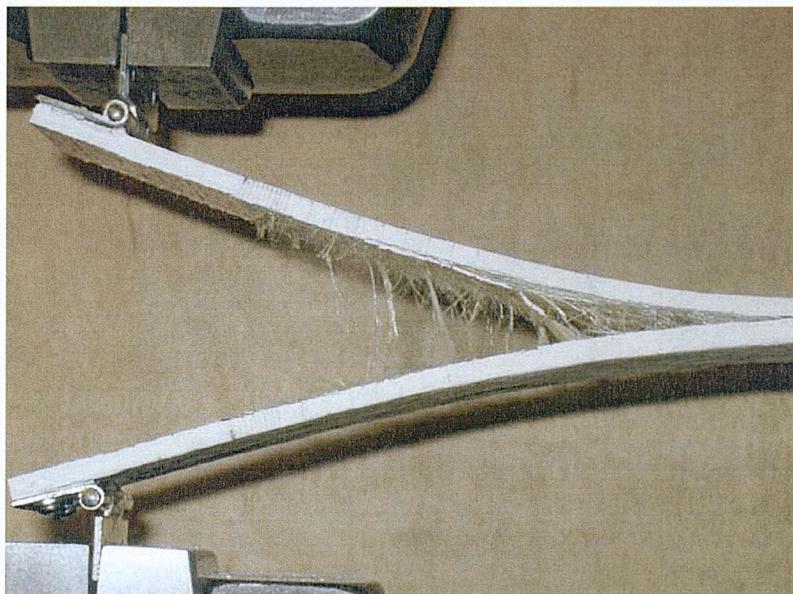
Figure B.1: Fibre bridging at a Kevlar/E-Glass/Ampreg 75 specimen whilst loaded in opening mode

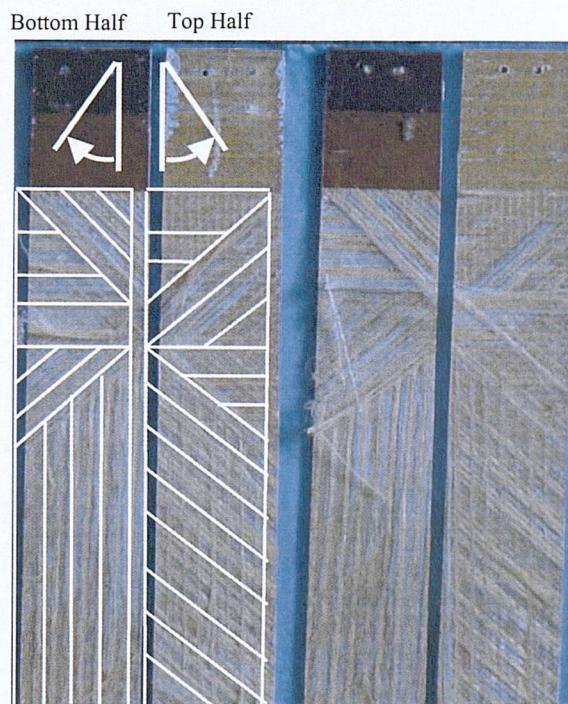
Figure B.4: Interfaces of two typical Group A Kevlar 75 specimens after complete failure

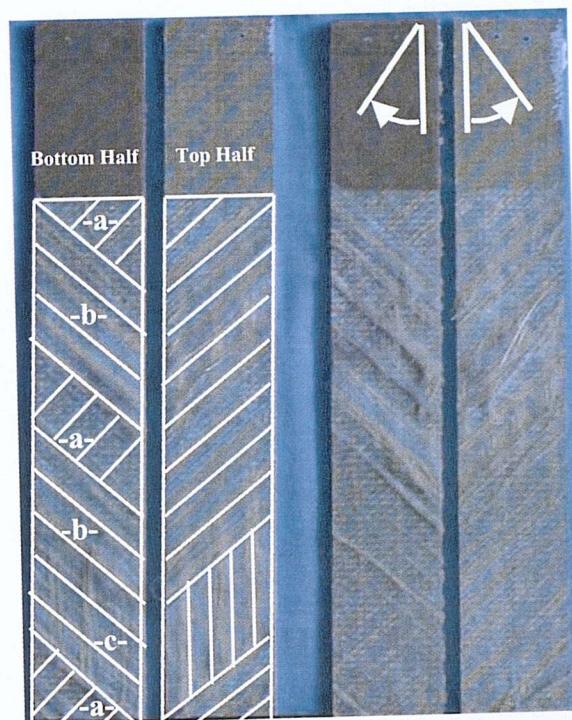
-a- : $-45^\circ/45^\circ$ interface

-b- : within -45° layer

Figure B.7: Interfaces of two typical Kevlar/E-Glass/Ampreg 26 specimens

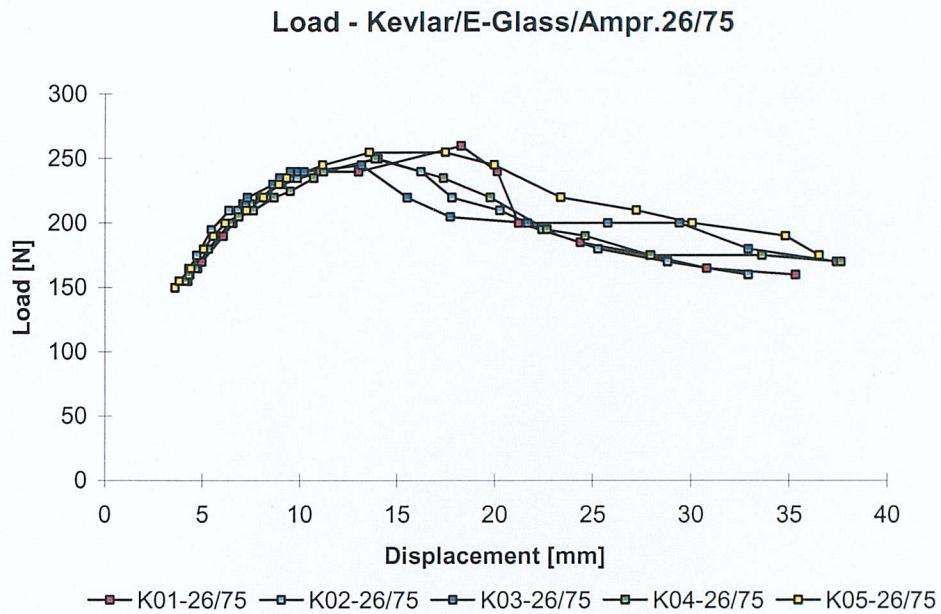
Figure B.8: Mode I load-displacement plot of Kevlar/E-Glass/Ampreg 26/75 specimens

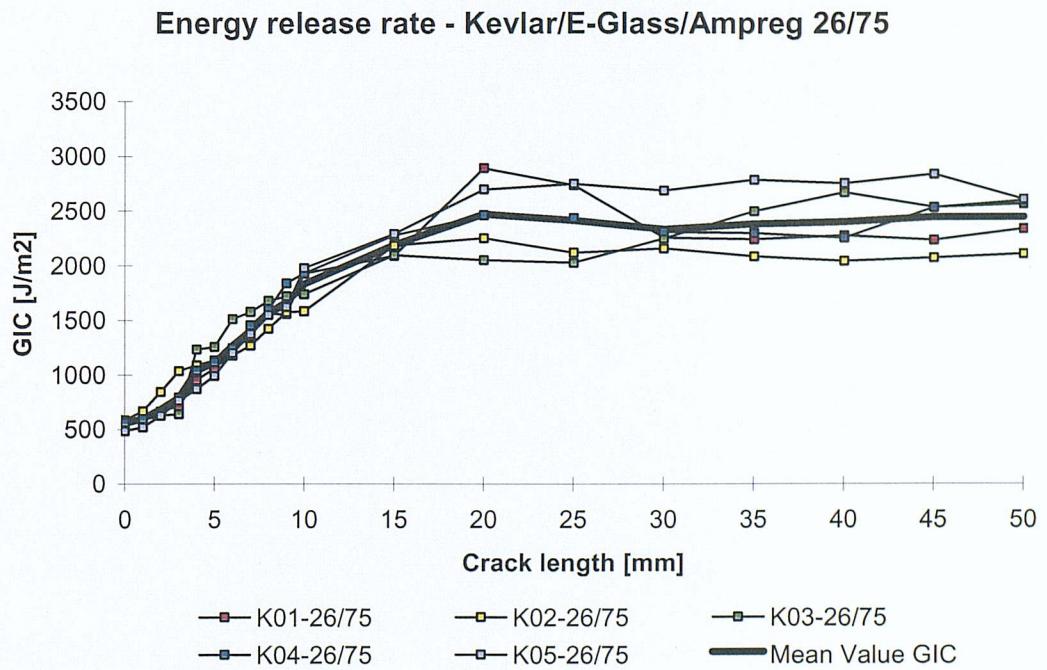
Figure B.9: Mode I energy release rate versus crack length plot of Kevlar/E-Glass/Ampreg 26/75 specimens

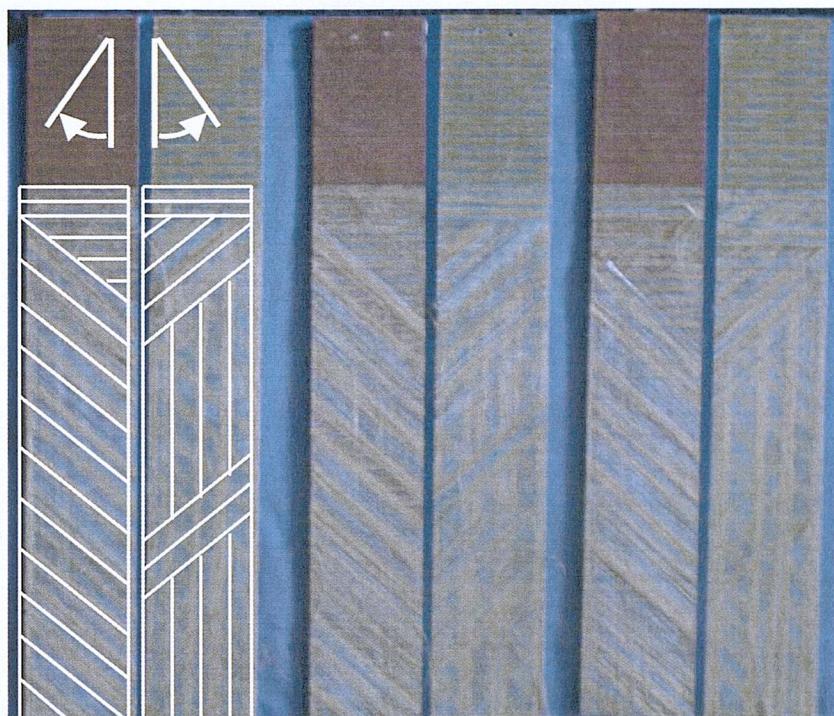
Bottom Half
Ampreg 75 Top Half
Ampreg 26

Figure B.10: Interfaces of three Kevlar/E-Glass/Ampreg 26/75 specimens

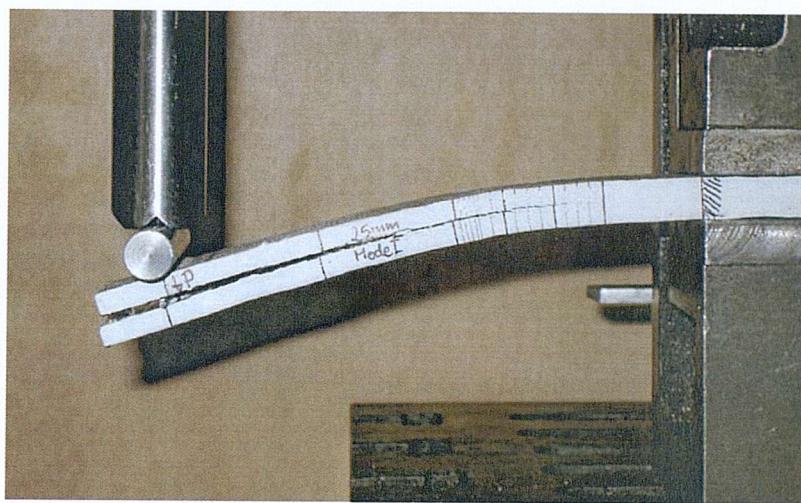
Figure B.11: Mode II test configuration and crack propagation

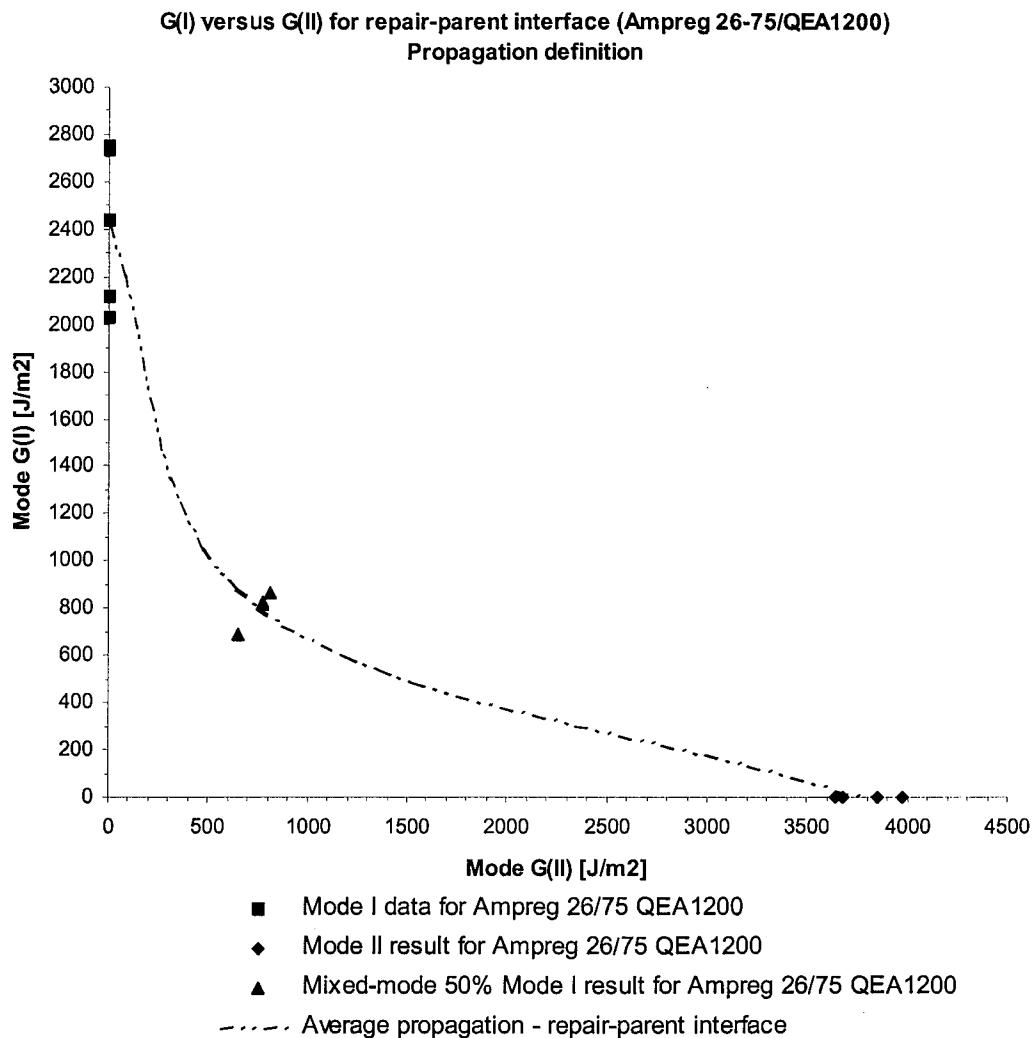
Figure B.23: G_I versus G_{II} for the repair-parent interface

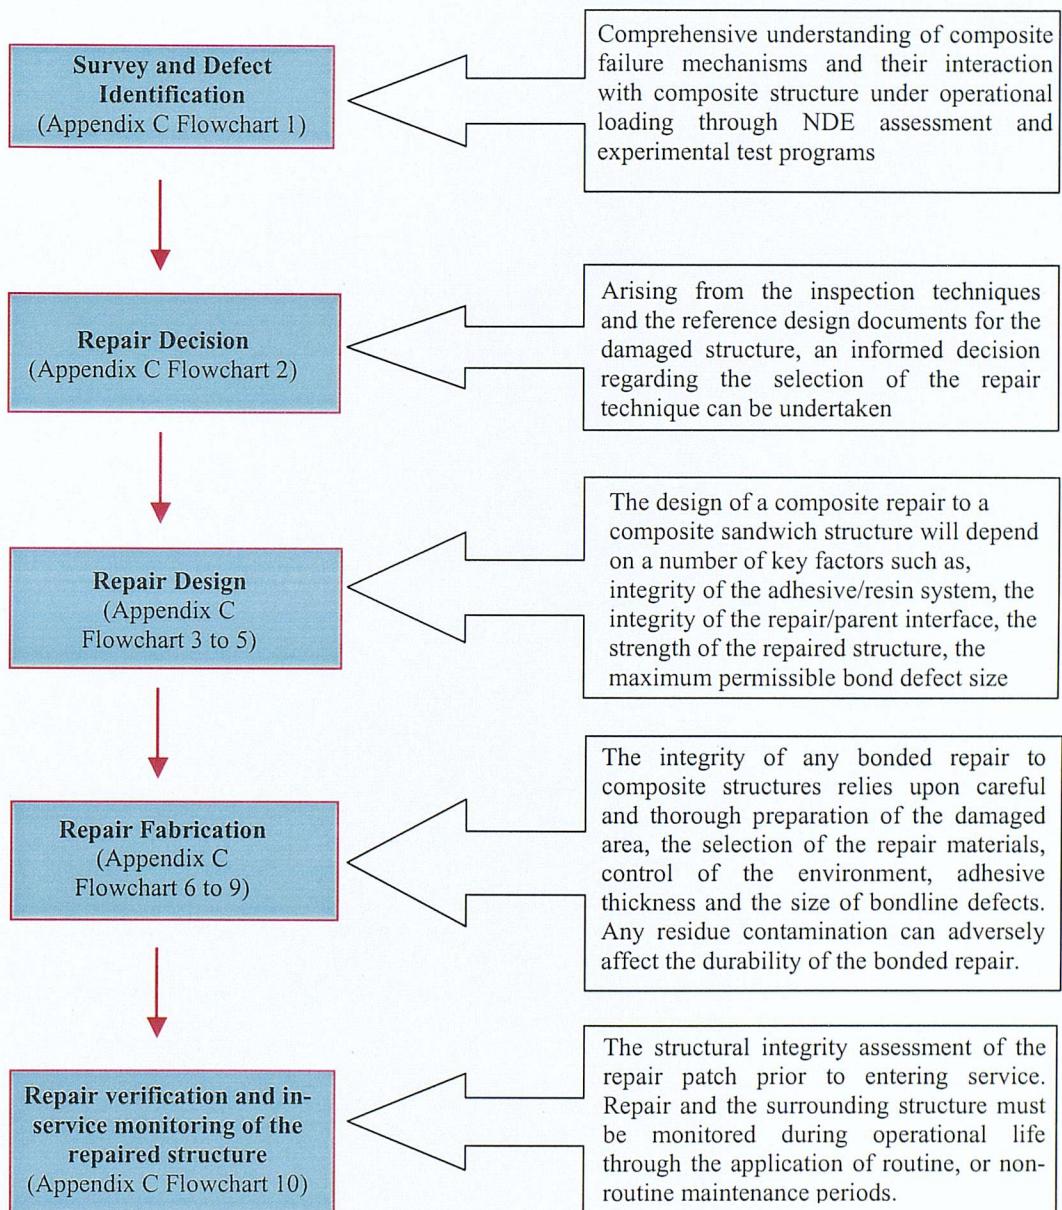
Figure C.1: Repair cycle for composite structures

This appendix contains the repair flowcharts for all of the key stages within the repair cycle identified in Figure C.1.

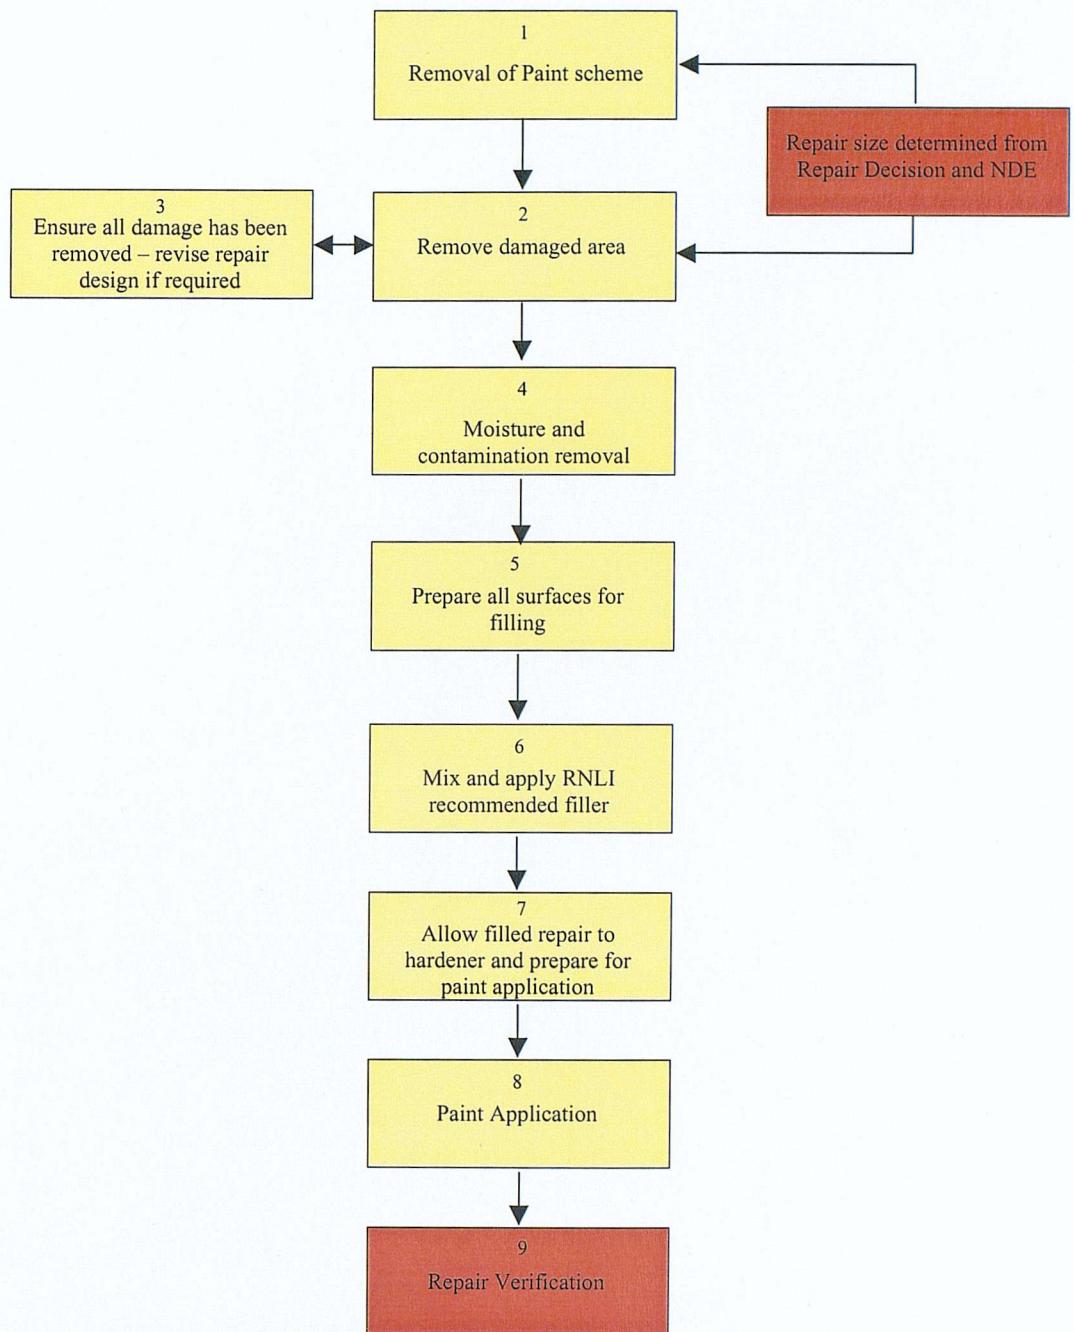
Figure C1.8: Flowchart 7 - Repair Fabrication for Cosmetic Repair
