Thesis: Harrell, T.M. (2019) "Characterisation of lightning strike induced damage in CFRP laminates and components for wind turbine blades", University of Southampton, Faculty of Engineering and Physical Sciences, PhD Thesis.

Characterisation of lightning strike induced damage in
CFRP laminates and components for wind turbine blades

Thesis for the degree of Doctor of Philosophy

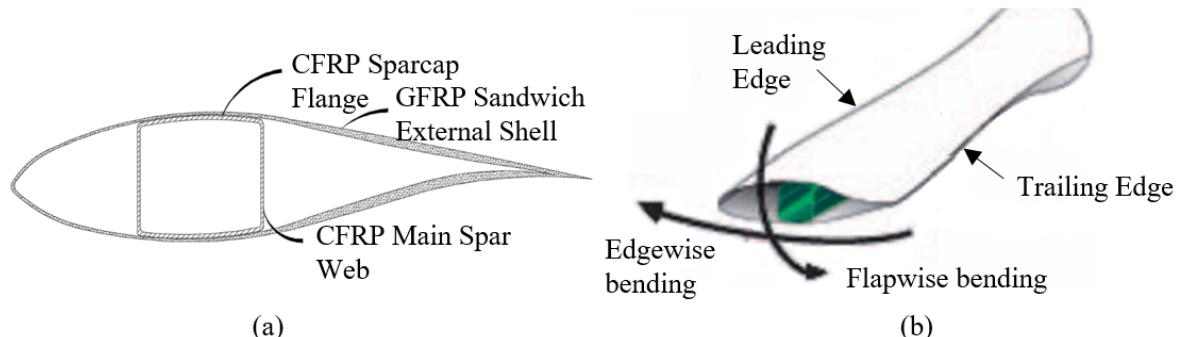
CFRP material is significantly more costly than GFRP, which in most cases makes it impractical to use for the whole structure. Accordingly, the CFRP materials are used specifically for blade elements that carry significant structural loads. The main application is to carry very large compressive and tensile loads in the sparcaps, when a WT blade is subjected to aerodynamic loading in flapwise bending [32]; see Figure 1.5. The sparcaps are encapsulated in an external shell. The external shell is used to create lift which turns the blade and is designed to transfer the

aerodynamic forces into the sparcap. These shells are typically made of a combination of GFRP sandwich laminates with foam core and monolithic GRFP elements [32].

Figure 1.5: (a) Cross sectional view of typical WT blade design and (b) is WT components with loading details for the flapwise and edgewise bending loads [32]

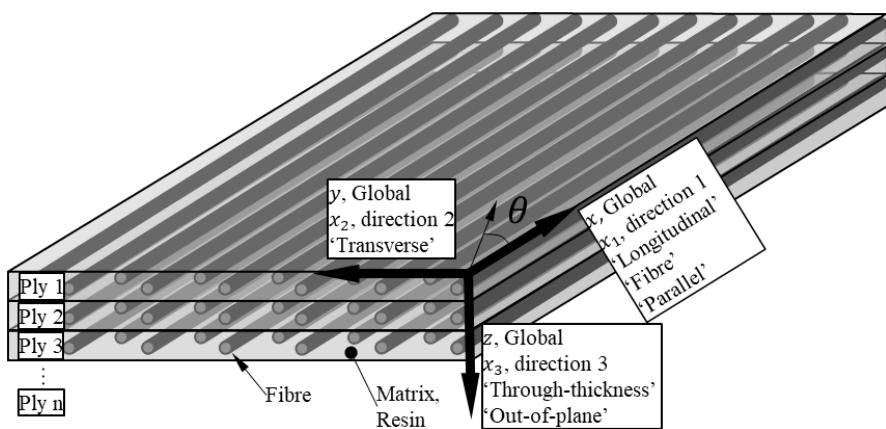
In this thesis, lightning strike induced damage on Carbon Fibre Reinforced Polymer (CFRP) materials are studied. CFRP composite materials are generally used as structural components because of their stiffness/strength to weight ratio [45]. An example of a ply and laminate configuration is shown in Figure 2.1. They comprise of carbon fibres and polymer resin, usually an epoxy. The carbon fibres have high strength and high stiffness to density, and they provide stiffness and strength of the resulting composite material. The epoxy resin (or other polymer resin such as polyester, vinyl ester, and polyurethane) is the substance that binds the carbon fibres together. Plies are closely packed carbon fibre tows stitched together with all fibres positioned in the same direction as shown Ply 1 of Figure 2.1 [45]. This gives two very distinct principal material orientations: values and properties in the fibre direction are typically denoted by a subscript 1 and called, throughout the thesis, the ‘longitudinal direction’. The values and properties in the direction orthogonal to the fibres are typically denoted by a subscript 2 and called, throughout the thesis, the ‘transverse direction’. The ply angle, θ , is defined by the angle between the longitudinal (fibre) direction and a reference direction, e.g. a global x direction as shown in Figure 2.1. Multiple plies can be stacked together to create a laminate and are typically labelled by their number from the top outer ply to the bottom outer ply as depicted in Figure 2.1. The laminate stack provides another distinct orientation where values and properties in this direction are typically denoted by a subscript 3 and called, throughout the thesis, the ‘through-thickness direction’. Figure 2.1 depicts a unidirectional (UD) stack-up as it is used in many Wind Turbine (WT) blade spars, which allows the fibres to provide the highest stiffness and strength in the loading direction [46].

Figure 2.1: Unidirectional ply stack showing three material orientations, and global coordinate system

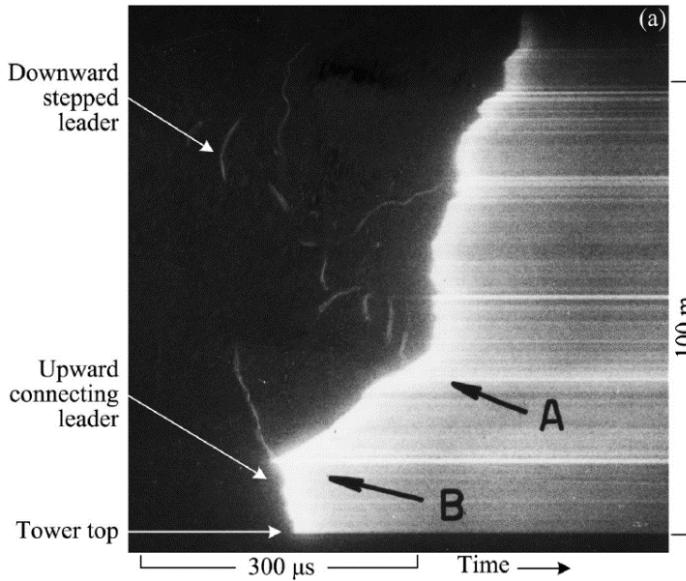
The invention of the streak camera helped to evolve our modern understanding of lightning. A streak camera contains a moving reel of film taking strips of an image at a rapid rate [54], which allowed ultra-fast time-lapse images to be made, and for the first time, was able to show the progression of a lightning strike. An example of a streak camera image is shown in Figure 2.2 [53], which shows conclusively a negative downward leader and an upward connecting leader [53], and provided the basis for the nomenclature associated with descriptions of lightning.

Figure 2.2: Streak camera photograph of a downward lightning flash attaching to a 55m tower on top of Mount San Salvatore in Lugano, Switzerland [53]

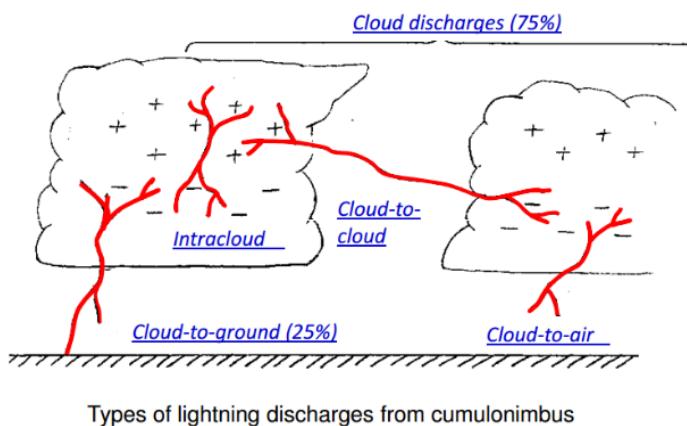
Lightning is categorized based on where the discharge originates and ends. There are four categories of discharge as shown in Figure 2.3: intracloud, cloud-to-ground, air discharges and cloud-to-cloud discharges [51]. Cloud-to-cloud and intracloud are the most common type of discharge accounting for more than 70% of all lightning discharges; however, cloud-to-ground is the most researched area because of its interactions with humans and man-made structures.

Figure 2.3: Lightning discharge categories for all types of lightning discharge represented by the red lines [51]

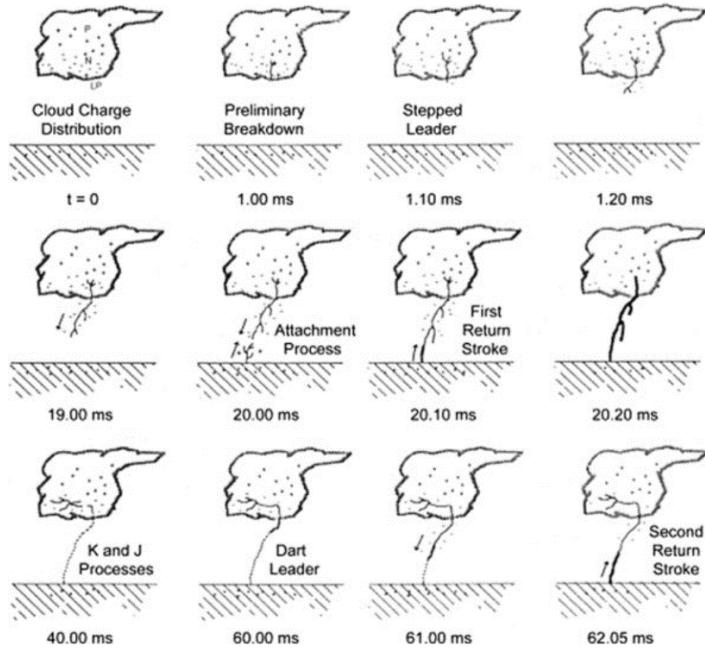
It is estimated that 90% or more of global cloud-to-ground lightning is accounted for by negatively charged downward lightning [51]. The other types of cloud-to-ground discharges in order of frequency are negative upward, positive upward, bipolar upward and positive downward [51]. Downward lightning is specified as initiating from the cloud and travelling to the ground, and upward lightning is specified as initiating from the ground and travelling to the cloud. The typical process of a downward leading is depicted in Figure 2.4. The source of the lightning discharge starts in a thunder cloud. In the initial phase there are three regions arranged vertically and indicated by the lettering P, LP, and N for main positive, lower positive charge regions and main negative charge, respectively.

Figure 2.4: Typical downward leading lightning discharge [50]

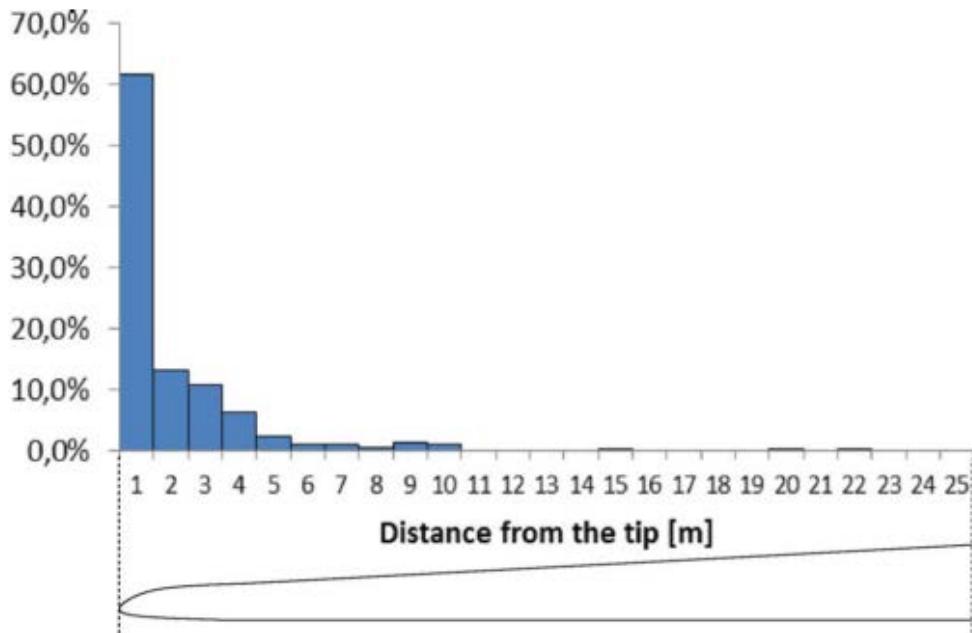
WT structures are highly susceptible to lightning strikes as they are often the tallest structures in the region and pointed at the end. As lightning downward leaders make their path from cloud-to-ground, higher structures are more likely to provide an upward leader to connect a downward leader and create a lightning stroke. Researchers have shown that the propensity for lightning to attach to a structure increases with its height [71], and further that the wind turbine, as the highest structure in the region, is more susceptible to lightning strikes. Additionally, the enhanced electric field at the blade tip, due to the sharp curvature and highest point of the structure, is the most likely place for lightning to attach [72]. Investigations, which consider the location of lightning attachment points along the WT blades [72], [73], have determined that the most susceptible area for a WT to be struck by lightning is at the very tip of the blade. More than 95% of the strikes that attach to a WT occur within the last 10 meters of the blade [74] as shown in Figure 2.6.

Figure 2.6: Lightning strike attachment points along the length of the blade from various wind turbines located in the US states of Kansas, Texas, and Illinois [74]

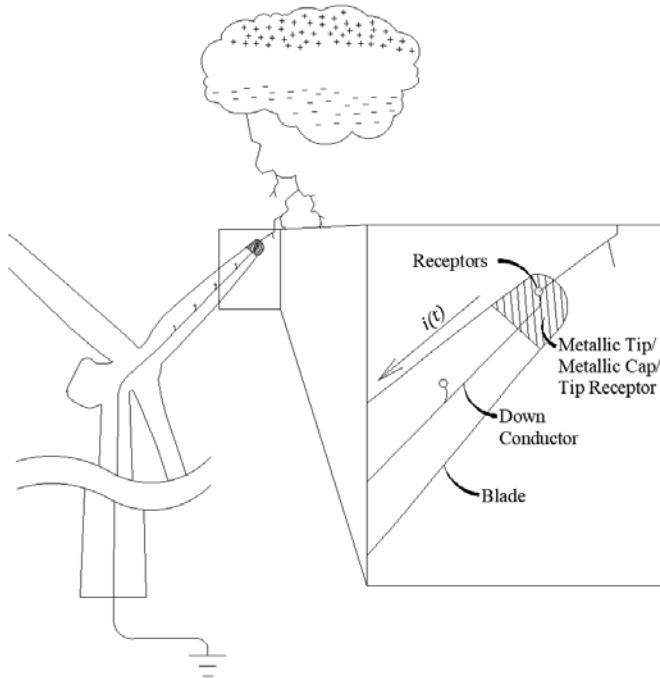
As previously mentioned, streak cameras and high-speed images show that most lightning strikes are composed of a downward leader connecting with an upward leader created by the enhanced electric field. The upward leaders are typically created in areas that have sharp radii, which on a WT blade is at the blade tip. The most ideal path to ground for a WT is for the lightning to strike a receptor allowing the current to travel down the conductor on a path to ground as shown in Figure 2.7. To aid in this, some WT blades have a metallic tip as a way to conduct the electric current from the lightning strike through a down conductor and into the ground. The down conductor is a thick gauge wire, usually copper or aluminium, which is very conductive and gives the current the least resistive path to ground.

Figure 2.7: Ideal lightning strike path to ground through wind turbine

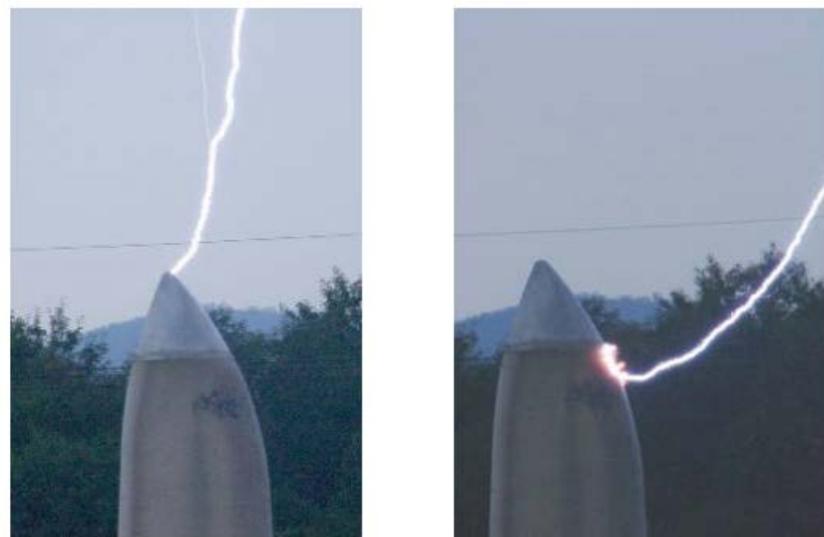
However, as can be seen in Figure 2.8, lightning attachment does not always take a direct path to the receptors and through the down conductor; in the photograph on the right it is clear the lightning has attached below the tip and is heating the GFRP blade by the electric current travelling on the surface of the blade until it reaches the cap receptor.

Figure 2.8: Simulated lightning attachment to wind turbine blade with cap type receptor [75]

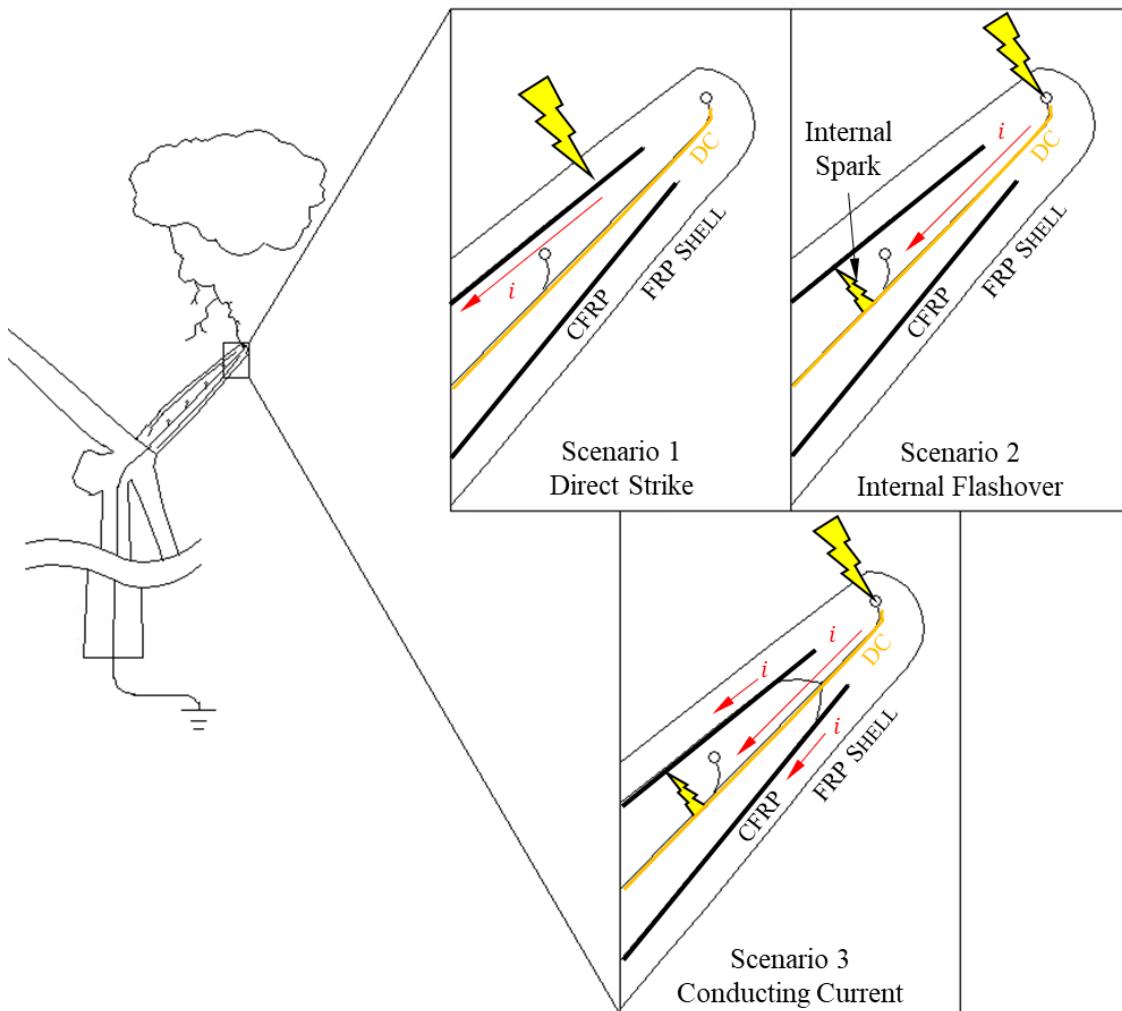
CFRP sparcaps in WT blades (or CFRP/GFRP hybrid sparcaps) represent a potential conductive path for lightning to travel to ground. There are three potential ways that lightning currents reach the CFRP composites materials/components, as illustrated in Figure 2.9. Scenario 1 is a direct attachment, also known as a direct strike or arc-entry, when a strike directly attaches to the CFRP if the sparcap end too close to the tip of the blade. The likelihood of this occurring is small but results

in the largest current experienced in the CFRP materials, and further generates the most Joule heating as the current is conducting through the most resistive path. Therefore, Scenario 1 typically causes the most damage. If this enters through GFRP material, there is also the potential for delamination between the GFRP external shell and the CFRP sparcaps. Scenario 2 is unintended internal flashover due to large voltage differences between the down conductor and the sparcaps. This happens when down conductors, badly designed side receptors, or additional components such as heating elements are not properly electrically connected or insulated. Flashovers from the current flowing through the down conductor contain only a fraction of the peak current but can still cause damage. There is a larger probability of Scenario 2 occurring with blades that do not have adequate lightning protection. Scenario 3 is the most likely case where the tip receptor intercepts the lightning attachment and the majority of the current is received through the down conductor. A typical design has an LPS with equipotential bonds between conductive elements, which include the structural CFRP materials, to ensure that flashovers cannot occur, but also allows for current in the CFRP sparcaps. Scenario 3 has the highest potential to control the electrical introduction into the CFRP materials, and to distribute the energy through the CFRP material to reduce damage.

Figure 2.9: Lightning attachment to an example wind turbine showing the typical attachment scenarios 1 to 3: (1) Direct strike, (2) Internal Flashover, and (3) Conducted Current

The 10/350 μ s waveform is appropriate for arc-entry situations; see Scenarios 1 and 2 of Figure 2.9. For conducting current cases (Scenario 3 Figure 2.9), the current is typically shared between the down conductor and the CFRP material. For this instance, a different waveform can be used. Based on the work done by Romero [79] a waveform of 10/110 μ s is identified as a more appropriate waveform for conducting current; see Figure 2.15.

Direct attachment (Scenario 1 & 2; Figure 2.9) needs lightning protection from direct effects. Almost all of the lightning strike protection solutions for direct attachment include the application of some electrically conductive substance on the surface such as metallic mesh usually copper [33], [87], carbon nanotubes [88], or conductive paints [89], [90].

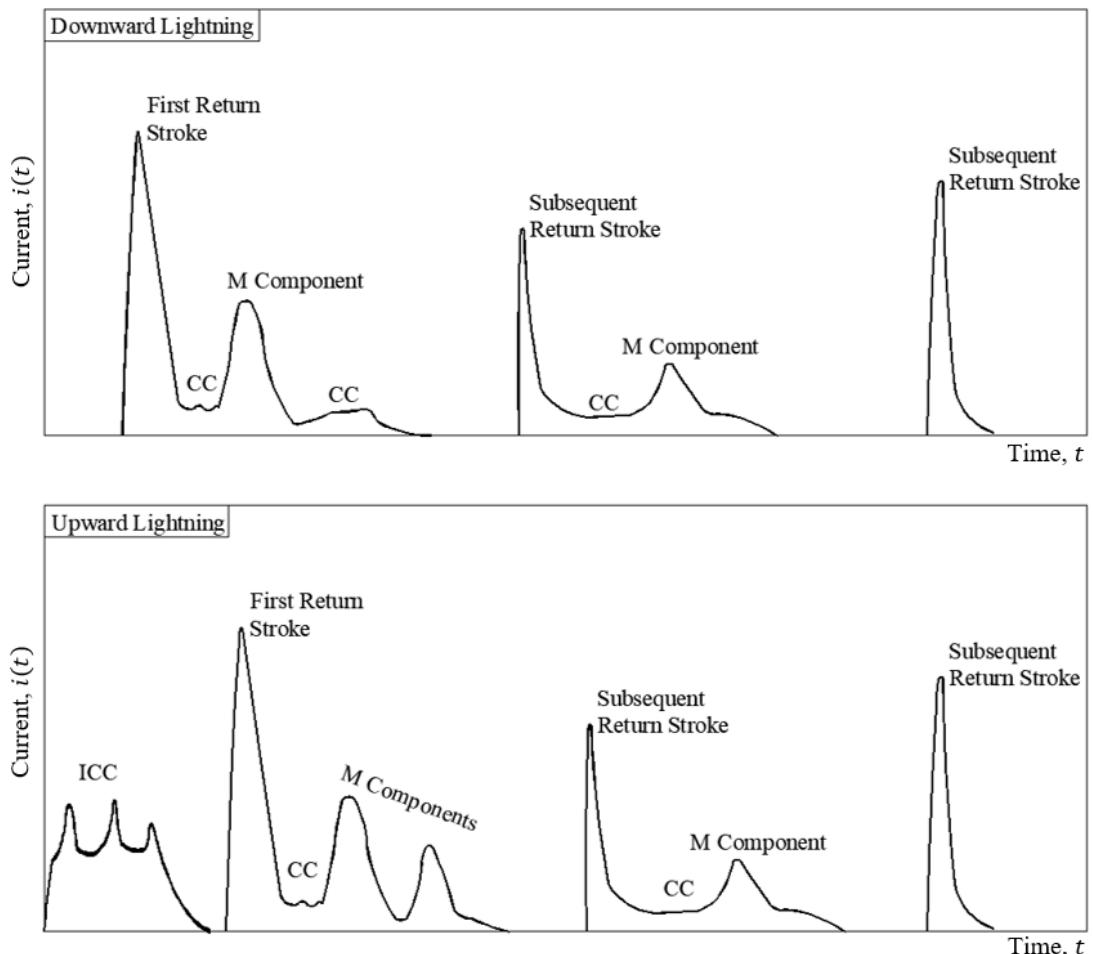
The current from a natural lightning stroke is variable. As discussed previously there are five types of cloud-to-ground: negative downward, negative upward, positive upward, bipolar upward and positive downward. Negative cloud-to-ground represents a typical current profile. Figure 2.10 presents a schematic of the characteristic elements of a downward lightning discharge and an upward lightning discharge. The first injection of current is the first return stroke. The first return stroke is characterised by a rapid rise time of the order of 10 μ s with a trailing duration of approximately 100 μ s. This is the most distinct characteristic of the downward lightning stroke. Continuous Current (CC) is possible in between strokes with a current range of about 10 A to around 1 kA. In between these portions of a lightning discharge, it is possible to have additional charge transferred by what is known as the M-component. The M-component is defined as a slow charge transfer that grows over a few milliseconds. Similarly, upward lightning strikes have a distinct characteristic current waveform. The initiation process of the upward lightning includes initial continuous current (ICC) in the form of rapid pulses measured in the range of μ s to ms. Once the ICC is extinguished a return stroke is seen which holds the same characteristics as downward lightning.

Figure 2.10: Schematic showing the current distribution in a downward (top) and upward (bottom) lightning discharge (adapted from [76])

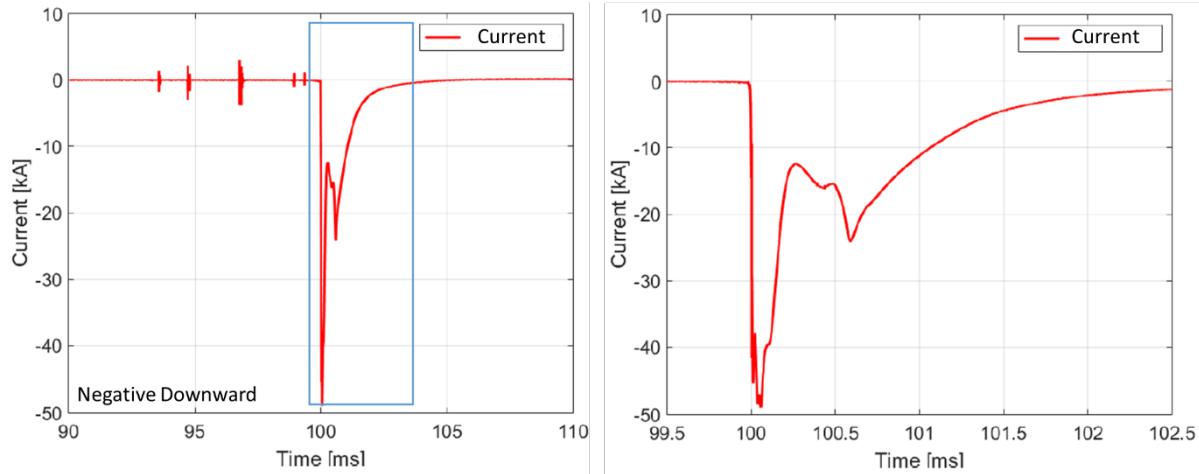
An example of negative downward lightning discharge on a WT blade is shown in Figure 2.11 where the electric current is shown in red for the time just before and after the lightning strike. The first approximately 8 ms before the first return stroke are small spikes in current that are associated with the formation of an upward leader and at 100 ms the full lightning strike is connected followed by a rapid increase in current. The blue box shows a closer view of the lightning strike on the right. The close-up view shows a single strike with continuous current and one M component until it returns to zero current.

Figure 2.11: Example of a negative downward lightning discharge on an offshore WT blade (left) is the full waveform with time before and after strike and (right) is a close-up view of the stroke [77]

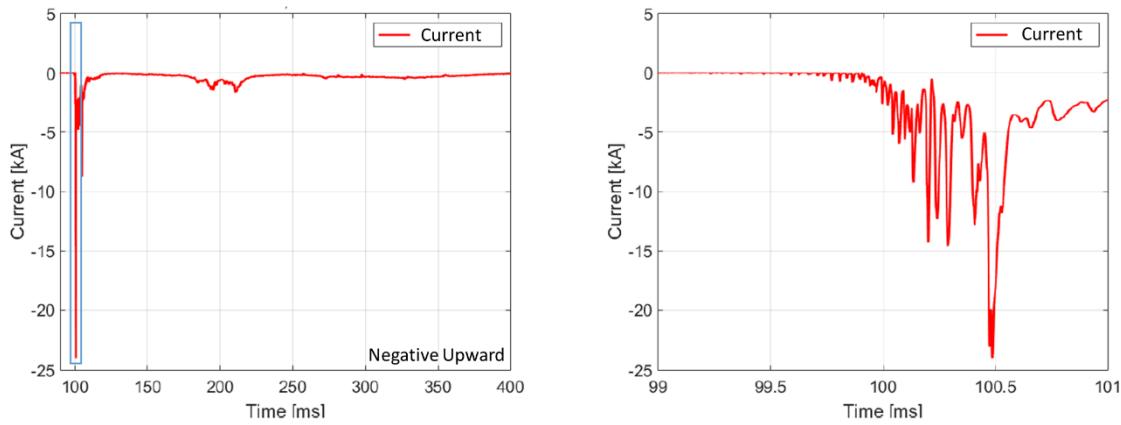
Figure 2.12 shows a negative upward lightning discharge where the blue region highlights the close-up view on the right. The right image shows a rapidly produced ICC with the first return stroke with a peak current just below 25 kA.

Figure 2.12: Example of a negative upward lightning discharge on an offshore WT blade [77]

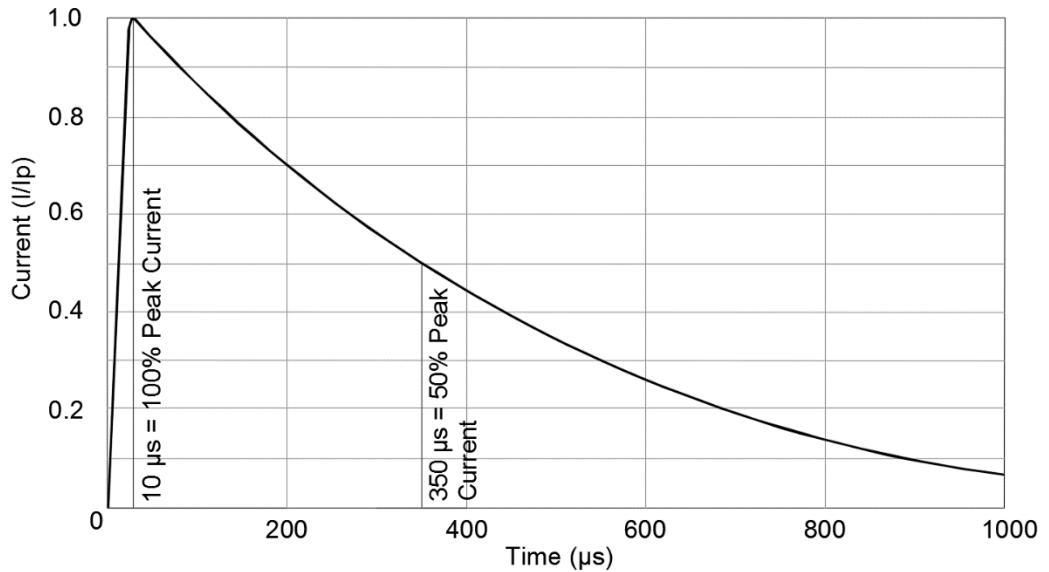
is implemented in the WT blade lightning protection standard IEC 61400-24 [48]. The waveform mostly used for WT blades is the 10/350 μ s waveform. Figure 2.13 shows the normalized 10/350 μ s waveform over 1000 μ s. The 10/350 μ s waveform is defined by 10 μ s rise time and a 350 μ s half time. The rise time is the time it takes the current to reach the peak current (a value of 1.0 in Figure 2.13) and the half time is the time the waveform is at half of the peak current.

Figure 2.13: Idealized natural lightning strike waveform, 10/350 μ s waveform, used in the IEC61400-24 wind turbine blade lightning protection standard [48].

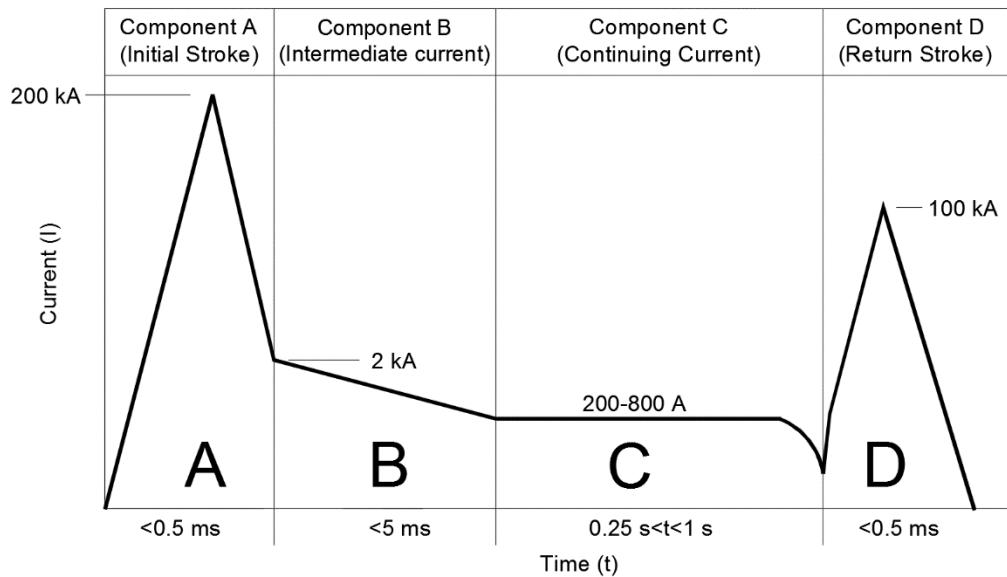
SAE-ARP 5412 [70] sub-divides lightning strikes into different components as shown in Figure 2.14. The four different components mimic the natural lightning process. Component A is the first return (or initial) stroke, Component B is the M-component, Component C is the continuing current, and Component D is the return stroke.

Figure 2.14: Typical lightning stroke waveform defined by SAE-ARP 5412 aircraft standard [70]

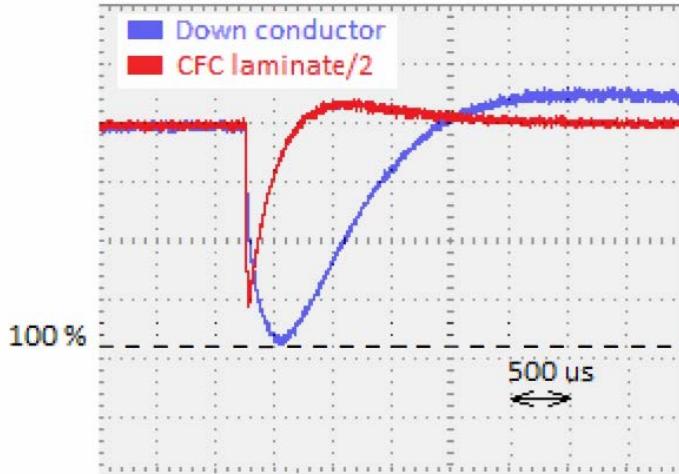
Figure 2.15: Experimental results of the current distribution between the down conductor and the sparcap on a scaled lightning protection system [79]

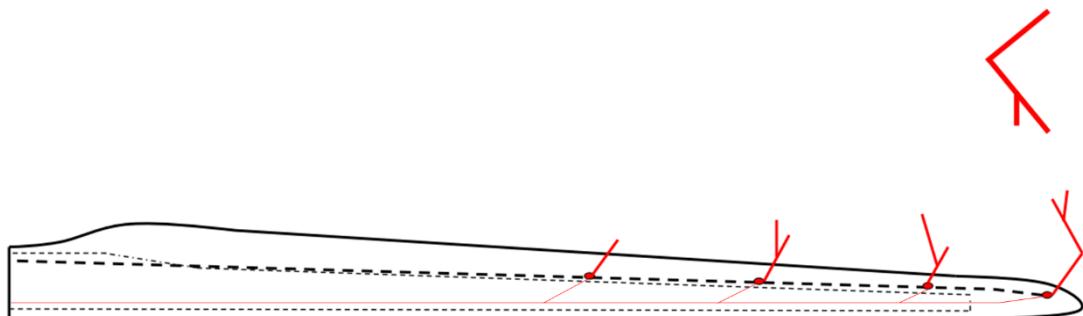
Most blade designs in the past utilized GFRP for the structural blade components. These blades had a common approach to LPS. The GFRP blade's LPS consisted of a number of discrete lightning attachment points, called receptors, and a down conductor inside the blade [80]. The receptors are metallic structures, typically aluminium, which are used to boost the likelihood of lightning strike attachment to a location which will give the least resistive path to ground; see Figure 2.16. Since the GFRP materials are non-conductive, the LPS provides an easy path to ground for the current to flow. If the lightning does not attach to one of the receptors, the current will typically travel on the surface to the receptor causing burning until the current finds the lowest resistive path to ground.

Figure 2.16: Example of LPS with multiple receptors with lightning attachment process [80]

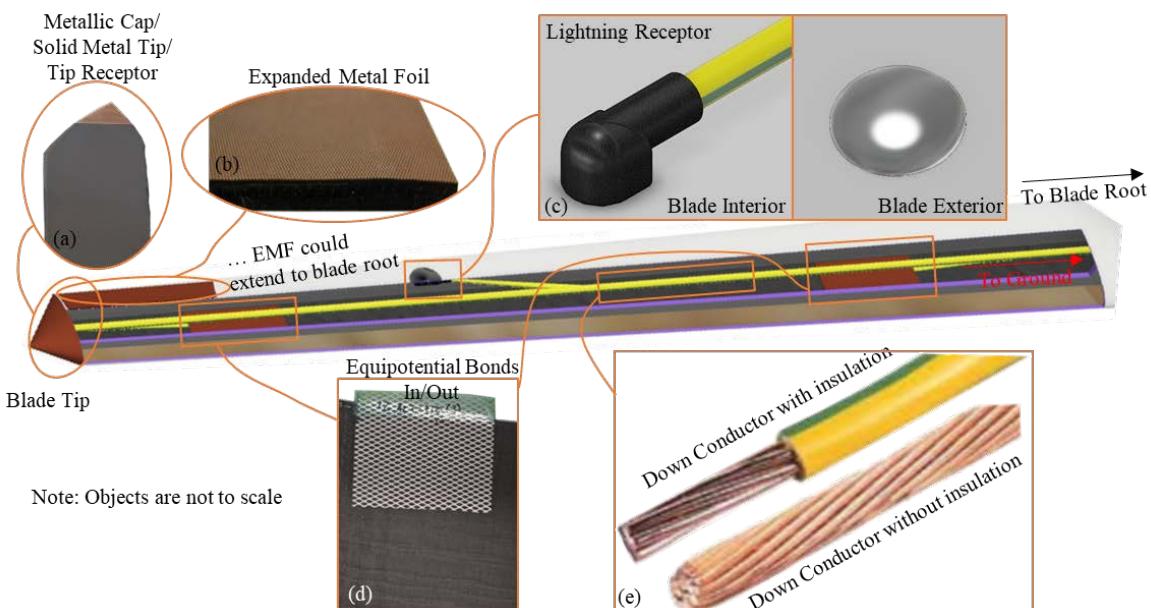
conducts the current to ground and is typically fashion with or without insulation as shown in Figure 2.17 (e). Metallic mesh or Expanded Metal Foil (EMF), Figure 2.17 (b), are optional protection measures and are installed to protect against direct strikes in the area with the highest risk of lightning attachment. Spaced along the blade lightning receptors, shown in Figure 2.17 (c), are typically installed to give the current a direct path from the insulating fibreglass shell to the down conductor. This lightning receptor is typically a circular metallic dome attached through a hole which connects the lightning receptor to the down conductor. The internal component is usually insulated to prevent internal flashover. Many WT manufacturers use equipotential bonds, as shown Figure 2.17 (d), to prevent internal flashover from the down conductor to the CFRP sparcaps. These bonds are typically made of EMF directly attached to the CFRP laminate and spaced so that the electric potential in the blade, developed from the lightning, will not be greater than the electric breakdown strength.

Figure 2.17: Common modern wind turbine blade lightning protection systems with 5 common components: (a) metallic tip receptor [75], (b) expanded metal foil, (c) lightning receptor, (d) equipotential bond, and (e) down conductor with and without insulation

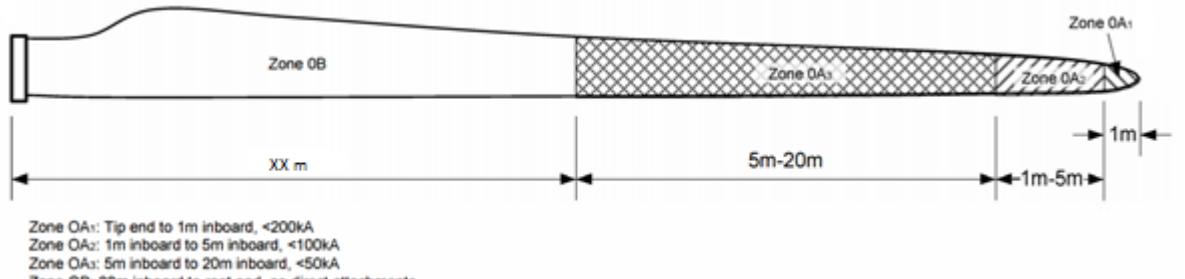
A recent methodology to aid in LPS design for WT blades was developed by Madsen [86] and implemented into the latest IEC standard [48]. A WT blade was partitioned into sections called Lightning Protection Zones (LPZ), as shown in Figure 2.18, according to their risk level based on highest probability of lightning strikes (see Figure 2.6). Their risk level is associated with the likelihood of being hit by a lightning strike as a function of location along the blade length. The

Figure 2.18: Wind turbine blade zoning concept [86]

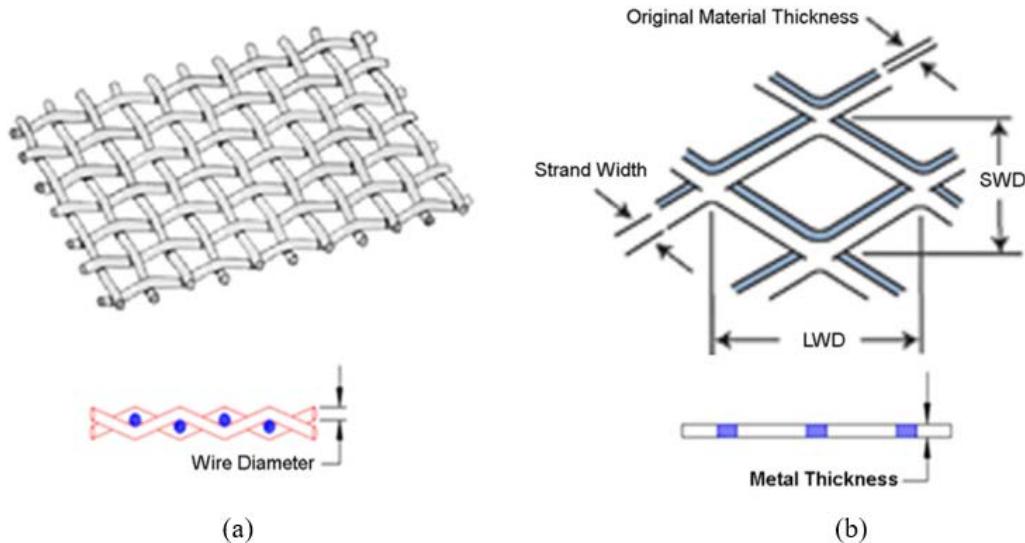
Metallic mesh or EMF is a protective measure applied to CFRP materials to reduce structural damage. Figure 2.19 shows two different metallic mesh structures. The meshes are typically thin flat sheets of metal, usually copper or aluminium, either woven or non-woven, which create an open holed structure [82]. A woven mesh is made from thin wires intertwined together, as shown in Figure 2.19 (a). It is heavier and has higher resistivity at the cross points of the wires. Despite these issues, the Boeing 787 aircraft (all CFRP composite aerostructures design) uses woven mesh to provide protection from lightning strike direct effects [82]. A non-woven mesh, as shown in Figure 2.19 (b), is produced by running metal sheets into a machine that cuts and stretches the metal simultaneously through a pressurized slitting and stretching process. The slits created by a knife allow the metal to be stretched. The process creates a metallic sheet with uniform holes. The finished product has four distinct geometric patterns. The geometric patterns are defined by: the ‘Long Way of the Diamond’ (LWD) - the longest length between links, the ‘Short Way of the Diamond’ (SWD) - the smaller distance between links, the strand width (SW) - the width of the copper strands in the mesh, and the thickness of the mesh. By varying the geometry and thickness of the non-woven mesh, the weight of the mesh can be tailored to the application. Previous research has shown that there is a minimum thickness to ensure the mesh is not vaporized [91].

Figure 2.19: Examples of woven (left) and non-woven (right) metallic mesh from [82]

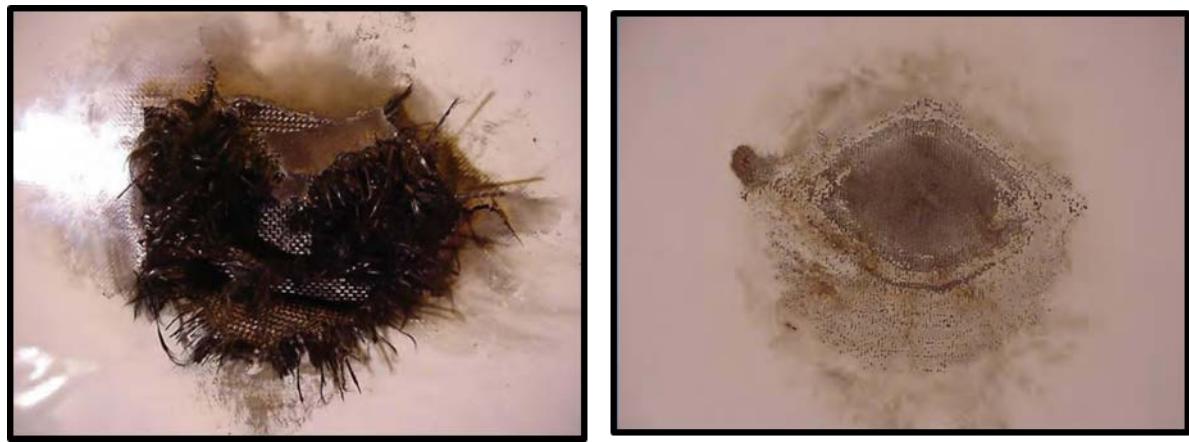
Metal meshes are bonded to CFRP laminates by resin, adhesives, or surface films. The metallic mesh can be bonded to the CFRP laminate in either its pre or post cured condition [85]. This addition adds a conductive path for the lightning to disperse the energy and reduce Joule heating. Figure 2.20 shows the difference in the damage incurred in a lightning strike on a CFRP laminated with and without a metallic mesh. However, adding the metallic mesh to the entire blade is cost and weight prohibitive [82].

Figure 2.20: Lightning damage on unprotected CFRP laminate (left) and CFRP laminate with copper mesh (right) [85]

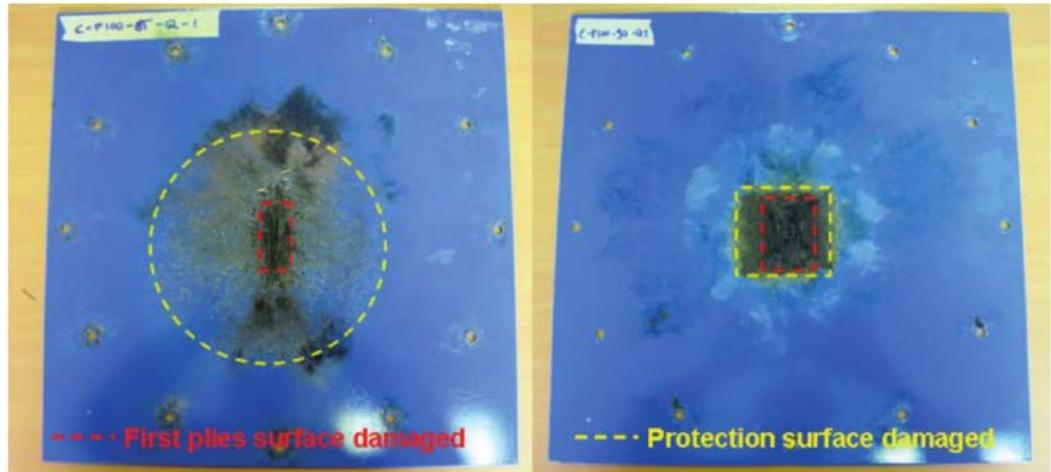
Conductive paints are another option, which are manufactured by adding metal particles to the paint. The paint surface is far less conductive than the molten metal surface and is only achieved by random contacts between neighbouring metal particles [92]. Figure 2.21 shows an example of the significant reduction in damage by applying conductive paint to the surface of a CFRP panel that is struck by lightning [34]. The drawbacks to this method are the lower conductivity compared to e.g. conductive meshes, and the difficulty in obtaining a uniform paint layer thickness, which tampers with the effectiveness of the paint [89].

Figure 2.21: Panel subjected to simulated lightning strikes with (left) having no protection and (right) having conductive paint [34]

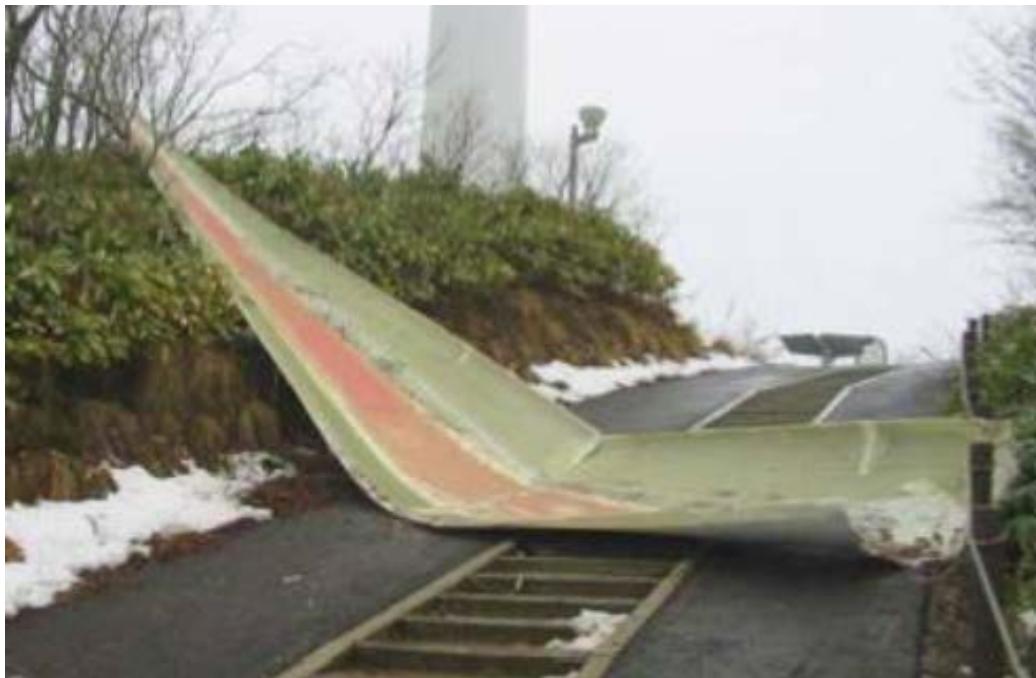
Therefore, it is necessary to protect vulnerable areas at risk to lightning strikes. The effects of lightning strikes on structures have been divided into two different categories: direct effects and indirect effects [83]. Direct effects are the effects of lightning at the location of attachment with the structure and indirect effects deal with damage to electrical system due to oversupply of current to the system from a lightning strike [83]. As discussed previously, CFRP materials have been implemented into WT blades and have the potential to be subjected to $10 \text{ MJ}/\Omega$ of energy from a lightning strike [48]. This can result in serious structural damage up to and including a loss of a blade [75] as shown in Figure 2.22.

Figure 2.22: The remainder of a blade detached from a wind turbine due to lightning damage [75]

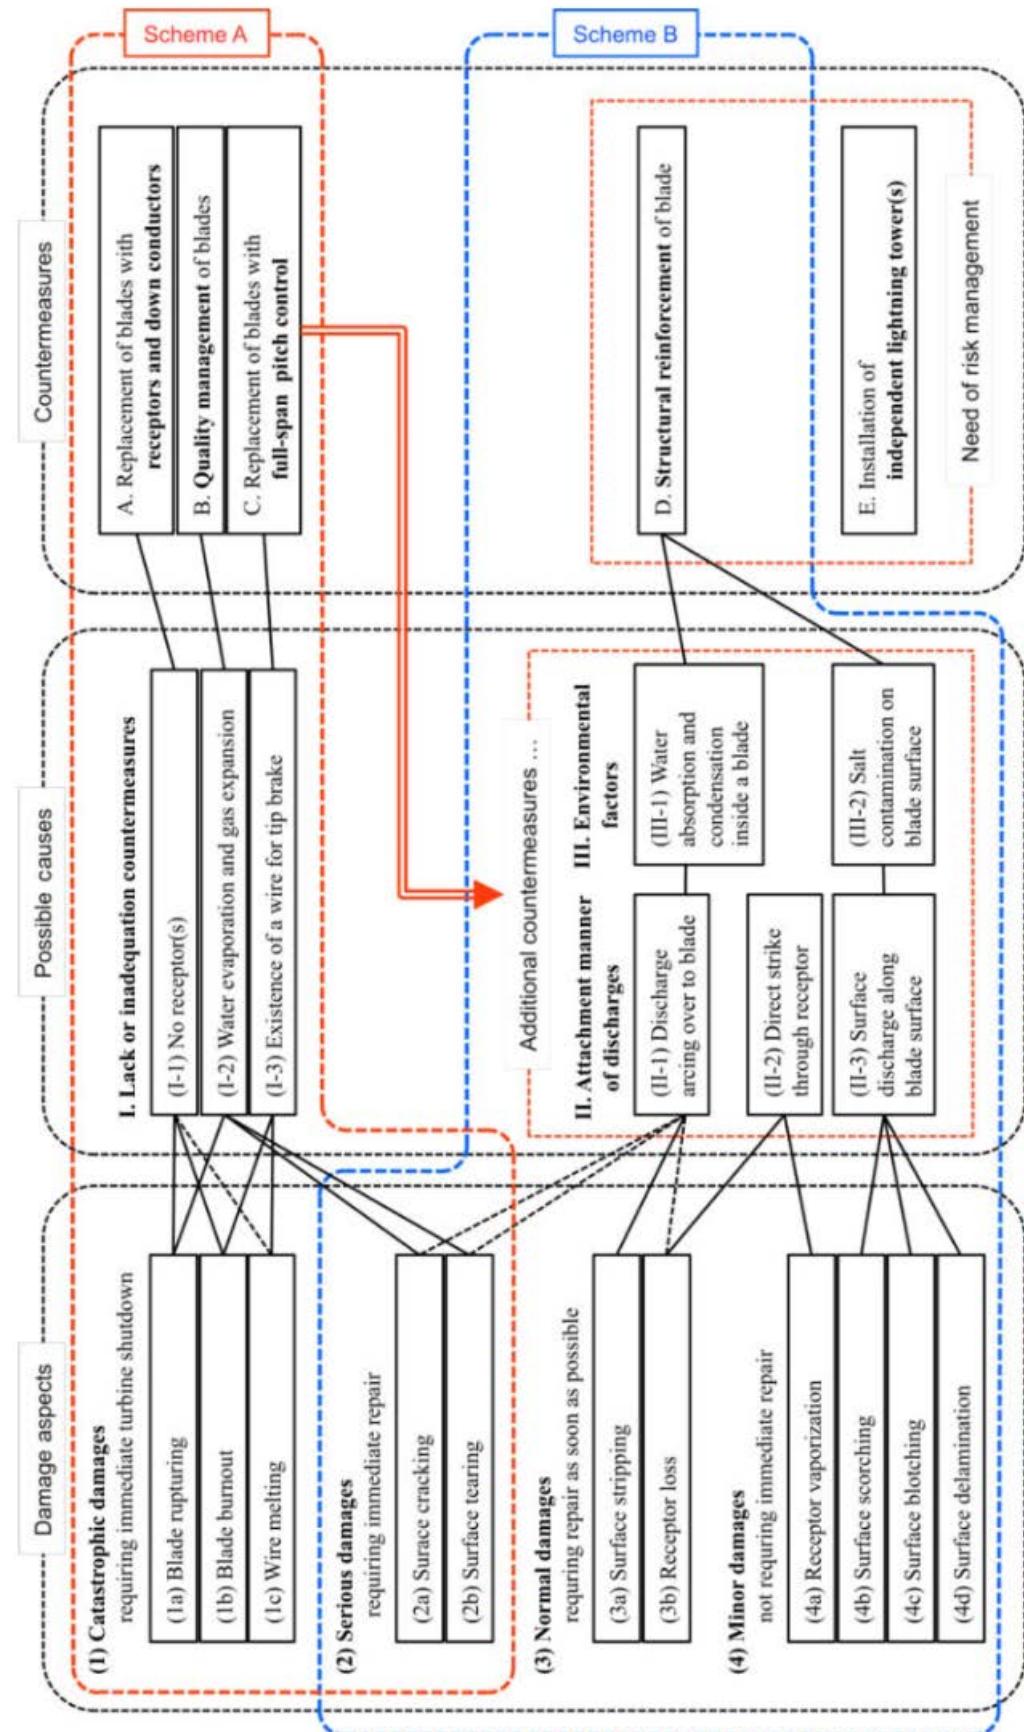
A classification chart, depicted in Figure 2.23, proposes the possible causes of damage to WT blades [93]. This chart categorises serious damage from catastrophic events that shut down WTs to minor events that require no work to fix. Carefully examining this chart shows that damage is mostly related to inadequate lightning protection. The first column is broken down into severity of damage. Following the connected links shows that the most catastrophic damage is associated with lack of lightning protection countermeasures. When there are adequate countermeasures the damage from a lightning strike can be repaired without replacement of an entire blade.

Figure 2.23: Schematic of relationship between damage and countermeasures [93]

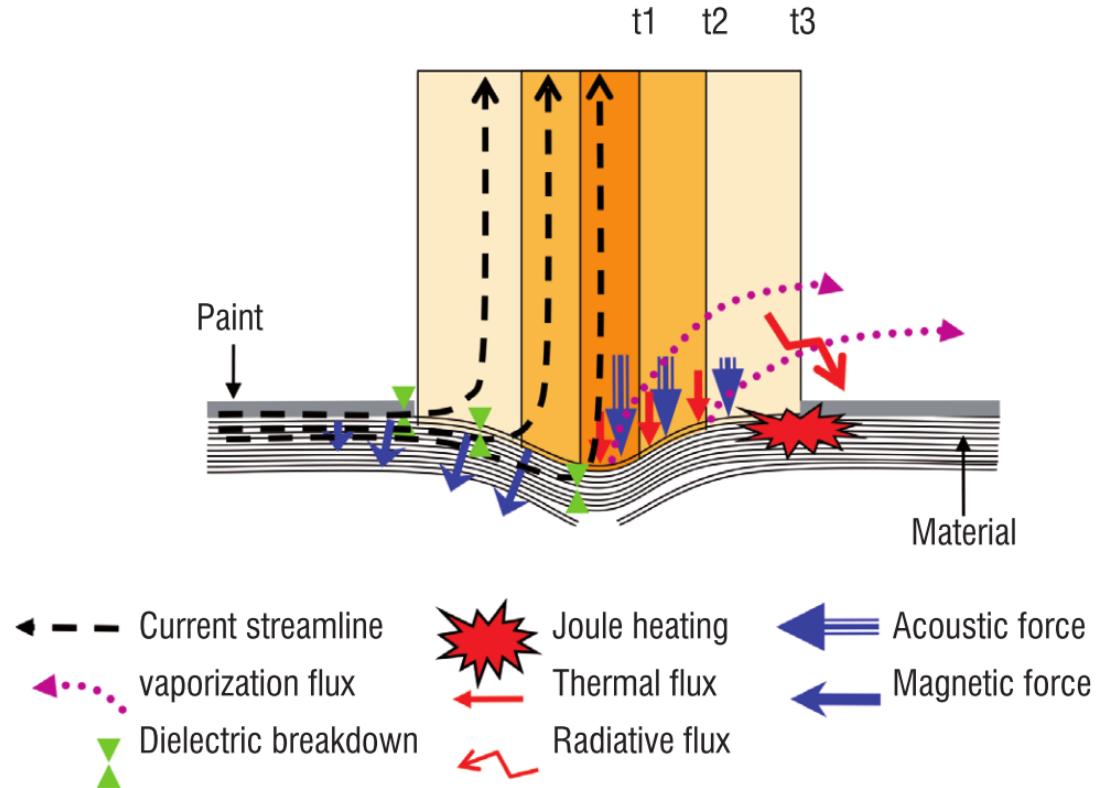
The above direct effects associated with the interaction of lightning on CFRP materials are shown in Figure 2.24. The application of current through the channel is initially small and gradually grows [34], [94] as indicated by the different colour channels in Figure 2.24, which increase with the time increments (t_1 , t_2 , and t_3) and changes the application of current density on the surface. The channel is restricted by the paint, which results in dielectric breakdown [34], [89]. The interaction between the vaporization of the protection and the paint layer must be considered to correctly simulate the expansion of the arc root [34]. The Joule heating effect is associated with heating of the CFRP material by the current and is typically considered to be the cause of melting and resistive temperature rise near and around the attachment point [34], [35], [39], [40], [46], [83], [95], [96]. Radiative flux transfer plays an important role in high temperature arcs and can also be used to determine the temperature rise under the channel [34]. Thermal flux is associated with the conduction of current from the plasma to the structure [34]. The acoustic forces are from overpressure events due to the fast deposit of energy during the ignition stage of the arc [34] that do not always make a significant impact. However if the arc is concentrated by an insulating feature such as paint or insulated surface, then the acoustic forces can increase and become a major contributor to damage [38], [89]. The magnetic force induced by the current circulation also makes a significant contribution to the mechanical constraint in the arc column and in the material [34]. The sparking and arcing at the bonds are typically associated with dielectric breakdown near or around holes. The current travels down the fibres and if the fibres end due to a hole, sparking can occur [83]. This is a large concern for aircrafts as they contain fuel which can combust in the presence of arcing or sparking.

Figure 2.24: Schematic of various loading conditions from a lightning stroke on a CFRP panel at the attachment point [34]

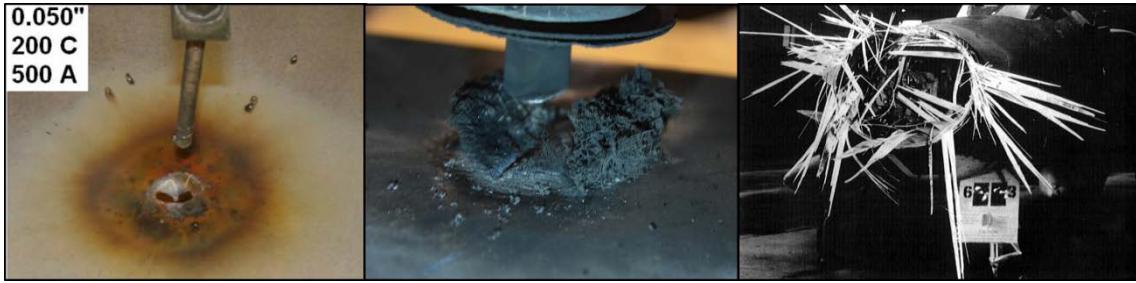
The mechanisms described above result in different degrees of damage severity for different materials. The main variables that effect the severity are the electrical and thermal conductivity of the material. Conductive metallic skins will melt with long duration currents being applied, but the area of damage is primarily concentrated to the attachment point [83]. Materials like CFRP typically have 1000 times lower electrical conductivity in the fibre direction than metals and an additional 1000 times lower electrical conductivity in the transverse direction [83]. Usually damage occurs either at or in the near vicinity of the attachment point, as the arc searches for a conductive path. For materials that are practically non-conductive like GFRP, the lower conductivity will result in the increasing of all five direct effects, listed above, until the current ultimately punctures the GFRP. This can result in catastrophic damage, especially in a pressurized system where GFRP materials struck with lightning can be completely destroyed. Examples of damage are shown in Figure 2.25. The metal material (left Figure 2.25) shows a damage shape nearly circular with melting and charring near the attachment point. The CFRP material (middle Figure 2.25) shows damage fibres being exposed and loss of resin near the attachment point. The GFRP material (right Figure 2.25) shows a completely destroyed radome from an aircraft.

Figure 2.25: Lightning direct effects on aluminium [97] (left), pultruded CFRP (middle), and GFRP [83] (right)
