Thesis: Harrell, T.M. (2019) "Characterisation of lightning strike induced damage in CFRP laminates and components for wind turbine blades", University of Southampton, Faculty of Engineering and Physical Sciences, PhD Thesis.

Characterisation of lightning strike induced damage in
CFRP laminates and components for wind turbine blades

Thesis for the degree of Doctor of Philosophy

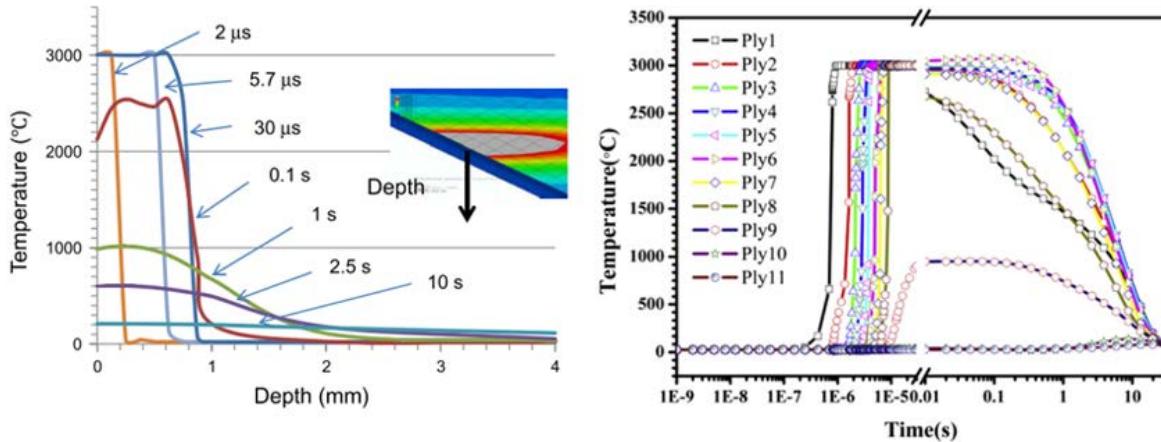
First return strokes are responsible for rapid thermal heating, magnetic and acoustic shock forces, and arcing. For CFRP structures, rapid thermal heating due to high impulse currents induce temperatures in the range of hundreds to thousands of degrees Celsius [98]. Figure 2.26 illustrates the typical temperatures predicted during a lightning strike ply-by-ply alongside the exposure and decay times. This leads to loss of resin due to pyrolysis and fibre loss due to ablation. As mentioned previously the conductivity of the laminate is largest in the longitudinal direction, which leads to heat damage spread disproportionately along the conductive fibre direction as they conduct the electrical current as shown in Figure 2.27. The figures show two ultrasonic inspections with quasi-isotropic laminates damaged by a lightning strike. The damage spreads with the direction of the fibres as shown by the text indicated the ply angles.

Figure 2.26: Example of a temperature profile through the depth of a quasi-isotropic CFRP from (left) Ogasawara [39] and (right) temperature response through time and ply from Dong [98]

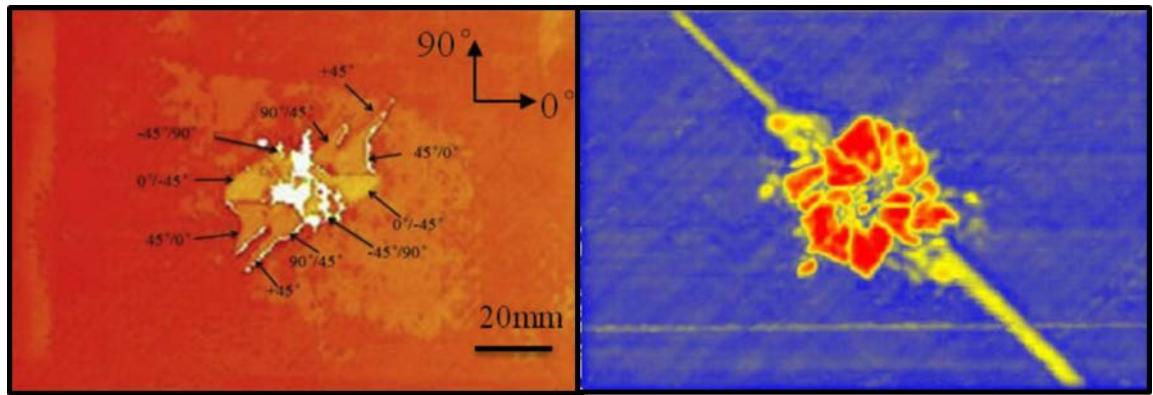
Figure 2.27: Two examples of damage area after lightning strike by ultrasonic C-scan result on quasi-isotropic CFRP samples: (left) 40kA peak current 4/20 μ s waveform damaged laminate [98] and (right) 40kA peak current 2.6/10.5 μ s waveform damaged laminate [99]

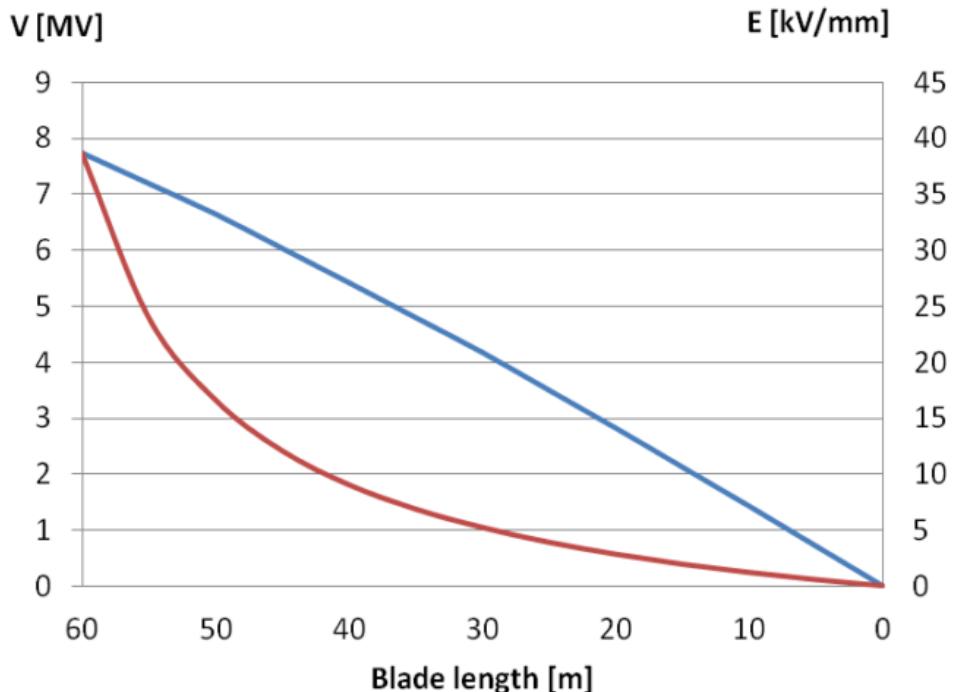
Indirect effects are typically associated with electrical transients in conductive components which can lead to electrical current being sent to sensitive devices. This issue is mainly associated with aircraft, where sensory and other sensitive devices can be affected due to extraneous current. In WT blades, the indirect effects that damage the CFRP structures are associated with induced voltages. An example transient simulation, which shows the voltage difference, can be seen in Figure 2.28. These induced voltages between the down conductor and the CFRP can cause flashovers if not properly managed; this can be seen in Scenario 2 as described in Figure 2.9. The voltages rapidly increase with the length of the blade to reach the breakdown voltage of air/insulating material between the down conductor and CFRP material [100].

Figure 2.28: Maximum voltage difference from simulation of negative first return stroke between a lightning conductor (blue) and average electric field (red) [80]

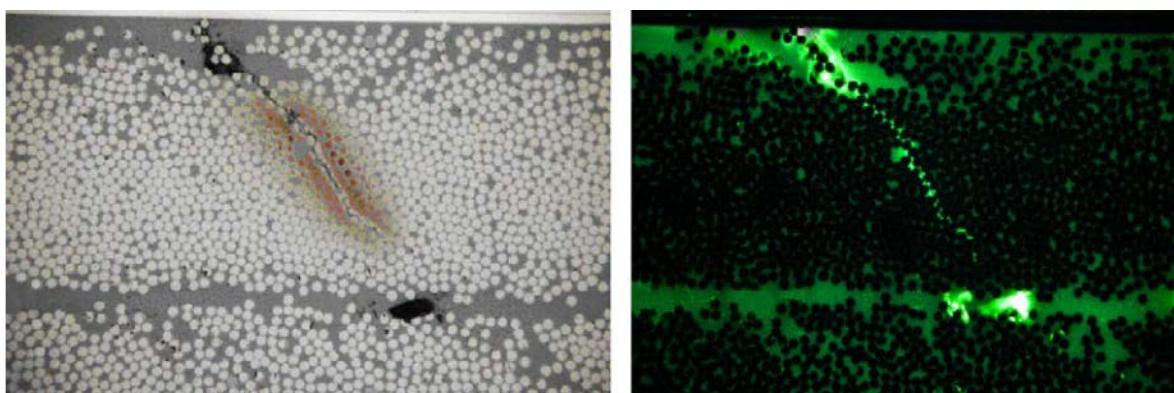
Researchers have used simulated lightning strikes in a laboratory setting to understand the damage observed on CFRP materials. These experimental methodologies were initially used to inspect metal damages on aircraft [101]. Figure 2.29 shows one of the first published reports on CFRP materials by Feraboli [35]. The direct effects on CFRP materials from a 10/25 μ s lightning waveform was examined through microscopy and UV dye penetrant [35]. The results indicate that there is a potential for cracking and burning near and around the attachment point. However, the lightning waveform currents applied to the samples were less than the design lightning waveform from the IEC standard or SAE standard. The specimens were also quasi-isotropic leading to a more isotropic electrical conductivity and thermal conductivity in terms of the laminate.

Figure 2.29: Micrograph of CFRP damage from a lightning strike near the attachment point where (left) is an inspection of cross-section under a brightfield illuminate under a microscope and (right) is an inspection of the cross-section under UV illumination and dye penetrant [35]

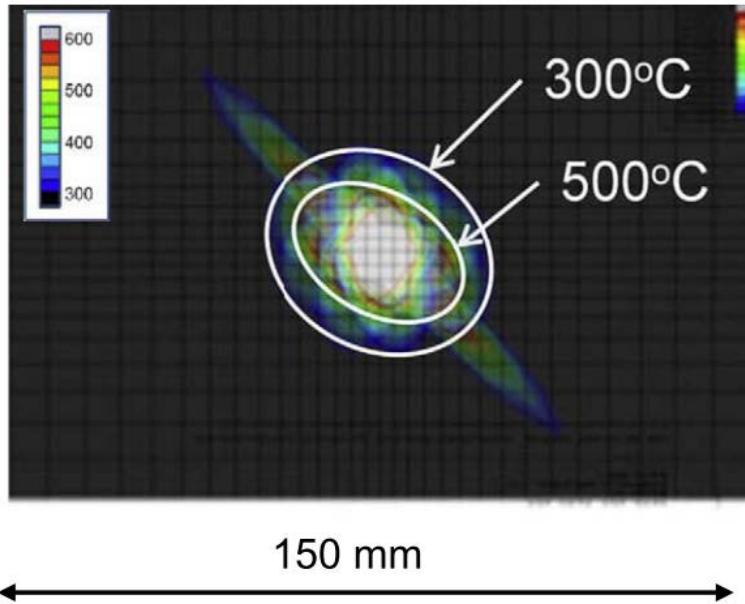
Typically, heating effects are modelled by adopting a Joule heating modelling framework, which essentially constitutes a coupled thermal-electrical model formulation used to predict the rise in temperature due to an applied electric current. Ogasawara [39] used a coupled thermo-electric finite element model to simulate the heat response of a CFRP material during a lightning strike and used the heat response to calculate damage through a pyrolysis equation. The damaged area, as shown in Figure 2.30, was estimated using temperature profiles from the results of the coupled thermo-electric mode. The predicted damage obtained from the FEM is observed to be under the attachment point. The laminate is quasi-isotropic which shows the spreading of the heat in the direction of the fibres and a predominate damage area are seen from elements which were exposed to heat above the degradation temperature 500°C .

Figure 2.30: Estimation of damaged area from superposed contour curves obtained by finite element analysis [39]

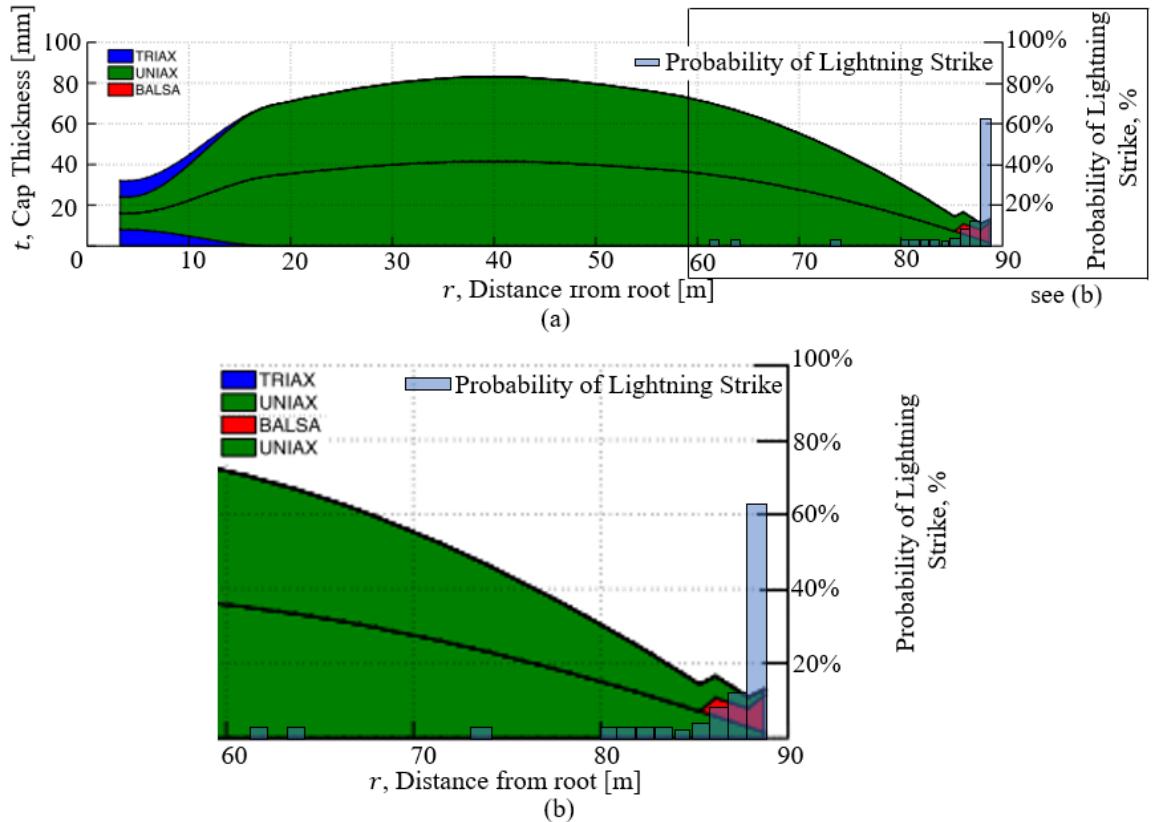
Figure 2.31: (a) Radial variation of sparcap thickness of the DTU wind turbine blade [115] plotted with lightning strike probability [74] along the whole length of the blade and (b) being the same as (a) but for the region of interest near the blade tip.

The damage modelling approaches described in the previous section are useful in understanding the potential extent of the lightning damage in a composite structure, but they do not provide any insight into the effect of the lightning strike on the structural performance. The most important aspect from an engineering point of view is to understand the impact of such damage on the structural response of the CFRP component/structure. To provide insight into how the loading condition, material, component thicknesses, and the risk of lightning damage, impact on the structural response recourse is made in two studies [74], [115]. A reference 88 meter WT blade with a rated power output of 10 MW designed by the Technical University of Denmark (DTU) is selected to examine the typical loading and material thicknesses used in a blade [115]. The probability of a direct lightning strike (Scenario 1; Figure 2.9) is used to determine the risk of a lightning strike along the blade length [74]. Figure 2.31 shows the material thicknesses and probability of a lightning strike on one plot along the blade length. Figure 2.31 (a) shows that the

blade is mostly made of UD plies (shown as UNIAX) along the blade lengths. The probability of lightning strike is shown as a histogram of the total number of lightning strikes along the length of a typical WT blade. Since most of the lightning strike happen at or near the blade tip, Figure 2.31 (b) shows a condensed version of the plot 30 m from the blade tip. Using this figure, a region of interest can be defined by where the cumulative lightning strike probability will be less than 5%, which is 10-20 meters from the blade tip as shown in Figure 2.31.

The region of interest defined using Figure 2.31 identifies a section of the blade that is typically made with fully UD laminates with relatively small thicknesses (>5 mm). The primary reason for the use of UD plies at this location is to carry tension and compression loads generated in the sparcaps due to the bending moments induced by the aerodynamic loading in flapwise bending (see Figure 1.5 (b)). Tension failure for a UD laminate being loaded in the fibre direction is defined by fibre fracture. This is not a likely scenario in a WT blade, but a direct attachment of a lightning strike may change the mechanical properties including the strength in tension. The key parameters to define failure for tension is the longitudinal direction (direction-1) strength, X_T , and the transverse direction (direction-2) strength, Y_T . These strengths may change due to lightning strike damage, but usually not by a significant amount because they are fibre dominated properties. The fibres are resistant to damage caused by Joule heating process because they have a much higher melting point (3000°C) when compared to the resin ($300\text{--}500^\circ\text{C}$) [116]. Feraboli [35] performed

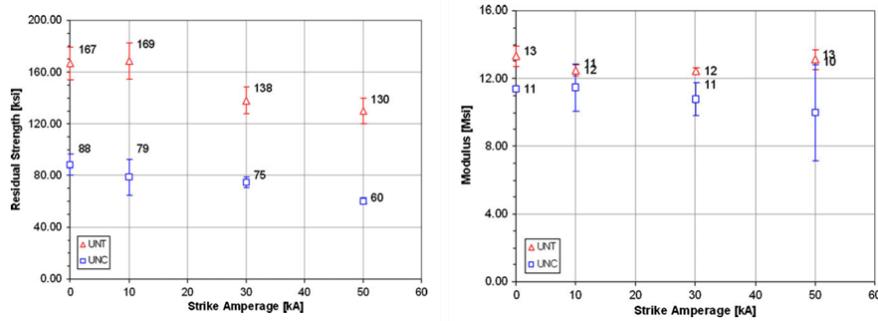
Figure 2.32: Residual tension/compression strength (left) and modulus (right) as a function of peak current [35]

both tensile and compressive tests on coupons damaged with simulated arc entry lightning testing, as shown in Figure 2.32. The results confirmed that the tensile strength is less severely affected than compressive strength. For a 50 kA lightning strike, the damage CFRP sample had reduced tensile strength properties by 22% and compression strength by 31% when compared to an undamaged sample. In the same work, the tensile and compressive stiffnesses showed little change on average from the undamaged samples but did show large variability at the higher current levels especially for compression; see Figure 2.32 (right). Heidlebaugh [117] similarly presented test results for uniaxial tension and compression tests conducted on coupon specimens. These results showed a similar trend with compression being more sensitive to decreases in strength when damage was induced. Feraboli [35] and Heidlebaugh [117] did not address the full lightning waveform, and applied the current on small width coupons that concentrated the arc.

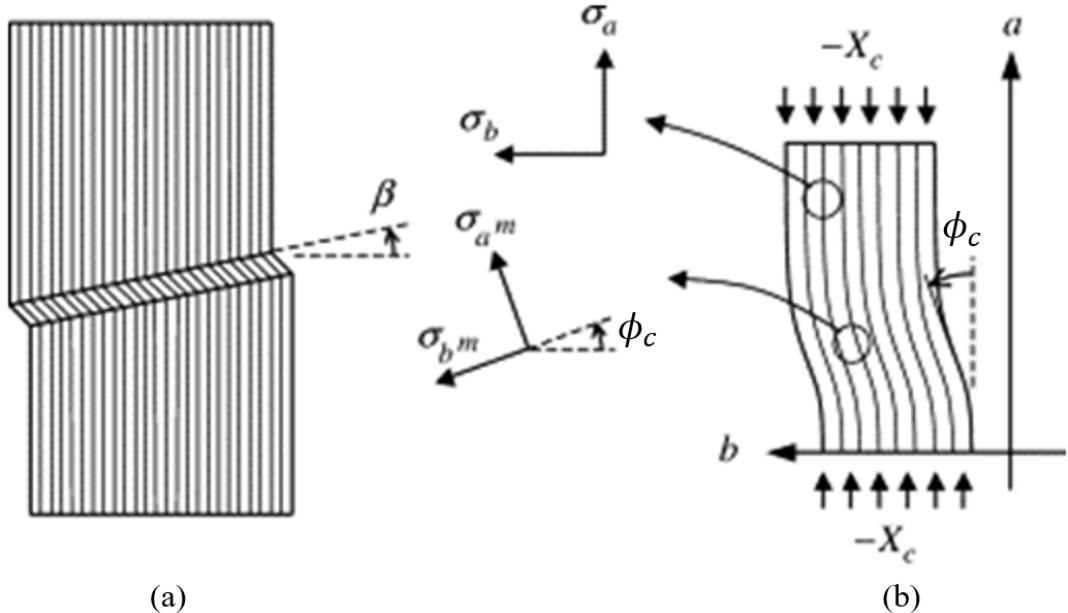
Figure 2.33: CFRP compression (a) fibre kink band failure mode with the compressive (b) misalignment frame [119]

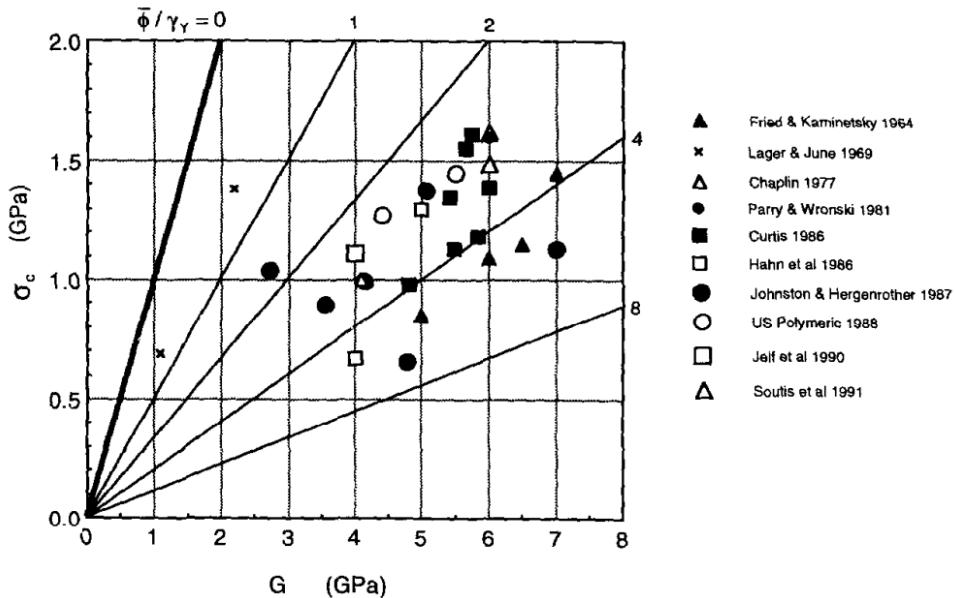
Figure 2.34: Elastic-ideally plastic predictions, compressive strength σ_c vs shear modulus G [118]

The effects of changing the shear modulus and the fibre misalignment has a large effect on the critical stress [118]. Examples of the critical stress due to microbuckling with different parameters are shown in Figure 2.34 [118]. This chart indicates the reduction in shear modulus results in a lower critical stress causing fibre kinking. As mentioned in section 2.5, resin melting (or evaporating) from elevated temperature due to Joule heating is the primary cause of damage in CFRP materials. Losing resin has a large effect on the compressive capability [116].

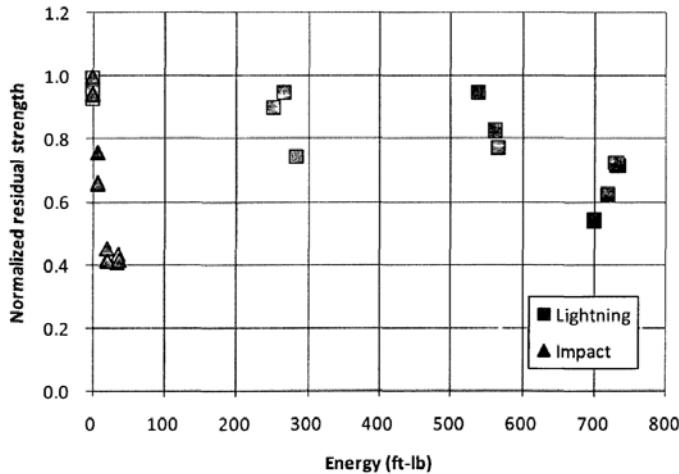
Figure 2.35: Comparison of normalized residual strength of CAI tests subjected to impact damage and lightning damage [122]

There is very little research published on the post lightning strike damage strength of CFRP materials and components. Kawakami [122] used compression after impact (CAI), as defined by ASTM D7136/D7137 [123], tests to compare different types of lightning damage because CAI tests are widely used for testing of aircraft structural composite materials. They are considered to be one of the most critical tests for certifying composite materials for aircraft structures [124]. Figure 2.35 shows the results from the test. They were conducted by subjecting small (140 mm by 140 mm) CFRP test specimens (effectively coupon level tests) to impact loading inflicted by a standardized blunt object to create impact damage labelled as 'Impact' in Figure 2.35 and compared to lightning damage impact labelled 'Lightning' in Figure 2.35. The panels were then fitted into a CAI panel compression rig that restricted the buckling modes, which ensured that only compressive load was applied. The load was taken to material failure and the results were compared. The tests showed that for the residual strength to decrease the lightning events typically had an order of magnitude higher energy level [122]. This result shows that impact and lightning damage have completely different responses to the induced damage. Although the energy levels were an order of magnitude different, the energy levels tested for the lightning cases were for typical lightning strike events and the residual strength was reduced by more than 40% [122].

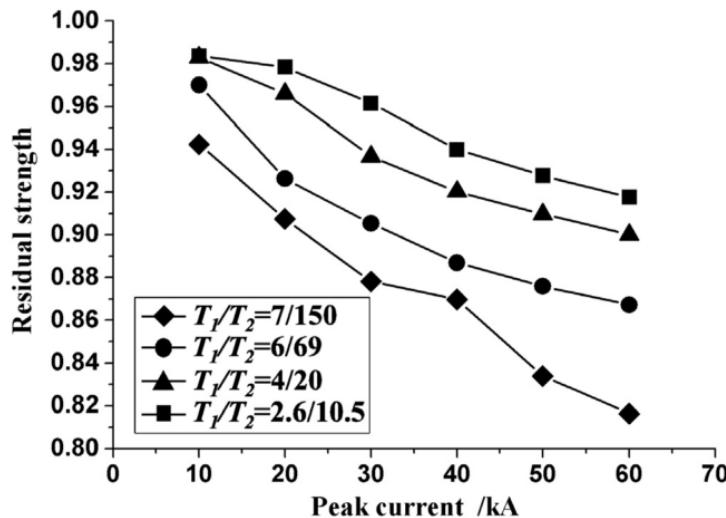
Figure 2.36: Prediction of residual strength on CFRP laminate subjected to different waveforms [125]

Wang [125] modelled lightning damage through a Joule heating model and subsequently modelled residual strength through a structural model. The lightning model used an ablation mechanism in areas of high heat flux to model the removal of carbon fibre to determine fibre damage. The ablative damaged regions were characterized as fully damaged (100%) with the regions damaged by pyrolysis range from 0% to 100% damage. Based on the estimated damaged areas, residual strength predictions were obtained using a FEM with fully damaged elements deleted and partially damaged elements assigned a percentage of their stiffness or strength properties based on the pyrolysis predictions. The residual strength structural FE model used the Hashin criteria to modify the element until the laminate's ultimate failure load was reached. The results of Wang's were for tensile case (not as critical). The predictive models showed that all strengths were above 80% of the undamaged (pristine) strength of the composite. This model is a first step into the structural response, however, the more critical case is to understand the response in compression.

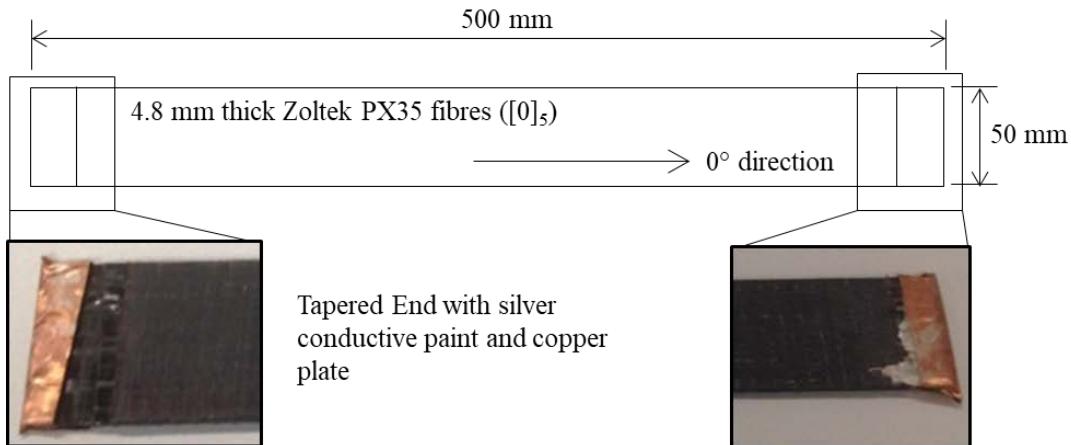
Figure 3.1: CFRP strip specimen with dimensions and plating used in simulated lightning strike experiment

Eight CFRP unidirectional (UD) five ply laminate specimens were manufactured using the carbon/epoxy material system PX-35 from Zoltek. The eight laminates were manufactured using vacuum liquid resin infusion producing CFRP laminate strips with dimensions of 500 mm long x

50 mm wide x 4.5 mm thick. The specimens were chamfered at the ends with an approximate 1:4 taper to expose the carbon fibres and provide a connection point. Silver conductive paint and copper plate were added to the tapered sections to aid in conducting the electric current to the exposed fibres. Figure 3.1 shows an example of the manufactured CFRP strips.

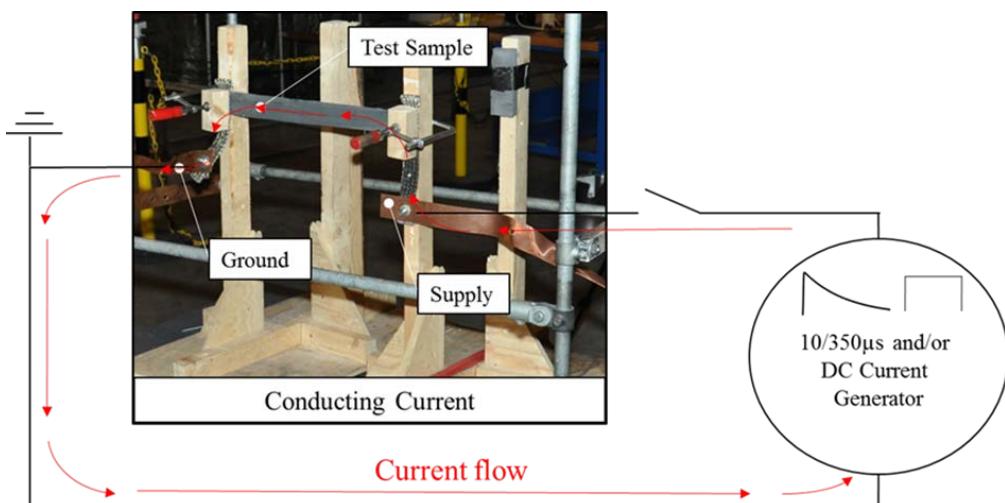
Figure 3.2: Electrical circuit describing the current introduction into the CFRP sample through conducted current superimposed on an image of the experimental setup

The CFRP strip specimens were subjected to electrical current with three different waveforms. The first waveform examined was a unipolar 10/350 μ s waveform simulating the first return stroke during a direct strike according to IEC 61400-24 Ed1.0 [47]. The second was a unipolar long stroke component (or DC) also defined by the IEC standards. The third waveform was a combination of the 10/350 μ s and DC waveforms. All of the current components were tested using the conducted current test method provided in Annex D3.4 of IEC 61400-24 Ed1.0 [47]. An example of the test setup and the current path during the testing is shown in Figure 3.2.

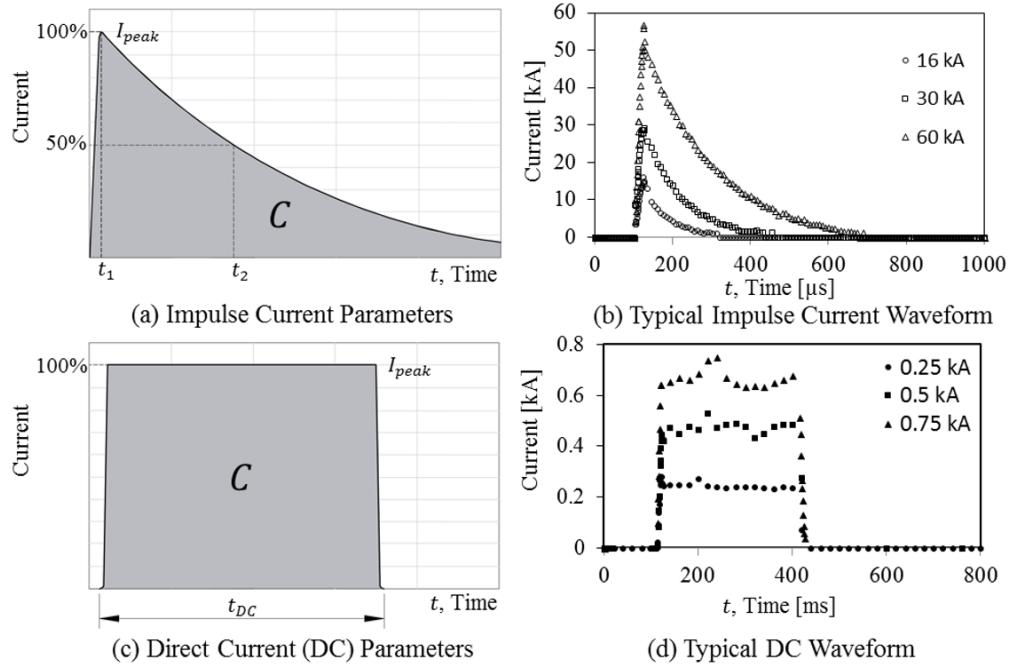
Figure 3.3: Lightning strike waveform with parameters for (a-b) impulse waveform characterization, and (c-d) DC waveform characterization

The initial stroke waveform was an impulse which is defined by three characteristic parameters; the peak current value (I_{peak}), the rise time to reach the peak current (t_1), and the time at which the current decays to half of the peak current (t_2), also known as the half time. The DC current is defined by the peak current value (I_{peak}), and the duration (t_{DC}), and these parameters are shown in Figure 3.3. The charge, Q , and the specific energy or action integral, AI , are used to compare different waveforms and are calculated from the beginning of the waveform or 0 to the final time at the end of the waveform or t_f as follows:

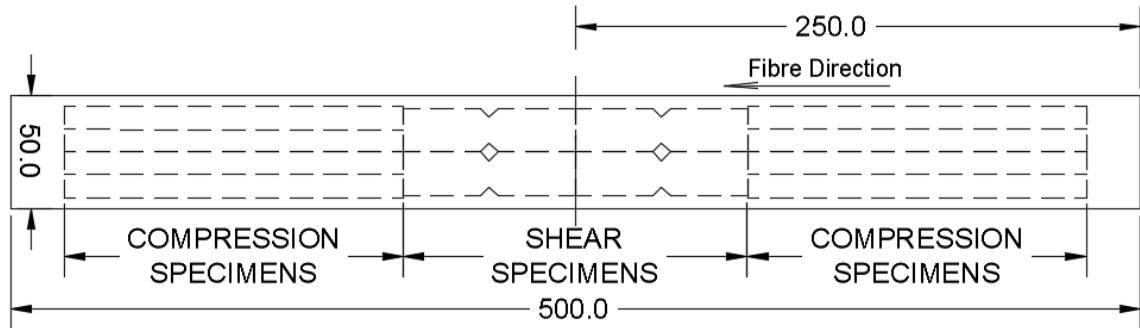
Figure 3.4: Waterjet cutting scheme for CFRP compression and shear test specimens

Compression and shear tests were conducted according to ASTM D6641 [126] (compression) and ASTM standard D5379 [127] (Iosipescu V-notch test), respectively. The coupon specimens were manufactured by waterjet cutting from the vacuum infused CFRP strips. The layout of the test specimen waterjet cutting scheme is shown in Figure 3.4.

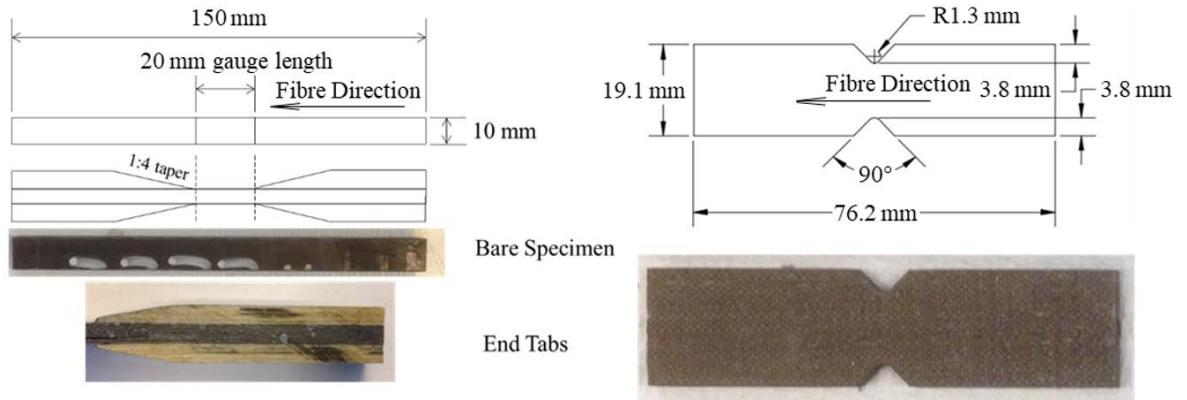
Figure 3.5: Compression specimen dimensions and image of a typical sample (b) shear specimen dimensions and image of a typical sample

The compression test specimens were 10 mm wide x 150 mm long and were mounted with end tabs made of S-glass with a 1:4 tapered section. The end tabs were bonded to the specimens using Araldite 4858. An example of the compression sample is shown in Figure 3.5 (a). The compression tests were conducted using an Instron 100 kN servo-hydraulic test machine with a loading rate of 0.2 mm/min in accordance with ASTM D6641 [126].

An example of the Iosipescu V-notch shear test specimens is shown in Figure 3.5 (b). The shear tests were conducted using an Instron 50 kN electro-mechanical test machine with a loading rate of 0.5 mm/min in accordance with ASTM standard D5379 [127].

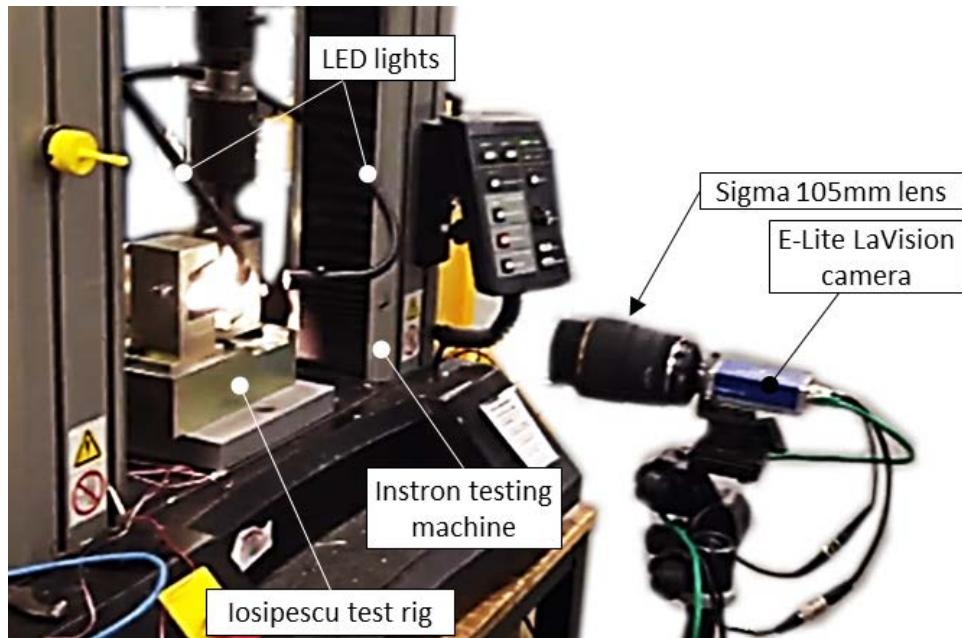
Figure 3.6: Experimental setup for Iosipescu tests

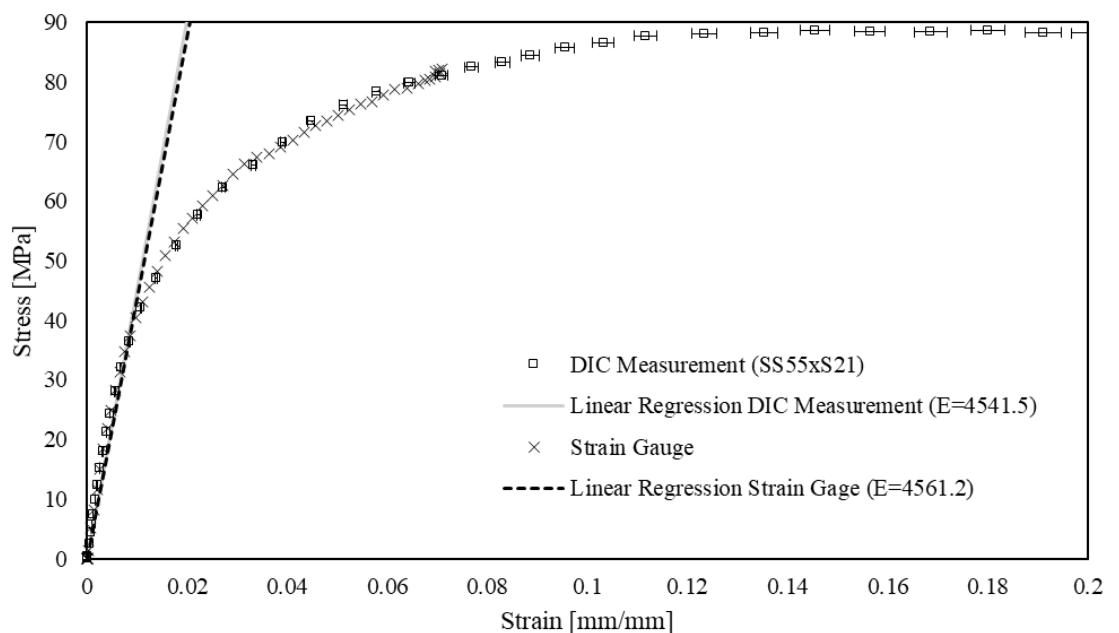
Figure 3.7: Sample stress-strain curve obtained for Iosipescu test - Strain gauge and DIC measurement data

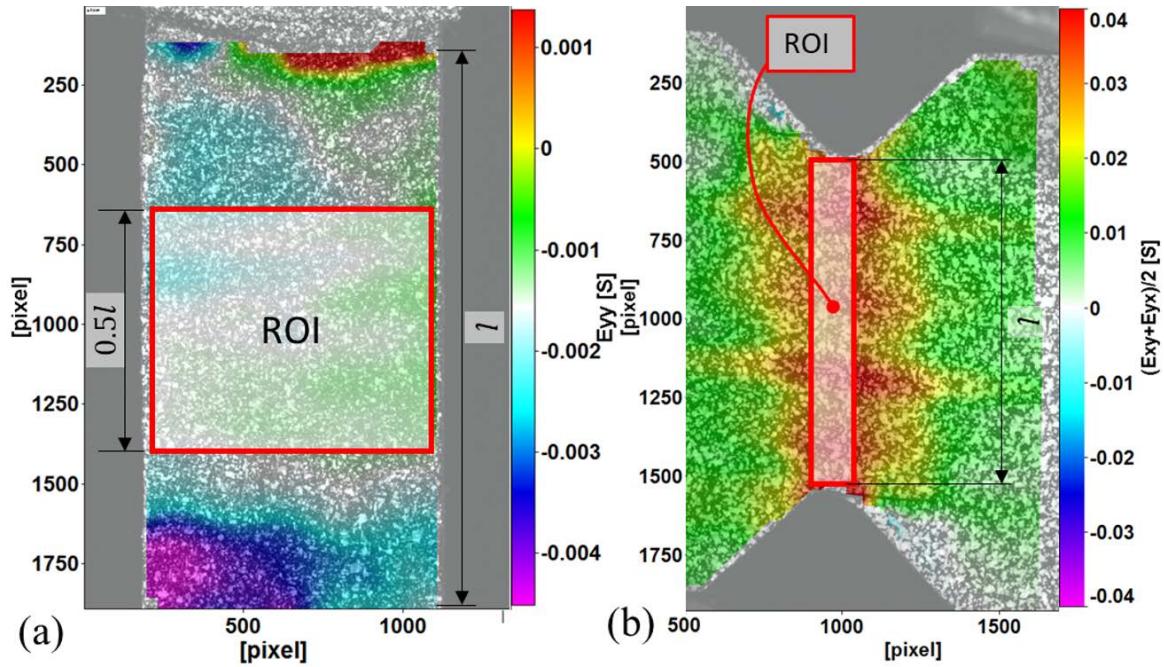
Figure 3.8: Example of DIC ROIs: (a) compression specimen, and (b) shear V-notch specimen with an overlay of the ROI area used to calculate the average compression and shear strains

For the DIC measurements, a Region of Interest (ROI) was defined in the gauge sections of the specimens as shown in Figure 3.8. The DIC data was post-processed by taking the mean of the

strains measured over the ROI. For the compression tests, the strains were averaged over 50% of the gauge section length. This was done for the ROI to avoid stress concentration due to load introduction from the end tabs. For the shear specimens, the strains were averaged over the whole gauge section was used for the ROI as proposed by [129], [130]. The averaged strains measured over the ROI zones were referenced against the average (or nominal) stresses in the gauge zone defined by the force measured by the load cell divided by the gauge zone cross section areas.

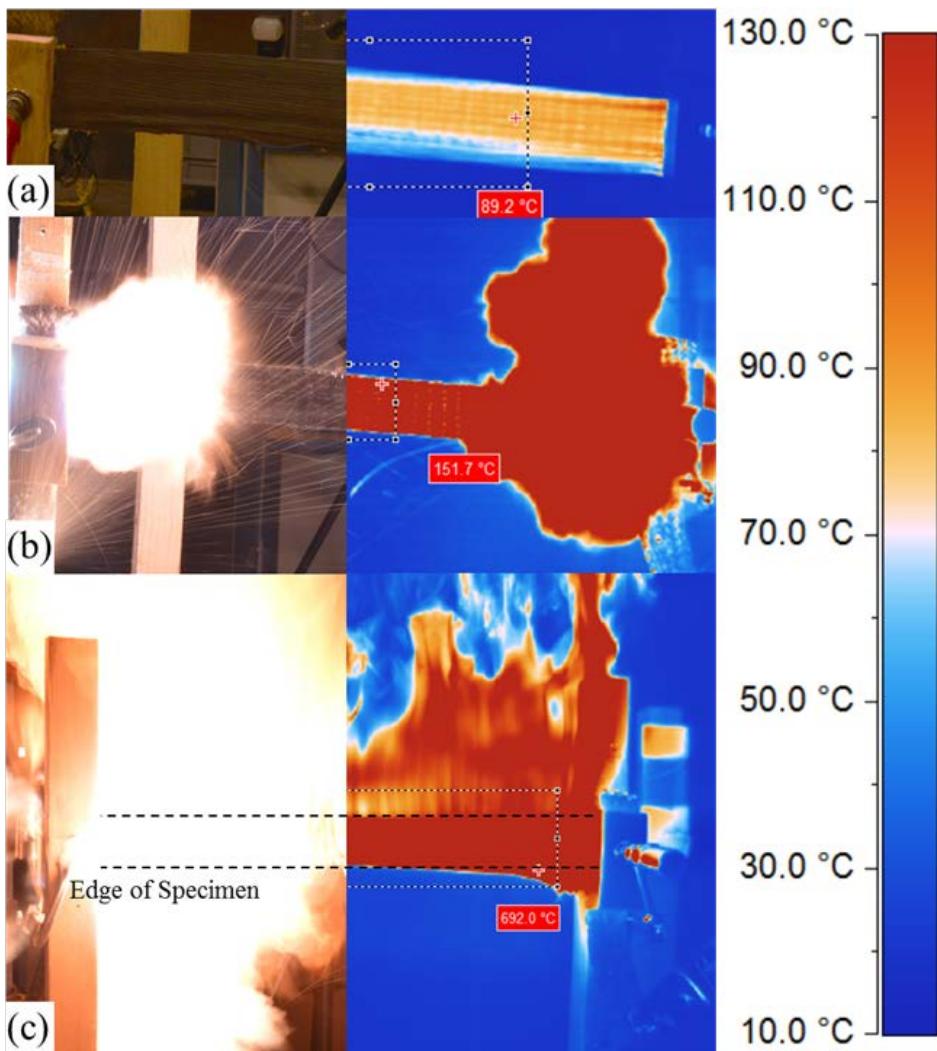
Figure 3.9: Selected photos and thermal images from: (a) DC tests, (b) Impulse test, and (c) Impulse+DC test

The temperature evolution during the DC, Impulse, and Impulse+DC tests were similar, as shown by images captured by the infrared camera in Figure 3.9, where the temperature increase distributed evenly throughout the samples. The largest increase in temperature corresponded to the largest specific energy used in the lightning tests. The DC tests yielded very little audible acoustic response and led to little or no visual indication of damage of the specimens. In contrast, the Impulse and Impulse+DC tests were much louder and rapid events with bright flames emitting from the current injection points that dissipated within a few seconds.

The images shown in Figure 3.9 were captured using a Nikon digital SLR camera and a PYROVIEW 640L infrared camera. Figure 3.9 splices white light images (Nikon) on the left with the thermal images (PYROVIEW) on the right. The white light images had an exposure time of 5 seconds that allowed the accumulation of light intensity to be captured throughout the tests. The thermal images were taken from the image frame immediately after the lightning strike test or where the maximum heating of the specimens occurred.

During the DC tests there were no visual indications of suspected damage in the white light images captured and as shown on the right in Figure 3.9 (a) the infrared image displays a uniform increase in temperature. The Impulse tests also showed no visual indication of damage despite the appearance of sparks and flames as described above. In Figure 3.9 (b), the white light image on the left does show flames and sparks, but these are products of air ignition between the metallic contact point and the CFRP testing material, as the combustion temperature of the CFRP was not reached. This is confirmed in the thermal images captured after the dissipation of the flames. These show a uniform temperature increase in the sample both where the flames appeared at the contact points, as well as in the middle where no flames appeared. The Impulse+DC tests displayed more extensive visual indication of damage, with flames engulfing the sample and lasting several seconds longer than end of the current supplied to the sample; see Figure 3.9 (c). In these tests, the combustion point of the specimens was reached, igniting the epoxy matrix. Although all samples showed increases in temperature only one sample, Impulse+DC, showed visible signs of damage.

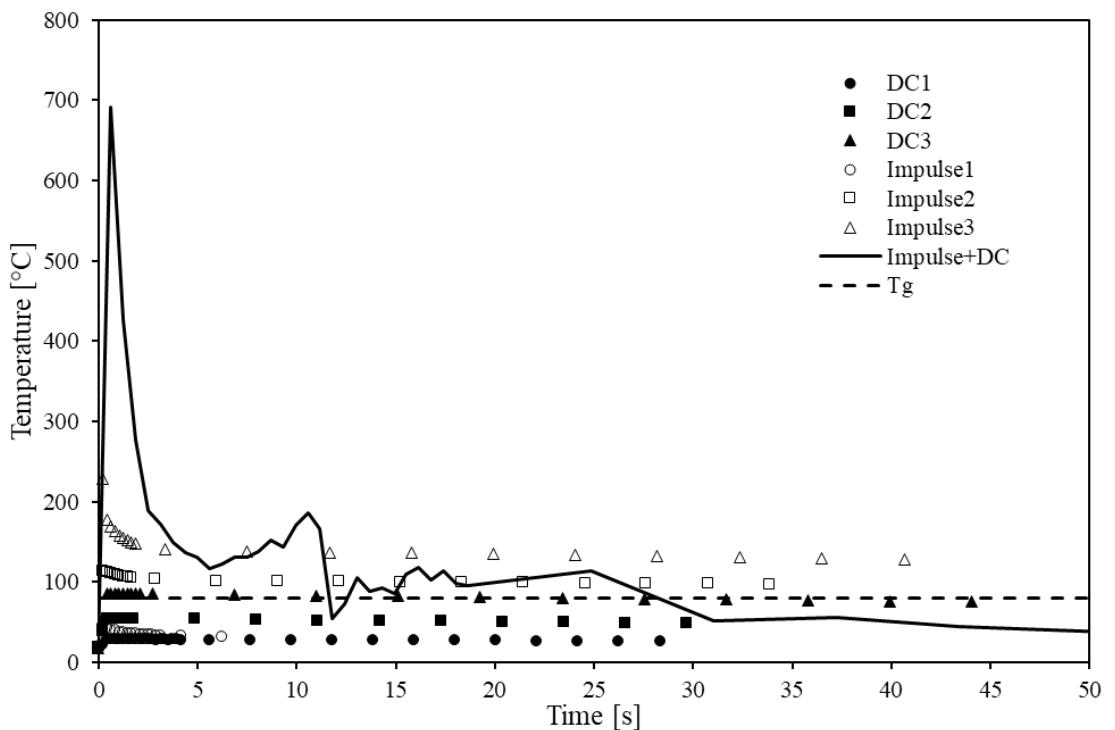
Figure 3.10: Average temperature measured at the centre of the specimens during lightning strike tests

The thermal data was recorded to find the maximum temperature during the lightning strike tests. The temperature data recorded at the centre of the specimens is shown in Figure 3.10. The thermal data results show that the maximum temperature always occurred after all the current was injected. This data can determine which CFRP specimens went above the glass transition temperature of 79°C for the resin system tested, and how long the specimens were above the glass transition temperature. The DC2-3, Impulse2-3 and Impulse+DC specimens all reached temperatures above the glass transition temperature for extended periods of time. Impulse+DC reached a temperature, which caused ignition of the sample and caused the sample to burn during the test. The second apparent peak of the Impulse+DC at 11s is due to flames that extinguished in the frame of the measurement.

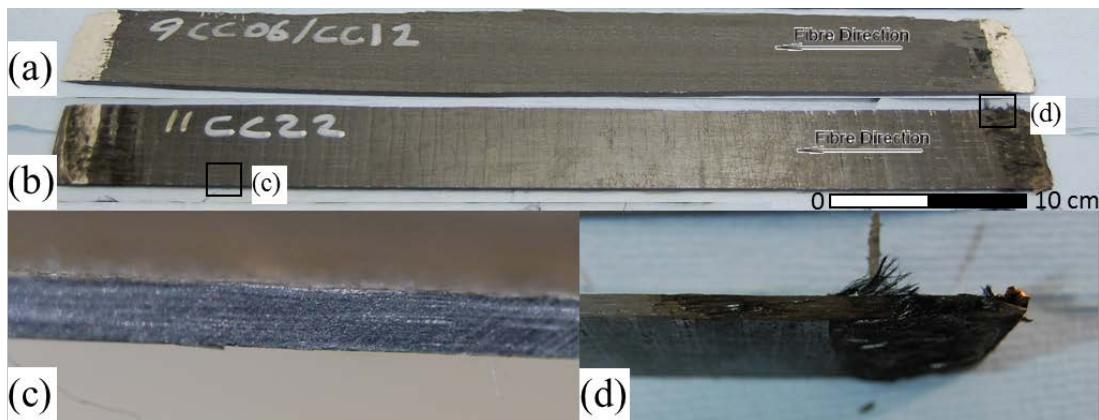
Figure 3.11: DC (a) and Impulse (b) post lightning strike damaged specimens with selected cross section images showing (c) typical non-damaged cross section observed for all DC and Impulse specimens (the image shows specimen Impulse3) and (d) damage cross-section c

The damaged specimens were inspected visually to assess the damage inflicted to the CFRP materials. The focus of the inspection was to identify fibre, resin, and delamination damage apparent on the surface. The visual inspection was conducted by eye both with and without a 10x magnification optical loupe to allow for a more detailed assessment of the surface. On the DC and Impulse specimens damage was concentrated near the connection points. For the DC and Impulse specimens, the only visible damage found was underneath the connection points, with the likely cause being the transfer from metallic connection to the CFRP, and on specimen Impulse3 within a distance of 2 cm from the connection point. Selected images from the DC3 and Impulse3

specimens are shown in Figure 3.11. In the areas where the coupons were cut out, see Figure 3.11 (a) and (b), the material showed no visual signs of damage. Further, Figure 3.11 (c) shows what a typical cross section looks like for all the Impulse and DC samples. This typical cross section has no signs of damage, and there are no visible bulges on the top surface to suggest internal delamination damage. Figure 3.11 (d) the image shows damaged fibres, loss of resin, and glass fibre stitching from the dry fabric pulled away from the specimen. However, the damaged area near the connection point is not used in the coupon tests.

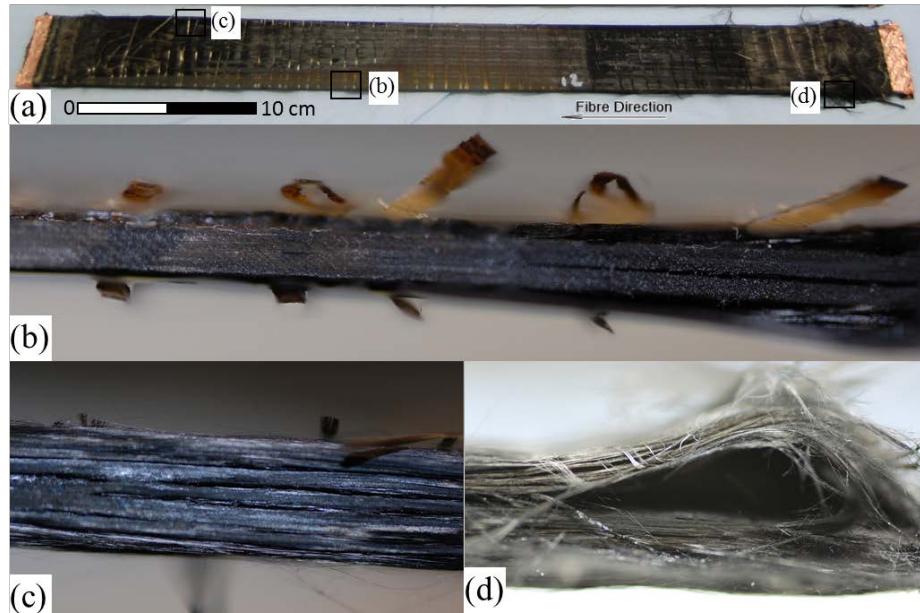
The Impulse+DC specimen shown in Figure 3.12 displays extensive damage. Both the top and bottom surfaces show resin damage from the flames burning the laminate, as indicated in Figure 3.12 (a). Almost all the cross section has exposed fibres and stitching as shown in Figure 3.12 (b). The resin in between the layers has burnt away which can be seen from the outer surface of the cross section, see Figure 3.12 (c). Figure 3.12 (d) and clearly shows delaminated plies.

Figure 3.12: Impulse+DC: (a) post lightning strike damage specimens with selected cross section images showing typical damage cross section with (b) glass fibre stitching pulled away from the laminate, (c) typical damaged cross-section, and (d) most severely damaged

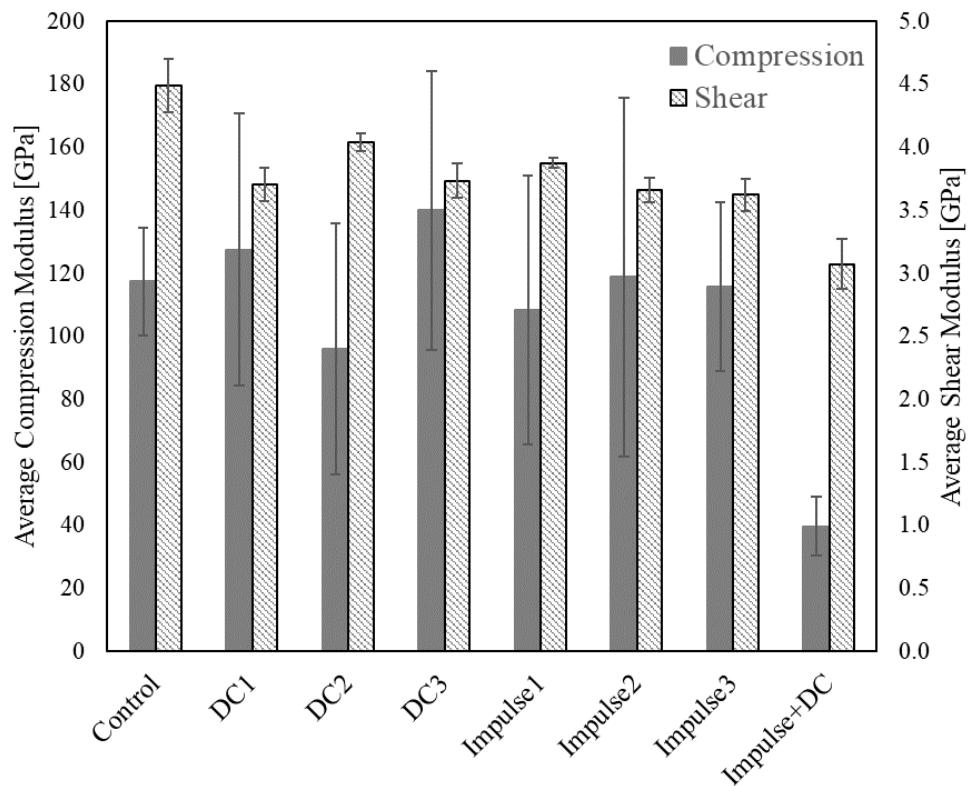
The Young's (E) and shear moduli (G) for both damaged and pristine specimens were also evaluated from the test data following the procedures outlined in ASTMD6641 [126] and ASTMD5379 [127]. The results are shown in Figure 3.13, and it is observed that only moderate changes to E and G were experienced for the DC and Impulse specimens. However, the Impulse+DC specimens showed significant reductions in both Young's (E) and shear moduli (G). The residual compressive modulus is reduced to almost a third of its pristine/undamaged value.

Figure 3.13: Residual compression and shear modulus based on specimen waveform

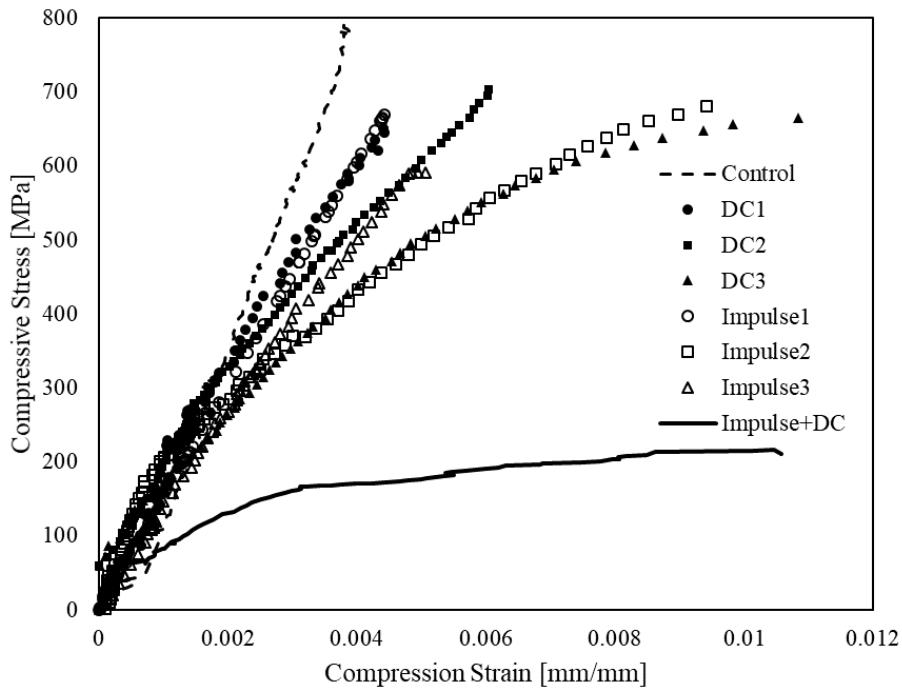
The stress vs strain relations were also recorded for all the test specimens, and typical stress-strain curves are shown in Figure 3.14 for the compression tests, and in Figure 3.15 for the shear tests. A significant change of the stress-strain response is observed for all cases (i.e. DC, Impulse and Impulse+DC), even for the DC and Impulse specimens where the residual strengths and moduli only changed modestly as shown in Table 3.3 and Table 3.4 and Figure 3.13. In particular, it is observed that as the lightning strike energy level increases, the nonlinearity of the stress-strain response as well as the strain to failure increases. The specimens subjected to the lightning strikes with the largest specific energy and charge display the highest level of non-linear behaviour. It is especially obvious for the Impulse+DC specimen, which displays the largest reduction of the

Figure 3.14: Typical stress-strain curves recorded for compression specimens

The failure initiation strength provides a quantitative measure of the stress where nonlinear stress-strain behaviour initiates. It is observed from Table 3.5 that this reduces significantly even for DC and Impulse simulated lightning strike events that led to modest changes of (initial) stiffness (E and G) and compressive/shear strengths, and where only limited visual damage could be identified. For the worst-case scenario of the Impulse+DC simulated lightning strike event, is it also clear from Table 3.5 that significant damage has been introduced. The initiation point of nonlinear behaviour/response has been reduced by 60%, for that specimen. This reduction can be seen in Figure 3.14 and Figure 3.15, as well as in Table 3.4 which shows a significant reduction in shear strength.
