Thesis: Harrell, T.M. (2019) "Characterisation of lightning strike induced damage in CFRP laminates and components for wind turbine blades", University of Southampton, Faculty of Engineering and Physical Sciences, PhD Thesis.

Characterisation of lightning strike induced damage in
CFRP laminates and components for wind turbine blades

Thesis for the degree of Doctor of Philosophy

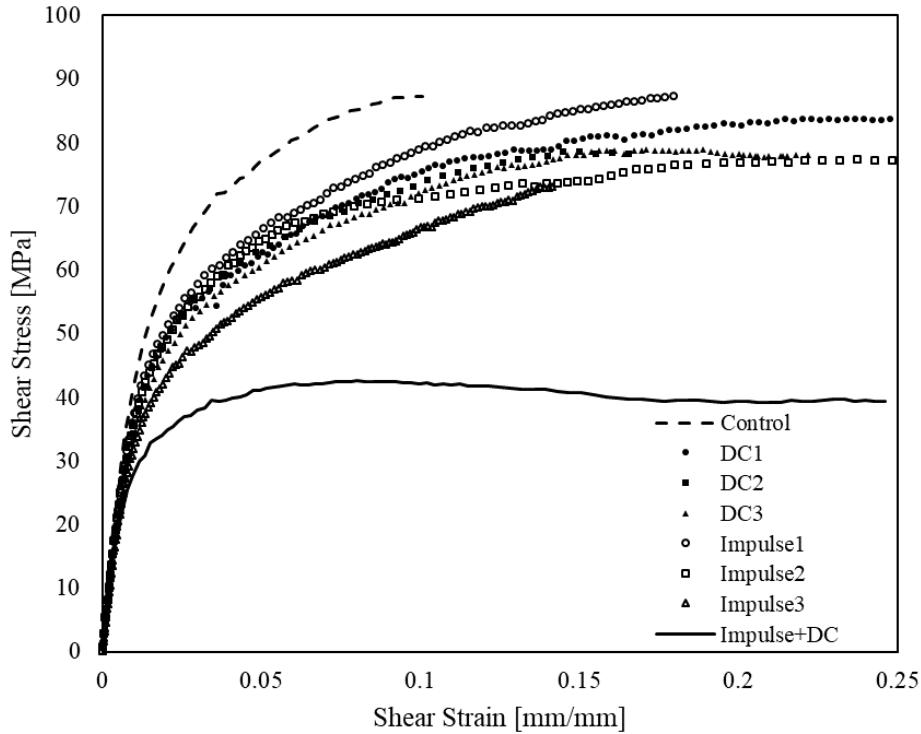
The stress vs strain relations were also recorded for all the test specimens, and typical stress-strain curves are shown in Figure 3.14 for the compression tests, and in Figure 3.15 for the shear tests. A significant change of the stress-strain response is observed for all cases (i.e. DC, Impulse and Impulse+DC), even for the DC and Impulse specimens where the residual strengths and moduli only changed modestly as shown in Table 3.3 and Table 3.4 and Figure 3.13. In particular, it is observed that as the lightning strike energy level increases, the nonlinearity of the stress-strain response as well as the strain to failure increases. The specimens subjected to the lightning strikes with the largest specific energy and charge display the highest level of non-linear behaviour. It is especially obvious for the Impulse+DC specimen, which displays the largest reduction of the

Figure 3.15: Typical stress-strain curves recorded for shear specimens

The failure initiation strength provides a quantitative measure of the stress where nonlinear stress-strain behaviour initiates. It is observed from Table 3.5 that this reduces significantly even for DC and Impulse simulated lightning strike events that led to modest changes of (initial) stiffness (E and G) and compressive/shear strengths, and where only limited visual damage could be identified. For the worst-case scenario of the Impulse+DC simulated lightning strike event, is it also clear from Table 3.5 that significant damage has been introduced. The initiation point of nonlinear behaviour/response has been reduced by 60%, for that specimen. This reduction can be seen in Figure 3.14 and Figure 3.15, as well as in Table 3.4 which shows a significant reduction in shear strength.

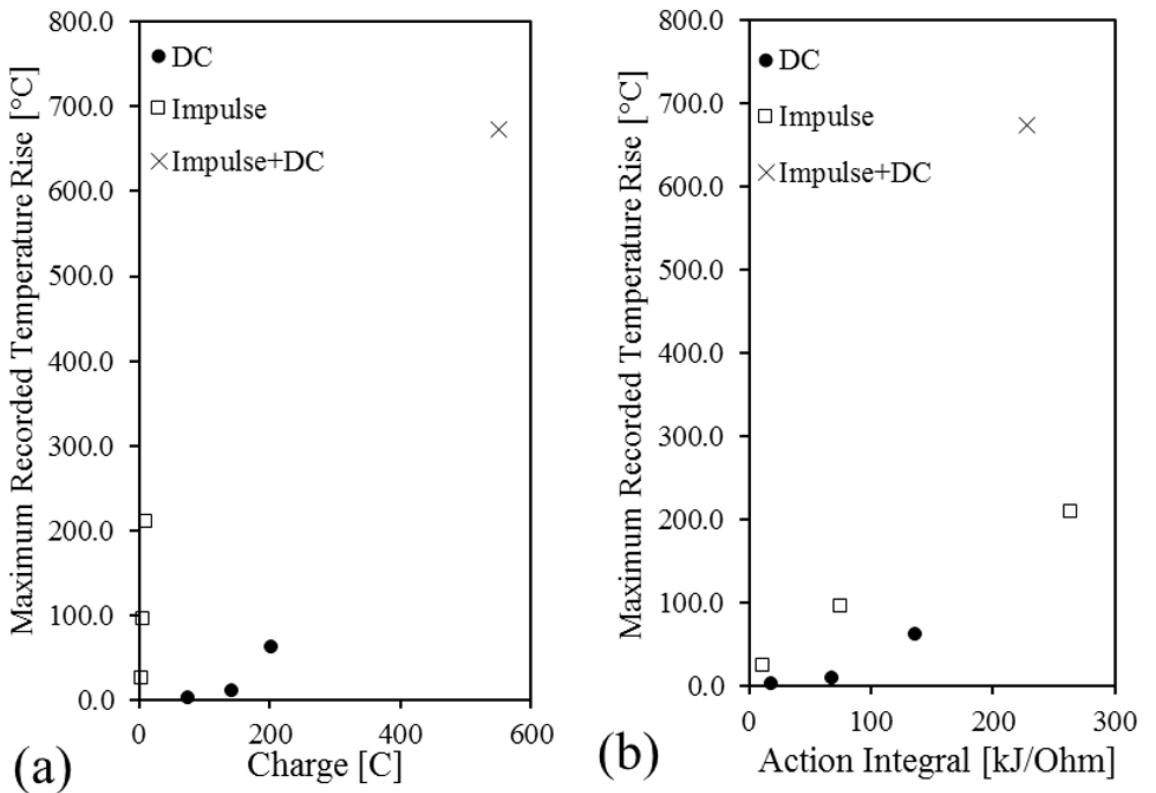
The strong correlation between sample temperature and the severity of a lightning strike event is indicated in Figure 3.16, which shows the surface temperature rise measured on the CFRP specimens using an infrared camera, and the charge and specific energy associated with the specific simulated lightning strike tests conducted. It is clear that the larger the amount of energy the higher the temperature. The Impulse+DC showed a recorded a maximum temperature at or above the maximum recordable temperature for the camera, which clearly indicates that it had received the largest amount of lightning specific energy and charge.

Figure 3.16: Maximum temperature rise measured on the CFRP specimen surfaces using vs (a) charge and (b) action integral (specific energy) associated with specific simulated lightning strike tests

It is observed from Figure 3.16 that the Impulse+DC tests conducted led to far higher specimen temperatures than the DC and Impulse tests, indicating much more damage being inflicted during the former. This corresponds very well with the results presented in section 3.3 where it was shown that the Impulse+DC tests inflicted very significant damage leading to large reductions of strength, stiffness, and failure initiation strength.

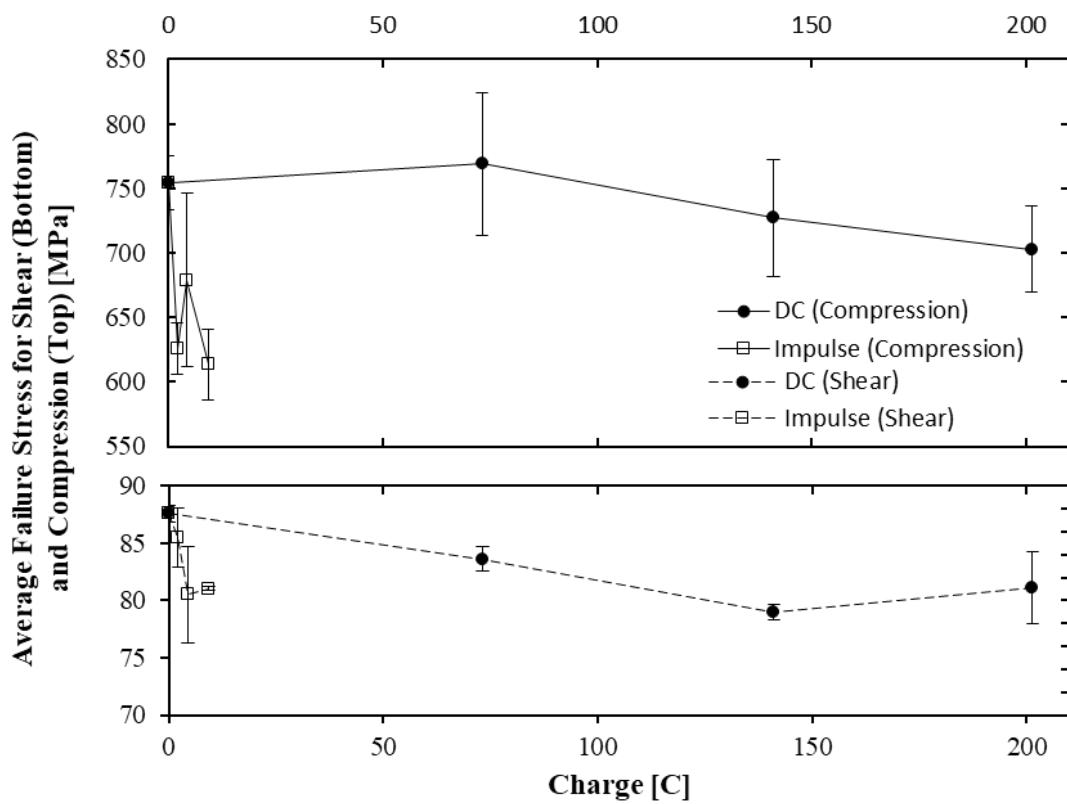
Although the visual inspections conducted on the DC and Impulse coupon tests did not reveal any significant damage, the mechanical tests revealed that both types of simulated lightning strikes reduced the strength for both the compression and shear load cases. This trend can be identified by evaluating the (residual) compression and shear strength measured for the CFRP specimens that did not combust (i.e. DC1-3 and Impulse1-3) against charge, see Figure 3.17, and specific energy, see Figure 3.18, of the simulated lightning strike. From Figure 3.17 and Figure 3.18 it is observed that the specific energy appears to have a stronger effect in reducing the residual strengths than the charge of the lightning strike event. It should also be noted that even though the simulated lightning strike waveforms displayed large variations with respect to the amount current and charge injected into the specimens, it is clear that the both the DC and Impulse test specimens display a clear strength reduction correlation with respect to the specific energy.

Figure 3.17: Residual Strength of damaged and undamaged CFRP specimens vs charge

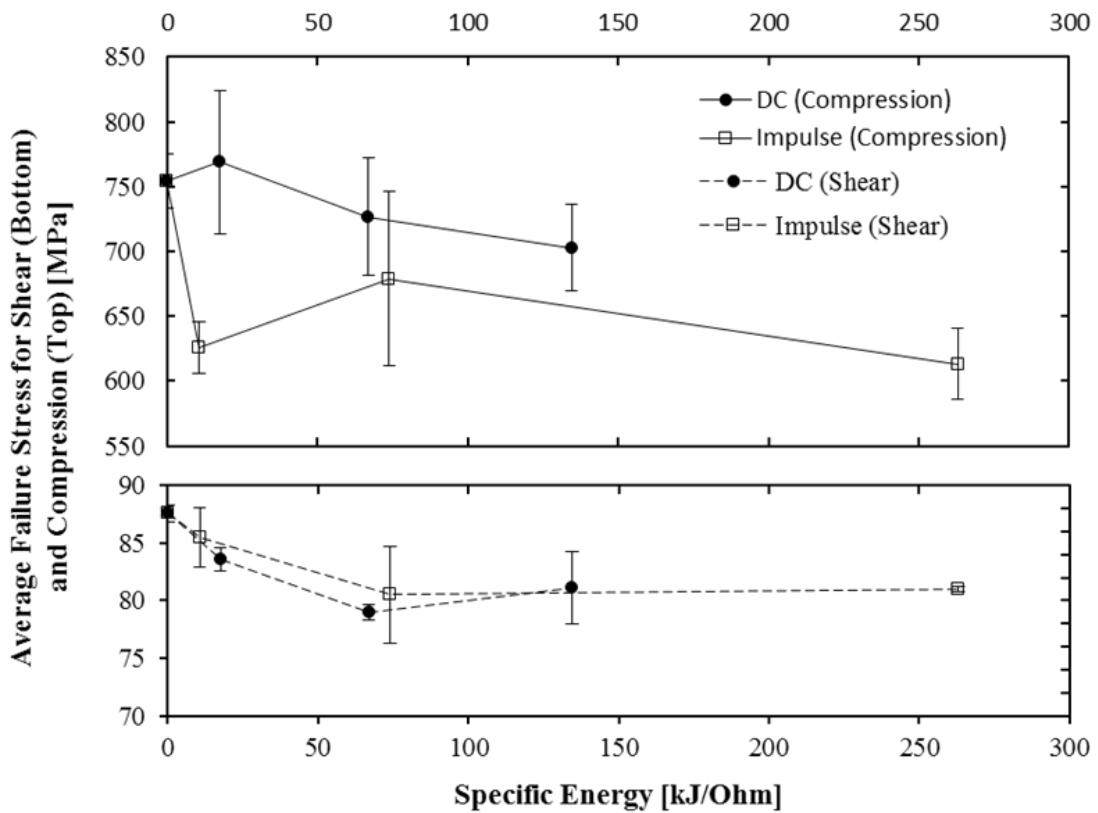
Figure 3.18: Residual Strength of damaged and undamaged CFRP specimens vs specific energy

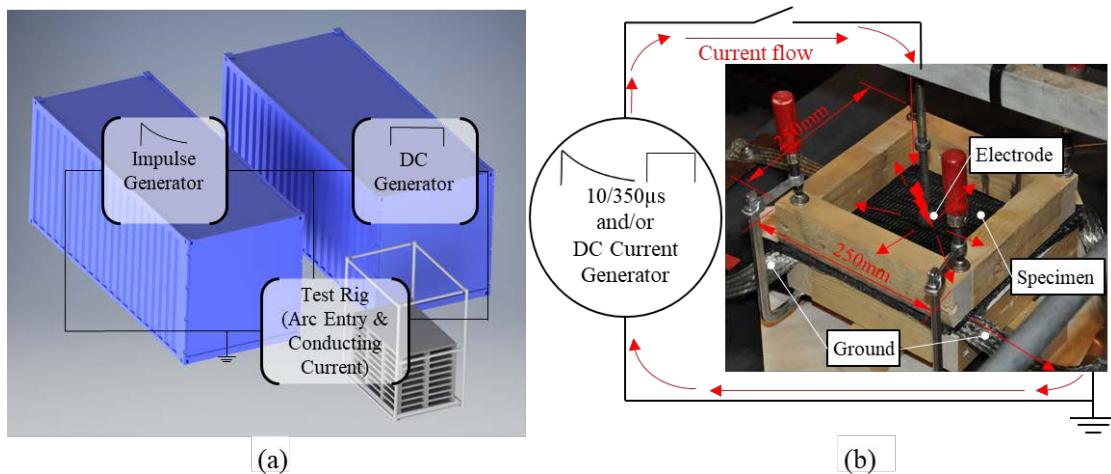
The setup at GLPS includes two generators, which in tandem can produce the 10/350 μ s waveform (or Component A from SAE ARP5416 [70]), and the continuing current (Component C from SAE ARP5416 [70]). A schematic overlay of the system is shown in Figure 4.1 (a). The impulse generator has several large capacitors which are capable of producing impulse currents like the 10/350 μ s lightning waveform. When the capacitors are charged, a mechanical trigger sends the current through the electrode and into the spark gap. A spark is generated which allows current to conduct from the electrode to the sample. The DC generator contains many batteries connected in series which produce DC waveforms to mimic the continuing current waveform. An ‘arc-entry’ or direct strike is associated with the current being supplied orthogonal to the surface of the sample. This event corresponds to Scenarios 1 & 2 in Figure 2.9 (page 16). For CFRP materials, this is the worst-case condition for the electric current to conduct into the CFRP, because the electrical conductivity in the through thickness direction is the lowest; typically, 3 orders of magnitude lower than in the fibre direction [46]. An image of the current flow through an arc entry experiment is shown in Figure 4.1 (b). During an arc entry test, the current flows from the generator through the electrode. The red directional lines show the current flow through the system. It shows the current flows from the generator through the electrode to the sample. The sample then conducts the current to the grounded connections.

Figure 4.1: (a) GLPS testing equipment and (b) a simplified pictorial schematic of current flow through an arc entry

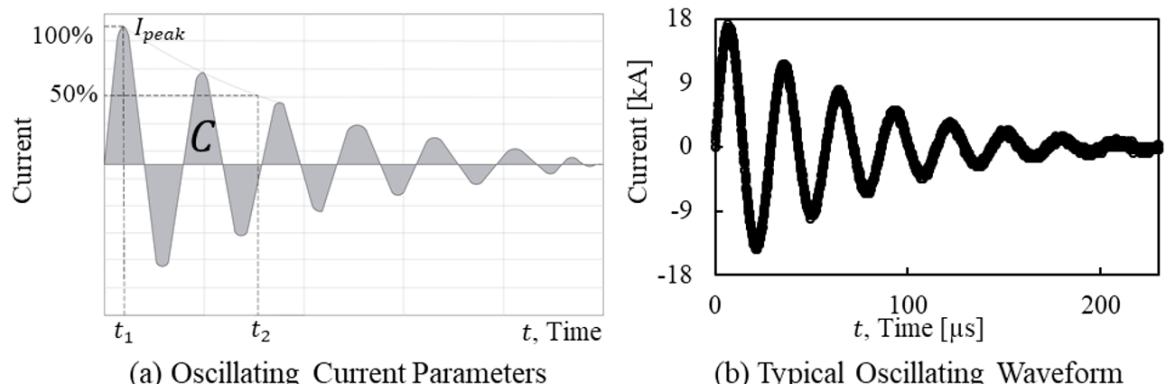
Figure 4.2: Lightning strike waveform characteristics with parameters for (a-b) an oscillating waveform

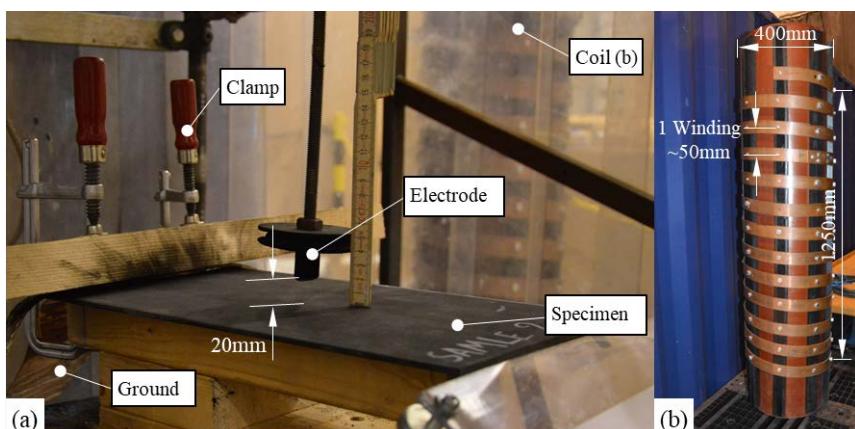
Figure 4.3 (a) shows the setup for the AE2 simulated lightning strike experiments, the specimen is clamped to the ground at the chamfered end with the electrode spaced vertically approximately 20 mm in a location roughly above the centre of the CFRP specimen. The AE2 test was conducted to determine the effects of similar specific energies into the CFRP laminate samples but with slightly reduced peak currents. This was done by adding inductance to the system through the use of a coil; shown in Figure 4.3 (b). The coil had holes at multiple locations which allowed for changing the number of windings used during the test. Increasing the number of windings increased the inductance which changes the waveform. All the waveforms applied to the specimens for test AE2 are shown in Figure 4.4. The changes from the coil can be seen in the waveforms. AE2-1 had no inductance included in the system and has the highest peak current and shortest half time. The inductance was increased for the remaining samples and the resulting waveforms (AE2-2 to AE2-4) show a reducing of the peak current and a spreading of the half time which increases the phase of the oscillations.

Figure 4.3: Simulated lightning strike test setup for both (a) the AE2 test and the AE3 test and (b) showing the coil used in AE2 with dimensions

The AE3 specimens were setup in the same configuration as the AE2 specimens, see Figure 4.3 (a). The AE3 test was conducted to investigate if lightning strikes of different charge inflict different levels of damage. The DC currents applied to the specimens were in accordance with the IEC standards and the only variation was the amount of time the DC waveform was applied, t_{DC} . All

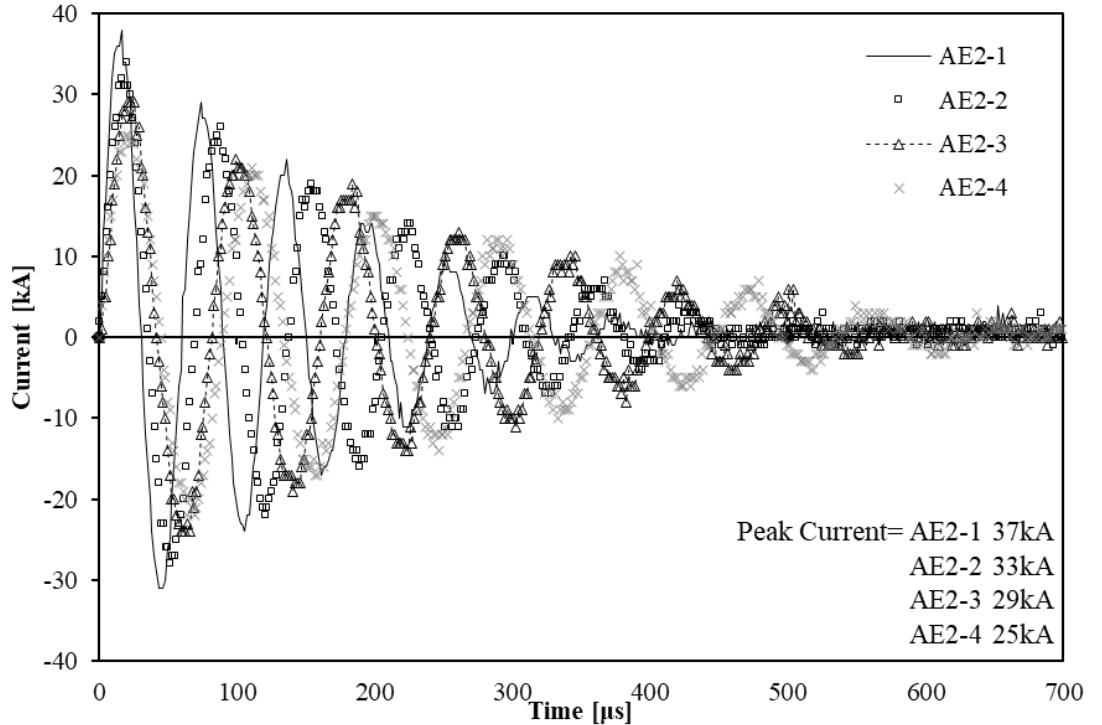
Figure 4.4: AE2 current waveforms

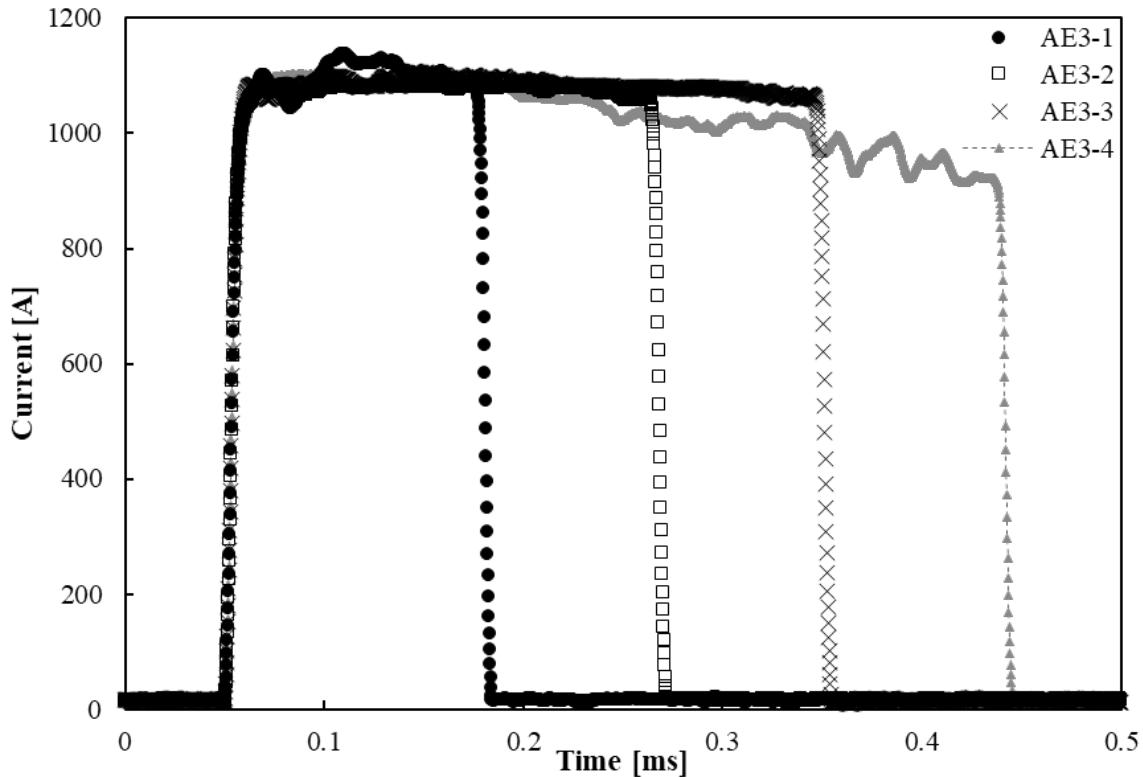
the waveforms applied to the specimens for test AE3 are shown in Figure 4.5. The change in the t_{DC} is seen by the amount of time the waveform is at/near the peak current. Since the amount of charge applied to the sample is an integration of the current with respect to time, the smallest charge for the AE3 specimens is AE3-1 and the largest is AE3-4.

Figure 4.5: AE3 current waveforms

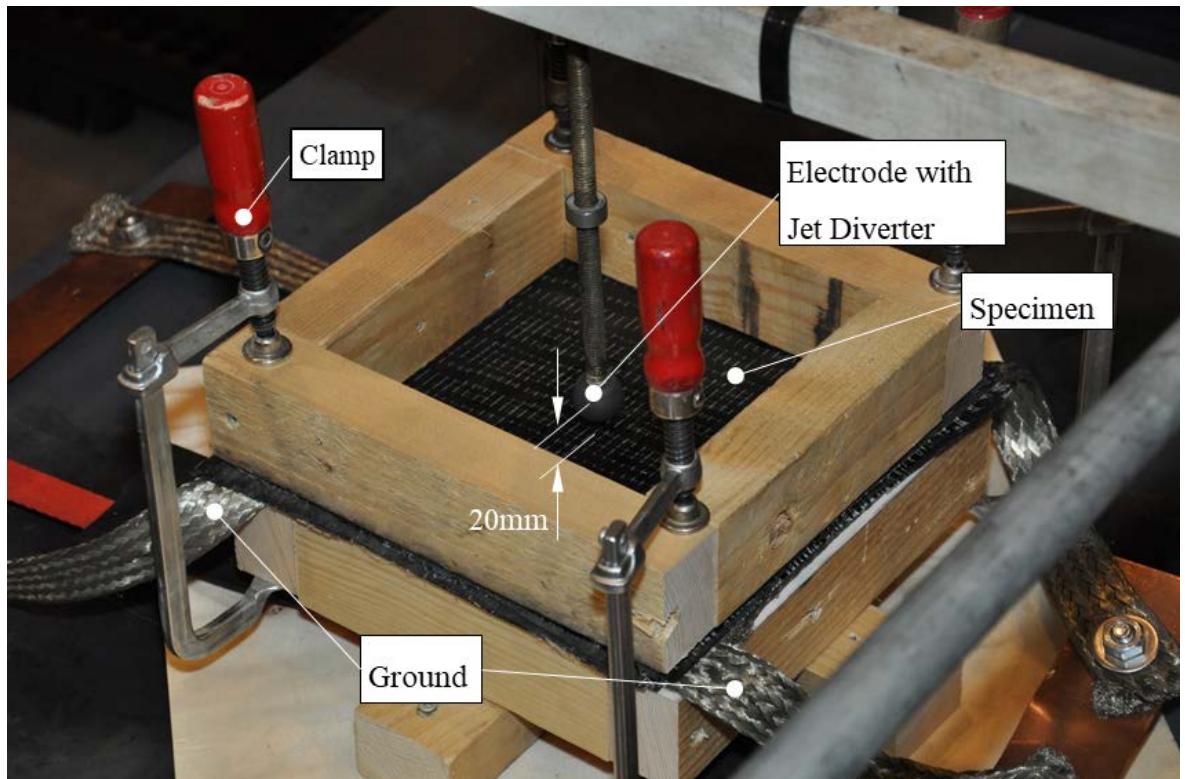
Figure 4.6 shows the setup for the AE4 simulated lightning strike experiments, which comprises the specimen clamped to the ground at their chamfered ends. The electrode was equipped with a jet diverter and was spaced vertically approximately 20 mm in a location roughly above the centre of the CFRP specimen. The waveform used was a combination of both an impulse and a DC waveform. The impulse was applied first, followed immediately by the DC current, thus making it a combined impulse and DC waveform. The desired impulse waveform was the 10/350 μ s to simulate the first return stroke during a direct strike according to IEC 61400-24 Ed1.0 [48], and the desired charge was met with the remaining DC portion.

Figure 4.6: Simulated lightning strike test setup for the AE4 test

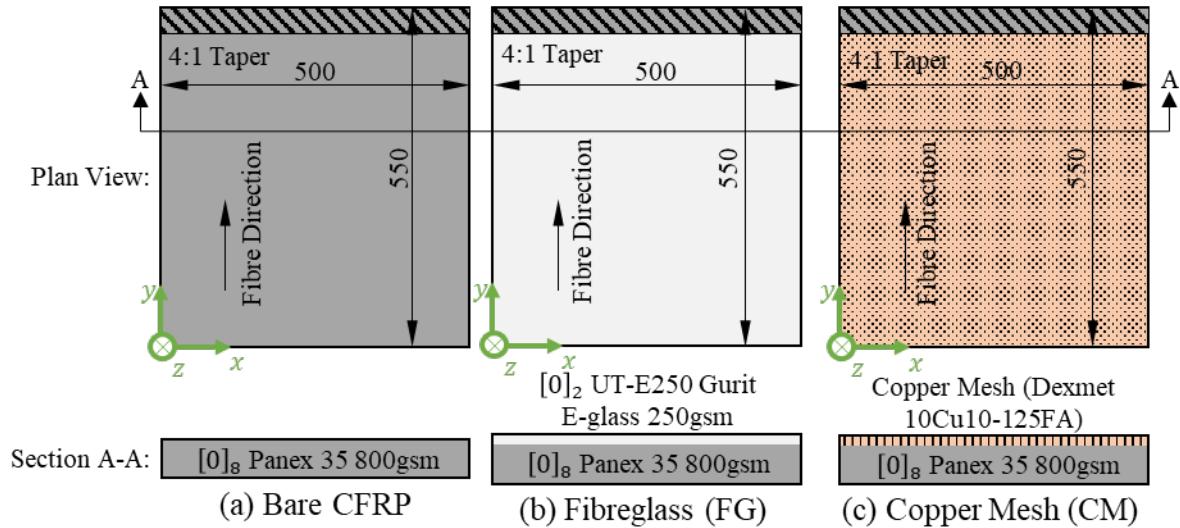
The final test plates had dimensions of 550 mm long and 500 mm wide with thicknesses of 7 mm for the bare specimens, 8.5 mm for the fibreglass surface specimens and 8 mm for the copper mesh surface specimens. One edge was chamfered to an approximate 4:1 taper to expose the fibres for electrical grounding as shown in Figure 4.7. Six of the specimens were set aside to be used as control (undamaged) specimens in the mechanical testing described in Chapter 6: 2 x bare surface, 2 x fibreglass surface, and 2 x copper mesh surface, with the 14 remaining specimens that were subjected to direct lightning strike tests.

Figure 4.7: Specimens for AE5: (a) bare CFRP, (b) fibreglass, and (c) copper mesh

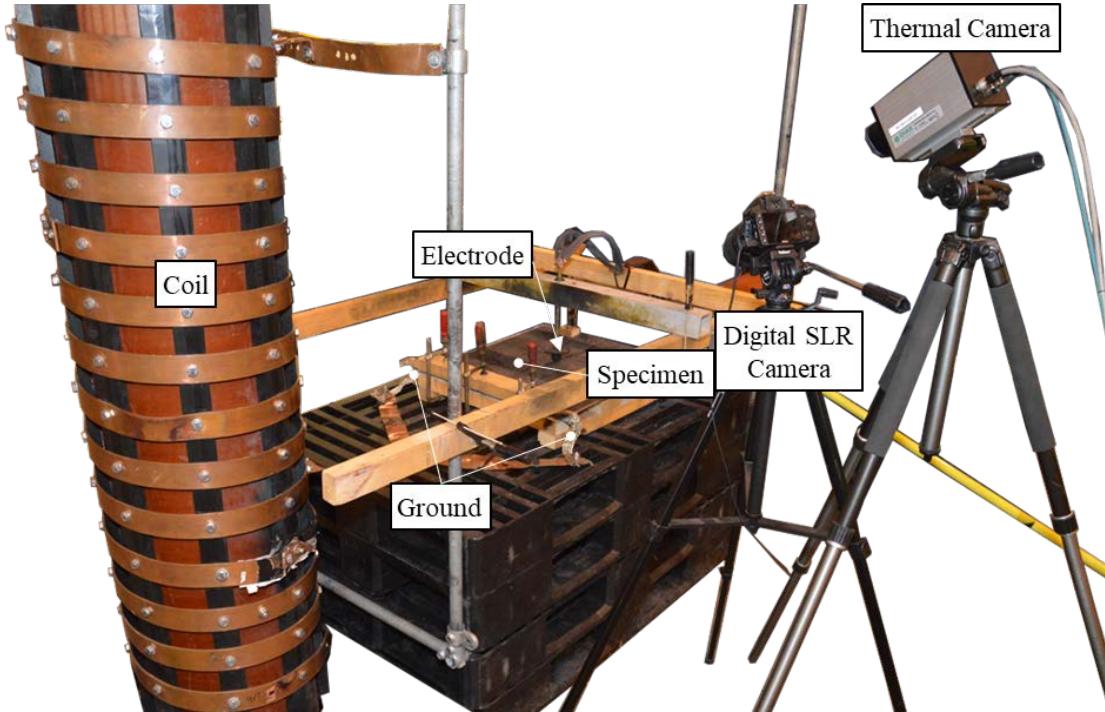
Figure 4.8 shows the setup for the AE5 simulated lightning strike experiments, which comprises of the specimen clamped to the ground at their chamfered end. The electrode was equipped with a jet diverter and was spaced vertically approximately 20 mm in a location roughly above the centre of the CFRP specimen. The CFRP panel specimens were subjected to electrical current with a unipolar 10/350 μ s waveform simulating the first return stroke during a direct strike according to IEC 61400-24 Ed1.0 [48]. The peak currents applied to the samples were 50, 75, 100, and 125 kA.

Figure 4.8: Experimental setup for AE5 simulated lightning strike tests

In the FEM one side surface was grounded, where the copper grounds were used in the experimental study (section 4.3.5, Figure 4.8). The FE mesh has 33,815 continuum solid elements, see Figure 5.6. A fine mesh was implemented near the attachment point with element lengths of 1 mm, and a coarser mesh was implemented away from the attachment point with element lengths of

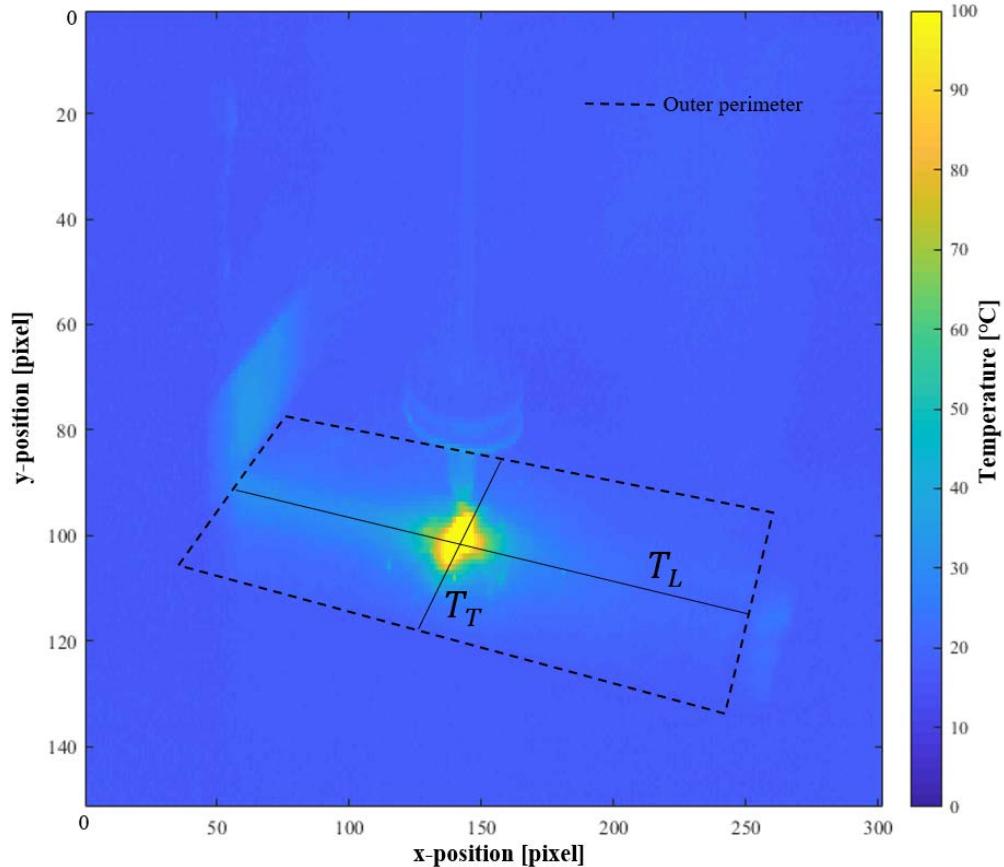
An example of an image of the panel captured by the thermal camera is shown in Figure 4.9. The outer perimeter of the top surface of the panel is shown by the dashed line. It is clear that a large temperature evolution occurs at the attachment point. Three data sets were recorded from the thermal video: the maximum temperature recorded, a temperature profile along the fibre direction through the centre of the simulated lightning attachment point, T_L , and a temperature profile along the transverse direction through the centre of the simulated lightning attachment point, T_T . Although the temperature shown in Figure 4.8 is at a maximum of 100°C , lightning strikes can cause much higher temperatures. The maximum temperature recording limit for this camera is 692°C which is also referred to as the saturation temperature.

Figure 4.9: Example thermal image from lightning strike test 0.5 seconds after a simulated direct lightning strike

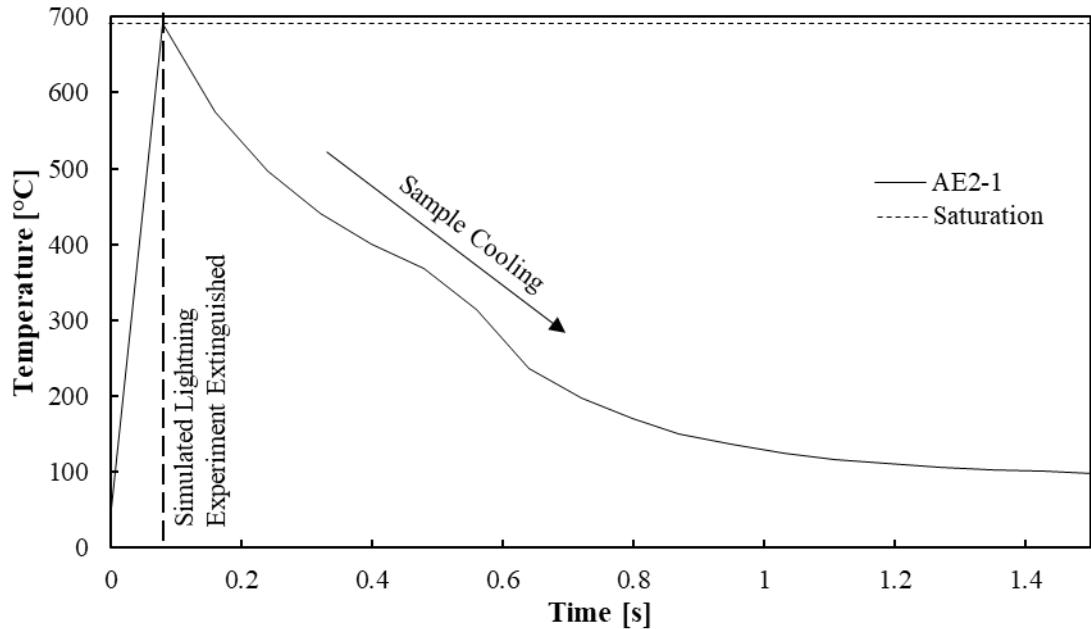
Figure 4.10 presents a typical maximum temperature evolution in test specimen AE2-1. The plot is a maximum temperature recorded on the full array of data from each image. The temperature rapidly increases from the ambient when the simulated lightning strike attaches. After the lightning strike is extinguished, the thermal decay is evident with temperatures returning to near ambient to around 100°C within a second. However, sometimes a small fire is ignited due to the lightning strike, which lasts about 2 seconds, when this happens, the maximum temperature remained at the saturation temperature until the flame is extinguished. The saturation temperature for this camera is shown as a dotted line in Figure 4.10 to show why the recording did not surpass this limit.

Figure 4.10: Example of the maximum temperature recorded from test specimen AE2-1's lightning strike test

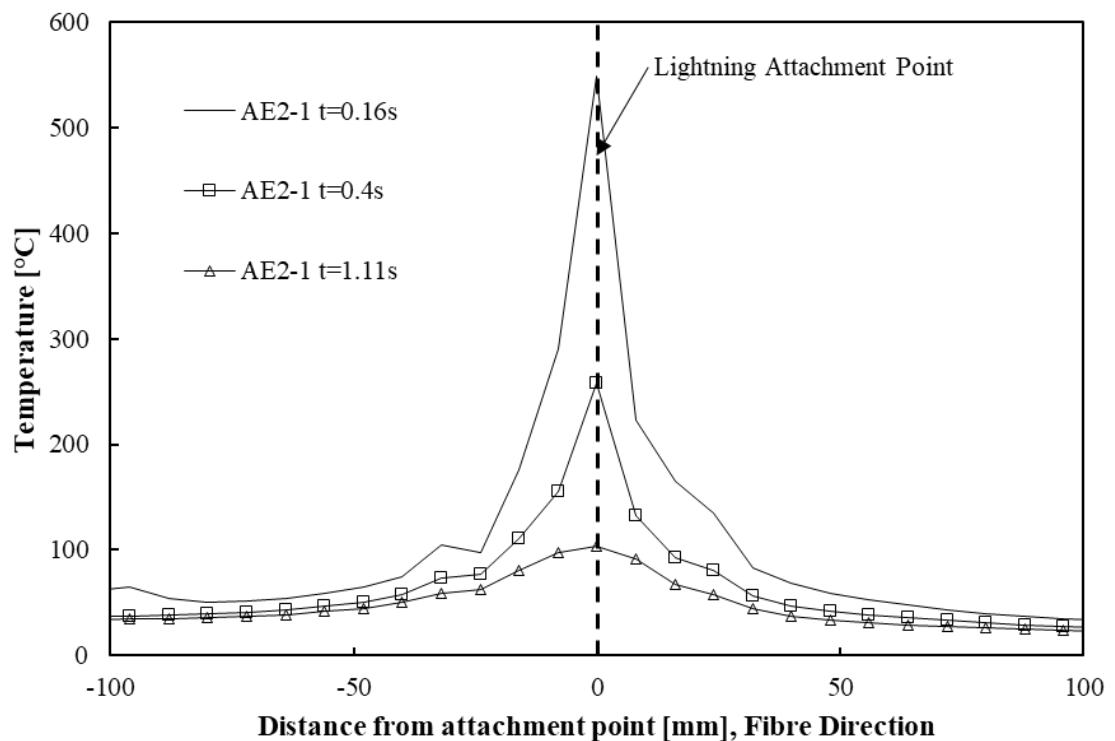
Figure 4.11 shows a typical temperature profile along T_L and Figure 4.12 shows a typical temperature profile along T_T taken at three different times following a lightning strike: 0.16 s, 0.4 s, and 1.11 s. The data is centred at the lightning strike attachment point and the distances are measured from the centre. Comparing these two plots allows for the determination of whether the fibre or transverse directions are receiving more heat. Further discussion of this comes in the general discussion section of this chapter.

Figure 4.11: Example longitudinal direction temperature profile for specimen AE2-1 at 0.16 s, 0.4 s, and 1.11 s

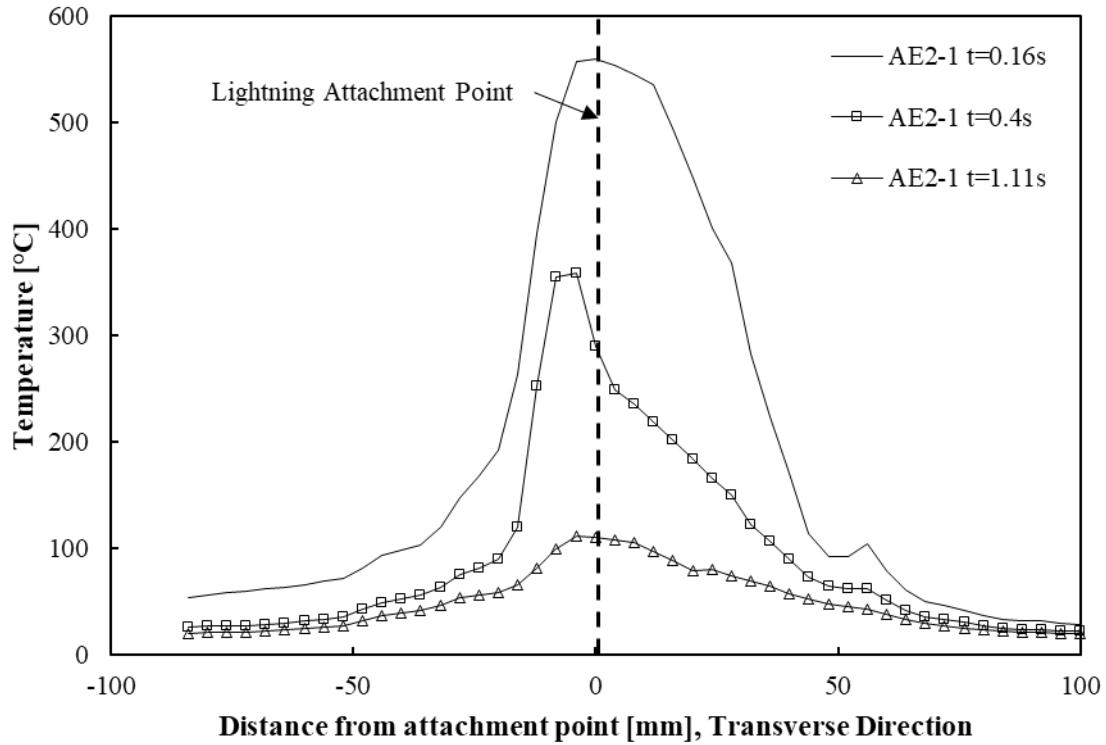
Figure 4.12: Example transverse direction temperature profile for specimen AE2-1 at 0.16 s, 0.4 s, and 1.11 s

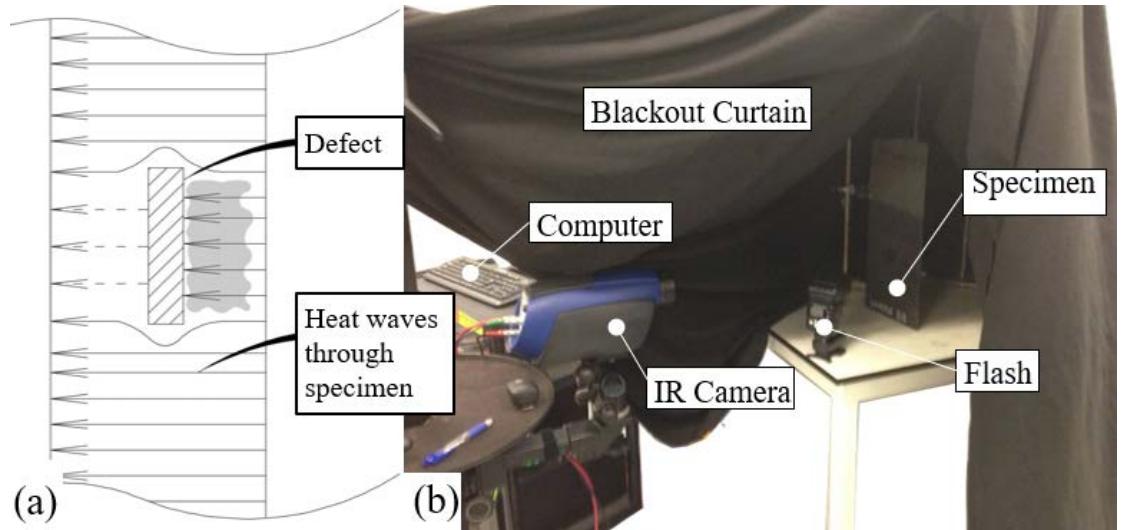
The arrangement used for thermography inspection in the present work is shown in Figure 4.13 (b). The arrangement has 4 components: (1) IR camera, (2) flash/heat source, (3) test specimen/sample, and (4) computer. The heat source was a Bowen studio flash and the thermal camera used was a Cedip silver 480m. The specification of the equipment used are presented in Table 4.6 along with the recording frame rates and durations. The position of the flash for this procedure is at the front of the sample adopting a technique known as ‘reflection thermography’.

Figure 4.13: (a) Thermography setup and (b) Temperature profile through sample with defect

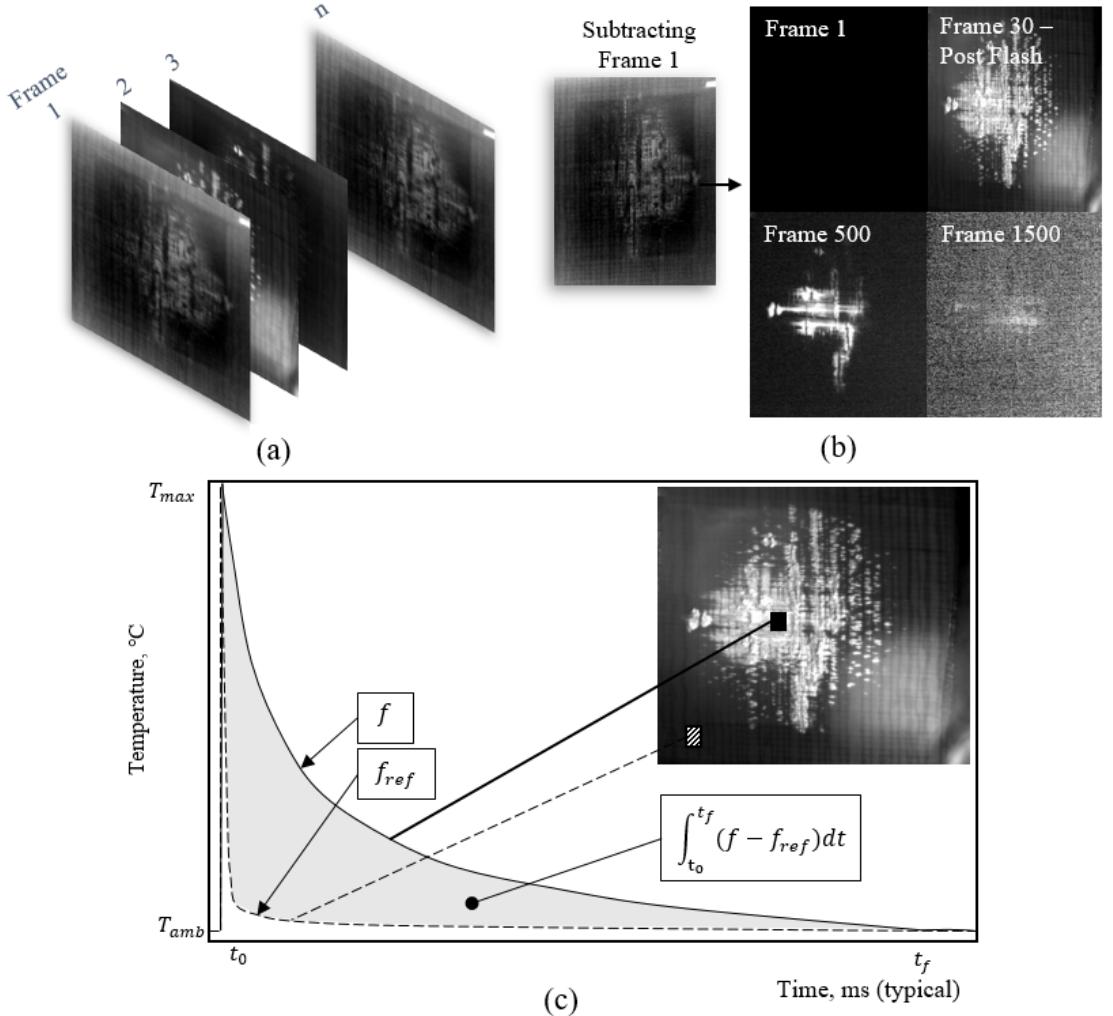
Figure 4.14: (a) Organization of thermal images stacked as 3D matrix for analysis in Matlab, (b) thermal images of lightning strike damaged specimen at different time steps after flash with subtraction of the first image, and (c) typical readout from thermography experiment where the dashed black line is the reference non-damaged inspected area and the solid black line is the damaged region. The grey area in the temperature profile shows the integration taken for the thermography analysis

that there is no damage). The “integration method” is carried out in three steps as shown in Figure 4.14:

1. An image series is captured by the IR camera which is long enough to fully capture the thermal decay. The temperature data from each pixel in the image series is assembled into a 3D matrix as shown in Figure 4.14 (a),
2. Remove any bias such as the reflection of the cooled IR detector by subtracting the first image from the rest of the data set as shown in Figure 4.14 (b), and
3. Numerically integrate the temperature data with respect to time using the trapezoidal rule, implemented in Matlab [137], as shown in Figure 4.14 (c).

The integration is executed from the time of the heat input until the specimen returns to ambient temperature. As shown in Figure 4.14 (c), the integral for the reference pixel is subtracted from all the other pixel integrals. The result also shown in Figure 4.14 (c), is a spatial array that includes the temporal information from the image series that provides a clear indication of the extent of the damage. The Matlab script for this procedure is included in Appendix B.

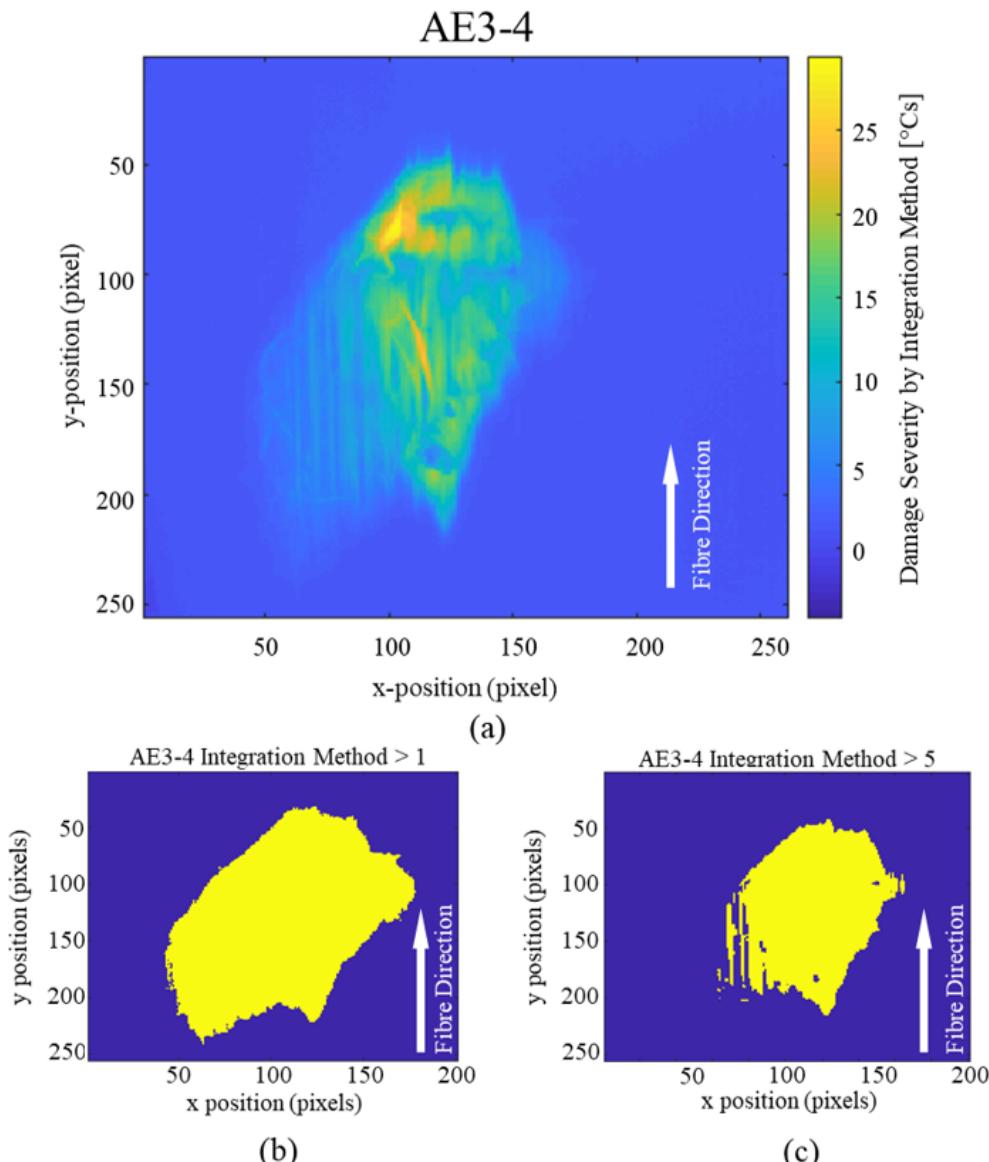
Figure 4.15: Thermography results for specimen AE3-4 where (a) is the nominal integration method measurement, (b) is the charred damage thresholded image, and (c) is the surface damage thresholded image

The plot of the damage severity obtained for specimen AE3-4 from the integration method is shown in Figure 4.15 (a), which displays typical characteristic features as obtained for the other specimens. The extent of the lightning damage area is clearly visible, and the severity of the damage is indicated by the large numerical values of the damage metric. The regions that are charred have a lower damage severity than the damage at the lightning attachment point. The integration method was used to quantify similar damage types as shown for specimen AE3-4 (Figure 4.15 (a)), similar to [138].

To identify similar damage types, characteristic threshold pixel values were selected. These threshold values were set based on visual inspection and evaluated as the values which were at least 3 standard deviations away from the reference non-damaged regions integrated values. The values at each pixel were compared to the selected threshold values and binarized by assigning a value of 1 if the value was above the threshold and 0 if the value was below the threshold. Each different

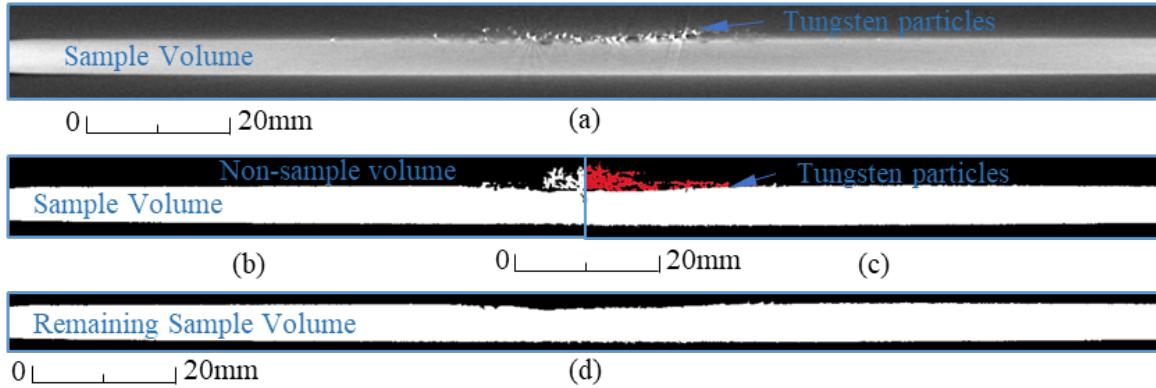
Figure 4.16: (a) X-ray CT of specimen AE3-2 showing a sliced image through the thickness, (b) processed threshold showing binary image where white is associated with the full volume, (c) is a processed image with the erroneous particles shown in red, and (d) is a sliced image of the fully processed remaining CFRP volume

value returns the sample volume without the including the effects of the tungsten deposits. The regions with the tungsten particles were shaded in red to indicate their location and is shown in Figure 4.16 (c). After this procedure, only the remaining CFRP sample volume was left, and this volume is shown in Figure 4.16 (d).

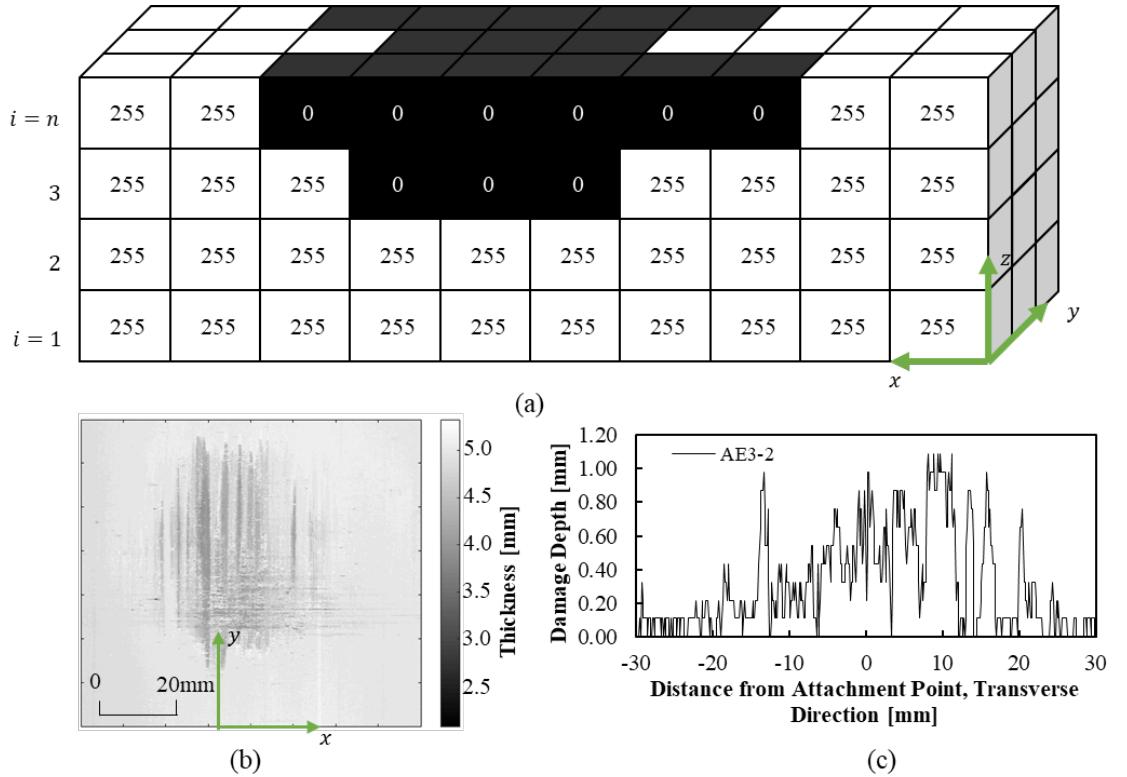
Figure 4.17: (a) An example result of the binarization process to a X-ray CT image showing the directions, thickness values and voxel values, (b) shows the 32-bit Real image of thickness values from the Z-project process associated with the AE3-2 damaged specimen and (c) shows the maximum damage depth plot processed from the Matlab script

Each image slice was combined into a single image by summing the slices in a process called “Z-project”. A graphical description of the voxel values and their directions are shown in Figure 4.17 (a) where the 255 values are the remaining sample volume and the 0 values are the remaining voxel values. The number of slices is shown in the z-direction with an index i . The voxels were summed together in the z-direction through all the slices and divided by binary value 255. This results in a count of the number of voxels which are assigned 255 in the z-direction or simply put the number of remaining sample voxels in the z-direction. The count is then multiplied by the spatial resolution to translate the image stack into millimetres as follows:

The resulting images obtained from the process are presented as 32-bit real data with x and y position datum at the centre point of the damage and the 32-bit greyscale values providing the remaining thickness of the sample, as shown in Figure 4.17 (b). The raw (32-bit real data) image data was interrogated in a Matlab [137] routine with the minimum thickness of each column (y direction) across the width of the sample was collected and arranged in a damage depth plot as shown in Figure 4.17 (c).
