Thesis: Harrell, T.M. (2019) "Characterisation of lightning strike induced damage in CFRP laminates and components for wind turbine blades", University of Southampton, Faculty of Engineering and Physical Sciences, PhD Thesis.

Characterisation of lightning strike induced damage in
CFRP laminates and components for wind turbine blades

Thesis for the degree of Doctor of Philosophy

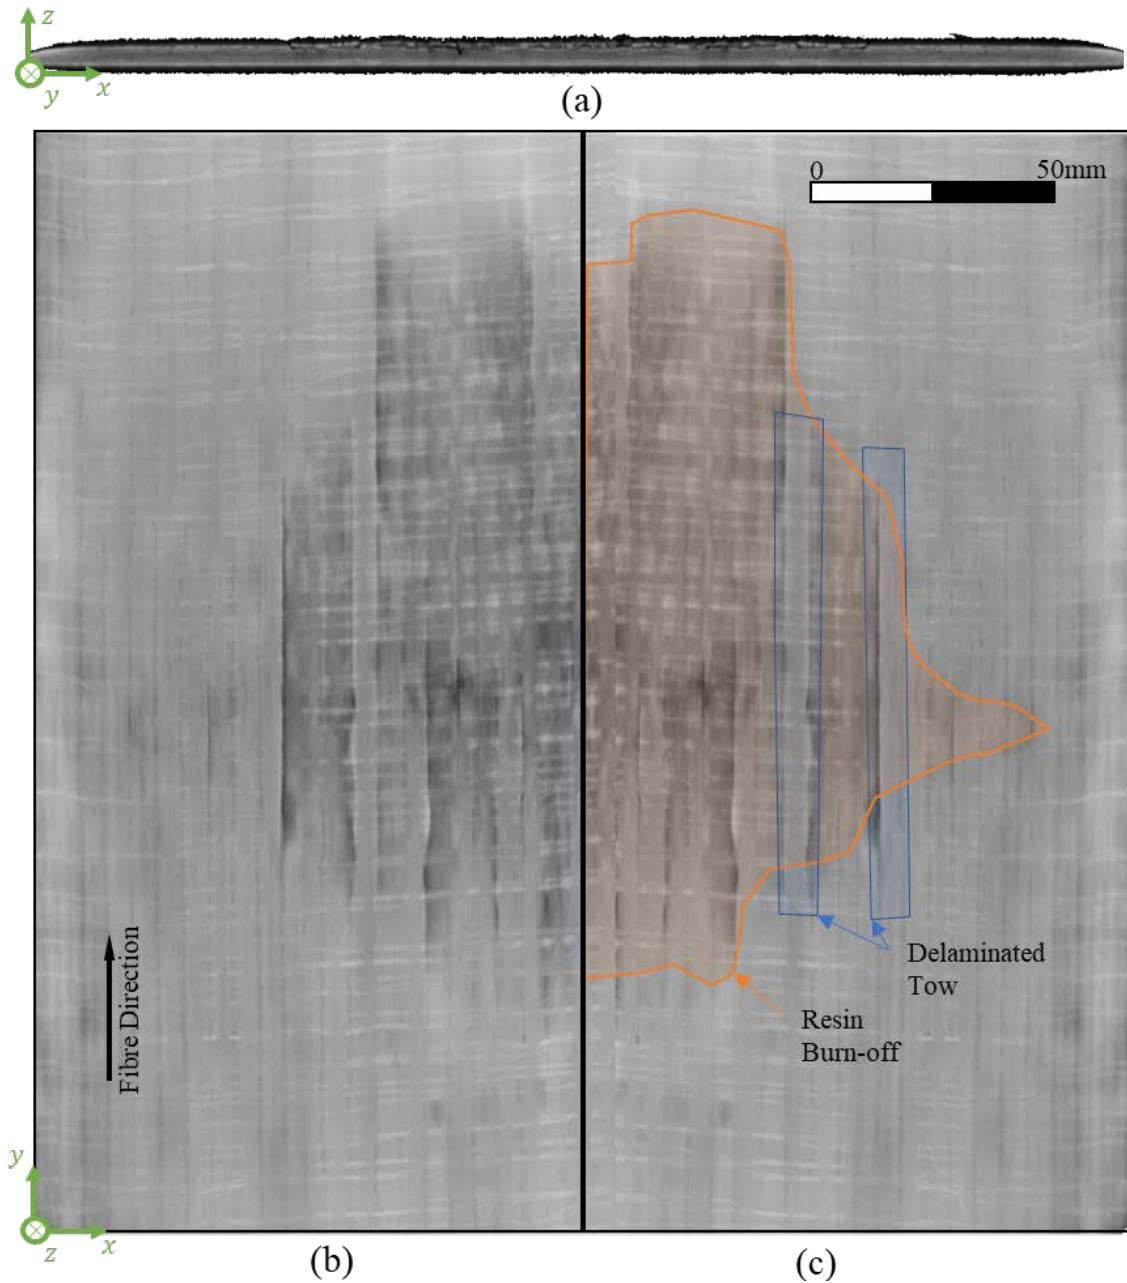
Figure 4.18: CT Results AE4 (a) cross-sectional view, (b) plan view original, and (c) plan view with damage polygon selection and description

The threshold-based method was efficient for the carbon/vinyl ester pultruded specimens (AE2–AE3). However, for panels AE4 and AE5 the results were inconclusive as the carbon/epoxy heavyweight fabrics were difficult to automatically distinguish between damage and non-damage as there was not enough contrast between the damaged region and the non-damaged region. Although the issue was not able to be parsed automatically, the damage was easily spotted by eye as can be seen in Figure 4.18. Figure 4.18 (a) shows the cross-section where damage is identified in the top plies and Figure 4.18 (b) shows a plan in the depth of the sample which clearly shows the damage by eye. The darker regions are associated with less dense material from processes such as material removal during the lightning strike event. To determine a damage depth, a second method was devised, herein referred to as the “manual threshold-based method”. In this method, the CT images were captured, reconstructed and imported into ImageJ. The volumes were converted to an 8-bit image format, so all the voxel values were at max 255. Following this, the image stack was converted back to a 16-bit image format without scaling the voxel greyscale values. This ensured that everything within the volume had a maximum greyscale value of 255, and after this each slice was examined manually for damage. The damaged area in each of the image slices was selected manually with a polygon selection tool. An example of a typical damage identification and selection polygon is shown in Figure 4.18 (c). The voxels in this slice had a value of 1000 added to their original greyscale values. This was done to ensure that all damaged voxel bit values were

above 255 and could easily be thresholded. Once the values were thresholded the same threshold-based method was used to find the thickness.

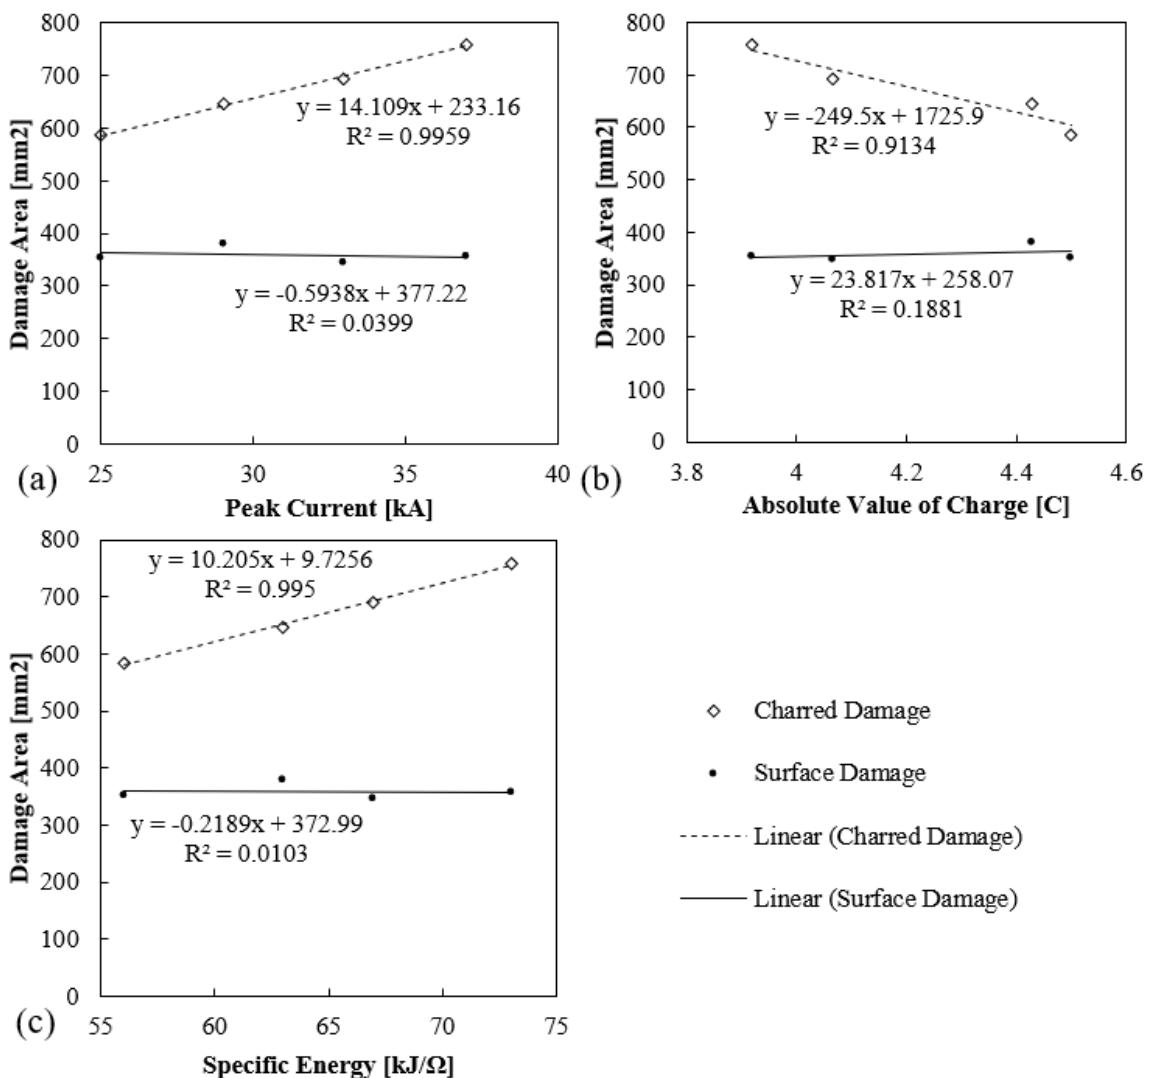
Figure 4.19: Thermography damage area results for test specimens AE2 against (a) peak current, (b) absolute value of charge and (c) specific energy

Figure 4.19 shows the damaged area identified by the IRT integration method. The surface damage was constant for all the parameters showing no significant increase in surface damage due to an increase in lightning parameters peak current, absolute value of charge, and specific energy. There is an increase of charring damage areas that was observed due to increasing peak current and specific energy (Figure 4.19 (a) and (c)) but reversed for increasing absolute value of charge (Figure 4.19 (b)).

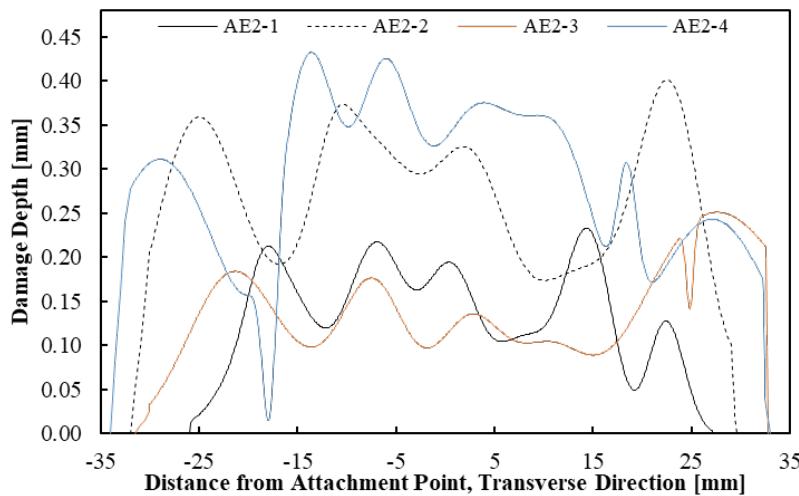
Figure 4.20: Maximum damage depth measurements from CT depth analysis AE2 specimen

Figure 4.20 presents the damage depths determined from the X-ray CT data. The results show that the damage depths were a maximum of 8.8% of the total laminate thickness. There are sharp edges enclosing the damage depth. This type of damage profile indicates that the removal of material was likely due to an ablation process rather than a pyrolysis process, as the pyrolysis process removes

material due to sustained heat and therefore has more gradual transitions of thickness. The ablation process typically evaporates the material quickly and results in fast removal of the heat, like a laser ablation process. The ideal shape for an ablation process would be similar to a square wave, however due to the heterogeneous material properties a perfect square wave will not be achieved as seen in Figure 4.20. The resin is burnt off and the fibres are left intact, which accounts for the profiles of the damaged depth plots seen in Figure 4.20.

Figure 4.23 presents the damage depths determined from the X-ray CT data. The results show that the maximum damage depth was around 30-32% of the total laminate thickness. Contrary to the previous impulse damage (AE2) from Figure 4.20, the damage was more smoothly transitioned from the edges of the damage to the maximum. This indicates that the damage is more similar to a pyrolysis process.

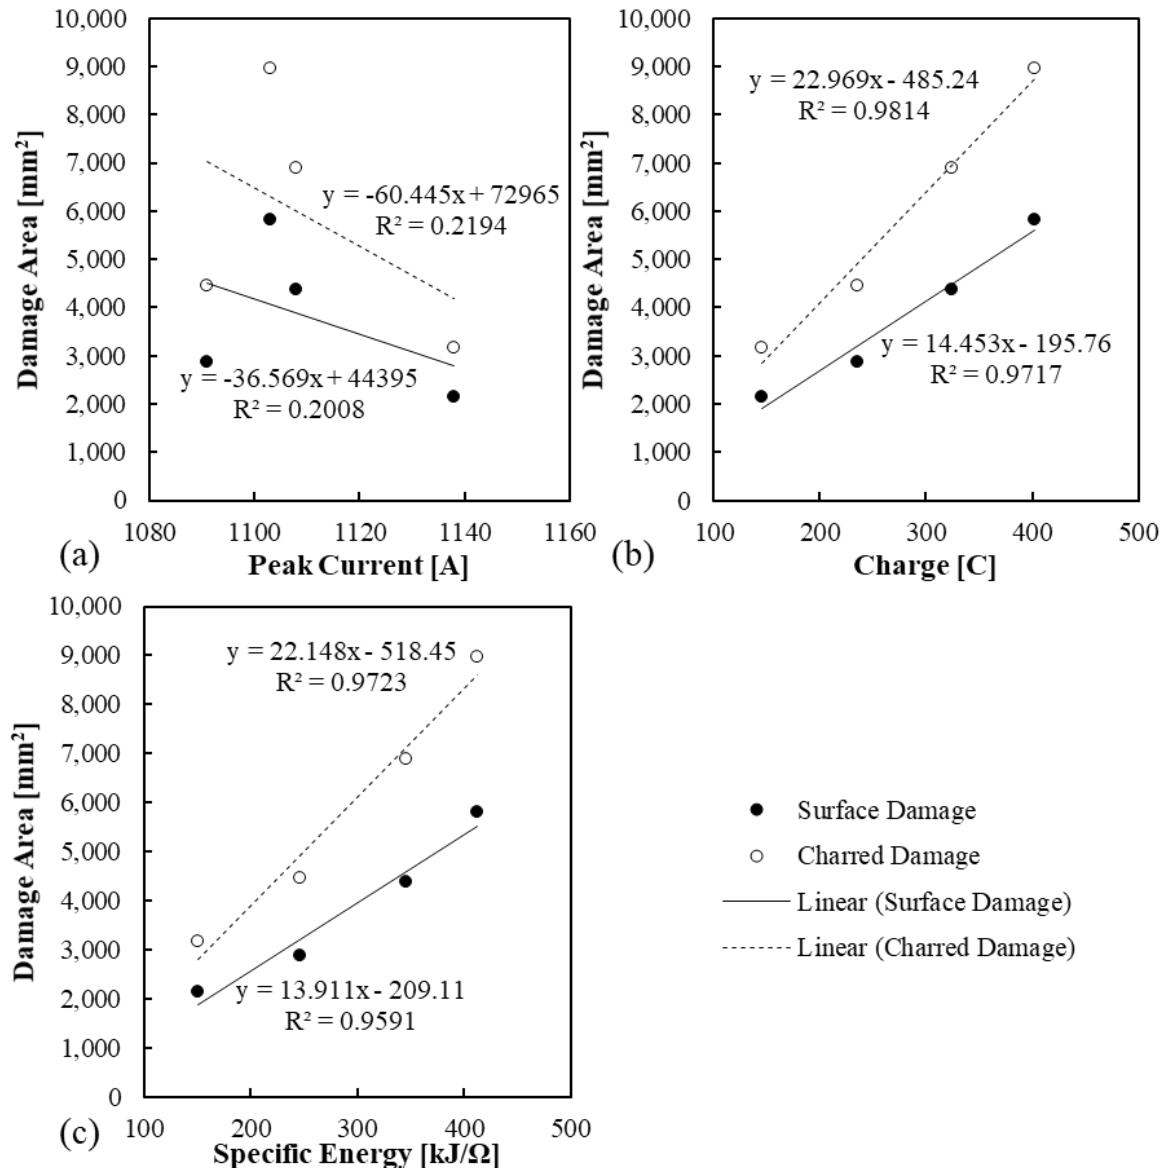
Figure 4.21: Thermography damage area results AE3 against (a) peak current, (b) charge and (c) specific energy

The thermography results are shown in Figure 4.21. The resulting damage shows a nearly linear correlation between surface/charred damage vs charge and specific energy with relatively high R^2 values; see Figure 4.21 (b)-(c). The opposite trend was shown for surface/charred damage vs the peak current and the resulting trend R^2 values; see Figure 4.21 (a). The apparent negative slope is artificial as the magnitude of the peak currents varied by less than 0.2 kA and are associated with differing levels of charge and specific energy, indicating that the aforementioned lightning parameters have more influence on the extent of the damage area.

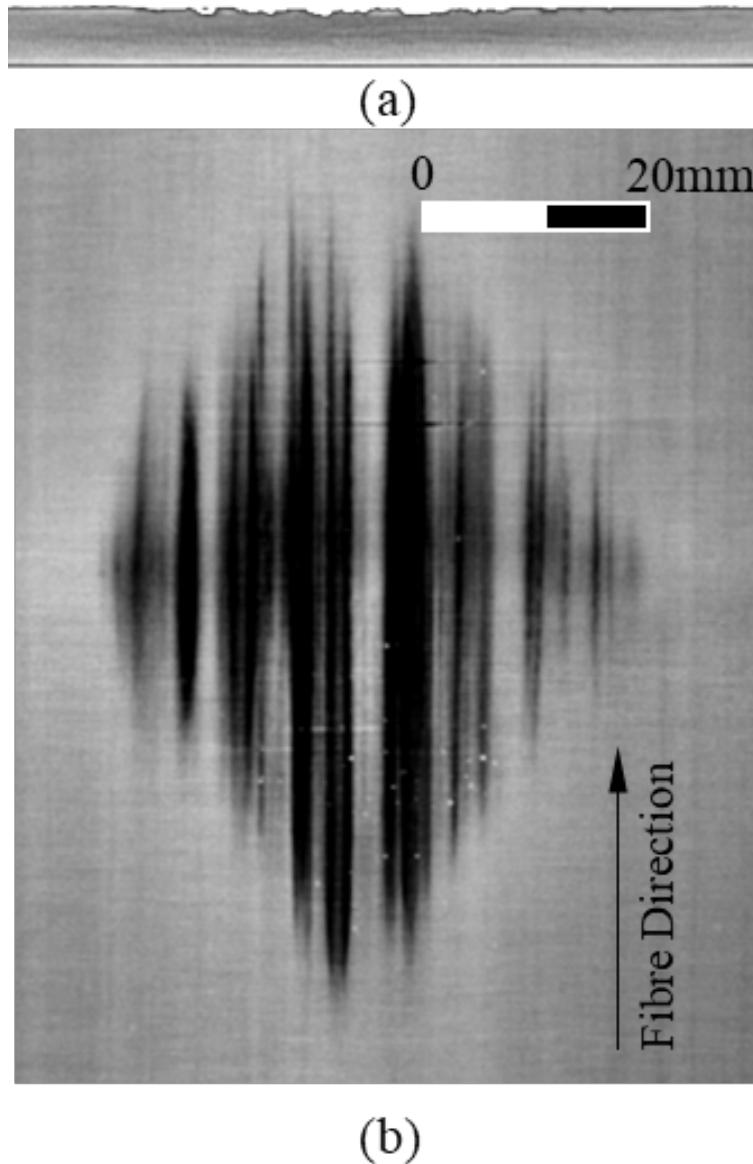
Figure 4.22: X-ray CT images of damage in specimen AE3-4 where (a) is the cross-section through the thickness and (b) is the top plan view

The visually identified damage, and the X-ray CT scans showed similarly shaped surface damage with resin burnt away. Further inspection into the depth of the specimen did not reveal discernible delamination or other damage below the surface damage. An example of the cross section in the thickness direction and a plan view sub-surface of the top surface from the X-ray CT scan of specimen AE3-4 is shown in Figure 4.22.

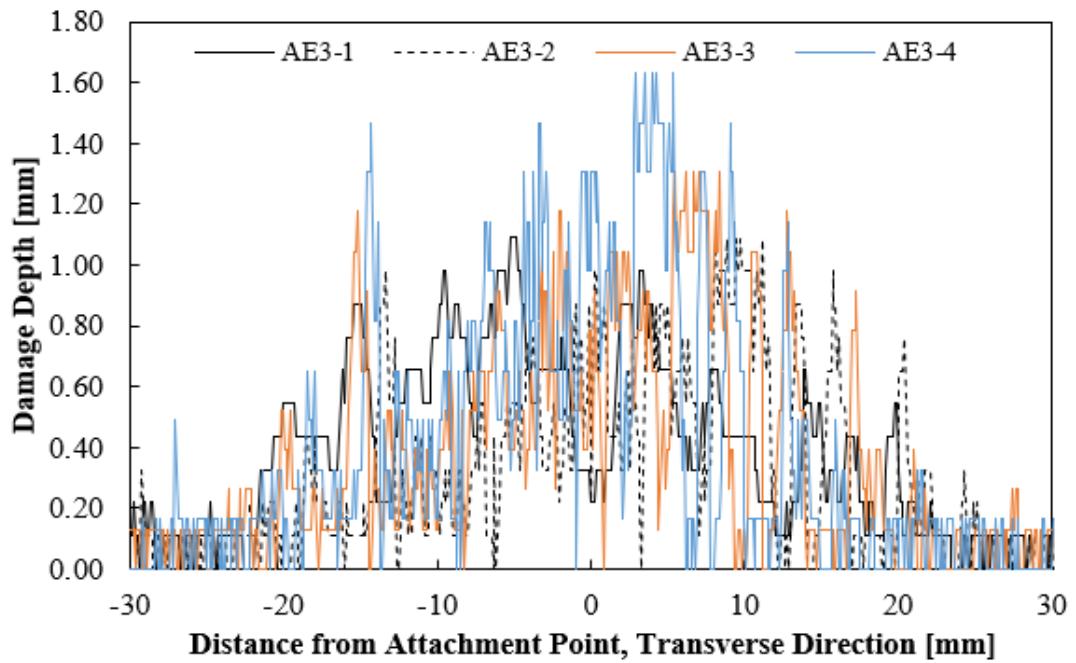
Figure 4.23: Maximum damage depth measurements from X-ray CT damage depth analysis of AE3 specimens

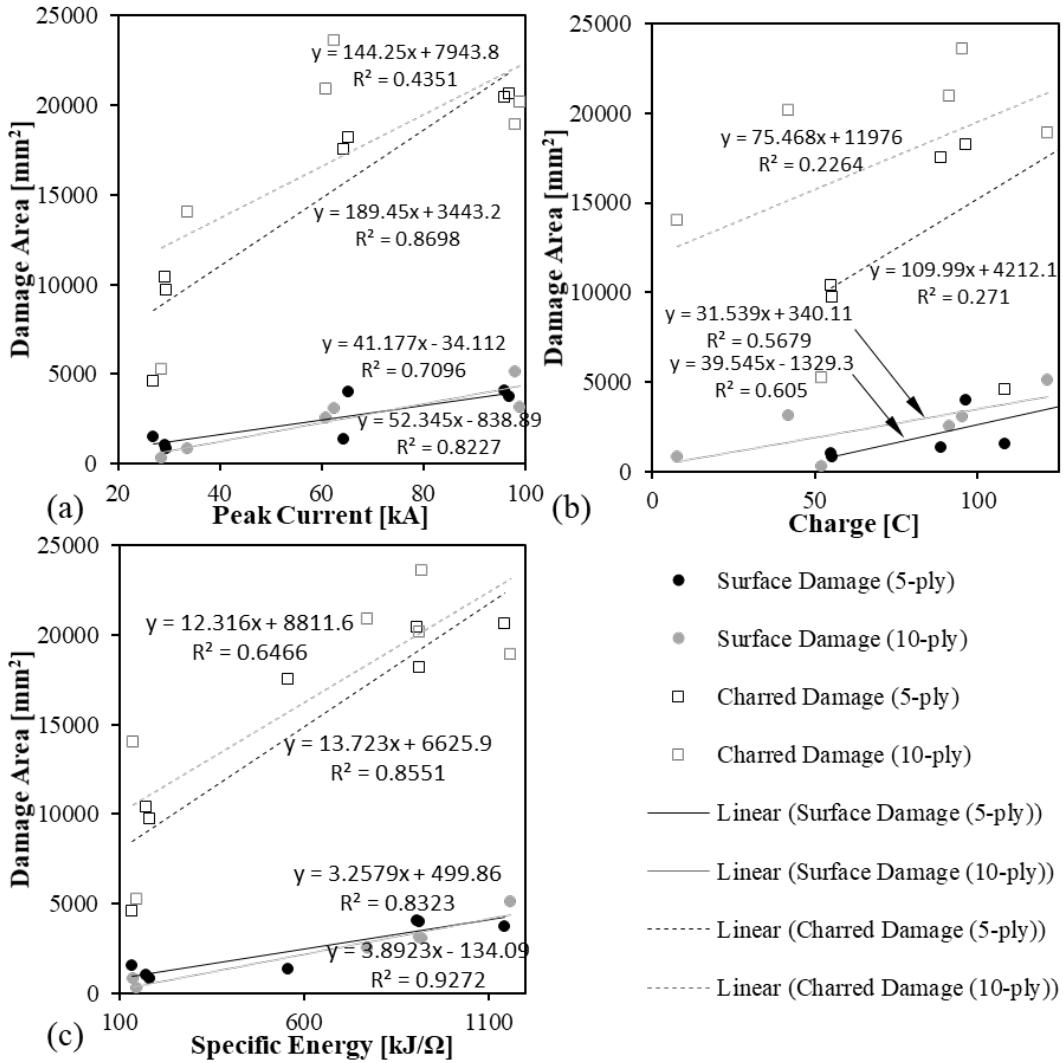
Figure 4.24: Damaged areas identified by thermography against the (a) peak current, (b) charge and (c) specific energy for specimens AE4

The damaged area thermography results vs the peak current, charge and specific energy are shown in Figure 4.24. Figure 4.24 (a) – (c) all show a similar result with the increasing peak current, charge, and specific energy all increasing the damaged area. The R^2 values can indicate which trends have a closer fit to the data. The specific energy had the highest R^2 values for all the damage trends.

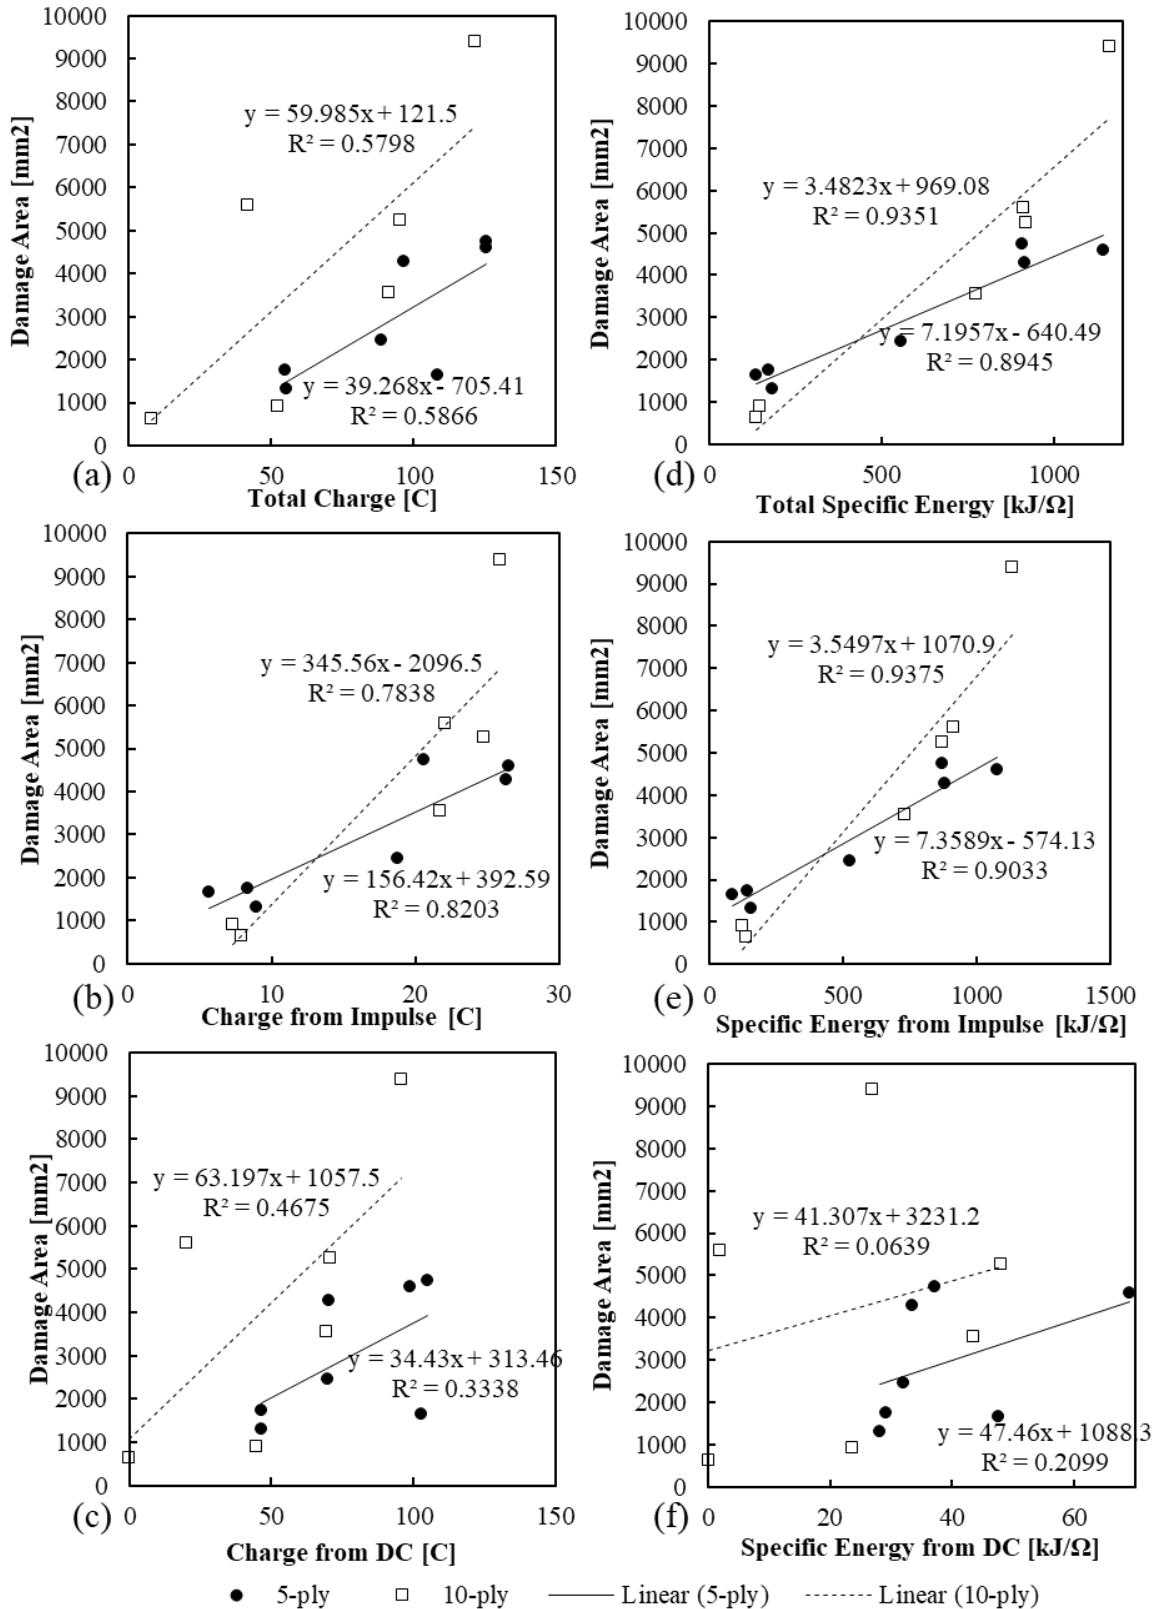
Figure 4.25: Charge and specific energy vs damaged areas identified using thermography from the 5-ply and 10-ply AE4 specimens comparing the charge and specific energy against the total, impulse and DC portion of the waveform. (a) is the charge from the total waveform, (b) is the charge from the impulse portion, (c) is the charge from the DC portion, (d) is the specific energy from the total waveform, (e) is the specific energy from the impulse portion, and (f) is the specific energy from the DC portion

In Figure 4.25, the total charge and total specific energies have been separated into the contributions stemming from the impulse and DC waveforms. From Table 4.4 (page 73), it is seen that more than 80% of the charge comes from the DC portion of the waveform and more than 90% of the specific energy comes from the impulse portion of the waveform. This enables separation of cause and effect. Assessing the R^2 values (least square fitting correlation) indicated in Figure 4.25, it is observed that the surface and charred damage fits closest to specific energy. The thermography results indicate the same correlation as the visual inspection. Figure 4.25 shows the thermography results with impulse vs DC and specific energy vs charge. Checking the R^2 values, the surface and charred damage fits closest to the specific energy. Separating the impulse and DC allows for a cause vs effect analysis. Figure 4.25 (b) and (c) show the R^2 values have the tightest fit between impulse and DC components which indicates that most of the damage is contributed by impulse. The R^2 values from Figure 4.25 (a) and (b) show that the best predictor of damage is specific energy. The R^2 values from Figure 4.25 (c) and (f) show that the lowest R^2 values were associated with the DC portion of the waveform.

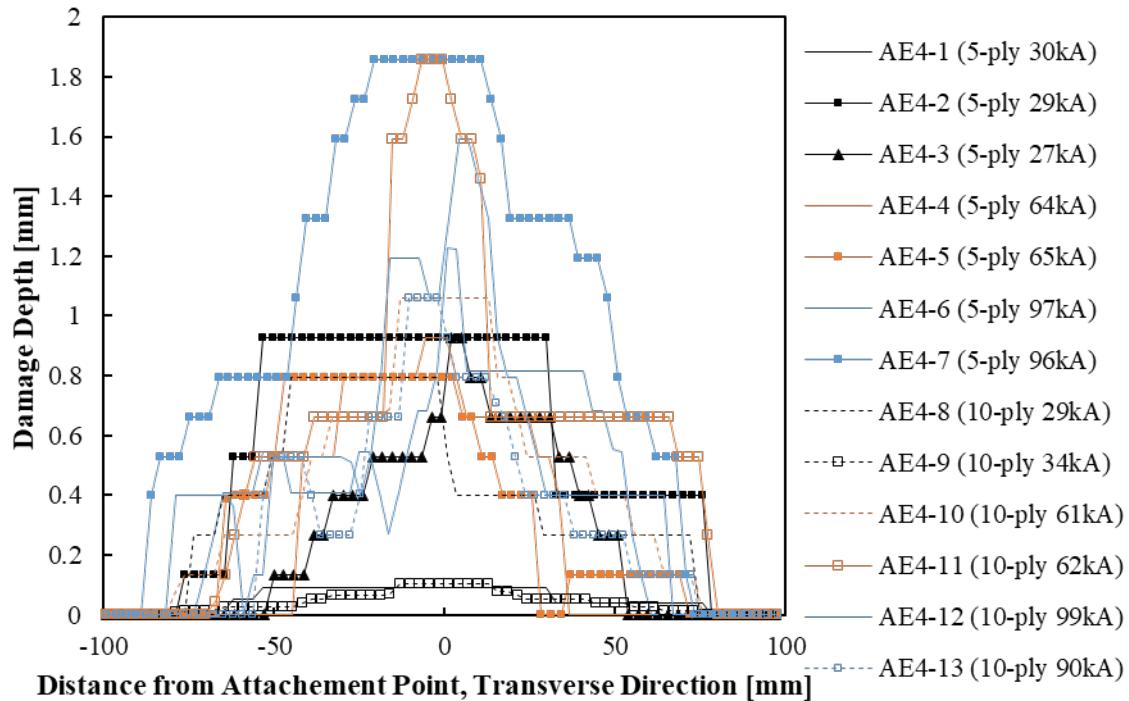
Figure 4.26: Maximum damage depth measurements obtained from X-ray CT depth analysis for the AE4 specimens

Figure 4.26 presents the damage depths determined from the X-ray CT data. The results show that the damage depths were maximum for the highest lightning strike intensities. At the highest intensities, the maximum damage depth was 41% of the total laminate thickness. The damage was more smoothly transitioned from the edges of the damage to the maximum. This indicates that this is more similar to a pyrolysis process.

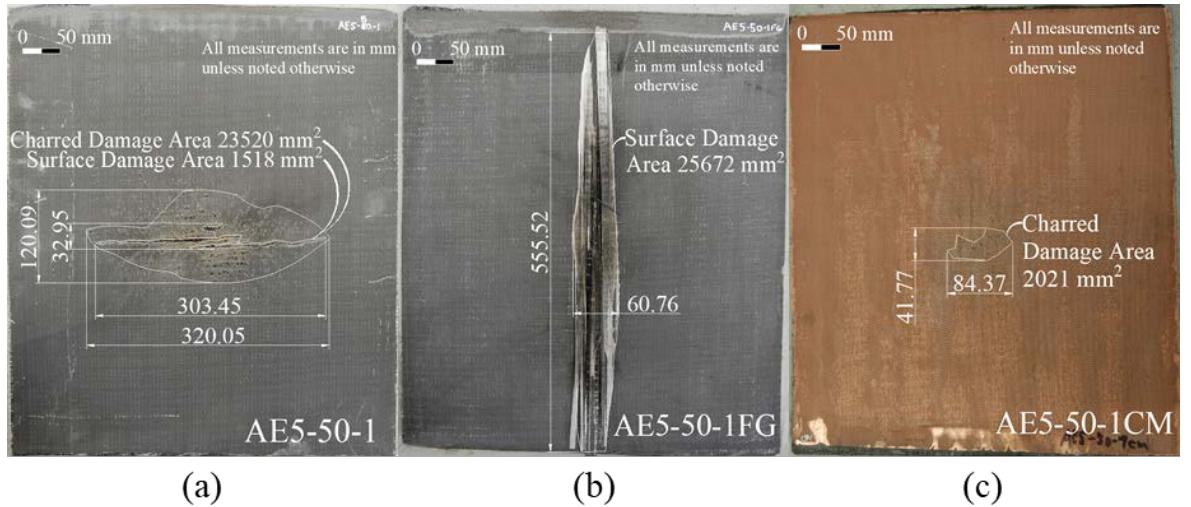
Figure 4.27: Visual inspection of the AE5 specimens subjected to 100 kA: (a) bare surface specimen, (b) fibreglass surface specimen, and (c) copper mesh surface specimen

Thirteen specimens were subjected to simulated lightning strike events for the AE5 (see section 4.3.5 for details of the specimen configurations and Table 4.5 for applied lightning waveforms). The results for the bare surface specimens were similar to the results obtained for the AE4 specimens. The shape of the damage area was elliptical with the major axis being in the transverse direction and the minor axis being parallel to the fibre direction. The bare surface specimens displayed increased damage area with increasing peak current, which subsequently increased the charge and energy. An example of the observed bare surface specimen damage is shown in Figure 4.27 (a). The damage observed for the fibreglass surface specimens was dissimilar to that observed for the bare specimens. Thus, the shape of the damaged area for the fibreglass specimens was elliptical as well, but with the major axis directed along the fibre direction and the minor axis directed along the transverse direction. Similarly, to the AE4 specimens, as the peak current increased, the amount of damage also increased. The surface damage areas were significantly larger than observed for all other specimen configurations (AE1-AE4), but with no significant

charred damage. Moreover, a portion of the fibreglass surface was completely delaminated from the base CFRP laminate. Figure 4.27 (b) shows an example of a damaged observed for the fibreglass surface specimen. The copper mesh surface samples remained intact as shown in Figure 4.27 (c) and there was no damage that included visibly exposed fibres. The surface damage observed for the copper mesh surface samples only showed small areas with loss of copper mesh and burnt off resin. Charred areas were measured as areas which had small spots of damaged copper mesh.

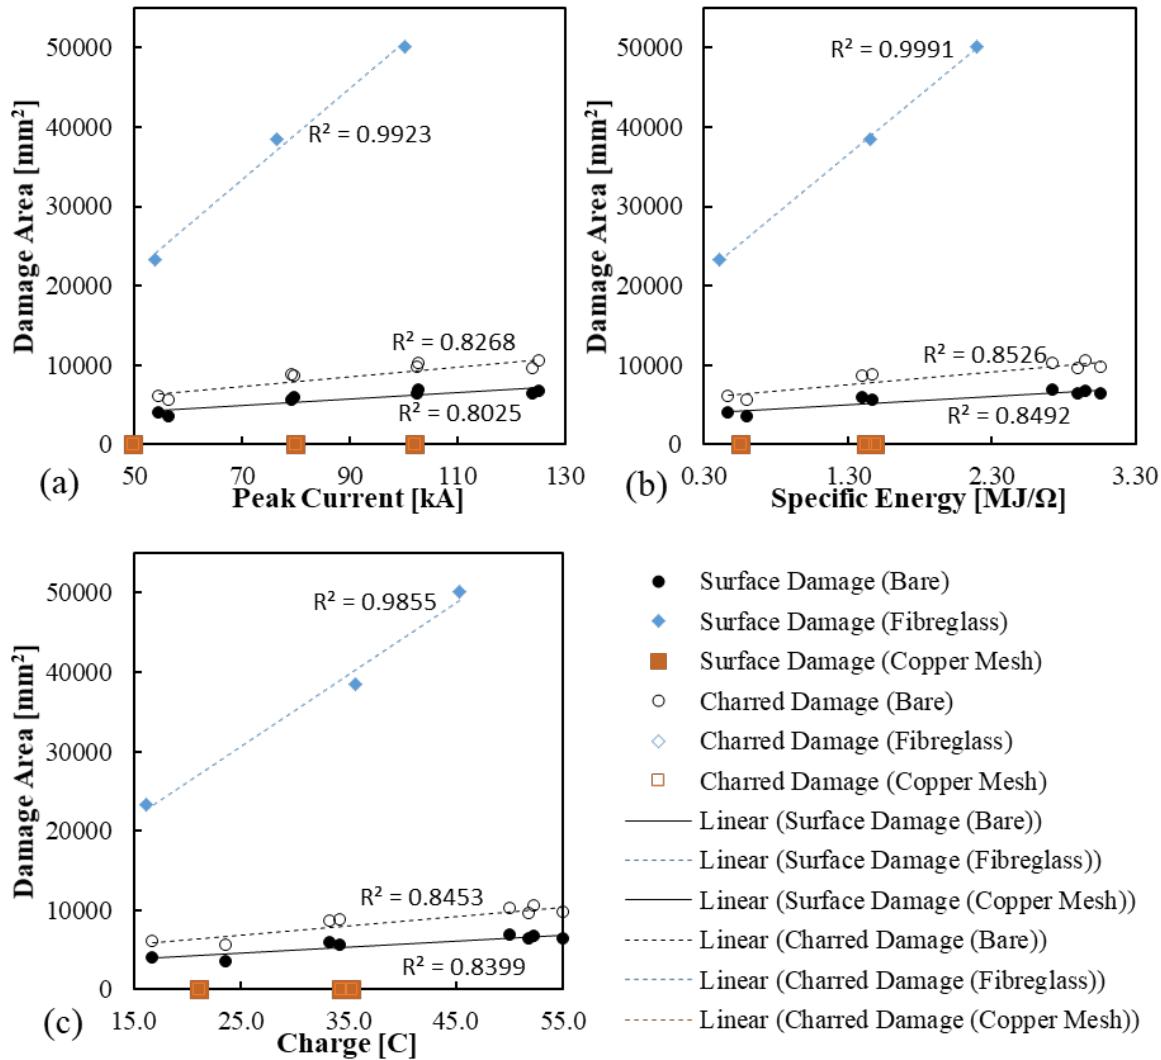
The damaged area thermography results vs the peak current, charge and specific energy are shown in Figure 4.28. Figure 4.28 (a) – (c) all show a similar result with the increasing peak current, charge, and specific energy all increasing the damaged area. The R^2 values can indicate which trends have a closer fit to the data. The specific energy had the highest R^2 values for all the damage trends. The significant results show that the difference in surface types has a drastic difference in the amount of damage. The surface damage was practically zero for all copper mesh specimens. The bare specimens were similar to the AE4 tests. The fibreglass specimens were dramatically different, showing 8 times more damage area than in the bare specimens.

Figure 4.28: Damaged areas recorded using thermography for the AE5 specimens vs (a) peak current, (b) charge and (c) specific energy

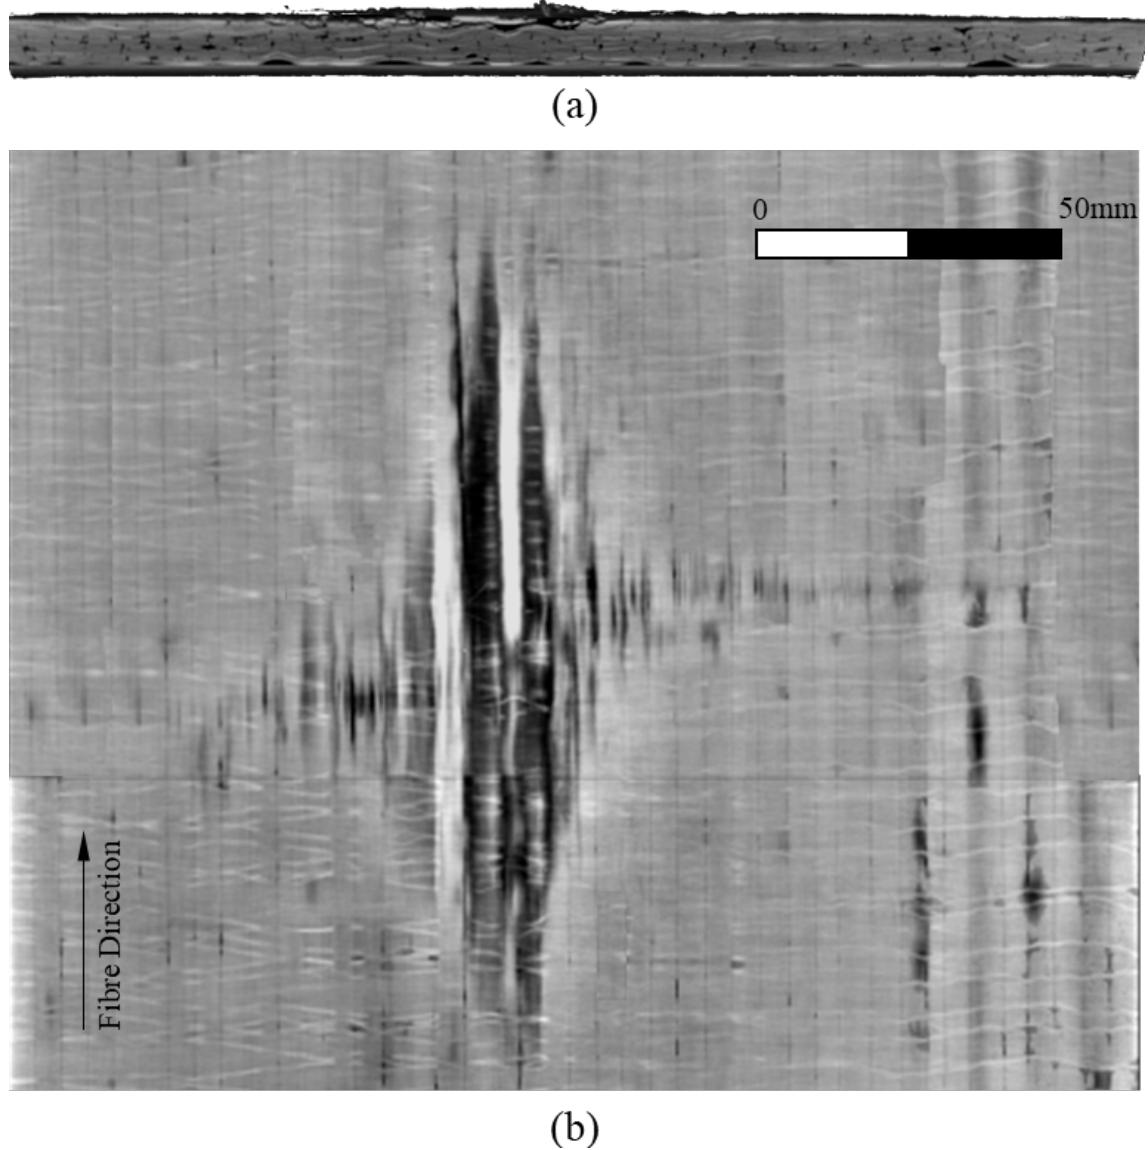
X-ray CT images were also captured and reconstructed for the AE5 specimens. Figure 4.29 (a) shows a cross-sectional view of bare surface specimen and Figure 4.29 (b) shows a plan view of the same specimen. The results are very similar to the observations for the AE4 specimens.

Figure 4.29: X-ray CT images of damaged bare surface specimen AE5-100-1 which was subjected to 100 kA peak current 10/350 μ s lightning waveform: (a) cross-sectional view and (b) plan view

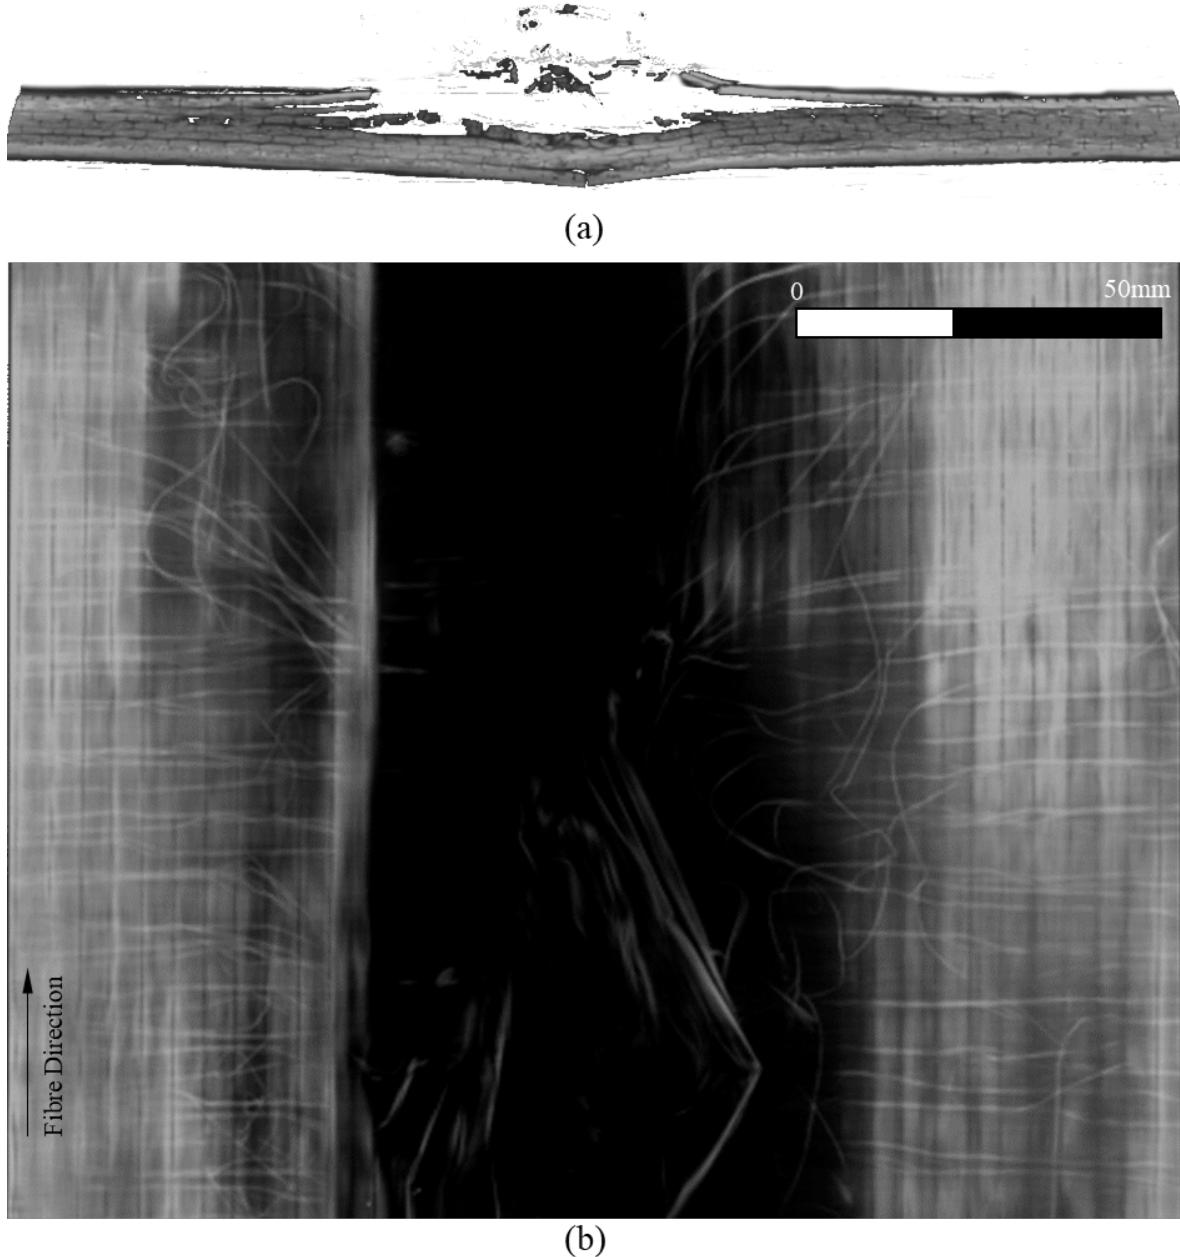
Figure 4.30 shows the X-ray CT images obtained for the fibreglass surface specimens AE5-100-1FG subjected to 100 kA peak current 10/350 μ s lightning waveform. Figure 4.30 (a) shows a cross-sectional view of the damage specimen, from which it is seen that the damage penetrated through the full laminate thickness. The back side, or opposite side from the lightning attachment, of the laminate has broken in the transverse direction. Furthermore, a delaminated region is observed one ply thickness above the back side. Figure 4.30 (b) shows the sub-surface plan view, which indicates a very low-density region indicated by the dark colour in the image. The damaged region starts in the middle of the specimen and extends along in the fibre direction.

Figure 4.30: X-ray CT images of damaged fibreglass surface specimen AE5-100-1FG which was subjected to 100 kA peak current 10/350 μ s lightning waveform: (a) cross-sectional view and (b) plan view

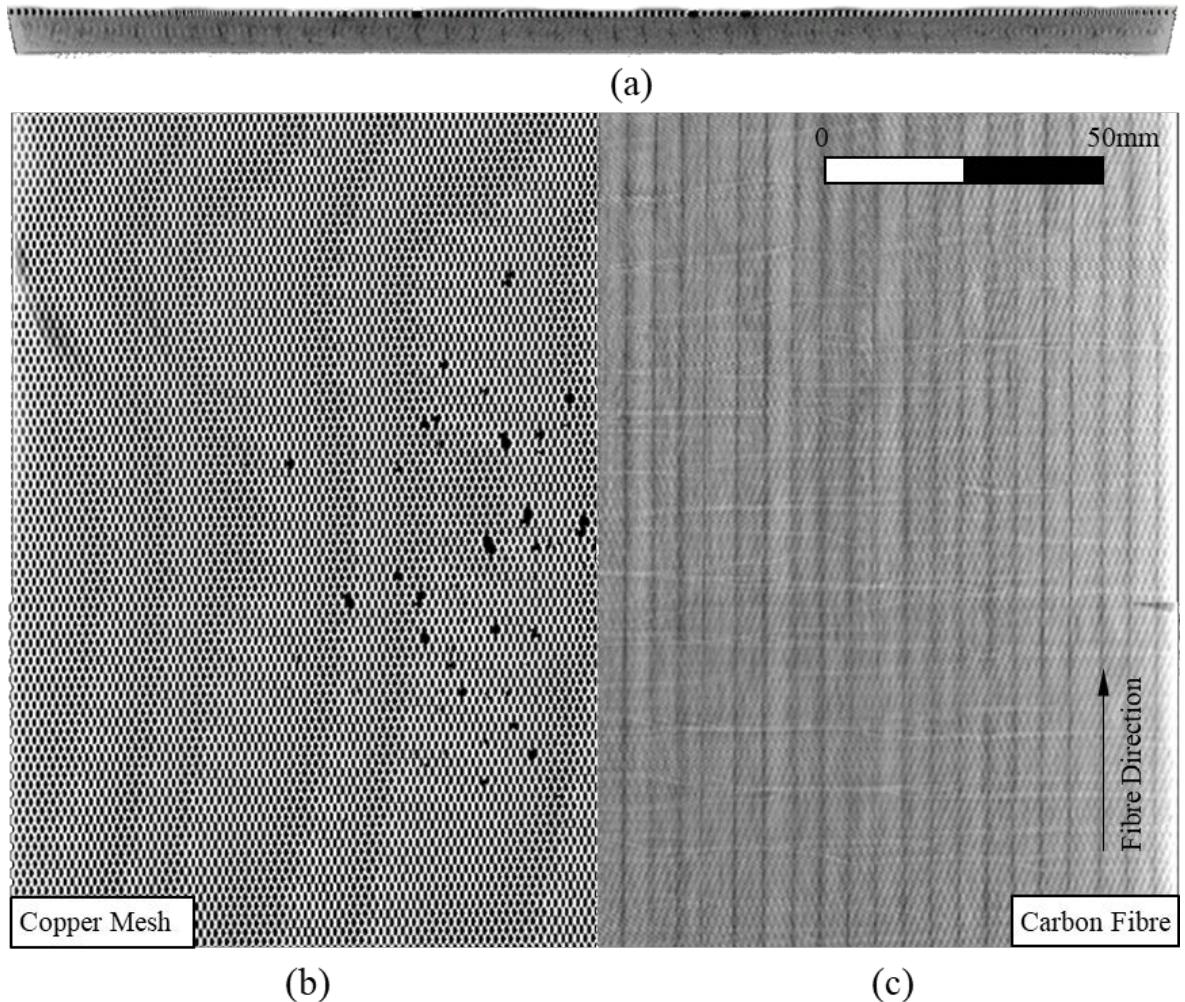
Figure 4.31 shows X-ray CT images obtained for the copper mesh surface specimens AE5-100-1CM subjected to 100 kA peak current 10/350 μ s lightning waveform. Figure 4.31 (a) shows a cross-sectional view, from which no damage can be observed, i.e. no noticeable damage in the CFRP laminate, no delaminations, and no separation between the copper mesh and the CFRP laminate. Figure 4.31 (b) shows a plan view of the copper mesh surface, and from this image it is observed that some of the copper mesh is burnt off. Figure 4.31 (c) shows the first CT slice with the CFRP laminate, and from this it is clear that only the copper mesh and not the CFRP laminates were damaged from the lightning strike.

Figure 4.31: X-ray CT images of damaged copper mesh surface specimen AE5-100-1CM subjected to 100 kA peak current 10/350 μ s lightning waveform: (a) cross-sectional view, (b) plan view of the copper mesh surface and (c) plan view of the top surface of the CFRP underneath the copper mesh surface

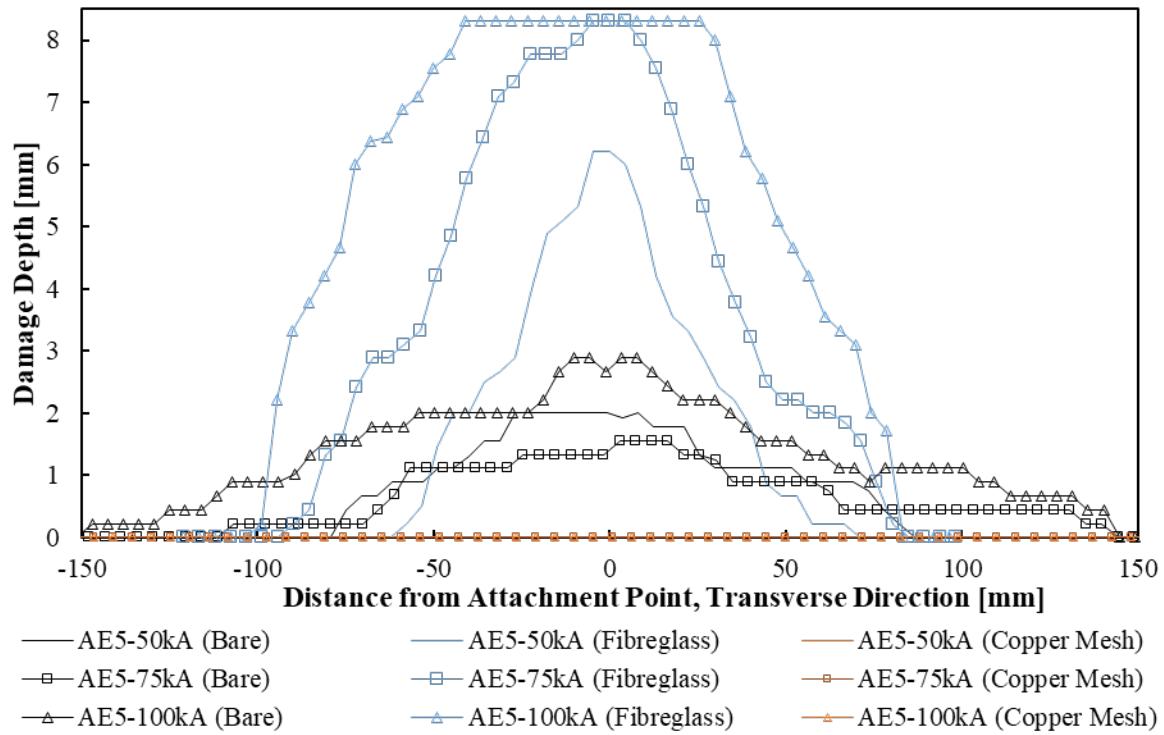
The depth of damage was calculated by using the CT slices from the CFRP laminate only. Figure 4.32 shows the damage depth obtained for all the AE5 samples. The maximum damage depth measured for the bare surface specimens was 35% relative to the undamaged CFRP laminate thicknesses, 100% for the fibreglass surface specimens, and 0% for the copper mesh surface specimens.

Figure 4.32: Maximum damage depth measurements obtained from X-ray CT depth analysis for the AE5 specimens

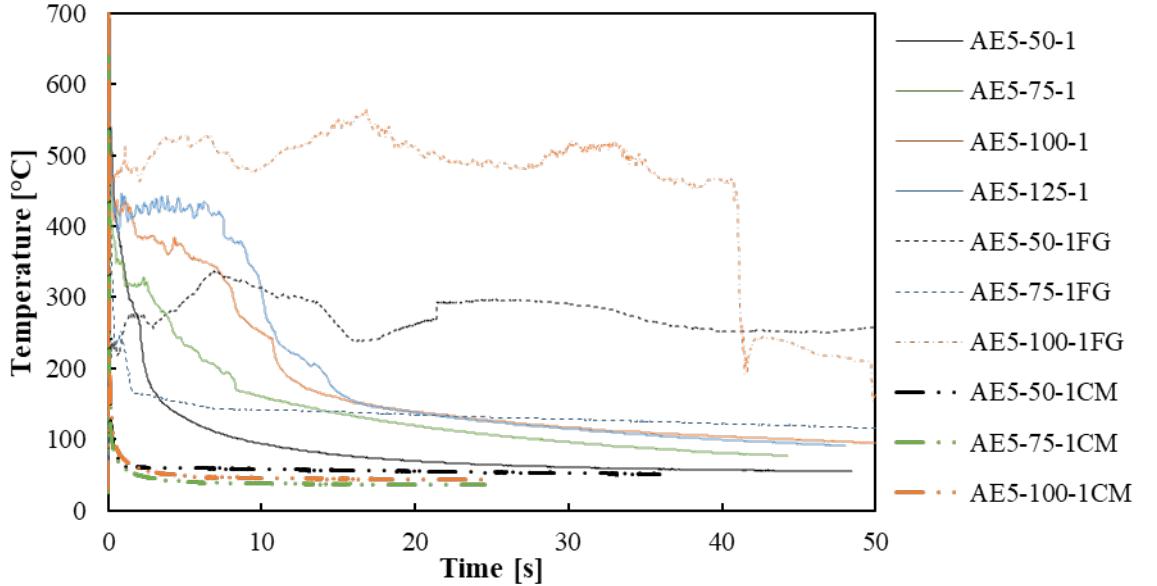
A thermal image video was captured with the thermal camera to study the temperature distribution on the surface of the composite specimens during and after the lightning strikes. The saturation temperature for this camera is 692°C. The temperature data recorded for the AE5 specimens is shown in Figure 4.33. The temperature responses were vastly different for the different specimen surface types. The bare surface specimen started with a large increase in temperature with the maximum temperature reducing to under 100°C around 10s. The fibreglass surface samples held the heat much longer than the other specimens with specimens holding heat over 300°C for more than 50s. This is due to the concentration of the arc, which caused more heat to be induced. The copper mesh surface specimens rapidly cooled back to near ambient temperature in less than 1s. This is due to the higher electrical conductivity in the copper mesh which spreads the arc across the surface more rapidly and reduces the Joule heating effect.

Figure 4.33: Maximum temperature evolution for AE5 specimens

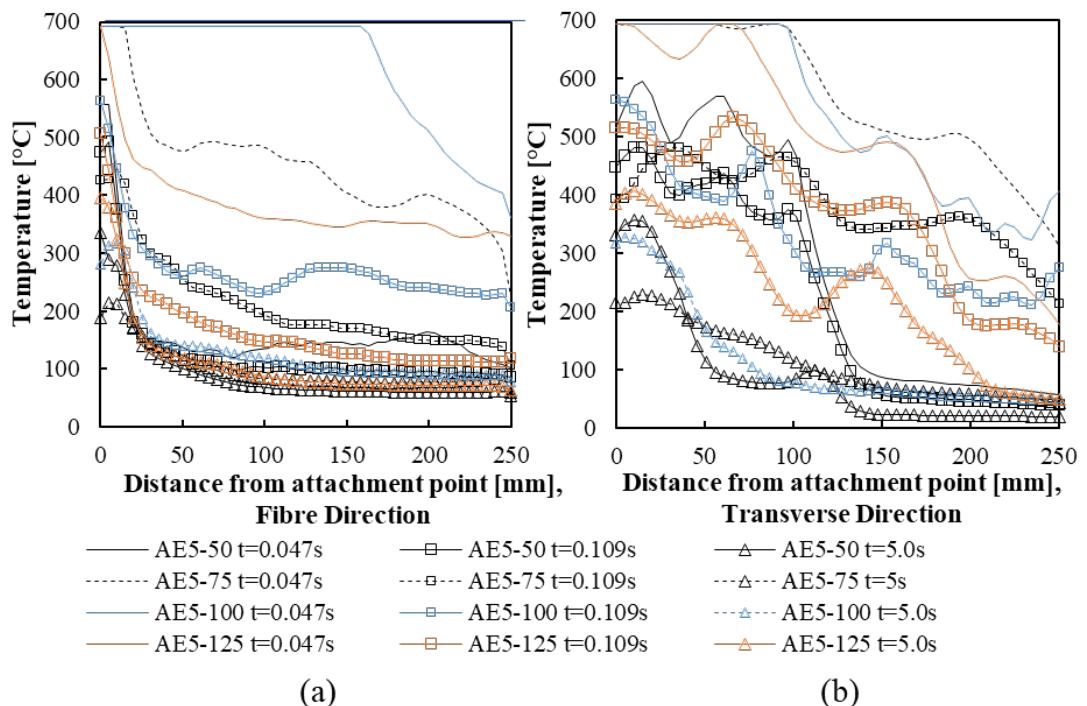
The temperature profile recorded in the longitudinal and transverse directions of the AE5 specimens are shown in Figure 4.34, Figure 4.35 and Figure 4.36 at three specific image frames (times of 0.047s, 0.109s, and 5.0s after the lightning strike). The temperature distribution observed for the bare surface shows a rapid decrease in temperature in the longitudinal direction Figure 4.34 (a). The temperature distribution for the bare surface shows much wider Joule heating spread in the transverse direction Figure 4.34 (b). This is an expected result after seeing the damage being more in the transverse direction.

Figure 4.34: Temperature distributions observed for the bare surface AE5 specimens: (a) fibre direction and (b) transverse direction
