Thesis: Harrell, T.M. (2019) "Characterisation of lightning strike induced damage in CFRP laminates and components for wind turbine blades", University of Southampton, Faculty of Engineering and Physical Sciences, PhD Thesis.

Characterisation of lightning strike induced damage in
CFRP laminates and components for wind turbine blades

Thesis for the degree of Doctor of Philosophy

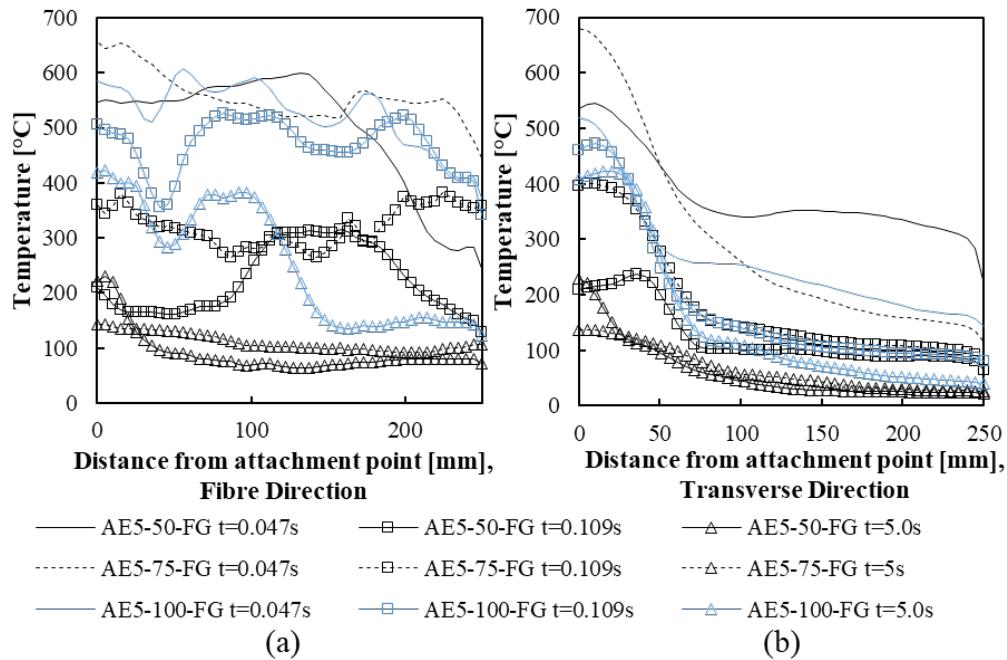
For the fibreglass surface AE5 specimens, the recorded temperature profiles align with the observed damage pattern as the measured temperatures are higher in the longitudinal (fibre) direction rather than in the transverse direction.

Figure 4.35: Temperature distributions observed for the fibreglass surface AE5 specimens in the (a) fibre direction and (b) transverse direction

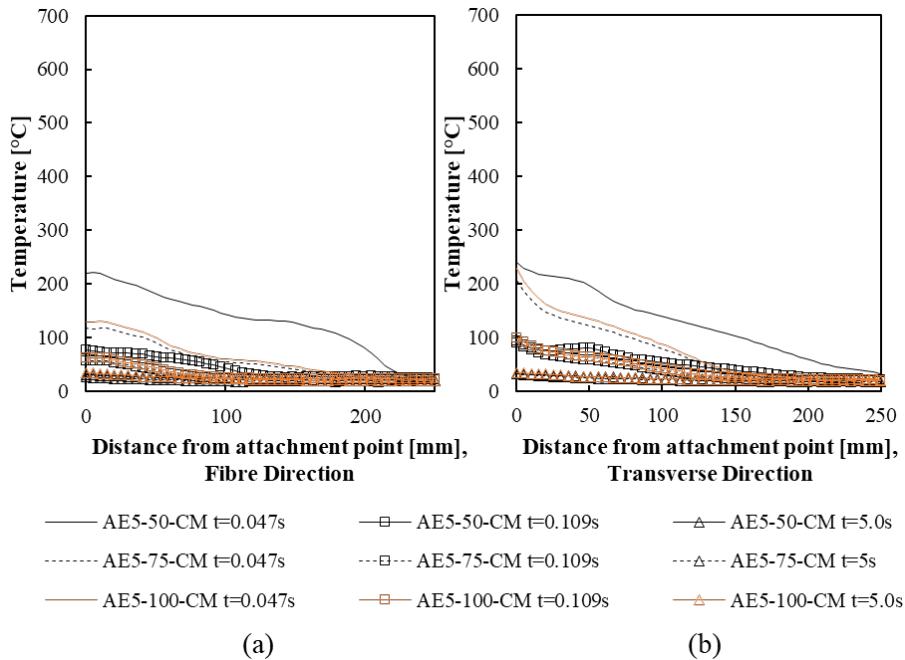
The copper mesh surfaced specimens showed a much smaller temperature rise than the other surface types, see Figure 4.36. The longitudinal direction and transverse directions were similar in size and profile, indicating that the current flows in a circular or nearly circular pattern.

Figure 4.36: Temperature distributions observed for copper mesh surface AE5 specimens: (a) fibre direction and (b) transverse direction

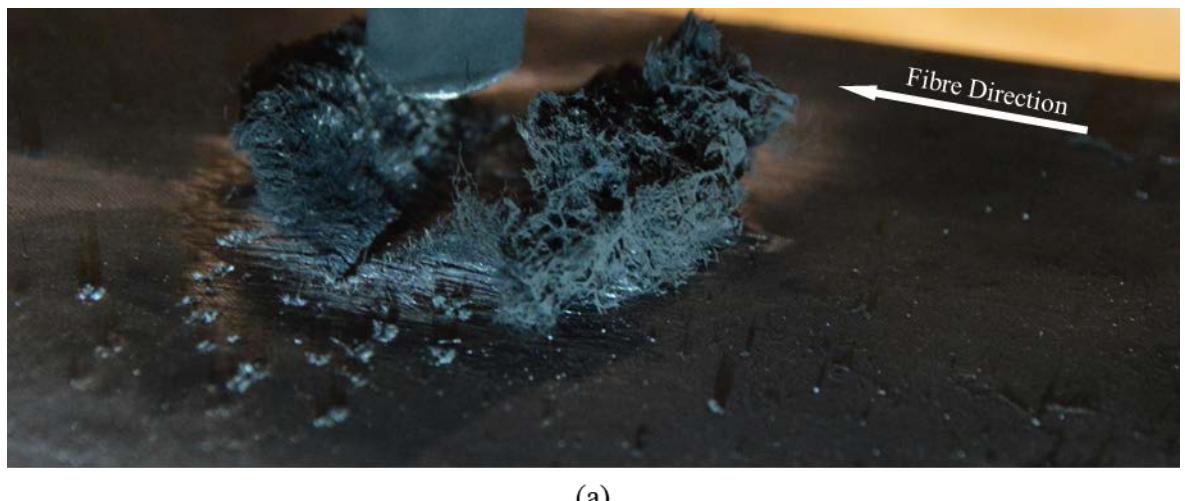
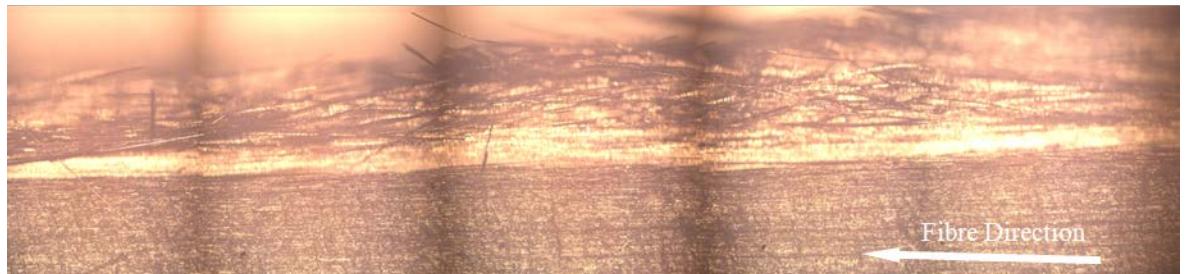
The lightning strike experiments have provided a comprehensive set of data regarding direct attachment lightning strike induced damage in UD CFRP materials. In section 4.6, damage was generally assigned to be surface and charred damage. From the lightning strike experiments reported in this chapter, the induced damage can be further attributed to four different damage types: fibre breakage, delaminations, resin burnoff, and charring. From the experiments conducted, surface damage was associated with fibre breakage, delamination, and resin burnoff. Charred damage was found to encompass all the described damage types, with fibre breakage present at the centre of the surface damaged region. Figure 4.37 shows an image of fibre breakage observed on specimen AE3-2 using an optical microscope. This damage is severe because the loss of fibres has a major effect on the local area strength and stiffness, especially for thin laminates.

Figure 4.37: Typical fibre breakage damage from AE3-2 experiment where (a) is a close-up image of fibre breakage taken on Nikon DSLR with an 80 mm lens and (b) is a micrograph of fibre breakage at 100x magnification

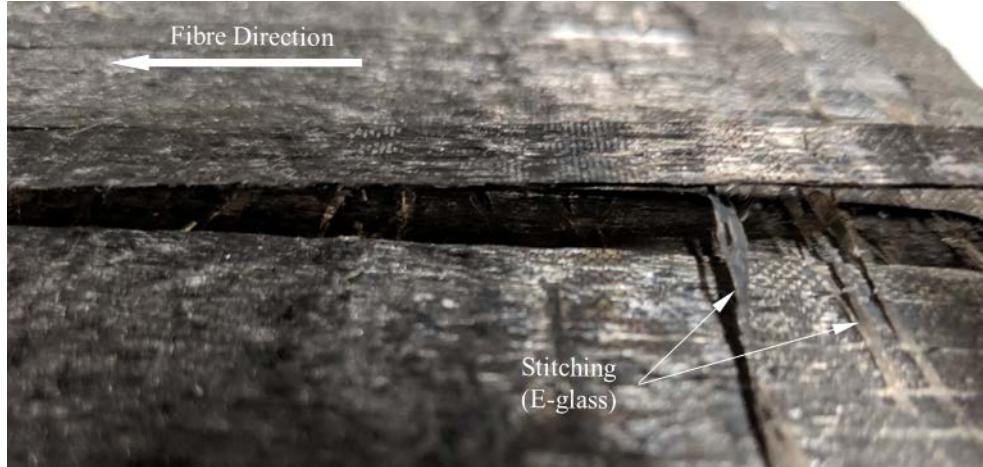
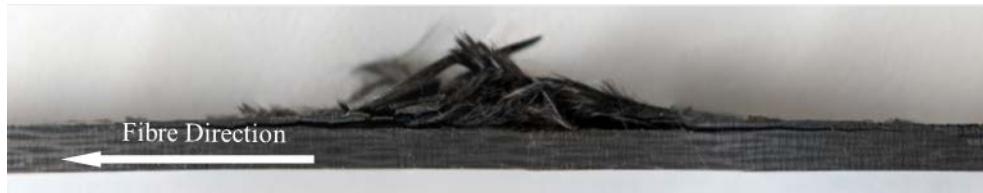
propagating throughout the structure. This type of defect was found through X-ray CT scans and also cutting the specimens followed by cross section evaluation and microscopy. Examples of lightning strike induced delaminations are shown in Figure 4.38 for specimens AE4-12 and AE1-4.

Figure 4.38: Typical lightning strike induced delamination: (a) close-up image of delamination damage in AE4-12 using Nikon DSLR with a 50 mm lens and (b) macro image of delamination in AE1-4 taken using Nikon DSLR with a 50 mm lens and 10x macro lens attachment

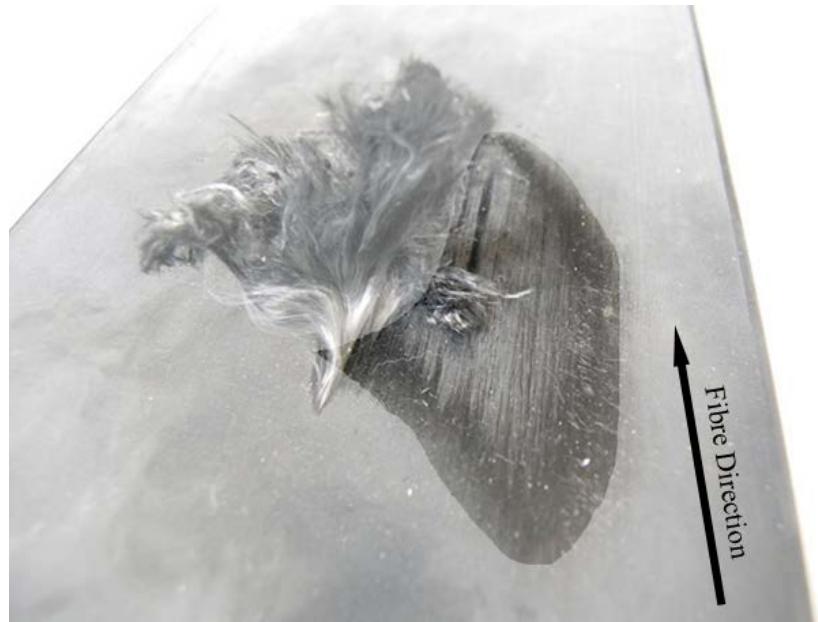
The third damage category is resin burnoff as shown in Figure 4.39. The polymer resin type used in most WT blade structures is epoxy which decomposes when subjected to temperatures between 300°C and 500°C [142]. Above 500°C, the material will char, and ablation will begin above 3000°C [142]. The local compressive strengths and stiffnesses are affected when there is no matrix to support the fibres and hold them in place.

Figure 4.39: Close-up image of the area with resin burn off in specimen AE3-4 taken using Nikon DSLR with 50 mm lens. Undamaged area is shaded.

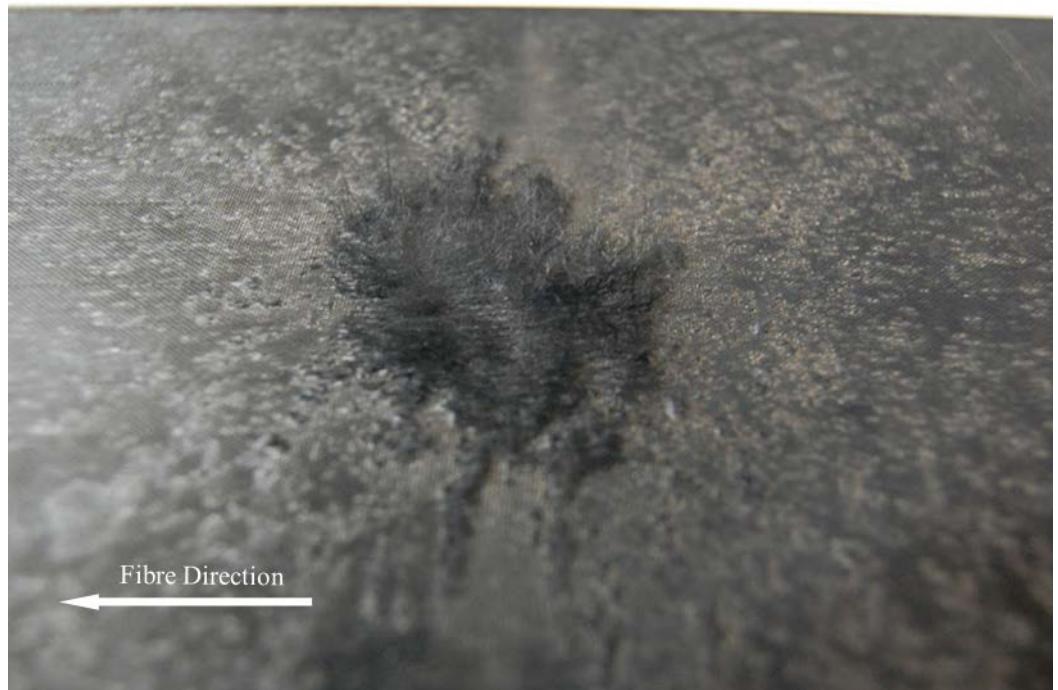
Charring is characterised by the burning of material, usually on the surface as shown in Figure 4.40. It is hypothesized that this does not exert a significant effect on the strength, as it is mainly a surface imperfection, and as it is typically not associated with loss of fibres or resin burnoff as has been observed in microscope investigations.

Figure 4.40: Close-up image of charring damage from specimen AE2-4 taken using Nikon DSLR with 50 mm lens

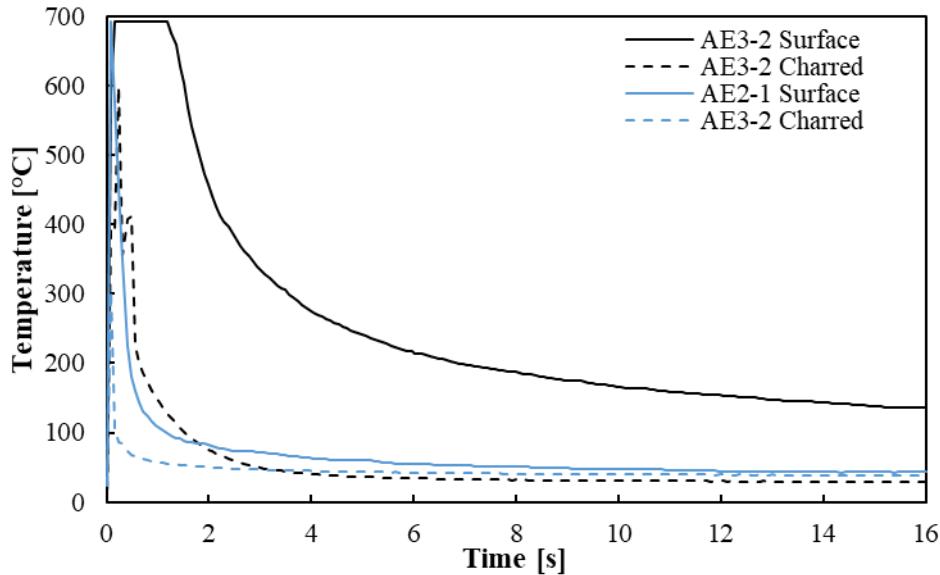
Figure 4.41 displays temperature profiles recorded for specimens AE3-2 and compares the temperature evolution for the surface damage region and the charred damage regions. The observed trend is that the charred damage areas cooled more rapidly than the surface damaged areas.

Figure 4.41: Temperature evolution of the charred damaged areas and surface damaged areas for the AE3 specimens

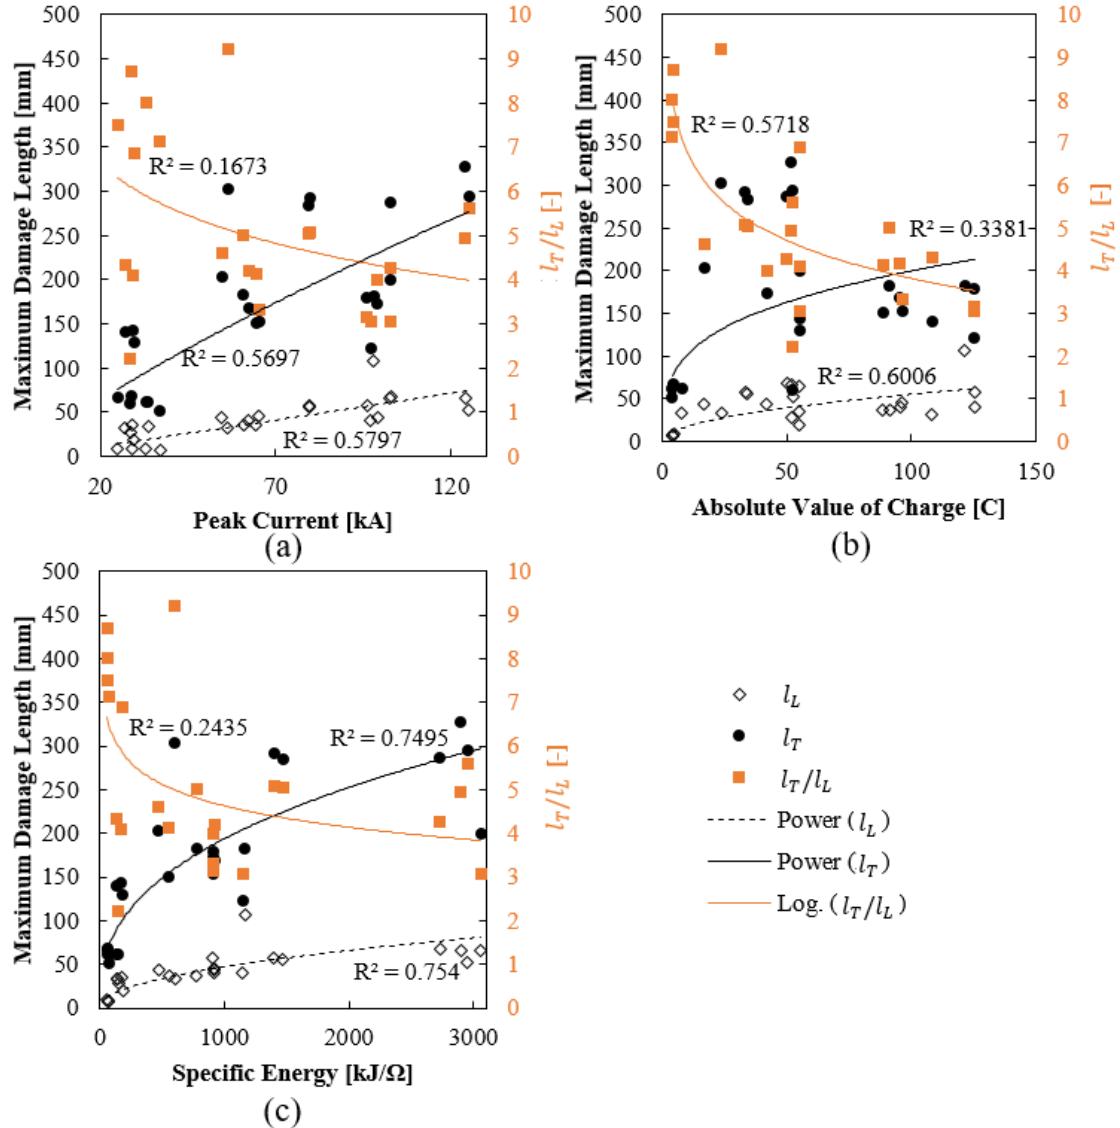
For all the impulse bare surface specimen configurations AE2, AE4 and AE5 (bare), it was found that upon lightning attachment the arc “spread” most significantly in the direction transverse to the fibre orientation. This was observed for both the oscillating and impulse currents. Figure 4.42 presents the results of the damage lengths for all the specimens UD CFRP test specimens subjected to impulse/oscillating current waveforms (AE2, AE4, and AE5 bare surface). Figure 4.42 (a)-(c) all show a similar trend with the damage lengths increasing with increasing peak current, charge and specific energy. It shows that as the damage increases through, the ratio goes down. However, when assessing the ratio of the damage lengths in the transverse direction to the damage length in the longitudinal direction, the average l_L/l_T ratio was approximately 5.11. This observation has not previously been reported in literature to the best knowledge of the author. Moreover, in previous research on lightning strike simulation, the ratio of longitudinal to transvers direction damage due to lightning strike has been reported to be in the range 0.28-0.63 [40], [108], [110] which is the opposite effect where it extends much further in the longitudinal direction than the transverse direction. The phenomena observed experimentally in this research may be attributed to a special condition presented when lightning strikes a UD laminate as used extensively in the load carrying elements of WT blades (especially in the blade regions with the highest risk of lightning strike attachment), whereas the majority of previous research has been conducted for quasi-isotropic laminate configurations that are relevant for composite aero-structures. This shows that there is a

Figure 4.42: Damage lengths results in the longitudinal (fibre) direction l_L and transverse direction l_T with the ratio of transverse length to longitudinal length (l_T/l_L) for all UD CFRP test specimens subjected to impulse/oscillating current waveforms (AE2, AE4, and AE5 bare surface) against (a) peak current, (b) absolute value of charge and (c) specific energy

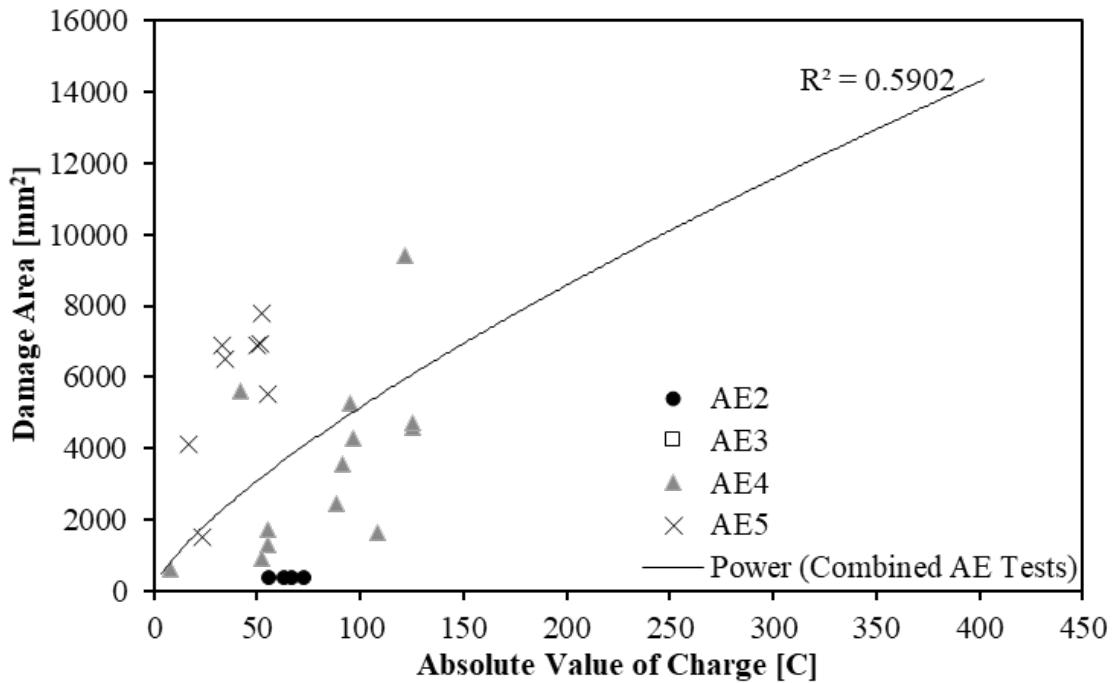
analysis, all the observed data were compiled and compared to each other. Figure 4.43 and Figure 4.44 show the damage area vs absolute value of charge and specific energy, respectively. It is clearly observed that a simple linear regression does not fit closely with the experimental data. Subsequently, various polynomial and power law fitting functions were assessed with their ability to fit the experimental data, and it was shown that the best fits were obtained by power laws.

Figure 4.43: Regression analysis of damage area vs absolute value of charge with power law curve fit to all AE2-AE5 test specimens

From Figure 4.43 and Figure 4.44 it is clearly seen that the best fit correlation coefficient (is obtained for Damage area vs Specific Energy with $R^2 = 0.8075$ against $R^2 = 0.5085$). This is important as the results indicate that the specific energy is more predictive of the damage area. Hence oscillating waveforms may be used where an impulse waveform is not achievable as the oscillating waveform is relatively easier to obtain ultimately offering a more straightforward means of lightning strike damage testing.

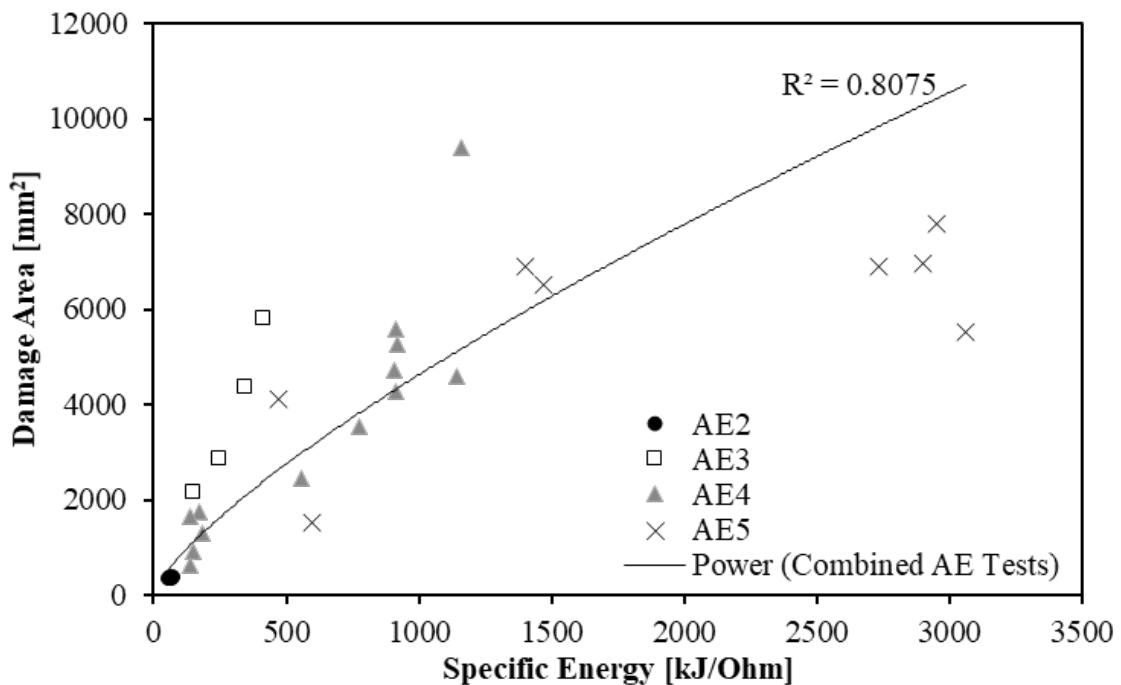
Figure 4.44: Regression analysis of damage area vs Specific Energy with power law curve fit to all AE2-AE5 test specimens

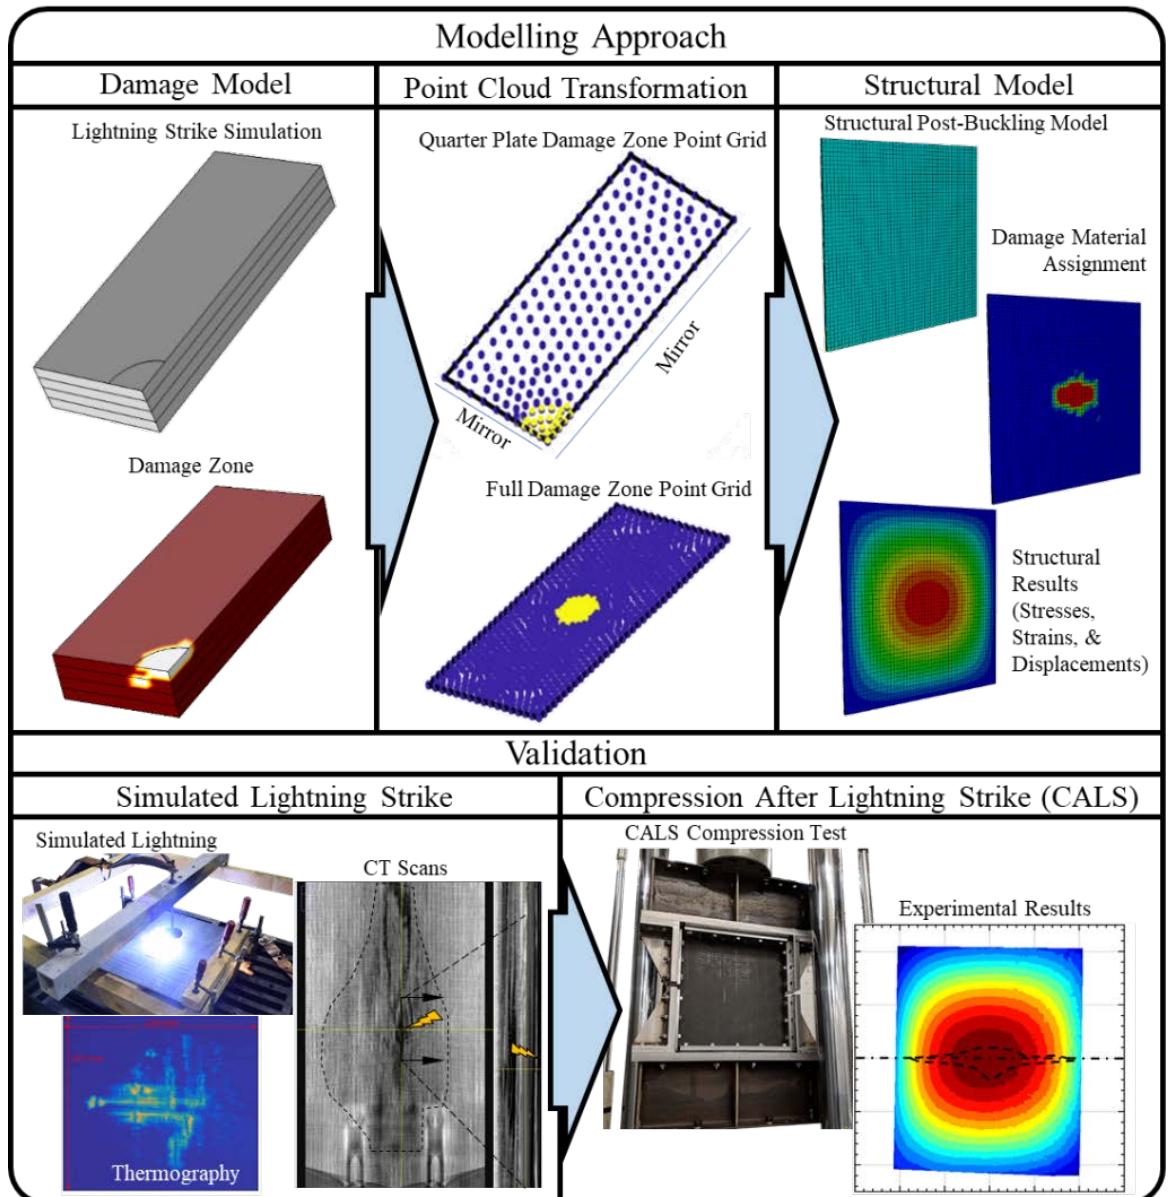
The key deliverable or outcome of this PhD project is a validated modelling framework that can predict lightning strike induced damage to a CFRP laminates and in turn use the results from the damage model to predict the loading response and residual strength. This approach can be achieved in various ways, but for this research, the developed modelling framework consists of a three-step modelling process. A diagram of the developed modelling framework is shown schematically in Figure 5.1. The three stages of the developed modelling approach are:

1. A coupled electrical-thermal meso-scale model (called the ‘Damage Model’), which for given material properties and lightning strike parameters can predict resin damage due to Joule heating.
2. Translate and transfer the meso-scale laminate damage predictions into a structural scale CFRP laminate panel or plate model representation. This is achieved by conducting what can be referred to as a point cloud transformation.
3. A structural model for the damage CFRP laminate. For this research, the damaged CFRP plate is modelled on the structural scale using geometrically nonlinear finite element (FE) analysis with an aim to simulate the load response, first ply failure and buckling behaviour of the damaged laminate when subjected to compression loading (considered as the critical design driver as explained previously in Chapter 2).

Figure 5.1: Modelling framework developed

The combined multi-scale modelling and experimental validation framework is shown in Figure 5.1 (page 113), where the bottom of the figure illustrates the experimental validation approach used. The developed modelling and validation framework have been utilised to assess many different lightning strike scenarios covering the load response and failure/collapse behaviour of undamaged CFRP laminate configurations to varying severity of lightning strike damaged CFRP panels. The developed modelling framework aims to deliver Research Objective 4.

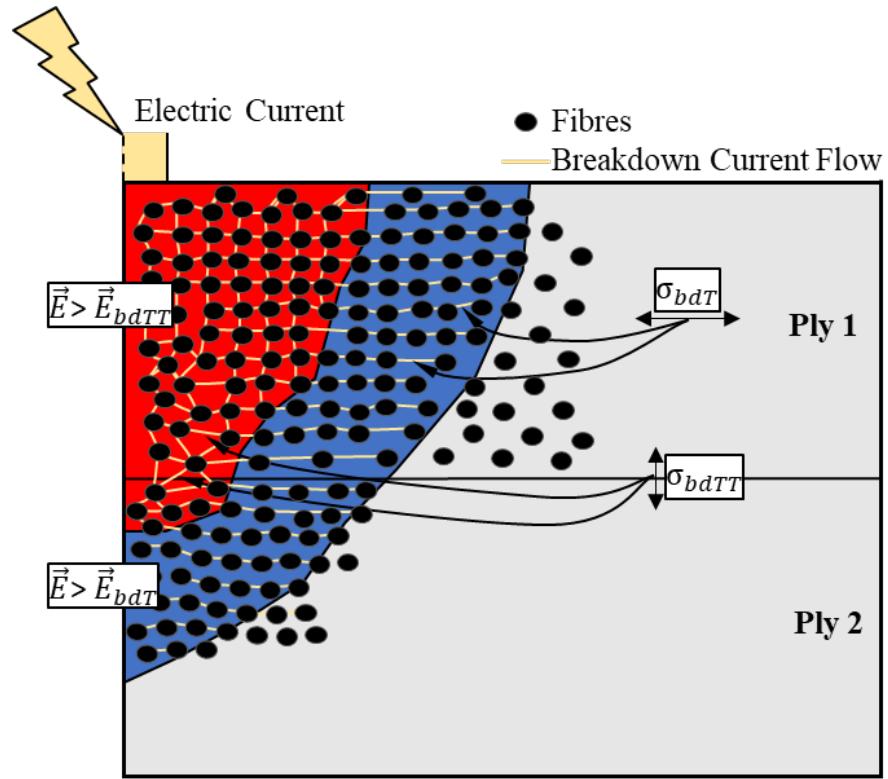
Electric breakdown is a physical phenomenon that can occur when electric current flows through an insulator, and it only occurs when the electric field exceeds the breakdown strength [145]. Note that the breakdown strength is expressed in the unit kV/mm. In other words, any electric field applied that is less than the breakdown strength will not allow current through the insulator. For insulators (including air), this value is typically determined experimentally [145]. For fibre reinforced polymer materials, i.e. composite materials, the polymer resin is an insulator. The breakdown strength is included in the model developed in this project, such that an electric current can flow in directions other than the conductive fibre direction if a given threshold is met. This threshold is the electric breakdown strength. The breakdown strength for the composite laminate assembly is different in the transverse and through-thickness directions, as distribution and amount of polymer resin (epoxy in this case) are different in the 2 directions due to the manner in which the layered laminate stack is compacted, infused and consolidated. Therefore, there are two different conditions set based on whether the electric field can breakdown in the transverse direction, \vec{E}_{bdT} and the through-thickness direction, \vec{E}_{bdTT} . Once the breakdown strength for that direction is exceeded, the electrical conductivity for that direction is changed to something suitably high. This can be seen in Figure 5.2. The red area indicates a region which the electric field has exceeded the through-thickness direction breakdown strength, the blue region has exceeded the transverse direction breakdown strength, and the grey region has an electric field that exceeds neither. The red

regions are associated with having larger conductivities in both the transverse and through-thickness directions. Therefore, a yellow line representing current flow can be seen flowing in both directions. In the blue regions only, the transverse direction is exceeded and accordingly only the current flow is in the transverse direction.

Figure 5.2: Surface discharge and electrical current paths considering the two different breakdown conditions: (Red) electric field greater than the breakdown strength in the through-thickness and transverse directions, and (Blue) electric field greater than the breakdown strength in the transverse direction

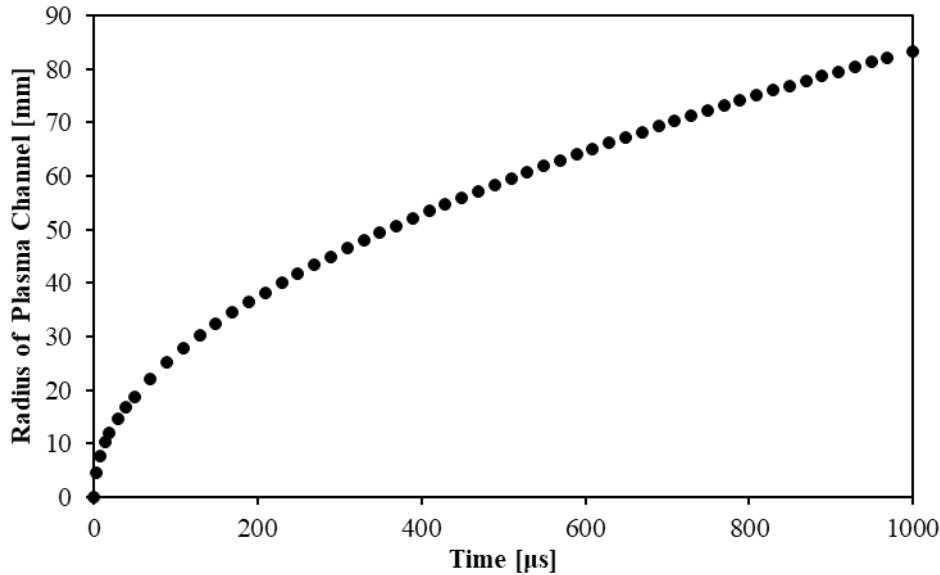
Equation (5.4) describes the expanding plasma channel where the peak current, I_{peak} , is in unit kA, the time, t , is in unit of μ s, and the predicted plasma channel radius, r_p , is in millimetres [149].

Figure 5.3 shows the radius of the current at different times during the model.

Figure 5.3: Radius change of plasma channel through time assuming Braginskii model [149] used in Damage Model

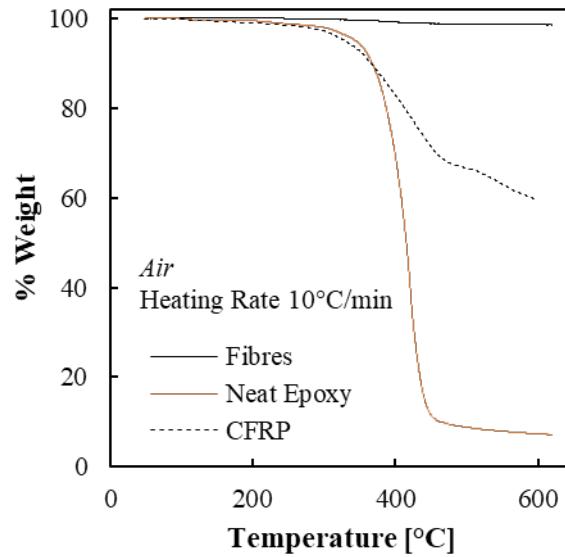
Figure 5.4: Thermogravimetric analysis results in air with heating rate of 10°C/min for the composite components used in this study. The results include all the carbon fibre/epoxy composite laminate with the “CFRP” being the infused laminate, the “Neat Epoxy” being the Baxxodur epoxy resin, and the “Fibres” being the Panex-35 fibres [142].

The pyrolysis behaviour for investigated CFRP material was evaluated using a thermogravimetric (TGA) analyser. The results of the TGA analysis are shown in Figure 5.4.

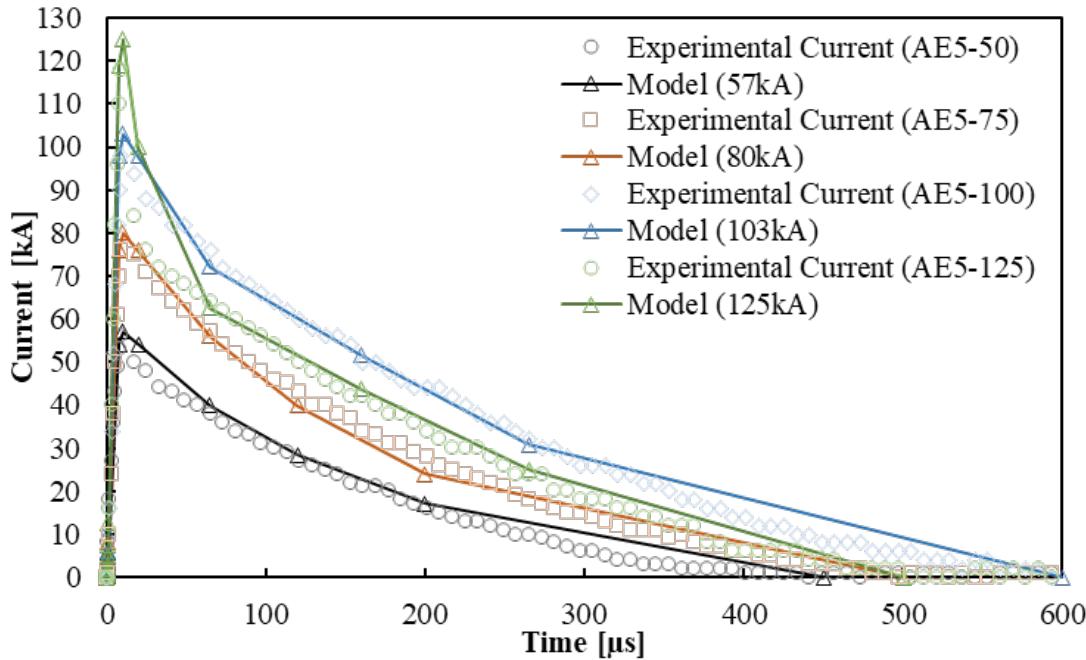
Figure 5.5: Simplified 10/350 μ s waveform used for modelling and experimental waveforms observed during simulated lightning strike tests AE5-50, AE5-75, AE5-100, and AE5-125.

Figure 5.5 shows the currents used for the model as well as the experimental waveforms observed during the simulated lightning strike tests. As reported in Chapter 4 section 4.3.5, several tests were conducted for the AE5 test configuration (see Table 4.5 page 75). Bare surface specimens were used for comparison. The AE5 specimens were subjected to four different loading conditions. Here,

the experimental data obtained for the AE5-50, AE5-75, AE5-100, and AE5-125 tests were used for the current waveforms. A simplified current waveform was used for the model, which matched closely to the experimental waveform.

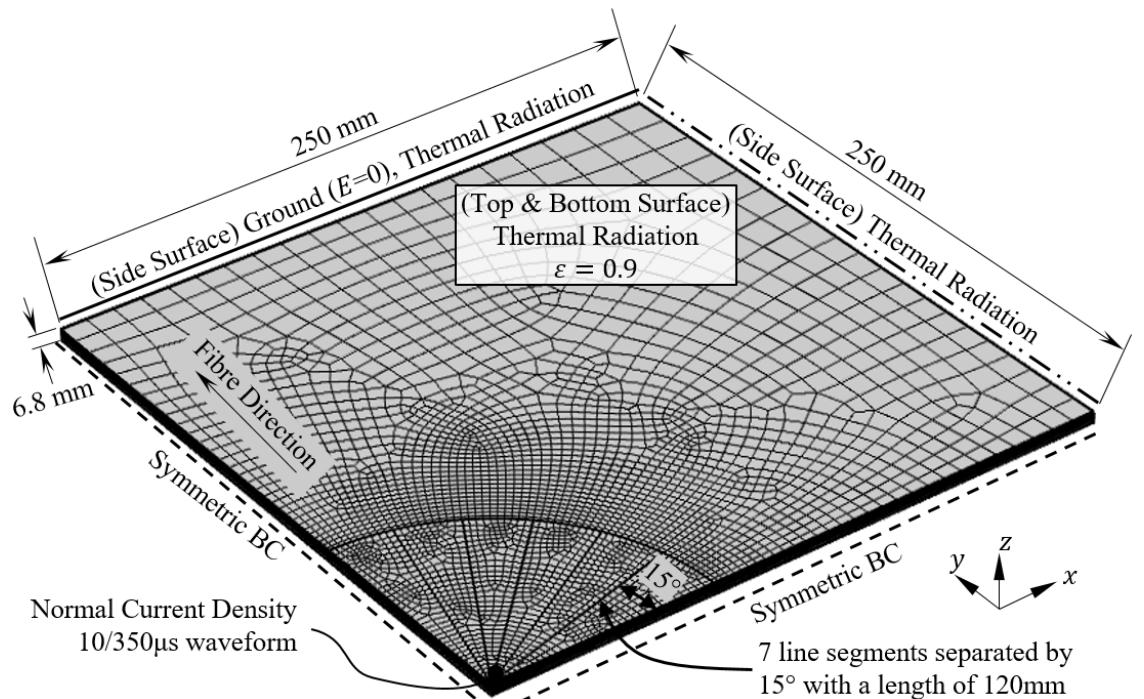
Figure 5.6: Quarter plate FE model with imposed boundary conditions

Figure 5.6 shows the geometry, boundary conditions, and mesh of the model. The CFRP composite panel specimens were made of carbon fibre/epoxy with an 8-ply unidirectional layup. The FE simulation reduced computation time by assuming the panel, the loading and the boundary conditions have 2 symmetry planes. Accordingly, symmetry conditions are imposed on the symmetry planes (xz and yz planes) as seen in Figure 5.6. This means that only a quarter plate FEM is considered. The dimensions of the quarter plate are 250 mm x 250 mm x 6.8 mm. The electric current is applied to the top surface of the model by imposing a normal current density, meaning that the current is orthogonal to the top surface of the plate. The imposed current density is calculated by finding the current at each time step (see Figure 5.5), and then dividing this by an assumed circular area (plasma tunnel radius) at each time step by adopting the radius, r_p , from equation (5.4).

In the FEM one side surface was grounded, where the copper grounds were used in the experimental study (section 4.3.5, Figure 4.8). The FE mesh has 33,815 continuum solid elements, see Figure 5.6. A fine mesh was implemented near the attachment point with element lengths of 1 mm, and a coarser mesh was implemented away from the attachment point with element lengths of

25 mm. Eleven elements were used through the thickness; 2 elements for ply 1,2 and 3 and 1 element through the thickness for the remaining plies.

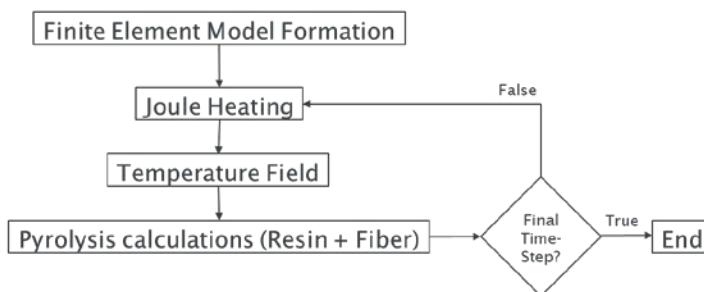
Figure 5.7: Damage Model flow chart

The coupled thermal-electric model is used to predict the temperature evolution associated with a direct lightning strike event, and the predicted temperature field is used to predict the extent of resin pyrolysis that this causes. The extent of the pyrolysis determines the amount of damage inflicted. The simple flow chart shown in Figure 5.7 shows how damage is predicted.

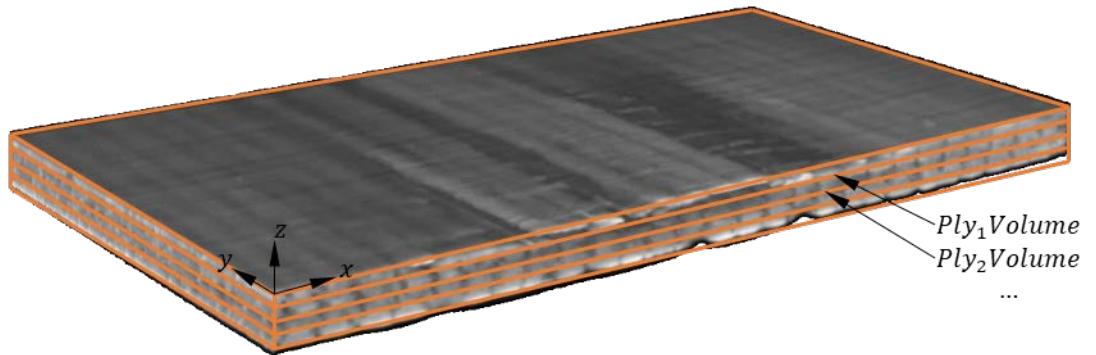
Figure 5.8: 3D greyscale image of X-ray CT volume for AE5-50-1 with overlays of the separated volume for individual plies in an orange colour (volumes are not to scale)

The validation compares the damage depth, shape, and size of the Damage Model, a conventional damage model and the experimental results from the AE5 bare surface test specimens (section 4.6.4). The results for the ply area are re-evaluated in this chapter for a better comparison between the FEM and the X-ray CT data. The areas when compared to the FEM are evaluated via a ply-by-ply basis because the proposed Damage Model uses continuum elements which are evaluated at the Gaussian points. Therefore, a method was devised to determine the results on a ply-by-ply basis rather than a slice by slice basis to provide a more accurate comparison of the results. The X-ray CT scans were separated into different volumes which represented a single ply. This was done by taking the total number of slices of the complete material volume and dividing by the total number of plies in the laminate. Then, the slices were evenly distributed over the total volume, thus leaving the resulting volumes as a representative volume of each ply. A representative image of this process is shown in Figure 5.8 on an example damaged specimen AE5-50-1. The 3D view of the CT image shows the full volume of the specimen with the coordinate system. The number of slices is typically measured in the z-direction as it represents the thickness dimensions of the specimen. The orange blocks represent an extracted volume of each ply which are used for further analysis. The extracted volumes represent the volume from a certain ply as shown by the *Ply_i Volume* indicator where *i* is an index from 1 to the number of plies in the sample.

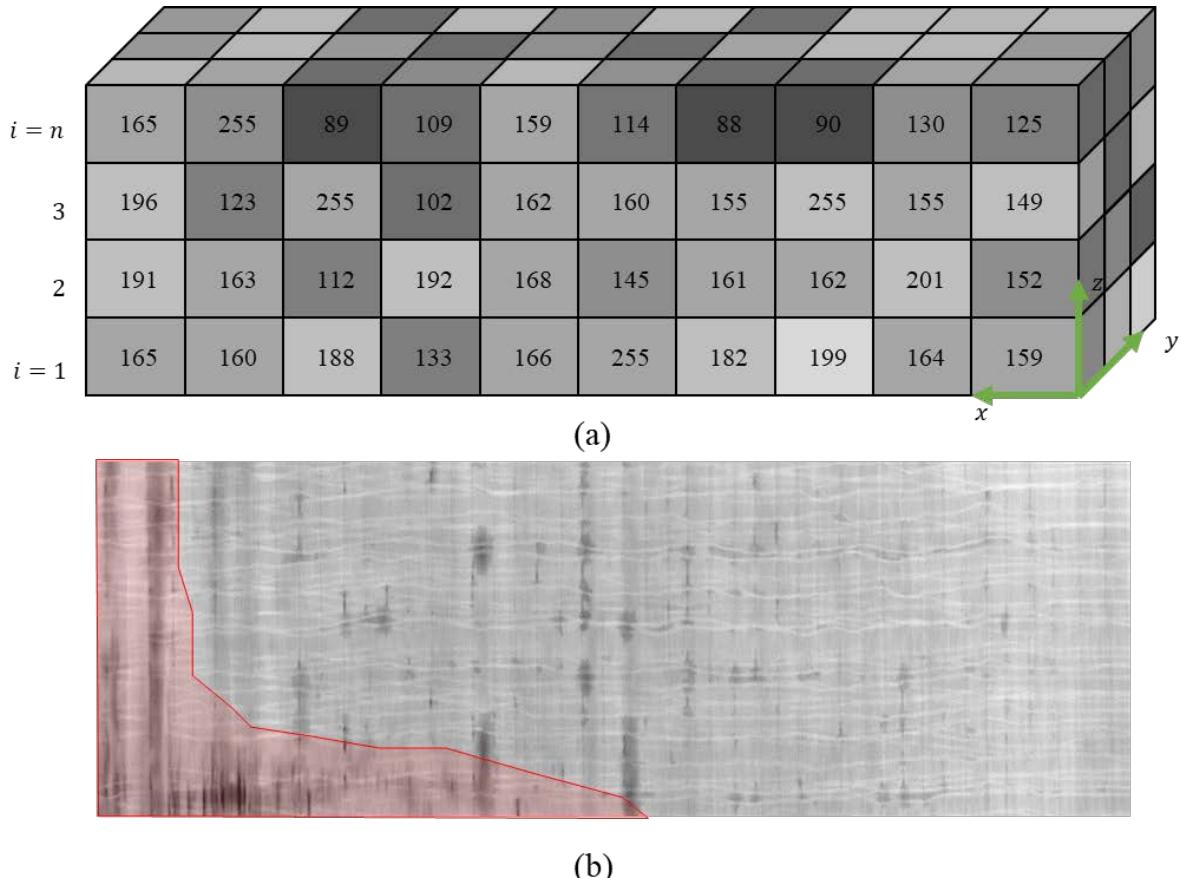
Figure 5.9: (a) A pictorial description of voxels with values from a representative X-ray CT ply volume showing the directions and (b) the result of the Average intensity ZProject on the ply 1 volume from AE5-50-1 with a polygon selection of the damaged area shown in red

Each ply volume was processed through an “Average intensity ZProject” process. This process simply adds the grayscale values from each voxel in the z-direction and divides the sum by the number of slices as indicated in equation (4.4). An example of a typical ply volume showing the directions are shown in Figure 5.9 (a). The volume is made up of voxels with differing grayscale values representing the density of the material at that location.

The Average intensity ZProject produces a 2D image representing an average intensity greyscale value of the ply which is used as a representative image of the ply to determine damage. An example of the results is shown in Figure 5.9 (b) for ply 1 from test specimen AE5-50-1. This 2D image can be separated into damage and non-damaged regions as indicated by the red area overlaid on the average intensity ZProjected image. The number of pixels in this damaged region can be counted and multiplied by the spatial resolution squared to produce the total damage area for the ply.

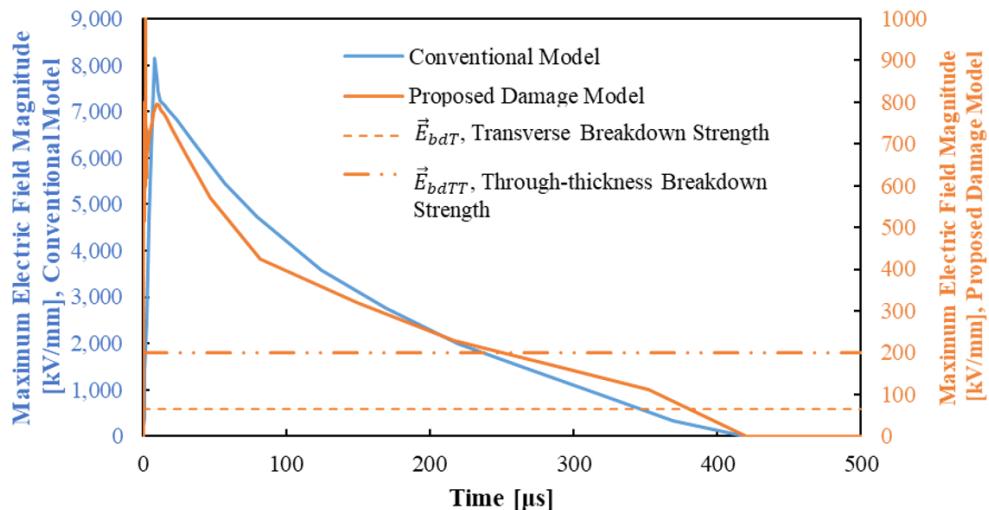
Figure 5.10: Predicted maximum electric field amplitude on the top surface of the specimen with different breakdown strengths – predicted by the electric field dependent and conventional damage models

The main effect of including electric field dependent material properties in the modelling is that the electric field is limited to the excessive build up and this enables current flow in the transverse and through-thickness direction when the critical breakdown strength values are exceeded. Figure 5.10 plots the results from the maximum electric field on the surface in both the proposed damage model and conventional damage model. The plot is shown on two y-axes with the axes being an order scaled to be an order of magnitude different from each other. The plot shows that the conventional model's and proposed model's maximum electric field has the same shape as the electric current waveform being applied. This is to be expected as the electric field is driven by the current. However, the interesting result shows that the electric field dependency dramatically reduces the electric field output by an order of magnitude. At time just before and after the peak current (10 μ s), there is a noticeable shift in the electric field being stunted due to the increased electric conductivity.

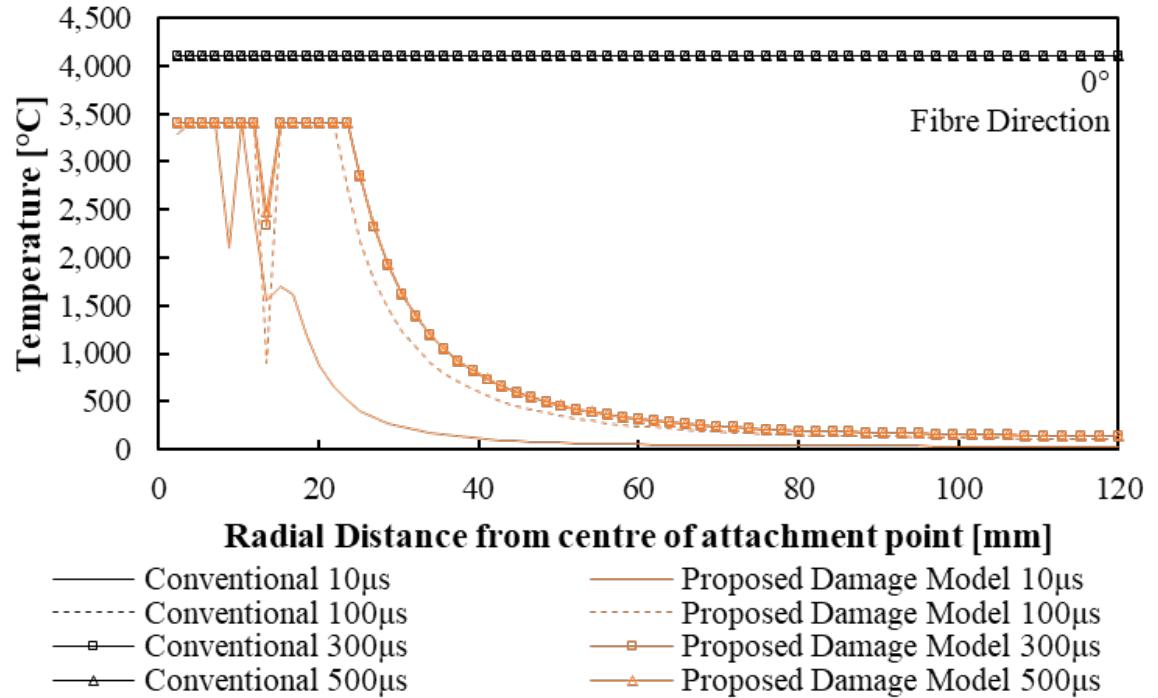
Figure 5.11: Electric field and conventional model predictions: 0° temperature profile from centre of the attachment point to 120 mm radial distance away

Figure 5.11 - Figure 5.13 show the predicted temperature profiles. Changing the probing angle from the fibre direction to the transverse direction show significant differences in temperature responses. Figure 5.11 shows the temperature profile in the fibre direction. The conventional model shows heat built up over the whole probe line and the proposed Damage Model shows a smooth but dramatic lowering of the heat from 3000°C to 300°C approximately 30 mm to 80 mm. Figure 5.12 shows the 45° angle temperature probe line. The temperature profile for the 45° angle probe line shows the conventional model has a temperature response which mimics a step function where the heat is high for the first 30 mm and then a sharp drop of heat response back to near ambient temperature. For the proposed damage model, the temperature is high for the first 35 mm and smoothly but dramatically reduces in temperature. The probe line results from Figure 5.12 can help explain the results in Figure 5.14 where the transition from Joule heating to no Joule heating predicted by the conventional model is observed in the damage pattern. This lack of transition in the presences of a very high electric field leads to inaccurate results. Figure 5.13 shows temperature profiles in the transverse direction (90°). This plot clearly shows the width of the channel the current takes in the conventional model from the heat results. The heat results are significantly high for the first 20 mm and only drop to ambient temperature the further away from the attachment point. The proposed Damage Model shows high temperatures for the first 60 mm and then a smooth transition to lower temperatures extending to the end of the 120 mm probe line. It is also shown for Figure 5.11 - Figure 5.13 that the heat stays in the same location for the conventional model which is indicated by the unchanged magnitude of heat throughout time. Whereas, the proposed Damage Model has an increase in the heat response over time due to the increase in conduction in the transverse direction. This is the reason for the damage pattern spreading in the proposed Damage Model and the lack of spreading in the conventional model. It should also be noted that there is a large difference, about an order of magnitude, between the model temperature predictions compared to the AE5 specimen temperature measurements; see Figure 4.34. A significant contributing factor is that the maximum recordable temperature is 692°C for the camera. In Figure 4.34 it is observed, that this leads to a truncation of the temperature measurements
