Thesis: Harrell, T.M. (2019) "Characterisation of lightning strike induced damage in CFRP laminates and components for wind turbine blades", University of Southampton, Faculty of Engineering and Physical Sciences, PhD Thesis.

Characterisation of lightning strike induced damage in
CFRP laminates and components for wind turbine blades

Thesis for the degree of Doctor of Philosophy

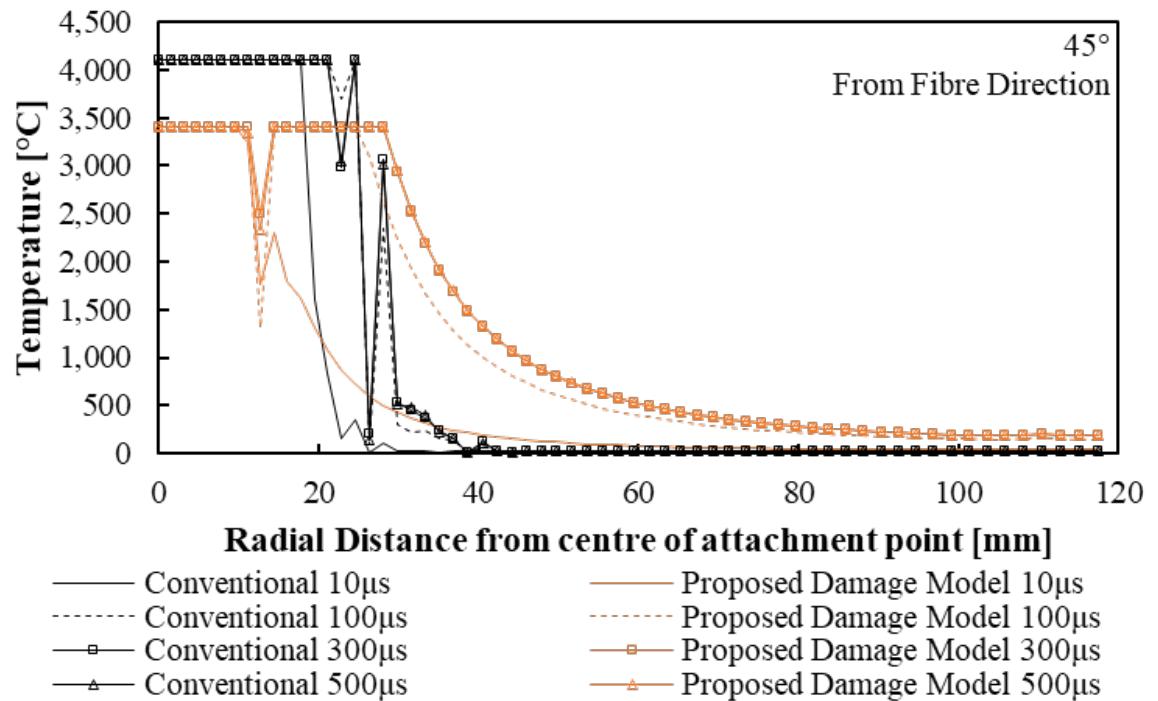
Figure 5.12: Electric field and conventional model predictions: 45° temperature profile from centre of the attachment point to 120 mm radial distance away

Figure 5.11 - Figure 5.13 show the predicted temperature profiles. Changing the probing angle from the fibre direction to the transverse direction show significant differences in temperature responses. Figure 5.11 shows the temperature profile in the fibre direction. The conventional model shows heat built up over the whole probe line and the proposed Damage Model shows a smooth but dramatic lowering of the heat from 3000°C to 300°C approximately 30 mm to 80 mm. Figure 5.12 shows the 45° angle temperature probe line. The temperature profile for the 45° angle probe line shows the conventional model has a temperature response which mimics a step function where the heat is high for the first 30 mm and then a sharp drop of heat response back to near ambient temperature. For the proposed damage model, the temperature is high for the first 35 mm and smoothly but dramatically reduces in temperature. The probe line results from Figure 5.12 can help explain the results in Figure 5.14 where the transition from Joule heating to no Joule heating predicted by the conventional model is observed in the damage pattern. This lack of transition in the presences of a very high electric field leads to inaccurate results. Figure 5.13 shows temperature profiles in the transverse direction (90°). This plot clearly shows the width of the channel the current takes in the conventional model from the heat results. The heat results are significantly high for the first 20 mm and only drop to ambient temperature the further away from the attachment point. The proposed Damage Model shows high temperatures for the first 60 mm and then a smooth transition to lower temperatures extending to the end of the 120 mm probe line. It is also shown for Figure 5.11 - Figure 5.13 that the heat stays in the same location for the conventional model which is indicated by the unchanged magnitude of heat throughout time. Whereas, the proposed Damage Model has an increase in the heat response over time due to the increase in conduction in the transverse direction. This is the reason for the damage pattern spreading in the proposed Damage Model and the lack of spreading in the conventional model. It should also be noted that there is a large difference, about an order of magnitude, between the model temperature predictions compared to the AE5 specimen temperature measurements; see Figure 4.34. A significant contributing factor is that the maximum recordable temperature is 692°C for the camera. In Figure 4.34 it is observed, that this leads to a truncation of the temperature measurements

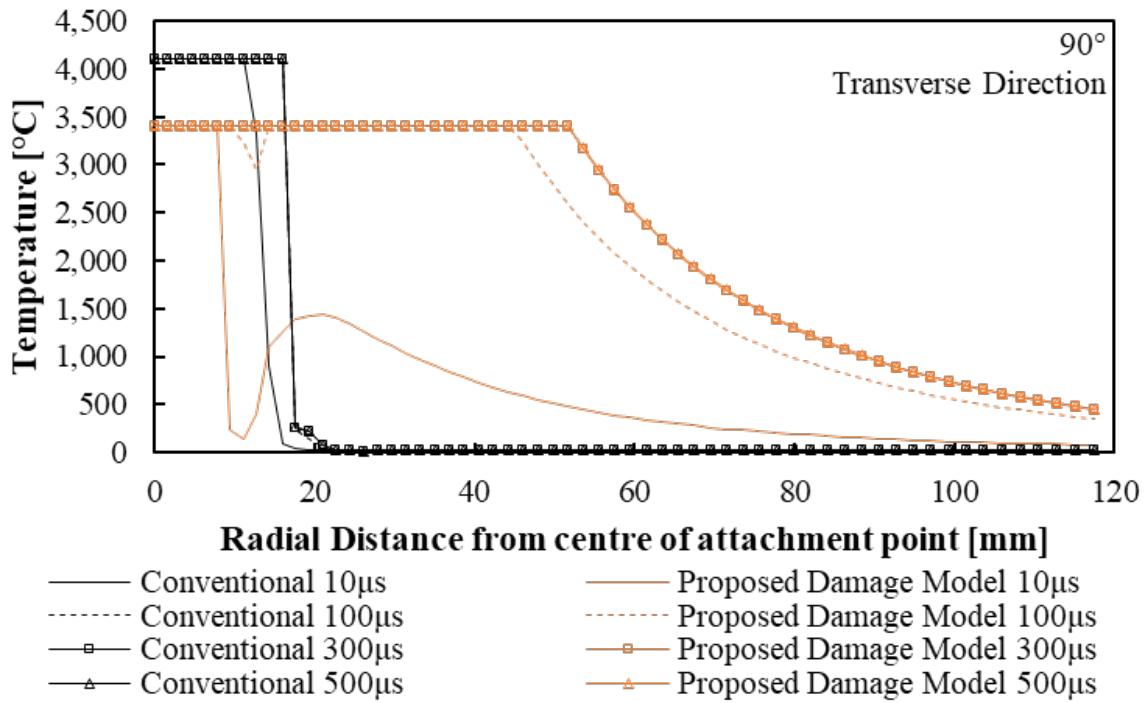
Figure 5.13: Electric field and conventional model predictions: 90° temperature profile from centre of the attachment point to 120 mm radial distance away

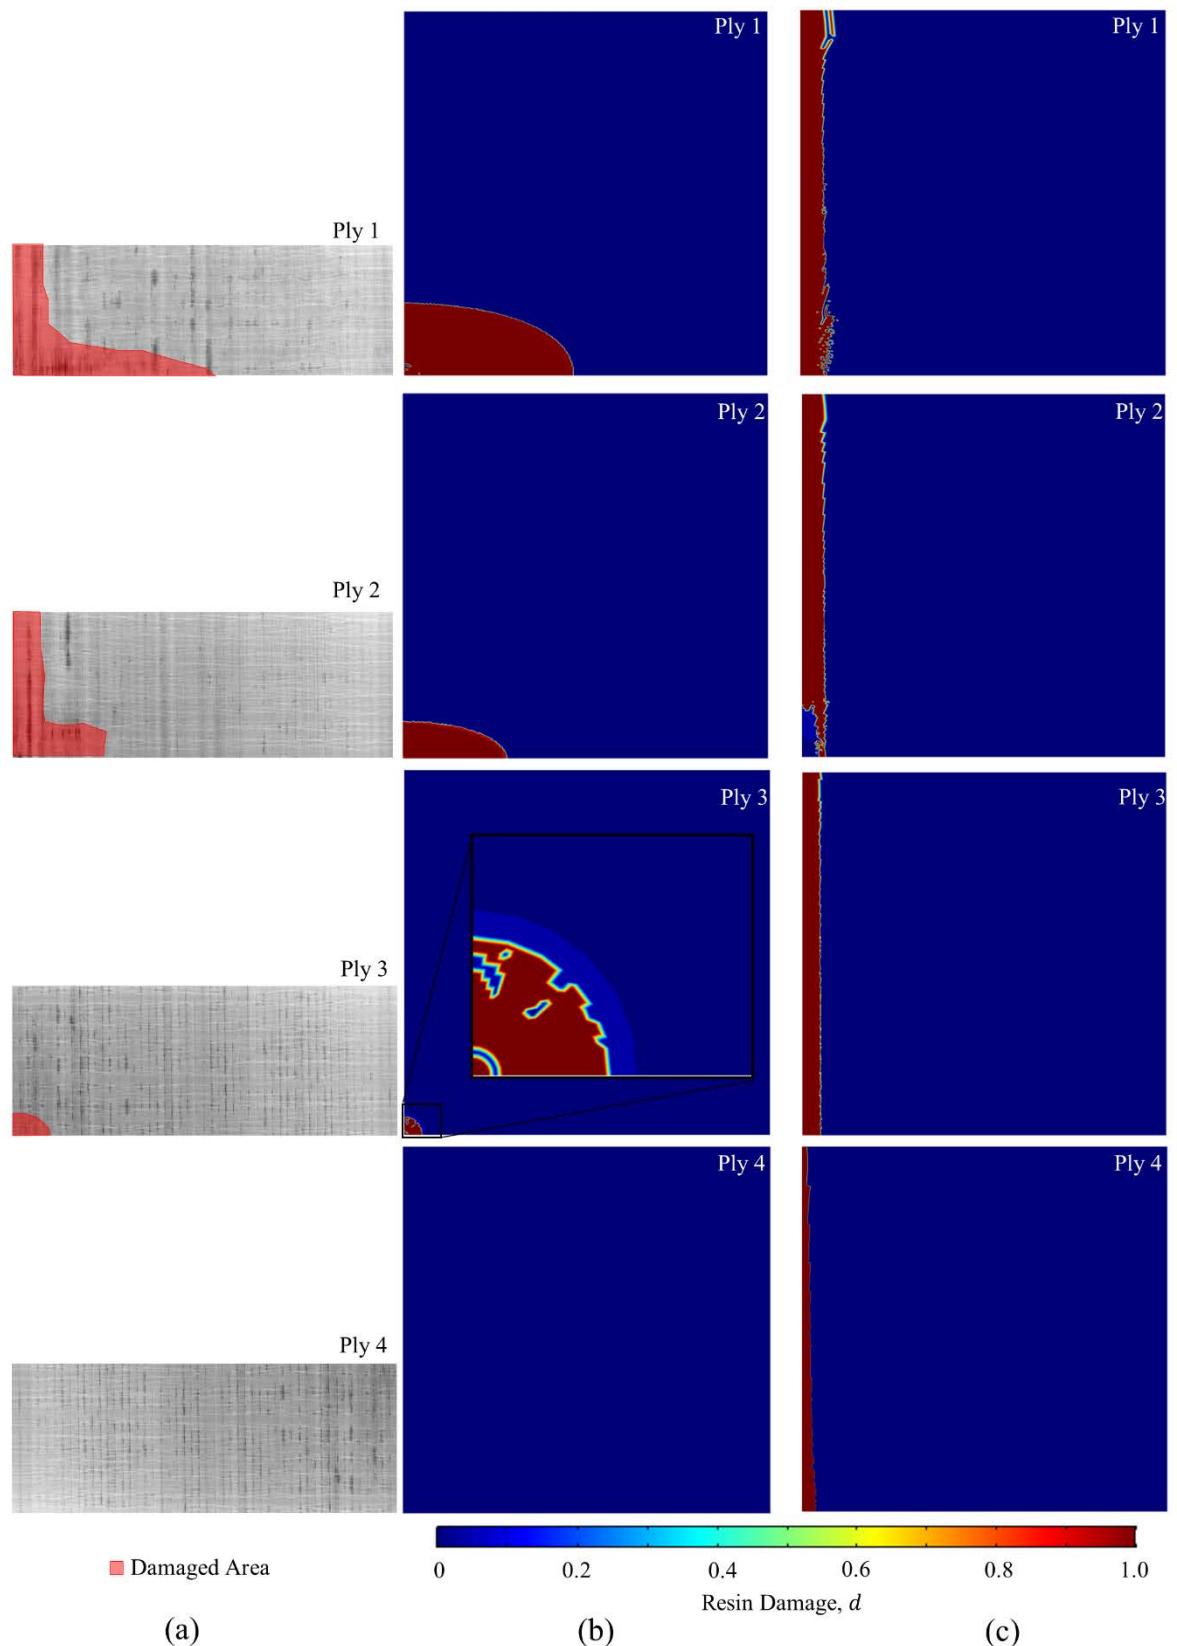
Figure 5.14: Comparison of X-ray CT results vs FE predictions: (a) X-ray scan ply images for specimen AE5-50-1, (b) FE predicted ply damage, and (c) FE predictions for conventional Joule heating model

The electric field model was validated through comparing the model predictions to X-ray CT scans obtained for specimens AE5-50-1 and conventional model with no electric field dependency. The results are presented in Figure 5.14. The comparison shows that the proposed Damage Model has a better match in the transverse direction. There is a lack of damage in the vertical direction and can be seen that the conventional model has a better prediction in this region. However, it is also shown that there is more damage in the depth of the model as indicated by the ply 4 damage present for the conventional model and none in the X-ray CR and proposed Damage Model.

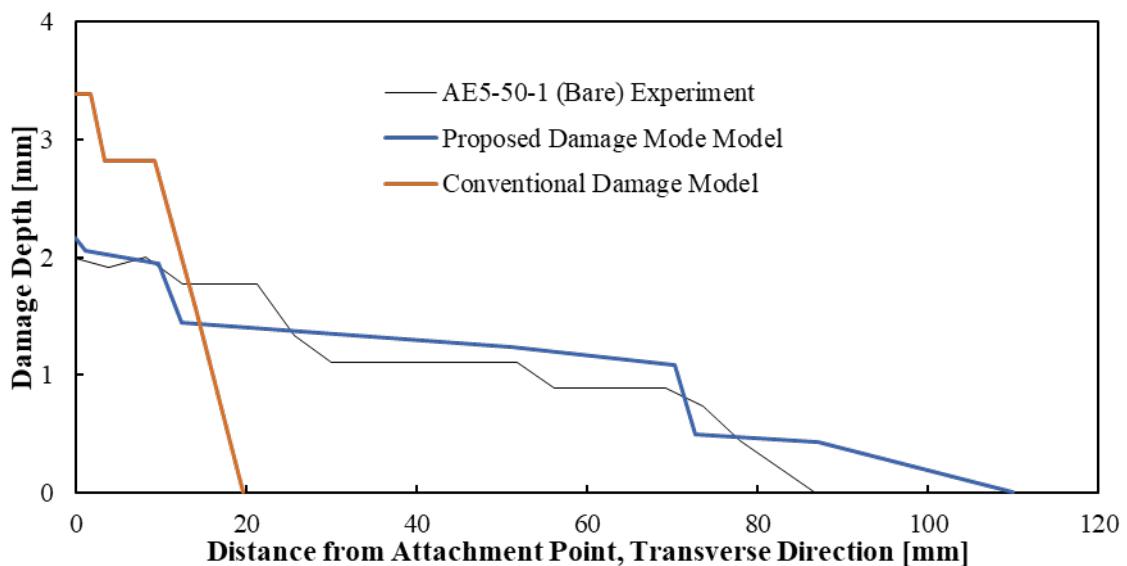
Figure 5.15: Damage depth of model prediction compared to experimental values and traditional damage model

Figure 5.15 shows the damage depth profile from the centre of the attachment point extending in the transverse direction. Two damage model predictions are presented: the electric field dependent Damage Model and the conventional model. These predictions are compared to the X-ray CT data obtained for specimen AE5-50-1 in Figure 5.15. It is observed that the conventional model overestimates the damage depth by 1.7x times the experimental value. The proposed electric field dependent Damage Model was less than 8% different than the experimental value. The damage depth also spread in the transverse direction by over 5 times more than the conventional model. The spread was much closer for the proposed Damage Model with 25% error when compared to the experimental data and the conventional model was 4x times less spread in the transverse direction to the experimental data and resulted in 77% error.

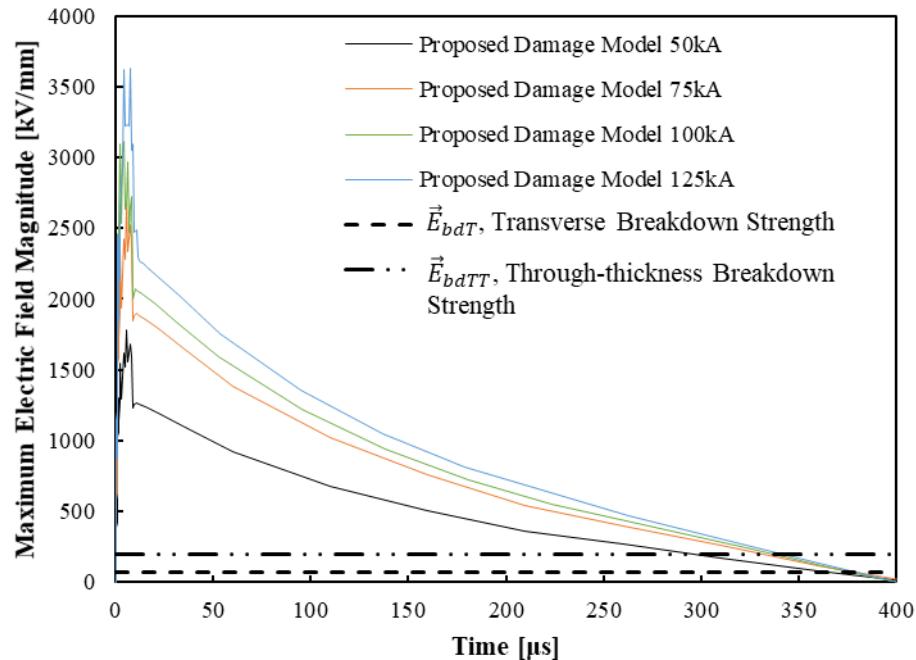
Figure 5.16: Predicted maximum electric field magnitude on the top surface of the specimen for 50, 75, 100, and 125 kA peak current

Figure 5.16 presents the maximum electric field on the top surface of the model for all the simulated cases. The figure presents that with increasing peak amperage there is a linear increase in the electric field on the surface. This indicates that the electric field breakdowns and allows for the conduction in the transverse and through-thickness directions but on the top surface the electric field is still primarily driven by the current density on the top surface.

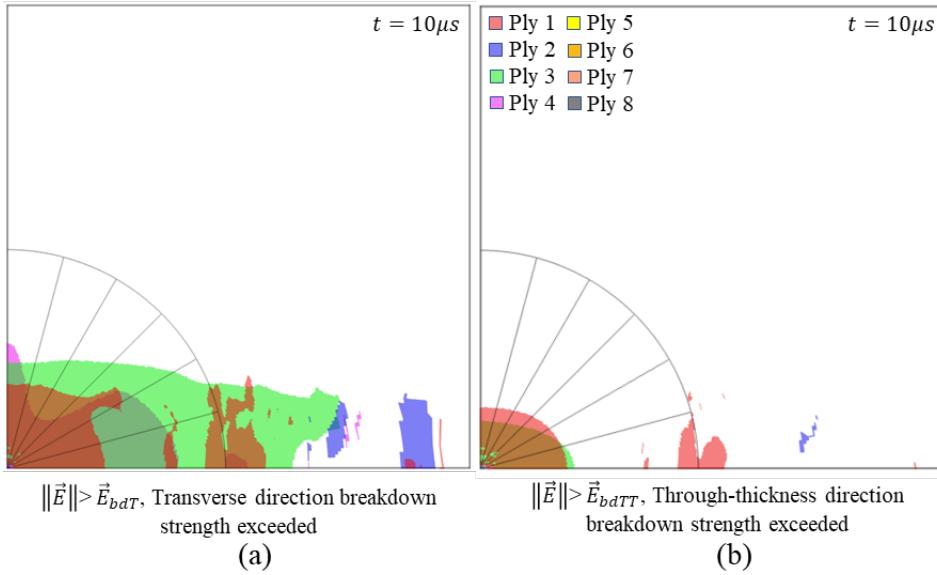
Figure 5.17: Predicted electric field magnitude for the 50 kA model that exceeds (a) the transverse direction breakdown strength and (b) the through-thickness direction breakdown strength by all plies in the laminate

To understand the difference in breakdown, Figure 5.17 - Figure 5.20 present where the magnitude of the electric field exceeded the two different breakdown conditions; \vec{E}_{bdT} and \vec{E}_{bdTT} . Figure 5.17 presents the 50 kA breakdown simulation at the peak current or $t = 10 \mu\text{s}$. Figure 5.17 (a) shows the transverse direction breakdown. It indicates that the transverse direction breakdown develops in 4 plies with the largest spread resulting in ply 3. The primary spread for this breakdown is in the transverse direction and is within the 140 mm circular probe. Figure 5.17 (b) shows the through-thickness direction breakdown. This plot indicates that the through-thickness breakdown develops in 3 plies with the largest area of the breakdown on ply 1.

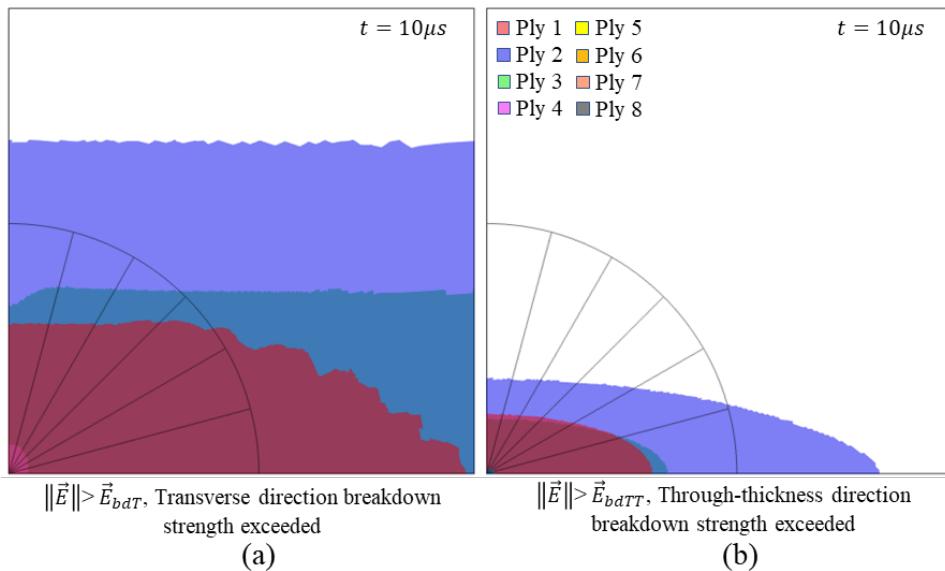
Figure 5.18: Predicted electric field magnitude for the 75 kA model that exceeds (a) the transverse direction breakdown strength and (b) the through-thickness direction breakdown strength by all plies in the laminate

Figure 5.18 presents the 75 kA breakdown simulation at the peak current or $t = 10\mu s$. Figure 5.18 (a) shows the transverse direction breakdown. It indicates that the transverse direction breakdown develops in 4 plies with the largest spread resulting in ply 2. This breakdown spreads in more of a rectangular area which almost envelops the entire sample. Figure 5.18 (b) shows the through-thickness direction breakdown. This plot indicates that the through-thickness breakdown develops in 3 plies with the largest area of the breakdown in ply 2. The through-thickness direction is dramatically reduced from the transverse direction. The shape in the through-thickness direction is elliptical with the major axis in the transverse direction.

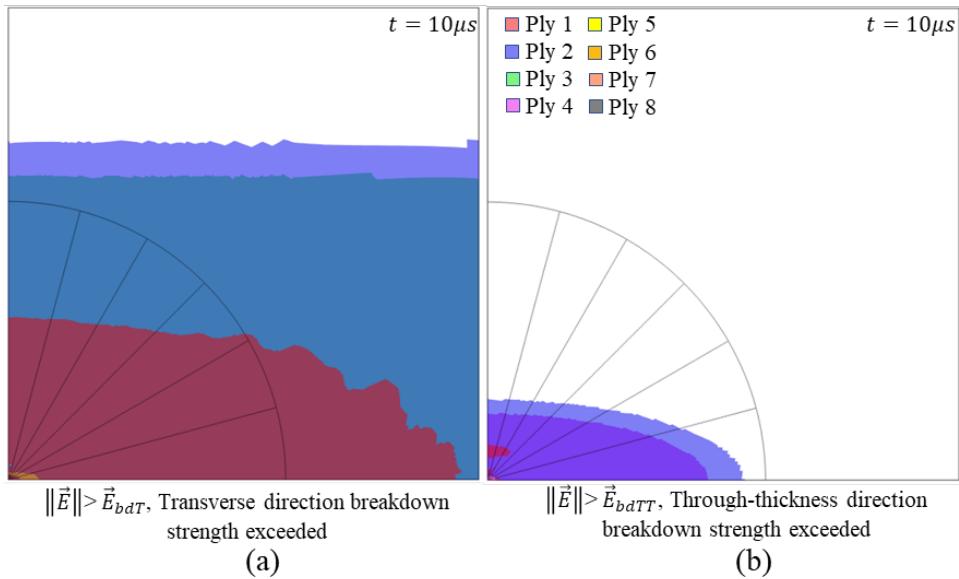
Figure 5.19: Predicted electric field magnitude for the 100 kA model that exceeds (a) the transverse direction breakdown strength and (b) the through-thickness direction breakdown strength by all plies in the laminate

Figure 5.19 presents the 100 kA breakdown simulation at the peak current or $t = 10 \mu\text{s}$. Figure 5.19 (a) shows the transverse direction breakdown. It indicates that the transverse direction breakdown increased the area over the 75 kA model and develops in 5 plies with the largest spread resulting in ply 2. This breakdown spreads in more of a rectangular area which almost envelops the entire sample. Figure 5.19 (b) shows the through-thickness direction breakdown. This plot indicates that the through-thickness breakdown develops in 3 plies with the largest area of the breakdown in ply 2. The through-thickness direction is dramatically reduced from the transverse direction. The shape in the through-thickness direction is elliptical with the major axis in the transverse direction.

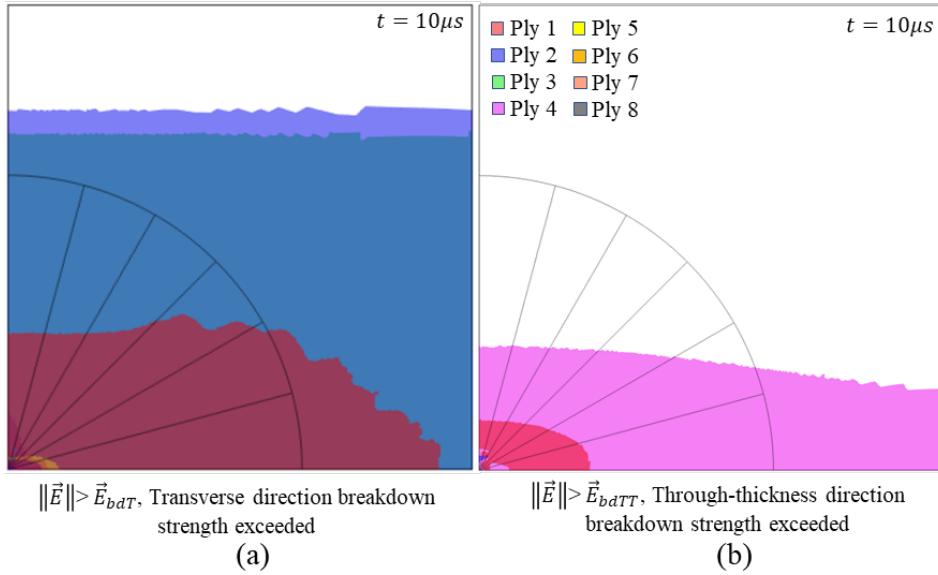
Figure 5.20: Predicted electric field magnitude for the 125 kA model that exceeds (a) the transverse direction breakdown strength and (b) the through-thickness direction breakdown strength by all plies in the laminate

Figure 5.20 presents the 125 kA breakdown simulation at the peak current or $t = 10 \mu\text{s}$. Figure 5.20 (a) shows the transverse direction breakdown. It indicates that the transverse direction breakdown increased the area over the 75 kA model and develops in 5 plies. It also increases the area of ply 4 and ply 5 breakdown. Similar to the previous 75 kA and 100 kA results, the transverse breakdown spreads in more of a rectangular area which almost envelops the entire sample. Figure 5.20 (b) shows the through-thickness direction breakdown. This plot indicates that the through-thickness breakdown develops in 4 plies with the largest area of the breakdown in ply 4. The through-thickness direction is dramatically reduced from the transverse direction. The shape in the through-thickness direction is elliptical with the major axis in the transverse direction.

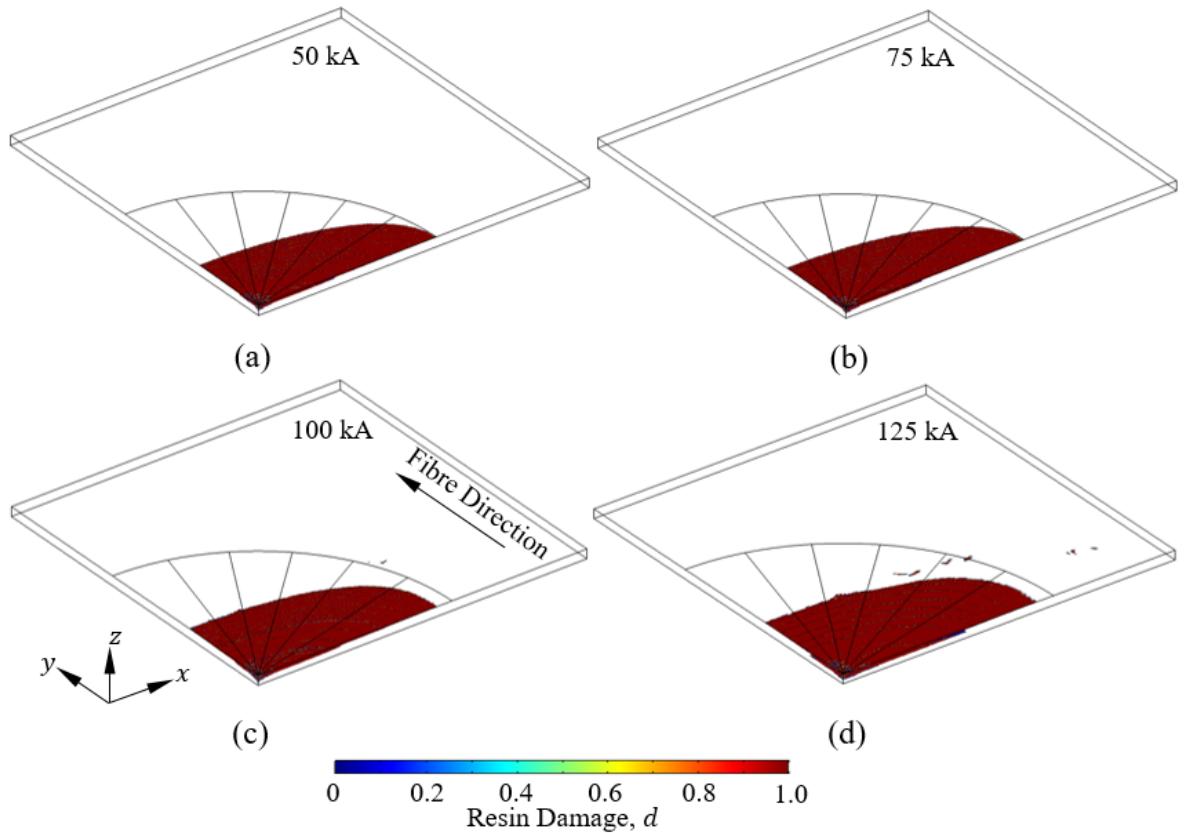
Figure 5.21: Predicted damage in bare surface CFRP laminate based on electric field dependent Damage Model for 4 different peak currents: (a) 50 kA, (b) 75 kA, (c) 100 kA, and (d) 125 kA

In this section the damage predicted by use of the electric field dependent Damage Model is presented for a bare surface CFRP laminate configuration. The simulations were conducted for four different lightning strike cases: 50, 75, 100, and 125 kA (Figure 5.5). For all cases, the shape of the predicted damage was elliptical, with the major axis being in the transverse direction, and the minor axis aligned with the fibre direction. This is similar to the experimental observations, as seen in e.g. Figure 4.30 where the damage is greater in the transverse direction (x -axis) rather than the longitudinal direction (y -axis). Figure 5.21 shows the full damaged regions from the developed model for the 4 different lightning strike cases. Figure 5.21 (a) shows the 50 kA damage results. The damage shows the elliptical damage with the major axis being in the transverse direction and the minor axis aligned with the fibre direction. The length of the major axis is approximately 140 mm. Figure 5.21 (b) shows the 75 kA damage results. A similar shape appears as the 50 kA damage with a slightly elongated minor axis. Figure 5.21 (c) shows the 100 kA damage results. A similar damage shape appears as the 75 kA and 50 kA, but the major axis reduces slightly to about 125 mm and the minor axis increases slightly. Figure 5.21 (d) shows the 125 kA damage results. A similar damage shape appears as the 100 kA damage with a slightly increased minor axis.

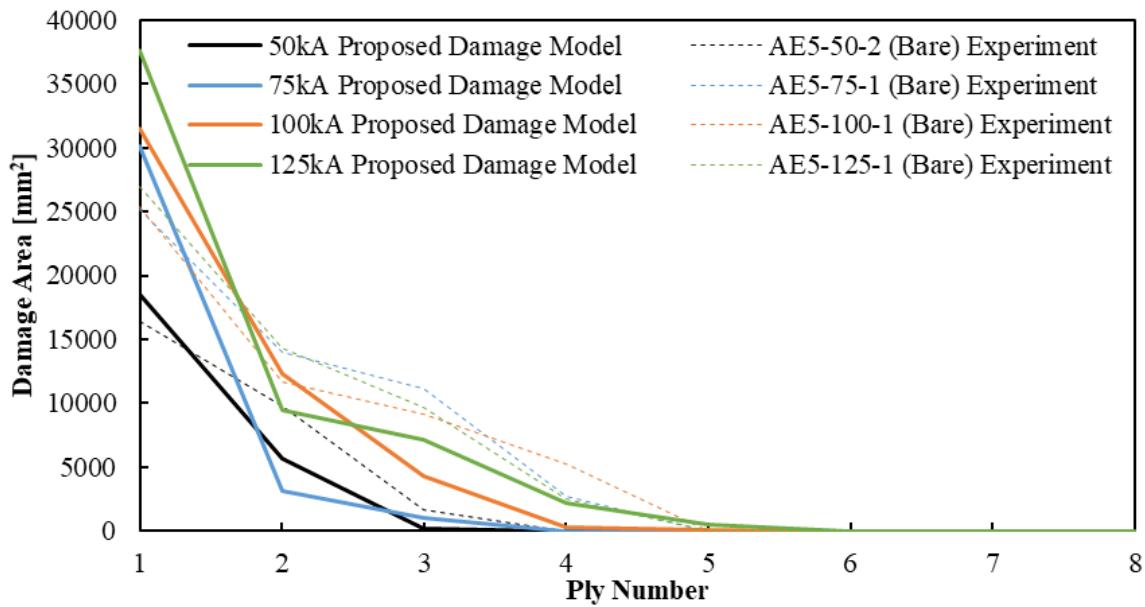
Figure 5.22: Predicted damage in bare surface CFRP laminate – displayed ply by ply – based on electric field dependent Damage Model for 4 different peak currents and X-ray CT measured damage area for the laminate plies from samples AE5-50-1, AE5-75-1, AE5-100-1 and AE5-125-1

Figure 5.22 shows the predicted damaged areas from the proposed Damage Model and the damaged areas of the X-ray CT scans measured ply by ply in the bare surface CFRP laminate specimens. Comparing the results show that the damage area for the first ply is conservative for all the damage intensities. The predictions overestimated the damage in the first 3 plies and underestimated the damage area in the remaining plies. All cases correctly predicted the end of the damage as the predictions for the Damage Model go to zero when the experimental values go to zero.

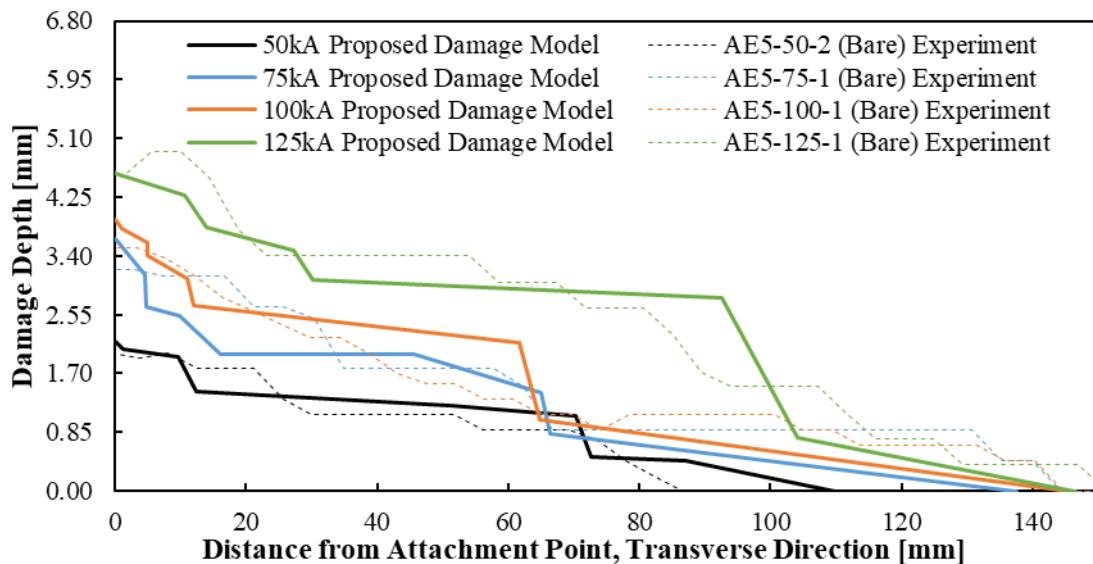
Figure 5.23: Predicted damage depth in bare surface CFRP laminate based on electric field dependent Damage Model for 4 different peak currents

Figure 5.23 shows the predictions for the damage depths and the experimental damage depths in the bare surface CFRP laminate specimens. As seen in the validation, the predicted damage fits well with the experimental damage by showing the correct spread in the transverse direction and the correct depth in the through-thickness direction.

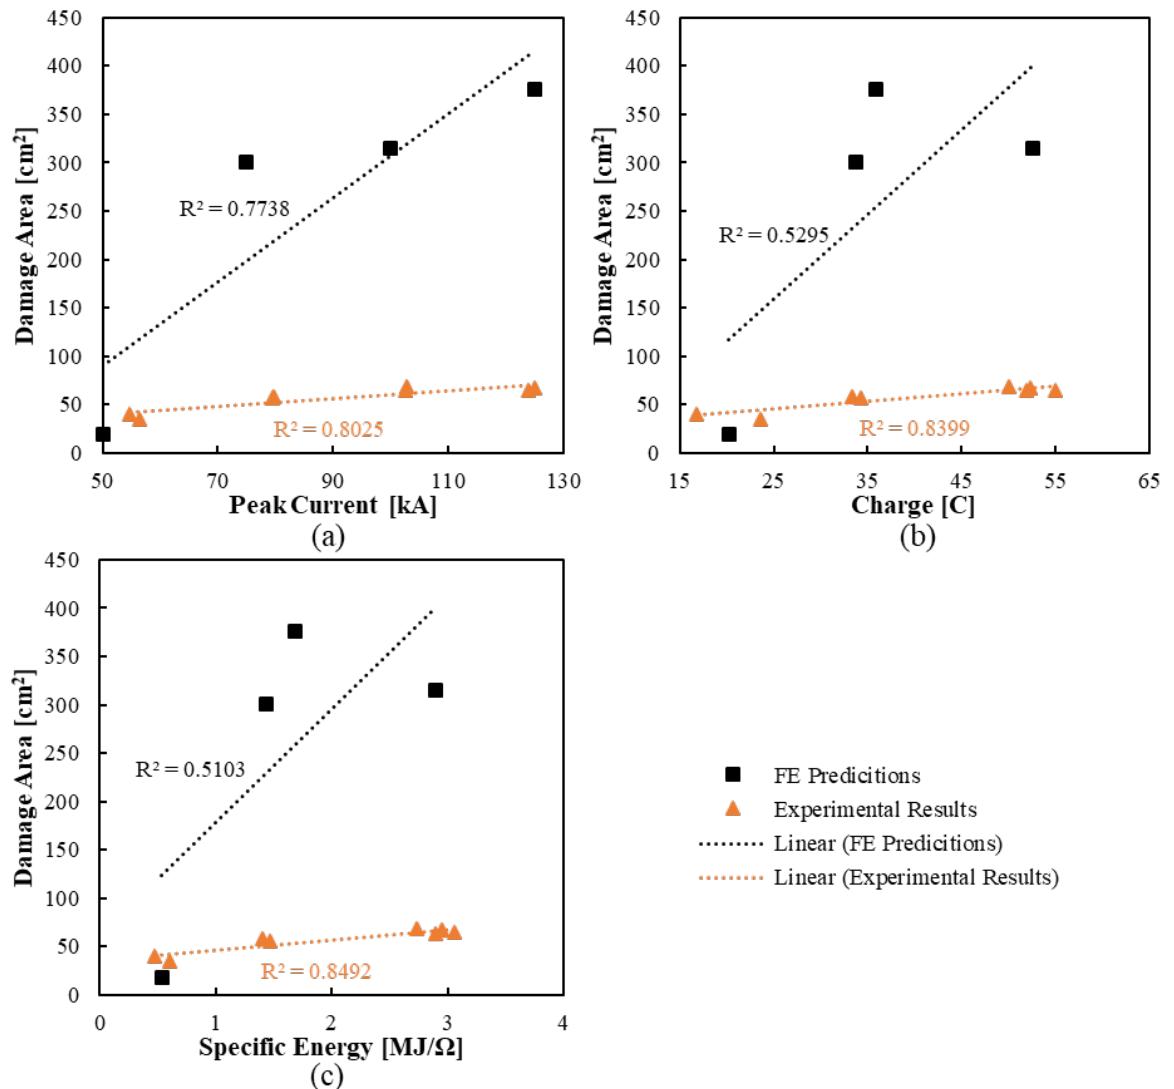
Figure 5.24: Maximum damaged areas identified by the Damage Model (FE Predictions) and the AE5 bare surface specimen (Experimental Results) against the (a) peak current, (b) charge and (c) specific energy

Figure 5.24 presents the maximum damage area results of the FE predictions and the experimental results compared against the lightning parameters peak current, charge, and specific energy. Figure 5.24 (a) –(c) all show similar results with the increasing peak current, charge, and specific energy all increasing the damaged area for both the Damage Model predictions and the experimental results. The Damage Model while able to produce damage in the transverse direction over predicted the maximum damaged area seen in the plies. The linear fit presented in Figure 5.24 (a) – (c) show that for all cases the predictions are becoming farther away from the results as indicated by the slope being larger for the FE predictions compared to the experimental results. It is also unfortunate that the results have the closest trend or highest R^2 value for the peak current as opposed to specific energy as found for the experimental results. The maximum damage area was always in ply 1 for both the Damage Model and the experimental results. Although it was noticed that the FE predictions over predicted the damaged area for ply 1 in Figure 5.22, it was noticed that the deeper plies the results were underpredicted. Therefore, a comparison to the damage volume was conducted and presented in Figure 5.25 that shows the predicted damage volume results from the Damage Model and the experimental results from the X-ray CT data compared against the lightning parameters peak current, charge, and specific energy. Figure 5.25 (a)–(c) all show a similar result with the increasing peak current, charge, and specific energy all increasing the damaged area for both the Damage Model predictions and the experimental results. The slopes of the fit lines for the damage volume results are all of similar magnitude. This indicates that the damage prediction on the individual ply level may not be sufficiently accurate. However, the damage volumes are more accurately predicted by the Damage Model. This may be due to the assumption adopted for the modelling that once the electric breakdown is exceeded, the conductivities are increased by an order of magnitude. The assumed increased in conductivity at the electric breakdown point may need to be adjusted to more accurately capture the damage response on the ply level.

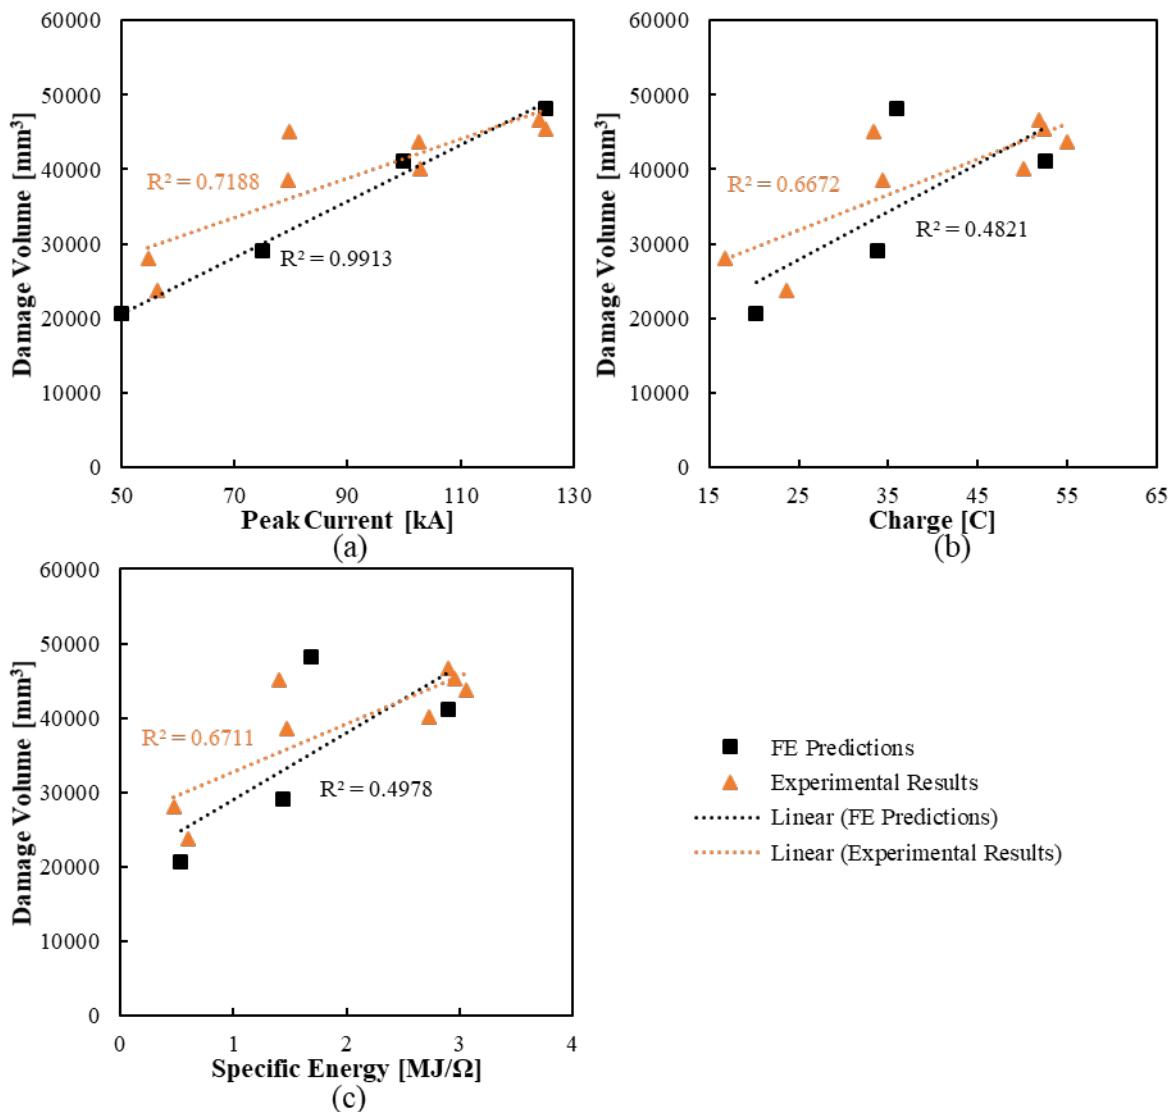
Figure 5.25: Maximum damaged volumes identified by the Damage Model (FE Predictions) and the AE5 bare surface specimen (Experimental Results) against the (a) peak current, (b) charge and (c) specific energy

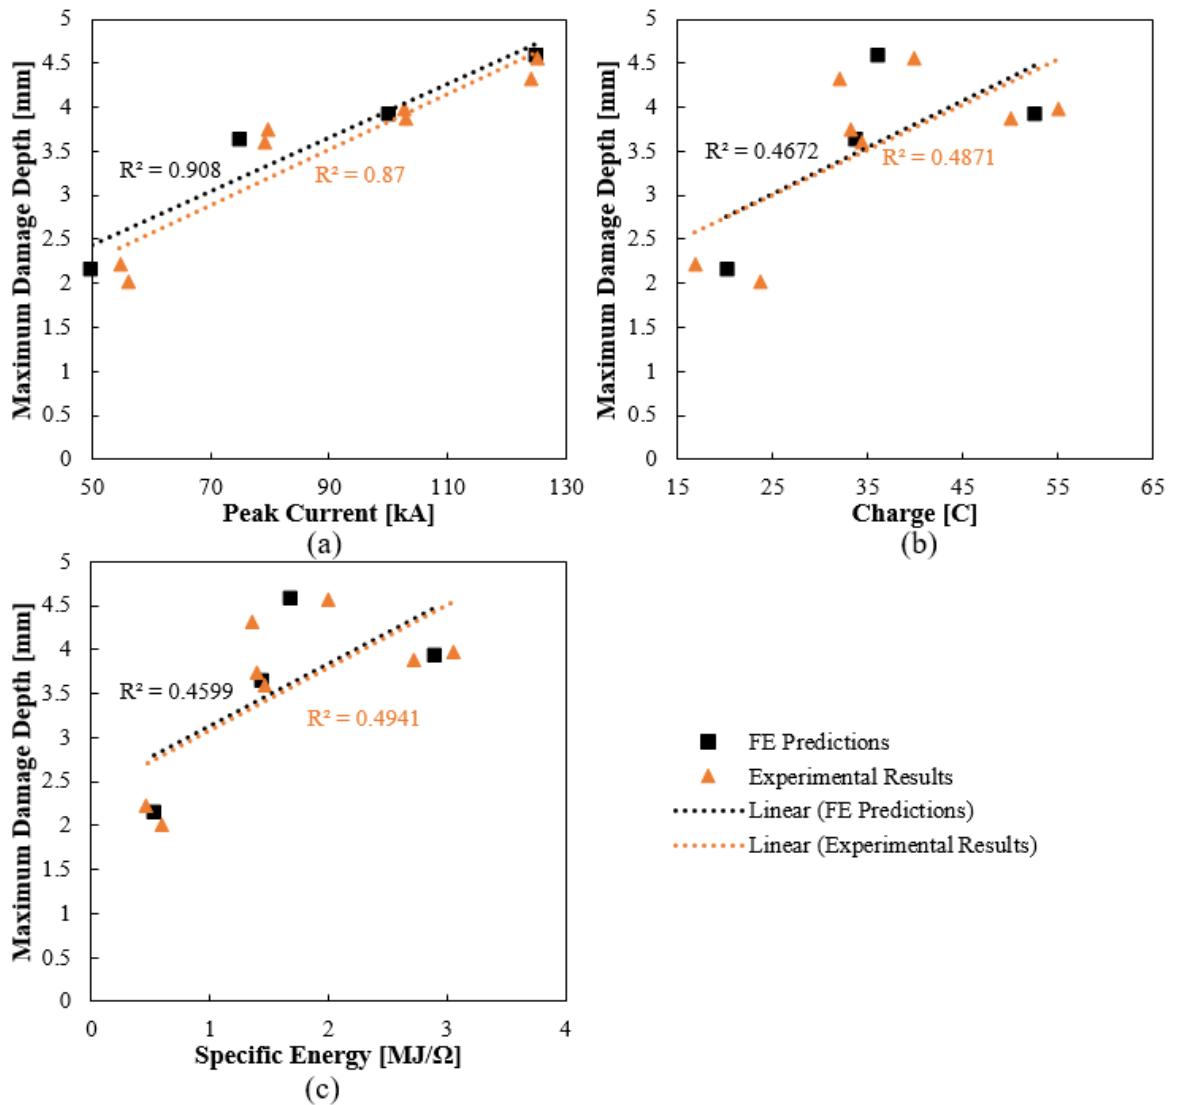
Figure 5.26 shows the damage depth predictions results from the Damage Model and the experimental results compared against the lightning parameters peak current, charge, and specific energy. Figure 5.26 (a)-(c) all show a similar result with the increasing peak current, charge, and specific energy all increasing the damaged depths for both the Damage Model predictions and the experimental results. The damage depth fit line slopes are all of similar magnitude. The damage depths were the closest match of the Damage Model to the experimental results and is much better match than previous research which indicated that lightning damage models on CFRP materials tend to overestimate the depth results [114].

Figure 5.26: Maximum damaged depths identified by the Damage Model (FE Predictions) and the AE5 bare surface specimen (Experimental Results) against the (a) peak current, (b) charge and (c) specific energy

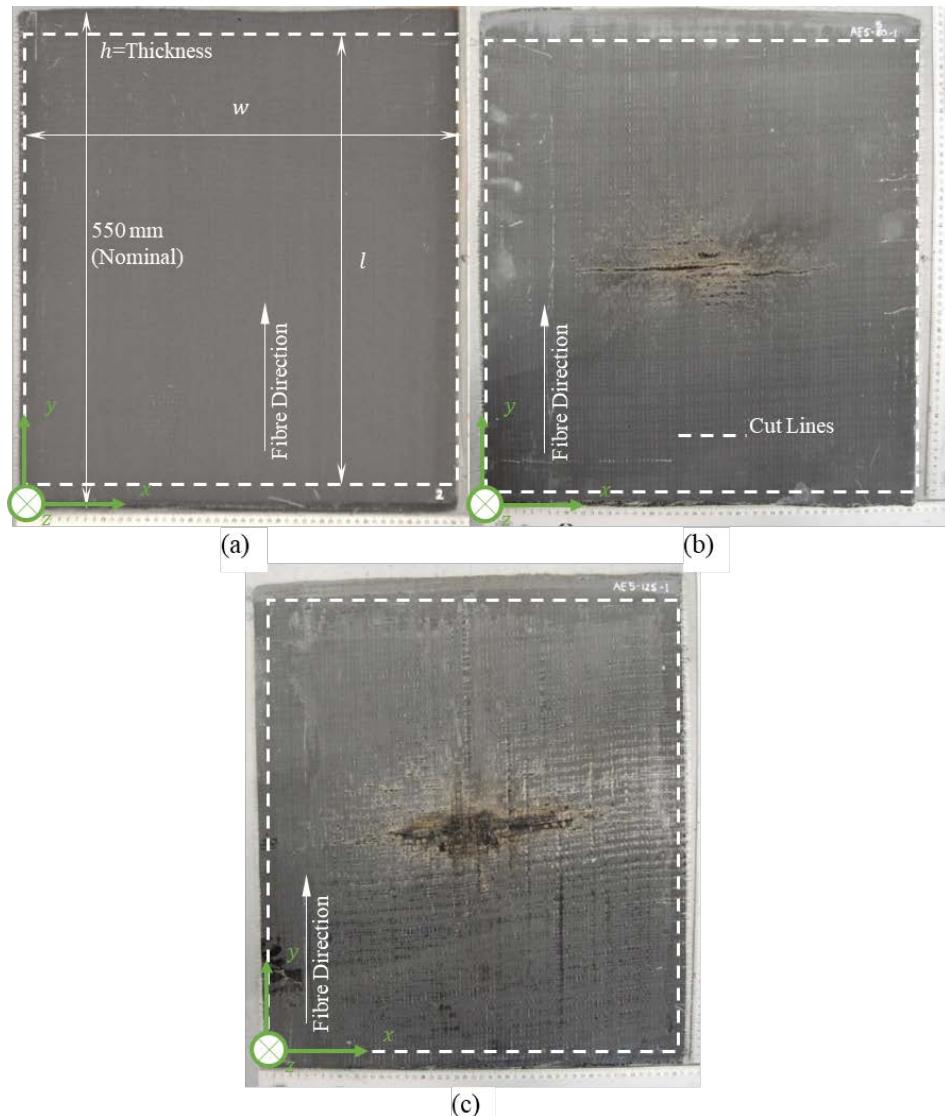
Figure 6.1: CFRP experimental specimens: (a) undamaged (control), (b) 50 kA peak current damaged and (c) 125 kA peak current damaged

As mentioned, compression tests were conducted on bare surface CFRP panel specimens from configuration AE5, see section 4.3.5. The CFRP panel specimens were 550 mm by 500 mm plates with an average thickness of 7 mm. The specimens had a chamfer on one edge to expose the fibres to allow for an electrical ground to the full thickness of the specimen. Eight panels were subjected to simulated lightning strikes with various amounts of lightning peak current and two were saved for control and therefore were undamaged. The damaged and undamaged (control) specimens were cut using a waterjet cutter to an approximate final plate dimensions of 500 mm by 490 mm with the damage located in the centre of the plate; see Figure 6.1. This removed the chamfer and other ply variations at the edges. The final plate dimensions are presented in Table 6.1.

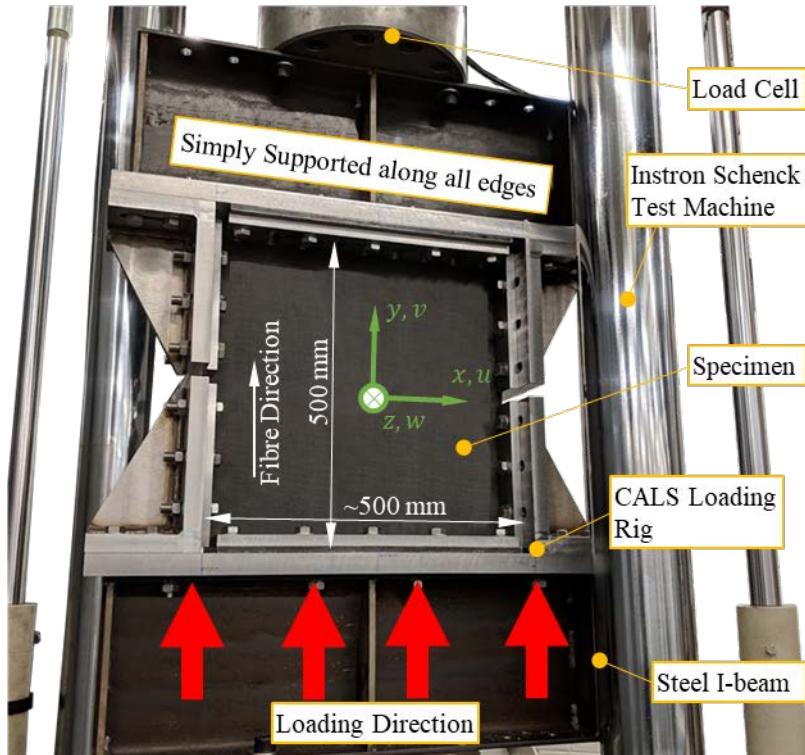
Figure 6.2: Compression After Lightning Strike (CALS) test rig with CFRP laminate plate specimen mounted in servo-hydraulic Instron Schenck test machine (630 kN capacity)

As described previously, a newly designed modified buckling rig (CALS) was designed, manufactured and commissioned to enable experimental characterisation of CFRP panels subjected to compression. The drawings of the CALS test rig are presented in Appendix E. The aim of the rig for this project was to capture the effects of lightning strike induced damage on the structural scale. The CALS test configuration and rig is shown in Figure 6.2, and it was designed to accommodate a variety of plate widths and lengths (larger than 480 mm), so as to closely resemble WT blade sparcap structures close to the blade tip, where the propensity for a direct lightning strike is the most severe (see section 2.6 and Figure 2.31). The rig was designed with interchangeable supports along the edges, and for this research simply supported conditions were assumed along all four edges, referred to as SSSS condition for simplicity. The true boundary conditions that a CFRP sparcap laminate will experience from the surrounding WT blade structures would be more restrictive/constrained but could not be nearly as restrained as e.g. clamped/fixed support conditions. Accordingly, SSSS boundary conditions were assumed and approximately accommodated for this research. The CFRP panel supports along the vertical edges were designed such that sliding was enabled in the vertical (y) direction, whilst the horizontal (x) direction and out-of-plane (z) displacements were restrained, thereby emulating simply support and guide rail support conditions along the edges.

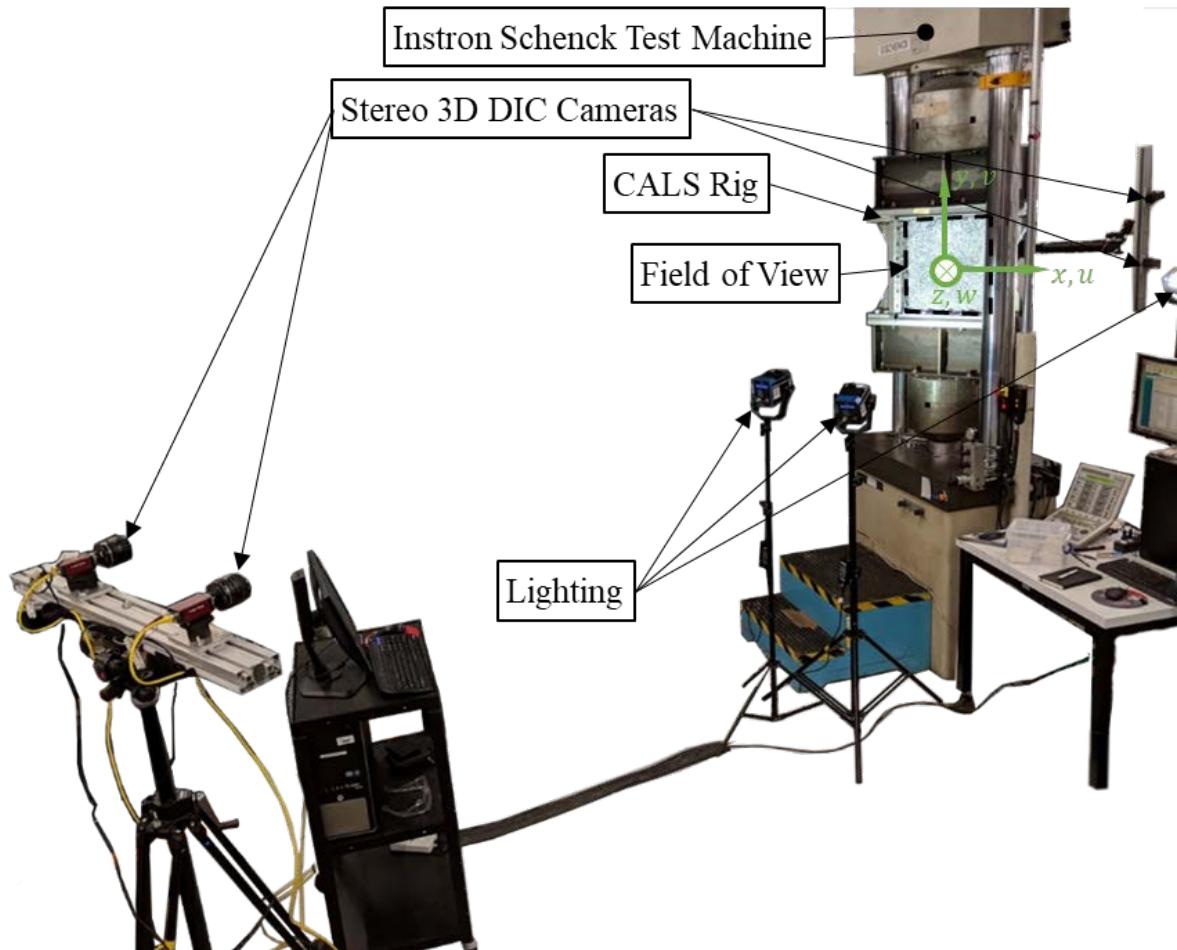
Figure 6.3: DIC Setup showing test machine, CALS rig, CFRP panel specimen and front side DIC system

Stereo DIC was used to obtain full field measurements of the strains on the plate specimens' surface during testing. A two camera DIC setup was used on each side of the specimen to capture displacements in all coordinate direction; u in the x -direction, v in the y -direction (height or fibre/load direction), and w in the z -direction (out-of-plane), see Figure 6.3. As the CFRP specimens were already black, they were coated with only a thin layer of black paint to make a uniform surface and then speckled with white paint. Images were captured using 4x Manta cameras equipped with 2x AF NIKKOR 28 mm F/8D lenses on the front side and 2x AF NIKKOR 50 mm F/8D lenses on the back side. The load levels were recorded from the test machine load cell, as the images were captured simultaneously using the MatchID software package [157]. The experimental setup is shown in Figure 6.3. The DIC was processed using the MatchID correlation software to determine the displacement and strain fields. For the post-processing, a substep size of 33 x 33 pixels and a step size of 16 were used. The full DIC setup and image correlation specifications are shown in Table 6.2. The noise floor was estimated by taking ten static images from the beginning

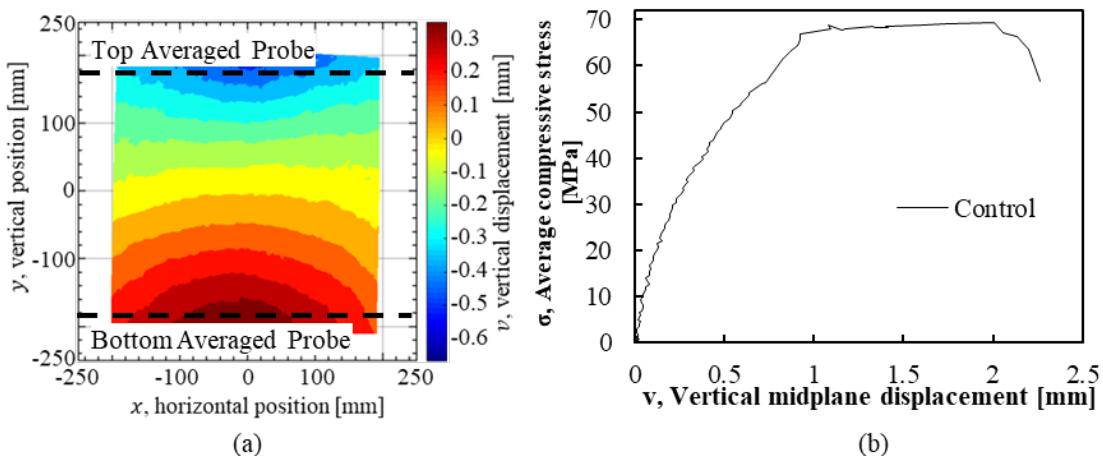
Figure 6.4: (a) Example of vertical (v) displacement field captured using DIC for an undamaged CFRP specimen (Control-1) subjected to a compressive pressure load of 60 MPa and with the “probe lines” indicated, and (b) load vs vertical displacement curve derived from the displacement fields captured using DIC

2. Following this, “probe” lines were selected, including data for both the front and back sides of the tested plate specimens. For the tests reported here, y -values (vertical or the loading/fibre direction) of ± 200 mm along the top and bottom specimen edges were selected; see Figure 6.4 (a). The vertical displacement values along these lines were interpolated from the closest DIC measurements.

5. The steps were executed for the data captured on both sides of each of the tested CFRP panel specimens
6. In the final step, the vertical displacement data generated for both specimen sides, following the above steps, were averaged to derive the midplane displacement. This data was then used to plot the load (load transducer data) vs the vertical midplane displacement (end shortening); see Figure 6.4 (b).

This procedure described above was adopted for all the tested panel specimens, and an example of the vertical displacement field and load vs vertical displacement plots is show in Figure 6.4 (b) for an undamaged CFRP panel specimen (Control-1).
