Thesis: Harrell, T.M. (2019) "Characterisation of lightning strike induced damage in CFRP laminates and components for wind turbine blades", University of Southampton, Faculty of Engineering and Physical Sciences, PhD Thesis.

Characterisation of lightning strike induced damage in
CFRP laminates and components for wind turbine blades

Thesis for the degree of Doctor of Philosophy

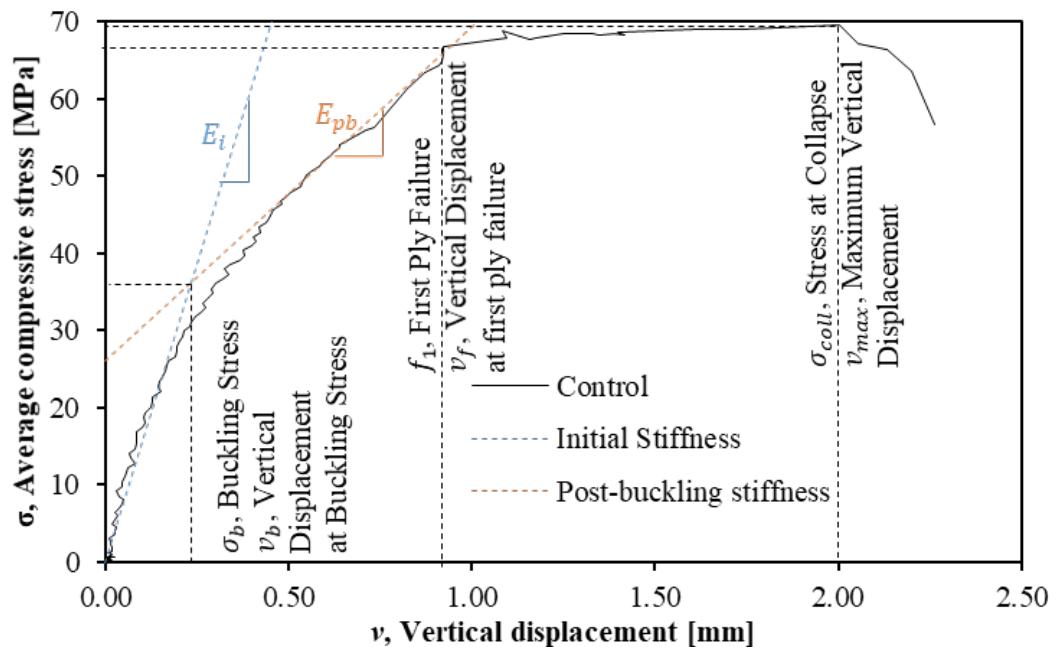
Figure 6.5: Load-displacement curve for CFRP plate specimen Control-1 with the structural behaviour descriptors indicated

The above indicators are shown for illustration in Figure 6.5, which displays the captured stress-displacement curve for CFRP plate specimen (Control-1) obtained by use of the procedure described above. It should be noted that the precise identification of characteristic behaviour descriptors or indicators described above, is associated with some uncertainty, as precise features of the stress-displacement curves recorded display scatter and variability to the scatter/variability associated with the DIC measurement themselves, as well as due to the gradual (rather than distinct) transitions between equilibrium and damage states associated with the buckling and damage phenomena occurring in the CFRP plate specimens.

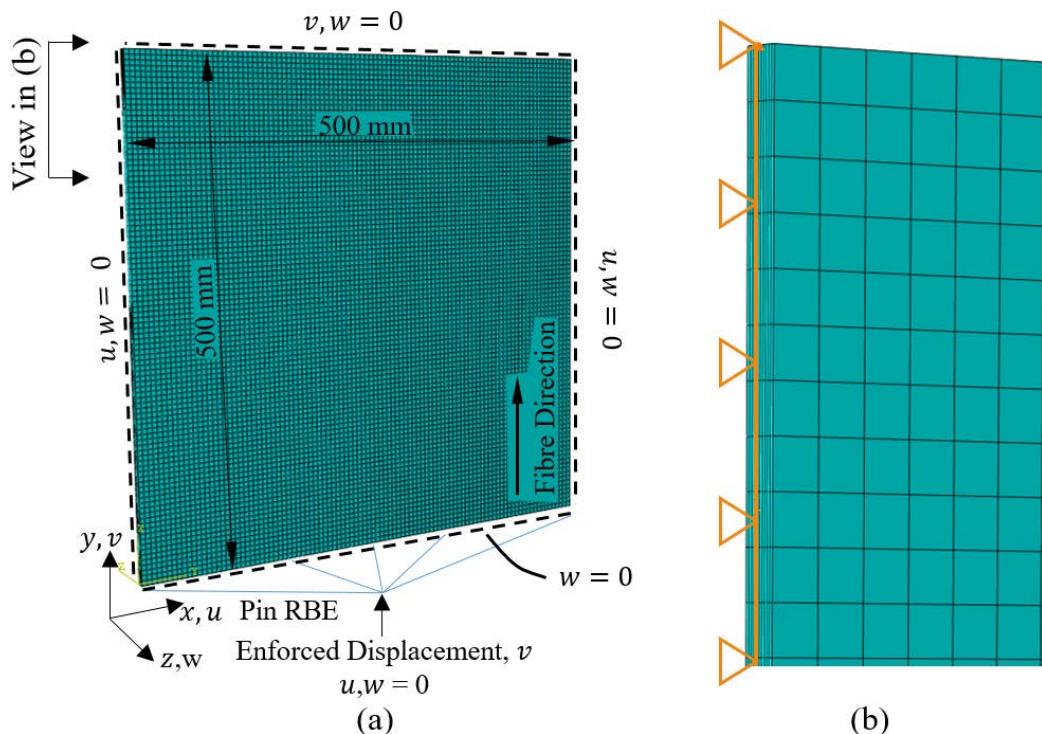
Figure 6.6: Structural FE model: (a) FE mesh and boundary condition imposed along plate edges, and (b) zoom of the edge constraints imposed along specimen/plate mid-plane

To simulate the CALS tests (see section 6.2.2), simple support conditions were assumed along all edges. The vertical sides of the CFRP plates were constrained with respect to the displacements in the x and z directions (see Figure 6.6 for coordinates), the non-loaded horizontal side (top in CALS rig) of the CFRP plate specimens were constrained with respect to the displacements in the y and z directions, and finally the loaded horizontal side of the specimens (bottom in the CALS rig) were constrained only with respect to the displacements in the z direction. The external compression load was imposed through prescribed displacement along the lower plate edge specified relative to a reference node 10 mm away from the plate edge. The reference node was connected to the bottom of the CFRP plate by a pinned rigid body element. The edge rotations as well as the prescribed displacement is restrained in the x and z directions were restrained to ensure the plate edge could only move in the y (vertical) direction. The full model and the boundary conditions are shown in Figure 6.6 (a). All displacement edge constraints were imposed on element nodes located in the specimen mid-plane as shown in Figure 6.6 (b).

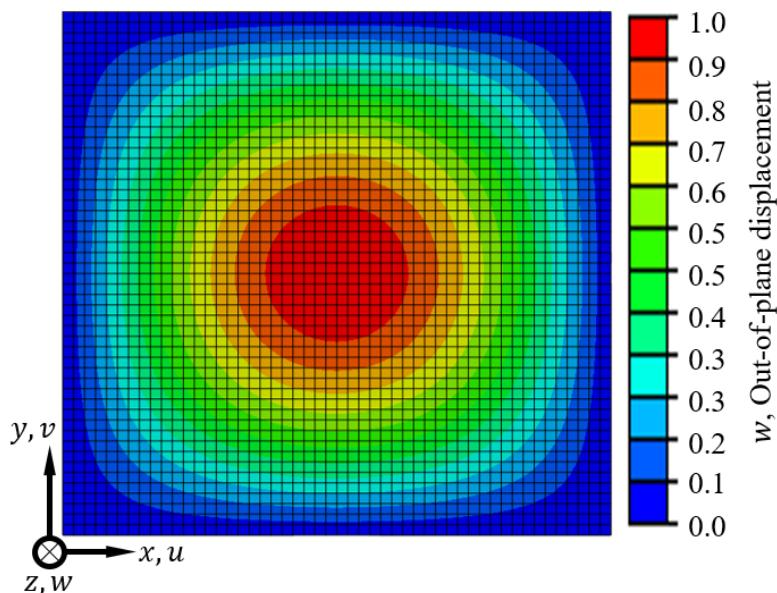
Figure 6.7: Eigenmode out-of-plane displacement results for mode shape one from the CFRP laminate plate FE model

The eigenvalue analysis corresponding to mode one was conducted for each plate considered, the resulting out-of-plane displacements for each node were used to define for the imperfection or pre-deformed state. Additional eigenmode simulations were conducted for higher mode shapes, and subsequently imposed in the plate FE model, but provided little effect to the resulting buckling and post-buckling responses. Therefore, only mode shape one was used for further modelling of the buckling and post-buckling responses. Mode shape one is shown in Figure 6.7.

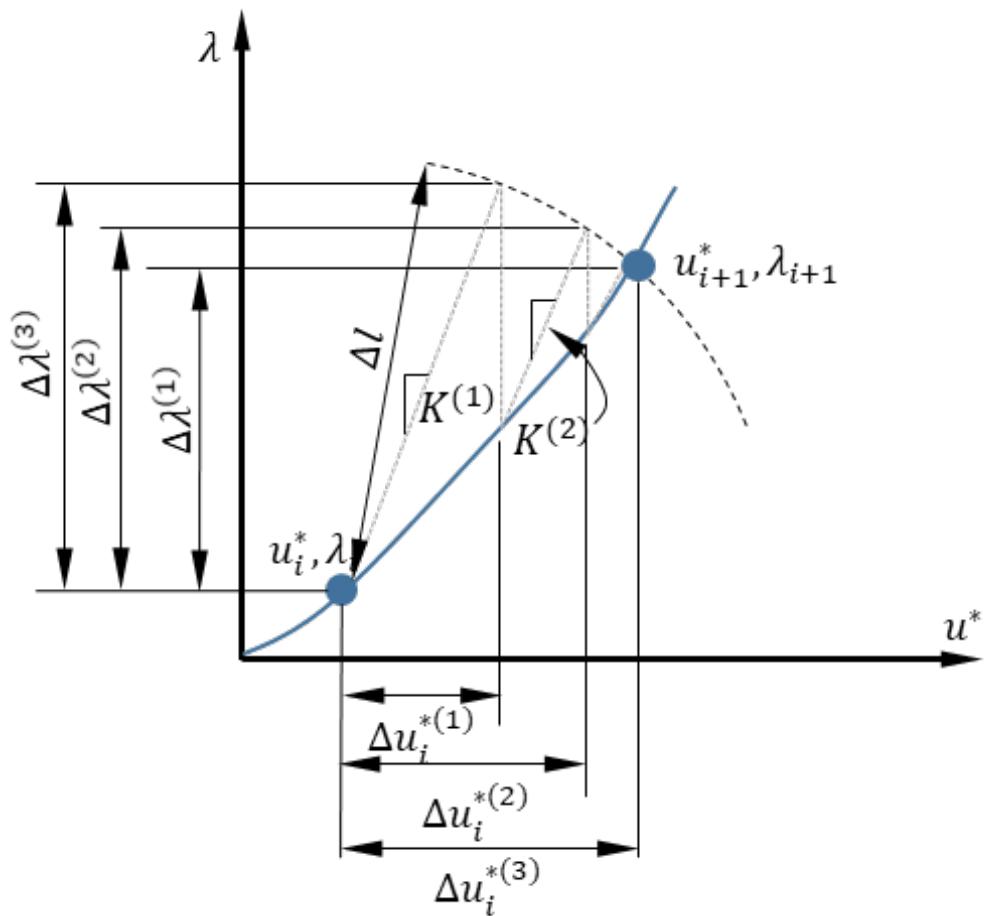
Figure 6.8: Modified Riks algorithm (Arc-length method) with iterations where u^* denotes normalized displacement and λ the load proportionality factor parameter. The increment is defined by the radius of the search circle Δl and the iterations are shown [147], [162]

The Riks method for the analysis of nonlinear structural load response is implemented as a standard feature in Abaqus. Details can be found in the Abaqus user's guide [147]. Figure 6.8 presents an example Rik's method iteration run. The Riks method works by assuming the loading is proportional to a single scalar parameter, λ and the load response is reasonably smooth [147]. The method solves for the displacement and load iteratively as shown in Figure 6.8. A thin plate does not have a critical bifurcation point because of membrane action [162]. For a plate, the stiffness increases as the displacements grow which is shown in the load response presented in Figure 6.8 [162]. In Figure 6.8, the K indicates the stiffness used to test the load response curve against and $\Delta\lambda$ being the change in load proportionality factor. The figure runs through 3 iterations before reaching a solution on the nonlinear load displacement curve u_{i+1}^* and λ_{i+1} .

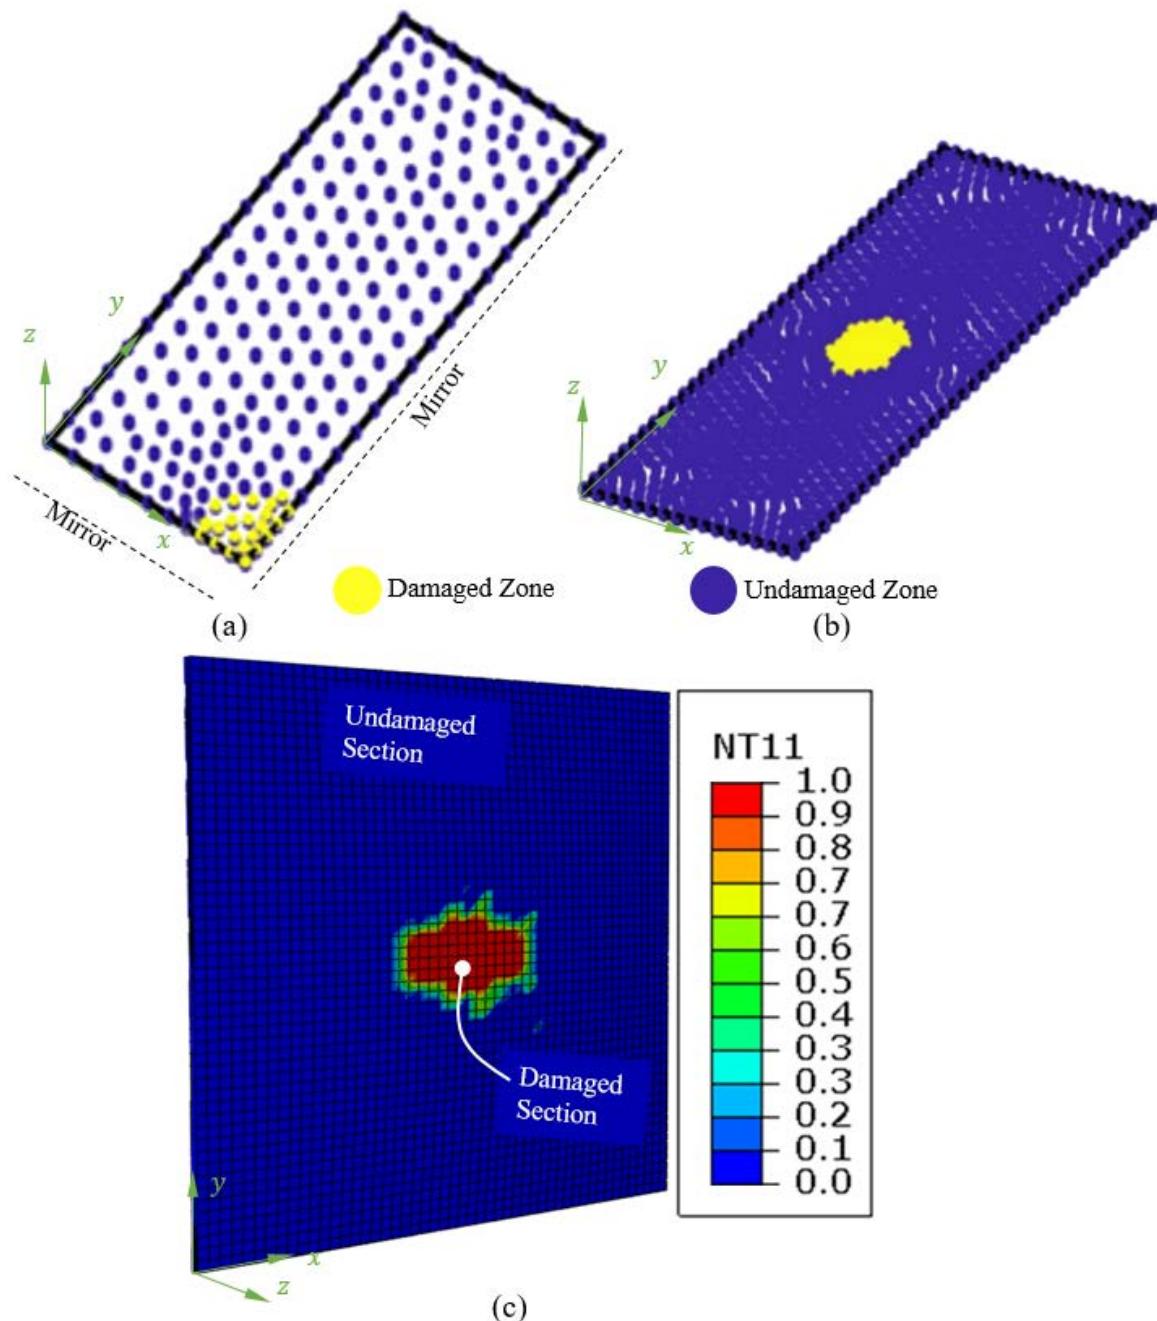
Figure 6.9: Damage model to structural model where (a) is the point cloud created from the Damage model, (b) is the transformed point cloud from quarter plate Damage Model prediction to full structural scale model damage state and (c) is the temperature introduced to assign damage material properties

As previously discussed in section 5.2, the developed modelling approach exports the predicted damage region from the Damage Model into a structural FEM of a representative CFRP plate on a sub-component scale. The Damage Model (see Chapter 5) has been developed and executed through COMSOL 5.4 and the structural scale modelling of the lightning strike damaged CFRP laminated plate was developed and executed using Abaqus 6.14 [142]. The damage region was developed on a quarter plate model (Damage Model) and needs to be transformed before it can be imported in the structural scale FEM. There are many approaches to do this, but for this project the Damage Model predictions were assigned to a point cloud. A point cloud is simply a set of data points in space [163]. Figure 6.9 shows the process and the resulting import of the data into the structural FEM. The procedure to create the damage state point cloud is by transferring the resulting resin damage regions calculated by the Damage Model (described in section 5.3) to a point cloud, then mirroring the quarter plate data to make a full plate point cloud and bringing the full plate data into the structural model. The damage state point cloud data where the damaged regions were assigned a value of 1 and the undamaged regions were assigned a value of 0. The point cloud data was generated from the Damage Model with a grid spaced over the model. In the $x - y$ plane (as seen in Figure 6.9 (a)) there were points generated spaced 1 mm by 1 mm apart from each other and 12 slices in the z -direction were taken creating 750,000 points. A reduced set of the generated point cloud is shown in Figure 6.9 (a) to aid in viewing where the blue points are assigned an undamaged value and the yellow points are damage. It should be recalled that the Damage Model was formulated for a quarter plate only (as can be seen in Figure 6.9 (a)), and because of this the point cloud is mirrored in the symmetric x and y directions to take the predicted damaged zone from the Damage Model quarter plate predictions to a full plate FE model. The procedure was conducted through a specially developed MATLAB script, where the predicted damage is imported as a field variable in Abaqus. The MATLAB script is presented in Appendix D. The results of the procedure are shown in Figure 6.9 (b).

through an interpolation function. The result of this interpolation for the 50 kA peak current case is shown in Figure 6.9 (c). This figure shows that nodal values of temperature (NT11) are assigned but there is a gradation of temperature values along the node from the interpolation function. The temperature dependent properties are assigned at the integration points and the aim of this FEM is to have discrete elements which are damaged and undamaged. Therefore, the temperature to change the material properties representing damage was set to 0.1°C. This ensured that all elements with a non-zero temperature assigned were also assigned with damaged state material properties, because Abaqus handles the temperature above the maximum as constant and assigns the same material properties as the maximum temperature material state, as shown in Figure 6.10. In Figure 6.10, the Young's modulus in the longitudinal and transverse and the Poisson's ratio are shown through a temperature range of below 0°C to above the 1°C maximum temperature assigned. It can be seen that at or below 0°C the values are equal to the undamaged state. Above 0°C to 0.1°C, there is a linear transition from the undamaged properties to the damaged properties. And above 0.1°C, the values are equal to the damaged properties.

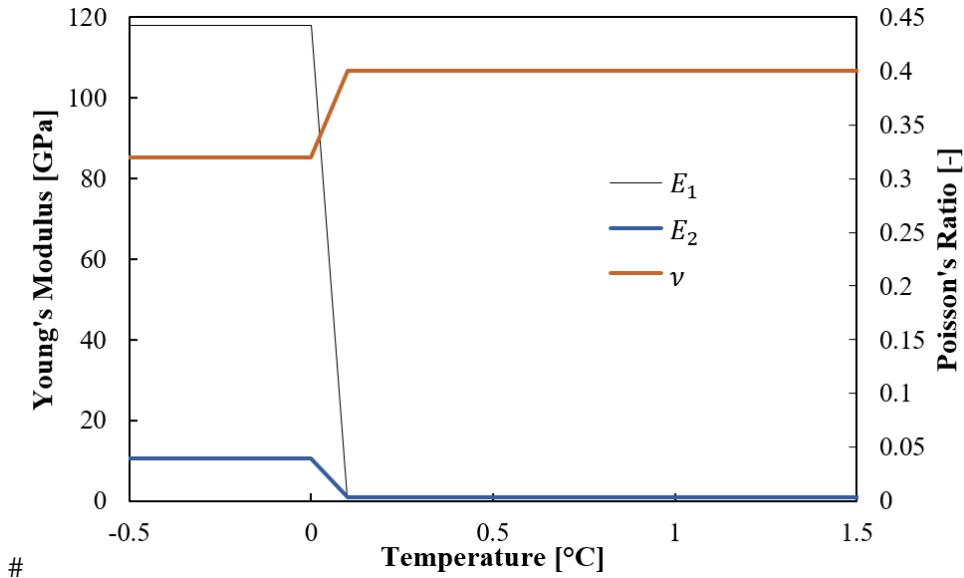
Figure 6.10: Young's modulus and Poisson's ratio temperature dependent material properties as a function of temperature

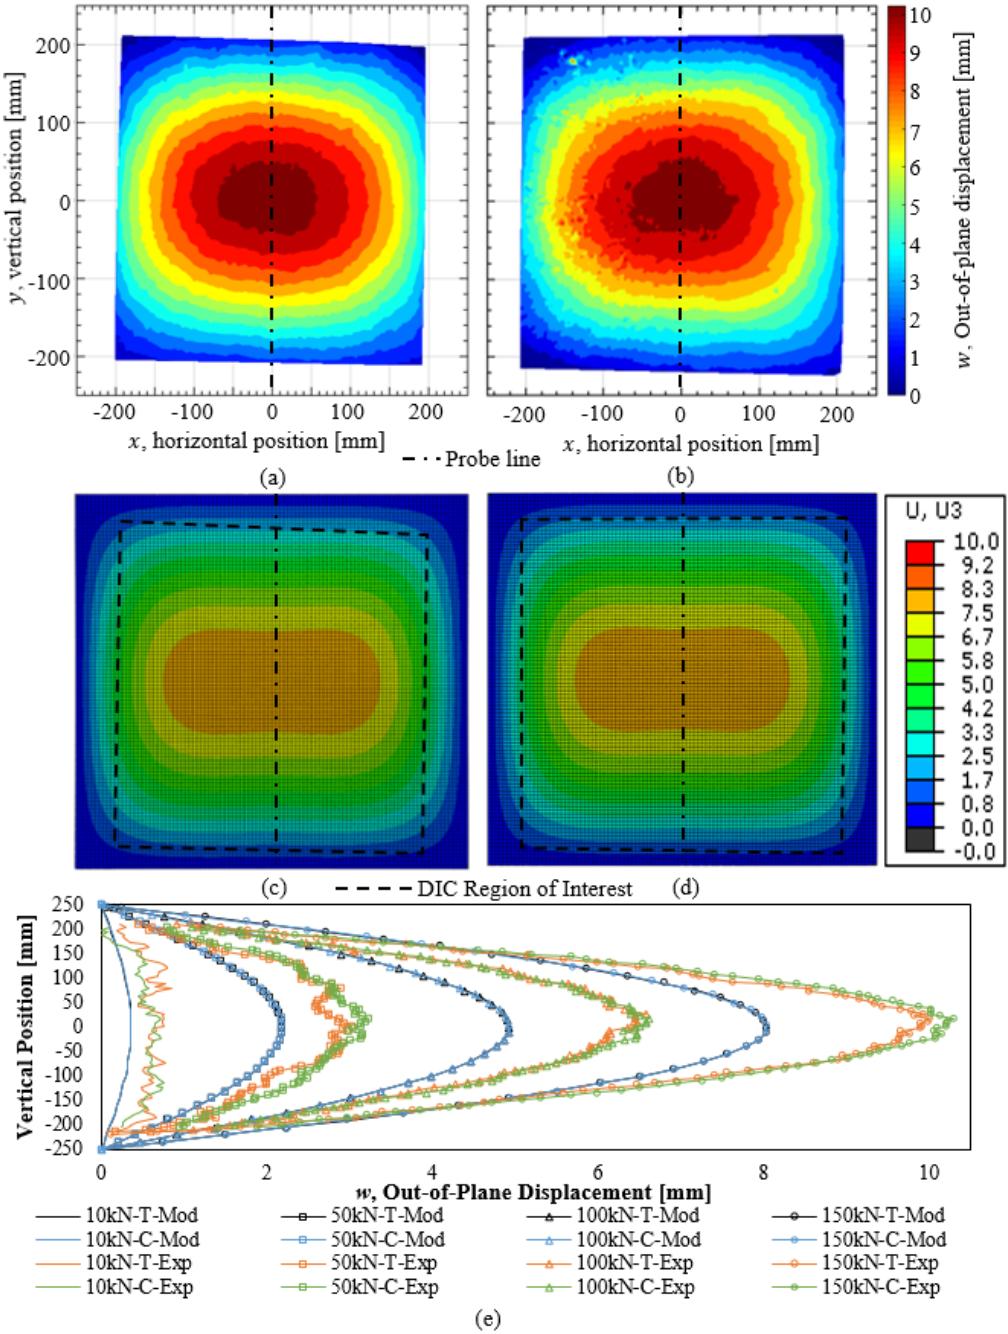
Figure 6.11: Out-of-plane displacements at 150 kN compression load: (a-b) measured using DIC for the compression and tension side, (c-d) FE predictions for the compression and tension sides and (e) measured and predicted displacements along a vertical centre/mid-line at four different compression load levels (10 kN, 50 kN, 100 kN, and 150 kN)

The first part of the model validation was based on comparison of the model predictions and the measured load-response and failure behaviour for the undamaged specimen (bare surface AE5 configuration control specimen). The measurement of panel deformation was conducted using stereo DIC as described previously. For the displacement and strain fields on the tensile and compressive side of the panel specimens, the FE model nodal point displacement and strain values were extracted for compression with the DIC measurements. The comparison between measured and predicted values were conducted at load levels above the initial buckling load where a stiffness change was recorded. Figure 6.11 shows the out-of-plane displacement fields obtained on the compression and tension sides of the undamaged CFRP at a compression load of 150kN, where (a-b) show the DIC measurements, and (c-d) show the FEM model predictions. It is seen that the experimental and predicted displacement fields are very similar with respect to the overall shape characteristics, but that the peak deflection amplitude predicted by the FE model is almost 25% smaller than the measured peak value. Despite the disagreement between the predicted and measured peak displacements, which can be due to incorrect assignment of model input parameters including e.g. the layer/plate thickness (that displayed significant variation in the manufacturing process), the otherwise good match with respect to shape of the deflected plate indicates that the FE model captures the correct physics.

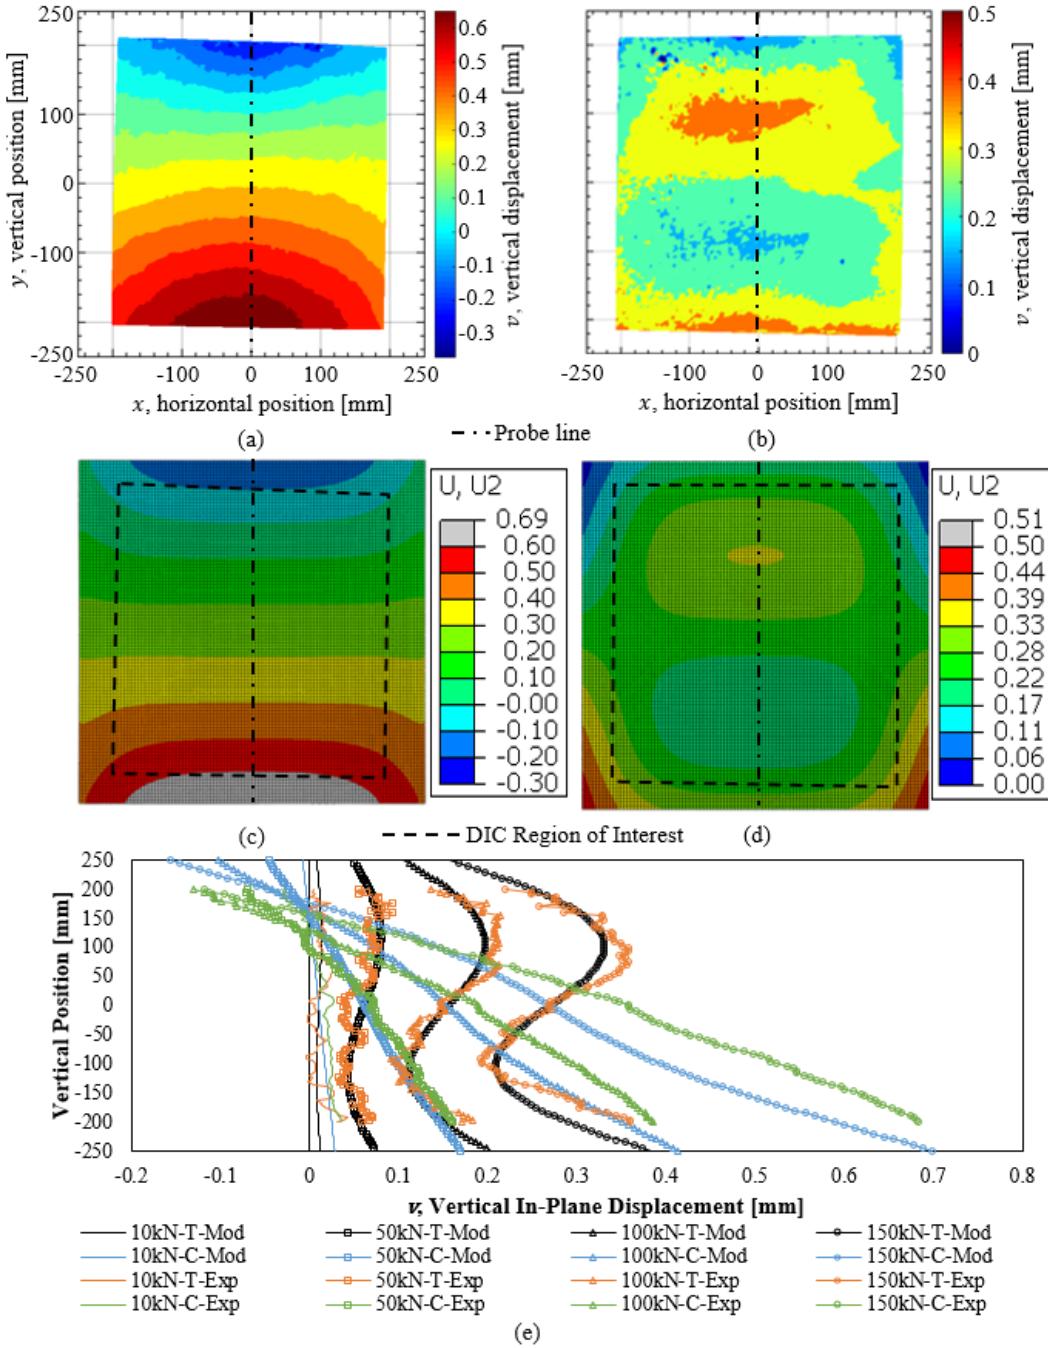
Figure 6.12: In-plane vertical displacement at 150 kN compression load: (a-b) measured using DIC for the compression and tension side, (c-d) FE predictions for the compression and tension sides and (e) measured and predicted displacements along a vertical centre/mid-line at four different compression load levels (10 kN, 50 kN, 100 kN, and 150 kN)

Figure 6.12 shows the measured and predicted in-plane vertical displacement fields obtained for the compression and tension side of the specimen at a compressive load of 150 kN. Figure 6.12 (a) and (c) show the measured in-plane vertical displacement fields captured using DIC for the compression loaded specimen side, and Figure 6.12 (b) and (d) show the same for the tension loaded specimen side. It is observed that the measured and predicted displacement field correlates relatively well overall. The vertical displacements show good agreement in both magnitude and shape. This indicates that the stiffnesses in the FEM model for the undamaged case are near the true value of the measured specimens.

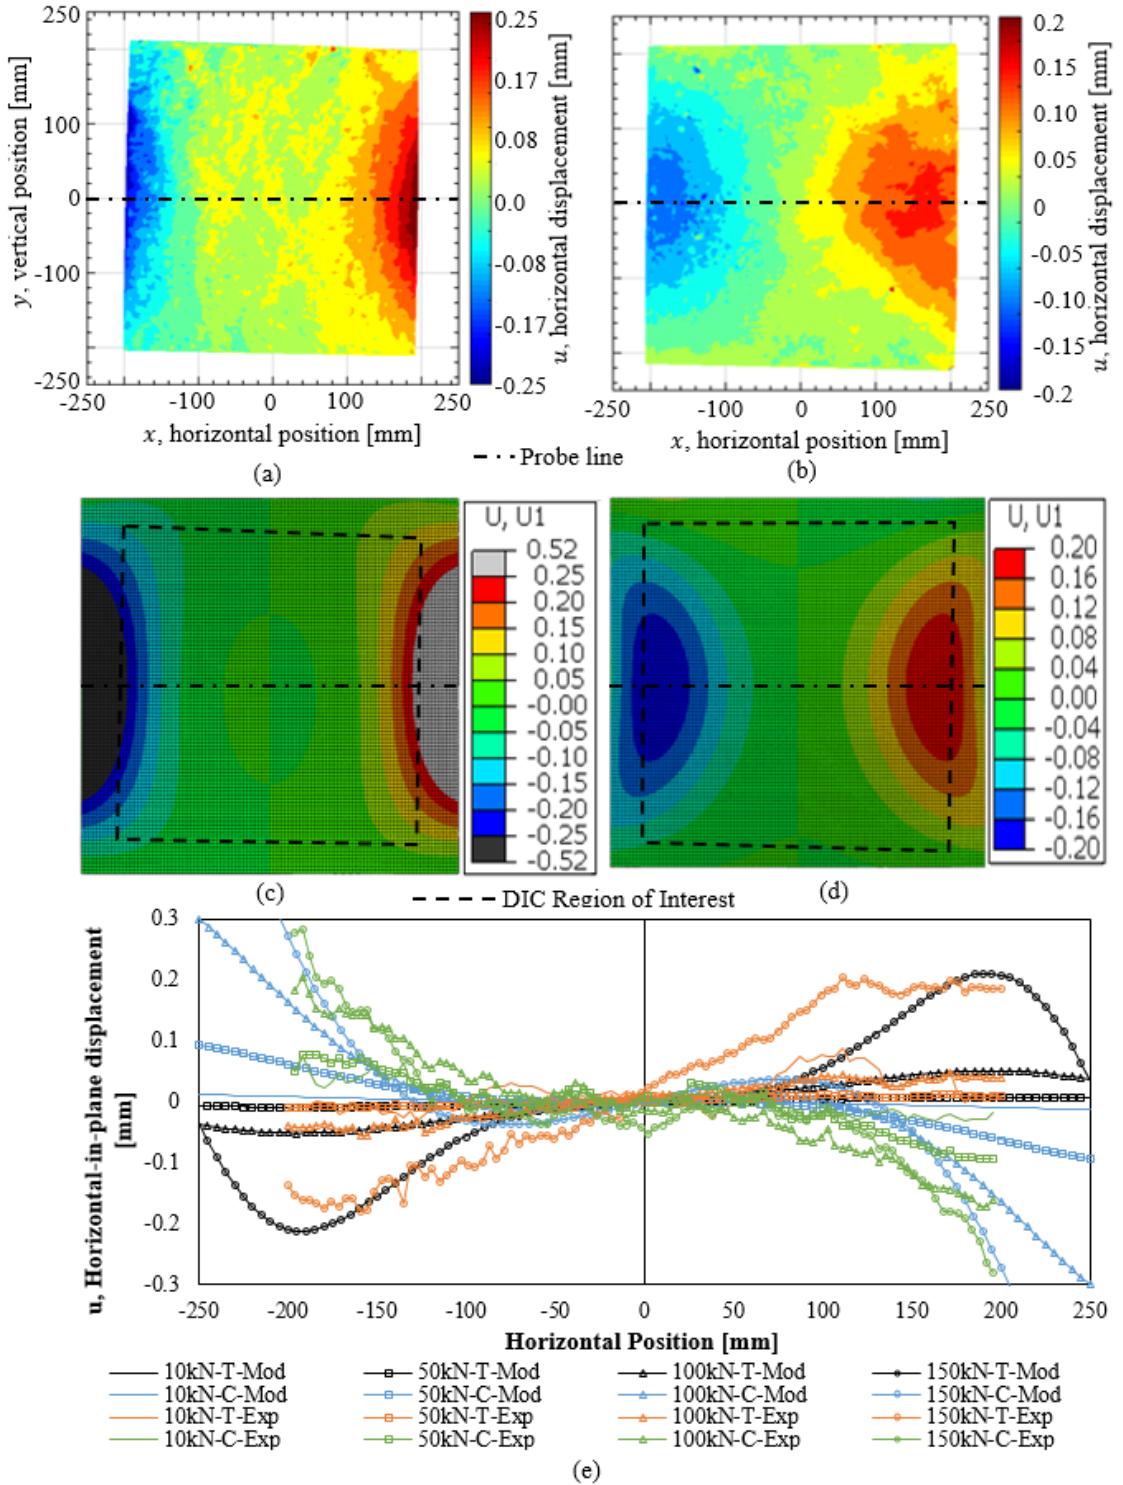
Figure 6.13: In-plane horizontal displacement at 150 kN compression load: (a-b) measured using DIC for the compression and tension side, (c-d) FE predictions for the compression and tension sides and (e) measured and predicted displacements along a vertical centre/mid-line at four different compression load levels (10 kN, 50 kN, 100 kN, and 150 kN)

Similar to Figure 6.12, Figure 6.13 shows the measured and predicted in-plane horizontal displacement fields obtained for the compression and tension sides of the specimen at a compressive load of 150 kN. It is observed that the measurement of the in-plane displacement fields is associated with significant noise, especially on the tension side, and some of which is likely to be associated with specimen misalignment. However, given this, it is seen that the measured displacement fields match the prediction of the FE model reasonably well.

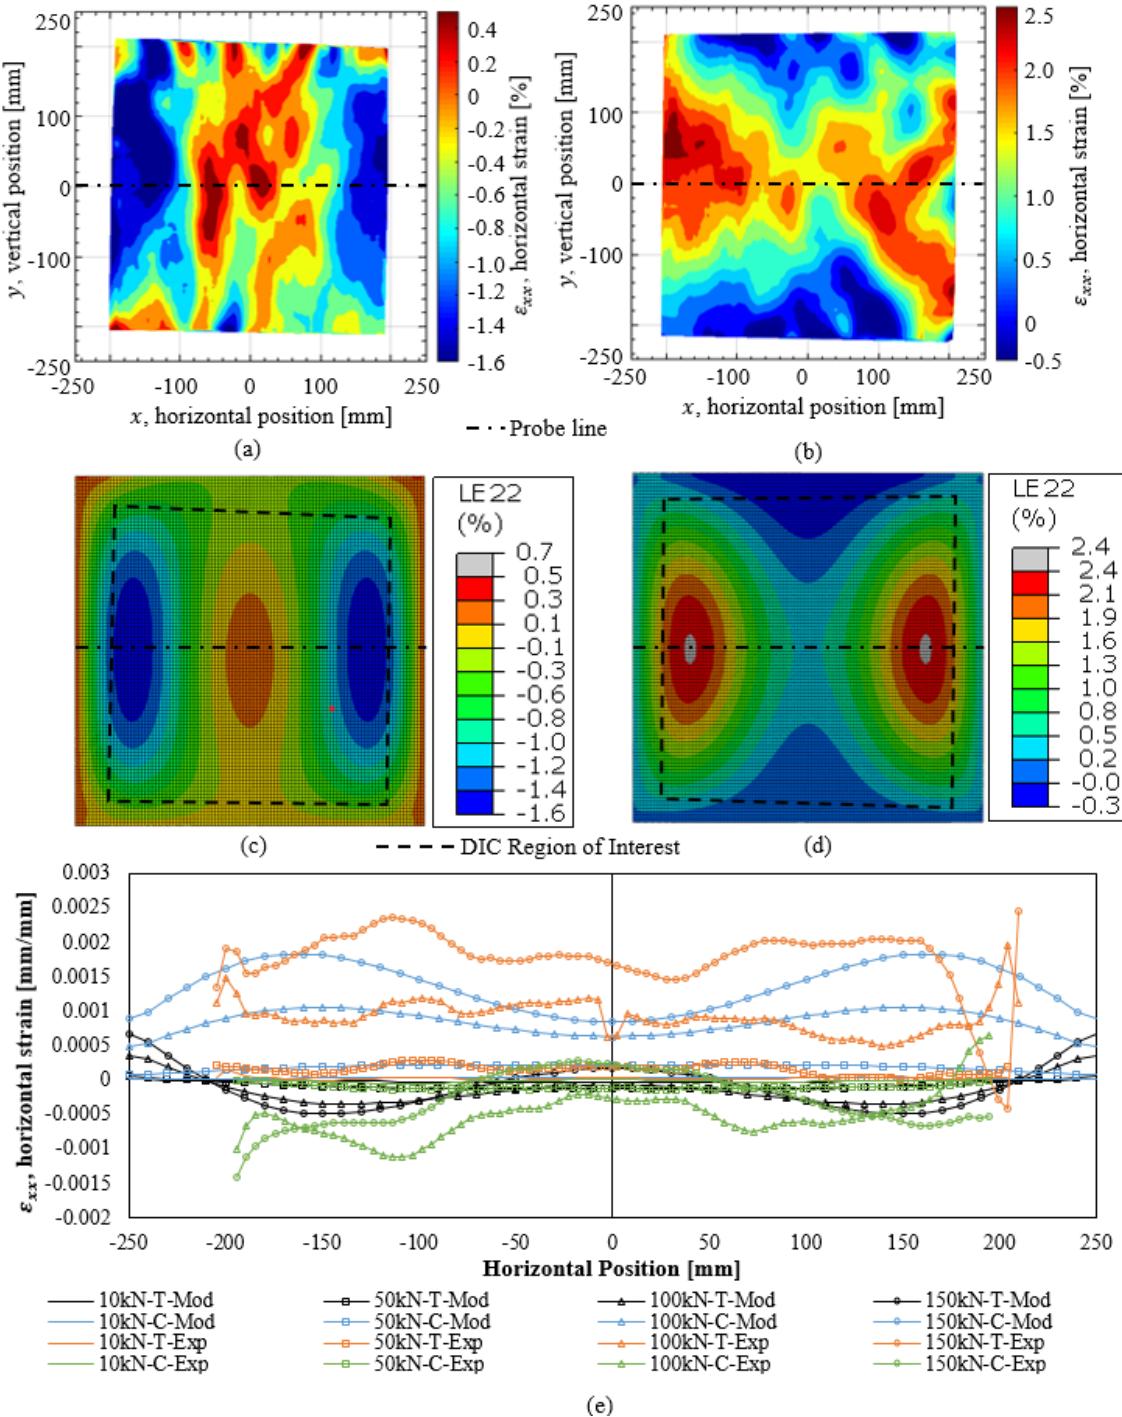
Figure 6.14: In-plane horizontal strain at 150 kN compression load: (a-b) measured using DIC for the compression and tension side, (c-d) FE predictions for the compression and tension sides and (e) measured and predicted displacements along a vertical centre/mid-line at four different compression load levels (10 kN, 50 kN, 100 kN, and 150 kN)

Figure 6.14 shows the results of the in-plane horizontal strain. Similarly, the DIC and FEM comparison shows relatively good agreement. Similarly, it is observed that the measurements of the in-plane horizontal (xx) strain displacement fields is associated with significant noise. However, given this, the maximum strains are captured by the DIC in comparison to the FEM.

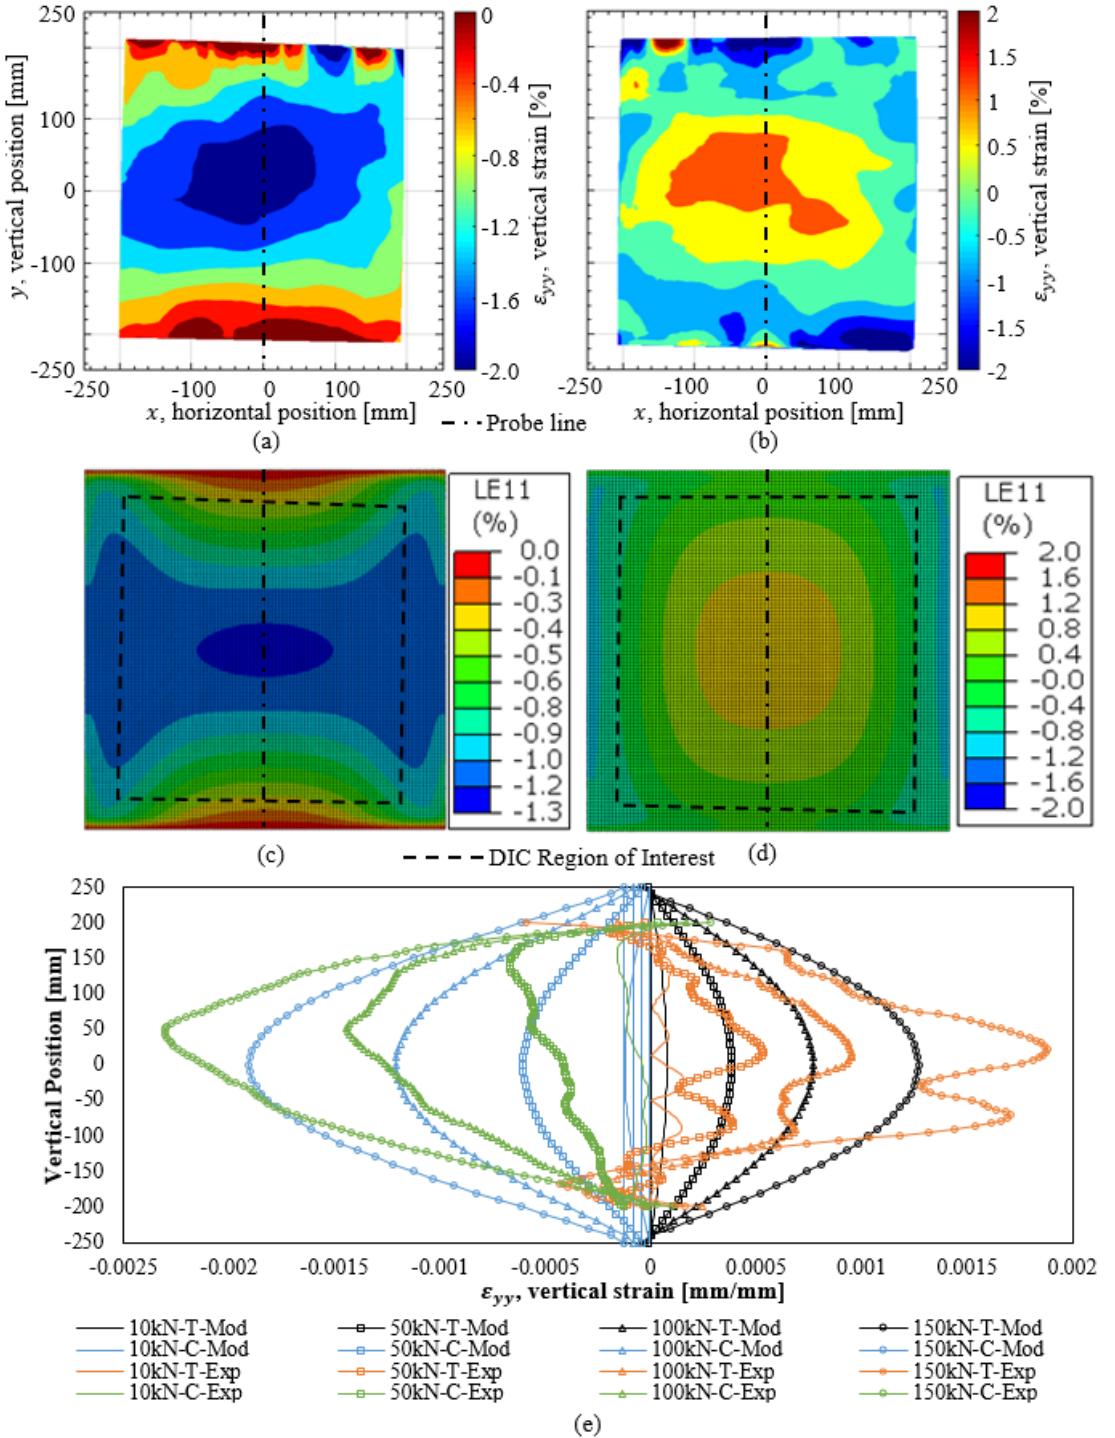
Figure 6.15 shows the results of the in-plane vertical strain. Similarly, it is observed that the measurement of the in-plane vertical (yy) strain displacement fields is associated with significant noise especially the tension side. However, given this, it is seen that the measured strain fields match the prediction of the FE model are good for the tension side. The compression side showed higher measured strain results compared to the FEM some of this is likely to be associated with specimen misalignment which over predicts the strains.

Figure 6.15: In-plane vertical strain at 150 kN compression load: (a-b) measured using DIC for the compression and tension side, (c-d) FE predictions for the compression and tension sides and (e) measured and predicted displacements along a vertical centre/mid-line at four different compression load levels (10 kN, 50 kN, 100 kN, and 150 kN)

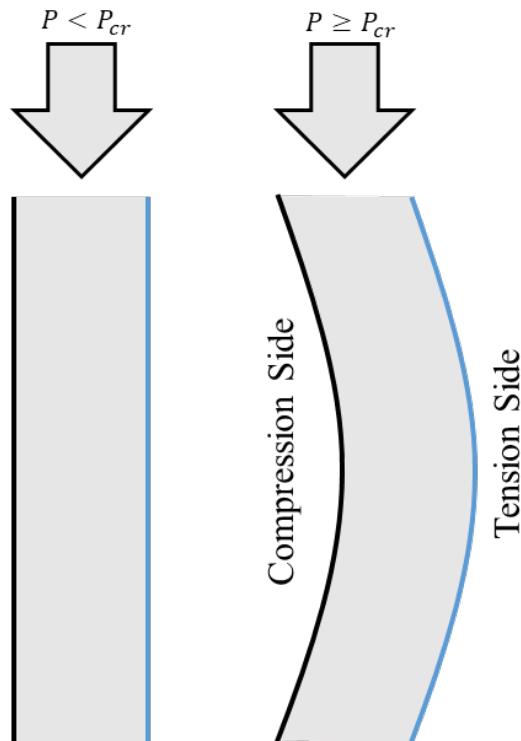
Figure 6.16: Pre/post buckling diagram

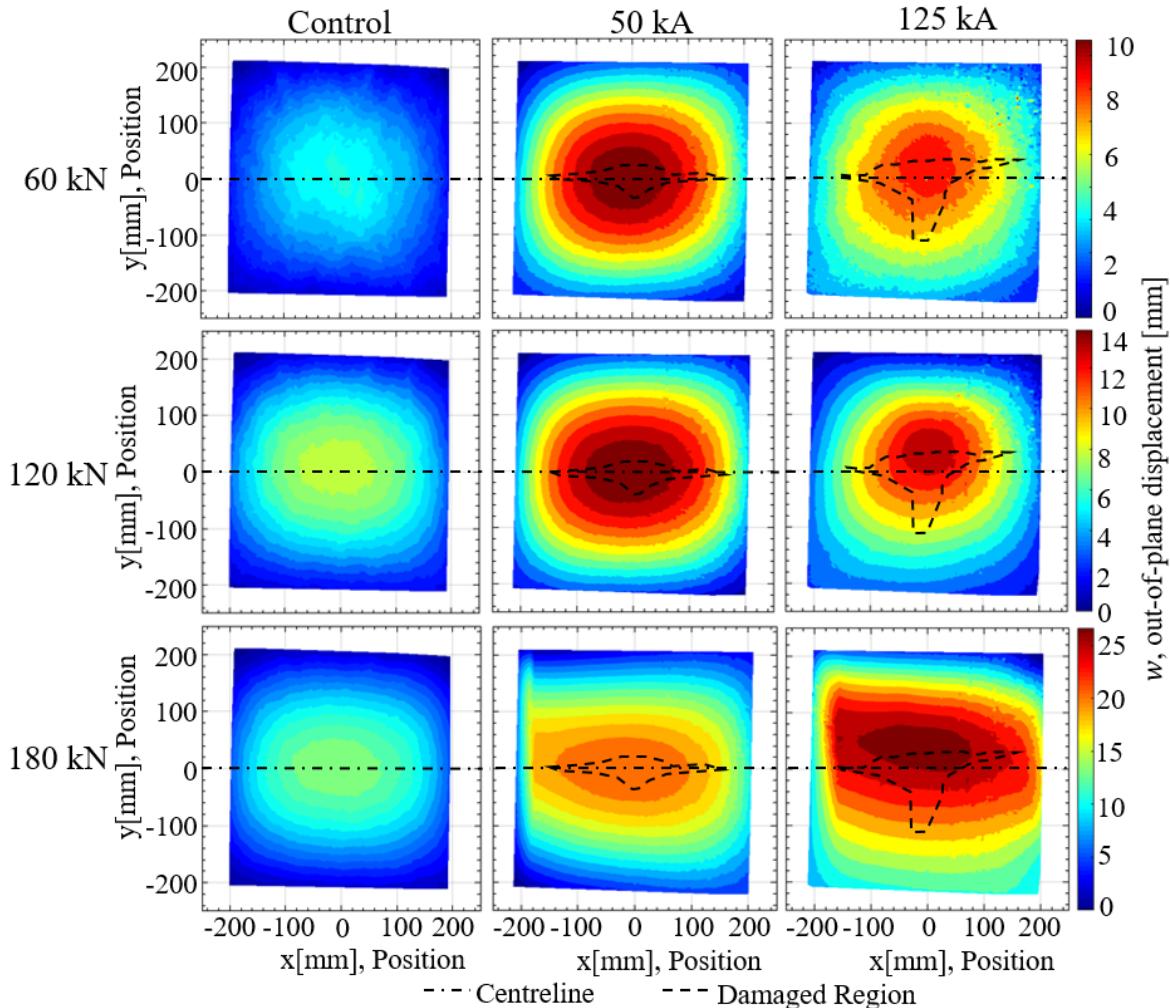
panel specimens. The most severely damaged specimen (lightning strike of 125 kA) for all load levels (Figure 6.17), in addition to showing the highest displacement amplitudes, displays a characteristic change of the shape of the out-of-plane displacement contours, and further that the point of maximum displacement moved away from the damaged region indicating that the panel stiffness in the damaged regions was significantly reduced by the lightning strike events.

Figure 6.17: Stereo DIC measurement of the out-of-plane displacements corresponding to compressions loads of 60, 120, and 180 kN, respectively, for the undamaged (control) specimen, and the lightning damaged specimens subjected to 50 kA and 125 kA peak currents

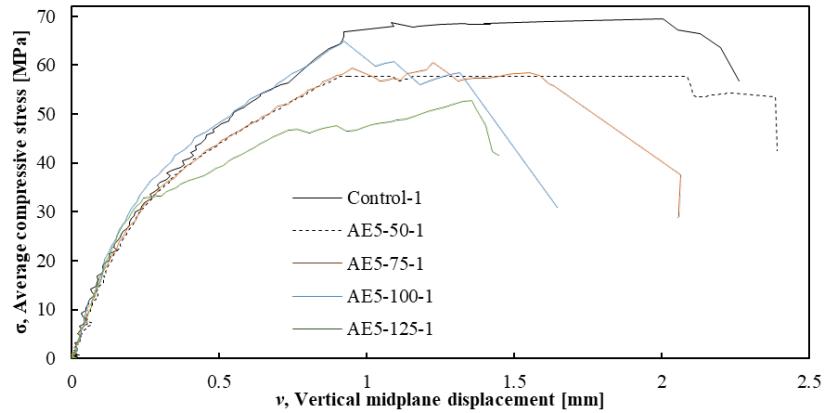
All the tested panels failed due to matrix tension along vertical strips along the vertical edges x -values $+- 180$ mm from the centre of the plate. In all cases, this failure initiated a flattening of the vertical load-displacement curve as shown in Figure 6.18. The flattening of the load-displacement curve reduced with the higher peak currents applied to the specimen. As shown in Figure 6.18 for the worst case AE5-125-1 which was subjected to the highest current and resulting in the most damage had the lowest maximum displacement and compressive stress at failure. The flattening was primarily triggered with an initiation of failure and the end of the flattening was the failure reaching the opposite side and ultimately lead to a structure which resemble that of a wide beam rather than a plate/panel simply supported along all four edges. The characteristic flattened load

Figure 6.18: Vertical load-displacement captured for undamaged, AE5-50-1, AE5-75-1, AE5-100-1, and AE5-125-1 damaged specimens

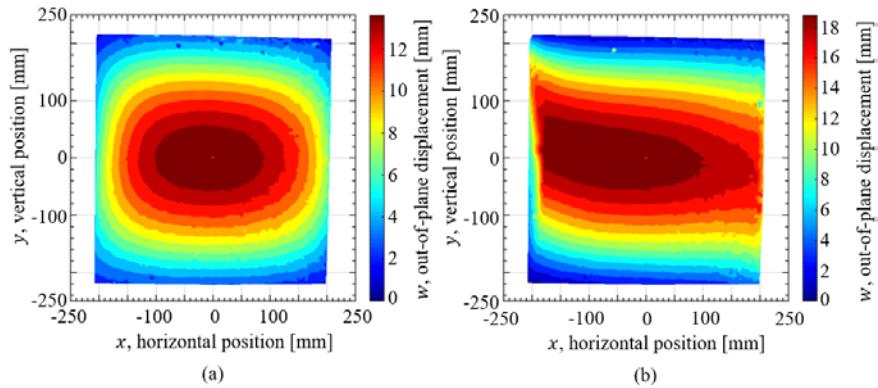
displacement curve, significantly reduced plate stiffness, persisted until total collapse occurred with a subsequent sudden drop in the load, as seen in Figure 6.18. The difference between the pre-first failure event and the post-first failure event is shown in Figure 6.19. Figure 6.19 (a) shows no failure and the out-of-plane displacement is resembles a plate with SSSS end conditions and Figure 6.19 (b) has striations at the failure mark and no longer has the eigenmode shape and resembles a wide beam.

Figure 6.19: Measured out-of-plane displacements recorded for the (a) first failure event at a compressive stress level of 60MPa and (b) prior to collapse in the post-buckled regime at a compressive stress of 69MPa

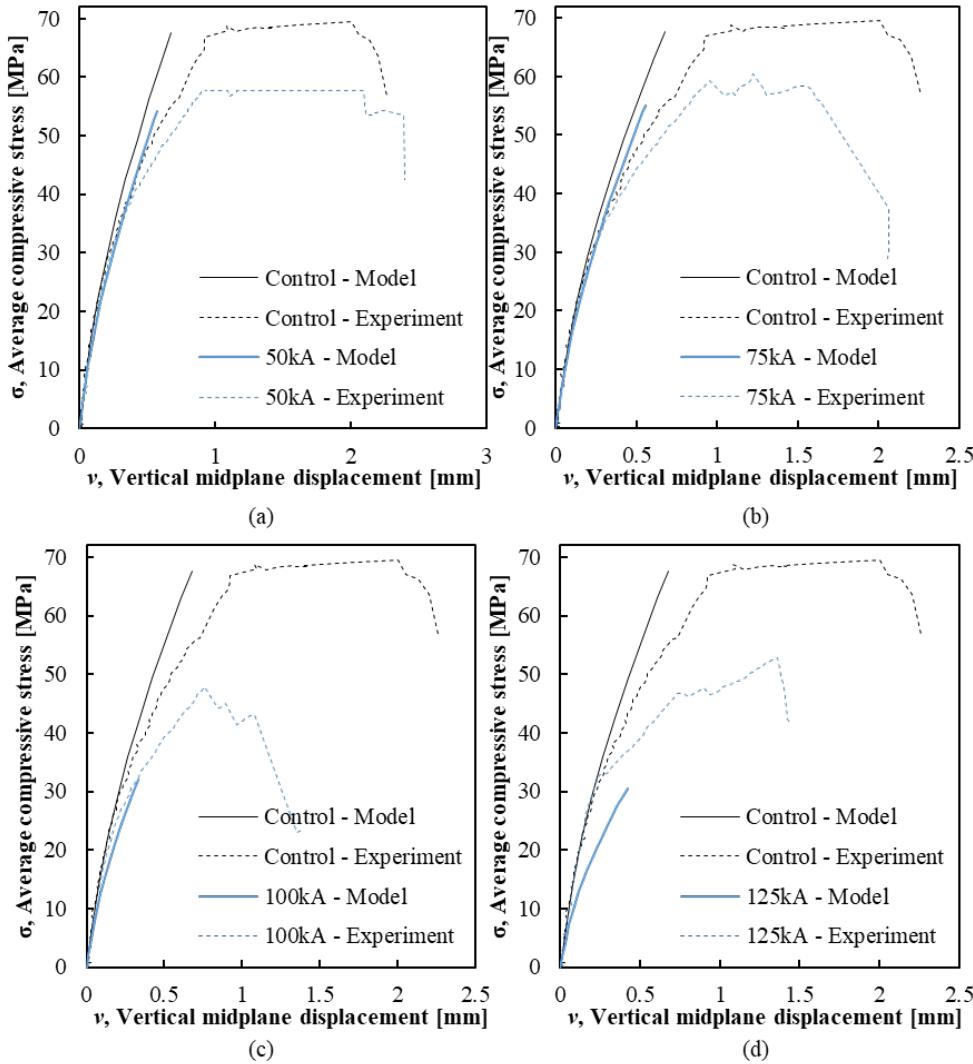
The vertical stress vs vertical displacement curves obtained from the CALS tests as well as the FE model predictions are presented in Figure 6.20 for the undamaged (control) and damaged CFRP panel cases. The model accurately predicts the initial stiffness of the plates however has small errors in the post-buckle region. This may be due to the non-linear stress-strain behaviour in the regions with shear and matrix-tension softening. Although there are some small errors in the displacements, the first ply failure occurs at a compressive pressure load level closely associated with the experimental first failure event. All the values from the experiment and the model are presented in Table 6.6, as well as the percentage difference between the model and the

Figure 6.20: Measured and predicted stress vs in-plane vertical displacement plots (mid-plane edge displacement at vertical specimen symmetry line) corresponding to undamaged (control) and damaged states: Experimental and Model in-plane vertical load displacement curve comparison of undamaged (control) and damaged panels (a) 50 kA, (b) 75 kA, (c) 100 kA, and (d) 125 kA

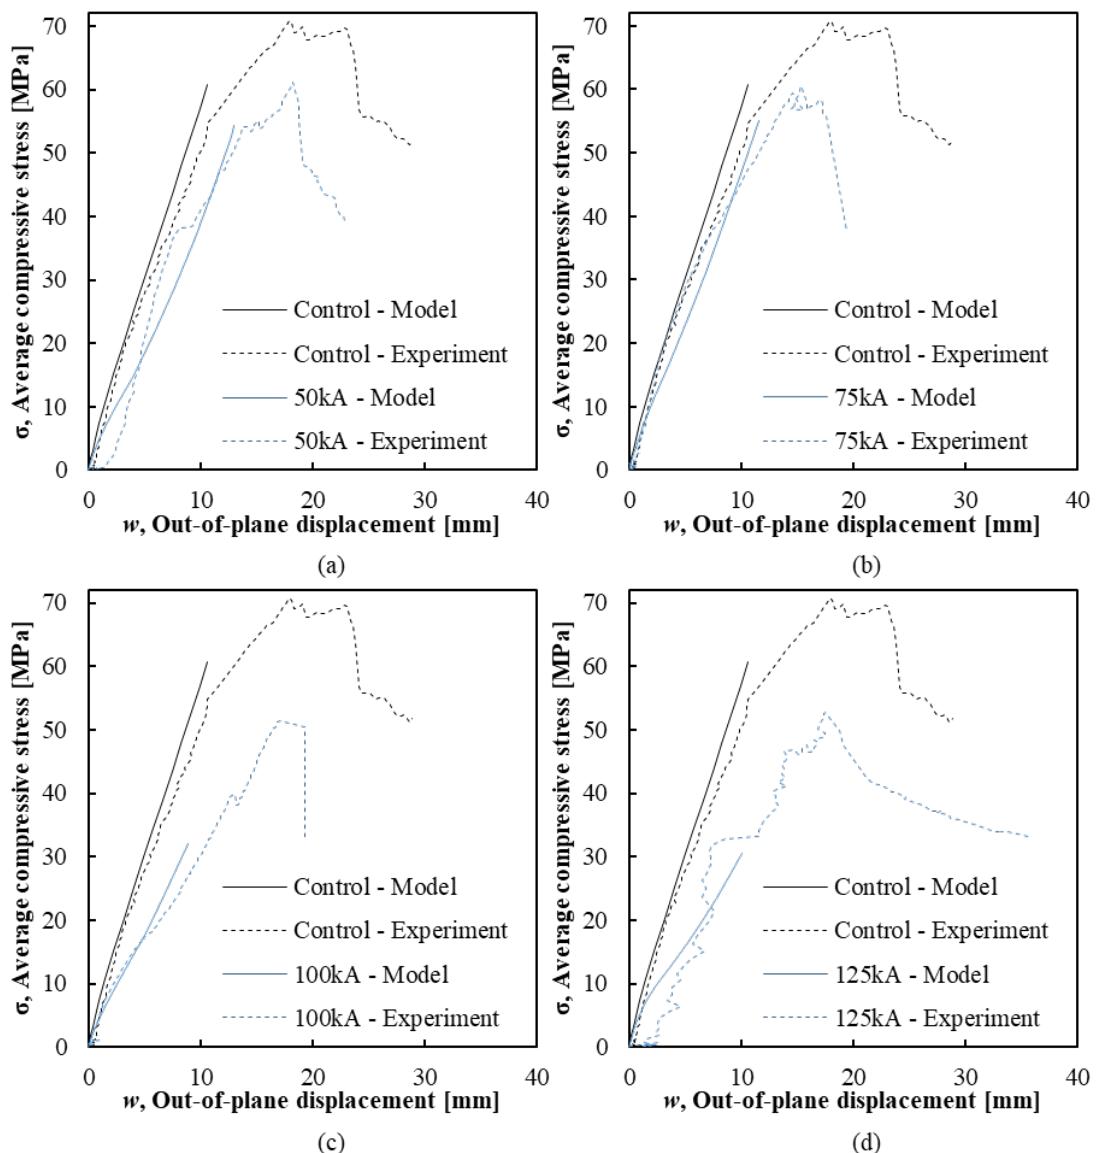
The out-of-plane load displacement curves are presented for the FEM and the measured experimental results in Figure 6.21. As seen, the model predicts the out-of-plane displacement relatively well up to the first ply failure event on the FE model. It can also be seen that there is a gradual softening of the load-displacement curve as the damage is increased. The DIC data, especially for the most severely damaged samples, was difficult to record as the uneven damage surfaces made it difficult to apply the DIC and accounts for the variation in the results shown in Figure 6.21 (d).

Figure 6.21: Experimental and Model out-of-plane vertical load displacement curve comparison of undamaged (control) and damaged panels (a) 50 kA, (b) 75 kA, (c) 100 kA, and (d) 125 kA
