Thesis: Harrell, T.M. (2019) "Characterisation of lightning strike induced damage in CFRP laminates and components for wind turbine blades", University of Southampton, Faculty of Engineering and Physical Sciences, PhD Thesis.

Characterisation of lightning strike induced damage in
CFRP laminates and components for wind turbine blades

Thesis for the degree of Doctor of Philosophy

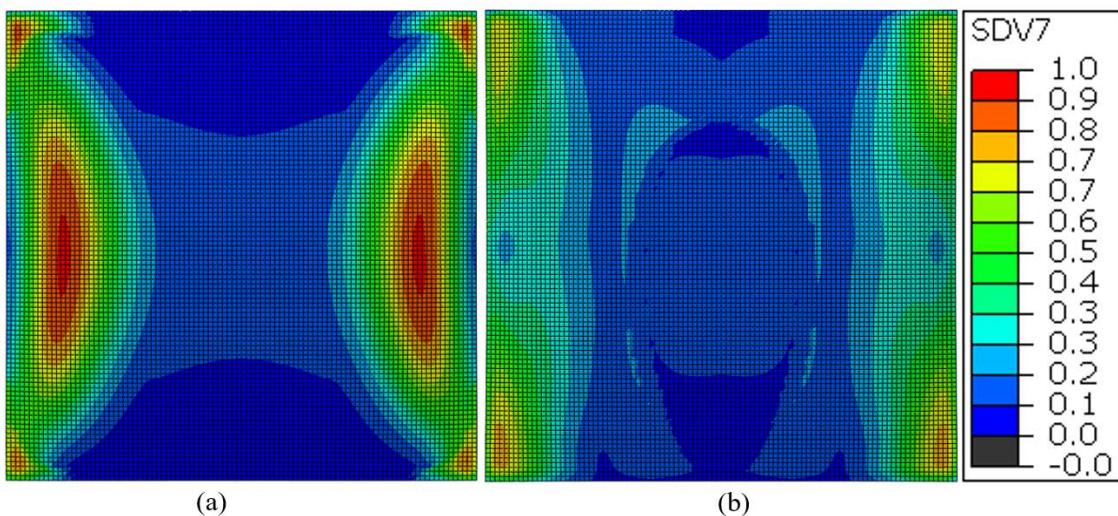
Figure 6.22 - Figure 6.26 show the LaRC failure maps at each damage state failure loads from the structural model. The SDV7 failure map indicates the maximum failure index from the 6 LaRC criteria where 0 means no load and 1 means failure. Figure 6.22 shows the undamaged case which shows that the failure happens on the tension side. The failure map is smooth across the tension side and is related to the undamaged nature of the sample. Checking the mode of the failed region shows that the LaRC criterion predicts failure in matrix tension which is the same results as the experimental study.

Figure 6.22: Maximum LaRC failure index (SDV7) failure map at 69.9 MPa compressive load of the undamaged (control) model for (a) tension side and (b) compression side

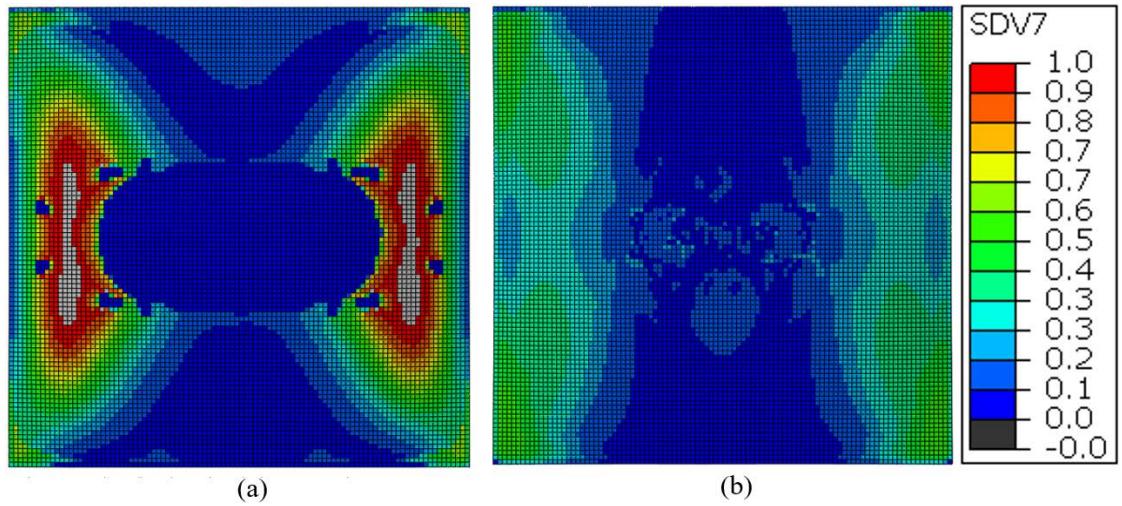
Figure 6.23 shows the failure map for the 50 kA damaged case. The failure map has changed from the control case showing that the zero regions in the centre of Figure 6.23 (a) are the damaged regions. These regions are zero as they have no stiffness and therefore have no load introduced into those elements. The failure map also shows that the failure is becoming more concentrated between the support and the damaged region due to the load redistributing around the damage region. The compression side, Figure 6.23 (b), is also showing the effect of the dispersing and concentrating of the failure indices underneath the damage. Similarly, as the control, the failure mode remained matrix tension.

Figure 6.23: Maximum LaRC failure index (SDV7) failure map at 56.5 MPa compressive load of the 50 kA damaged model for (a) tension side and (b) compression side

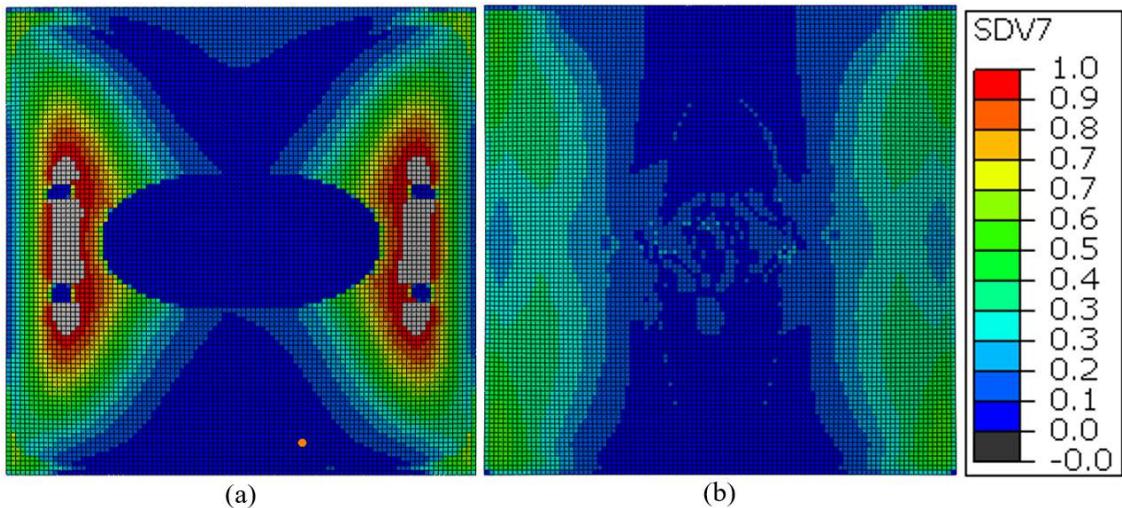
Figure 6.24 shows the failure map for the 75 kA damaged case. The failure map has changed from the control case showing that the zero regions in the centre of Figure 6.24 (a) are the damaged regions. This failure map is different to the 50 kA case as the damaged shape is not as wide and therefore less concentration and less load being redistributed. The compression side, Figure 6.24 (b), is also showing the effect of the introduction of damage into the structural load response. The failure mode remained matrix tension.

Figure 6.24: Maximum LaRC failure index (SDV7) failure map at 59.4 MPa compressive load of the 75 kA damaged model for (a) tension side and (b) compression side

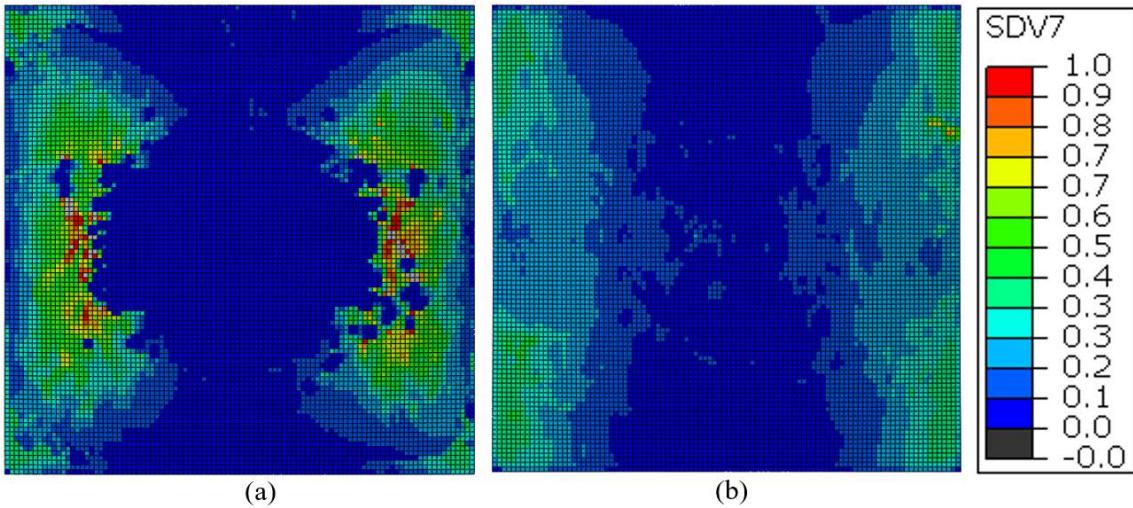
Figure 6.25 shows the failure map for the 100 kA damaged case. The failure map has changed from the control case showing that the zero regions in the centre of Figure 6.25 (a) are the damaged regions. As can be seen in Figure 6.25 (a), the failure map is becoming less smooth and more impacted by the damage. The redistribution of load is concentrating the load between the damage and the support. The compression side, Figure 6.25 (b), is also showing the effect of the load redistribution from the damage. However, the failure mode remained matrix tension.

Figure 6.25: Maximum LaRC failure index (SDV7) failure map at 32.5 MPa compressive load of the 100 kA damaged model for (a) tension side and (b) compression side

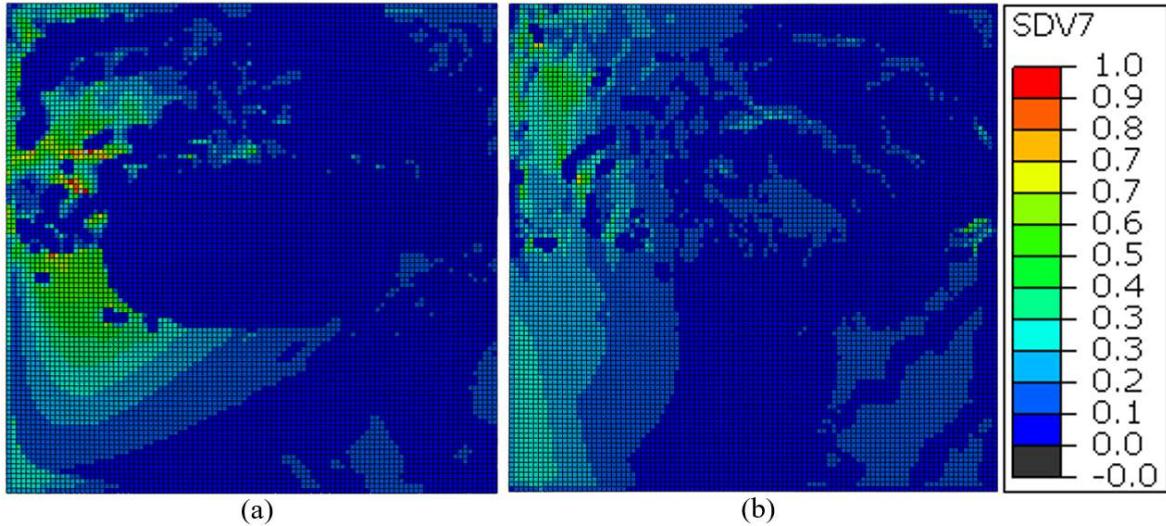
Figure 6.26 shows the failure map for the 125 kA damaged case. The failure map has changed from the control case showing that the zero regions in the centre of Figure 6.26 (a) are the damaged regions. As can be seen in Figure 6.26 (a), the failure map is becoming less smooth and more impacted by the damage. Also, it can be seen that the failure map is now non-symmetric with the failure occurring on the left side. Figure 6.26 (b) shows that the non-symmetry has also developed on the compression side. However, the failure mode remained matrix tension.

Figure 6.26: Maximum LaRC failure index (SDV7) failure map at 32.9 MPa compressive load of the 125 kA damaged model for (a) tension side and (b) compression side

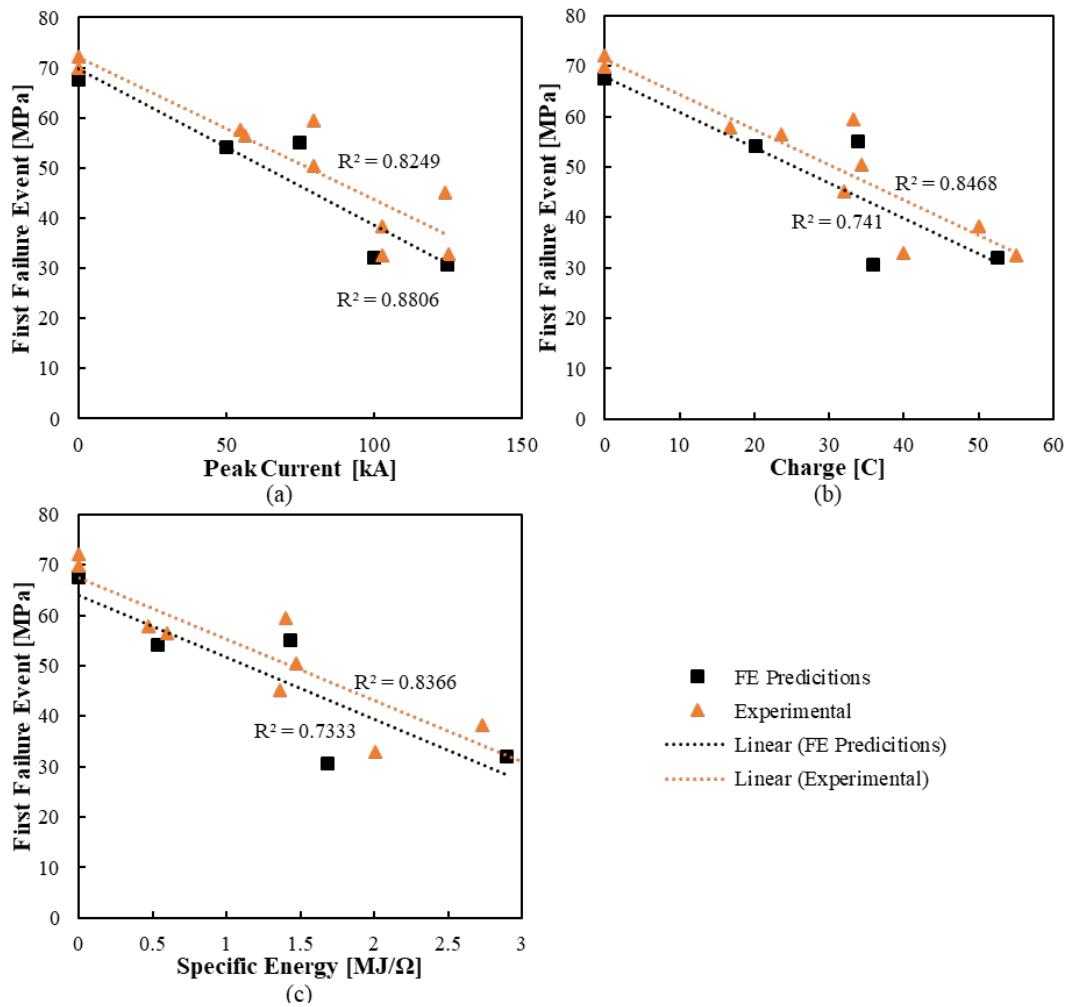
failure event of the FE predictions and the experimental results compared against the lightning parameters peak current, charge, and specific energy. Figure 6.27 (a)-(c) all show a similar result with the increasing peak current, charge, and specific energy all decreasing the compressive stress level which causes the first failure event in the post-buckling failure load-response. The proposed structural model results matched the experimental results for all the lightning parameters with linear fits which had slopes with similar magnitudes.

Figure 6.27: First failure event identified by the structural model (FE predictions) and the AE5 bare surface specimen experimental results against the (a) peak current, (b) charge and (c) specific energy

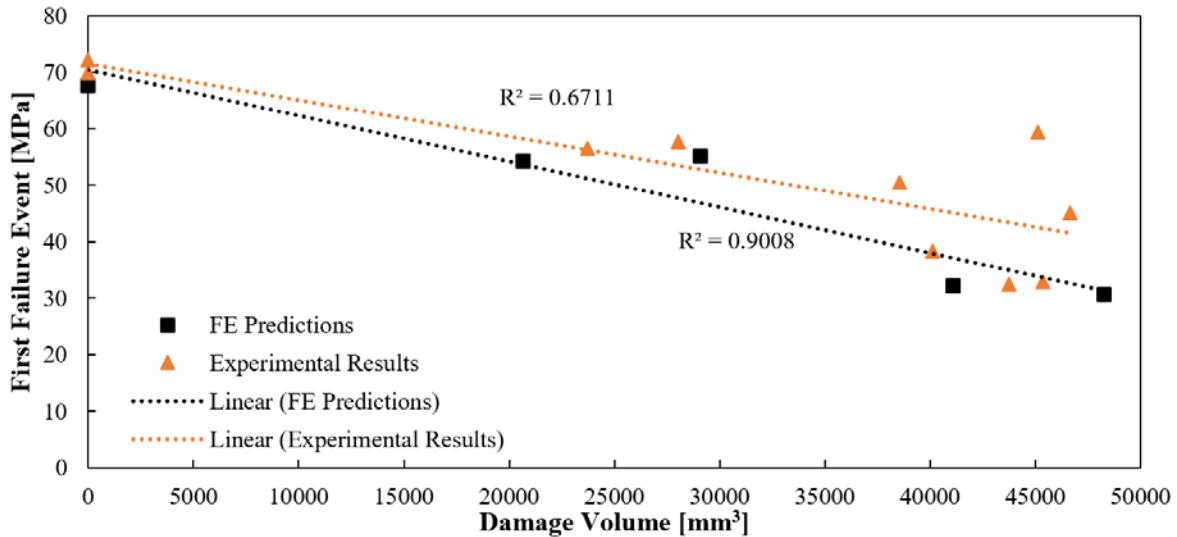
Figure 6.28 shows the first failure event compared to the damage volume and Figure 6.29 shows the first failure event against the damage depth. The results show a similar trend as the damage volume and damage depth increase as the first failure event stress decrease. Although both trends match closely the highest linear fit or R^2 value was with the damage volume and FE predictions. However, the damage volume slopes have a higher degree of difference and can be seen that the slope for the FE predictions are becoming further different to the experimental results. The slopes of the damage depth to first ply failure have more similar magnitudes. This indicates that the damage depth is the more important parameter to be accurate to predict the correct first failure event.

Figure 6.28: First failure event identified by the structural model (FE predictions) and the AE5 bare surface specimen experimental results against the damage volume measured by the Damage Model for the FE predictions and X-ray CT results for the experimental results

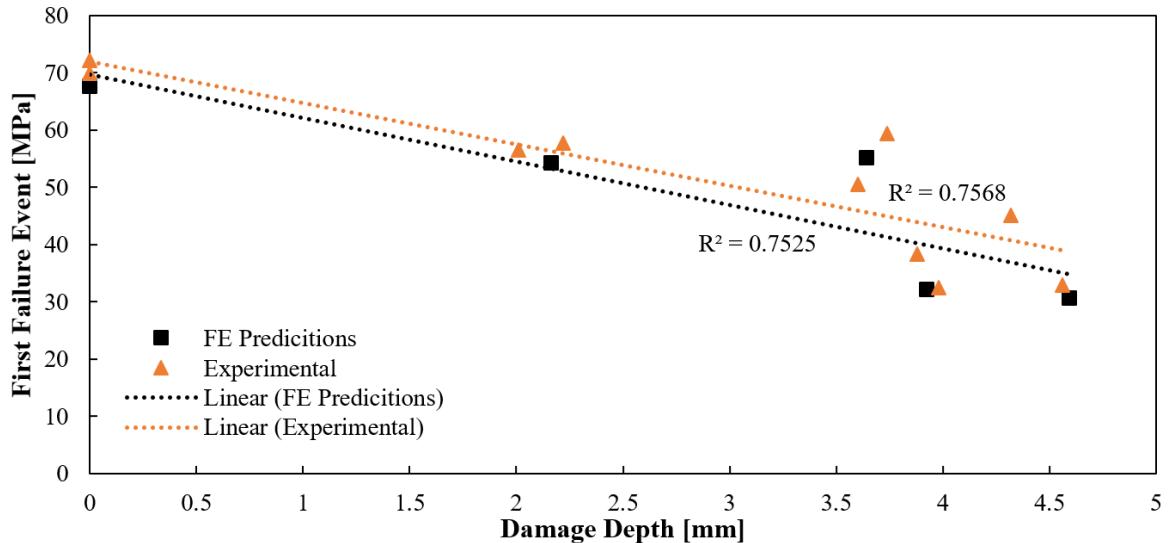
Figure 6.29: First failure event identified by the structural model (FE predictions) and the AE5 bare surface specimen experimental results against the damage depth measured by the Damage Model for the FE predictions and X-ray CT results for the experimental results

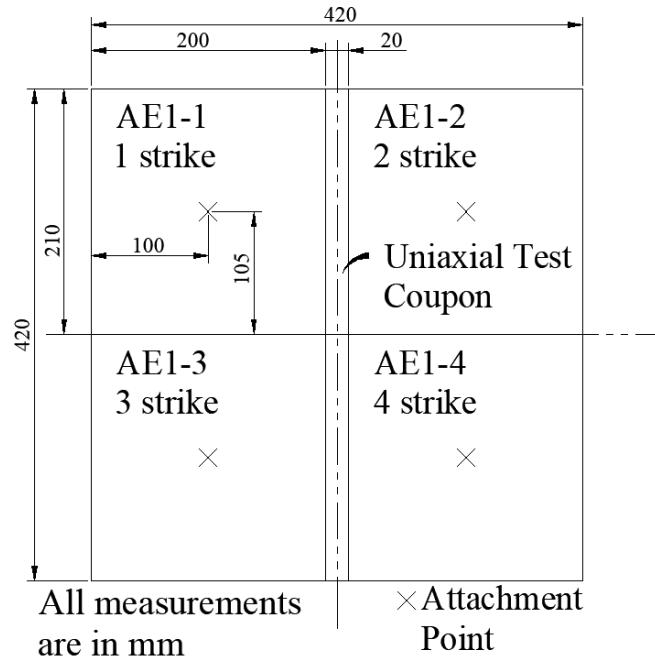
AE1 test was conducted to determine the effect of multiple lightning strikes at the same location. The composite materials were made up of woven carbon fibre dry fabric (375 gsm) and epoxy resin. An eight-ply woven CFRP composite large plate with dimensions of 420mm x 420mm x 4.03mm was manufactured by vacuum liquid resin infusion. Four lightning strike specimens were cut from the large plate with dimensions 200mm long x 200mm wide x 3.90mm thick. Two uniaxial test specimens were cut to measure the control. Figure A.2 shows the large plate with the cut lines used to make the final specimens. The individual specimens were chamfered along the four edges with an approximate 1:4 taper to expose the carbon fibres and to provide a connection to ground.

Figure A.2: Specimen construction for AE1 - influence of repeated lightning strikes

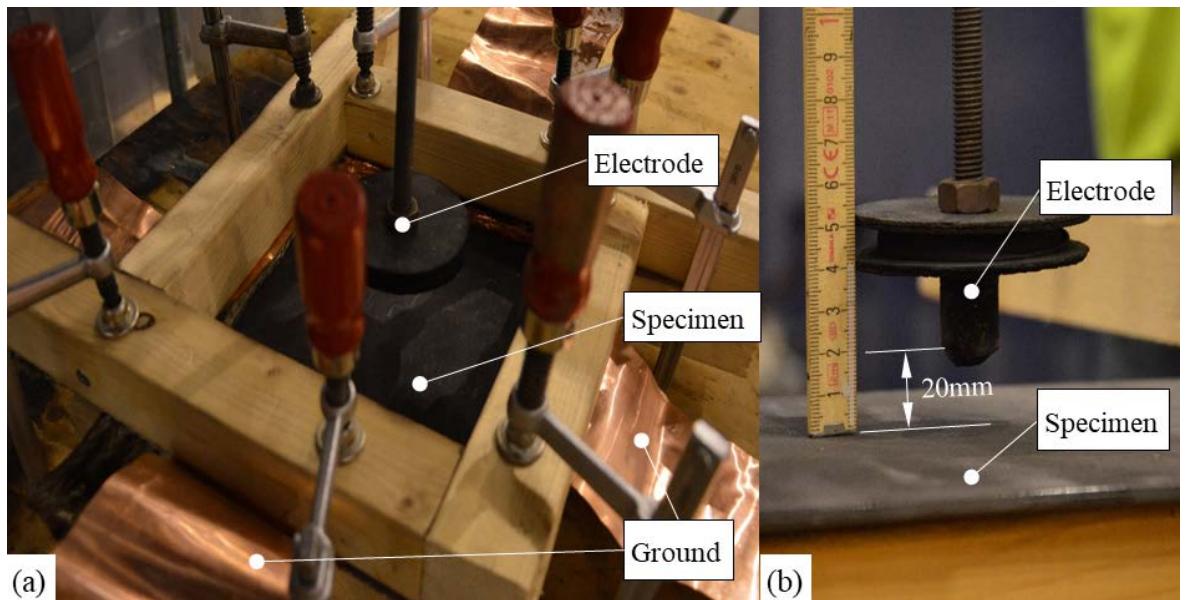
The lightning test setup is shown in Figure A.3. Figure A.3 (a) shows the test rig that includes the electrode, the specimen, and the copper grounds. The copper grounds are attached along all 4 edges of the specimen. The specimen is placed approximately 20mm away from the electrode as shown in Figure A.3 (b). The current travels from this electrode to the closest surface before going through the sample to ground.

Figure A.3: (a) Test setup for AE1 and (b) electrode gap

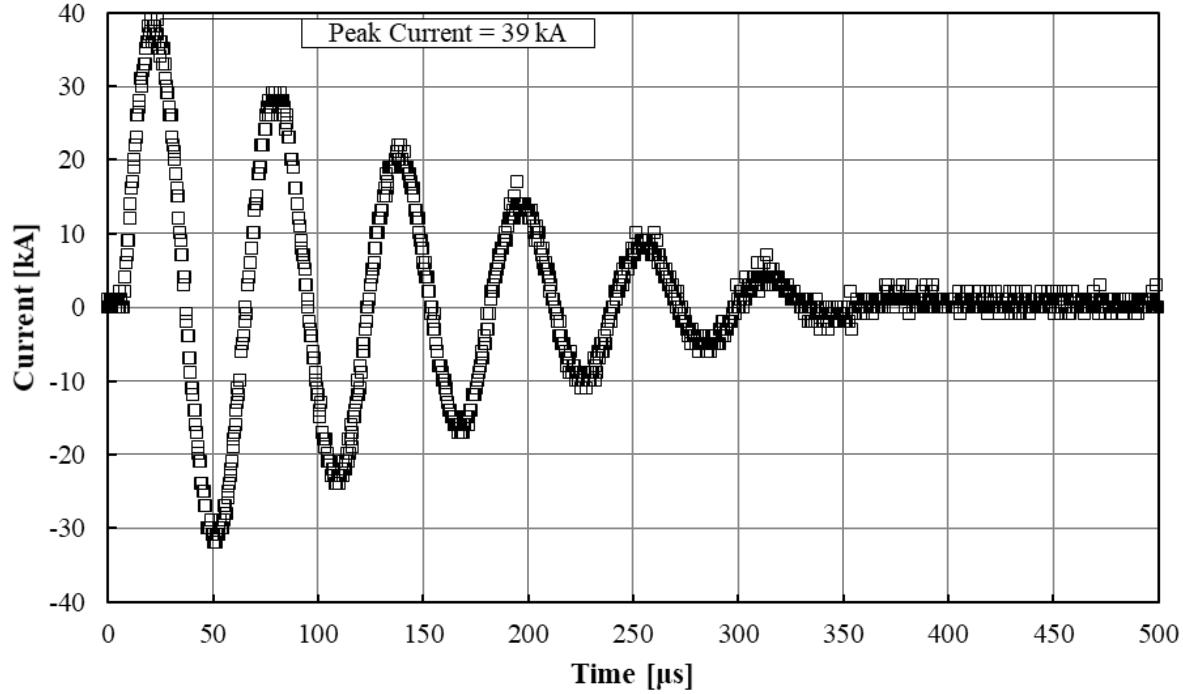
17/145 μ s waveform characteristics. Figure A.4 shows an example of the waveform for the first simulated lightning strike on the first specimen (AE1-A-1).

Figure A.4: AE1-A-1 current waveform

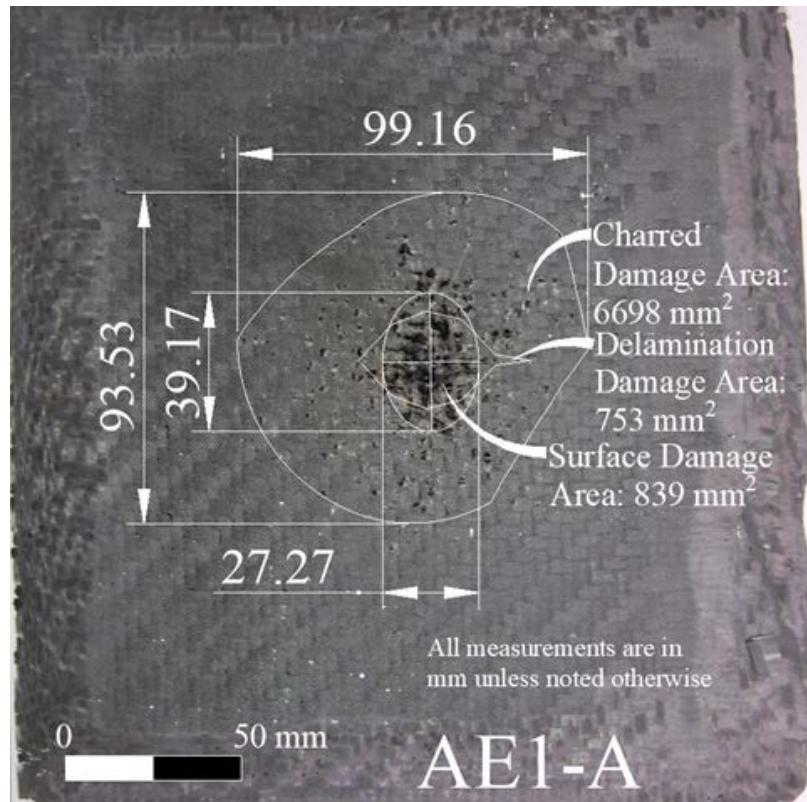
Four CFRP specimens were subjected to simulated lightning strike events for test AE1. The four specimens were struck with 1, 2, 3, and 4 lightning strikes respectively. For all AE1 specimens, the surface damage and charred damage were primarily in a circular shape; see specimen AE1-A in Figure A.5. AE1-A through AE1-D had similar patterns of surface and damage shapes and sizes.

Figure A.5: Visual inspection AE1-A

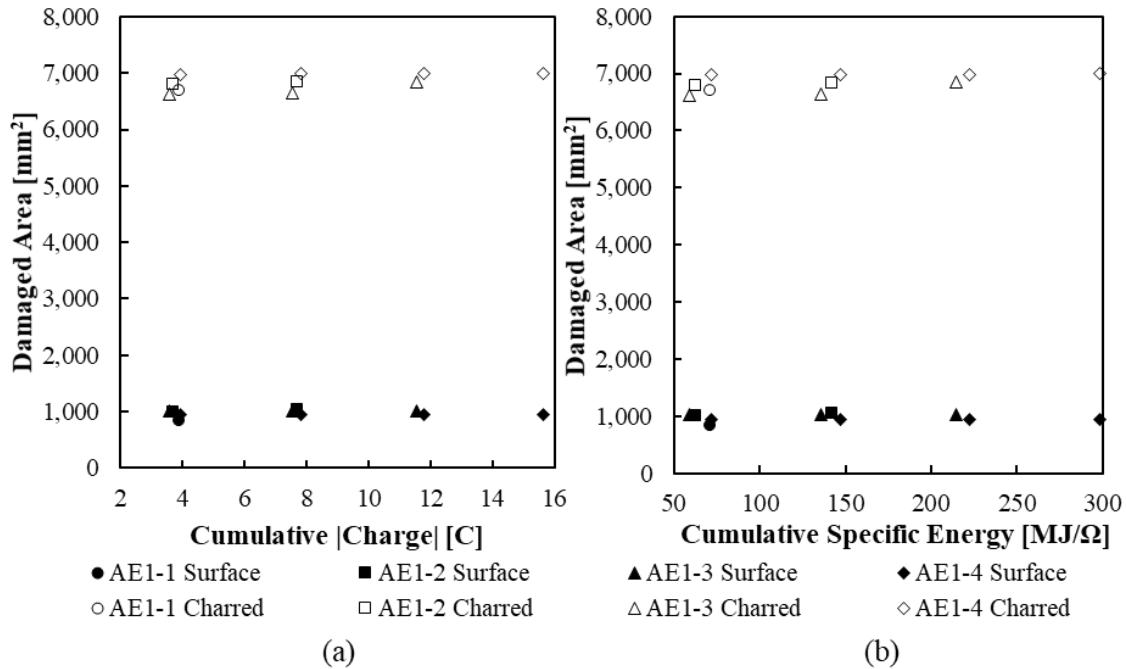
As can be seen in Table A.3, additional lightning strikes applied to the specimen do not increase the amount of damage. The areas are presented in Figure A.6 (a) and (b) which plots the damage area against the cumulative charge and specific energy.

Figure A.6: Visual inspection damage area compared to number of lightning strikes from AE1 against (a) cumulative /charge/ and (b) cumulative specific energy

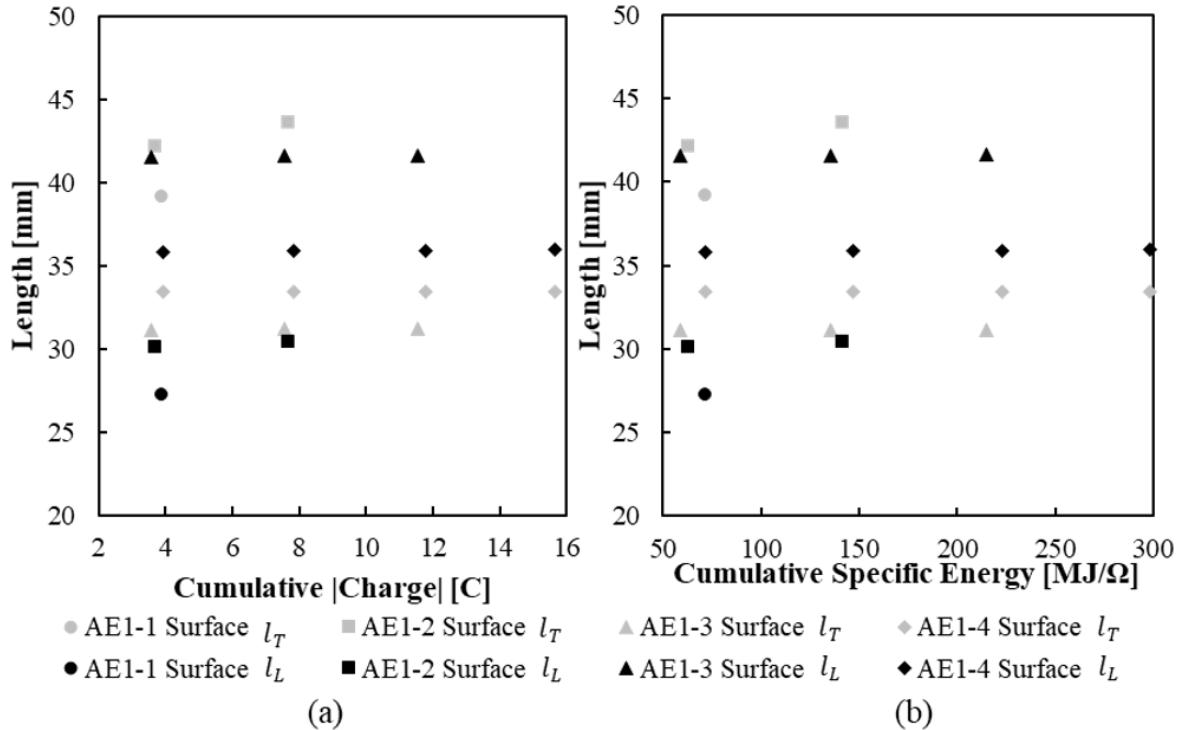
Similar to the area, Figure A.7 (a) and (b) shows the outer extreme lengths of the damage are not increased with additional lightning strikes applied to the specimen.

Figure A.7: Visual inspection damage lengths to test AE1 against (a) cumulative |charge| and (b) cumulative specific energy

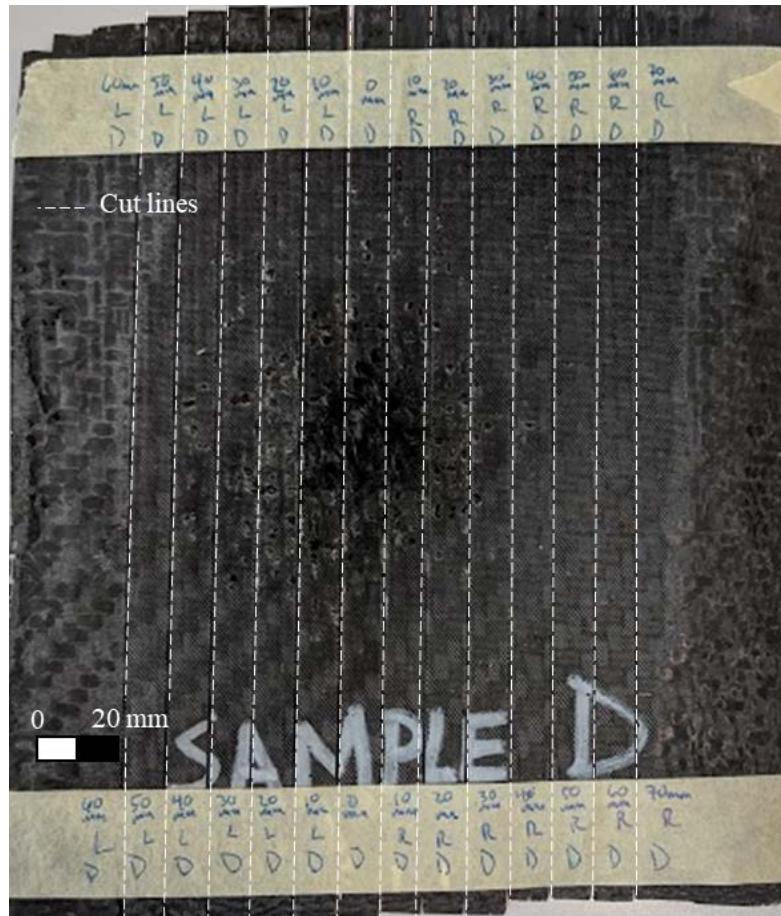
10mm strips were cut from all the AE1 test specimens; see Figure A.8. The strips were used to evaluate the sub-surface defects.

Figure A.8: Waterjet cut of AE1 specimens

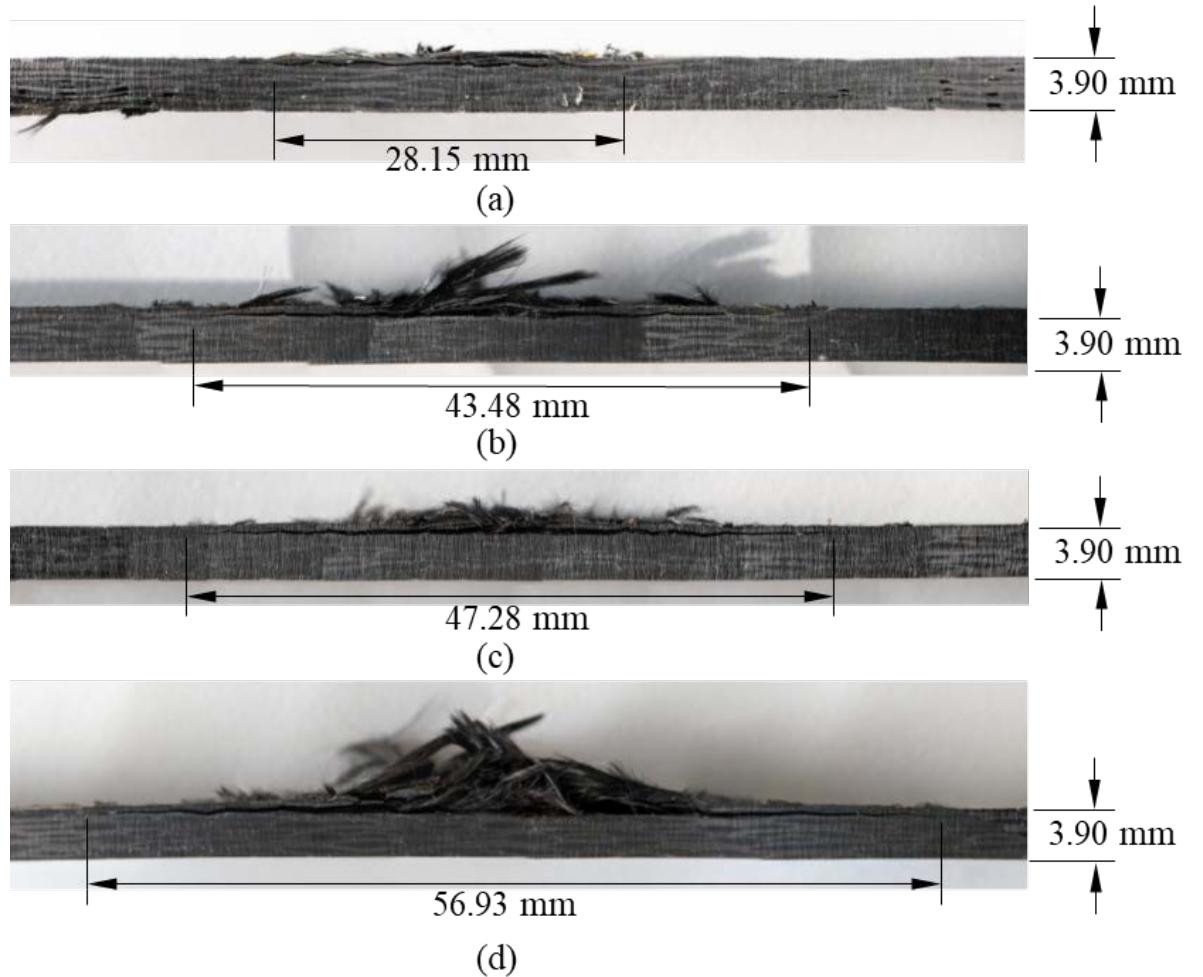
Examining the edges of the waterjet strips, each specimen had clear delaminations. The delamination damage increased with each successive lightning strike. Examples of the delaminations are shown in Figure A.9.

Figure A.9: Microscopy images (a) AE1-A, (b) AE1-B, (c) AE1-C, and (d) AE1-D

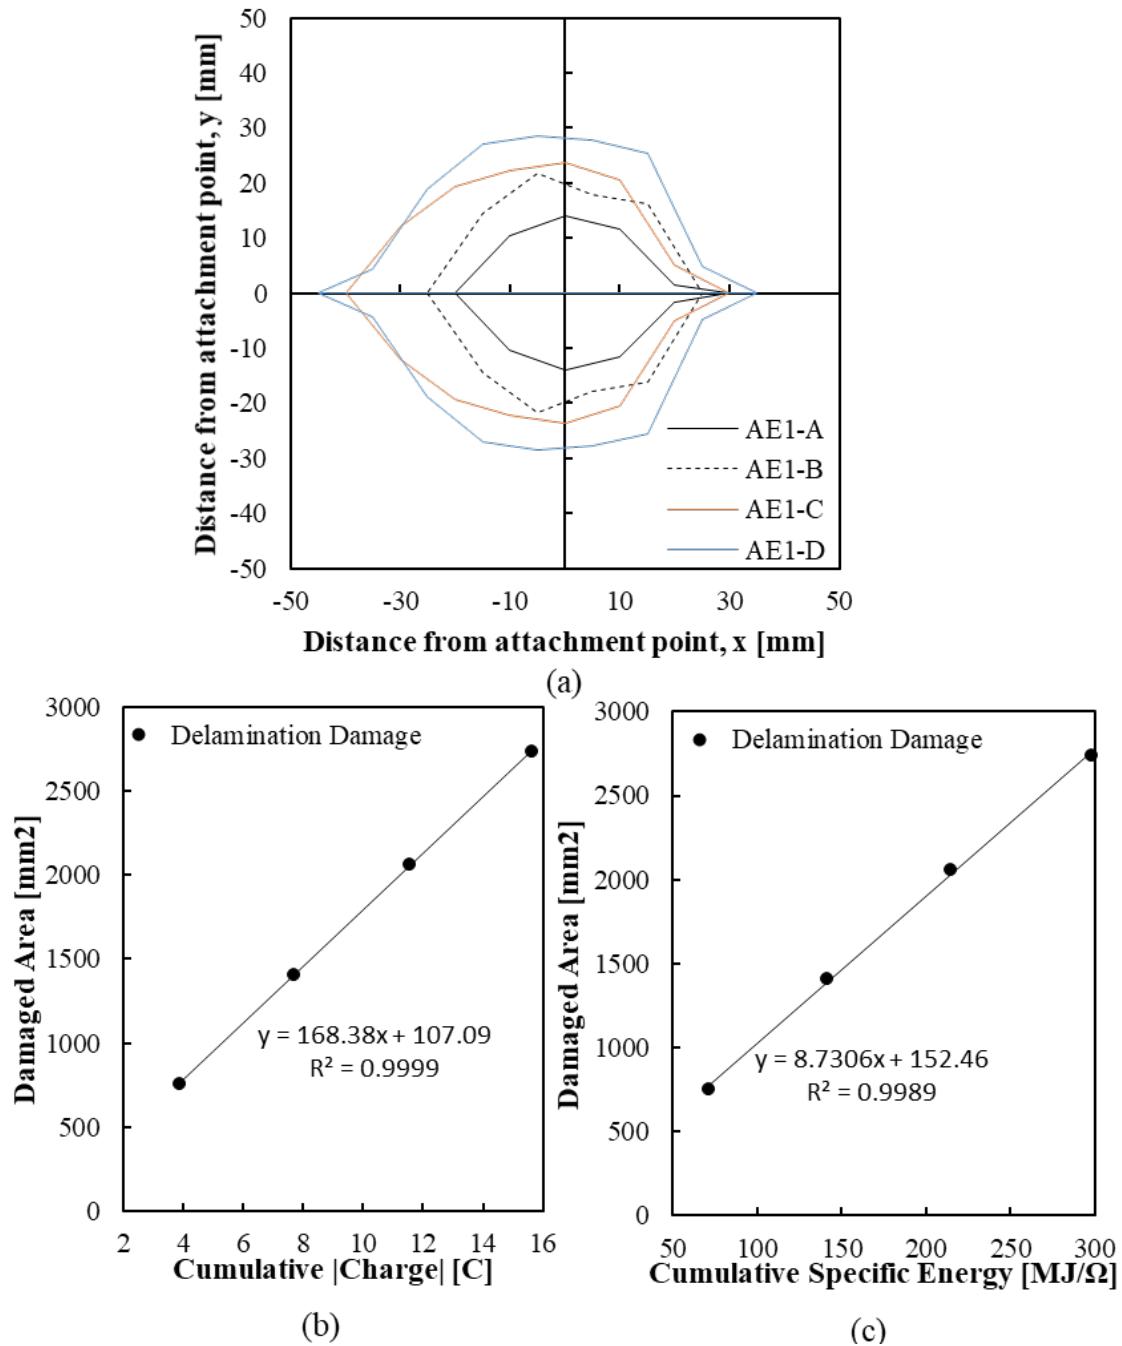
Each strip edge delaminated length was measured. The measured distances were added to a chart with the distance from the centre of the damage in Figure A.10 (a). This provided a delaminated region. The coordinates of this region were used to calculate a delamination area. The delaminated areas were compared against the cumulative $|\text{charge}|$ and specific energy in Figure A.10 (b) and (c). The figure shows that the delamination region for each sample grew in a linear fashion with both $|\text{charge}|$ and specific energy being good indicators of the amount of delamination damage.

Figure A.10: Delamination damage from specimens in test AE1 where (a) is an overview of the area, (b) is the total area compared to the cumulative |charge| and (c) is the total area compared to the cumulative specific energy

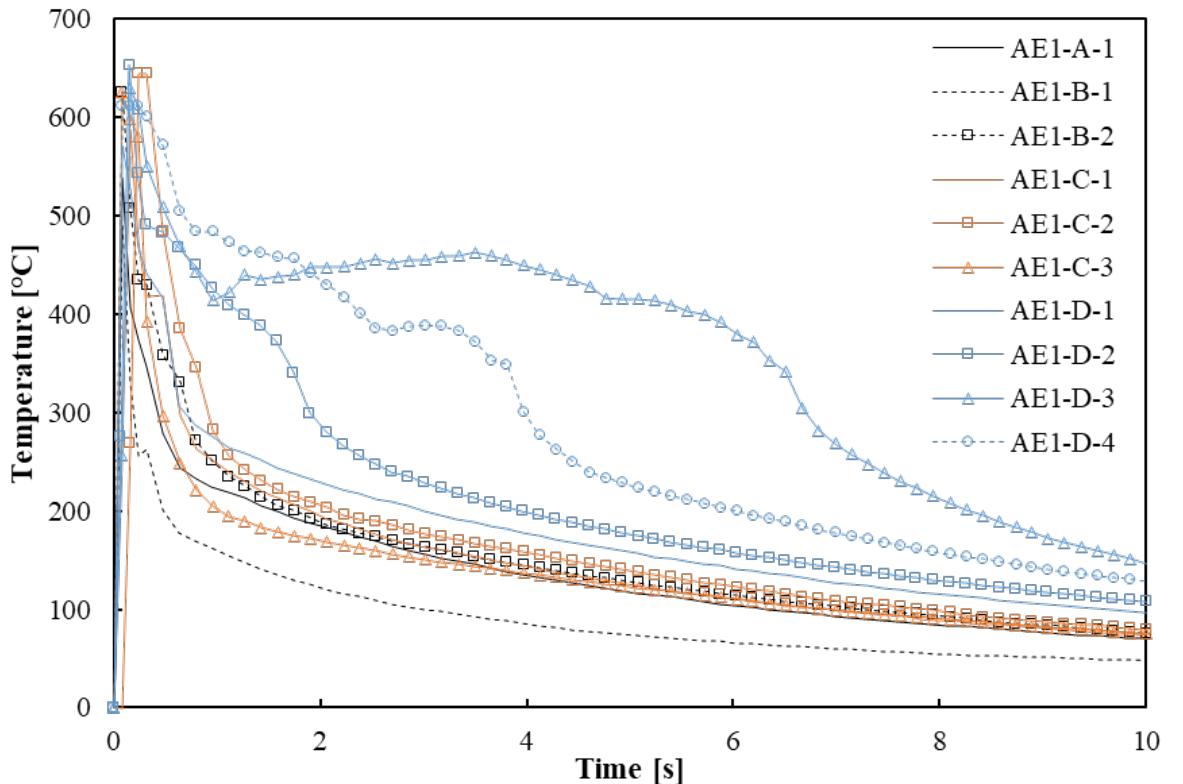
The thermal data was recorded to find the maximum temperature during the lightning strike tests. The temperature data recorded for AE1 is shown in Figure A.11. The thermal data results show that the maximum temperature always occurred directly after the lightning strike event and exponentially decayed afterwards. On all samples, the initial lightning strike thermal evolution decayed the fastest. The repeated lightning strikes held the heat longer. This would indicate either higher specific heat or lower electrical/thermal conductivities in the damaged region. The one outlier is the AE1-D-3 specimens because the maximum temperature is taken by an ignited piece of the specimen that did not extinguish for approximately 6 seconds.

Figure A.11: Maximum temperature evolution of AE1 tests

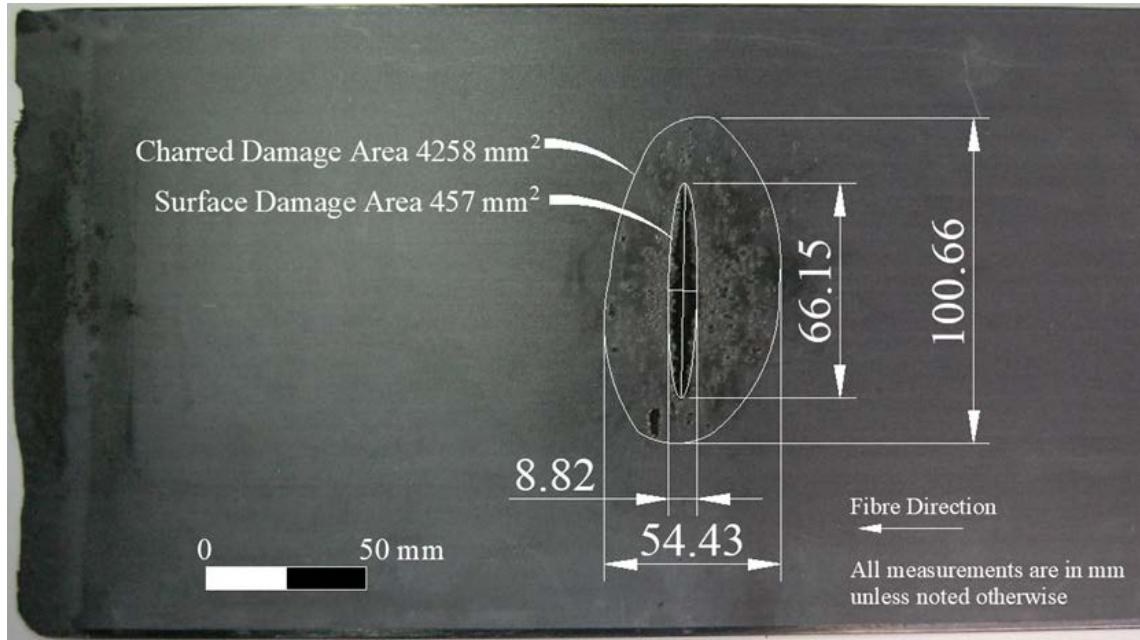
Four CFRP specimens were subjected to simulated lightning strike events for test AE2. All AE2 specimens showed surface damage and charred damage primarily in elliptical shapes with the major axis in the transverse direction; see specimen AE2-4 in Figure A.12. AE2-1 through AE2-4 had similar patterns of surface damage shape.

Figure A.12: Visual inspection of damaged specimen from AE2-4 struck with oscillating waveform

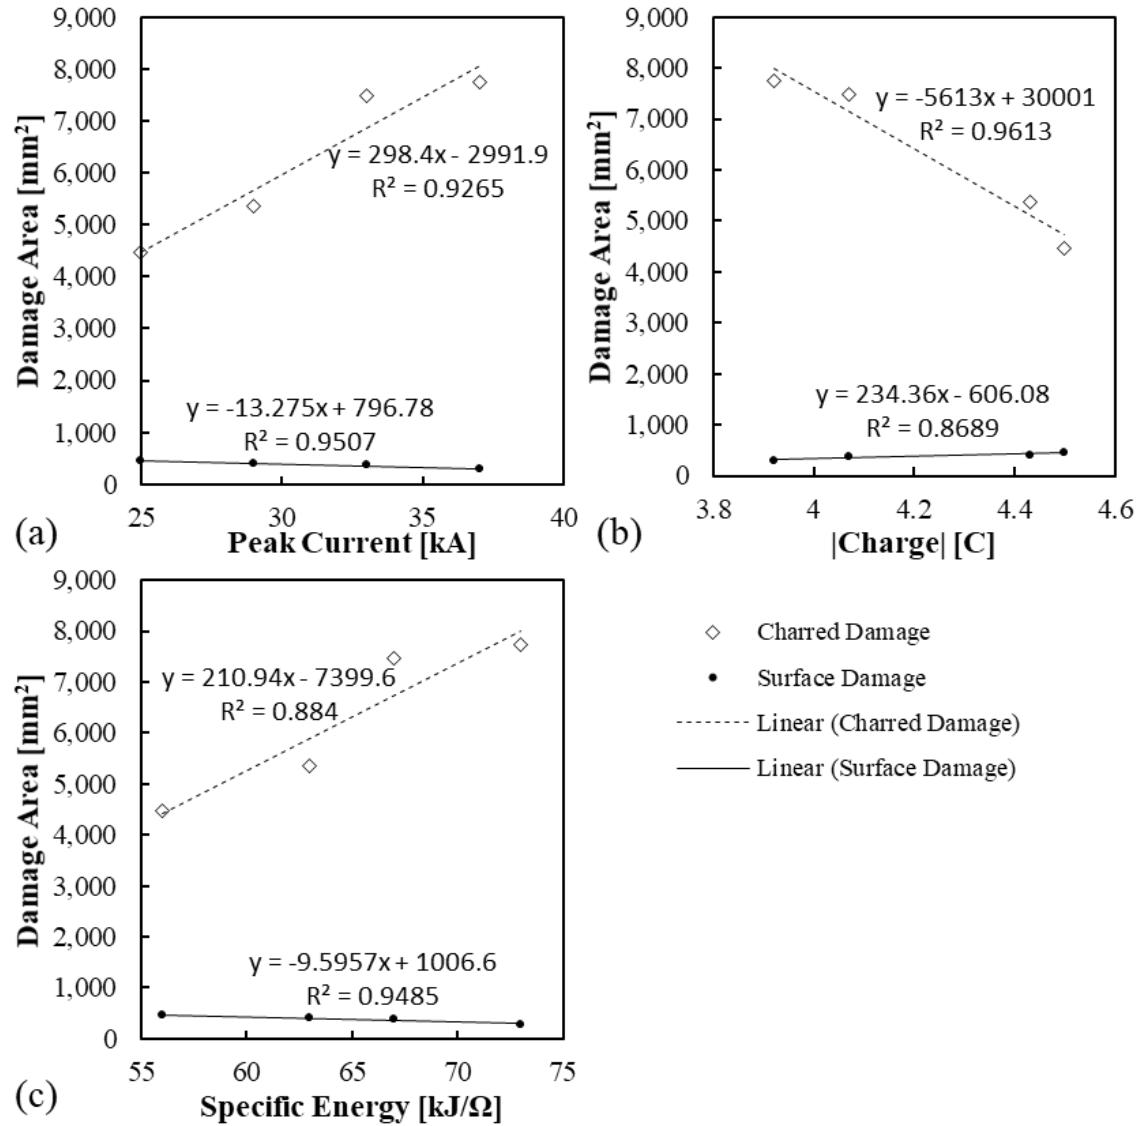
Figure A.13 shows the results of the visual inspection. The resulting visual inspection showed very little change in the surface damage and a much larger change in charring damage due to an increase in peak current and specific energy. The $|charge|$ had the inverse effect the increase in $|charge|$ reduced the charring damage. This may indicate that the specific energy is a better link to damage than charge.

Figure A.13: Visual inspection damage area for AE2 experiments against (a) peak current, (b) /charge/ and (c) specific energy

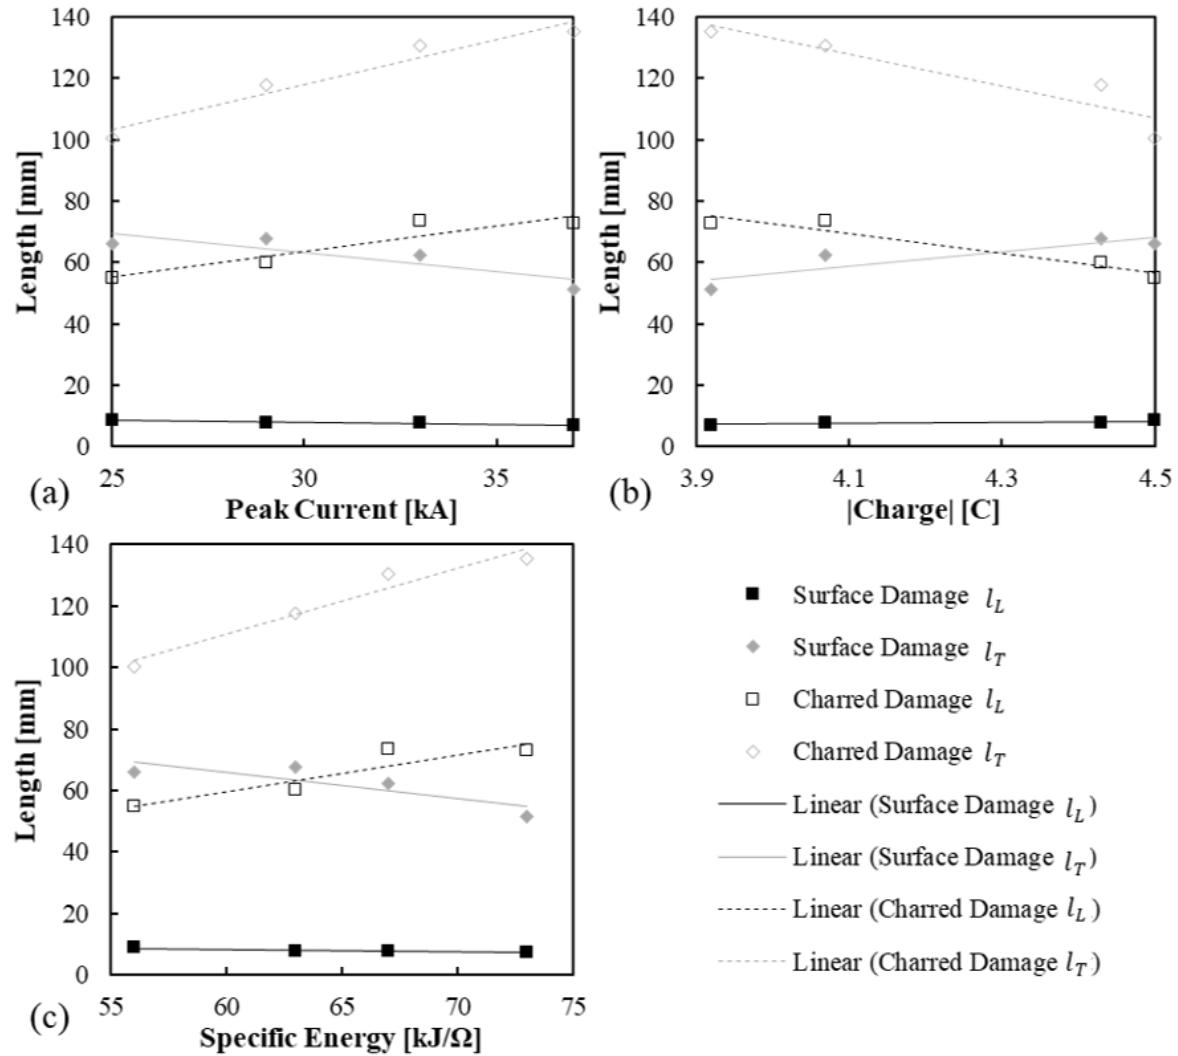
The outer lengths of the damage in the transverse and longitudinal directions are shown in Figure A.14. The plot shows for test AE2 that the length in the longitudinal direction is approximately 7 times larger for the surface damage and only about 1.8 times larger for the charred damage. This indicates that the charred damage is much more circular in shape and may be more related to other physics than just Joule heating. Typical models would indicate that the spread of damage would be more in the longitudinal direction. This indicates that some other process is occurring. The results for the peak current and specific energy (Figure A.14 (a) and (c)) are similar where the absolute charge is inverse.

Figure A.14: Outer lengths of surface and charred damage in the longitudinal and transverse direction against (a) peak current, (b) charge, and (c) specific energy

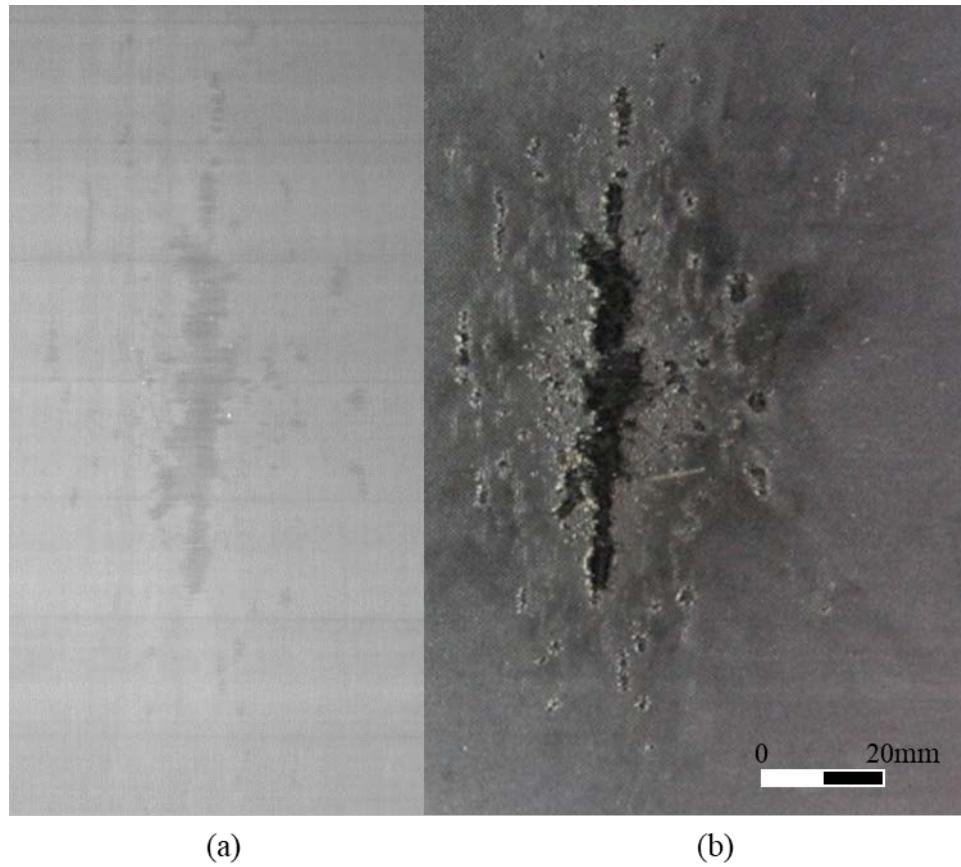
The damage was visually inspected and not determined to be deep, matching a similar profile as damage seen on the surface. Further inspection shows no discernible delamination or other damage seen below a depth of 0.45mm below the surface. The resulting CT scan is shown in Figure A.15 (a).

Figure A.15: Image of damage (a) CT image and (b) visual inspection

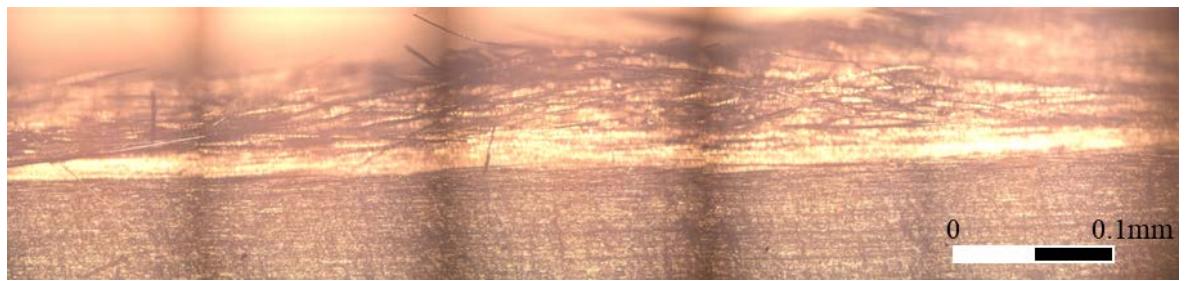
Evaluating the CT scans further, there was no discernible additional damage, delamination or otherwise, from the lightning strike. This was confirmed with microscopy images shown in Figure A.16.

Figure A.16: Microscope image of AE2-2

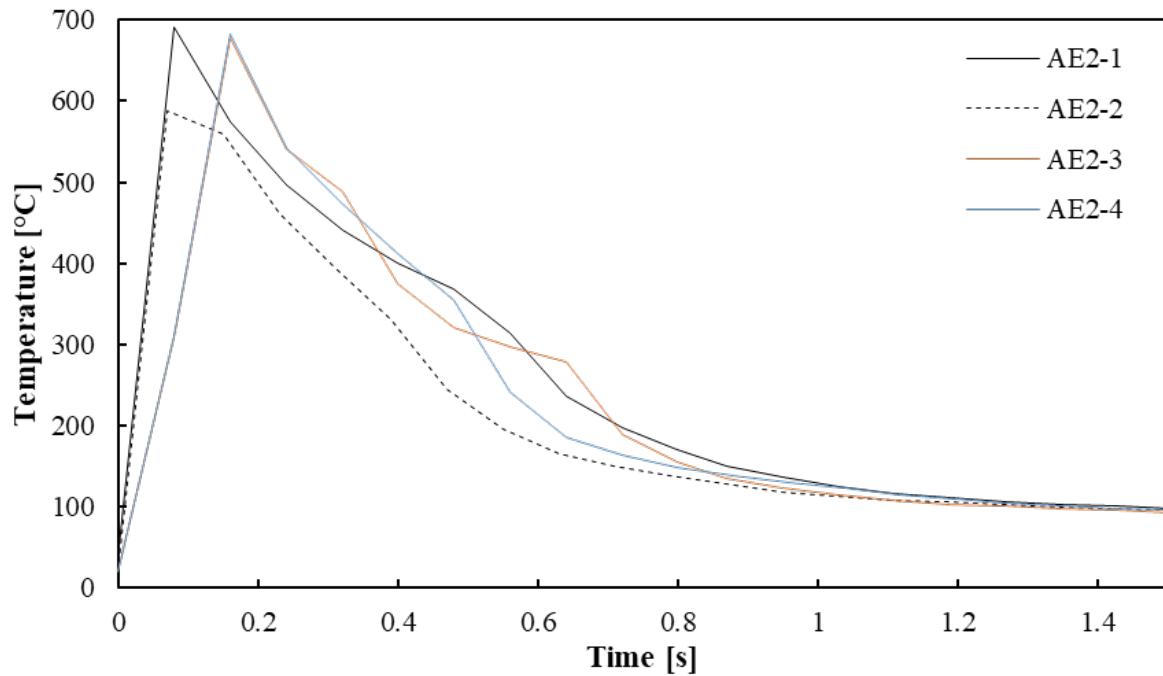
The maximum temperature data recorded for AE2 is shown in Figure A.17. The thermal data results showed that the maximum temperature always occurred directly after the lightning strike event and exponentially decayed afterwards. All of the samples struck had similar times from peak to less than 100°C of around 1.4 seconds. The lightning waveform for AE2 lasts for less than 1 ms and it is difficult to capture the full temperature evolution with today's thermal camera equipment. The resin burning and pyrolysis effects last longer. Also, due to intense brightness and ignition of air near and around the lightning attachment zone, the thermal profile observed at that moment may not be accurate.

Figure A.17: Maximum temperature evolution for AE2
