Thesis: Harrell, T.M. (2019) "Characterisation of lightning strike induced damage in CFRP laminates and components for wind turbine blades", University of Southampton, Faculty of Engineering and Physical Sciences, PhD Thesis.

Characterisation of lightning strike induced damage in
CFRP laminates and components for wind turbine blades

Thesis for the degree of Doctor of Philosophy

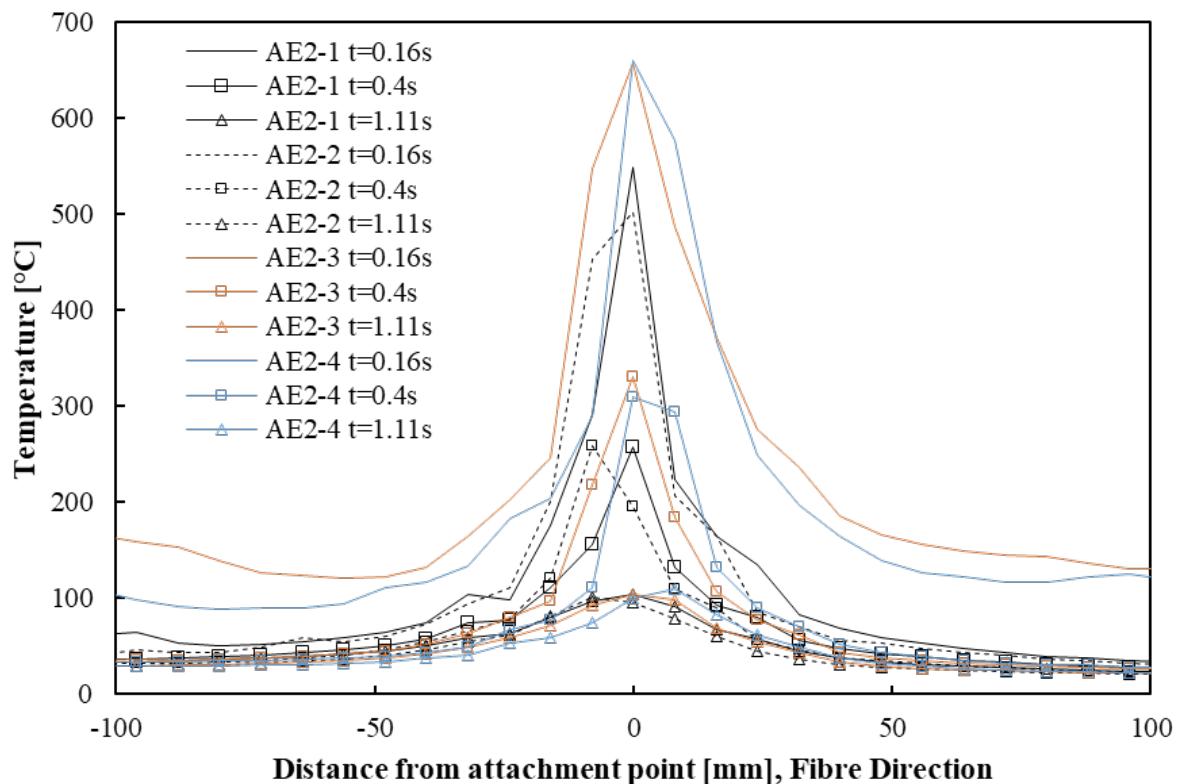
The temperature profile recorded in the longitudinal and transverse directions are shown in Figure A.18 and Figure A.19 at three specific frames (times of 0.16s, 0.4s, and 1.11s). As can be seen in the figures, the temperature profiles match closely with the surface damage.

Figure A.18: Temperature distributed in the fibre direction for AE2 tests

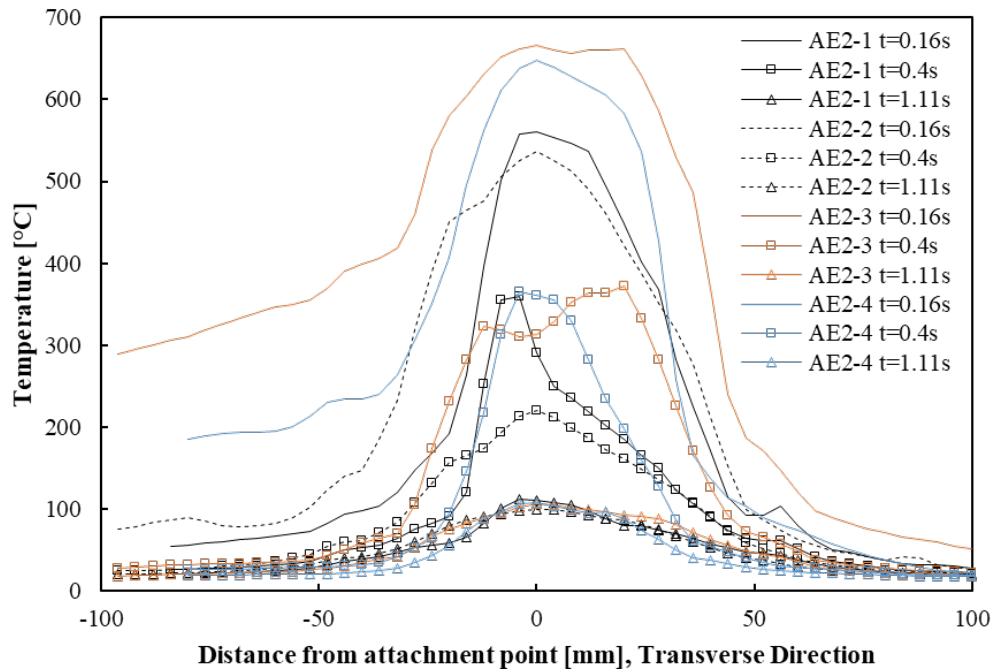
Figure A.19: Temperature distributed in the transverse direction for AE2 tests

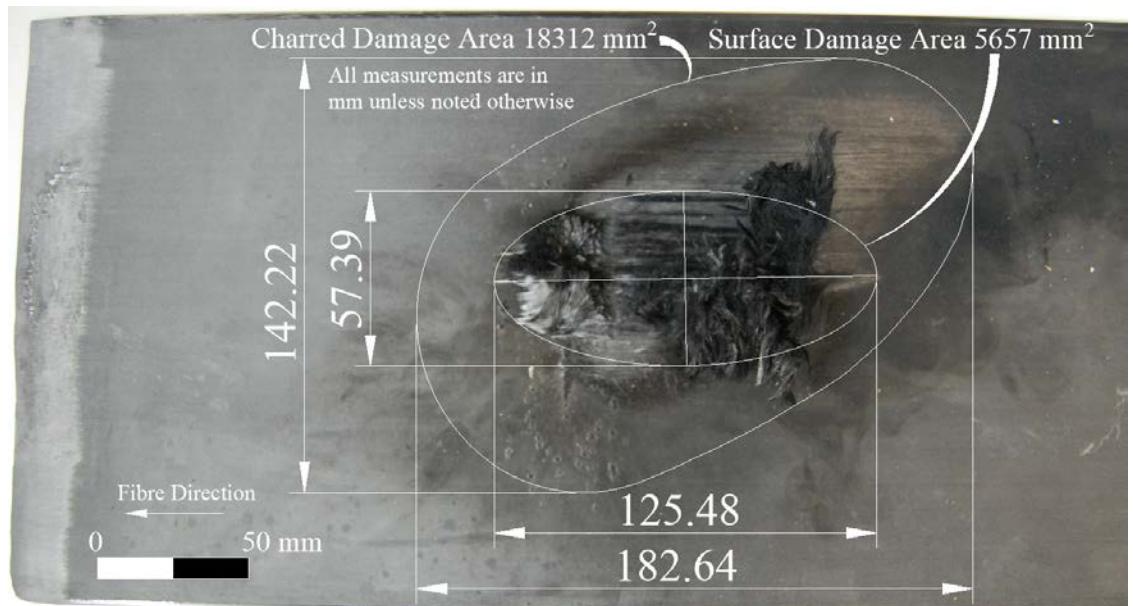
Four CFRP specimens were subjected to simulated lightning strike events for AE3. All AE3 specimens were subjected to DC current. The only variation was the amount of time exposed. For all AE3 specimens, the surface damage was primarily in an elliptical shape with the major axis in the longitudinal direction; see specimen AE3-4 in Figure A.20. AE3-1 through AE3-4 had similar patterns of surface and defect shapes and sizes.

Figure A.20: Visual inspection of damaged specimen AE3-4 struck

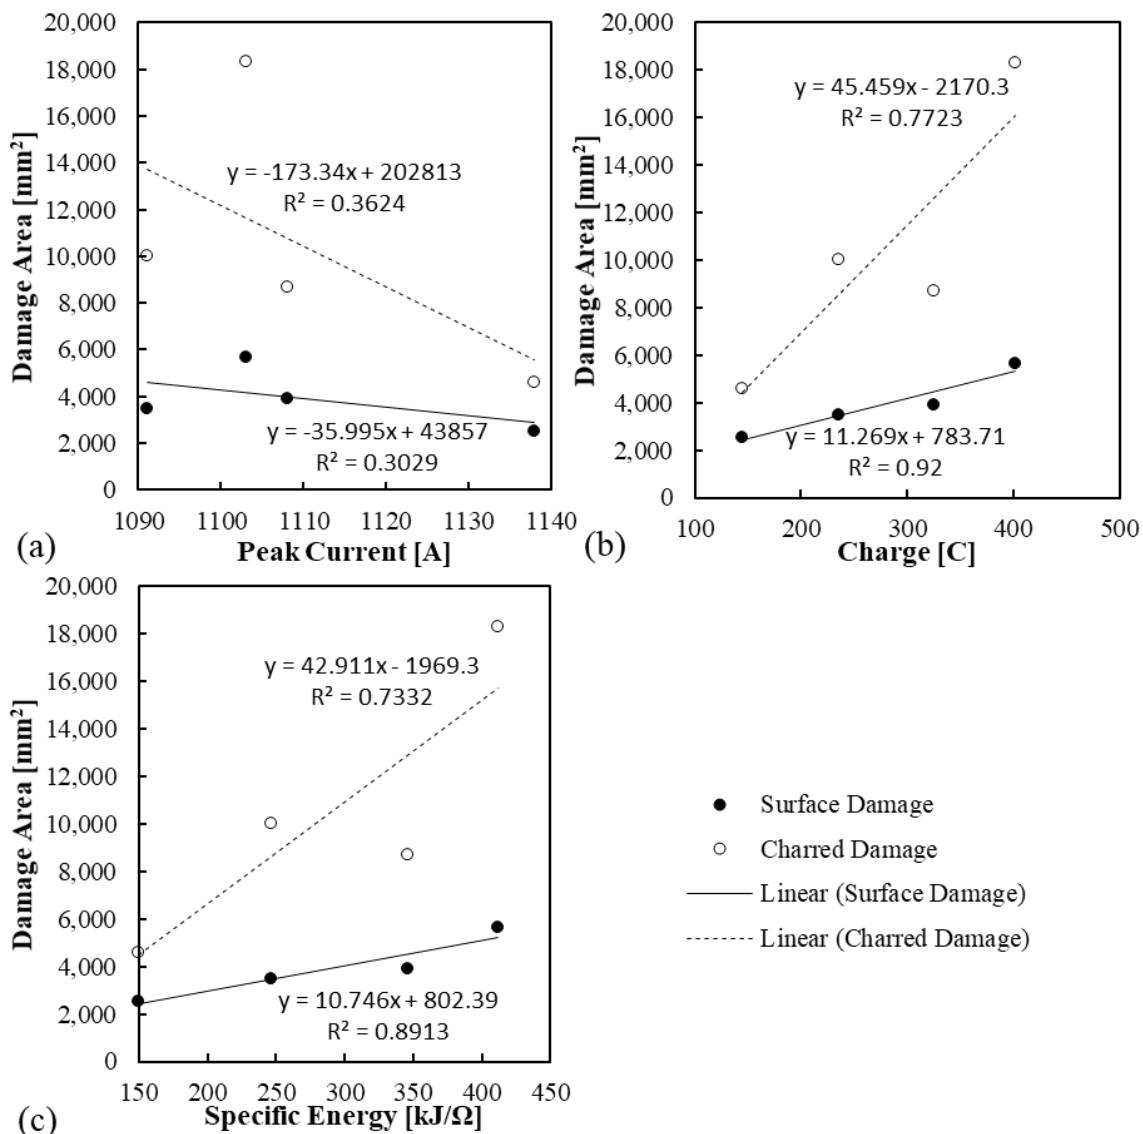
The results show that an increase of both charring damage and surface damage was observed due to change of charge and specific energy; see Figure A.21. Comparing the R^2 values of the plots the charge and specific energy are the best indicators of damage for DC currents rather than peak current.

Figure A.21: Visual inspection damage area from AE3 against (a) peak current, (b) /charge/ and (c) specific energy

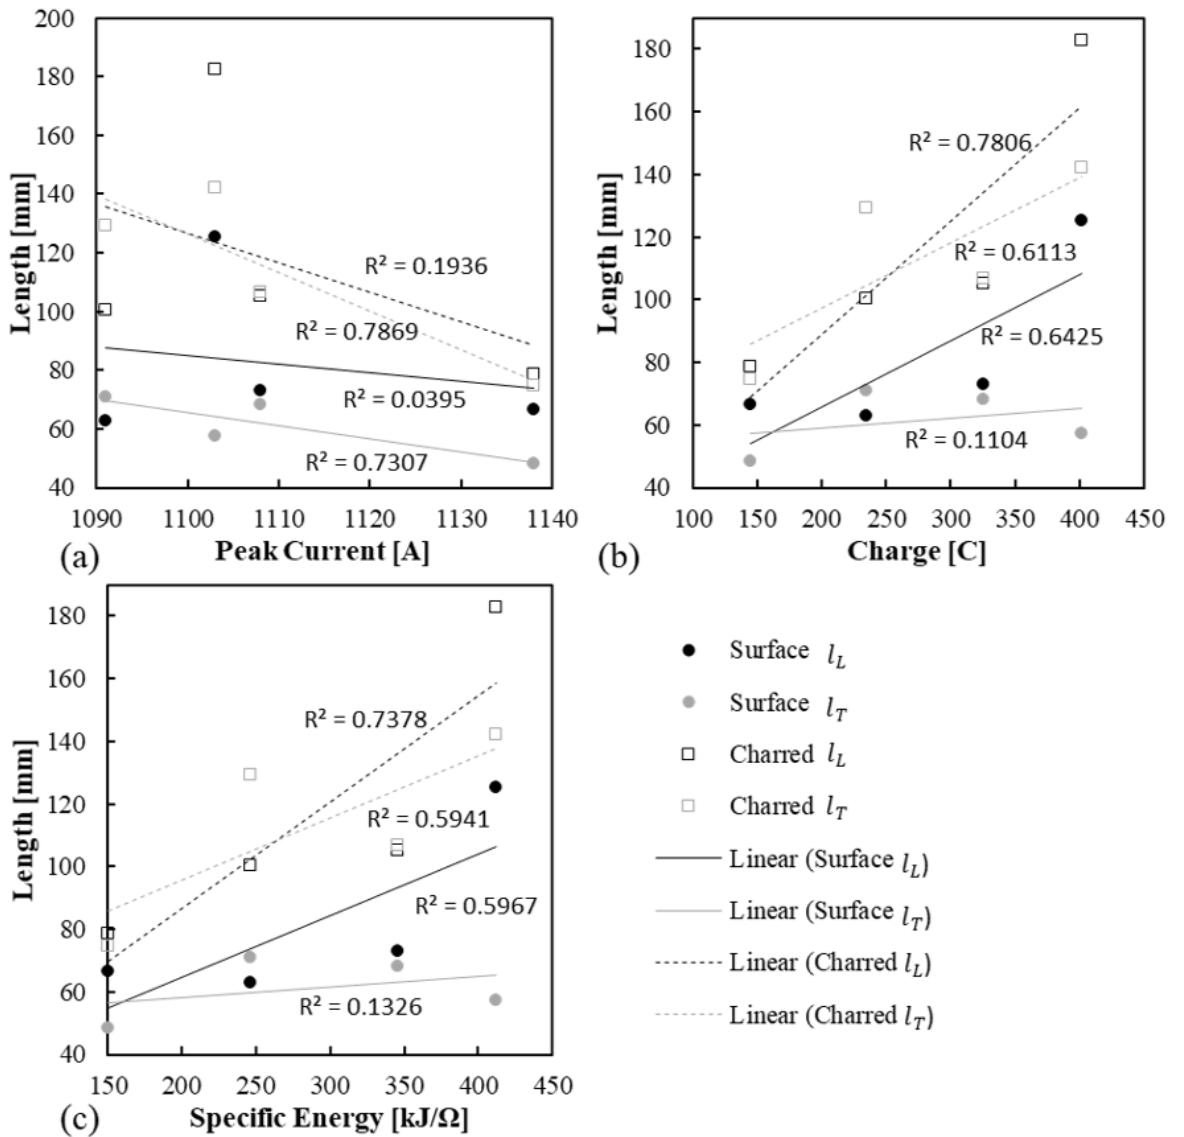
The outer lengths of the damage in the transverse and longitudinal directions are shown in Figure A.22. The plot shows that the results for the AE3 tests are much harder to predict than the area. It is interesting to note that the longitudinal direction has a closer fit than the transverse direction.

Figure A.22: Visual inspection damage lengths from AE3 against (a) peak current, (b) /charge/ and (c) specific energy

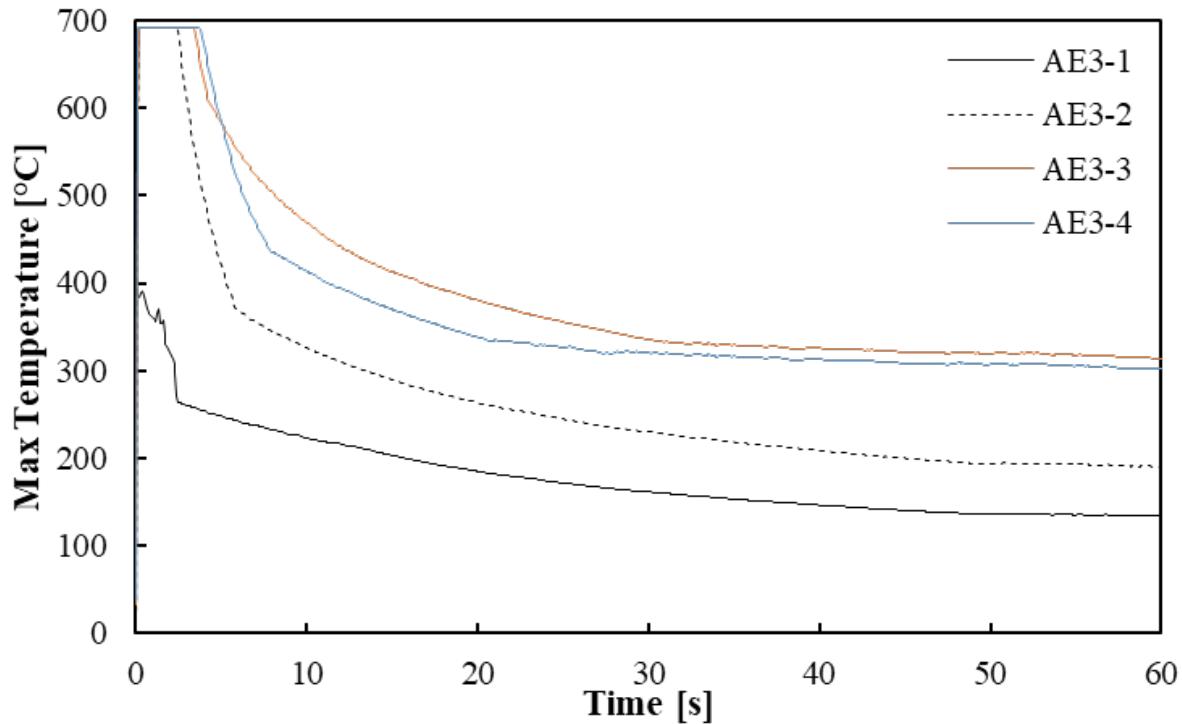
The maximum temperature data recorded for AE3 is shown in Figure A.23. The thermal data results showed that the DC current resulted in a longer duration of ignited material near 5 seconds, decayed rapidly for approximately 10 seconds and then flattened with the heat slowly radiating away taking at least 60s for the surface to be less than 100°C.

Figure A.23: Maximum temperature evolution for AE3

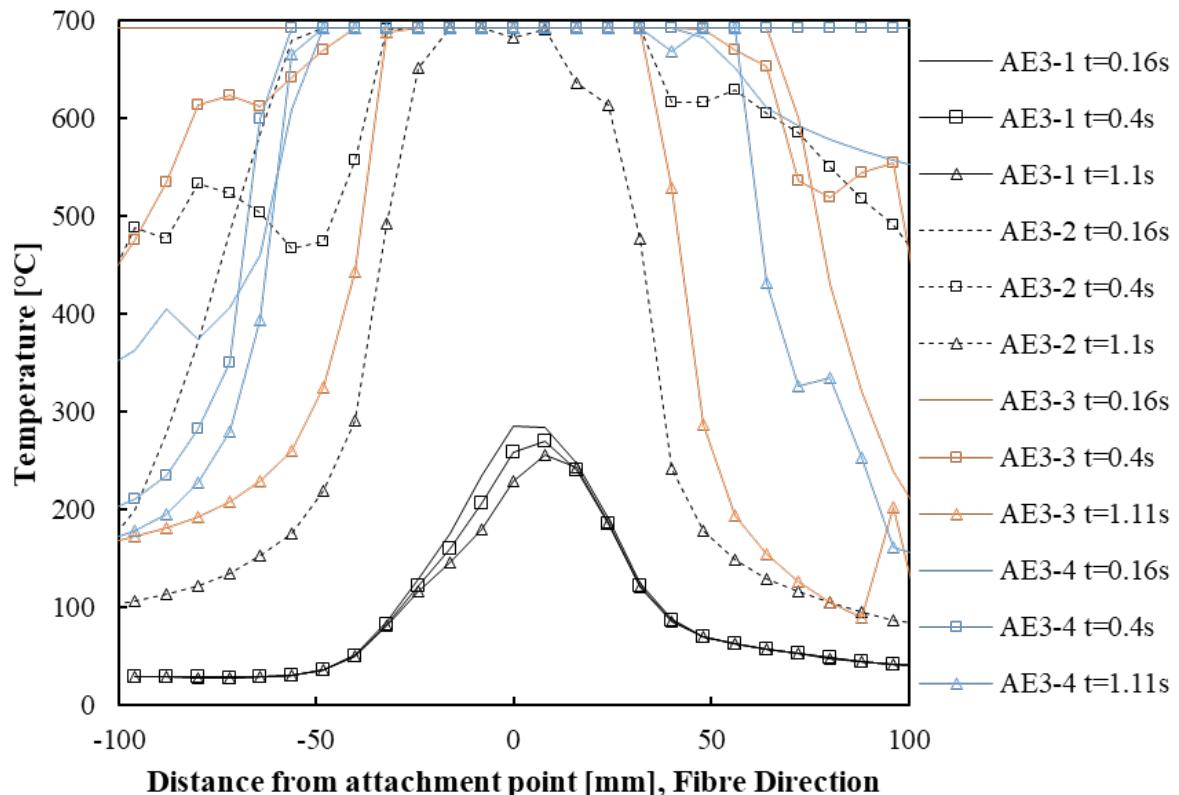
The temperature profile recorded in the longitudinal and transverse directions are shown in Figure A.24 and Figure A.25 at three specific frames (times of 0.16s, 0.4s, and 1.11s).

Figure A.24: Temperature profile in the fibre direction for AE3 at time steps 0.16s, 0.4s, and 1.11s

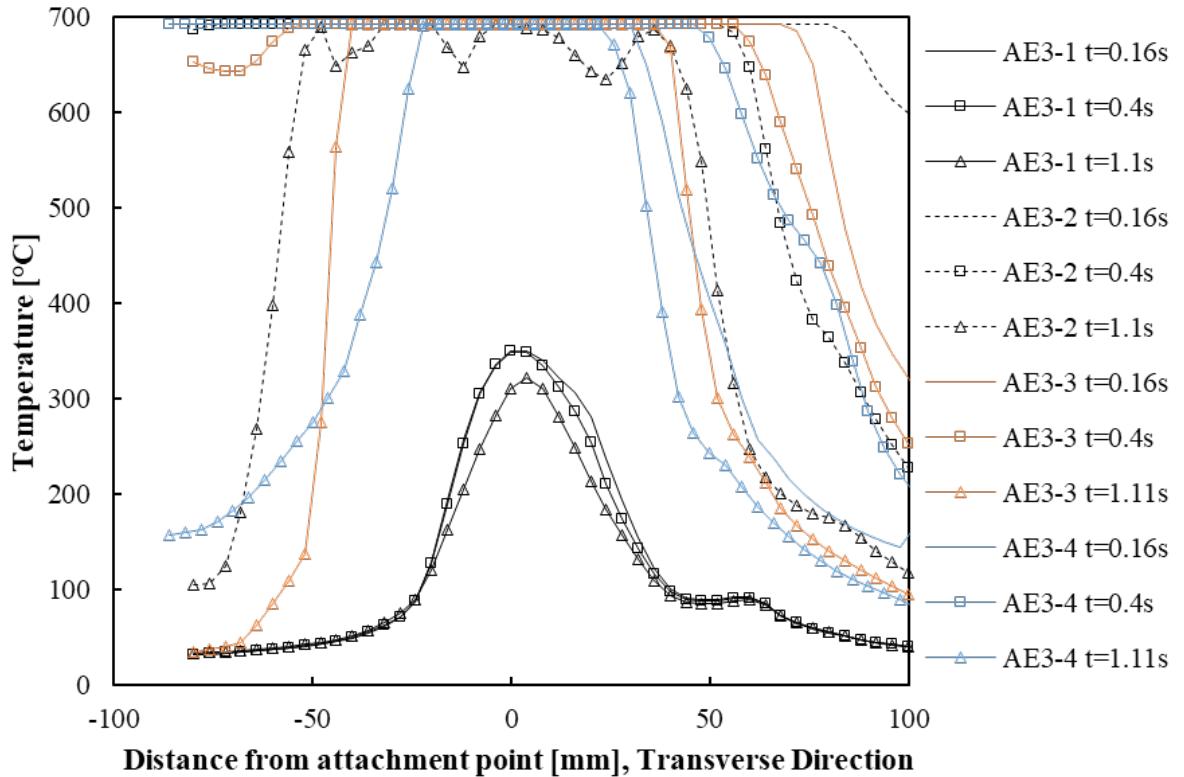
Figure A.25: Temperature profile in the transverse direction for AE3 at time steps 0.16s, 0.4s, and 1.11s

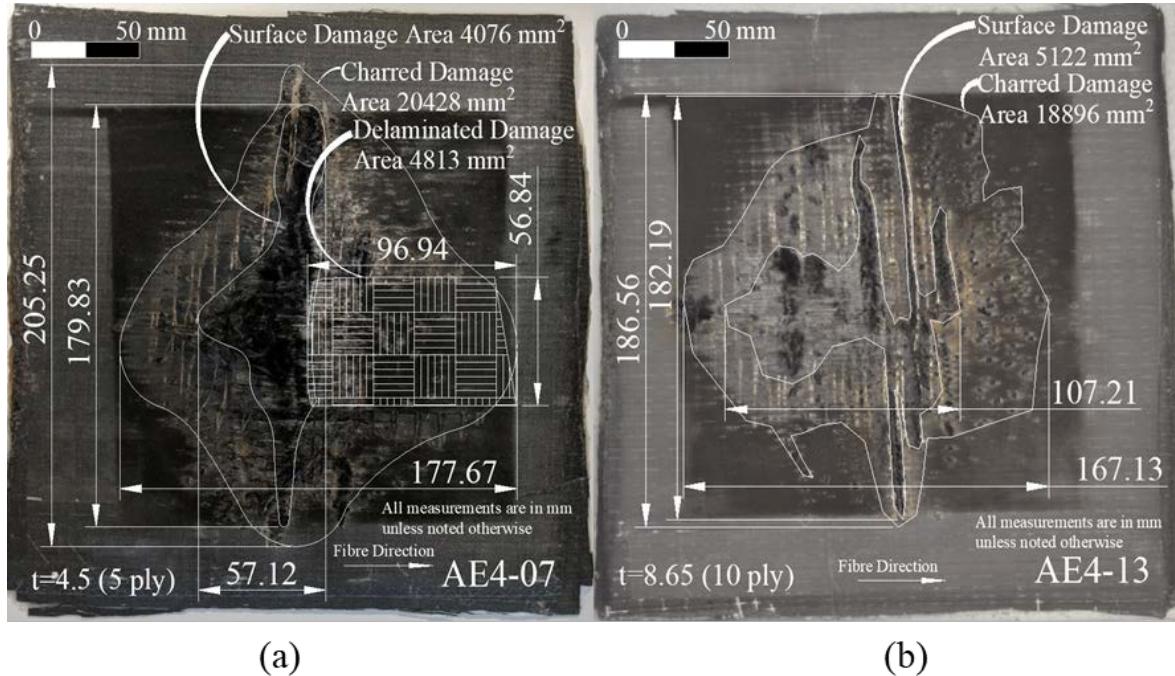
13 CFRP specimens were subjected to simulated lightning strike events for test AE4: 7 on 5 ply thick specimens and 6 on 10 ply specimen. The specimens were struck with a combined impulse and DC waveform. The impulse was as close to a 10/350 μ s waveform as possible with differing peak currents. The AE4 specimens, the surface damage and the charred damage were primarily in elliptical shapes with the major axis in the transverse direction; see specimen AE4-7 in Figure A.26 (a) and AE4-13 in Figure A.26 (b). AE2-1 through AE2-4 had similar patterns of surface and charred damage shapes.

Figure A.26: Damaged specimen from test AE4 (AE4-07) struck with 10/350 μ s waveform

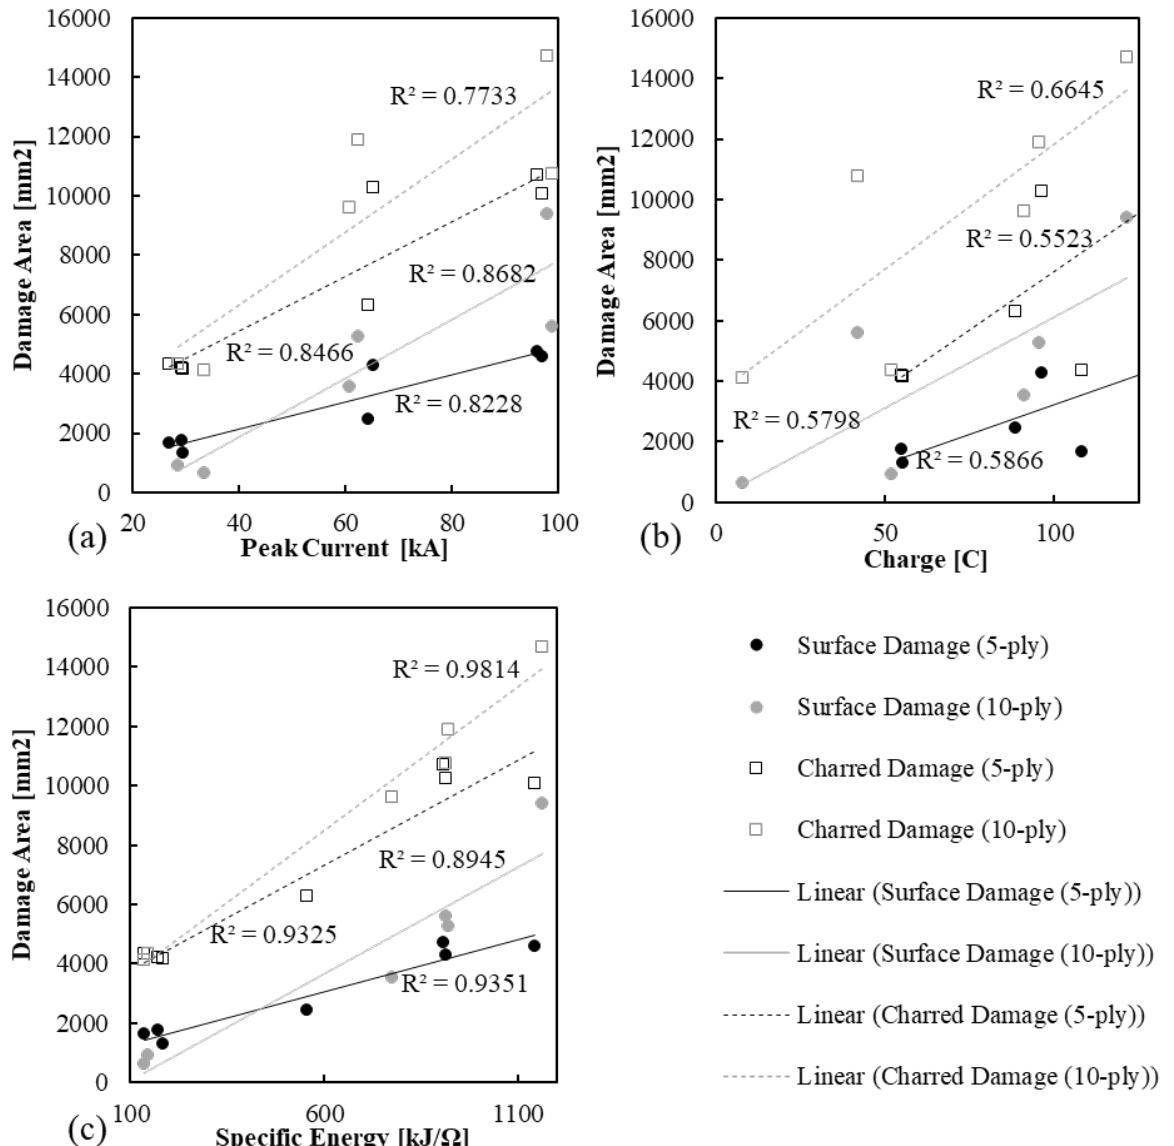
The results show that an increase of both charring damage and surface damage was observed due to change of peak current, charge, and specific energy; see Figure A.27. Comparing the R^2 values of the plot show that the specific energy is the best indicator of damage for combined DC and Impulse waveform.

Figure A.27: Visual inspection damage area AE4 experiments against (a) peak current, (b) charge and (c) specific energy

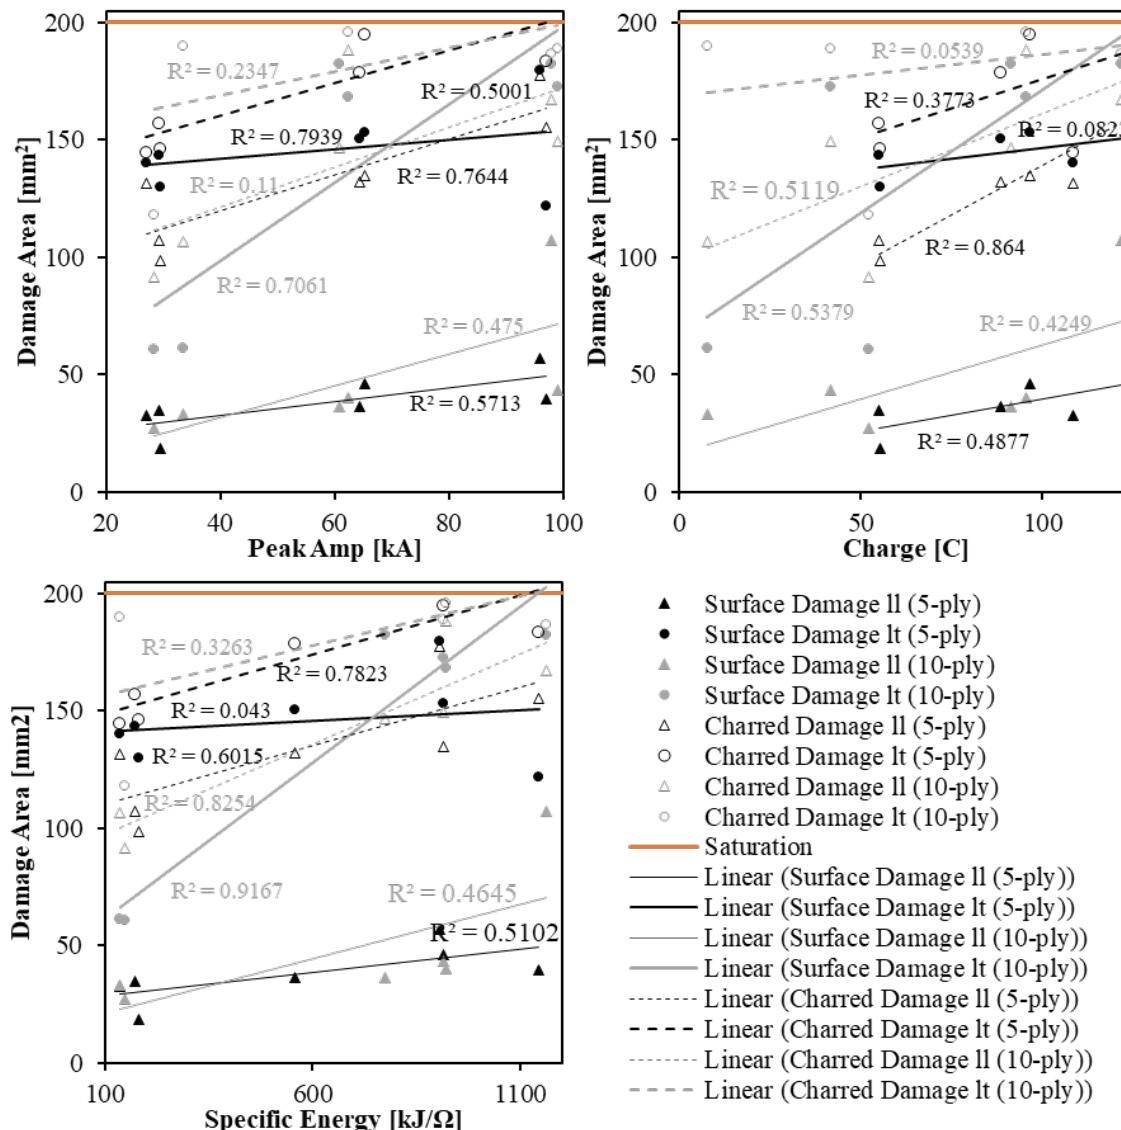
Figure A.28 shows the results from the AE4 visual inspection results. The saturation line shows the distance between the grounds. It clearly shows that even at low levels of lightning peak currents, damage will spread more than 200mm in the transverse direction and may not capture the full extent of the damage, although the damage area did increase in this case.

Figure A.28: Visual inspection damage lengths for AE4 experiments against (a) peak current, (b) charge and (c) specific energy

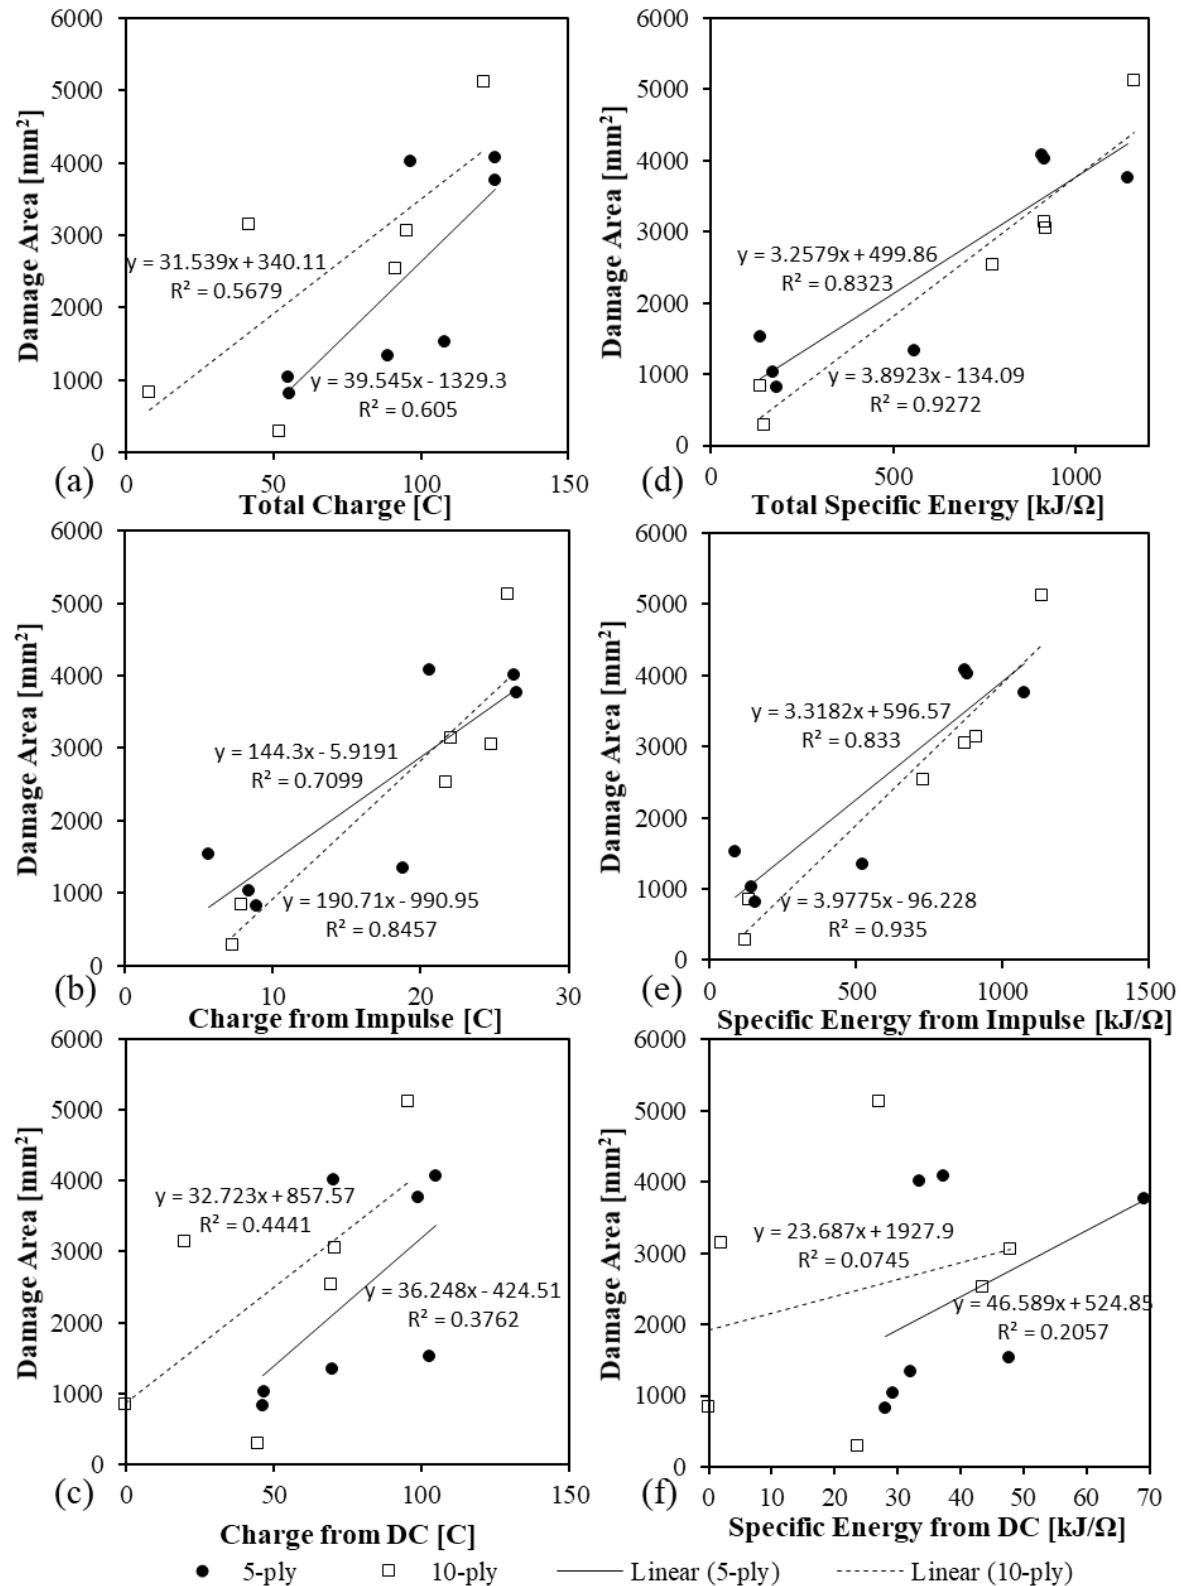
Figure A.29 separates total charge and total specific energy into portions, each from the impulse and DC waveforms. From Table 4.4 (page 73), the charge comes 80% from the DC and the specific energy comes 90% from the impulse. This allows for separation of cause and effect. Checking the R^2 values, the surface and charred damage fits closest to the specific energy. Separating the impulse and DC allows for a cause vs effect analysis. Figure A.29 (b) and (c) show the R^2 values have the tightest fit between impulse and DC components which indicates that most of the damage is contributed by impulse. The R^2 values from Figure A.29 (a) and (b) show that the best predictor of damage is specific energy.

Figure A.29: Charge and specific energy vs the visual inspection damage area from the 5-ply and 10-ply specimens AE4 specimen comparing the charge and specific energy against the total, impulse and DC portion of the waveform. (a) is the charge from the total waveform, (b) is the charge from the impulse portion, (c) is the charge from the DC portion, (d) is the specific energy from the total waveform, (e) is the specific energy from the impulse portion, and (f) is the specific energy from the DC portion

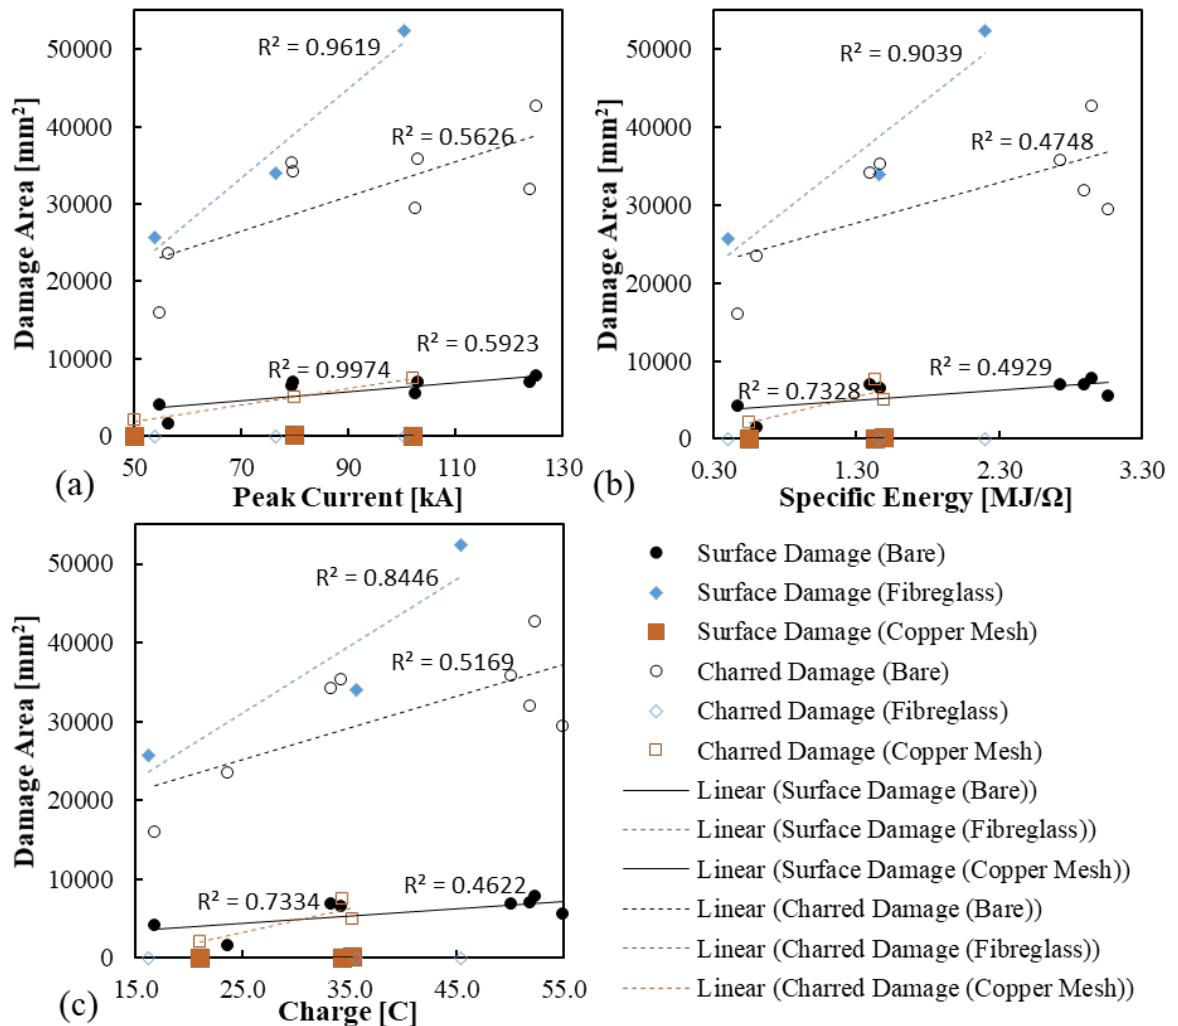
The results show that an increase of both charring damage and surface damage was observed due to increasing change of peak current, charge, and specific energy; see Figure A.30. The significant results show that the difference in surface types has a drastic difference in the amount of damage. The surface damage was practically zero for all copper mesh specimens. The bare specimens were similar to the AE4 tests. The fibreglass specimens were dramatically different, showing 8 times more damage area than in the bare specimens.

Figure A.30: Visual inspection damage area for AE5 experiments against (a) peak current, (b) charge and (c) specific energy
