The Warship *Hazardous Prize* – Site Investigations 1992–2022

Daniel Pascoe, Iain Grant & Dave Johnston

In shallow water off the coast of West Sussex in England lies the wreck of a French built, English warship, lost in 1706. The remains represent a hybrid of French construction and armament with English organisation and adaption. This paper brings the site's investigations up to date, discussing new records relating to the structure and internal layout of the main site, as well as the discovery of several new areas, rich in guns and other artefacts.

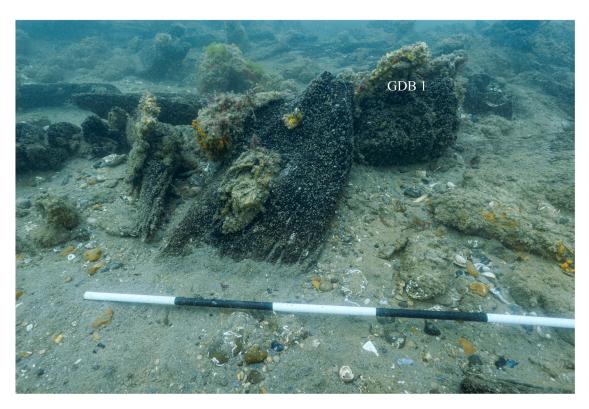
Figure 6. Hanging knee on aft side of gundeck beam 1 (GDB 1). Scale is 1 m with 20 cm increments (photo by Daniel Pascoe).

the deck vertically. Due to the current level of sand, it is not possible to distinguish between hanging and lodging knees at all locations of the deck beams. The exceptions are at beam 1 and beam 3. At beam 1 there is only a hanging knee located on the aft side, which extends diagonally down and aft rather than vertically from the side of the beam (Figure 6). It is substantial in build with a 320 mm (12.6 in) sided dimension. The lack of a lodging knee is likely due to the lack of space at the forward end of the deck. Due to the lack of space between beam 3 and 4 there appears to be only space for a hanging knee on the aft side of beam (Figure 7). Evidence from the later wreck, and larger ship, of Invincible (1744-58) recorded lodging knees on the aft side and iron hanging knees on the forward side of the four most forward deck beams (Bingeman, 2010, p. 52 and personal observations during the 2017-19 excavations). The evidence from Hazardous suggests that where there was insufficient space between beams for lodging knees, hanging knees were used instead.

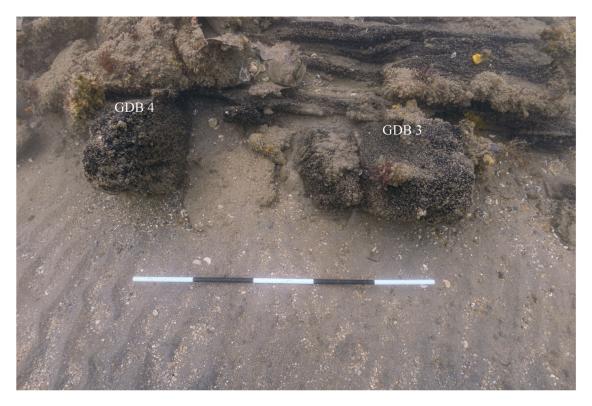
Figure 7. Hanging knee fastened on the aft side of gundeck beam 3 (GDB 3). Scale is 1 m with 20 cm increments (photo by Daniel Pascoe).

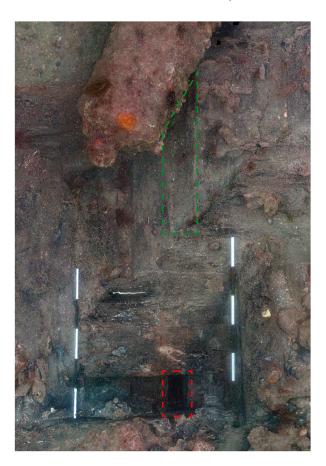
Figure 10. The dashed red line showing the space between the frames and the green dashed line showing that space filled by an additional timber, possibly known as a 'filling'. Scales are 1 m with 20 cm increments (survey and model produced by Daniel Pascoe).

At the platform deck, the air strake and eroded planks have exposed the frames below. This is one of several areas on the wreck where the framing configuration of Hazardous is visible, showing that the hull was constructed with a system of double frames i.e. paired timbers, side by side and referred to as bends (Boudriot, 1986a, p. 80). At the location of the air strake, it is possible to see a space between two bends, but 960 mm above that space has been filled with a timber (Figure 10). It is possible that this timber is what Boudriot refers to in the later construction of French 74s, as a 'filling'. Fillings were wedged shaped timbers used to maintain the space between the frames and stiffen the floors, thus adding strength (Boudriot, 1986a, p. 99). Similar timbers have been found between frames on the structural remains of Invincible (Figure 11). With the case of Invincible these filling timbers are located regularly and have been recorded in consecutive spaces between bends. This is not the case with Hazardous, as is clear from plan of the structure at the southern end of the site, which was lost in 1995 (Figure 3). Here, no fillings were present between 19 consecutive frame bends, and they also do not appear with the exposed ends-of-frames along the eastern edge of the surviving section of the main site, suggesting that fillings were not a feature of the lower hull structure. Only further excavation will determine whether the filling is an isolated example or a feature more common at gundeck level and above. If they are regular features, it may have been a measure to make the structure from main gundeck level and above more resistant to gunshot.

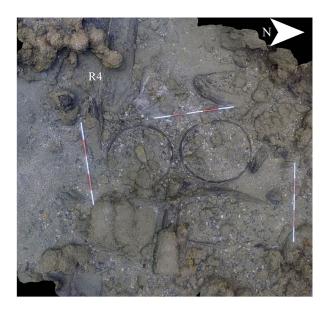
Figure 19. 2022 3D textured model of group of barrels, one of which has been excavated and backfilled with sandbags, between riders 3 and 4. R4 - rider 4. The scales are 1 m with 20 cm increments (survey and model produced by Daniel Pascoe).

and its current location suggests it was originally located in the hold forward of the main mast (Figure 3). Between riders 3-4 and 4-5 is the location of the forward hold. This is the location of several large storage barrels, positioned upright and horizontal (Figure 19). The large quantities of animal bone in this area suggests at least some of these barrels contained butchered meat.

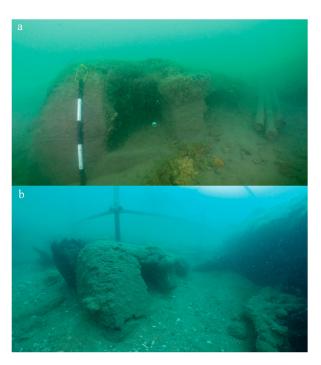
Figure 20. Photo A) the mast cap as found in 2016. Image B) mast cap leaning against possible platform beam. Mast caps joined the tops of the lower masts to the upper mast. The square hole slotted onto a square tenon at the top of the lower mast and the upper mast passed through the circular hole. The scale is 50 cm with 10 cm increments (photos by Daniel Pascoe).

The excavation in the area of the forward platform found a carpenter's jack plane and a spare mast-cap two metres further forward, which became exposed naturally (Figure 20). A mast-cap is a rectangular timber with two adjacent holes, one square and one circular, used to secure the upper masts to the lower masts. The tops of the lower masts were cut into a square tenon that slotted into the square hole on the cap, with the end of the upper mast being passed through the circular hole on the cap (Steel, 1796, p. 91). These are the type of artefacts that would be expected to be found in the storerooms on the forward platform.

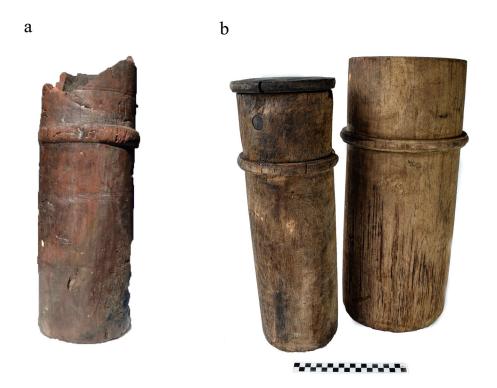
Figure 22. Image A) showing cartridge case from *Hazardous*, it has a diameter of 155 mm (6.1 in) and was suitable for the 18-pounder charges. Image B) showing cartridge cases from *Invincible* 1758, scale is 20 cm with 1 cm increments (photos Daniel Pascoe).

uncovered a fragment of a cartridge case. Cartridge cases were turned from a single piece of wood and had a separate lid attached by a lanyard (Figure 22). They were used to transport a single charge of gunpowder from the filling room up to the gundecks. The filling room was located at the forward end of

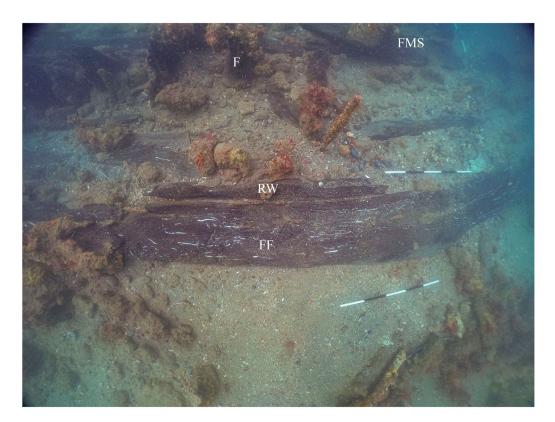
Figure 24. Photo of the forefoot, FF – forefoot, RW – rising-wood, F – frames and FMS foremast-step. The scales in the image are 1 m with 20 cm increments (photo taken in 2022 by Daniel Pascoe).

increases to 585 mm (23 in). At the forward end is a long plane scarph, which is 1.21 m long (4 ft) (Figures 14 and 24). The aft end has the section of rising-wood as described above fastened to the upper surface.

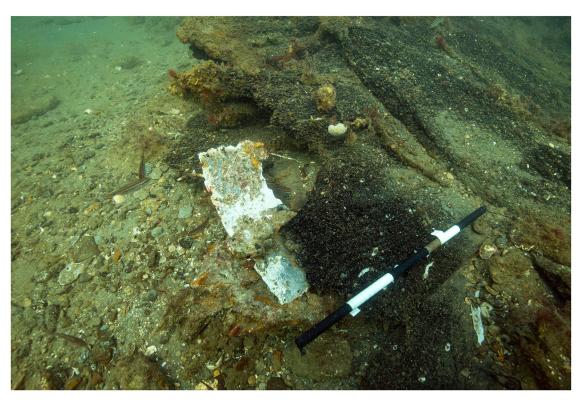
Figure 27. Photo showing lead tingle between sheathing and outer planks. Scale in photo is 50 cm with 10 cm increments (photo by Daniel Pascoe).

Another interesting feature on the outside of the hull is the presence of a lead tingle between the outer planking and the sheathing, which suggests the condition of the outer planks may not have been in a good state before the sheathing was added (Figure 27). There is historical evidence to support this as Captain Harris writes to the Admiralty prior to the voyage to Virginia asking that the bottom of the hull should be cleaned as it is very foul. He also states that the carpenters are repairing the doublings, possibly referring to a second layer of planking (TNA, ADM 106/609/106).

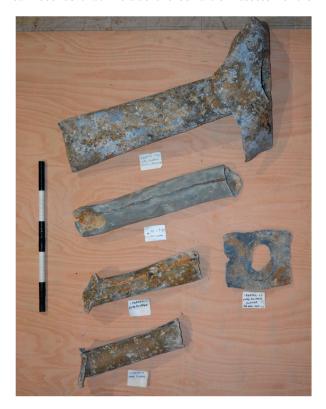
Figure 37. Scuppers in order of size from the top down. The scale is 0.5 m with 10 cm increments (photo by Daniel Pascoe).

Lead scuppers allowed water to drain through the sides of the hull from the waterways along the sides of the decks. Several scuppers have been found from across the wreck area and, so far, four have been recovered (Figure 37). There are variations in their form, and they are all different sizes. Their lengths are a good indicator of the thickness of the hull and can determine which deck above the waterline they were from. The longest scupper (HZ A020-22) has a length of 700 mm (27.6 in), which suggests it most likely passed through inner planking, frame and wale. The wales were located in pairs below and above the main gundeck. Scupper MS-250-99 is 570 mm (22.4 in), which suggests it passed through at main gundeck level but through regular outer planking instead of a wale. Scupper HZ A005-17 is 400 mm (15.7 in) and scupper HZ A013-16 is 365 mm (14.4 in), which suggests locations from the upper gundeck and possibly higher.

The most common form of scupper from Hazardous consists of a pipe with a soldered joint running along its length with a circular flange at one end (Figure 37). Following the evidence from the scuppers recorded from the wreck of the fifth-rate Dartmouth, the soldered joint is located along the upper side of the pipe and the circular flange was located on the

outboard side of the hull. The inboard end was fitted with an L-shaped apron, edge-nailed to the waterway and inside of the hull (Martin, 1978, p. 52). A detached apron, HZ A006-17, associated with scupper HZ A005-17, shows that the inboard ends were also fitted with an apron, which was originally soldered onto the end of the pipe. It is rectangular rather than L- shaped showing that it was fastened to the side of the hull only (Figure 37). The scuppers are angled downwards to the outboard flange to allow the free flow of water and leather flapper valves would have been attached to the top of the outer flange to prevent ingress of sea water when the ship rolled or waves struck the hull (Martin, 1978, p. 52). The outboard flanges from Hazardous all have nail holes around their circumference showing they were fastened securely to the outer hull planking. The exception is HZ A0020-22, where the inboard apron has no iron nail holes and it appears that it did not have an outboard flange (Figure 37).
