## BACKGROUND

- The presence of hydrogen in the microstructure of steel bearings exacerbates catastrophic failure in extreme load applications such as wind turbine gearboxes & compressors for hydrogen fuel cells.
- This results from hydrogen embrittlement (HE) and in rolling-contact-fatigue is often associated with the formation of detrimental sub-surface cracking known as White-Etching Cracks (WECs).
- This early failure is halting investment in these renewables due to the added maintenance costs.
- Presently no theory can “explain the effects of hydrogen in bearing steels” and no understanding exists for predicting and preventing hydrogen damage.

## AIMS:

- To investigate the influence of lubricant environments on premature bearing failure due to the development of cracks in AISI 52100 steel.
- To explore how test atmosphere and the anti-wear additive, Zinc Dialkyldithiophosphate (ZDDP), help to reduce the effects of HE and compare the results with those found when using a perfluorinated lubricant.

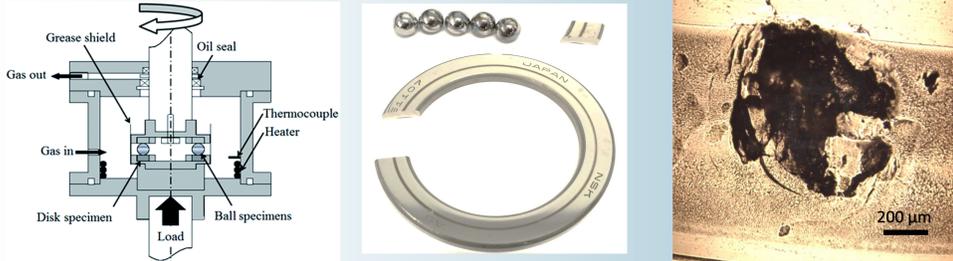
Fig. 1. (a) RCF Test Rig set-up, (b) Bearing balls and raceway after test and TDS, (c) Deep spall in race tested in argon.

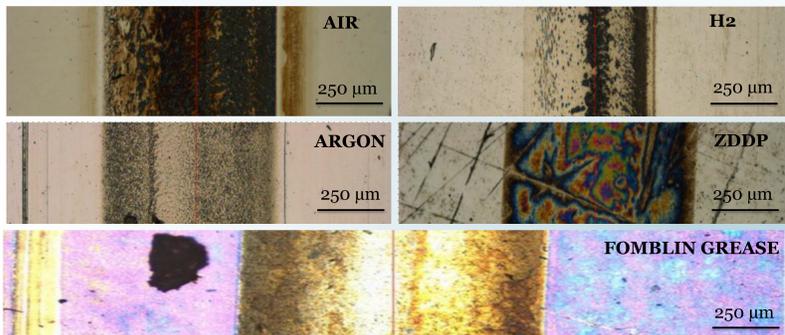
- Optical microscopy was used to characterize the wear tracks and quantify the surface defects.

Fig. 2. Optical micrographs of raceway wear scars after testing under the conditions indicated

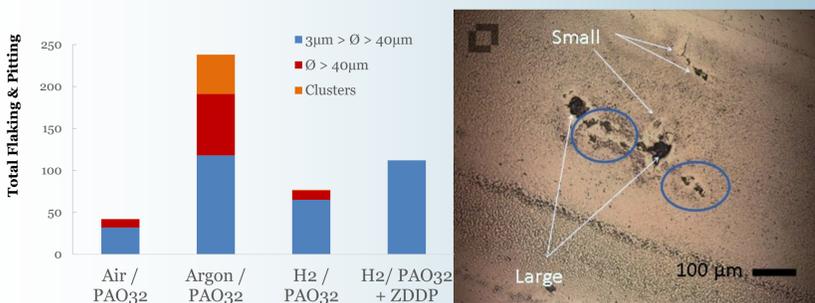
Fig. 3. Surface Defect Analysis: (a) Results. (b) Areas of pitting and flaking: small flaking ( $3\mu\text{m} < \phi < 40\mu\text{m}$ ), large flaking ( $\phi > 40\mu\text{m}$ ) and clusters (circled) group of 4+ small pits in an area of  $100\mu\text{m}$  diameter

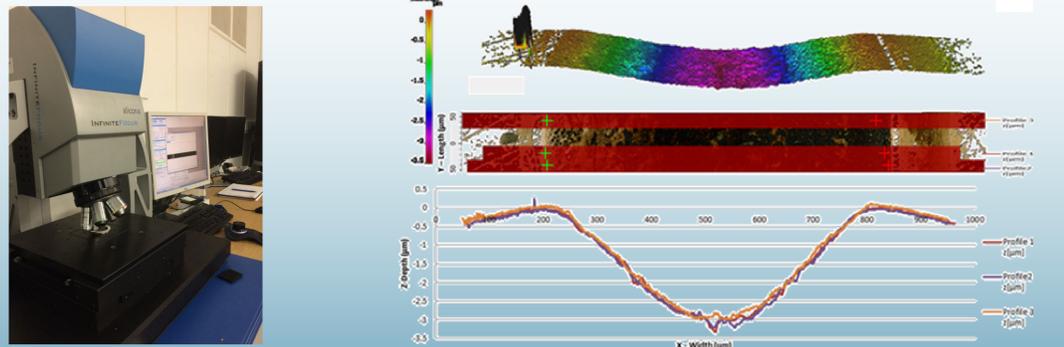
- Wear tracks widths, depths and profiles were measured using Alicona profilometry to compare volume loss and roughness of the wear scars.

Fig. 4. (a) ALICONA Optical Profilometry apparatus (b) Alicona scans across the wear tracks.

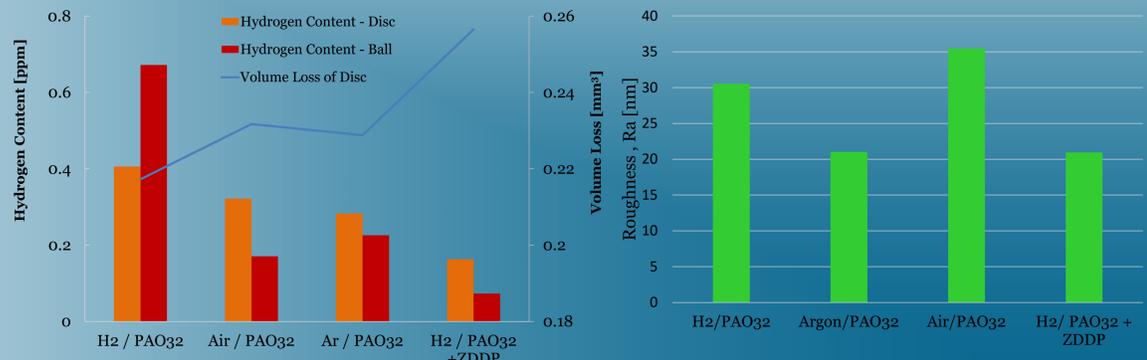
Fig. 5. (a) Total volume loss in the disc and hydrogen content of disc and ball (b) Average wear track roughness, Ra, after testing in various environments

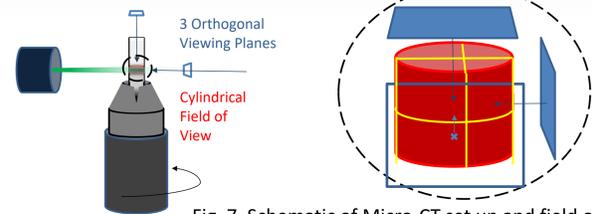
- The viability of Micro-CT Scanning as a new technique to find and characterise WECs was investigated and compared with traditional sectioning methods.

Fig. 7. Schematic of Micro-CT set up and field of View

- Scan/Sectioning locations were chosen based on regions with high population of surface defects and/or thick carbon deposits.

- Specimens ground to < 1mm thick cross-section to minimise noise from x-ray transmission through steel.

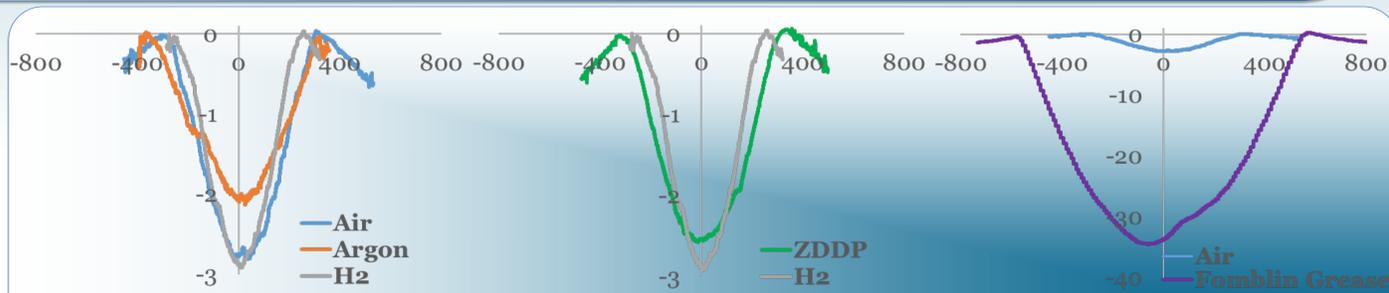
Fig. 6. Averaged wear track profiles under various test conditions. (a) PAO samples (b) Effect of ZDDP on wear scars produced in hydrogen environment (c) Wear tracks after testing in PAO and a perfluorinated fomblin grease in an air environment

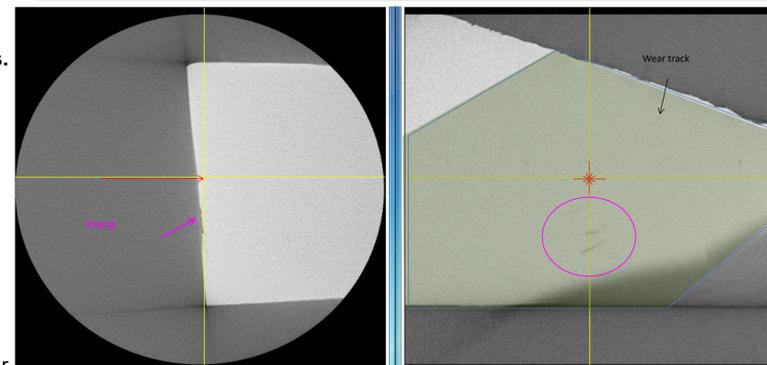
Fig. 9. CT scanned images, showing the sub-surface in two orthogonal viewing planes, of a heavily flaked region of the race tested in Argon.

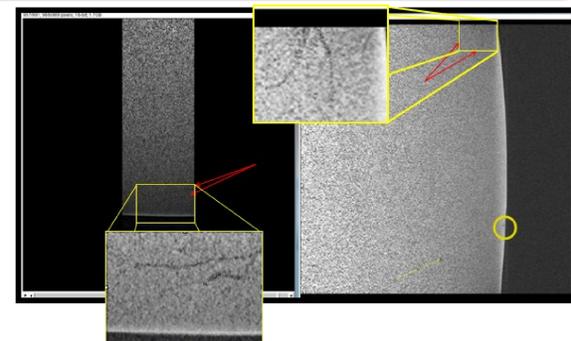
Fig. 10. Micro-CT scans of ball tested in H<sub>2</sub> atmosphere and PAO lubricant highlighting, in two orthogonal planes, a multi-pathed crack propagating parallel to surface

- The use of lubricants that do not contain hydrogen (such as Fomblin grease) avoided HE related wear and dramatically increased fatigue life.
- Micro-CT as a non-destructive technique for investigating WECs gives a reasonable crack depiction of the 3D crack morphology.
