Figure 1: Microstructure of test materials (a) U720Li – orthophosphoric etch (b) U720Li – carbon extraction replica (c) U720Li-LG – orthophosphoric etch (d) U720Li-LG – carbon extraction replica (e) U720Li-LP – orthophosphoric etch (f) U720Li-LP – carbon extraction replica

Figure 3: da/dN versus ΔK behaviour of all 3 alloys at room temperature.

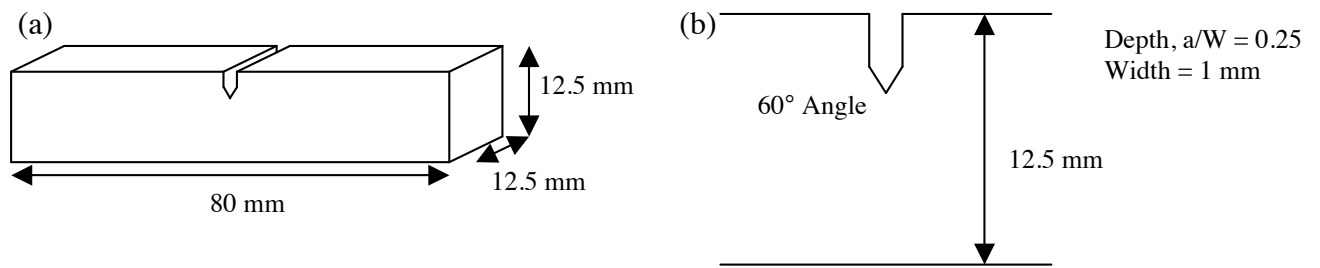
Figure 2: SENB specimen geometry used in long crack tests.

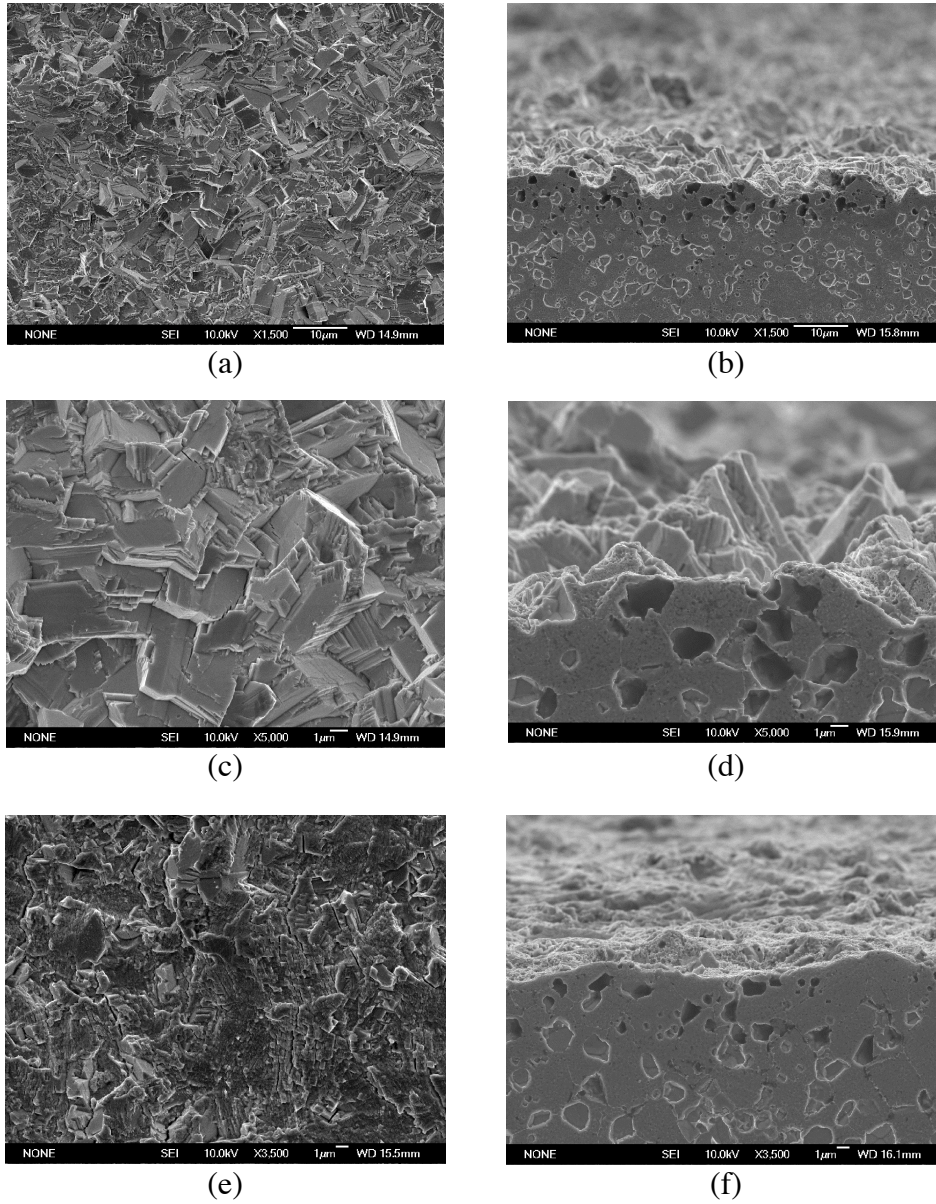
Figure 4: U720Li fractography: (a) Fracture surface near threshold at $\Delta K \approx 7.5$ MPa $\sqrt{\text{m}}$ (b) Section of fracture surface, showing crack path through microstructure at $\Delta K \approx 7.5$ MPa $\sqrt{\text{m}}$ (c) Close-up of (a) (d) Close-up of (b) (e) Fracture surface at $\Delta K \approx 25$ MPa $\sqrt{\text{m}}$ (f) Section of fracture surface, showing crack path through microstructure at $\Delta K \approx 23$ MPa $\sqrt{\text{m}}$

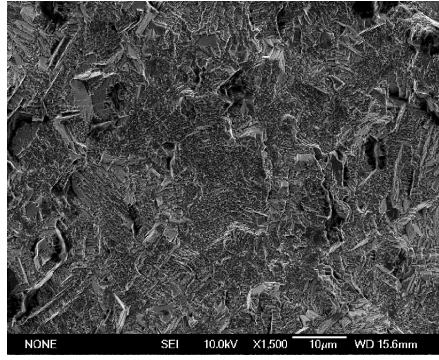
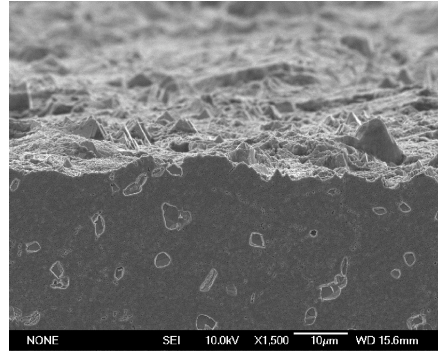
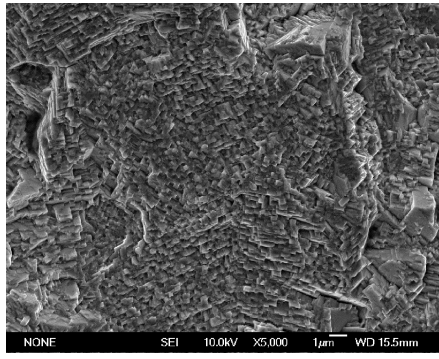
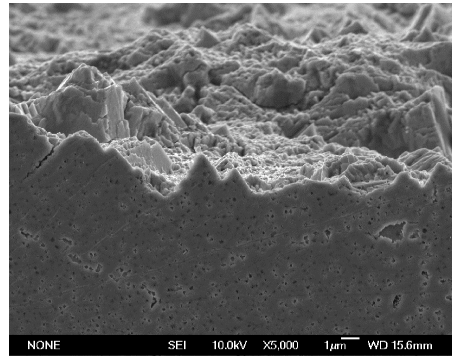
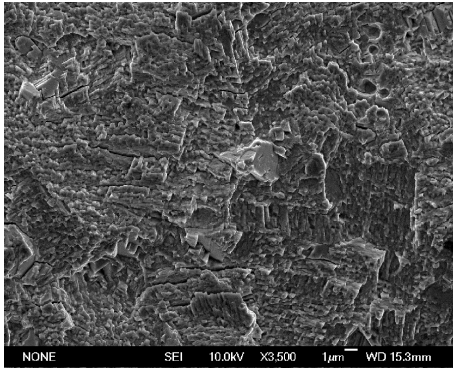
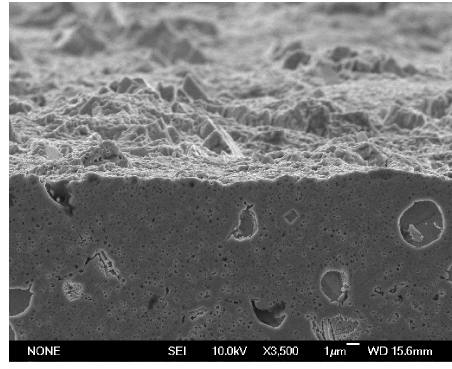
Figure 5: U720Li-LG fractography: (a) Fracture surface near threshold at $\Delta K \approx 8.5$ MPa \sqrt{m} (b) Section of fracture surface, showing crack path through microstructure at $\Delta K \approx 8.5$ MPa \sqrt{m} (c) Close-up of (a) (d) Close-up of (b) (e) Fracture surface at $\Delta K \approx 23$ MPa \sqrt{m} (f) Section of fracture surface, showing crack path through microstructure at $\Delta K \approx 23$ MPa \sqrt{m}

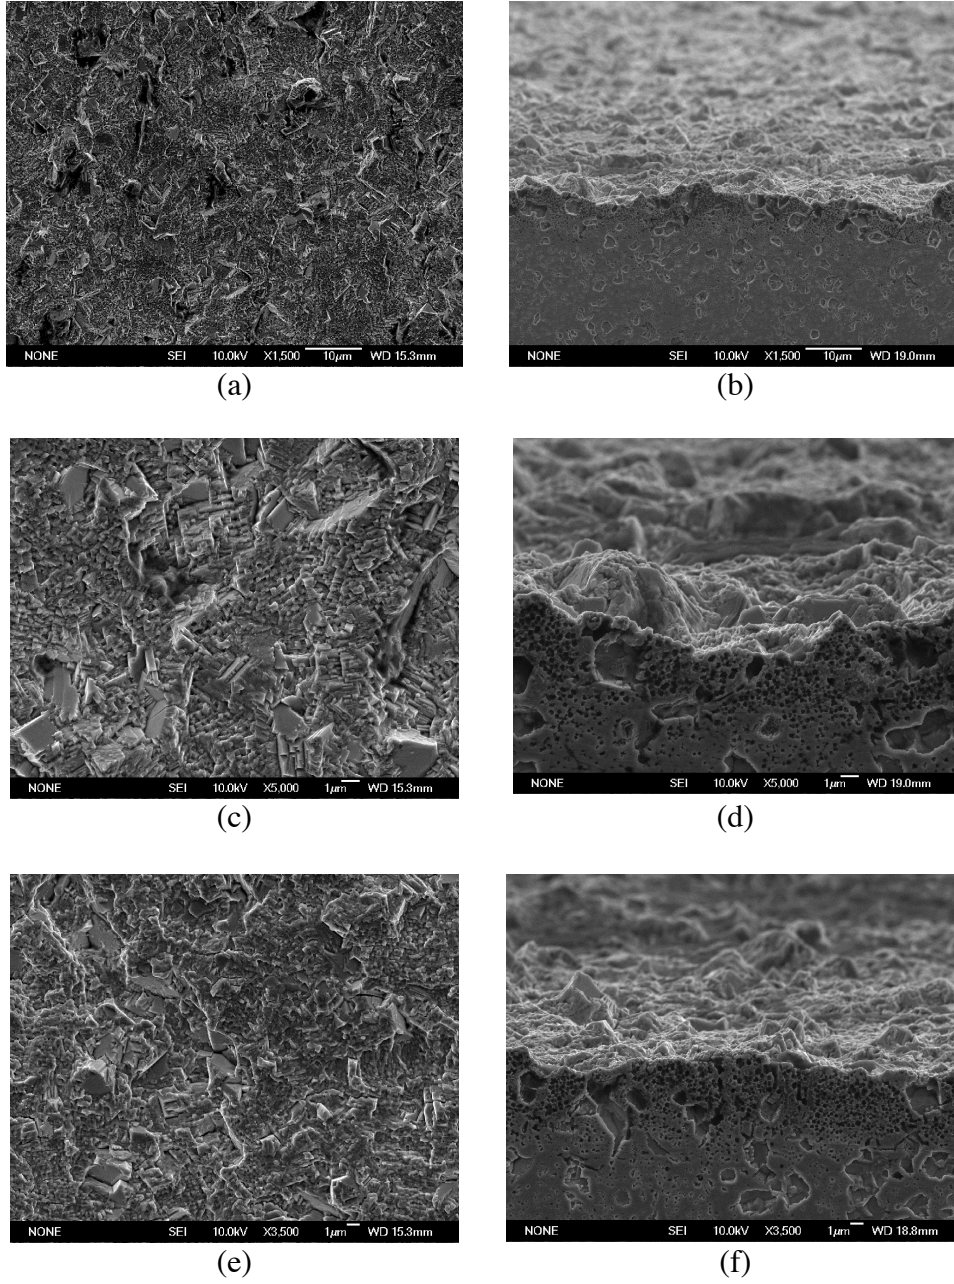
Figure 6: U720Li-LP fractography: (a) Fracture surface near threshold at $\Delta K \approx 6$ MPa $\sqrt{\text{m}}$ (b) Section of fracture surface, showing crack path through microstructure at $\Delta K \approx 6$ MPa $\sqrt{\text{m}}$ (c) Close-up of (a) (d) Close-up of (b) (e) Fracture surface at $\Delta K \approx 24$ MPa $\sqrt{\text{m}}$ (f) Section of fracture surface, showing crack path through microstructure at $\Delta K \approx 22$ MPa $\sqrt{\text{m}}$

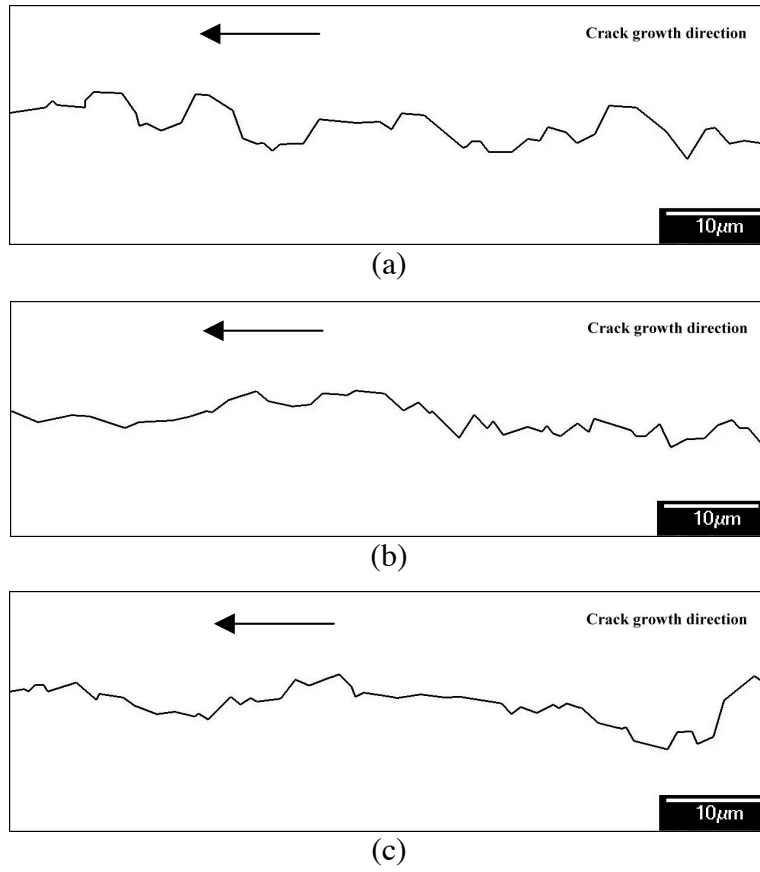
Figure 6: Crack profile at near-threshold ΔK (a) U720Li (b) U720Li-LG (c) U720Li-LP

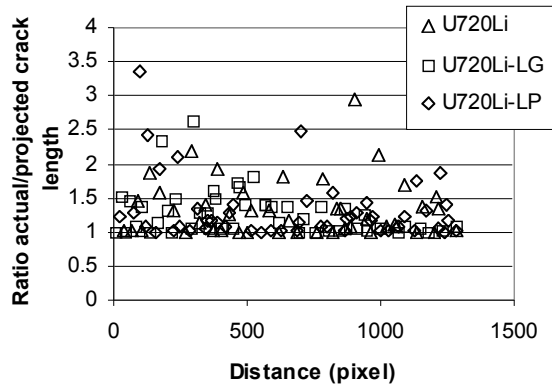
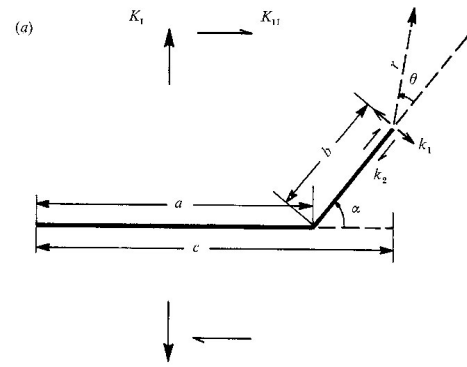
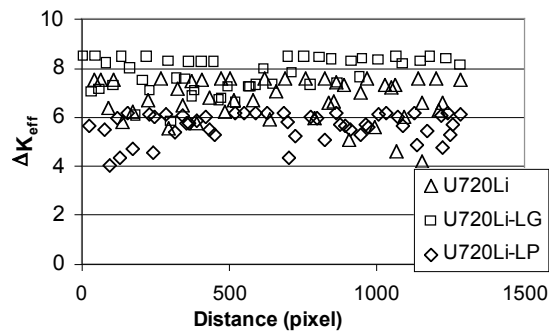
Figure 7: Crack deflection measurements: (a) Actual/projected crack length (b) Schematic representation of a deflected crack geometry (c) Local ΔK_{eff} variation due to crack deflection.

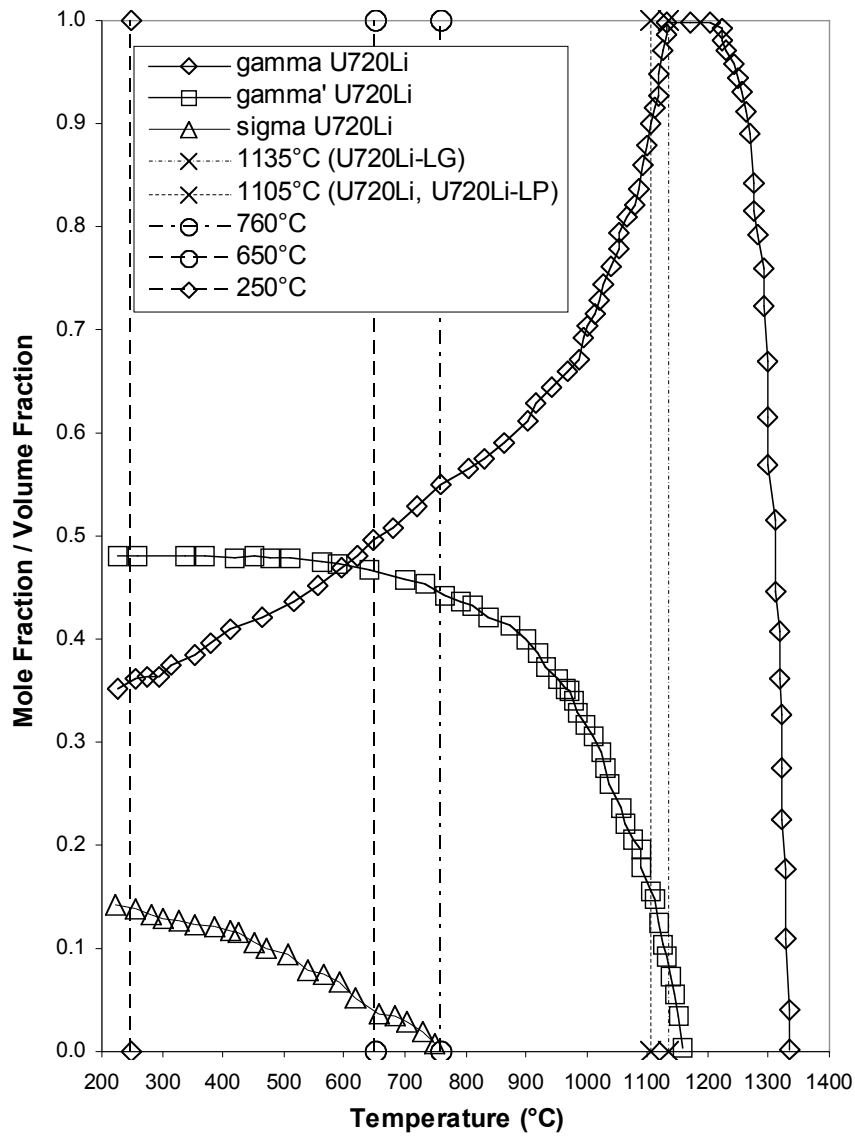
Figure 9: Thermo-calc prediction of phase distribution for U720Li (Cantab ref).

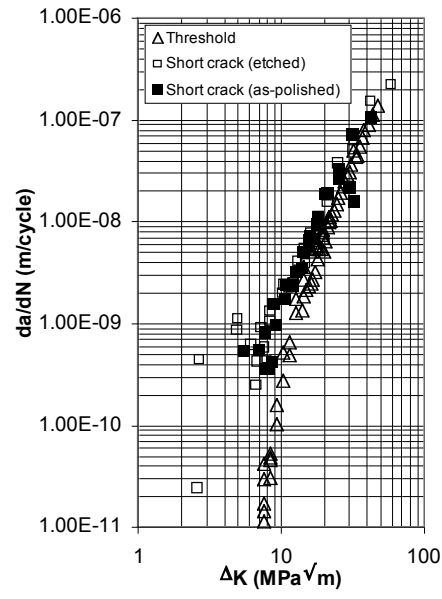
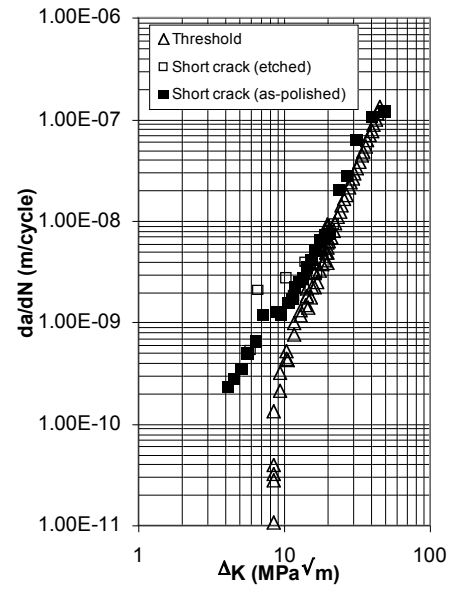
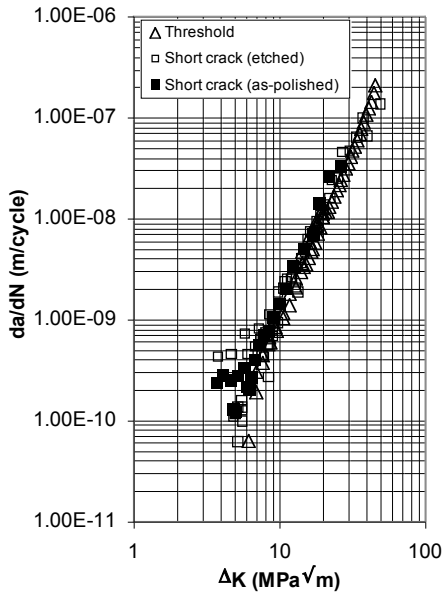
Figure 10: Room temperature long crack-short crack comparison (a) U720Li (b) U720Li-LG (c) U720Li-LP

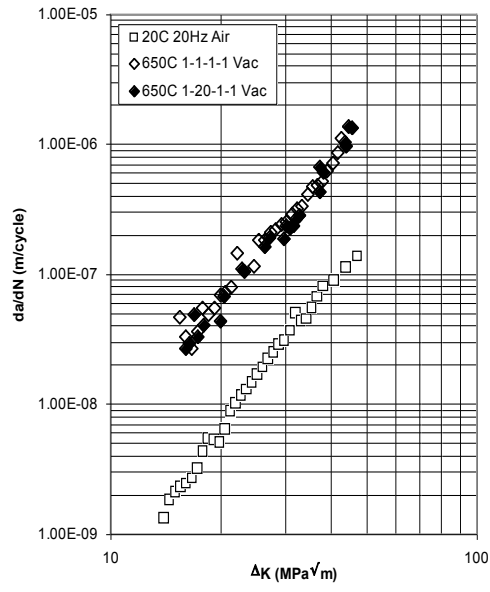
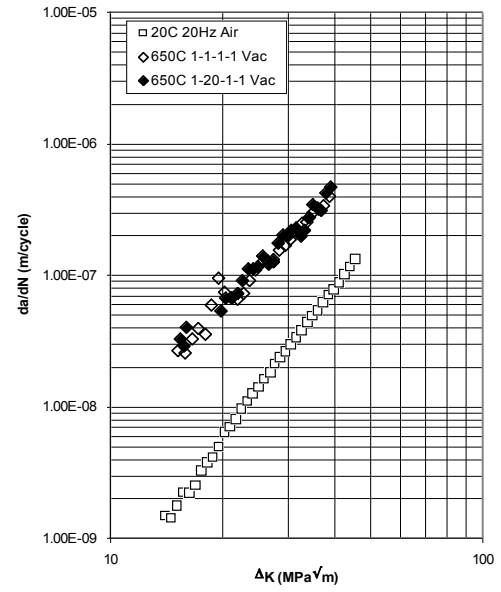
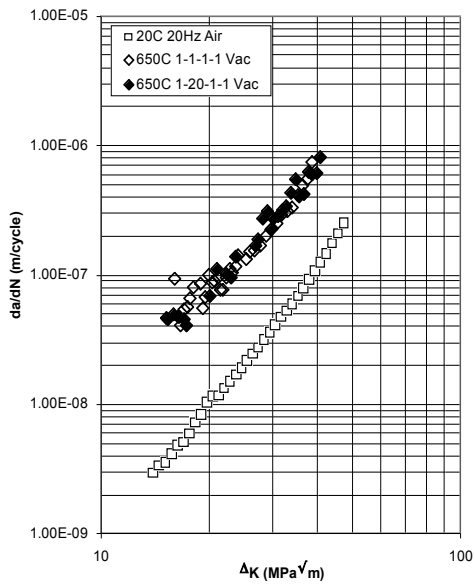
Figure 11: Room temperature vs. 650°C long crack growth comparison (a) U720Li (b) U720Li-LG (c) U720Li-LP
