Transformer Oil Passivation and Impact of Corrosive Sulphur

P. S. Amaro^{*1}, J. A. Pilgrim¹, P. L. Lewin¹, R. C. D. Brown² and G. Wilson³

¹ The Tony Davis High Voltage Laboratory, University of Southampton

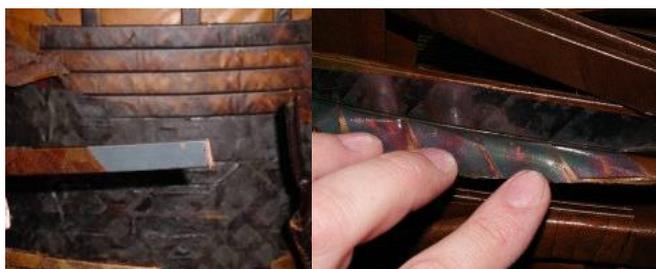
Figure 1: Conductor and papers from the inspection of a failed unit [1].

In recent years a significant volume of research has been undertaken in order to understand the recent failures in oil insulated power apparatus due to deposition of copper sulphide on the conductors and in the insulation paper. Dibenzyl Disulfide (DBDS) has been found to be the leading corrosive sulphur compound in the insulation oil [1]. The process of copper sulphide formation and the deposition in the paper is still being investigated, but a recently proposed method seems to be gaining some confidence [1]. This method suggests a two-step process; initially the DBDS and some oil soluble copper complexes are formed. Secondly the copper complexes are absorbed in the paper insulation, where they then decompose into copper sulphide [2]. The most commonly used mitigating technique for corrosive sulphur contaminated oil is passivation, normally using Irgamet 39 or 1, 2, 3-benzotriazole (BTA). The passivator is diluted into the oil to a concentration of around 100ppm, where it then reacts with the copper conductors to form a complex layer around the copper, preventing it from interacting with DBDS compounds and forming copper sulphide.
