Developments in GFRP Reinforced Bolted Joints in Glass

Mithila Achintha ^a, Tudor Zirbo ^a

^a Faculty of Engineering and the Environment, University of Southampton, United Kingdom, e-mail
(Mithila.Achintha@soton.ac.uk)

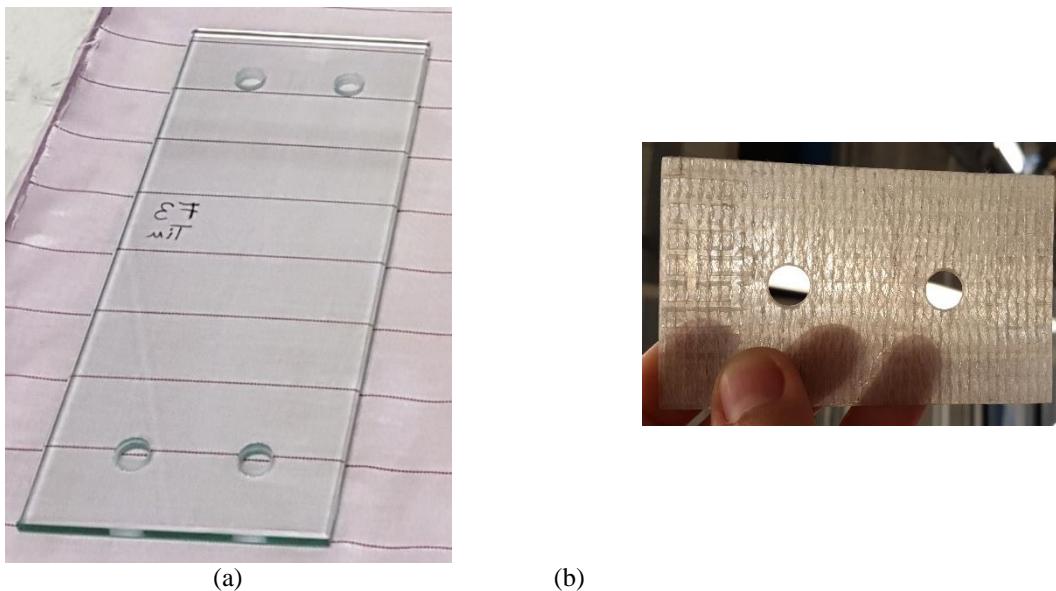
Fig. 1 (a) 250 mm x 100 mm glass specimens with four 11 mm diameter drilled holes (b) 60 mm x 100 mm GFRP strip with two 11 mm diameter drilled holes

6 mm thick annealed glass and fully-toughened glass cut in to the dimensions of 250 mm x 100 mm, purchased from a commercial supplier was used in the present study. The glass specimens had four 11 mm diameter holes, drilled by the commercial supplier, at both ends as shown in Fig. 1a. All edges of the glass specimens and the inner surfaces of the drilled holes were polished up to the industrial standard use by the commercial supplier.

Prefabricated GFRP strips were used in the present study to reinforce bolted joints in annealed glass. The GFRP laminate that was used in the previous research of the first author on glass–GFRP composites (Achinthia and Balan 2017; Achinthia and Bessonov 2017) was used to reinforce the bolted joints. The GFRP strips were fabricated by impregnating unidirectional ‘E-glass’ dry fibre sheets using a commercially available epoxy resin by means of a hand lay-up method. The average thickness of the final cured GFRP laminate was ~1.35 mm. The fibre volume fraction of the GFRP was calculated to be ~33%, and the Young’s modulus and the Poisson ratio of the GFRP were 450 MPa, 24.5 GPa and 0.10 respectively (Achinthia and Balan, 2017). The width of the GFRP strip was taken to be the same as that of the glass sheet (i.e. 100 mm) and the length was taken to be 60 mm. 11 mm holes were also drilled in GFRPs in order to match with those in the glass (see Fig. 1b).

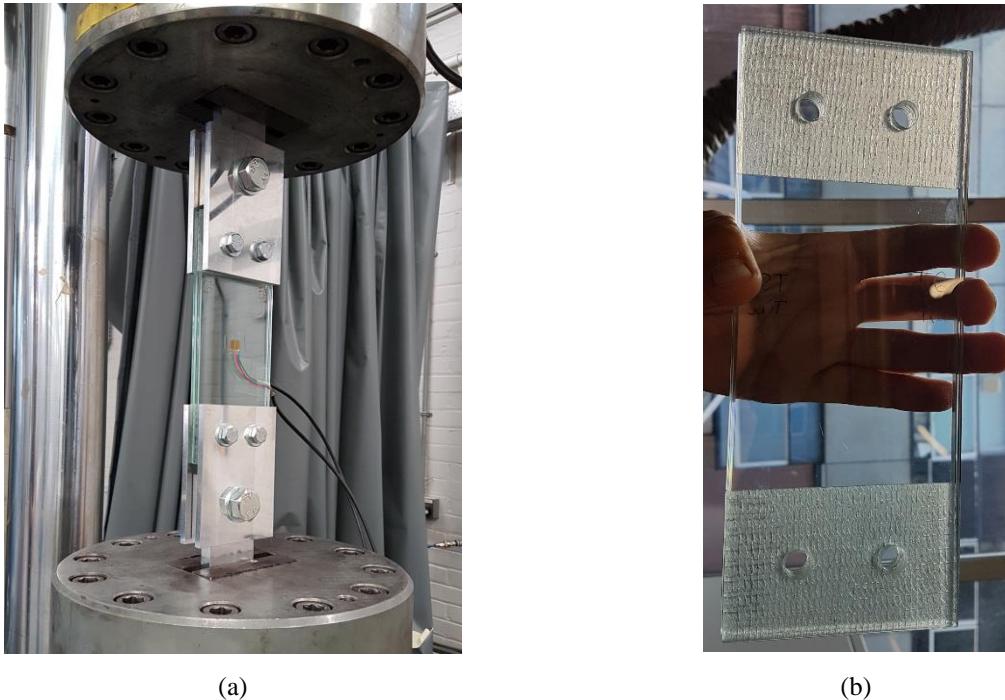
Fig. 2 (a) Test arrangement of a reference test specimen (b) Two glass pieces with an adhesively bonded GFRP strip between the two glass pieces

Fig. 2a shows the arrangement of the reference test specimens (i.e. bolted joints in annealed glass and tempered glass specimens without GFRP reinforcement). As shown in the figure, two glass pieces and two aluminium pieces, each with the same thickness and width as the glass specimens, were connected together using four bolts. 10 mm diameter

(M10) bolts were used in the present study. EPDM rubber was used as a bushing material between the bolt shank and the internal surface of the holes. M10 EPDM rubber washers were also placed on the both external surfaces of the glass assembly. This allowed a gap of ~2 mm between the glass and the aluminium pieces in the joint areas. In order to fix the test assembly into a test machine, a thicker aluminium piece each was connected at each end of the test specimen using larger bolts (see Fig. 2a). 20 mm diameter (M20) bolt was used for this connection. This arrangement of the test specimens ensured the thick aluminium plates were connected to the two sides of the test machine whilst eliminating the need for connecting glass directly into the test machine. The thickness of the thicker aluminium plates was chosen such that the test specimen can be loaded in tension without an eccentricity or out-of-plane loading on bolted the joints.

The GFRP reinforced annealed glass test specimens were prepared in the same way as the reference test specimens. However, prefabricated GFRP strips (shown in Fig. 1b) were bonded to the glass specimens prior to connecting the aluminium plates and the bolts. The GFRP strips were bonded to glass and cured using the methodology employed in the previous successful research works on glass–GFRP composites (Achinthia and Balan, 2017; Achinthia and Bessonov, 2017). Prior to the bonding of the GFRP, the bonding surfaces of the glass and the GFRP were first thoroughly cleaned and degreased using acetone. The volume of the adhesive required to obtain a thin layer of ~0.1 mm adhesive was evenly spread using a spatula over the inner surface (i.e. bonding surface) of each glass specimen. The GFRP strip was carefully bonded to the glass surface, between the two glass pieces whilst ensuring no air bubbles were trapped in between and the holes in the glass and the GFRP strip were perfectly aligned. The GFRP strips were bonded at both ends of the glass pieces covering areas in the vicinity of the bolted joints. The test specimens were then secured using a few small clamps and cured using the same curing procedure used in the previous study of Achinthia and Balan (2017) (24-hour oven curing at 40°C temperature and atmospheric pressure, followed by further six days of curing under ambient conditions). Fig. 2b shows one of the fully-cured GFRP bonded glass test specimen prior to connecting the aluminium pieces and the bolts.

Two linear strain gauges were attached on the front and back outer glass surfaces at the mid-height of the test specimens (see Fig. 2a). Strain gauges were used on both sides in order to estimate possible eccentricity (if any) during the loading and also to make corrective measures for small eccentricities. All the reinforced and the reference bolted joint test specimens were tested in tension, displacement control at a slow displacement rate (1 mm/min), which is believed to be representative of a static load. The applied load values were recorded in the in-built digital data storage in the test machine, and the strain gauge data was recorded using a digital data acquisition system. During the testing, graphical information of glass around the bolted joints was recorded using a digital camera. For each test specimen, the recorded strain gauge data suggested that the applied load–longitudinal strain relationships of both sides of the test specimen were largely the same. This ensured the effect of potential eccentricity of the applied load was negligible, and the use of the average values of the two data sets is representative of the actual behaviour of the test specimen.

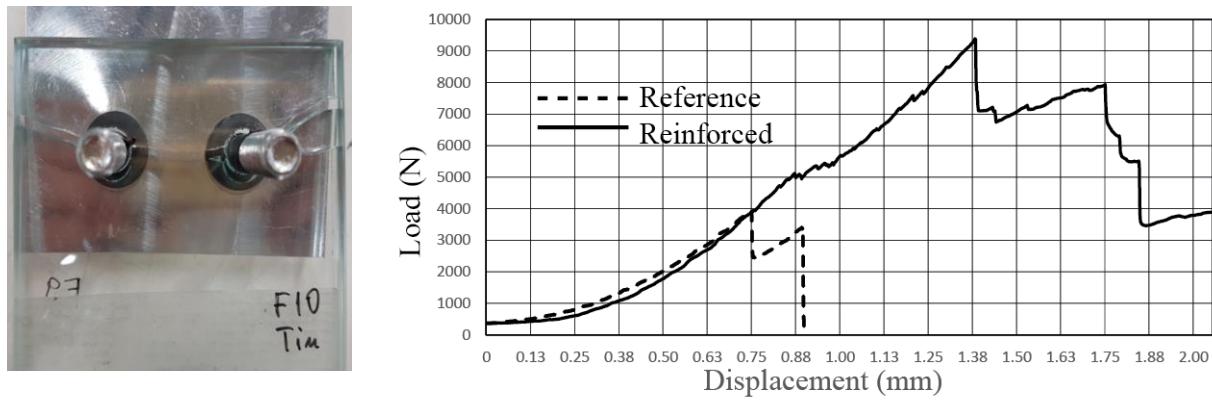
Fig. 3 (a) Failure of glass in the vicinity of the joint in annealed glass reference test specimen (b) Applied load – displacement relationships of the reference and reinforced bolted joints in annealed glass

In annealed glass test specimens, a complete failure of glass across the bolted joint caused the failure of the test specimen. Fig. 3a shows the failure pattern observed in the vicinity of the bolted joints in a reference annealed glass test specimen. The applied load–axial displacement relationships shown in Fig. 3b suggests the load capacity of the reference annealed glass test specimen was ~ 3800 N. In this test specimen, one glass piece was failed first causing a drop in the load resistance (see Fig. 3b). Although the other glass sheet then started to carry the load, it also failed soon after the failure of the first one. As the load-displacement relationship shown in Fig. 3b suggests the final failure of reference annealed glass test specimen was brittle. However, as shown in Fig. 4, the glass only failed in the vicinity of the bolts where the mid-length regions of the glass specimens remained intact.

The applied load–axial displacement relationships of the reinforced annealed glass bolted joint and the reference annealed glass joint shown in Fig. 3b suggest the behaviour of the two joints were very similar at lower loads (i.e. prior to the failure of glass in the reference specimen). However, the strengthened specimen carried a higher load than the reference specimen. The load capacity of the strengthened joint was ~9360 N, ~150% higher compared to that of the reference specimen (~3800 N). The figure also shows the reinforced joint showed an ability to resist the applied load after the peak load – i.e. even after the glass failed in the vicinity of the bolt. Although, the load capacity of the strengthened joint (~9360 N) was still lower than that of an equivalent joint in fully-toughened glass (~14300 N), a safe failure behaviour of the former after the attainment of the peak load is very commendable. The results suggest the use of a GFRP reinforcement strip increased the load resistance of the bolted joint in annealed glass, and it also ensured a notable ductility compared to brittle failure observed in conventional bolted joints in annealed and fully-toughened glass.

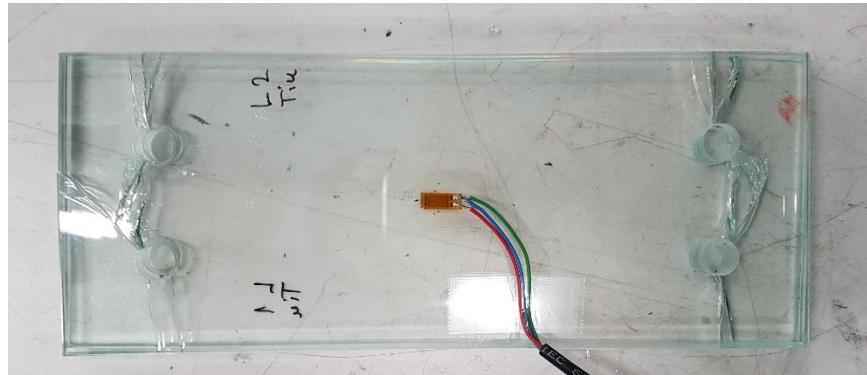
Fig. 4 The mid-length regions of the reference annealed glass specimens were undamaged

behaviour was different to the reference annealed glass test specimen where the failure was localised to the vicinity of the bolted joints (see Fig. 4). The applied load–axial displacement relationship shown in Fig. 5b suggests no post-fracture load resistance was existed in the reference tempered glass test specimens. Nevertheless, as expected, the reported load capacity of the joints were higher compared to that of the reference annealed glass bolted joints. For example, the reference tempered glass bolted joint test specimen shown in the Fig. 5a, failed at ~14300 N, ~275 % higher than the observed failure load of 3800 N of the reference annealed glass test specimen shown in Fig. 3a.

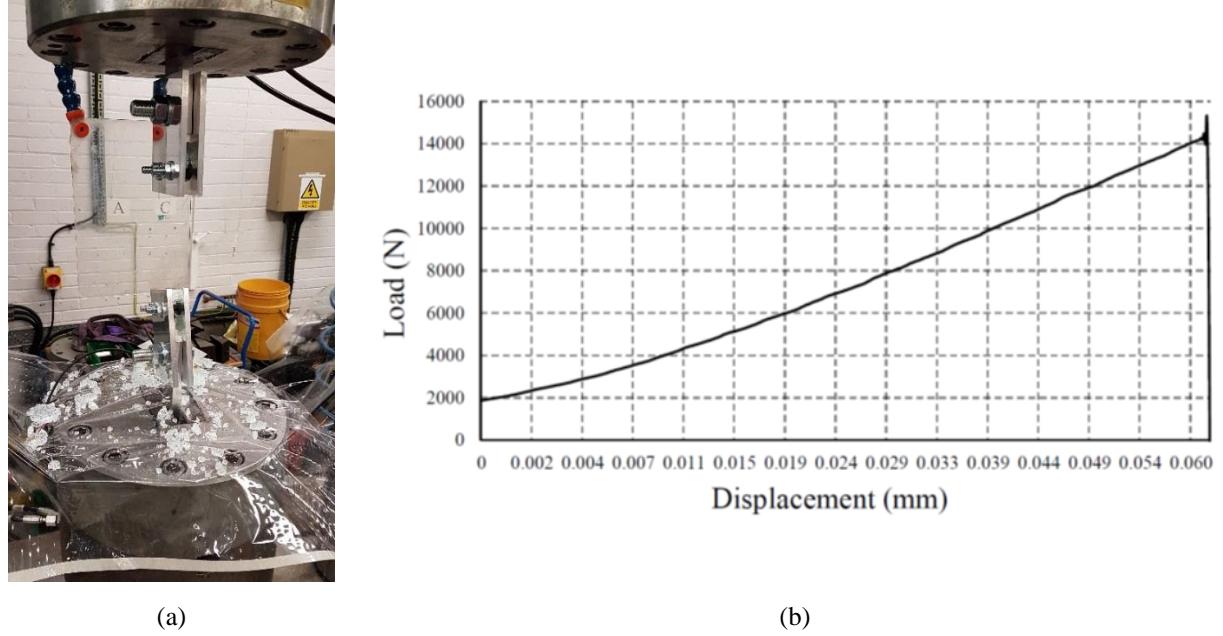
Fig. 5 (a) Complete fragmentation of both two glass specimens in a reference fully-toughened bolted joint
 (b) Applied load–displacement relationship of a reference bolted joint in fully-toughened glass test specimen

As expected, the reference tempered glass bolted joint test specimen shattered into small dice as shown in Fig. 5a. The failure of the joint was instantaneous and caused complete fragmentation of the entire two glass specimens. This

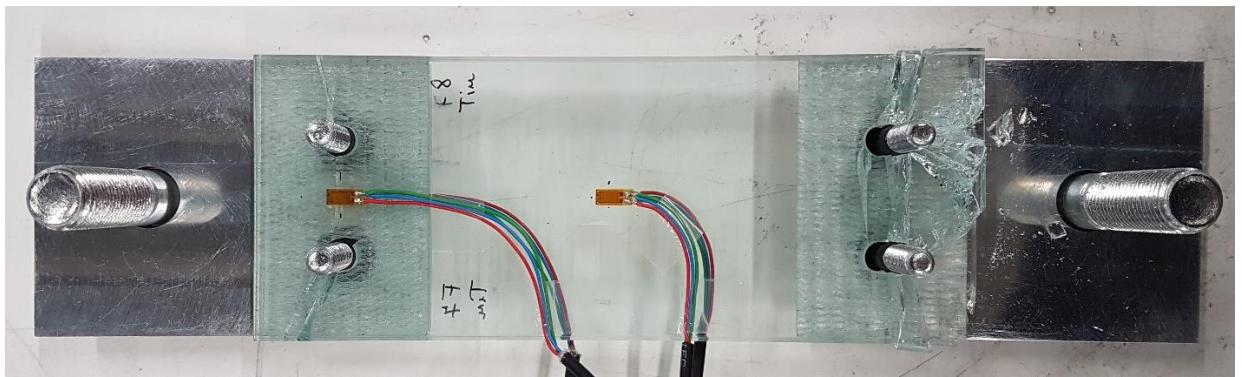
Fig. 6 Failure pattern of a reinforced annealed glass test specimen

As expected, the reinforced bolted joints in annealed glass specimens also failed due to failure of glass in the vicinity of the bolted joint. However, unlike the reference test specimens, the reinforced joint did not fail instantaneously after the initiation of a critical crack in glass. For example, the applied load–axial displacement relationship of one of the reinforced test specimens shown in Fig. 3b suggests that the joint resisted the applied load after the formation of the first major crack in the test specimen. Fig. 6 shows this reinforced annealed glass test specimen after removing from the testing machine. The figure shows that unlike in the reference annealed glass test specimens where complete fractures occurred across the bolted joints, or the references fully-toughened test specimens where entire glass shattered into small pieces, no complete fracture occurred in the reinforced annealed glass bolted joint test specimen.

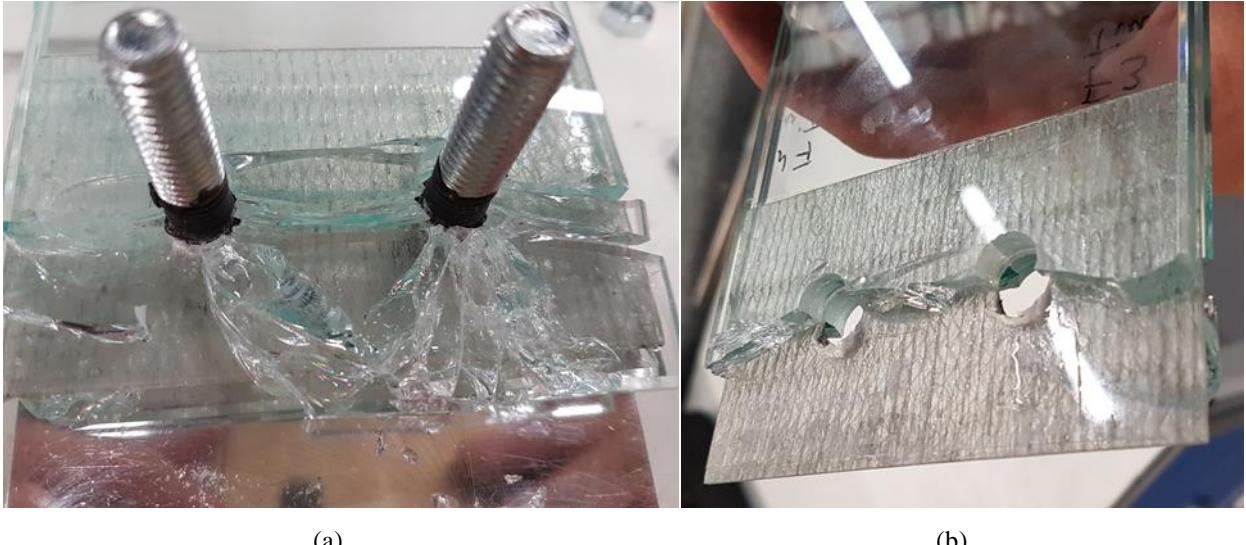
Fig. 7: Failure of glass in a reinforced annealed glass joint configuration (a) Glass fractured in the vicinity of the bolts (b) The GFRP strip remains intact although the glass has fractured

Although the reinforced joint still failed in the vicinity of the bolted joints, the GFRP strip prevented a complete failure of the test specimen by holding the broken glass pieces together. Fig. 7a shows a close-up view of a reinforced bolted joint where the most damaged in glass occurred among all the test specimens tested in the present study. As can be seen from Fig. 7b, despite the glass was damaged very significantly in the joint shown in Fig. 7a, the GFRP strip remained intact. It is anticipated that the GFRP strip will have potential to contribute to the resisting the applied load even after a complete failure of the glass in the vicinity of the joint.
