Multi-instrument multi-scale experimental damage mechanics for fibre reinforced composites

To cite this article: Stepan V Lomov et al 2018 IOP Conf. Ser.: Mater. Sci. Eng. 406 012057

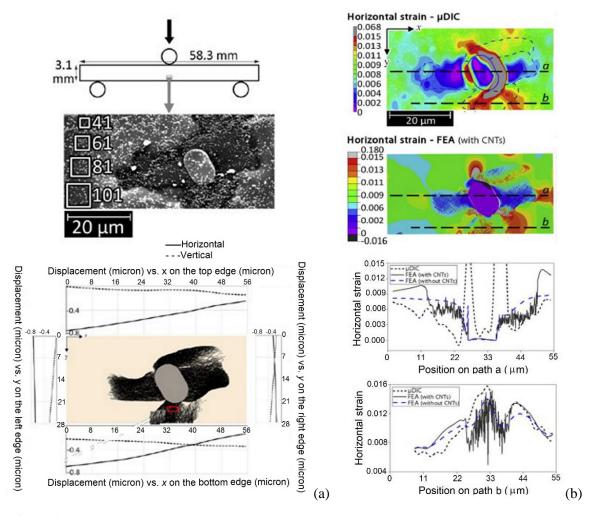
Figure 2. Micro-DIC discovering fibre debonding: (a) schematics on the specimen in three-point bending, region of interest (ROI) and FE model simulating CNTs grown on the surface of the fibre, with the DIC-measured displacements profiles on each edge of the ROI; "horizontal" and "vertical" correspond to the image orientation; (b) DIC-measured and calculated strain fields and profiles [2]

Figure 2 illustrates results of the measurements. Features such as fibre, matrix, aligned CNT forest, and debonded regions at the fibre/matrix interface were detected. Openings as small as 35 nm in the debonded regions near the fibres were measured. The image correlation uncertainty in the displacement analysis was found to be below 5 nm, as estimated from the standard deviation confidence of the match. The micro-DIC results were compared with predictions of a two-scale numerical model, and a good agreement between the two was observed.

Micro-DIC measurements revealed propagation of the debond around and/or along the fibre, which manifested itself in a non-linear trend in the opening of the debonded region as function of the applied deformation.

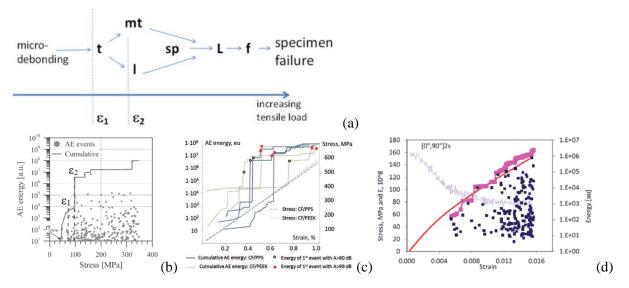
Figure 3. Damage thresholds in cross-ply and textile laminates identified with AE: (a) a sequence of damage modes (t: transverse cracks in yarns/plies and the matrix (mt); l: micro-delaminations; sp: longitudinal splitting; L: macro-delaminations; f: fibre breakage) [16]; (b) typical AE identification of the damage thresholds in a woven glass/epoxy laminate [9]; (c) damage thresholds in carbon/PPS and carbon/PEEK woven laminates [5]; (d) stress-strain, stiffness-strain and AE energy diagrams for tensile loading of flax quasi-UD woven laminates [6]

The sequence of damage events in cross-ply and textile laminates [16] (Figure 3) suggests a presence of two thresholds of the applied load. The first, designated as ε_1 , corresponds to the onset of the transverse cracking (*t*-cracks), which may not at this stage span the whole width of the specimen, being limited by the yarn crimp and/or presence of stitching in the textile reinforcement structure. The second, designated as ε_2 , corresponds to, on one hand, the onset of local delaminations (*l*-cracks) and, on the other hand, to the formation of "strong" transverse cracks, which span the width of the specimen.

The damage thresholds can be identified using acoustic emission (AE) registration during the tensile loading, namely, a curve of cumulative energy (E) of the AE events. The damage threshold ε_1 is related to the first increase of the $E(\varepsilon)$ curve, and the damage threshold ε_2 – to the second sharp increase of this

curve. This approach was used in 2005-2018 for various textile composites; Figure 3 gives examples for such measurements for composites with carbon, glass and flax fibres with thermoset and thermoplastic matrices. The AE registration allows quantification of the influence of the reinforcement architecture, matrix ductility or fibre properties on the damage initiation behaviour of the composite.

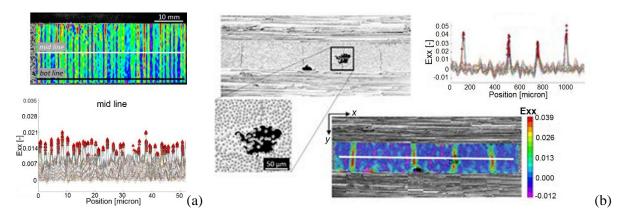
Figure 5. DIC-enhancement of the edge crack registration: (a) cracks identified as peaks on the strain profile; (b) cracks related to voids in 90° plies [8].

The observation of cracks on the specimen edge can be enhanced with the use of DIC. In [8], the cracks were monitored via identification of peaks in the strain profile on the specimen surface in each deformation step, which is carried out semi-automatically. The method was applied to study the influence of voids on the cracking process (Figure 5).

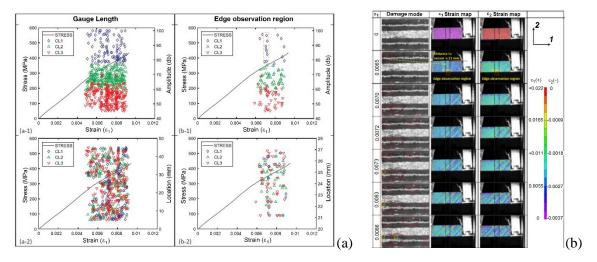
Figure 6. Concurrent use of AE (a), edge microscopy and surface DIC (b) for damage identification during tension of carbon/epoxy QI laminates [7].

presents the necessity of multi-instrument optical observations for damage-mode identification and correlation with AE registrations: concurrent use of AE registration, optical edge observations and surface strain mapping by DIC (Figure 6).

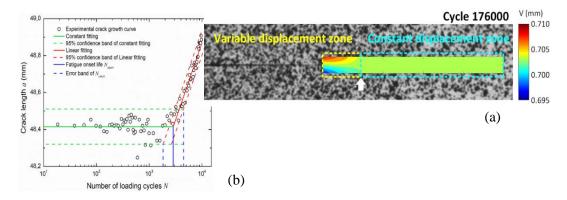
Figure 7. DIC-based method for tracking a fatigue Mode I crack: (a) detection of the crack tip position (white arrow); (b) identification of fatigue onset life $N_{\rm onset}$ [10].

Optical methods are effectively used for following tracking damage development in fatigue loading. In [9] a DIC-based method is proposed to characterize Mode I fatigue delamination onset and propagation in laminated composites. Images of the fatigue delamination on one side of the specimen were automatically recorded at a maximum displacement at specific fatigue cycles. The displacement field around a delamination crack is obtained and further processed to determine the position of the crack tip (Figure 7a). With this method the delamination length can be measured automatically in each cycle with a precision on the order of few hundreds of micrometers. The fatigue delamination onset life is then determined by detecting the increase of the delamination length, and the fatigue delamination propagation rate is calculated. The proposed method produces more conservative fatigue life measurements in comparison with the 5% compliance increase method in ASTM D6115 (Figure 7b).

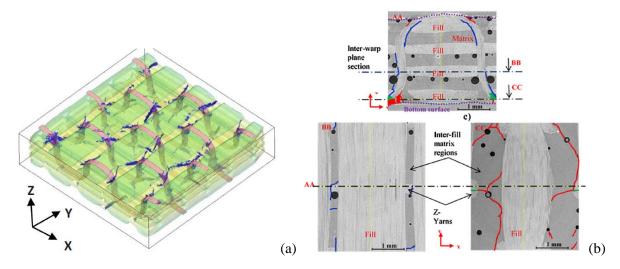
Figure 8. Thermal fatigue of a 3D woven carbon/epoxy composites in the presence of voids: (a) cracks identified using micro-CT; (b) details of the crack morphology [11]

In [11] a carbon fibre/epoxy matrix composite material reinforced with a non-crimp 3D orthogonal woven preform was investigated. The aim was to characterize the damage mechanisms – i.e. matrix cracking – induced by thermal cycling. Qualitative and quantitative descriptions of the morphology and the evolution of cracks with thermal cycling are carried out through the analysis of μ CT scans of samples at different cycle numbers. Through suitable image processing, which is of general and wide application, qualitative and quantitative descriptions of the initial porosity, of morphology and evolution of matrix cracking up to 1400 thermal cycles were performed (Figure 8a).

In addition, since the specimens have a certain level of porosity due to the infusion process, a complete description of this defect is carried out, and its influence on the damage mechanisms induced by thermal cycling is analysed. At first sight, the presence of pores seems to facilitate the propagation of cracks, pores acting as "attractors" when they are in the vicinity of the crack path (Figure 8b).
