Leading edge topography of blades - a critical review

Keywords: Leading edge topography, roughness, additive mechanisms, subtractive mechanisms, turbomachinery, performance degradation

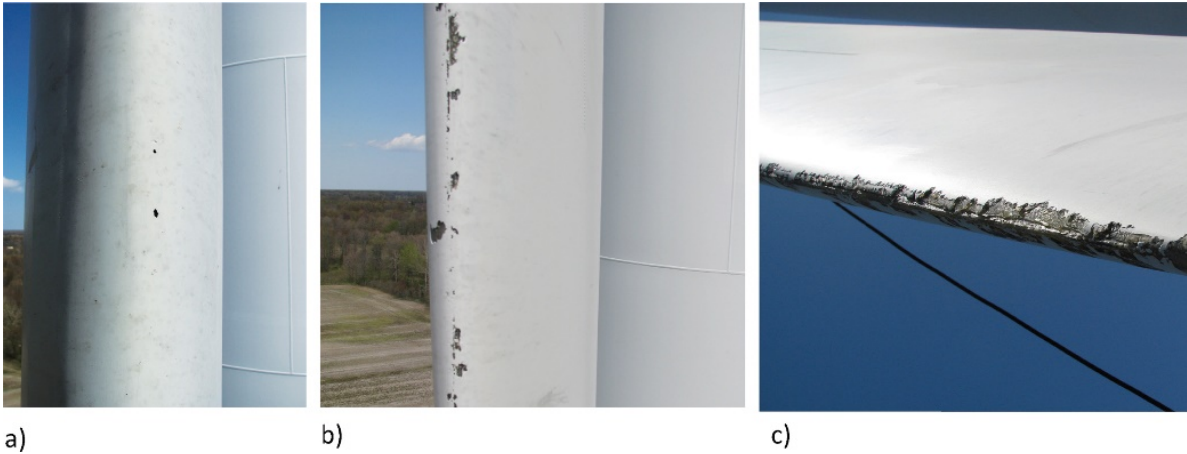
Figure 1 Examples of wind turbine leading edge erosion across a range of years in service [1, 2]

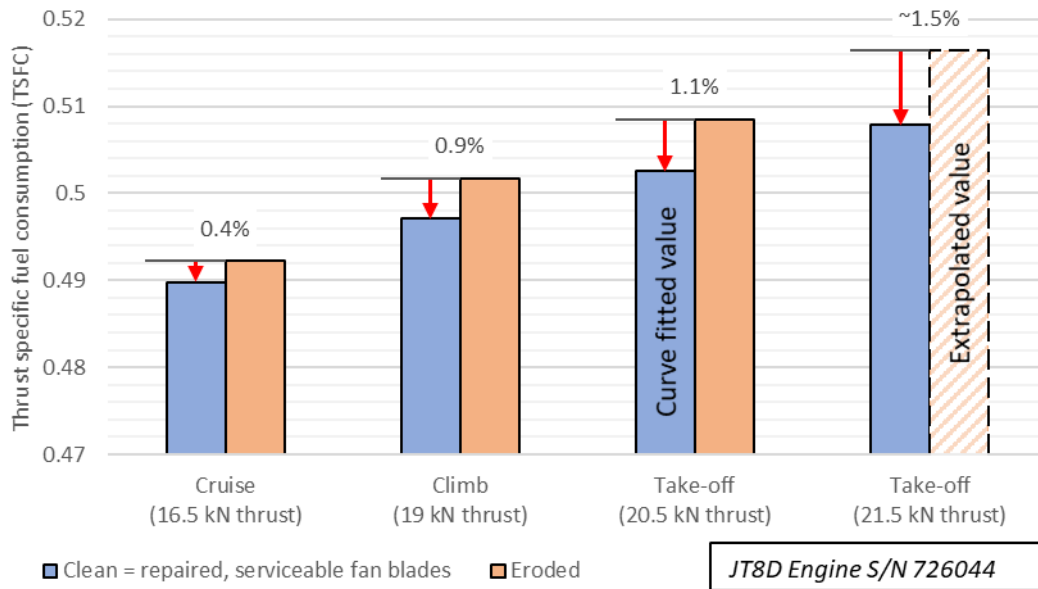
Figure 2 Thrust specific fuel consumption (TSFC) comparison of eroded vs. serviceable fan blades, adopted from [3]

The fuel burn data from an aeroengine test with eroded and redressed fan blades has recently been made available. Based on the combined effect of the different degrees in efficiency loss across the engine cycle, a 1% increase in fuel burn was seen due to erosion of the leading edges [3]. If this erosion can be eliminated and by using typical flight data from USA mainland and regional commercial carriers then fuel savings between 80M and 100M gal per year and drops in emissions by 750 M to 1B kg CO₂ pa and 700 M to 1B kg NO_x pa are predicted [4], see Figure 2.

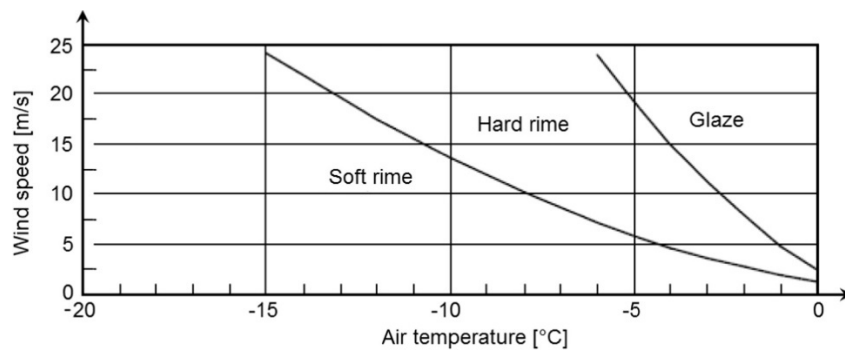
Figure 3 Type of in-cloud icing as a function of wind speed and air temperature [34]

In-cloud icing occurs when supercooled water droplets hit a surface below 0°C and freeze on impact. The droplet temperature can be as low as -30°C, but due to their size, they do not freeze in air. Accretion of ice exhibits different sizes, shapes and properties based on the number of water droplets in the air (liquid water content - LWC) and their size (median volume diameter - MVD), temperature, wind speed, duration and collection efficiency. The density of accreted ice ranges from low (soft rime) over medium (hard rime) to high (glaze). Soft rime is represented by thin ice with needle and flake shapes. This type of icing with low density and low adhesion occurs when the temperature is far below 0°C together with low LWC and MVD. The hard rime formed under higher MVD and LWC conditions has a higher density and is more difficult to remove. Glazing occurs when a portion of a droplet does not freeze on impact, instead they flow across the surface and subsequently freeze. It is usually associated with precipitation and results in a very dense and adherent glaze [33]. The types of in-cloud icing as a function of wind speed and air temperature are shown in Figure 3.

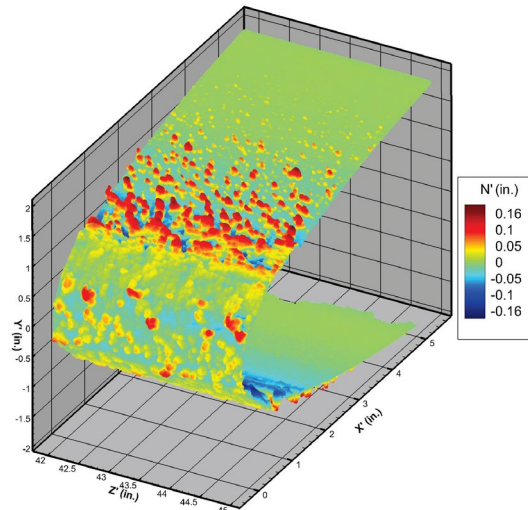
Figure 4 Roughness visualization of the 031414.01 ice surface [35]

Precipitation icing can result from wet snow or freezing rain, which may accrete at a much higher rate and cause more damage than in-cloud icing. Wet snow refers to slightly liquid snow at air temperature between 0°C to -3°C. Removing wet snow from the surface is easy, but removal will become very difficult when the surface is frozen. Icing from freezing rain often occurs during inversion, when rain falls on a surface at a temperature below 0°C. Both the density and adhesion are high with this type of icing. Frost occurs when water vapor cures directly on a cool surface. It often occurs during light winds, and the adhesion can be very strong. An example of icing on a wind turbine blade are show in Figure 4 and Figure 5.

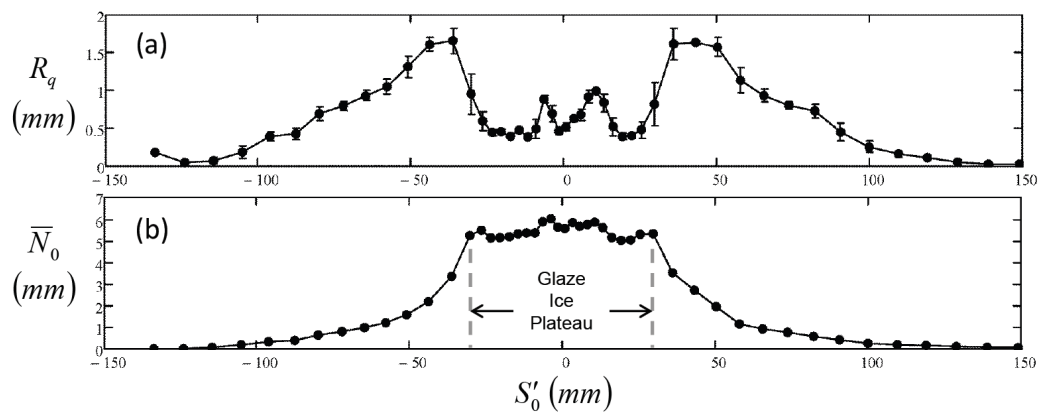
Figure 5 Reduced roughness (a) and thickness (b) variations along the 031414.01 ice surface [35]

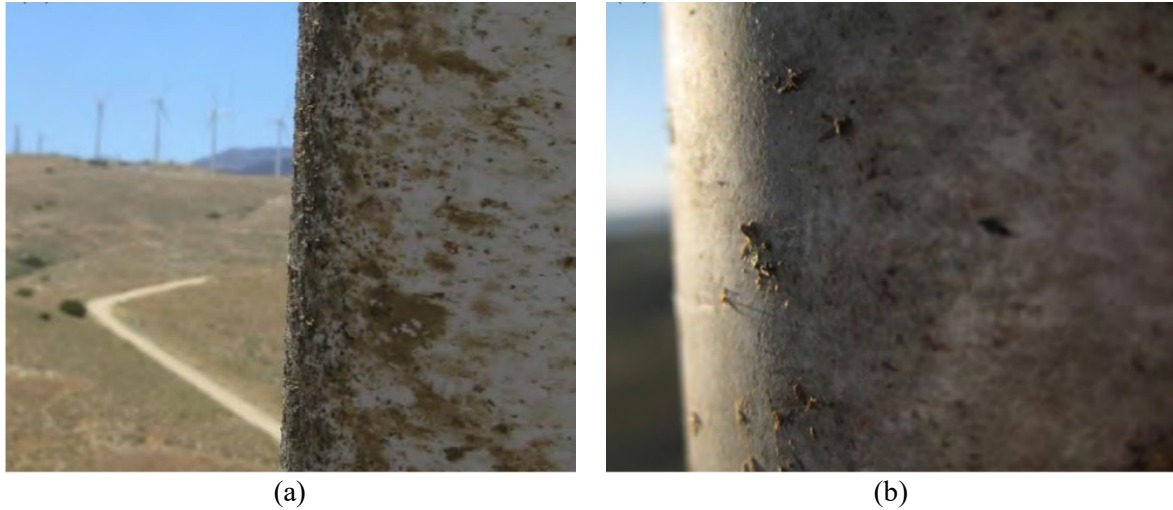
Figure 6 Images of insect roughness on leading edges. (a) Heavy insect roughness from Spruce [43, 44] and (b) minimal insect accumulation from Ehrmann [42]

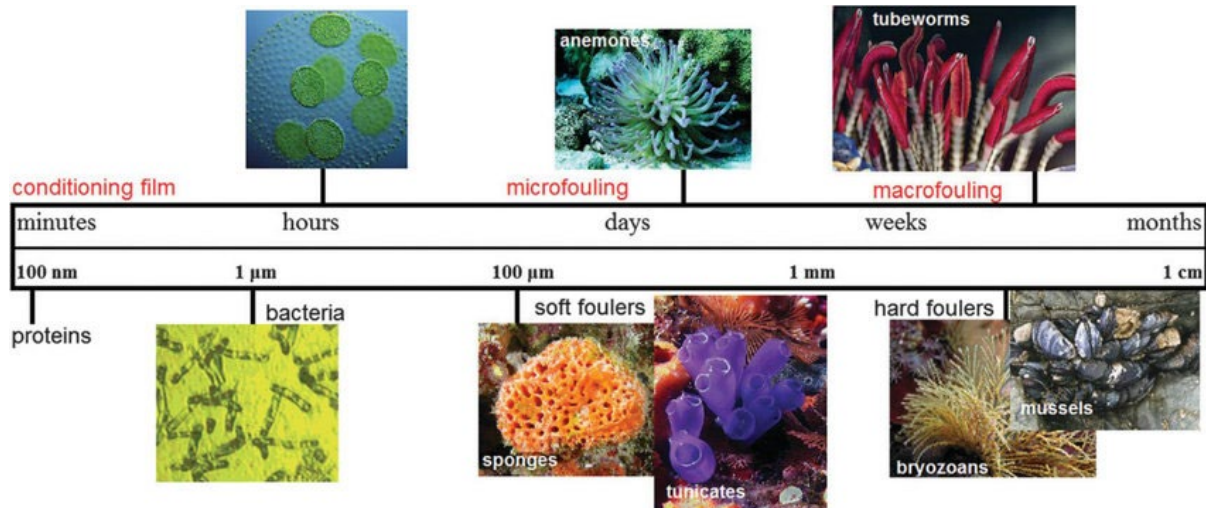
Figure 7 Different phases of marine biofouling: Time-line evolution and respective roughness increase [53]

The evolution of marine biofouling organisms and changes in their morphology and size over time are shown in Figure 7. Biofouling of turbine rotor blades increases the surface roughness, and the increased roughness will alter the flow field near the blade surface (i.e., the boundary layer). At moderate to high Reynolds numbers, increased surface roughness decreases lift and increases drag, thus reducing time-averaged hydrodynamic torque on the rotor [54]. The magnitude of this reduction depends on the roughness height, chord position, fouling density and aerofoil shape. Surface roughness increases mixing in the boundary layer and may lead to earlier and longer turbulence transitions along the aerofoil [55]. In addition, as the roughness height increases, the viscous resistance increases due to the higher local velocity shear rate of the blade surface [54]. Impact of biofouling on turbine hydrodynamics depends on the species composition and maturity. Even biofilms as thin as 0.1 mm have been shown to increase skin friction on flat plates [56], while the barnacle heights can exceed 10 mm [57]. Barnacles at such size would cause local flow separation on the turbine blades and thus affect lift and drag components, and even lead to dynamic stall [49].

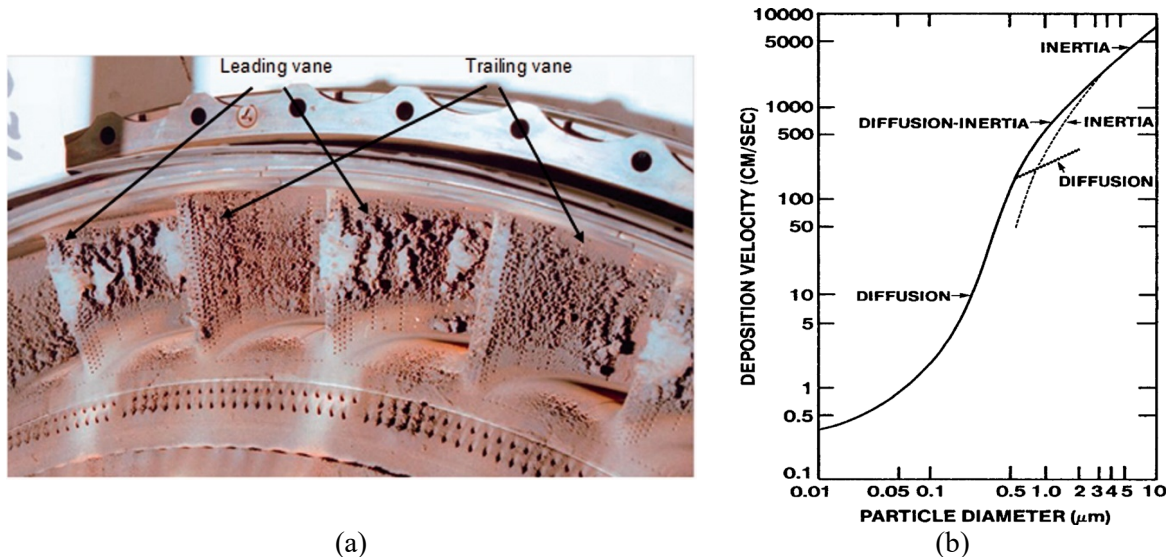
Figure 8 (a) Volcanic ash deposition on turbine vanes [59] and (b) Turbine vane deposition vs particle diameter [60]

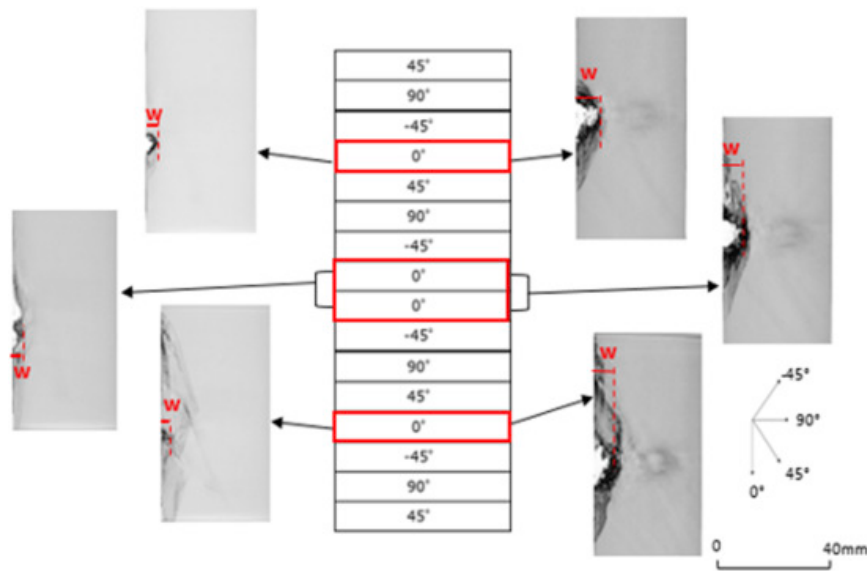
Figure 10 Fibre fracture width definition for edge impacted laminates at impact velocities 200 m/s (left) and 350 m/s (right) [90]

Other work has looked at the damage from high-speed cubes impacting the leading edge of aerofoil specimens. This type of FOD can be characterized as a combination of notch indentation, material loss, material shearing, material folding, heat formation, shear bands and microcracks. All of those characteristics can lead to material fatigue and thus reduce the overall performance of the blade [89]. An experimental study of high velocity oblique impact on carbon/ epoxy laminates was conducted by Kristnama, and Figure 10 present the CT scan of the post-impact damages for edge impacted laminates at 200m/s and 350m/s [90]. As the impact angle of the foreign object varies, its influence on the fatigue performance of the blade are also different. Moreover, the residual stress caused by the FOD can also adversely affect the fatigue performance of blades [91].

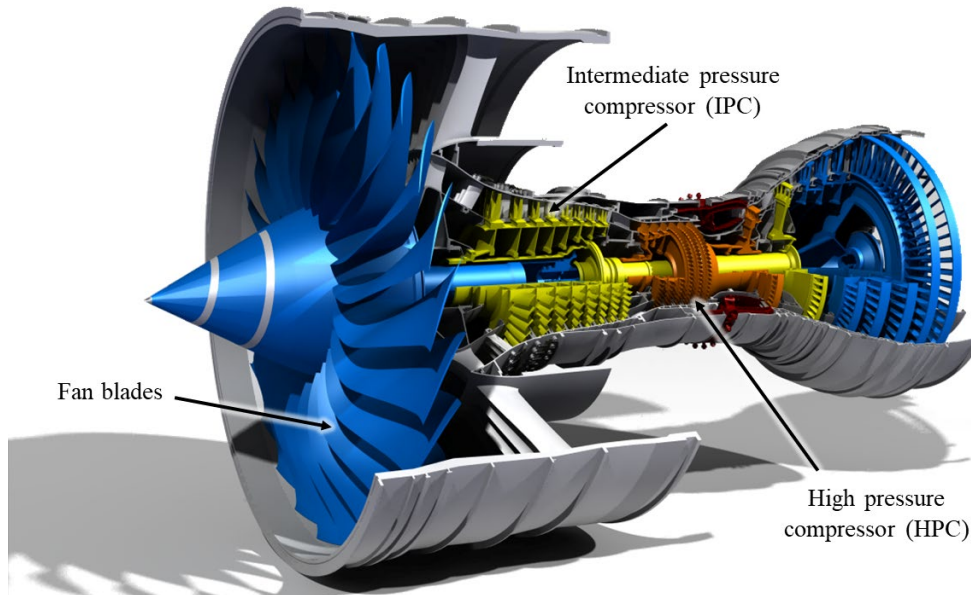
Figure 11 Cutaway view of the Rolls-Royce Trent 900 turbofan engine [92]

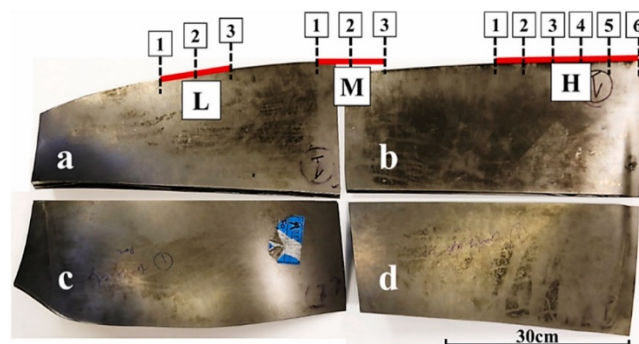
Figure 12 ex-service turbofan blade [104]

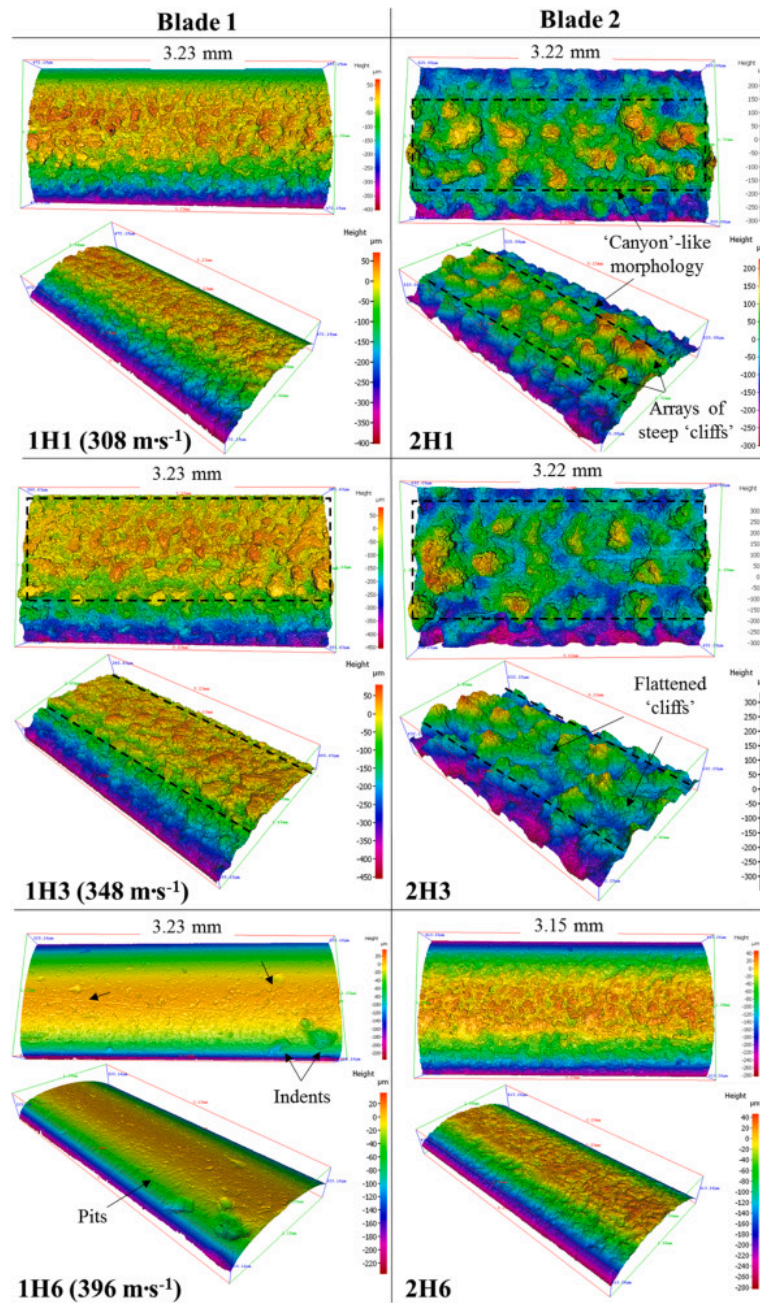
Figure 13 3D profiles of H1, H3 and H6 zones of both leading edges [104]

Ma et al [104] produced a forensic analysis of rain erosion damage of the leading edges of two ex-service Ti-6Al-4V fan blades from different aeroengines with respect to the microstructure, morphology and impact conditions to examine the WDE damage mechanisms on the leading edges and their evolution. This work shows the rain erosion process develops with increasing impact velocity, see Figure 13. At M (moderate speed) and H (high speed) zones, shown in Figure 12, ‘canyon’-like morphology starts to form on both blades due to significantly increased material loss. However, more prominent ‘canyon’ features are observed on Blade 2 leading edge with steeper ‘peaks’ and deeper ‘valleys’, as shown in Figure 13 - 2H1 and 2H3. The severity of the rain erosion damage decreases after the H3 zone towards the tip of the blade (H6 zone) at both leading edges. This is attributable to the shielding effect of the fan blade casing and flow field at the blade tip. The impact velocity was assumed to be

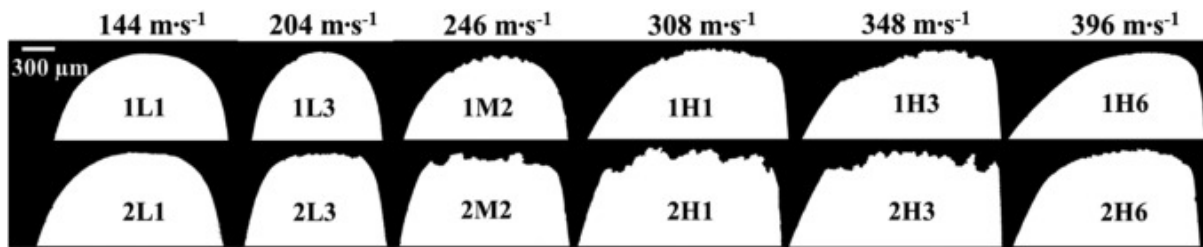
Figure 14 Comparison of cross-sectional profiles of ex-service turbofan leading edges [104]

Cross-sectional observations on the leading edge specimens shown in Figure 14 can further verify the relation shown in Eq. (1). Comparison of Blade 1 and Blade 2 cross-sections reveals that the rain erosion damage initiates at the highest curvature of the leading edge profile, as shown in Figure 14- 2L1. The affected zone is then expanded with increasing impact velocity. The severity of material removal increases significantly for impact velocity over 246 m s⁻¹. The whole tip of the leading edge was removed in 2M2, 2H1 and 2H3. The paper summarises the development of roughness and flattening of the leading edge using Figure 15. This schematic figure was informed by multiple cross-sections and SEM analysis of the damaged blade at multiple locations on each blade.

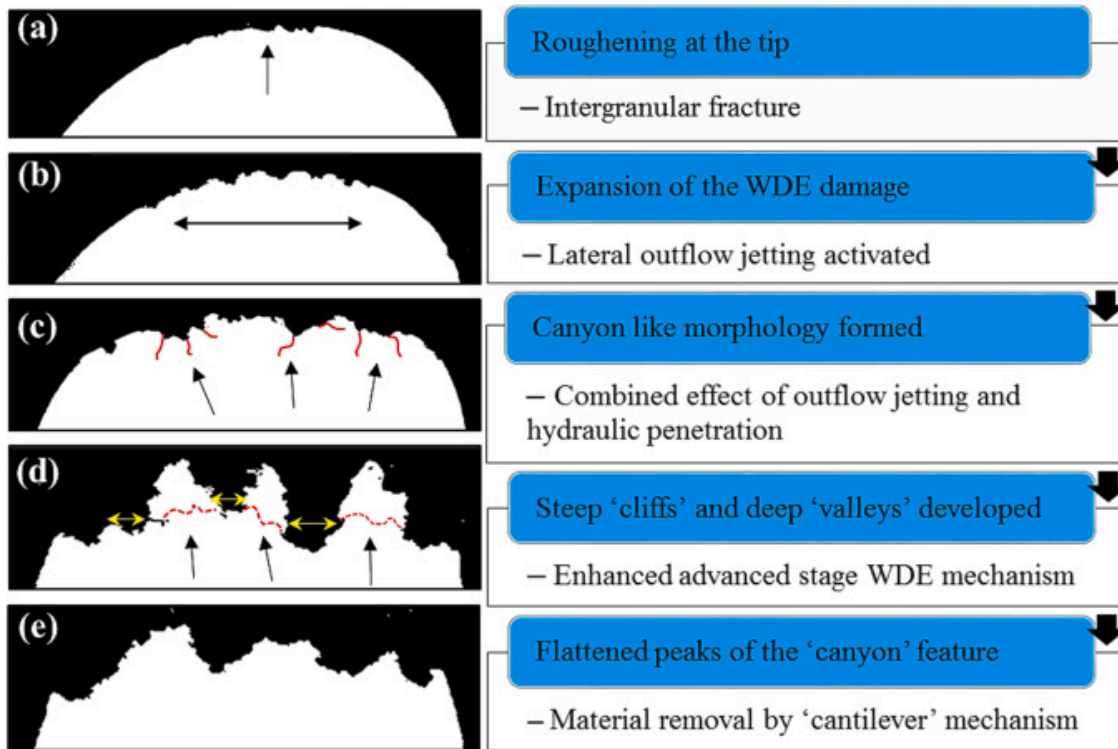
Figure 15 Evolution of rain erosion at the leading edge of Ti-6Al-4V turbfan blades [104]

The evolution of rain erosion at the leading edge of Ti-6Al-4V turbfan blades is demonstrated with a series of cross-sectional blade profiles shown in Figure 15.

- The initiation of rain erosion occurs at the highest curvature of the leading edge profile. The intergranular fracture observed in the early stages of WDE can be attributed to the high anisotropic behaviour of α -grains in Ti-6Al-4V blade material under water-hammer pressure.

- Followed by the initial short and high pressure compressible stage of impact, the shear stress due to the activation of the lateral outflow jetting leads to the formation of cracks and erosion craters. Subsequently, the WDE damage area expands.

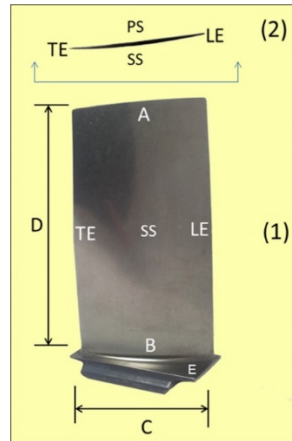
Figure 16 Generic compressor blade nomenclature; (1)-side view and (2)-tip view(x section) showing; LE-leading edge, A-tip, B-root, C-chord (chordwise direction), TE-trailing edge, D-Span (spanwise direction), SS-suction side (convex), PS-pressure side (concave), E-end wall [108].

The degradation of the leading edge of a compressor blade in an aircraft engine during service has a disproportionate effect on compressor efficiency. Wilshee [106] tested compressor blades with roughness imposed onto discrete regions and found that applying roughness over the leading edge and the first 4% of the chord (for blade nomenclature see Figure 16) increased the aerodynamic losses by

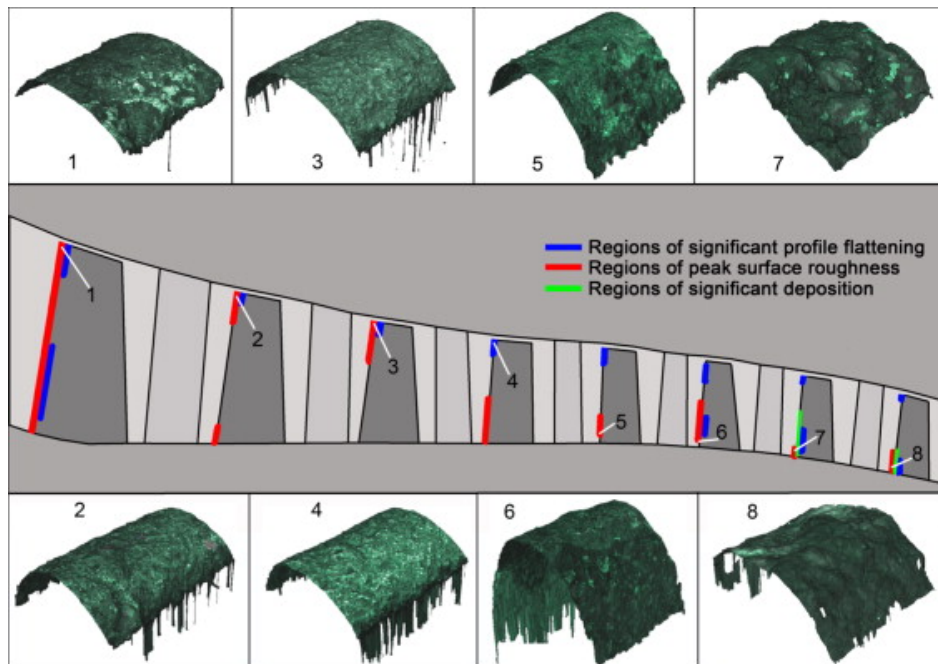
Figure 17 Schematic annulus diagram of the IPC showing blade number. In red are regions of peak surface roughness. In blue are regions of (relative) pronounced increase of fitted radius due to erosion of profile. Above and below are leading edge fields from the numbered blades in the LE positions indicated by the white lines [108]

Walton et al [108] presented a study that focused on the leading edges of the rotor blades from a single engine; measurements were taken from one blade from each row of the IPC and one from each row of the HPC. This allowed him to study leading edge of different sizes as well as different levels of degradation. Walton detailed an automated technique for roughness of the leading edge characterisation in terms of areal parameters and the spatial distribution of peaks in this characteristic roughness.

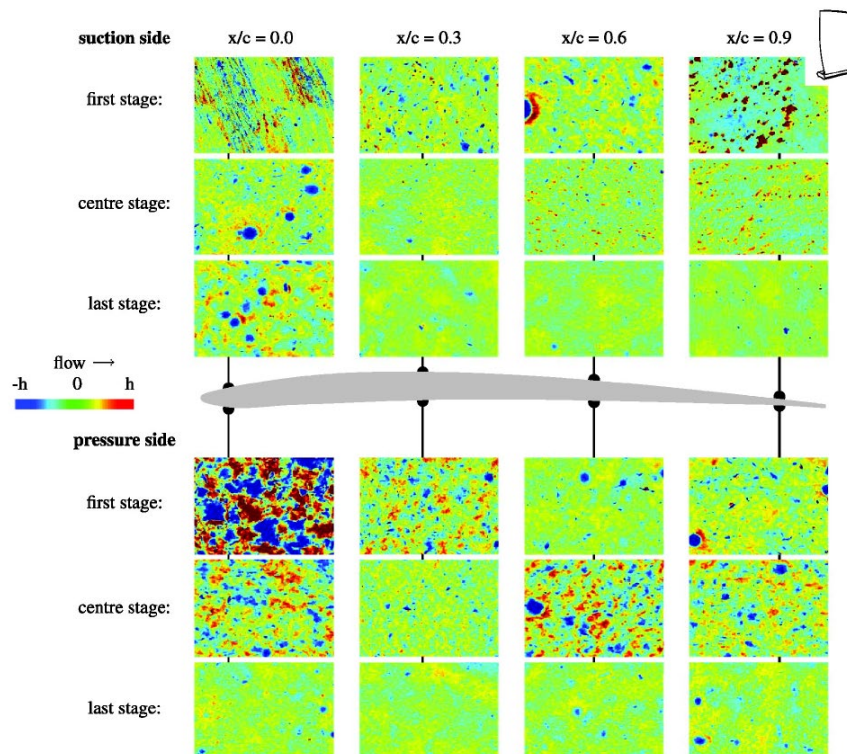
Figure 18 Examples of single-blade roughnesses from a high-pressure compressor of a mid-size aircraft engine from different stages and measurement positions. The size of the measurement area is 0.890 mm by 1.280 mm [109].

A recent paper, has investigated the surface roughness of rotor blades of a compressor from different stages of an axial high-pressure compressor and a first stage BLISK (Blade-Integrated-dISK) of a regional aircraft engine, see Figure 18. Measurements by a three-dimensional laser scanning microscope found the largest roughness height in the first stage followed by the centre stage and the last stage of the compressor. Basic types of roughness structures were identified as impacts as round depressions of different sizes, depositions isotropically distributed single elements with steep flanks in different size and anisotropic roughness structures. Although the anisotropic structures can only be detected at the leading edge of a single blade in the first stage of a medium-sized engine. These structures are oriented at an angle ranging from 45° to 90° normal to the flow direction and are the result of leakage oil and flow particles. These structures lead to a higher equivalent sand grain roughness (k_s) magnitude, which is not detectable in the standard roughness parameters (Ra , Rq and Rz). On the pressure side, the highest roughness is detected at the leading edge, identified as a mix of erosion, impacts and depositions [109].

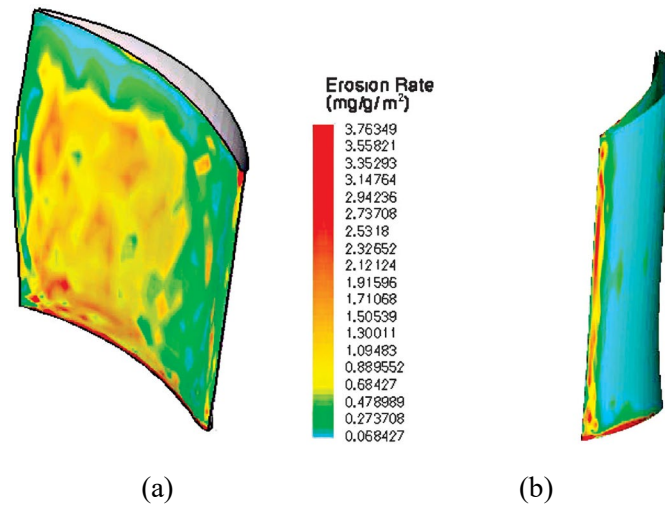
Figure 19 Erosion Rate: (a) vane pressure surface and (b) vane leading edge [100]

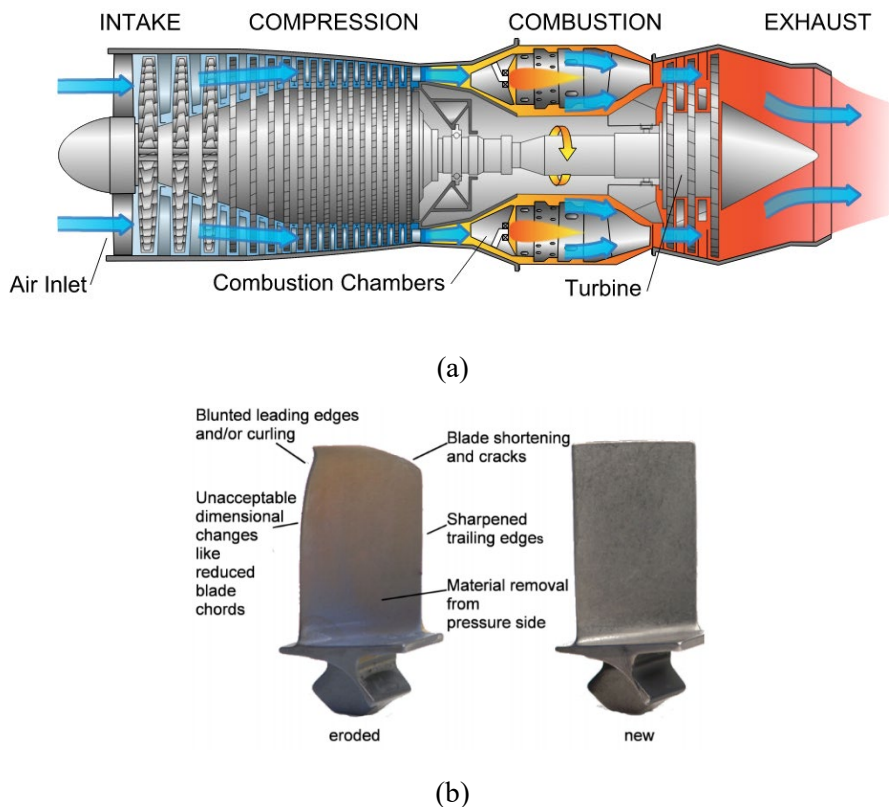
Figure 20 (a) A diagram of a gas turbine engine and (b) Comparison of eroded and new compressor blade [117]

As mentioned in [117], WDE is also seen in compressor blades of gas turbines where the inlet air is cooled (fog cooling) to maximize air density (intake air mass) and thereby increase the power output of the turbine and the efficiency of the unit [118]. Although this method was proven to be effective, droplets are observed to cause severe damage to the leading edge of the compressor blades [119], as illustrated in Figure 20. This damage causes vibrations, which in turn increases the loss in the efficiency and results in serious fatigue damage [105].

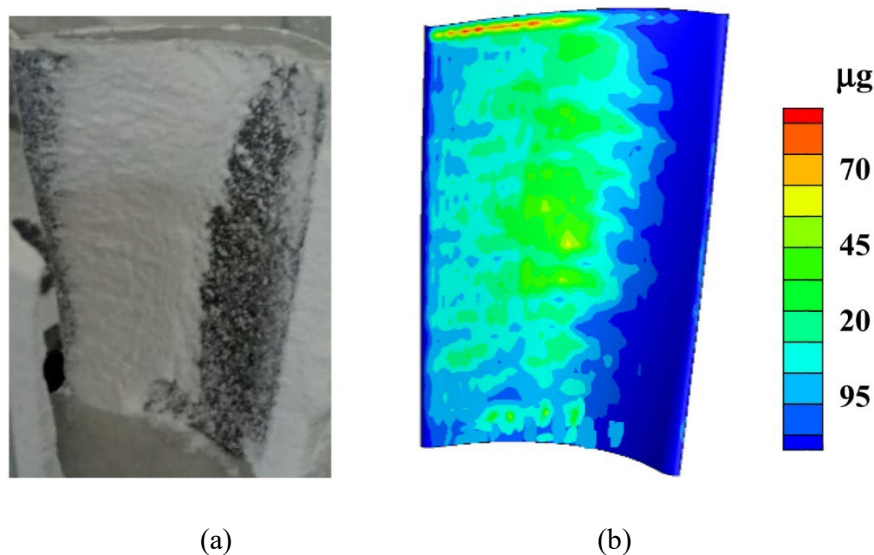
Figure 21 Deposition area verification. (a) experimental, (b) simulation [133]

Fouling in gas turbines is caused by airborne contaminants which, under certain conditions, adhere to aerodynamic surfaces upon impact is one of the principal degradation mechanisms in the compressor section of heavy-duty gas turbines. Usually, foulants in the ppm range, not captured by the air filtration system, i.e., in the range $0\text{--}2 \mu\text{m}$ cause deposits on blading and result in severe performance drop of the compressor. Therefore, there is considerable interest in determining which areas of the compressor aerofoils are affected by these contaminants as a function of the location of the power unit. Work by Suman et al [132] looks at the estimation of the actual deposits on the blade surface in terms of location and quantity. Particle size, their concentration, and the filtration efficiency are studied to produce a realistic quantitative analysis of fouling of an axial compressor. The study combines the impact/adhesion characteristic of the particles obtained through a computational fluid dynamics (CFD) and the real size distribution of the contaminants in the air ingested by the compressor. The blade zones affected by the deposits are reported by using easy-to-use contaminant maps realized on the blade surface in terms of contaminant mass. In a more recent work, Xu proposed a model for particle deposition in flue gas turbines, and the simulation results agree with the experimental results, see Figure 21.

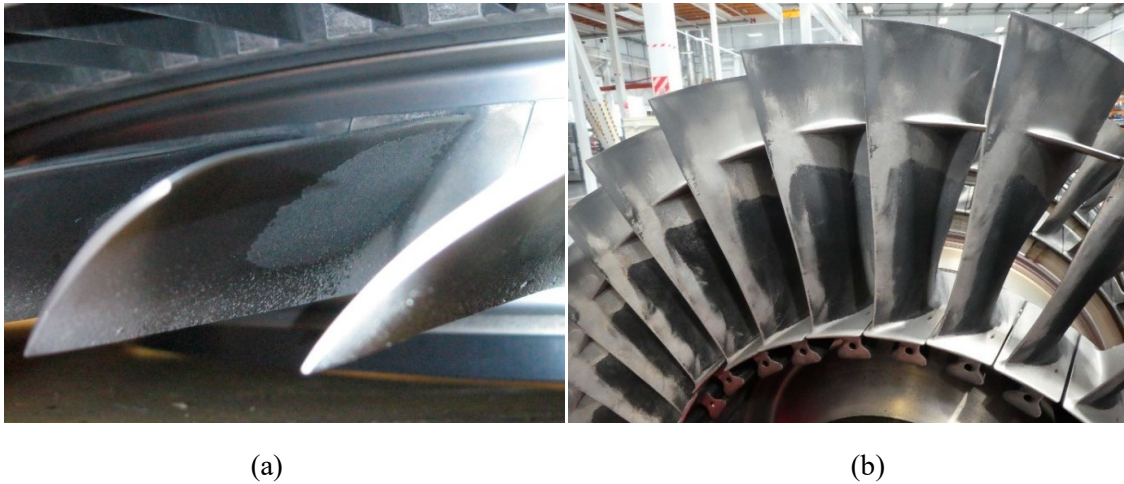
Figure 22 Deposits on Low-pressure compressor (LPC) stage 2.5 blades and on High-pressure compressor (HPC) stage 3 blade [98]

The growth of these solid deposits leads to geometric changes of the blades in terms of both mean shape and roughness level, see Figure 22. The consequences of particle deposition range from performance degradation to life shortening to complete loss of power. Due to the importance of the phenomenon, models are being developed to predict the outcome of solid particle ingestion on gas turbine blades.

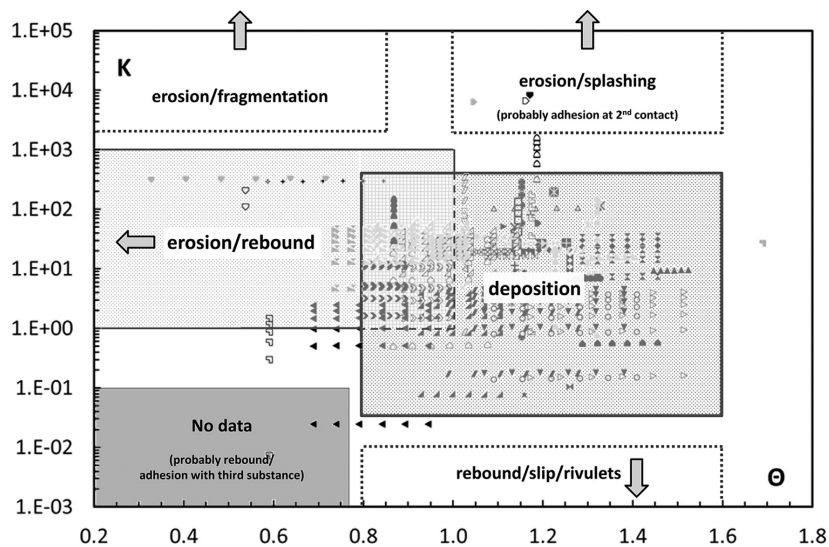
Figure 23 Impact behaviour map using non-dimensional groups $K = E_{kin} / E_{surf}$; $\Theta = T / T_{soft}$ [134]

Suman et al [134] performed a very comprehensive analysis of the available data, using two non-dimensional parameters to describe the interaction between the incident particles and the substrate, with particular reference to sticking behaviour in a gas turbine. They examined historical experimental data on particle adhesion under gas turbine-like conditions through relevant dimensional quantities (e.g. particle viscosity, surface tension, and kinetic energy). The data were also divided into non-dimensional groups based on particle characteristics and identified impact conditions, with generic thresholds from erosion to deposition and from fragmentation to spattering. The relation between K (particle kinetic energy/surface energy) and Θ (the particle temperature normalized by the softening temperature) represents the basis of a promising adhesion criterion and predictive map of behaviour, see Figure 23.

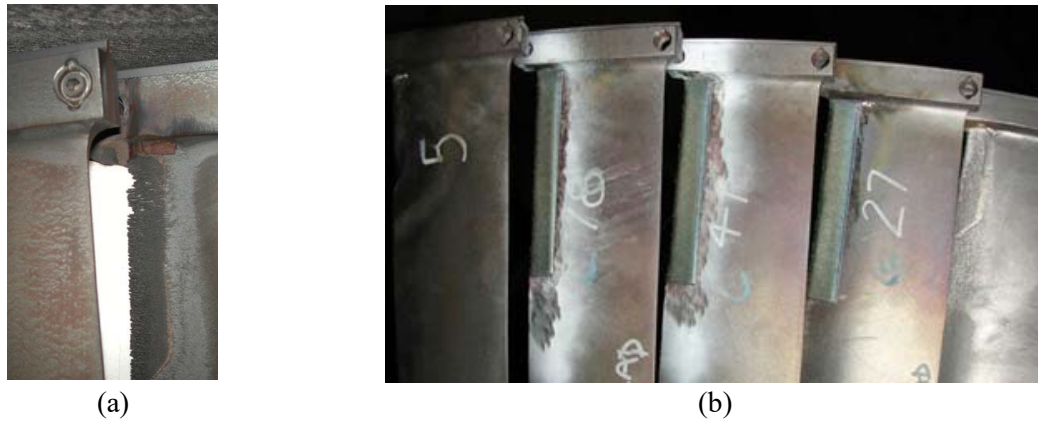
Figure 24 Power generating steam turbine (a) Erosion of the blade (b) In-situ laser repaired blades (Reproduced from [135], with the permission of AIP Publishing)

Brandt and his co-workers reported that in-situ laser repairing (LC) using Stellite 6 onto steam turbine blades (AISI 420 martensitic stainless steel), which suffers from the similar damage as gas turbines, in a power station is feasible and practical using a fiber delivered diode laser and a robot, Figure 24 shows the leading edges of the turbine blades after LC. After one year, the turbine was inspected and the laser-repaired blades showed good performance without sign of damage [135, 136]. However, it should be noted that the repaired blades are thicker than the original blades, which suggests the form of the leading edge was changed.

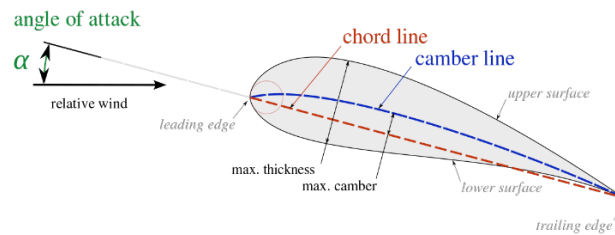
Figure 26 Blade aerofoil nomenclature [139]

the major position in wind turbine designs. For lift-type wind turbine, the nomenclature of a typical blade design is shown in Figure 26. This type of turbine are very sensitive to changes in blade profile, design and surface roughness [138].

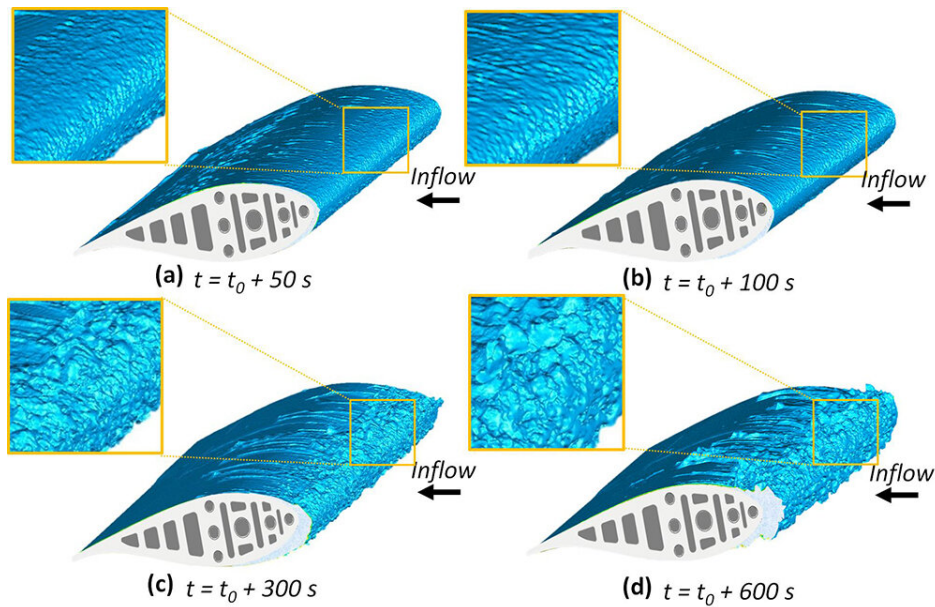
Figure 27 Time evolution of the 3D shapes of the ice structures accreted over the surface of the turbine blade model under a typical glaze icing condition of $V_\infty = 40$ m/s, $LWC = 1.1$ g/m³ and $T_\infty = -5.0$ C [156]

An experimental study was performed in Icing Research Tunnel located at Iowa State University (ISU-IRT) with a typical glaze icing condition that wind turbines usually experience in cold and wet winters, $V_\infty = 40$ m/s, liquid water content ($LWC = 1.1$ g/m³ and $T_\infty = -5^\circ\text{C}$). A Digital Image Projection (DIP) - based 3D scanning system was used to achieve ‘in situ’ measurements of the 3D shapes of the ice structures. Four representative instants, i.e., at 50 s, 100 s, 300 s and 600 s, after starting the ice accretion experiment were captured and shown in Figure 27 [156]. Characteristics of the dynamic ice accretion process on the turbine blade model were revealed clearly and quantitatively as a function of the ice accretion time. Quantitative measurements of 3D shape variations in ice structures accumulated on turbine blade models can be used to validate and verify various empirical and theoretical models used for ice accumulation prediction, and the findings from this study will also be very useful in improving our understanding of the potential icing physics associated with wind turbine icing phenomena, which is essential for the development of effective and robust de-icing/deicing strategies specifically targeting wind turbine icing mitigation measures.

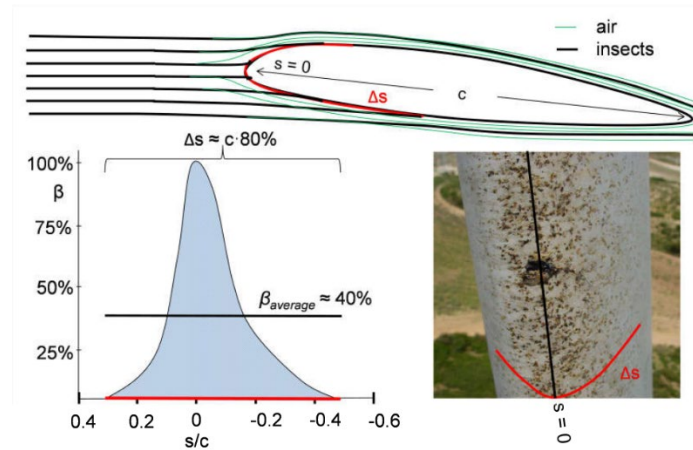
Figure 28 Approximation of the effective impact area of a rotor blade following the analysis of Wilcox & White (2016). Top: insect trajectories on an aerofoil (wrap distance s , leading edge at $s=0$, chord length c , impact length Δs (red line). Left: collection efficiency β as function of distance (s/c) from the leading edge ($s=0$) and the average integral collection efficiency β_{average} assumed in the model. Variability depending on pitch angle and insect inertia is neglected. Right: Photo of insect residues (refer to Figure 3) explaining leading edge and impact length of a rotor blade as used in the model [158].

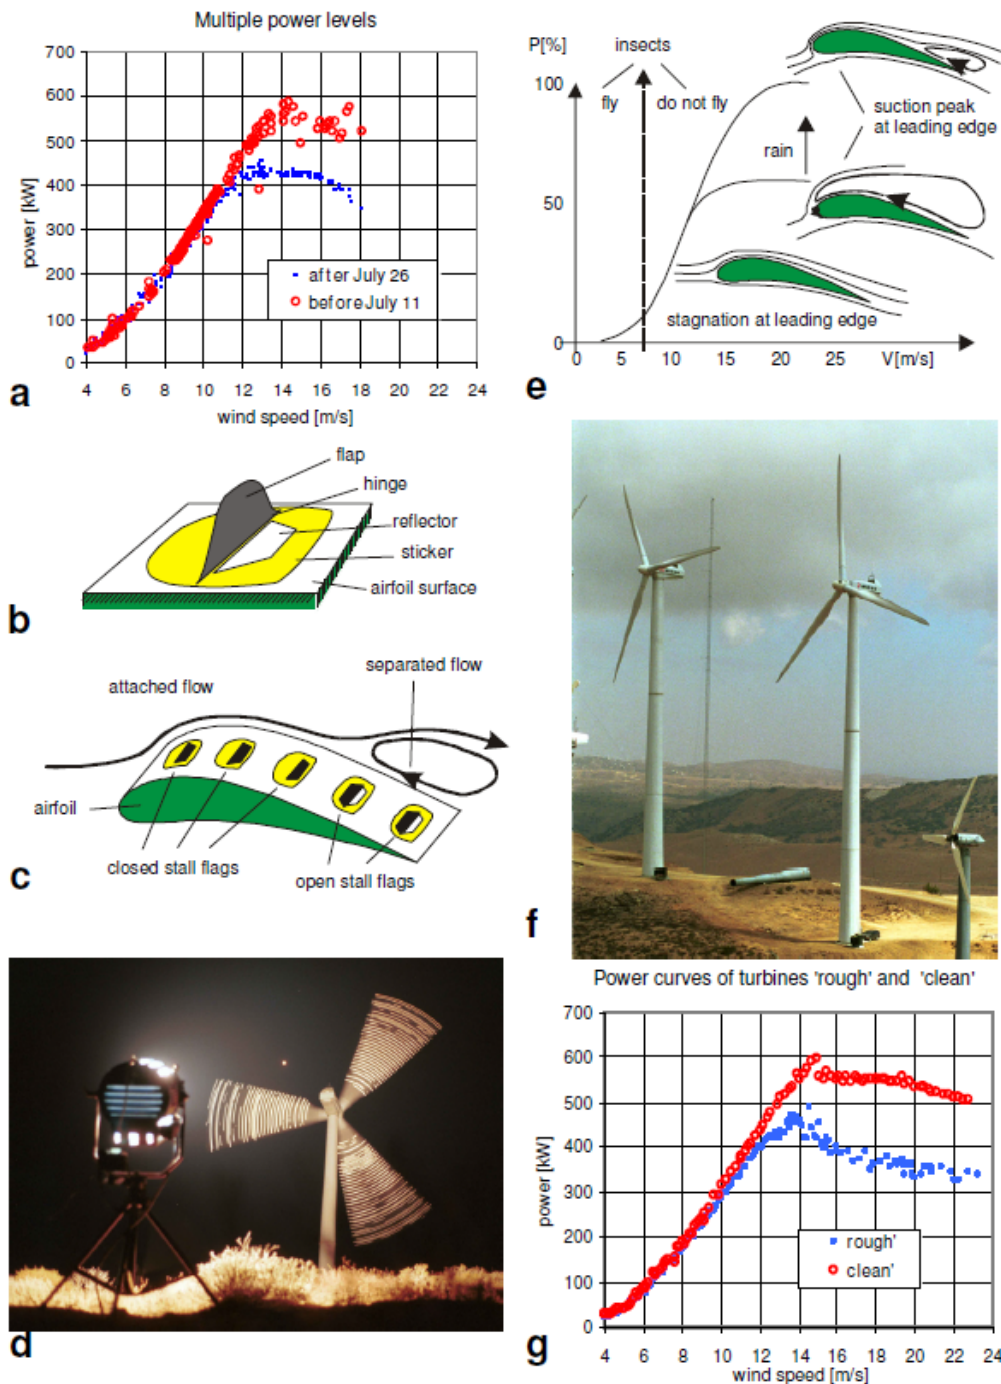
Figure 29 Insects cause multiple power levels from wind turbines. a, Example of two power levels at the same wind speed on different dates. b, The stall flag, consisting of a hinged flap and a reflector. c, Stall flags, showing the separated flow area on an aerofoil. d, Recording of stall flag signals from the NEG Micon turbine in California. The light tracks are produced by reflected light from open stall flags. e, Illustration of the insect hypothesis proposed to explain multiple power levels. f, The two turbines used for the validation of the insect hypothesis; these were only 50 m apart to ensure equal air inflow. g, The power curves for the two turbines with 'rough' and 'clean' blades, which are similar to those in a. [41]

caused by leading edge roughness were validated by an experimental testing using stall flagging to compare airflow over smooth blades with that over blades whose leading edges were artificially roughened (by installing a zigzag tape of maximum thickness of 1.15 mm), see Figure 29.

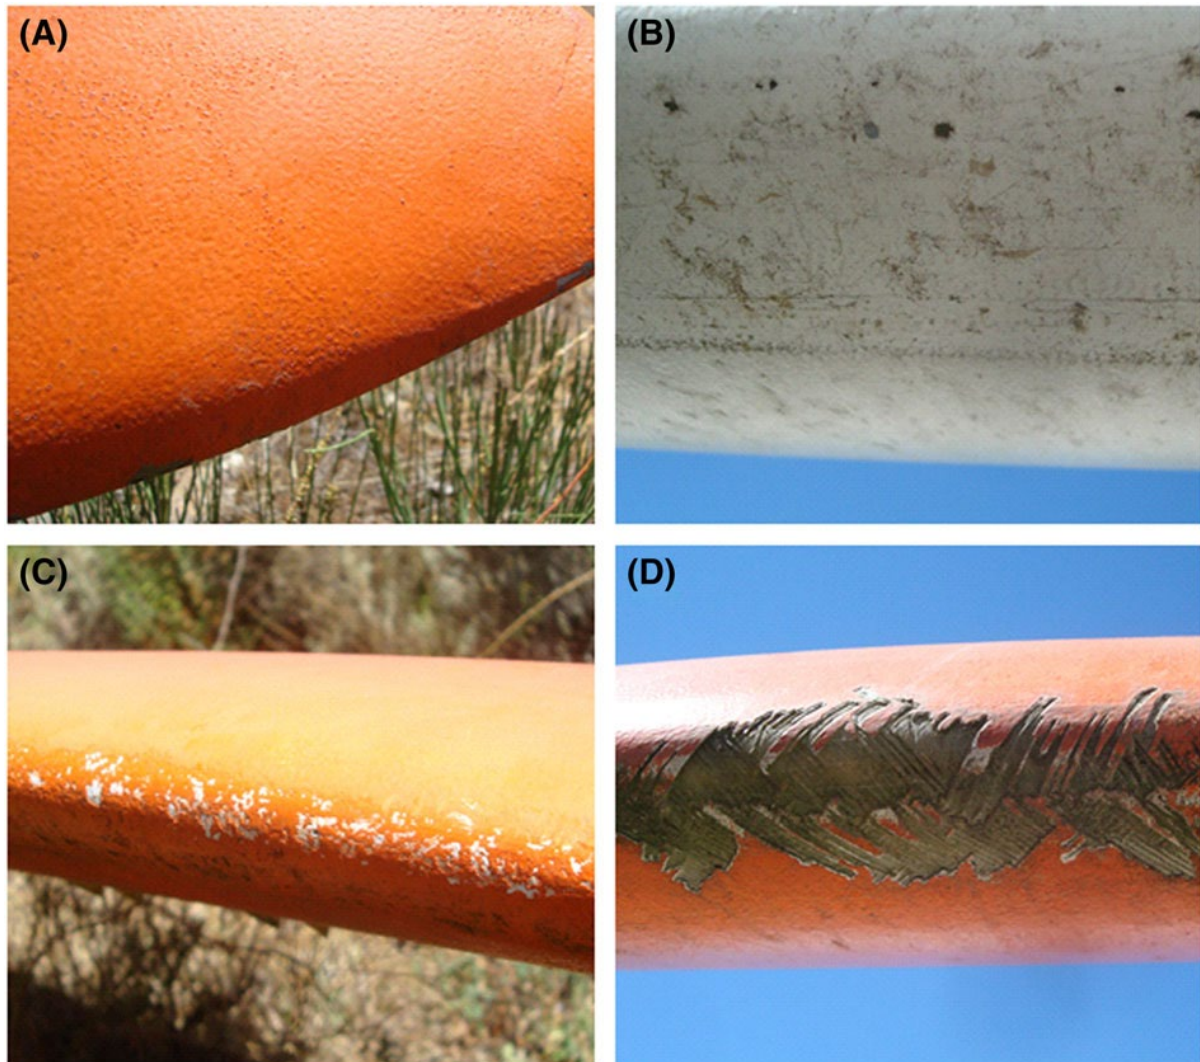
Figure 30 Progressive stages: A, pitting; B, cracking; C, cratering; and D, delamination, of the rain erosion on the leading edge of blades [160]

The water droplet erosion (WDE) process on wind turbine blades typically begins with the formation of small pits near the leading edge, which increase in density over time and combine to form cracks and then grooves. Eventually, the cluster of grooves develops into a failure of material integrity, causing delamination near the leading edge [152, 160], see Figure 30.

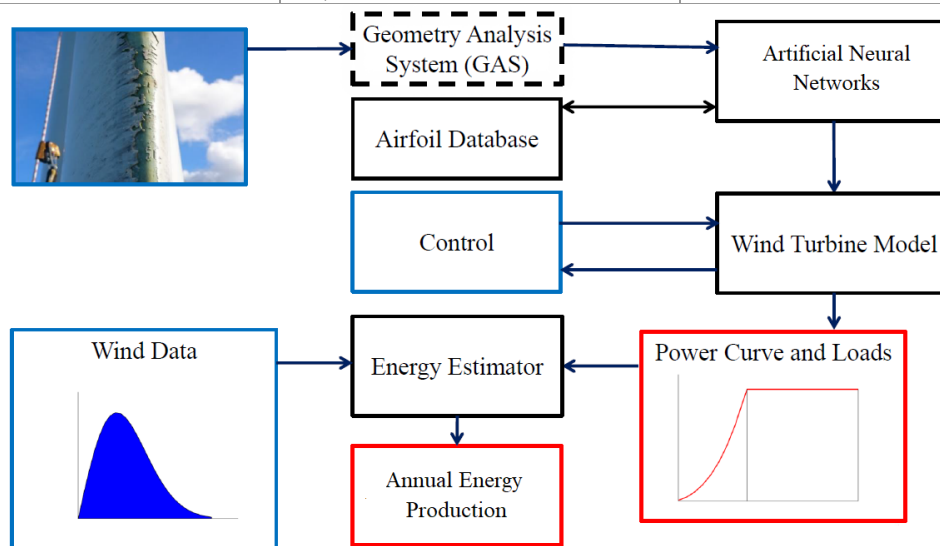
Figure 31 Adaptive control based on aerofoil force estimation of leading edge damaged blades [164].

Apart from protective strategies, other techniques such as protuberance leading edges [163] and employing artificial intelligence to adaptive control the performance impact from leading edge roughness are being developed recently. An example was given in Figure 31, that operation and maintenance could be optimized based on the geometry of damaged blades. A comparison between adaptive and standard control is given in Table 2.

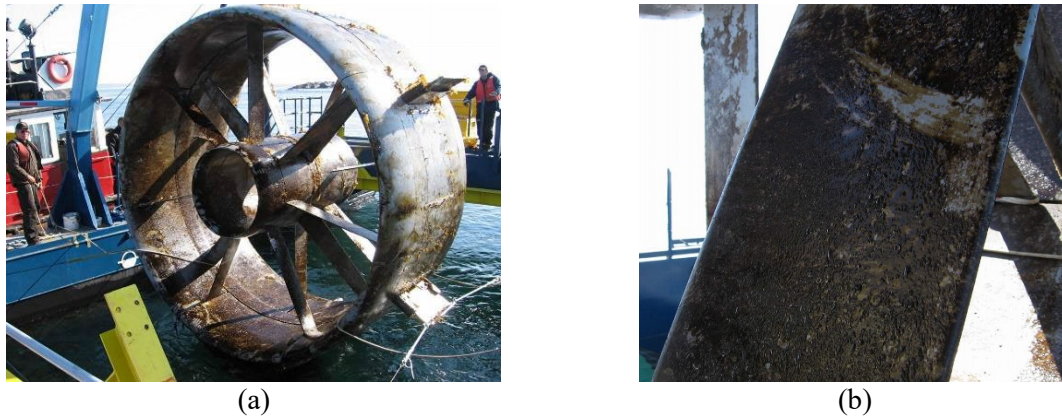
Figure 32 (a) Fouling after 6 month (b) Encrustations of diatoms or hydroids on blade (Clean Current Tidal Power Demonstration Project) [170, 174]
