# The Amintore Galli Theatre in Rimini: A Dataset of Building Simulation Tools for its Acoustic Design

The Amintore Galli theater in Rimini re-opened in 2018, after more than 60 years of inactivity. Its acoustics have been studied in depth, starting in 2009 until the re-opening of the theater. This paper analyses the following different steps of the acoustic design of the Opera House: the analysis of the acoustics of similar other theaters, the design of the acoustics of the new main hall, the analysis of the acoustic characteristics of the diffusing panels in the theater, and the acoustic design of other rooms, including the rehearsal room. Moreover, this paper reports some of the most relevant results of the acoustic surveys conducted after the re-opening, comparing the values of some acoustic parameters obtained after the simulation processes, and the values of the same parameters during the final validation of the theater.

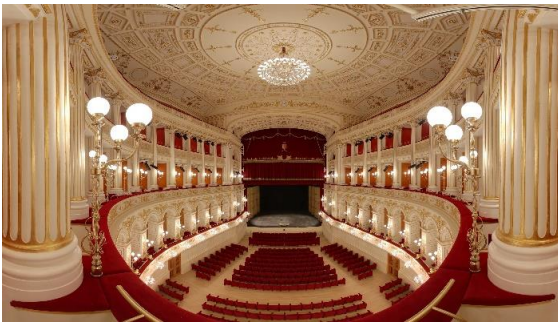
Fig. 1 – Internal view of the Galli theater of Rimini

The main hall of Galli theater could host more than 700 people. All these seats are distributed as 268 seats in the stalls, and 324 seats on the three orders of boxes and 108 seats in the gallery. The dimensions of the main axes of the horseshoe shape plan are 22 m and 16 m [L, W,], which are crowned by three orders of balconies, surmounted by a gallery having a capacity of 108 seats. The total height of the main hall is 20 m. The floor of the stalls is composed of oak planks, slightly inclined (2 %) towards the stage.

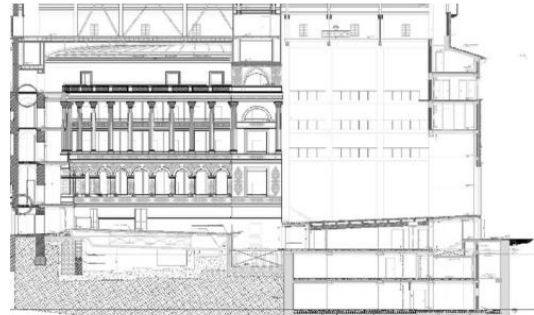
crowned by a three-order balcony, with a gallery at the top that can accommodate 108 seats. The floor of the stalls is slightly inclined towards the stage, composed of oak planks, as shown in Fig. 2.

Fig. 2 – Longitudinal section of Amintore Galli Theater

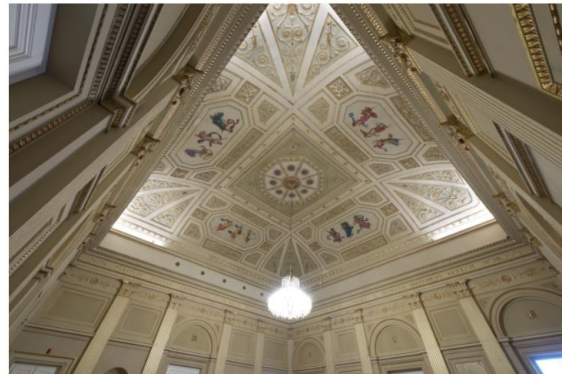
After a period of long repair, the main hall still retains the original historical appearance dominated by ivory and gold. The floor and ceiling have been reinforced, and the decorations and painting have been restored (Toyota, 2020), as shown in Fig. 3. Further, pomegranate red has been used on seats and for the upholstery of the boxes.

Fig. 3 – Reliefs have been restored

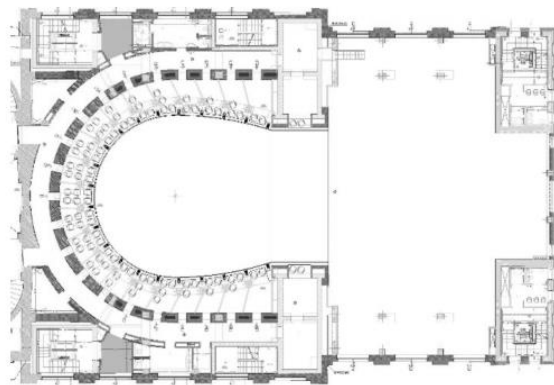
Fig. 4 – Plan layout of the main hall

The total area of the stage is 358 m<sup>2</sup> and the proscenium arch is 13 m large and 17 m high, the stage inclined by 2 %. The orchestra pit is 5.5 m deep and 12 m wide. Fig. 4 shows the horseshoe-shaped layout of the main hall.

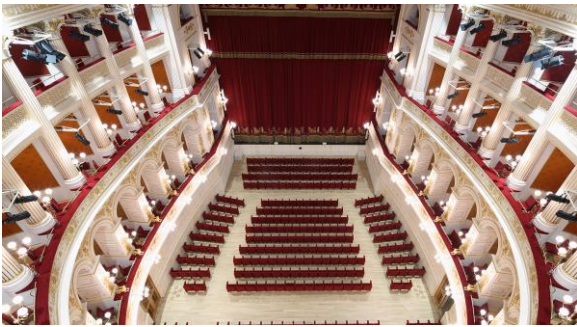
Fig. 5 – View of the main hall of Teatro Galli of Rimini

Elaborate decoration is installed all around the main hall, with floor finishings, seats, upholstery and the walls of the boxes. Having a pomegranate red color. Other dominant colors are ivory and gold, used on the wooden decorations.

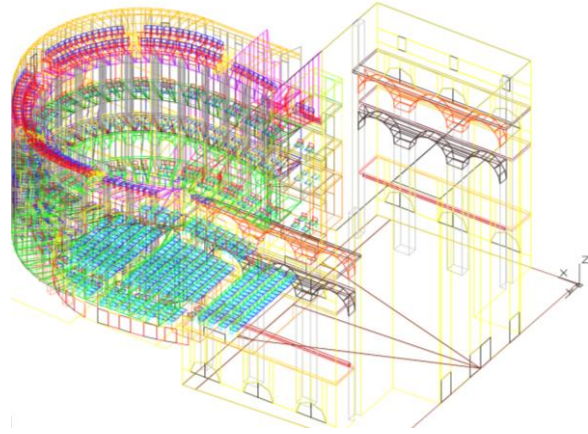
The acoustics of Teatro Galli have been studied since 2010, when a specific 3D model was created in order to determine the future sound distribution in the main hall. Fig. 6 reports the numeric model of the theater.

Fig. 6 – 3D numeric model of Teatro Galli

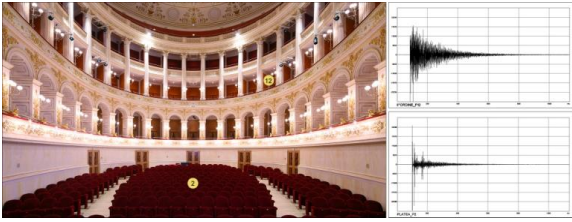
Fig. 8 reports a screenshot of two impulse responses, measured in the stalls and in the box.

Fig. 8 – Impulse responses measured in the stalls (n 2) and box (2nd order (n 12))

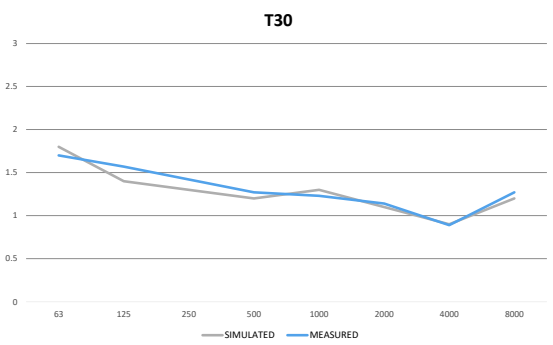
Fig. 9 reposts the comparison for reverberation time  $T_{30}$  obtained after reconstruction with the same parameter simulated in 2010.

Fig. 9 – Reverberation time measured after reconstruction compared with the values obtained during the acoustic design in 2010

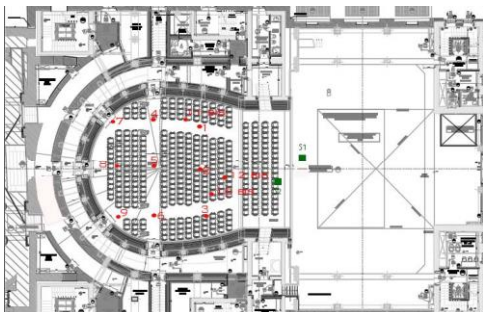
The sound source was located 1.4 m from the stage floor, while the receivers were positioned at a height of 1.2 m on stalls and boxes. The excitation signal emitted by the sound source was the Exponential Sine Sweep (ESS), having a duration of 15 s at a uniform sound pressure level for the between 40 Hz and 20 kHz range. The measurements were undertaken in unoccupied conditions and without any scenery or acoustic chamber mounted. Fig. 10 and Fig. 11 show the measurement positions of sound source and receivers placed across the sitting areas.

Fig. 10 – Scheme of the equipment location during the acoustic measurements in the stalls of Teatro Galli of Rimini

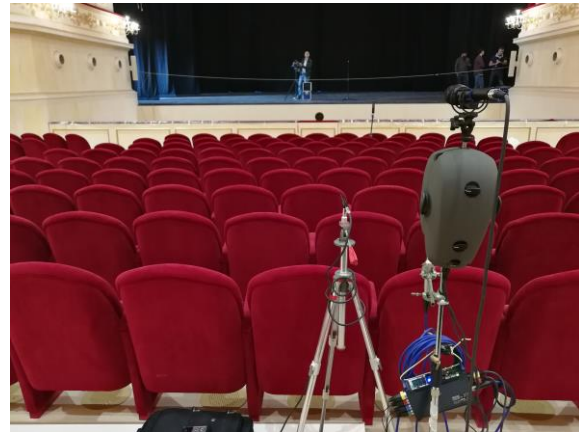
Fig. 11 – One of the surveys conducted in Teatro Galli in Rimini

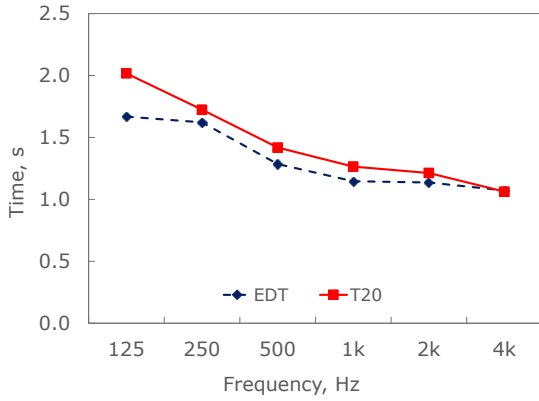
Fig. 12 and Fig. 14 show the graphs of the measurements of the main acoustic parameters. Fig. 13 shows the frequency response of the EDT and  $T_{20}$  parameters. If optimal values of EDT for concert halls are considered to range between 1.8 and 2.6 s, as defined by the literature, this target was not achieved by the measured values related to the selected bandwidth. However, if compared with several other opera houses, the results for Teatro Galli are much better than the others.

Fig. 12 – Measured results of clarity indexes (C50 and C80)

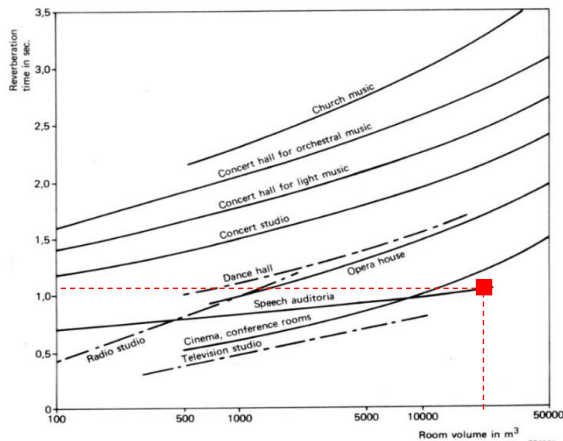
Fig. 13 – Optimum reverberation time values in function of room volume

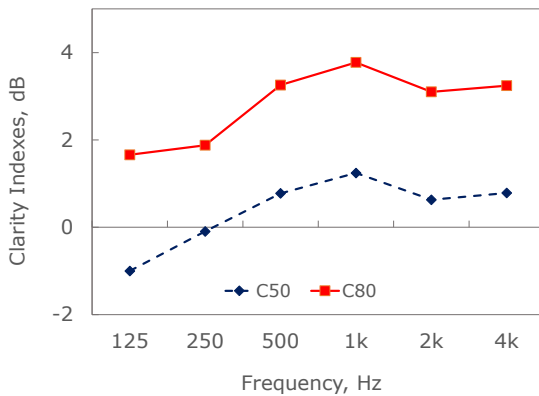
Fig. 14 – Measured results of clarity indexes (C50 and C80)

Following the research studies by Reichardt, the optimum values for the speech clarity index ( $C_{50}$ ) would be  $\geq 0$  dB. In Teatro Galli, this parameter floats between +1 and +4 dB, at low and high frequency bands, respectively. Based on the results of Fig. 14, the good response of  $C_{50}$  was achieved at frequencies higher than 500 Hz. However, the shortfall at low frequencies found to be slightly

below the lowest range limit is not to be interpreted as a negative result.

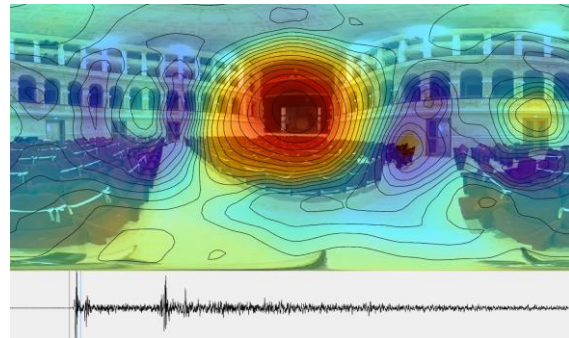
The colors shown in the map overlay range between red tinge (indicating the high level of sound energy) and blue-violet shades (representing a poor energy sound wave). Fig. 15 shows an illustration of the outcomes.

Fig. 15 – Acoustic map showing direct sound arriving to the receiver placed in the stalls

Fig. 15 shows the late reflections hitting the ceiling surface area. As per the above discussion, the overlay videoclip allows the surface areas that contribute toward creating the early and late reflections to be visualized. The bar at the bottom of the image indicates the flow time of the IR.
