**FAILURE MECHANISMS FOR SMALL
DIAMETER CAST IRON WATER PIPES**

Phillipa Jane O'Shea

**A THESIS SUBMITTED FOR THE DEGREE OF DOCTOR OF
PHILOSOPHY**

AUGUST, 2000

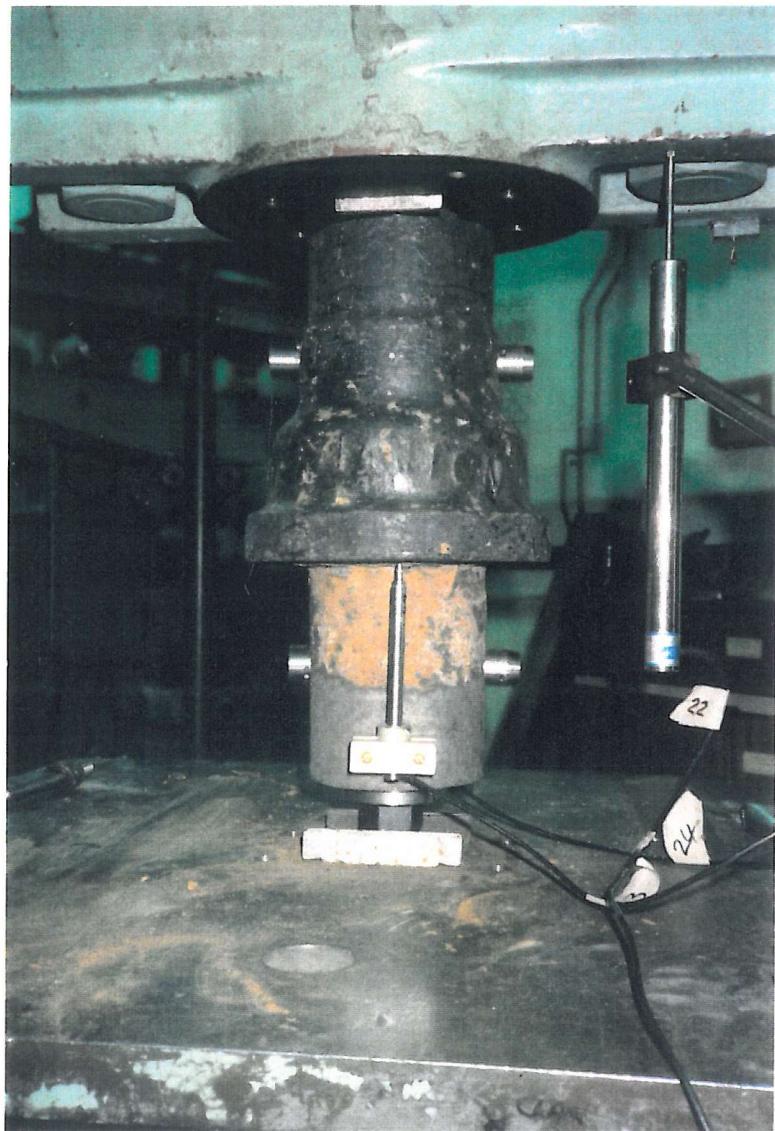
Figure 3.12: Photo of Embelton Road Joint#2 showing set up of LVDTs in screw loading rig.

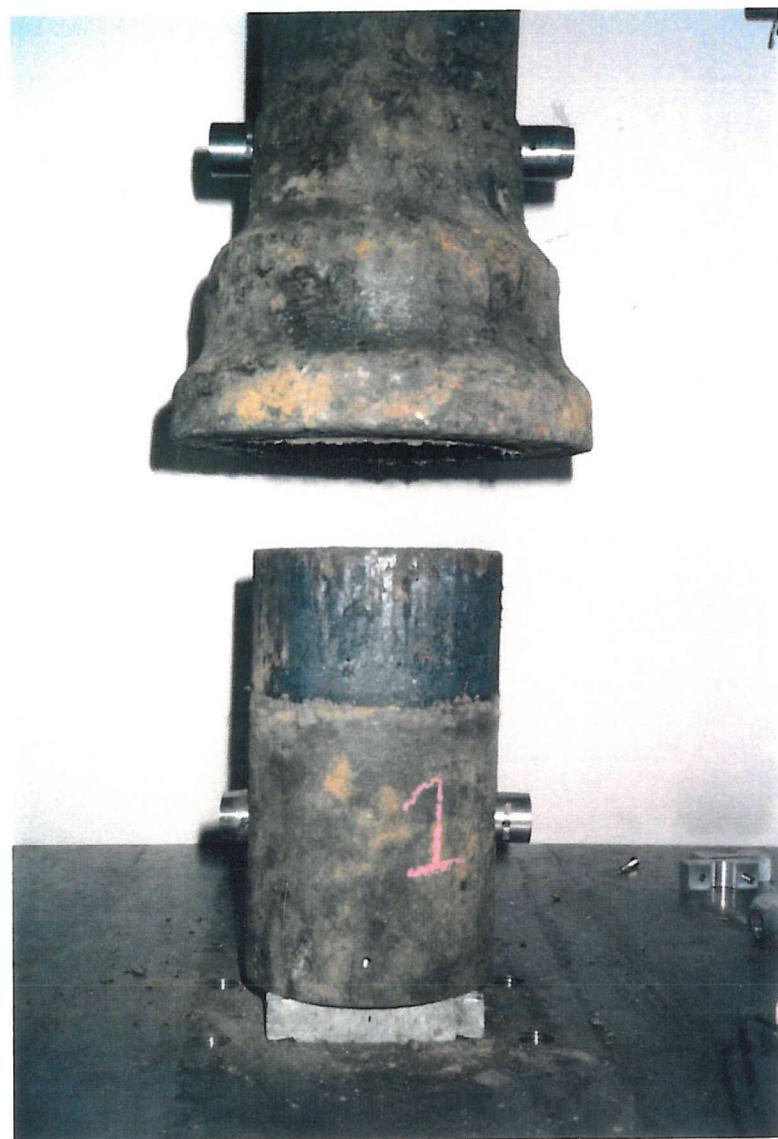
Figure 3.14: Photo of Embelton Road Joint#7 showing displacement of spigot from bell.

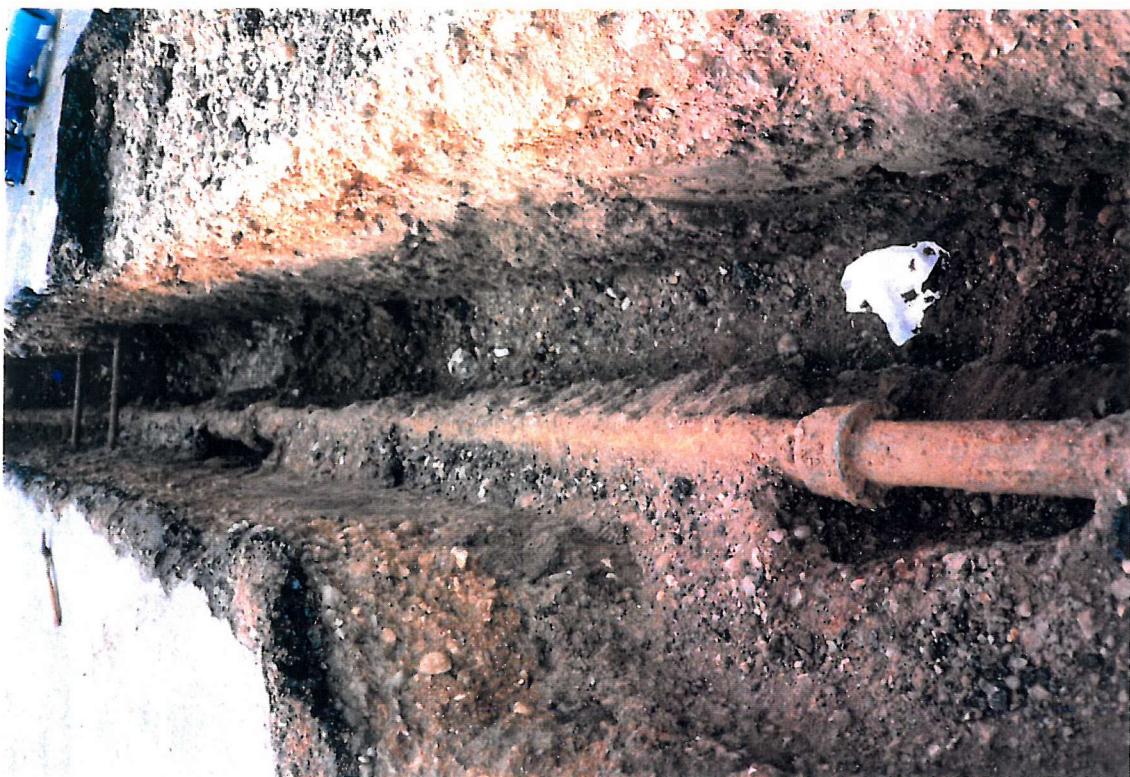
On 29th July 1998, a trench along the axis of the pipe was excavated (Figure 1). In the morning of 30th July, the mains supply through the pipe was interrupted and a section of approximately 10 metres of the pipe was removed. Samples of the pipe, joints and soil were taken. A new section of MDPE pipe was then fitted between the remaining iron main (Figure 2), permitting resumption of water supply. The site work was carried out by Total Pipeline Solutions, which is a subsidiary of Thames Water.

Figure 1 View of excavated trench, from north

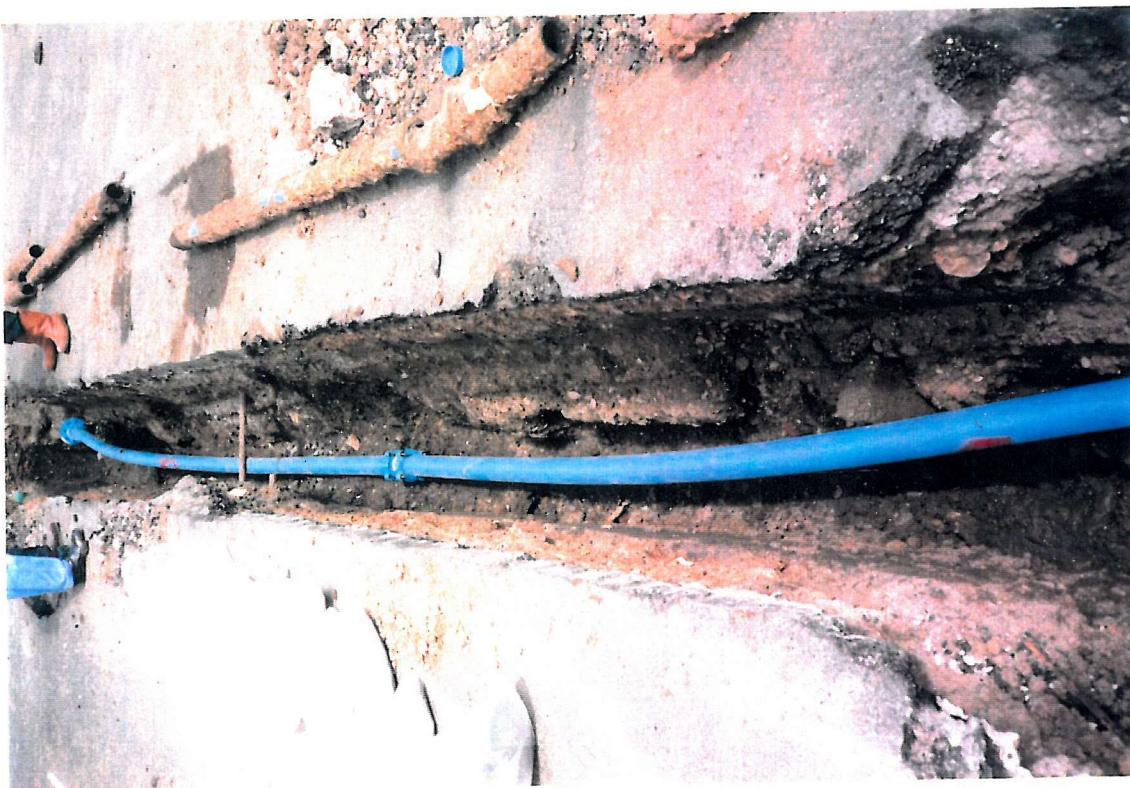
Figure 2 View of replaced pipe

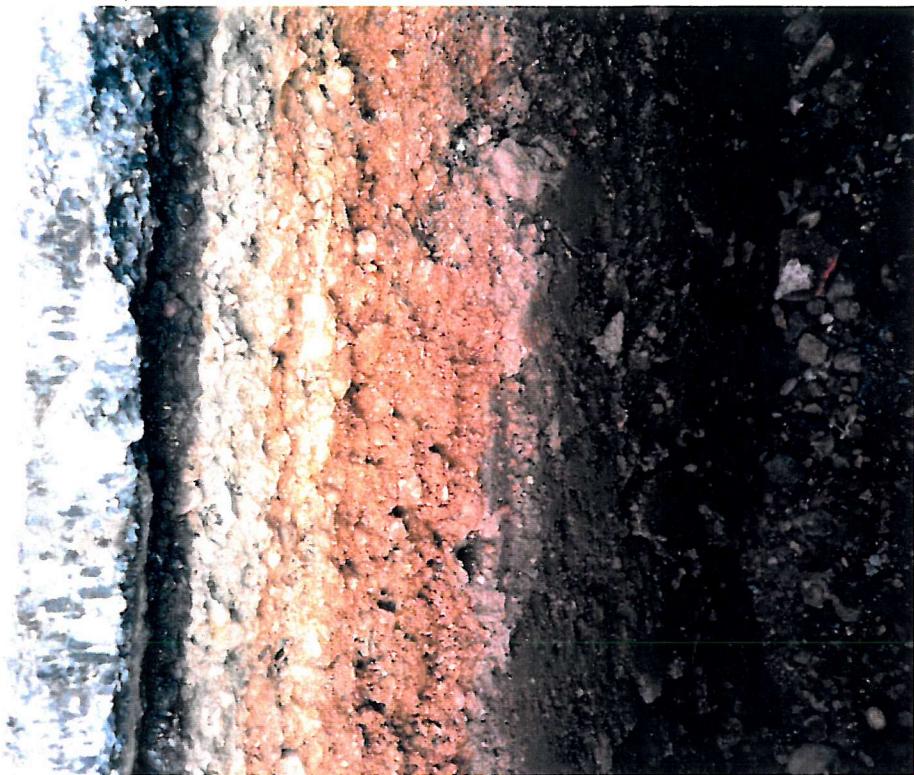
The invert of the pipe was 0.76 to 0.80 m below the road surface. The asphalt was 10 cm thick and was underlain by 25-26 cm thickness of sub-base (Figure 4). The pipe was laid in made ground. (Disturbed, bag samples of the material have been acquired.) Two small diameter pipes crossed the pipe transversely, about 20 cm above crown level, at 4 and 4.6 m, respectively, from the south end of the trench (Figure 5). There were two disconnected tapped ferrules and two plugged ferrules (see Figure 5) in the midsection of the pipe (between 3.8 and 6.3 m from the south end). At the north end of the trench, two conduits for cable utilities had been installed in a backfilled trench (Figure 6). The base of the cable trench was 10-15 cm above the level of the pipe crown. A patch repair to the road surface in the vicinity of the ferrules and transverse pipes (Figure 7), had been backfilled with Type 1 backfill and pea gravel.

Figure 4 Side wall of trench, showing asphalt, road sub-base layer and pipe backfill

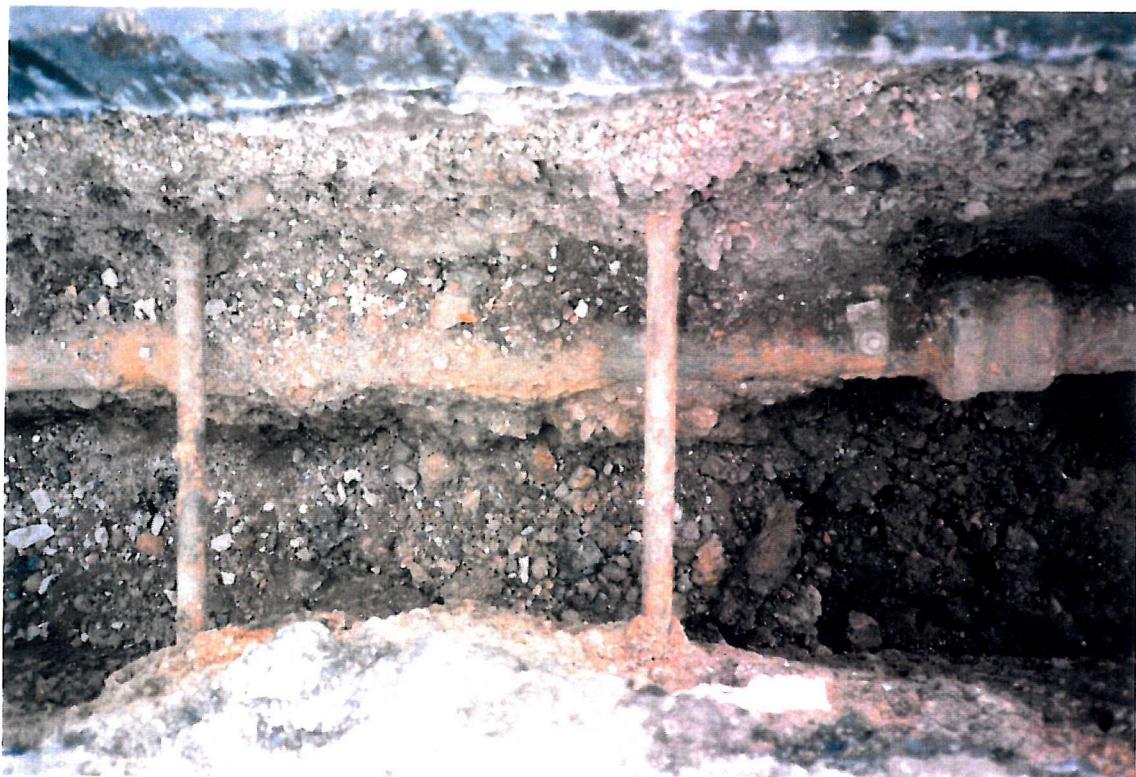
Figure 5 Small diameter pipes crossing path of 3" pipe; also Joint C and capped ferrules.

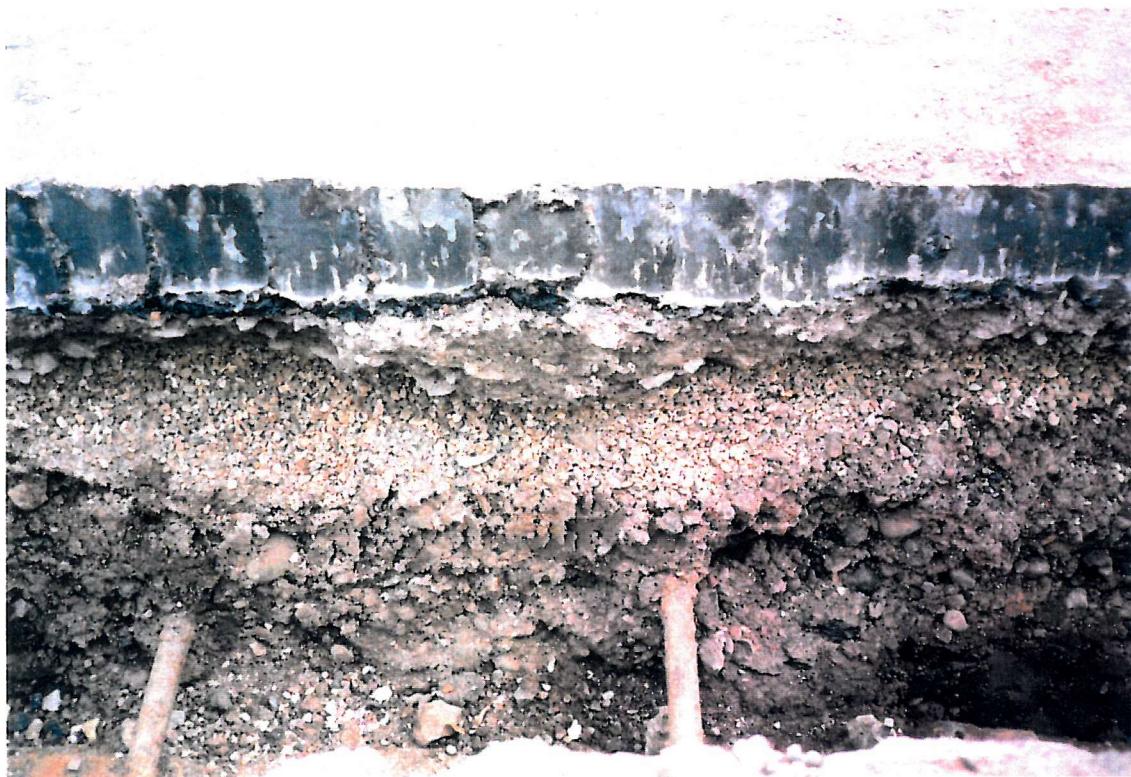
Figure 7 Patch repair, showing pea gravel

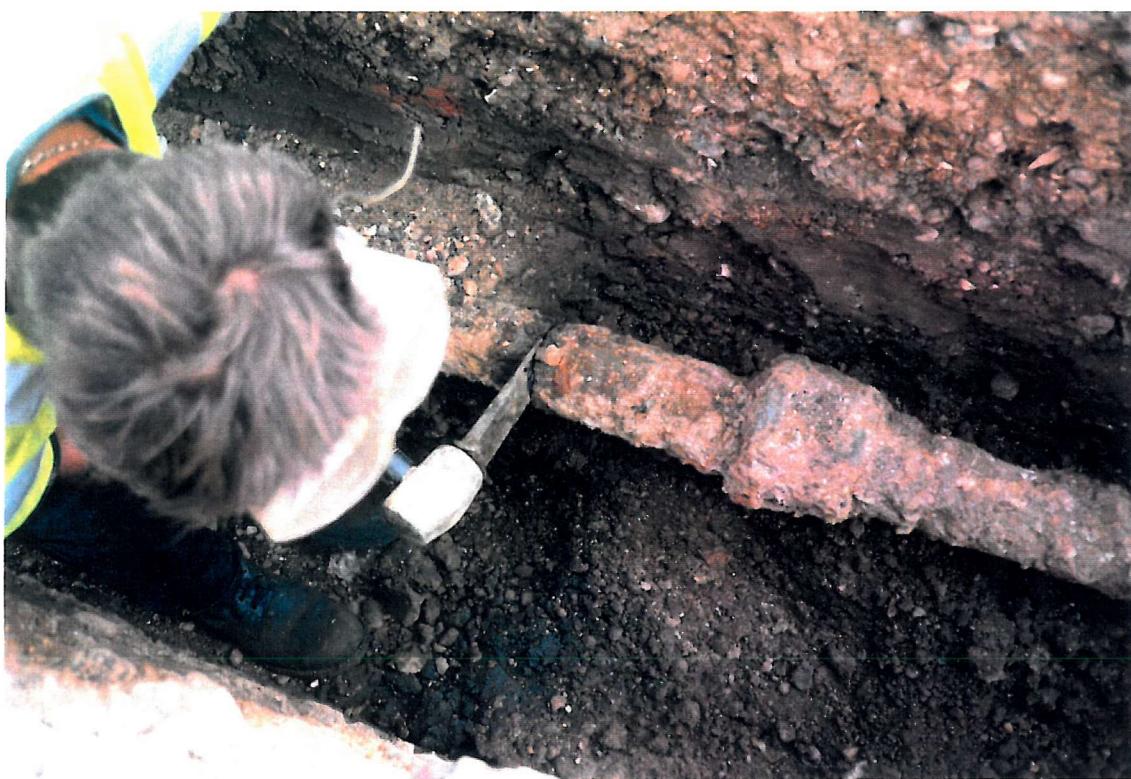
The pipe was detached from the network in three parts. The pipe segments were removed by cutting a slot through the pipe and by hammering a wedge into the slot (Figure 8).

Figure 8 Use of wedge in removal of pipe segments

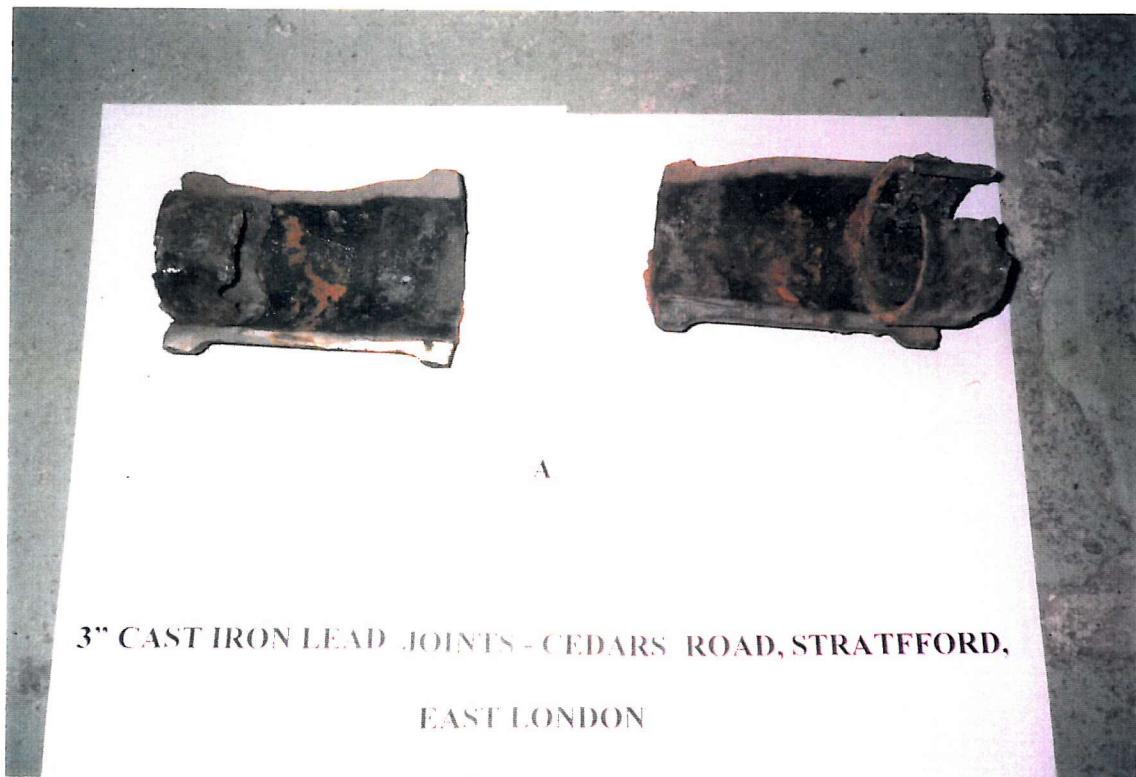
Figure 9 Joint A

Joint A (24 cm long), between southernmost unexhumed pipe and pipe section 4 (Figure 9)

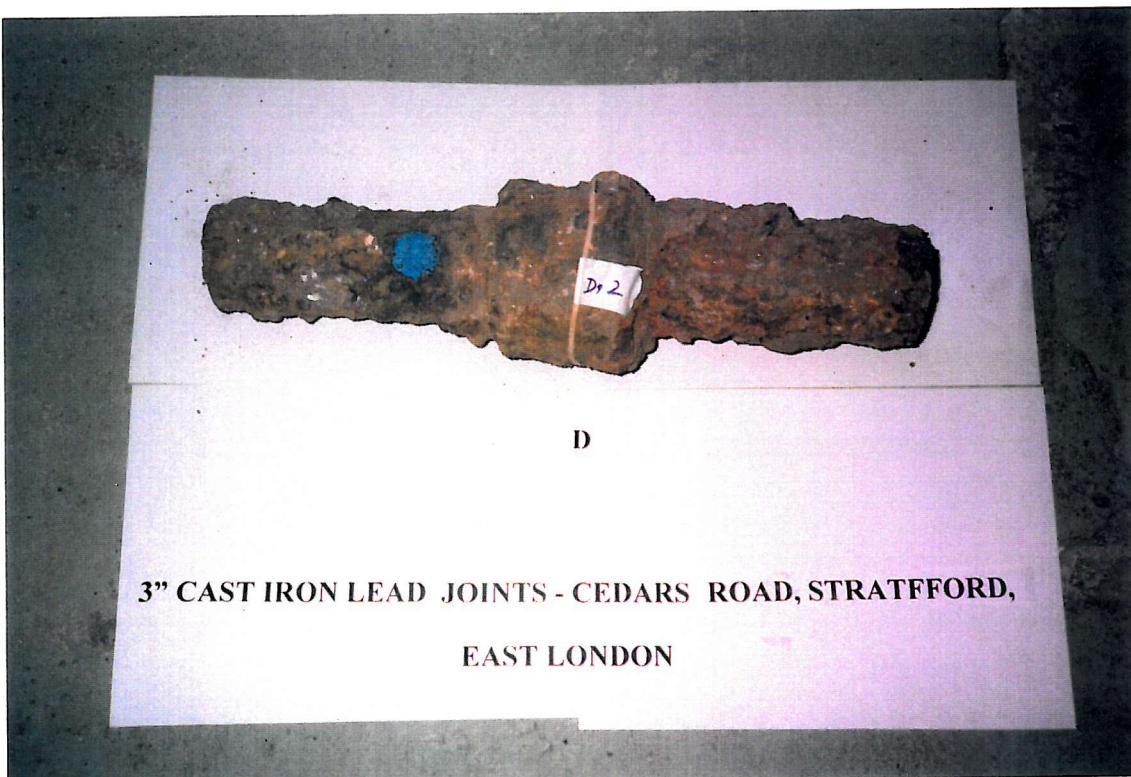
Figure 11 Joint D

Joint D (12 cm), between pipe sections 1 and 2 (Figure 11)

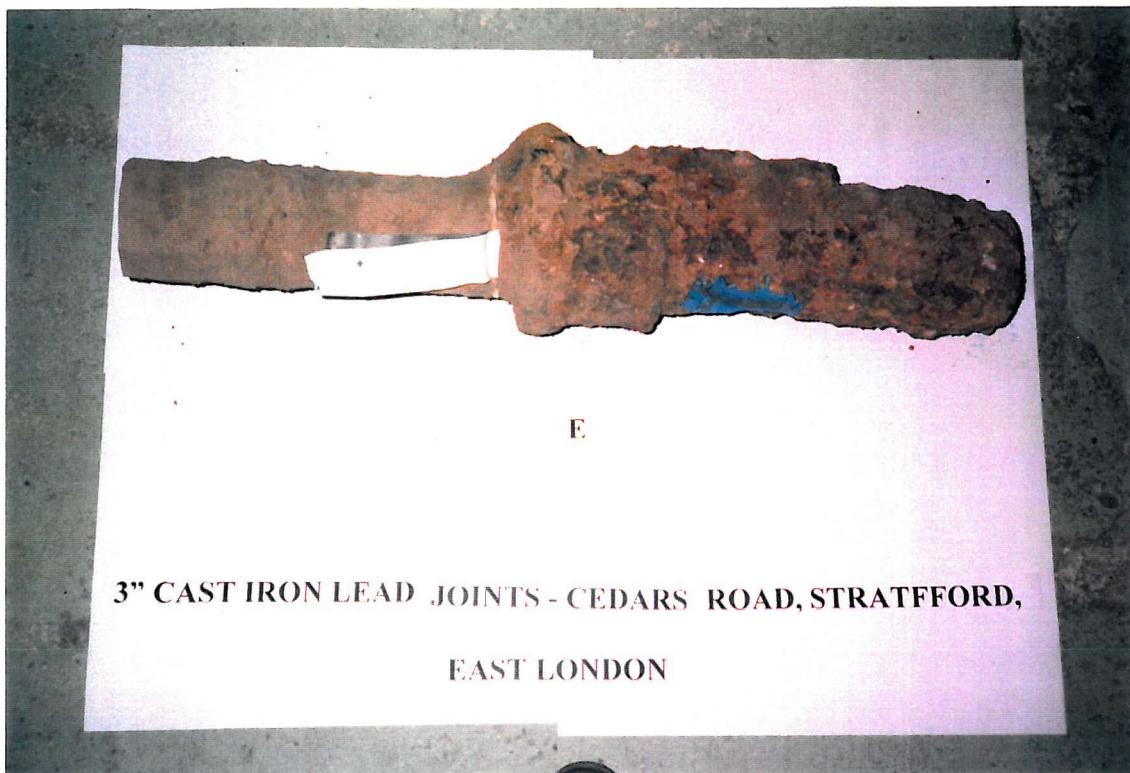
Figure 12 Joint E

Joint E (12 cm), between the northernmost unexhumed pipe and pipe section 1 (Figure 12)

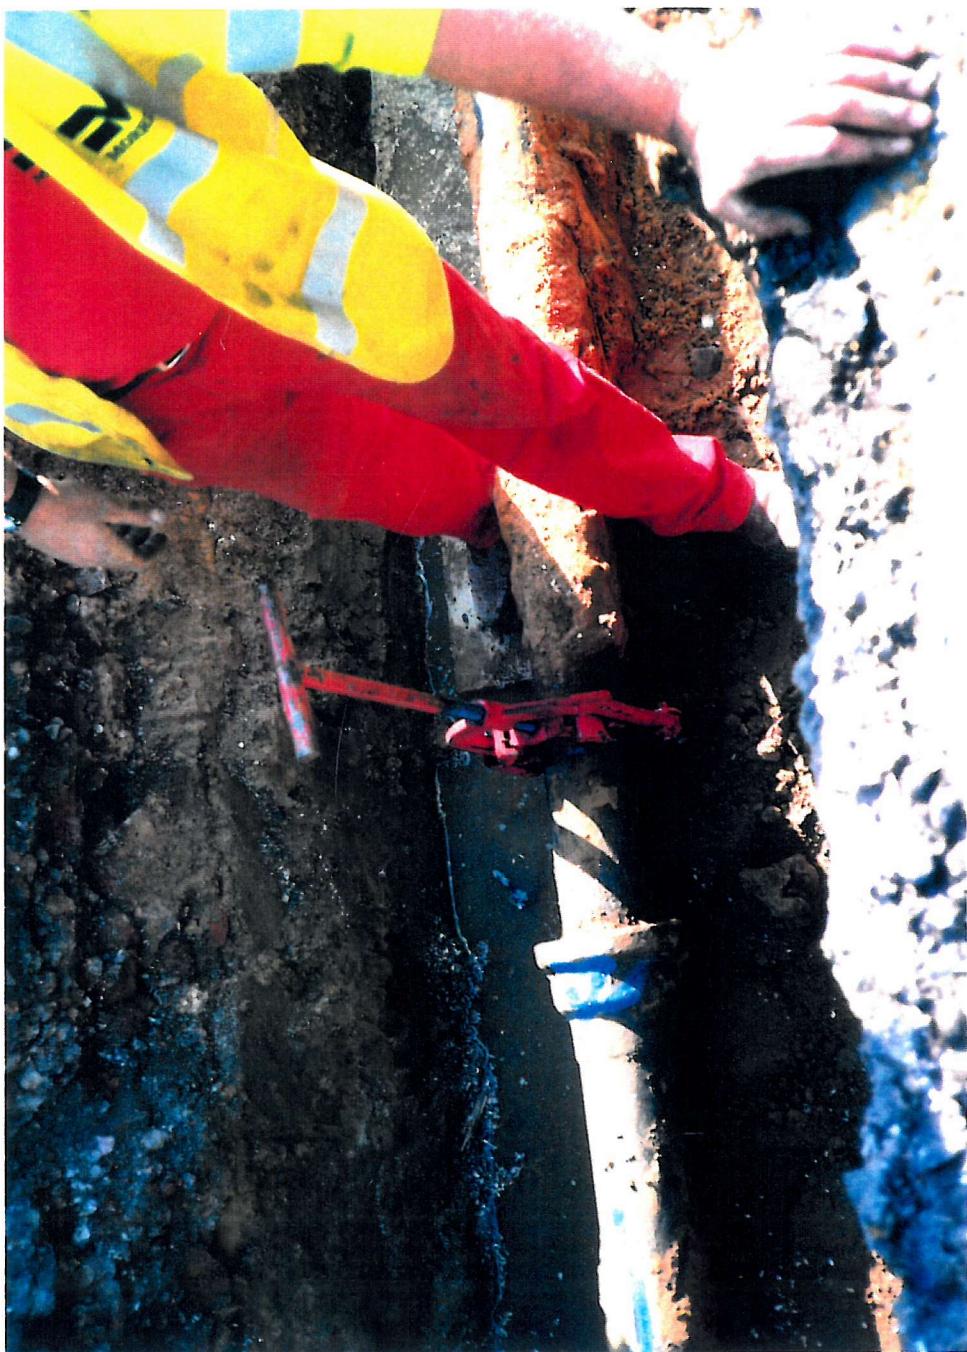
Figure 3 Use of pipe cutter in removal of pipe segments

The pipe was detached from the network in seven parts. One pipe segment was removed using a pipe cutter, to prevent the joint from experiencing excessive stress (Figure 3). One of the blades of the pipe cutter failed and therefore the rest of the pipe segments had to be removed by cutting a slot through the pipe with a disc cutter and hammering a wedge into the slot (Figure 4).

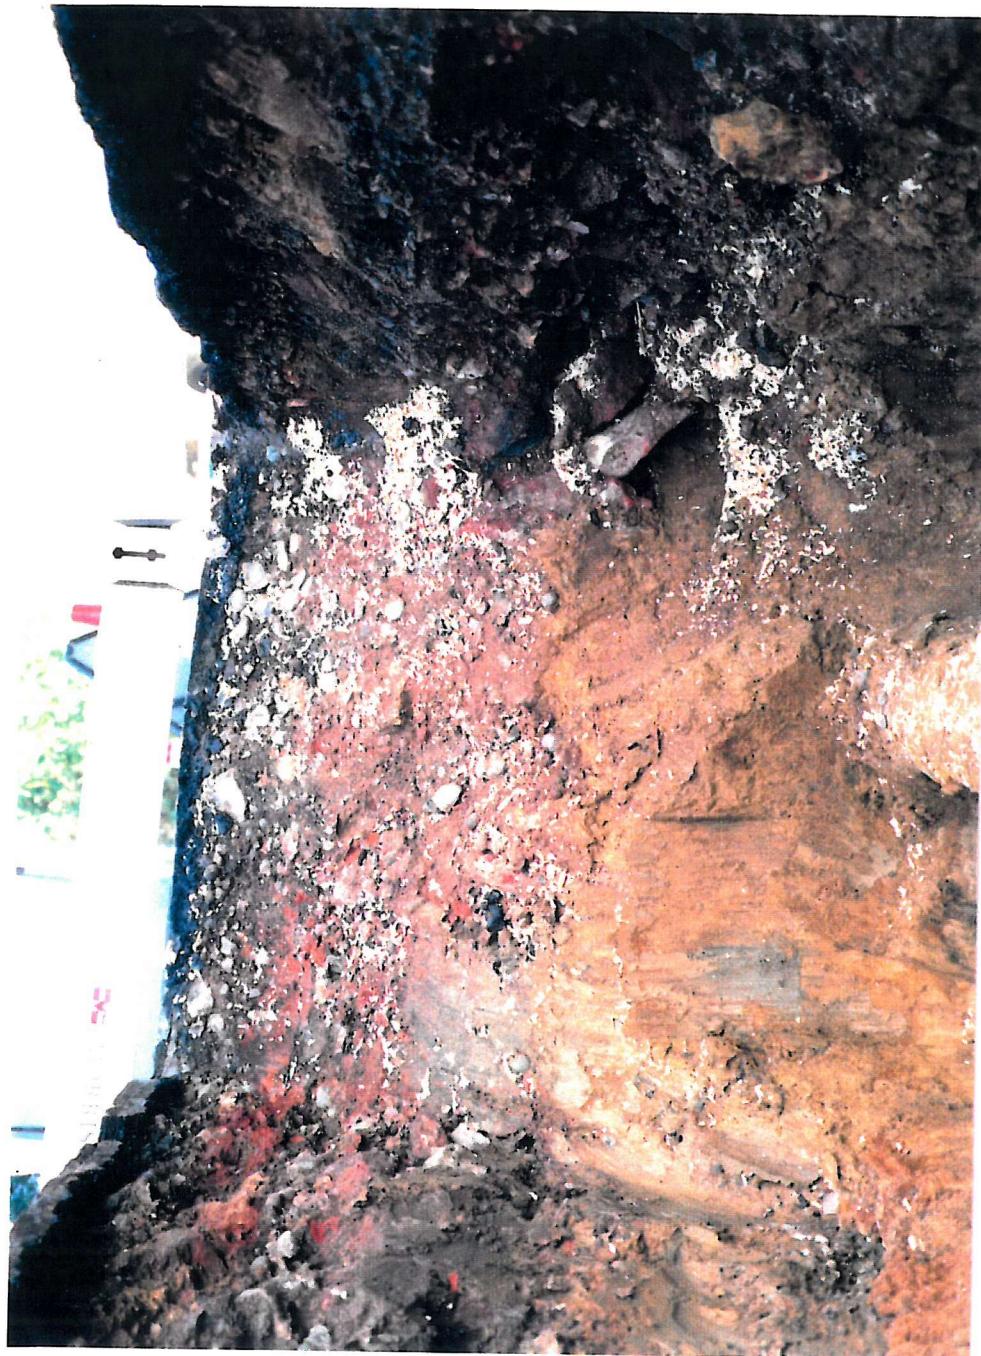
(Disturbed, bag samples of the material have been acquired). At the north end of the trench (from between joints 5 and 6) the asphalt was 5 cm thick and was underlain by 30 cm sub-base underlain by sand (Figure 12). (Disturbed, bag samples of the material have been acquired).

Figure 12 North end of trench, showing asphalt, sub-base and pipe backfill (sand)

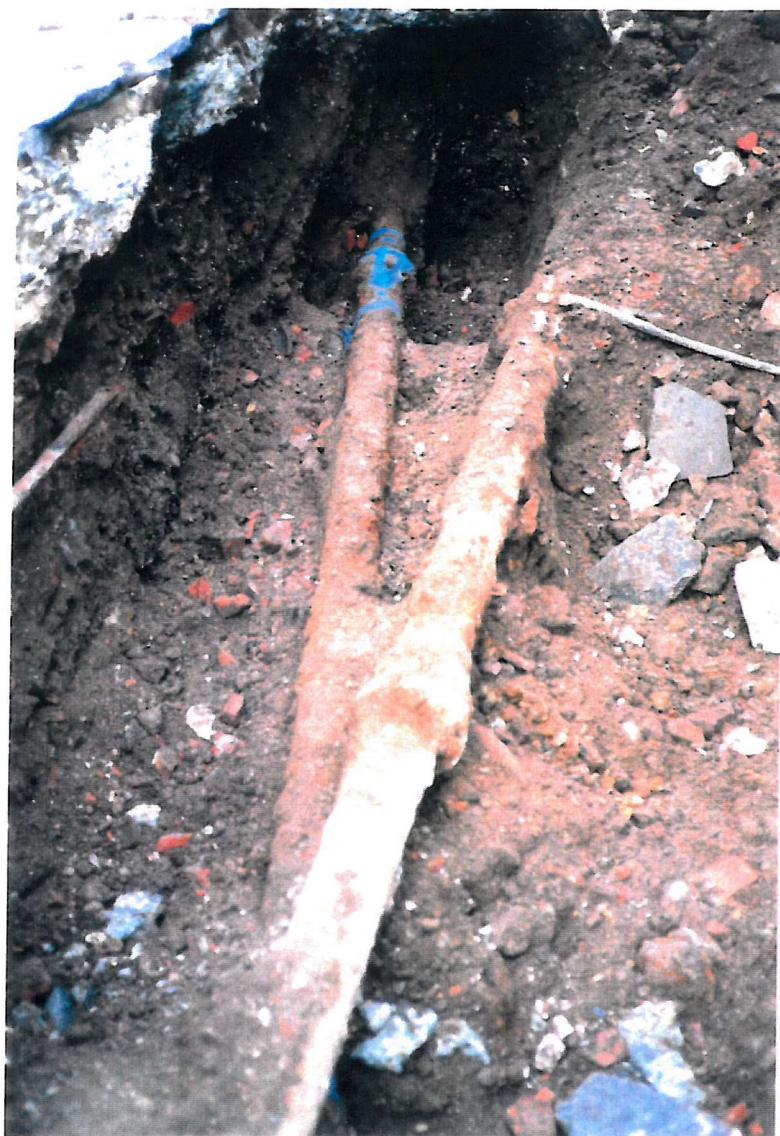
A section of Theed/Roupell Street was fenced off to replace the existing cast iron pipe with MDPE pipe, as this area was thought to have previous failure history. On 2nd December 1998, a trench (A) along the axis of the pipe was excavated (Figure 1). In the morning of the 2nd December, the mains supply through the pipe was interrupted and a section of approximately 10m of the pipe was removed (3 inch diameter cast iron pipe from Theed Street). Samples of the pipe, joints and soil were taken. A new section of MDPE pipe was then fitted between the remaining iron main permitting resumption of water supply. The site work was carried out by Morrisons.

Figure 1 View of excavated trench, from north end
